2 Coral Way

Electrical Safety Inspection
Project No.: S4210.01
Issued Date: June 4, 2025

Structural Safety Inspection
Project No.: S4210.01
Issued Date: March 24, 2025

Intertek understands that the City of Coral Gables sent a Notice of Hearing to the owner concerning the 25-year recertification of the building structure. This letter addresses your concern raised in the NOTICE OF UNSAFE STRUCTURE VIOLATION FOR FAILURE TO RECERTIFY AND NOTICE OF HEARING dated February 28, 2025.

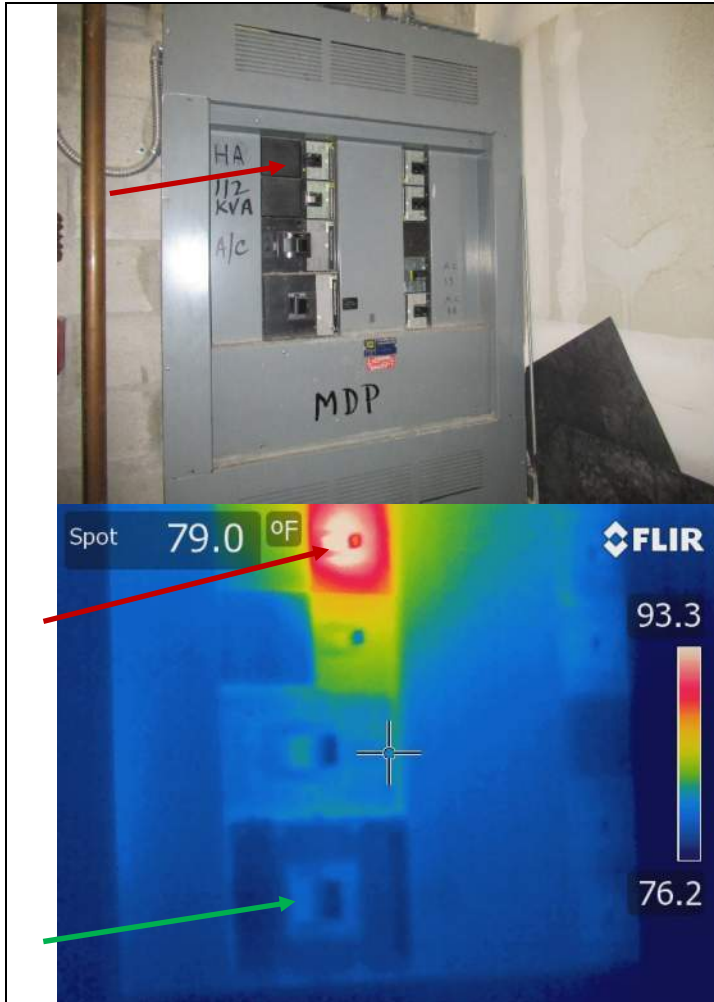
Photograph No. 3.

The MDP panel with thermal picture of the HA circuit breaker (red arrow) at an operational temperature of 93.3 degrees.

The 600-amp service entrance circuit breaker (green arrow) is running ambient temperature of 78 degrees.

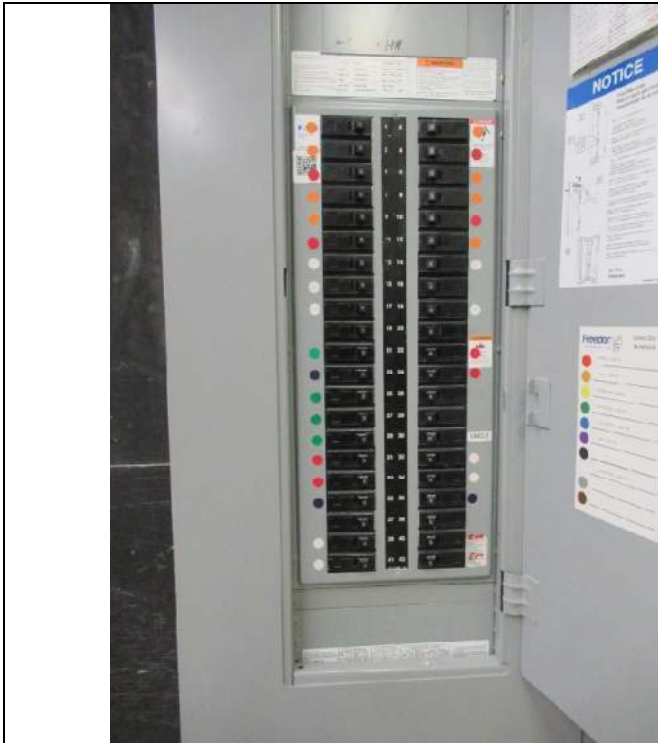
Photograph No. 4.

The HA subpanel is powered by the MDP.

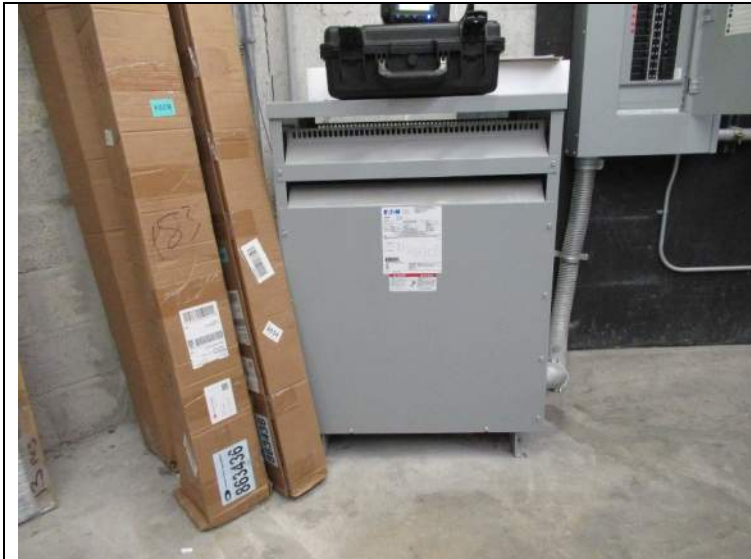
Photograph No. 6.

The transformer is powered by the MDP.

The 75 kva transformer stepping down 480Y277 to 208Y120 volts operating at 83.5 degrees vent temperature.

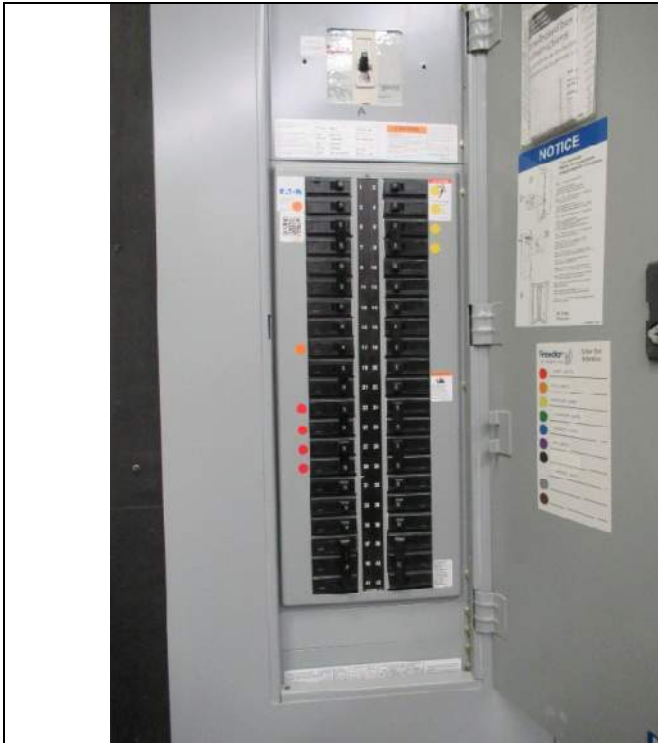
Photograph No. 7.

The LA subpanel is powered from the MDP to the 75 kva transformer.

The LA 208Y120 sub-panel with maximum temperature at 82.5 degrees.

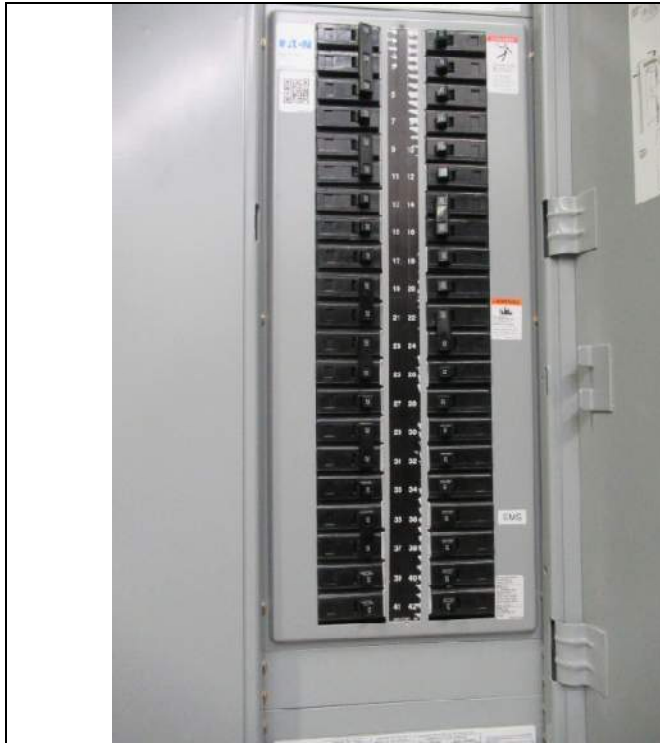
Photograph No. 8.

The LB subpanel is powered by the LA subpanel CB 38, 40, 42.

The LB 208Y120 sub-panel with maximum temperature at 82.4 degrees. The LB panel is supplied by the LA panels (CB 38, 40, & 42).

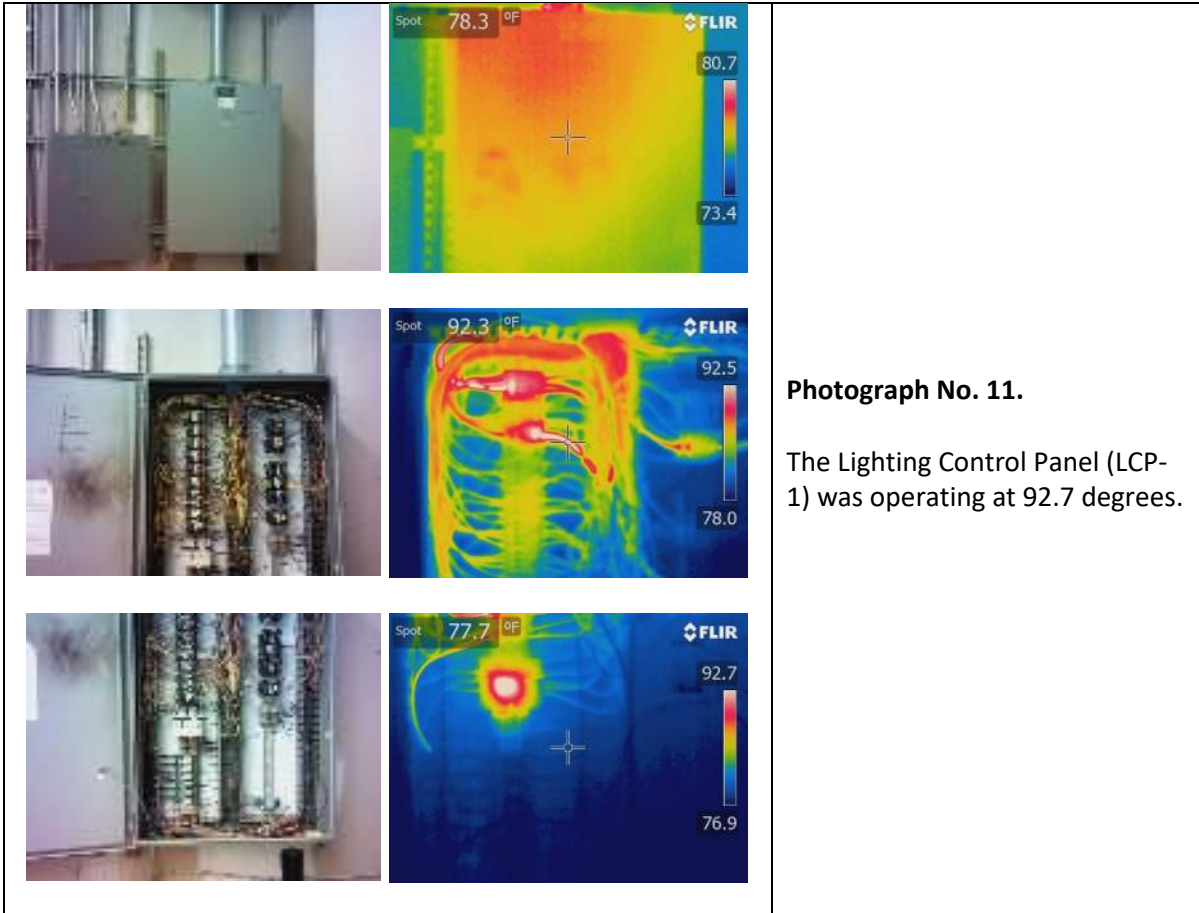
Photograph No. 11.

The Lighting Control Panel (LCP-1) was operating at 92.7 degrees.

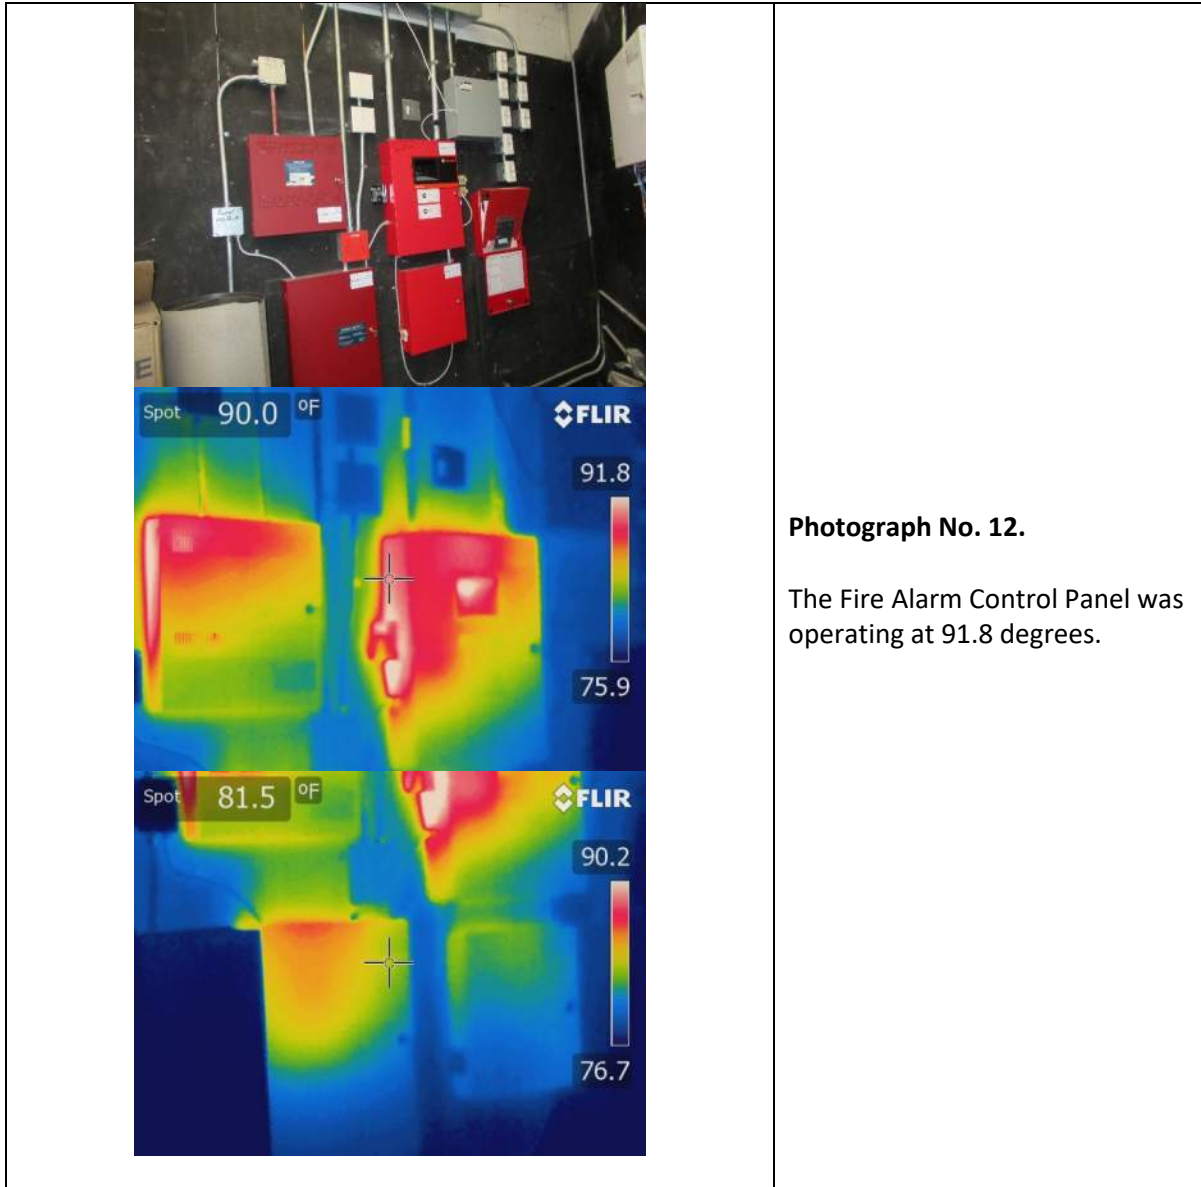
Photograph No. 12.

The Fire Alarm Control Panel was operating at 91.8 degrees.

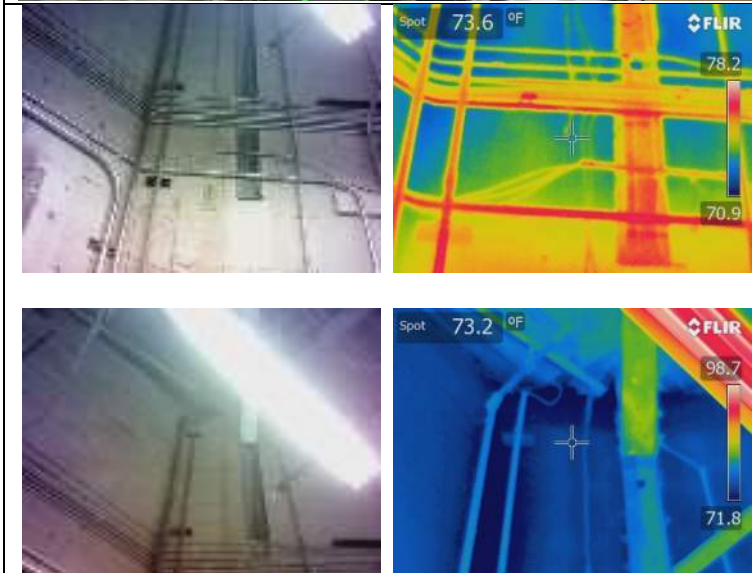
Photograph No. 14.

The EMT conduit temperatures agreed with the room's temperature.

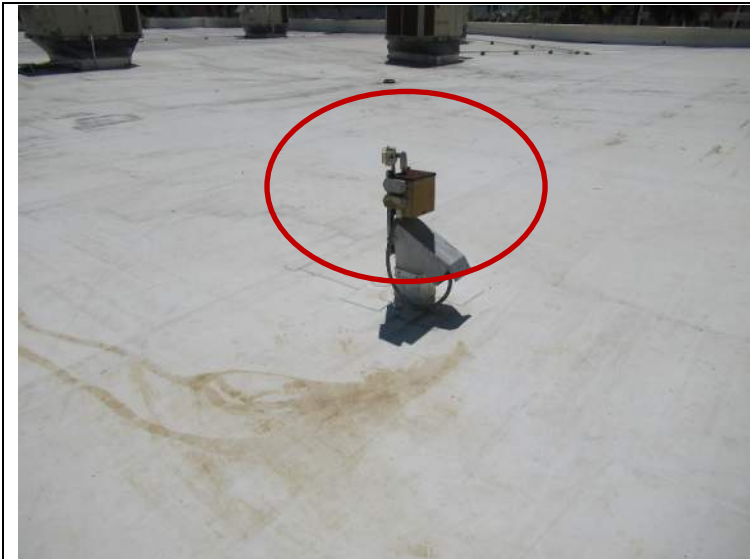
Photograph No. 15.

The store's lighting control sensors were located on the roof and observed in good condition.

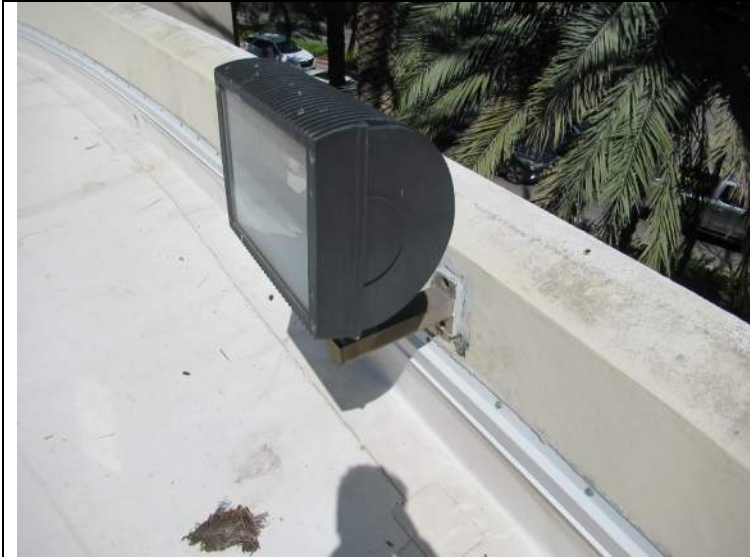
Photograph No. 19.

The roof top illumination lights were observed in good condition.

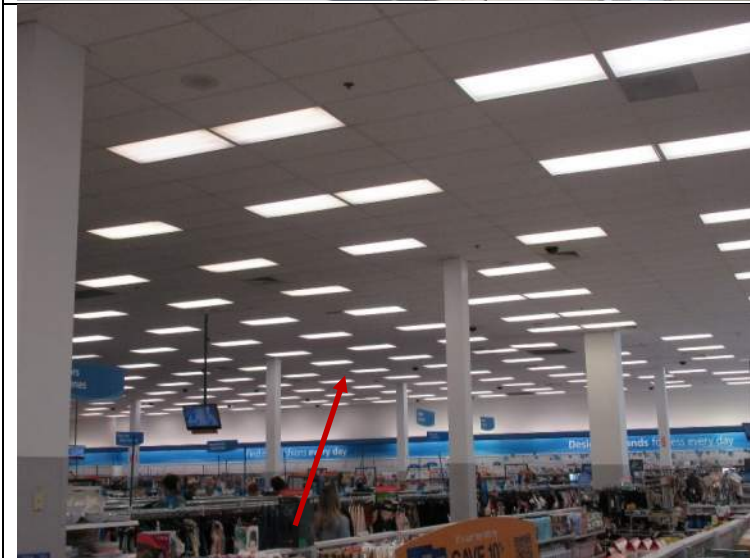
Photograph No. 20.

Fire alarm ceiling strobe/annunciator observed in good condition.

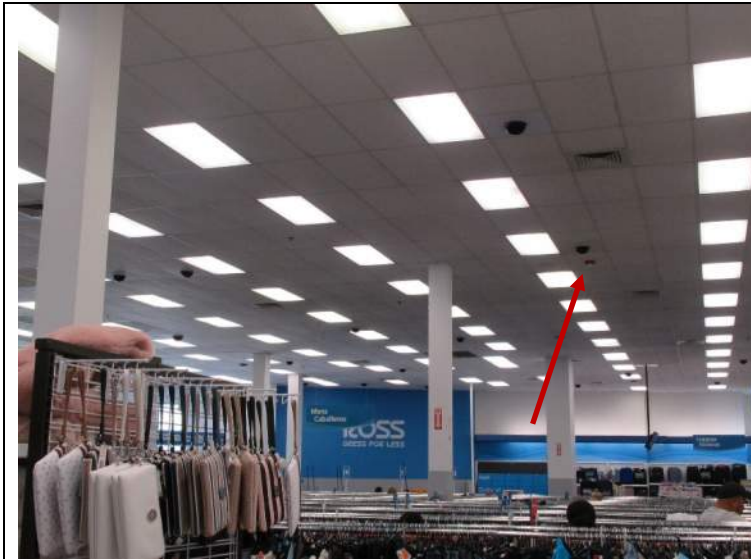
Photograph No. 21.

Fire alarm ceiling strobe/annunciator observed in good condition.

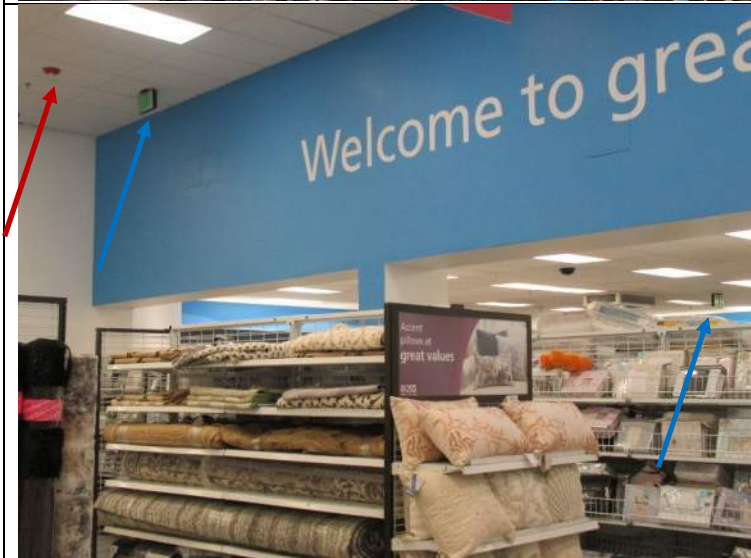
Photograph No. 22.

Fire alarm ceiling sensor/strobe/annunciator (red arrow) observed in good condition. Egress lighting (blue arrow) observed in good condition.

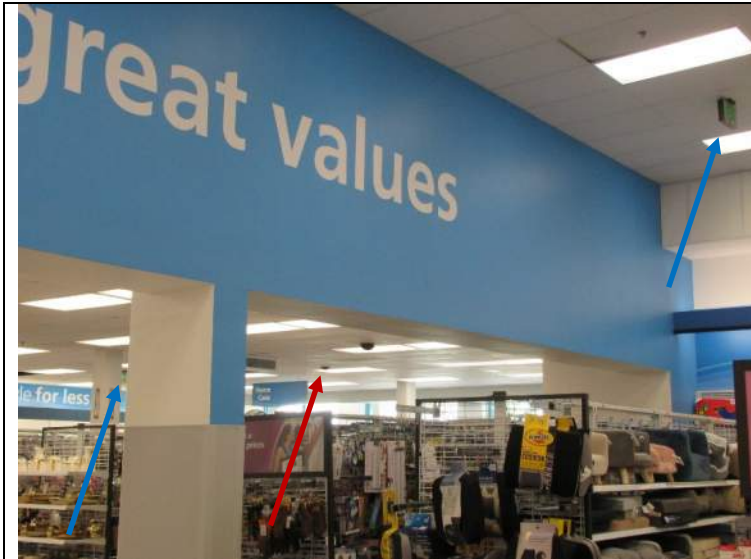
Photograph No. 23.

Fire alarm ceiling sensor/strobe/annunciator (red arrow) observed in good condition. Egress lighting (blue arrow) observed in good condition.

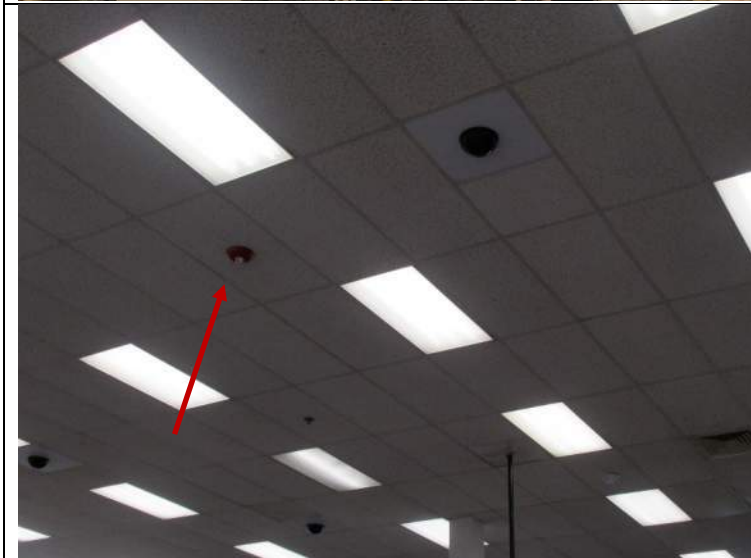
Photograph No. 24.

Fire alarm ceiling sensor/strobe/annunciator (red arrow) observed in good condition.

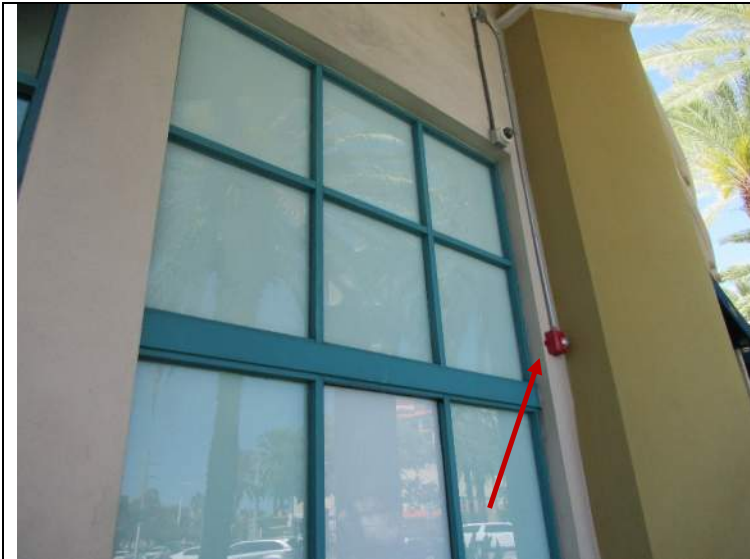
Photograph No. 25.

Fire alarm exterior strobe/annunciator observed in good condition.

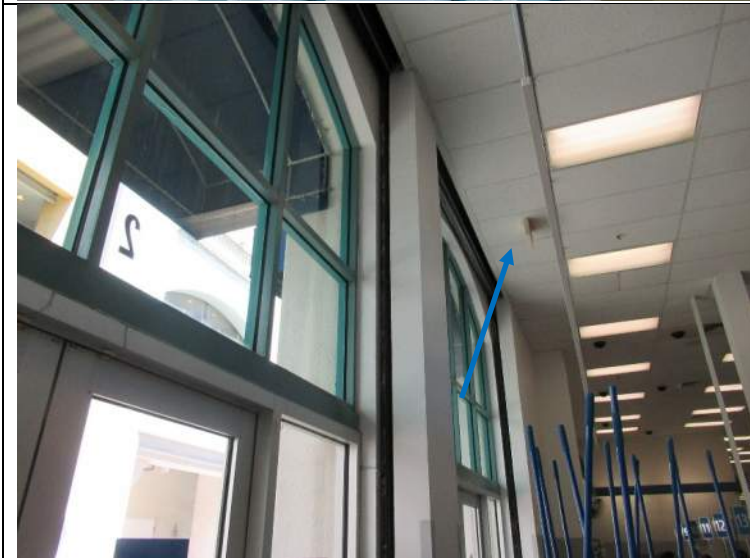
Photograph No. 26.

Egress lighting (blue arrow) observed in good condition.

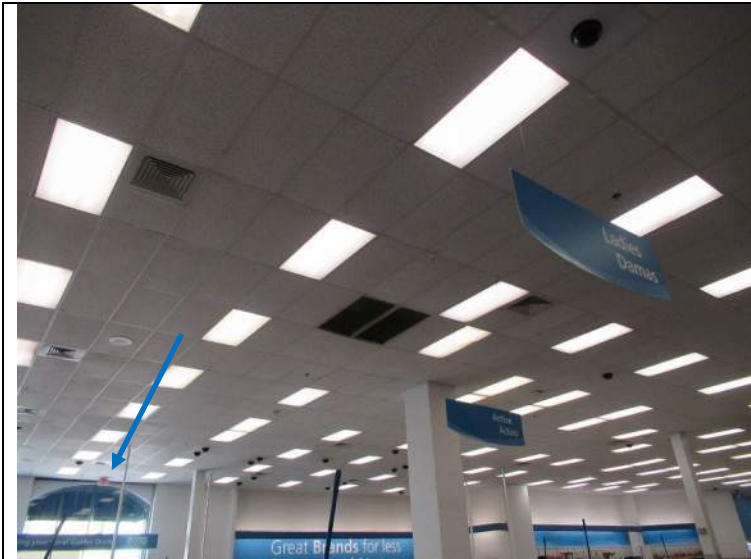
Photograph No. 27.

Egress lighting (blue arrow) observed in good condition.

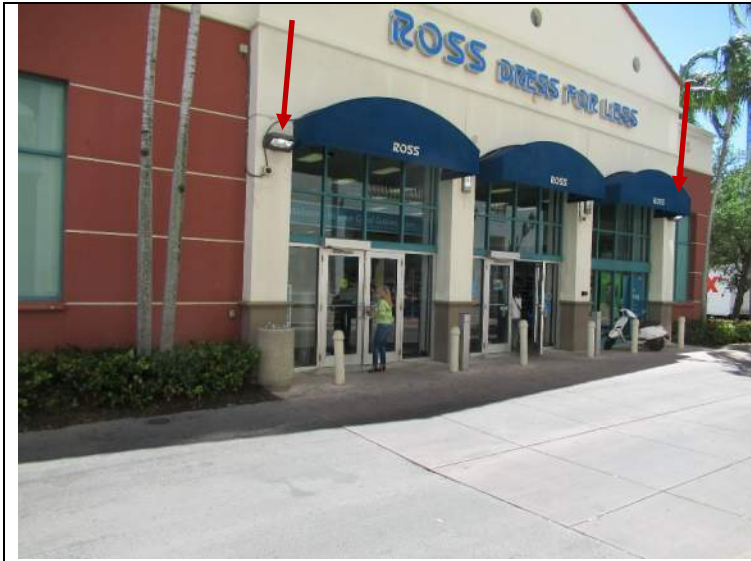
Photograph No. 29.

The wall sconce security lighting for public sidewalk along service alley entrance (west) was observed in good condition. No on-site parking provided at this store location.

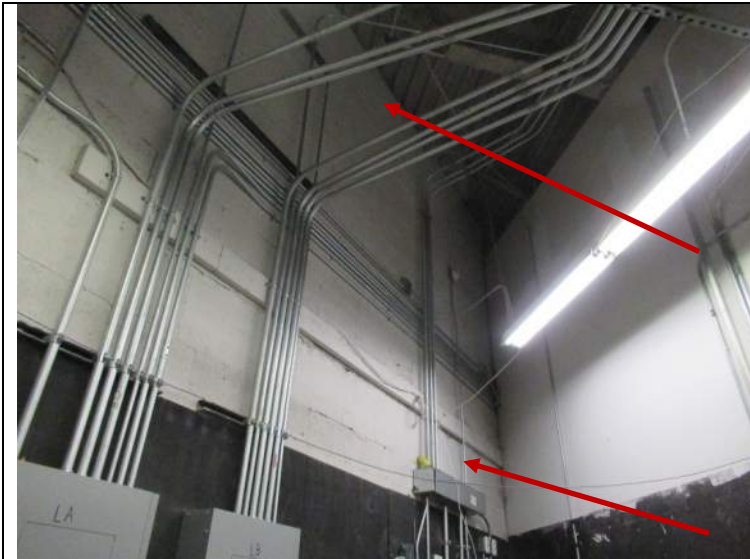
Photograph No. 7.

Typical exterior wall panel with re-enforced CMU block walls and two (2) tie beams at 10 feet (arrow) and 20 feet (arrow). No concrete tie-columns were observed on the wall panels.

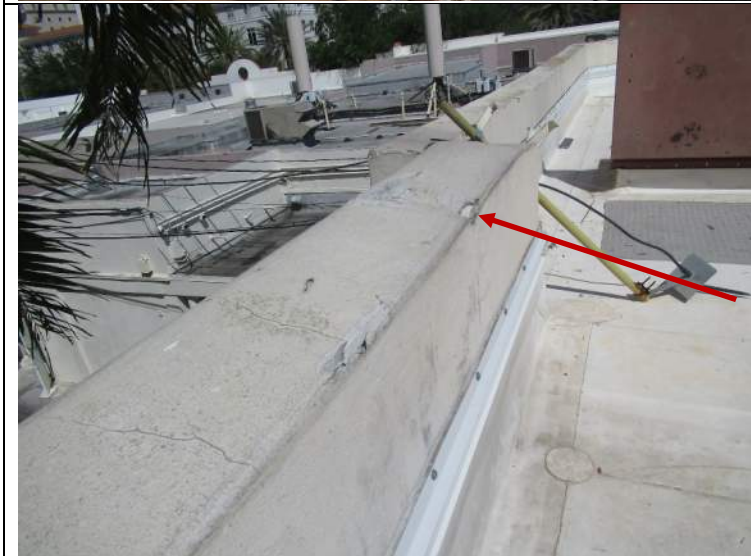
Photograph No. 10.

The parapet wall along the west elevation of the building. The top of the wall is a rounded EPS foam/EIFS cap that is adhered to the concrete tie beam. The cap has impact damage from prior storms.

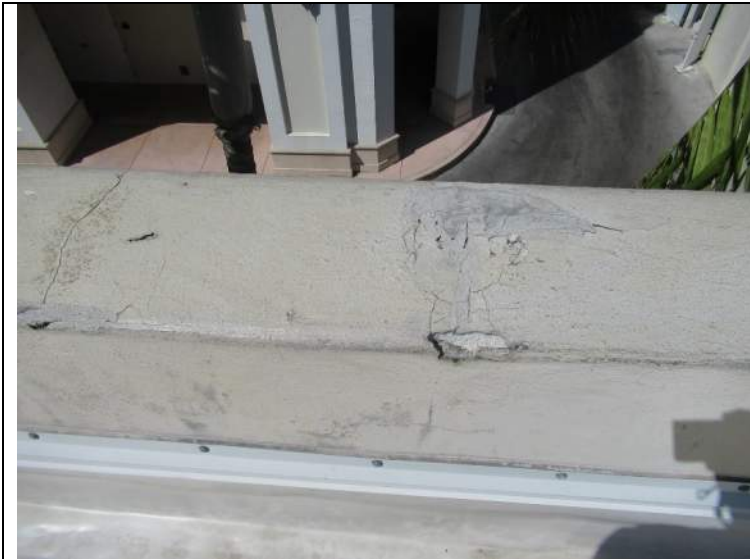
Photograph No. 11.

Close up of prior picture (arrow) showing EPS foam under EIFS acrylic stucco and top of concrete tie-beam. Spider radial cracking from impact damage can be seen. The exposed EPS foam needs to be covered, and the cap painted.

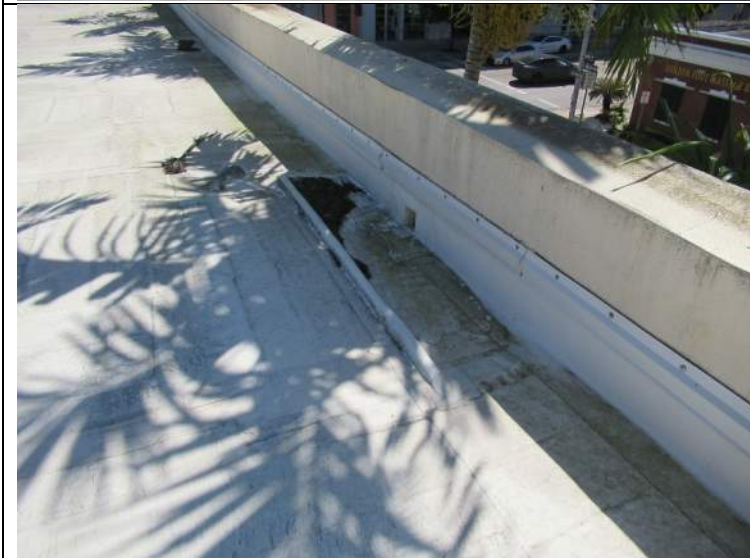
Photograph No. 12.

Typical through parapet wall overflow scupper. The picture also shows the roof termination flashing installed with drop-in anchors showing the solidness of the parapet wall.

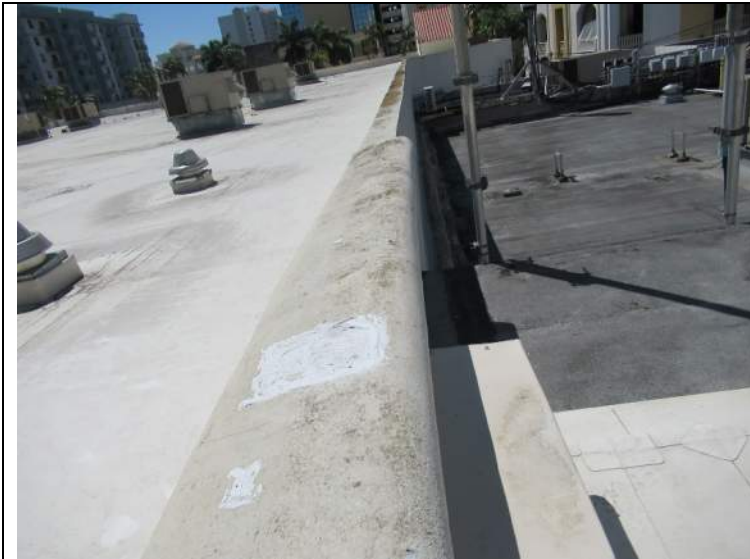
Photograph No. 13.

The zero property line walls between the Ross store property and the expansion space (lower roof) to the west. There are two independent walls on the property line. This view is looking south from the front (north) of the building. Note the prior repair to the parapet cap EIFS/eps surface.

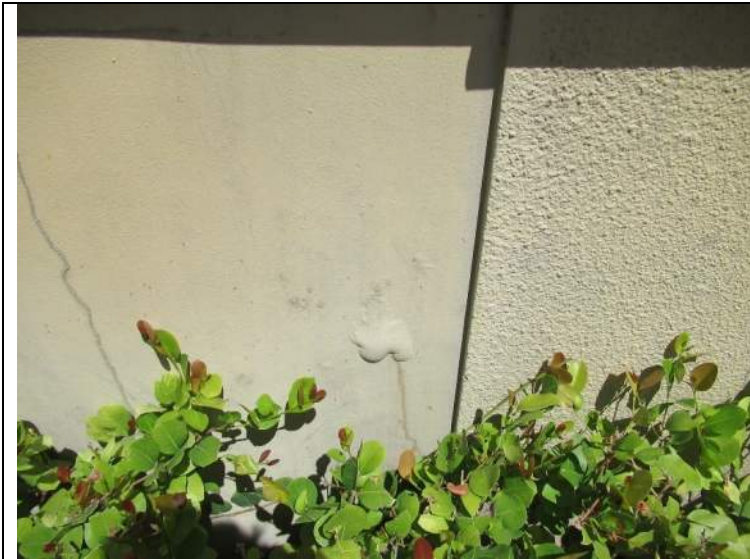
Photograph No. 17.

Wall paint bubble filled with water along with a hairline crack to the left in the stucco surface.

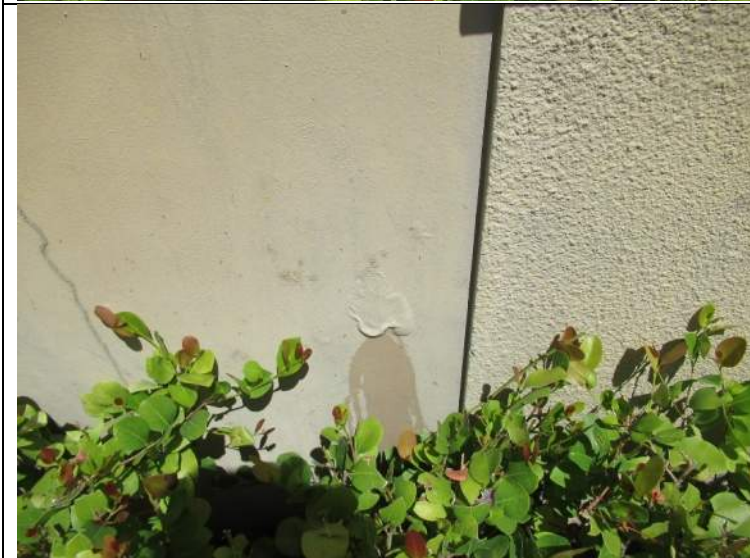
Photograph No. 18.

The above picture after the bottom was nicked draining the water out of the bubble.

The paint was worn, chalking, and had no pigment brightness indicating end of useful life protecting the building.

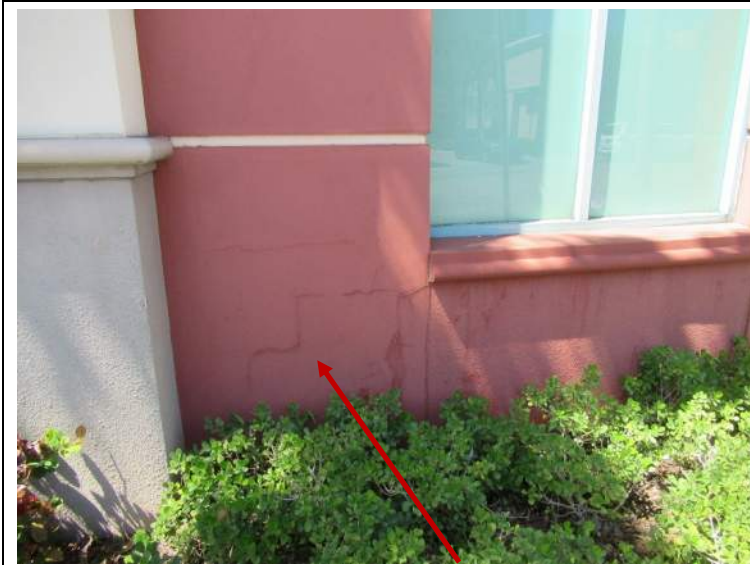
Photograph No. 19.

Stairstep mortar joint telegraphing cracks in stucco surface on the east elevation along Douglas Road. The cracks appear to have been present for a significant amount of time based on dirt in cracks. The cracks need to be properly treated and sealed when the building is painted. These are typical storm related movement cracks. The building is structurally sound.

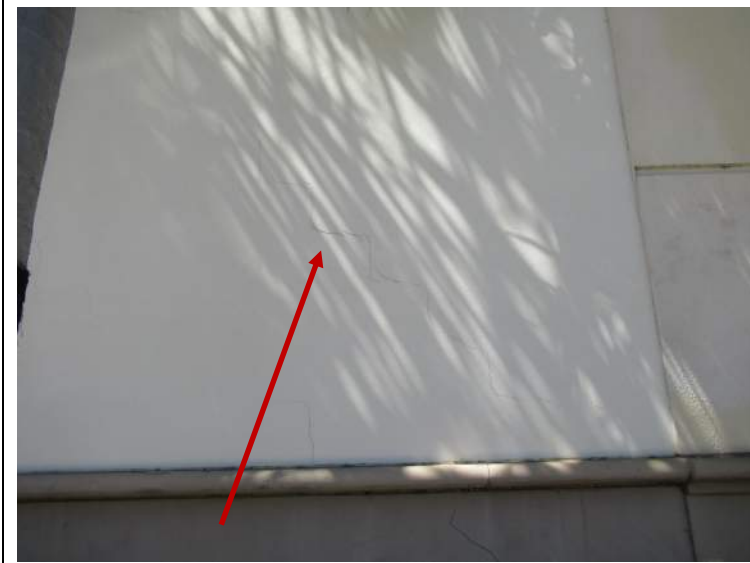
Photograph No. 20.

Stairstep mortar joint telegraphing cracks in stucco surface on the east elevation along Douglas Road. The cracks appear to have been present for a significant amount of time based on dirt in cracks. The cracks need to be properly treated and sealed when the building is painted. These are typical storm related movement cracks. The building is structurally sound.

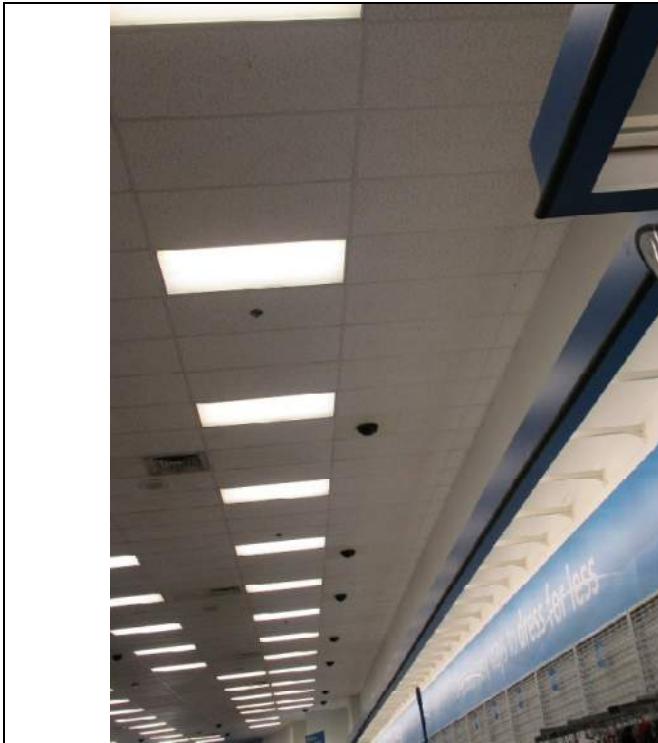
Photograph No. 21.

The interior GWB surface on the backside of the east elevation exterior wall. No distress seen in the GWB surfaces. No water staining observed in the GWB or ceiling tiles.

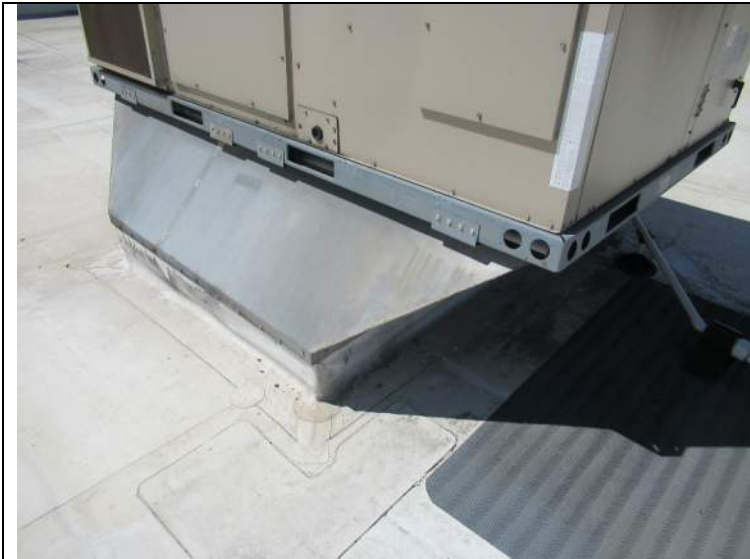
Photograph No. 25.

The RTU are relatively new and have welded steel adapters that connect the original roof curb to the new RTUs.

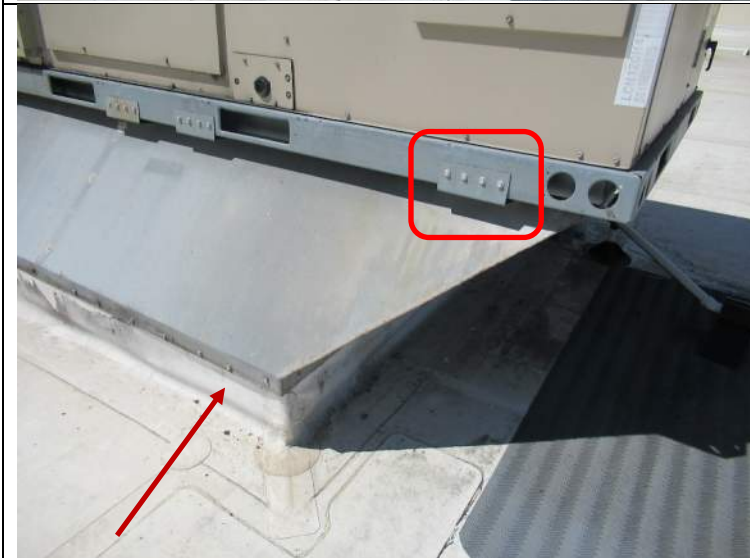
Photograph No. 26.

Adequate curb to adapter screws observed. Tie-down clips between adapter and RTU observed.

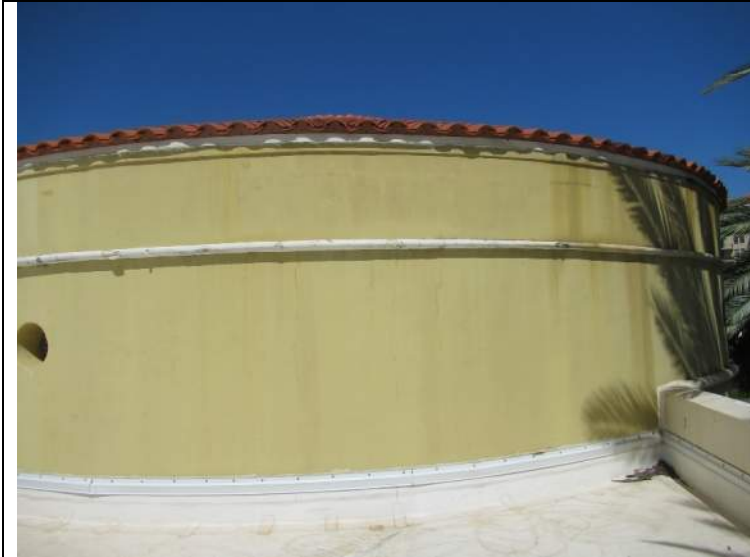
Photograph No. 27.

The round silo roof structure over the main (NE) entrance doors. The structure is solid CMU / concrete with no access from the roof to the silo's interior.

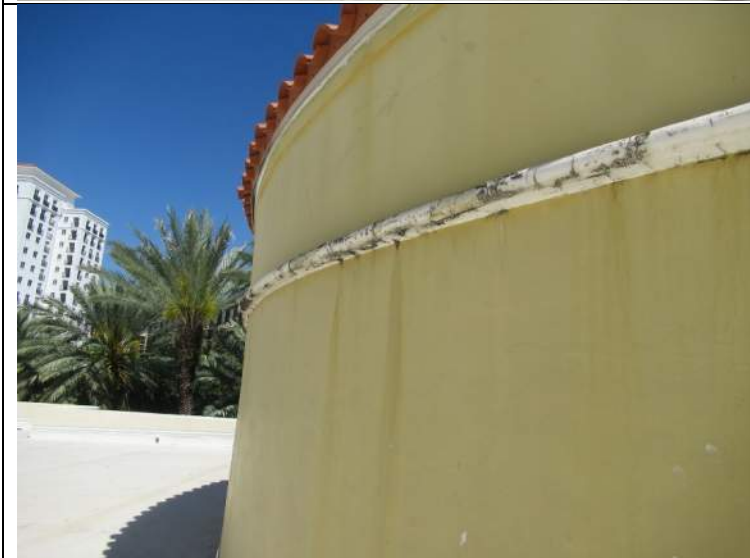
Photograph No. 28.

Impact damage to the surface adhered EIFS/eps trim/band observed. The impact damage needs to be repaired when the building is painted.

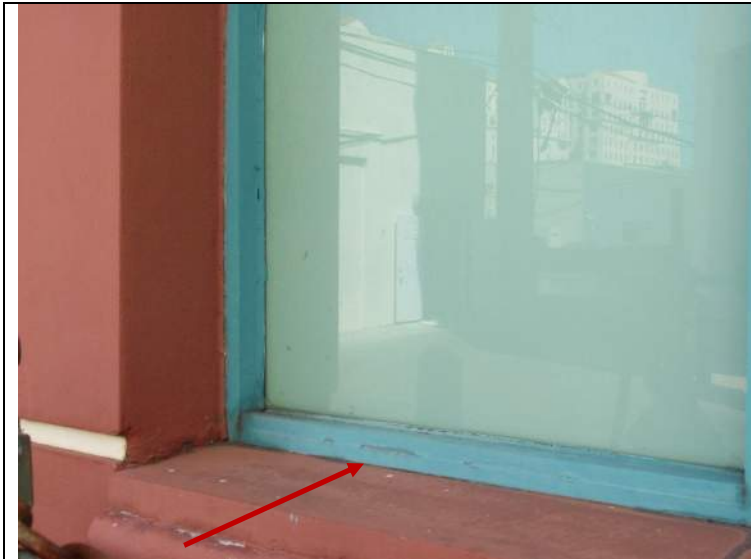
Photograph No. 33.

Paint starting to peel off the storefront frames.

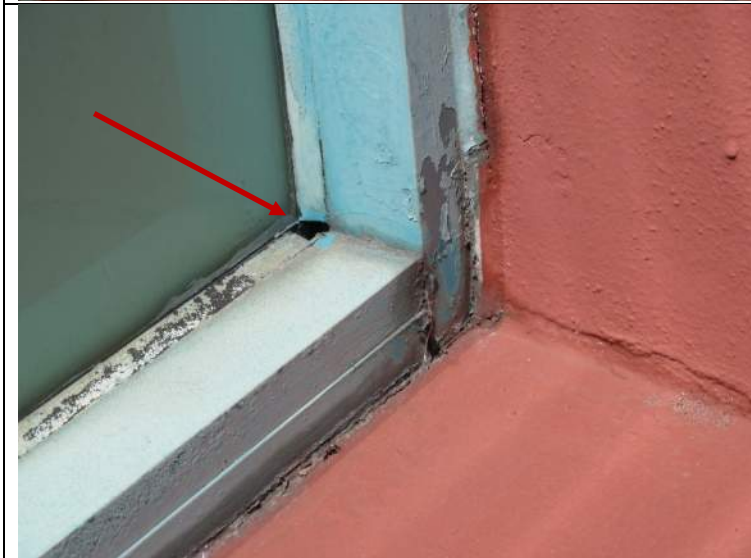
Photograph No. 34.

Paint peeling off frame and glass gasket shrinkage observed.

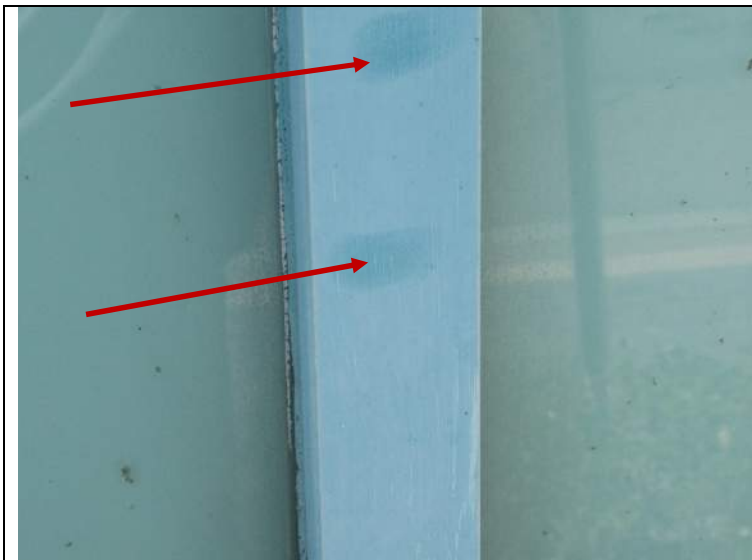
Photograph No. 35.

Chalking thumb prints in frame paint.

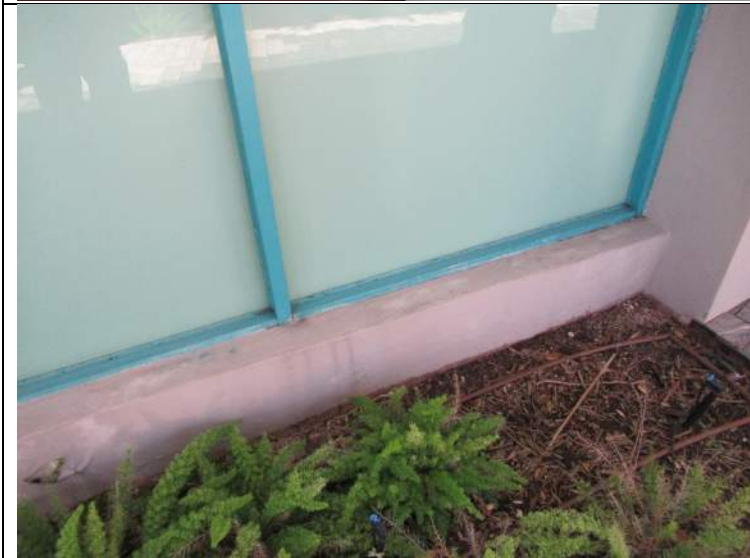
Photograph No. 42.

Water stains on exterior wall sill showing trapped water leaking out of frame. This is an indication that the glass gasket is leaking excessive water into the frame. The glass to frame should be wet sealed with sealant.

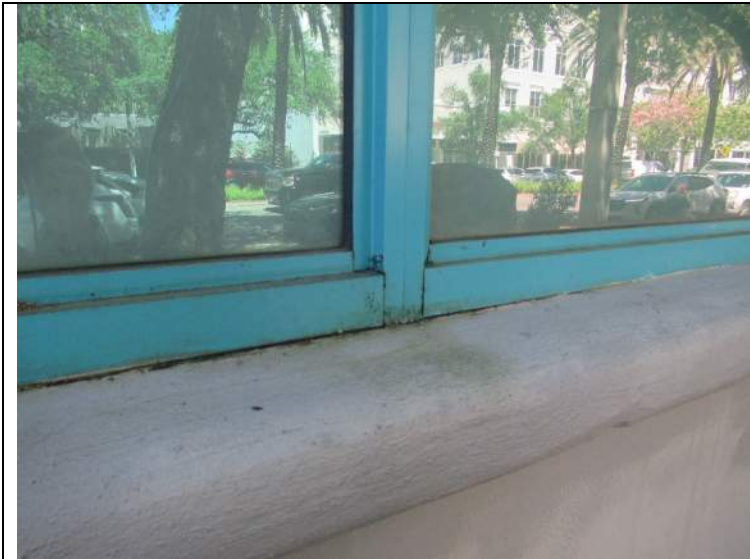
Photograph No. 43.

Water stains on exterior wall sill showing trapped water leaking out of frame. This is an indication that the glass gasket is leaking excessive water into the frame. The glass to frame should be wet sealed with sealant.

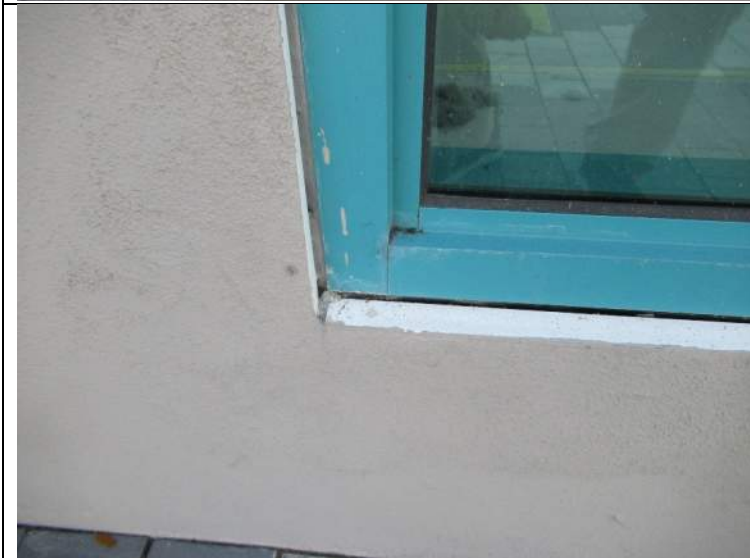
Photograph No. 44.

No sealant observed between stucco L-bead and storefront windows allowing water to get behind stucco. Seal joint with new sealant along the Coral Way elevation.

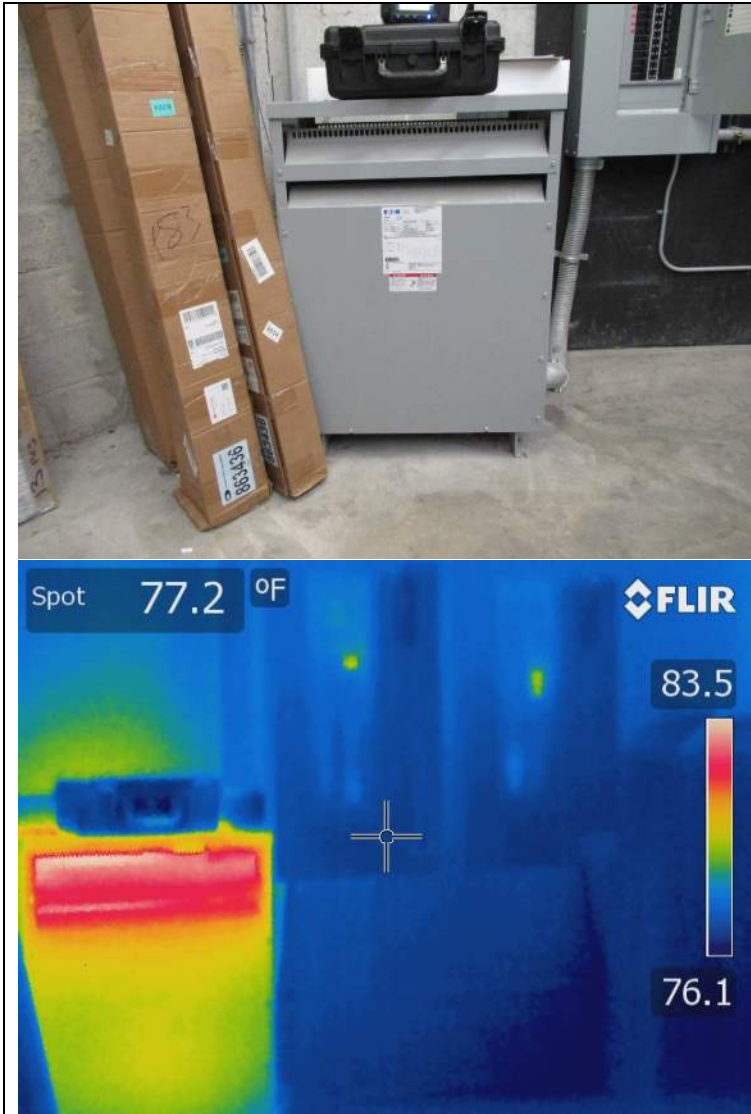
Photograph No. 48.

The 75 kva transformer stepping down 480Y277 to 208Y120 volts operating at 83.5 degrees vent temperature.

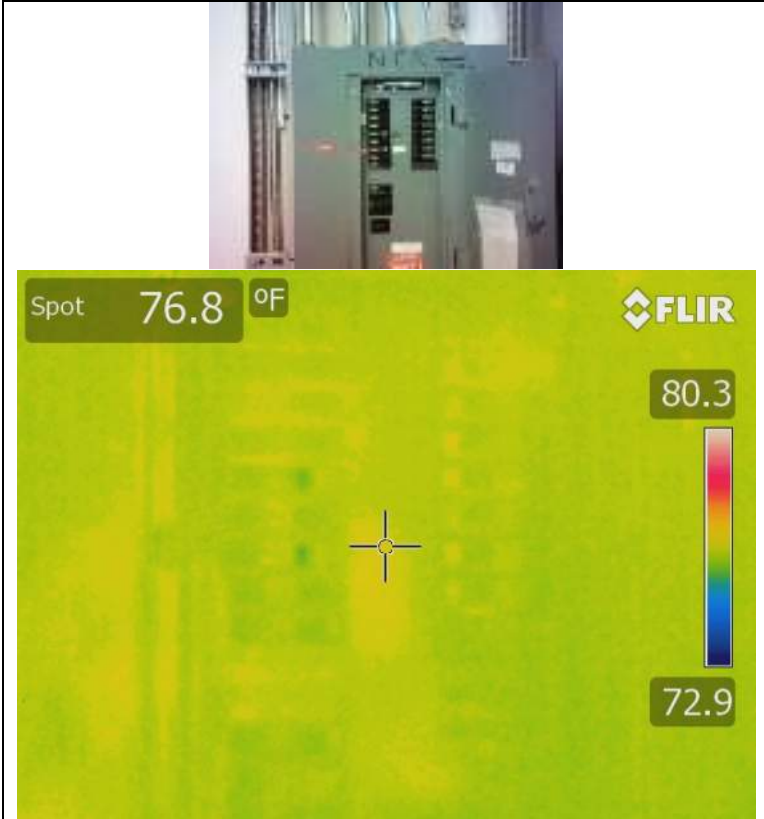
<p>Photograph No. 51.</p> <p>The NCR sub-panel with maximum temperature at 80.3 degrees. The NCR panel is supplied by the LA panels (CB 37, 39, & 41).</p>
--	---
