OFFICE OF THE PROPERTY APPRAISER

| Property Information | | | | | |
|---|--|--|--|--|--|
| Property Address: | 250 CATALONIA AVE Coral Gables, FL 33134-6735 | | | | |

RE-INSPECTION OF 250 CATALONIA PASSED INSPECTION, ALL DEFICIENCIES NOTED IN THE

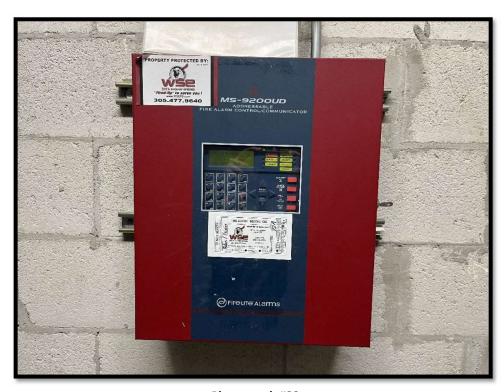
Photograph #22
Fire alarm control panel properly identified.

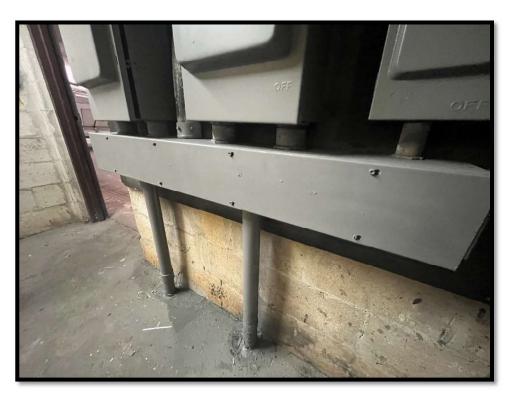
Photograph #72
Gutter in good condition.

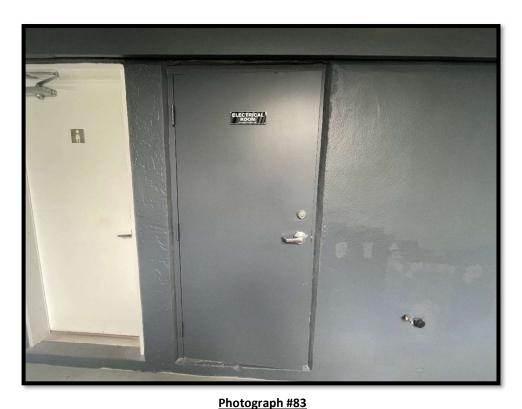
Electrical Room 8 floor properly identified.

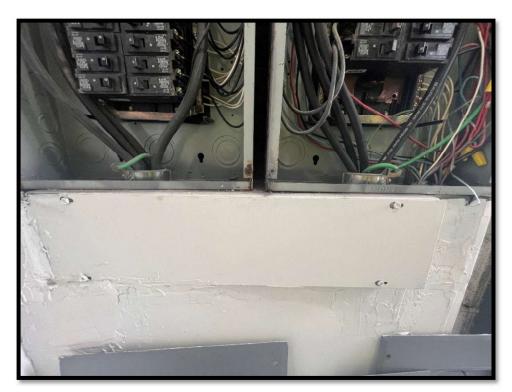
Photograph #94
Gutter in good conditions.

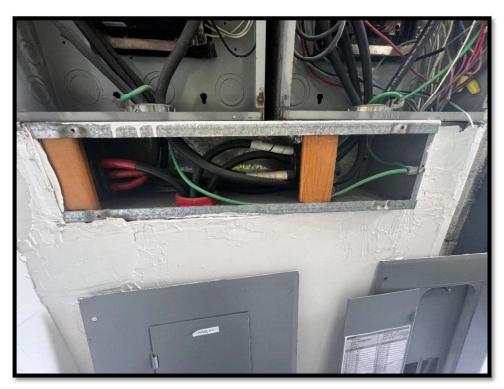
Photograph #95
Gutter properly installed and good standing.

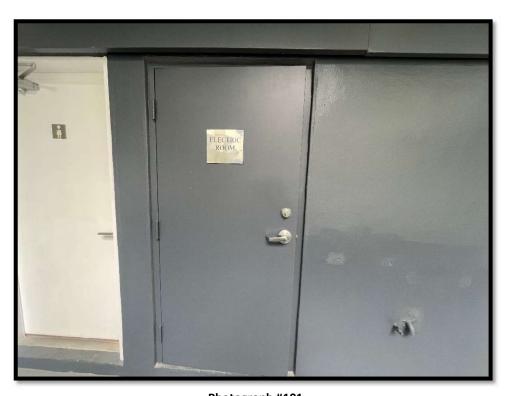
Photograph #101 Electrical Room 7 floor properly identified.

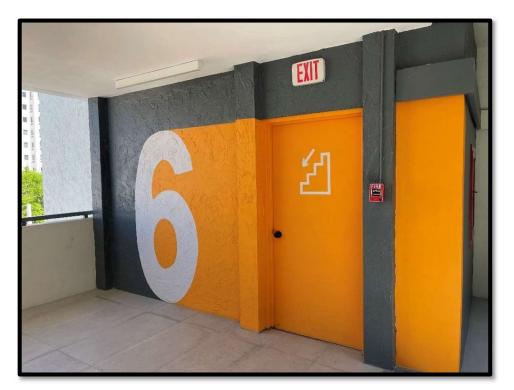
Photograph #111 Exit sign lights outdoor day time at 6th floors in the building in good working condition.

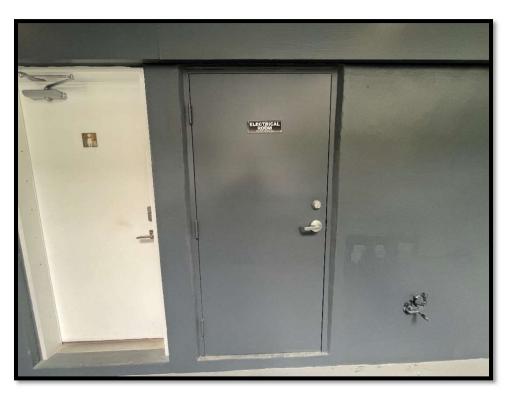
Photograph #112 Electrical Room 6 floor properly identified.

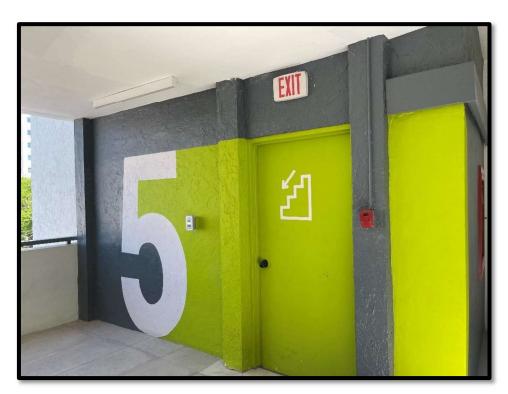
Photograph #123
Exit sign lights outdoor day time at 5th floors in the building in good working condition.

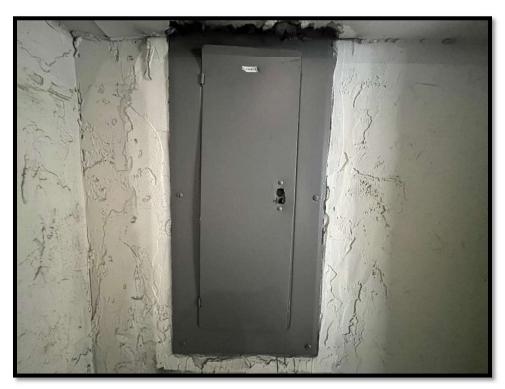
Photograph #136

Circuit Breaker Panel 4 properly identified.

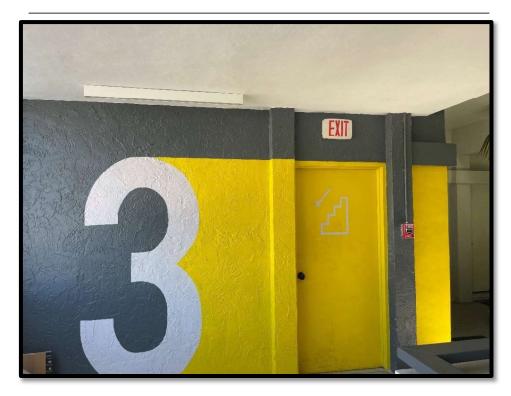
Photograph #140
Exit sign lights outdoor day time at 3rd floors in the building in good working condition.

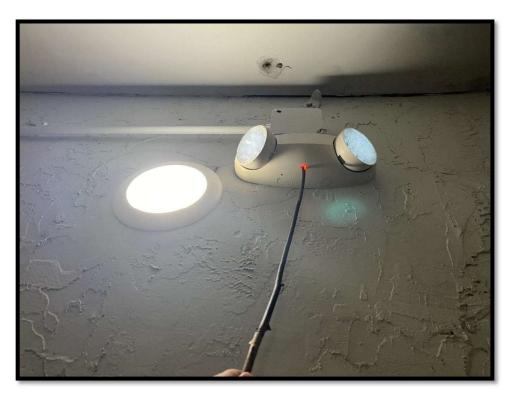
Photograph #167
Emergency lights properly installed and in good working condition.

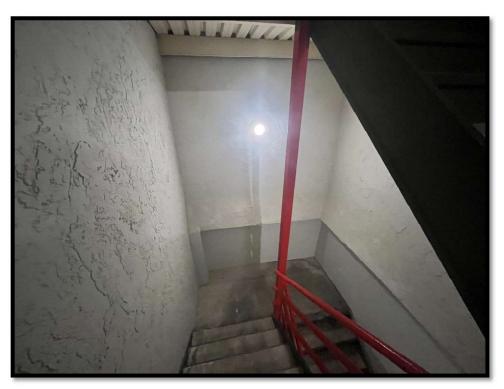
Photograph #168
The stairway landing properly illuminated.

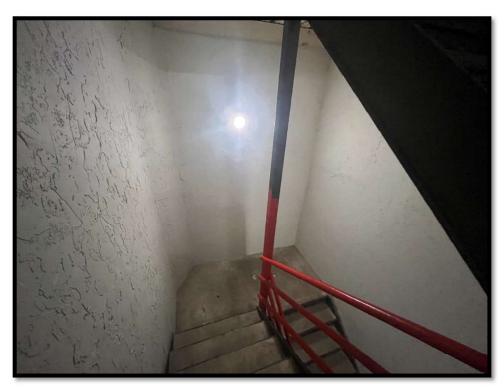
Photograph #174
The stairway landing properly illuminated.

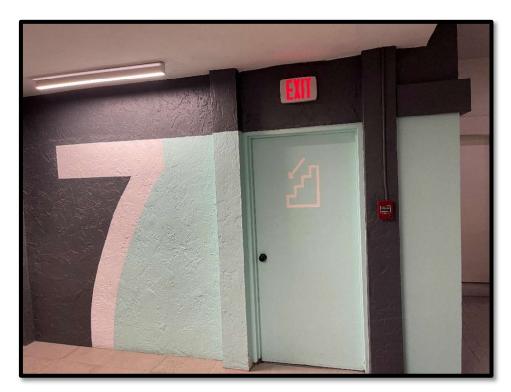
Photograph #186
Exit sign lights outdoor nighttime at 7th floors in the building in good working condition.

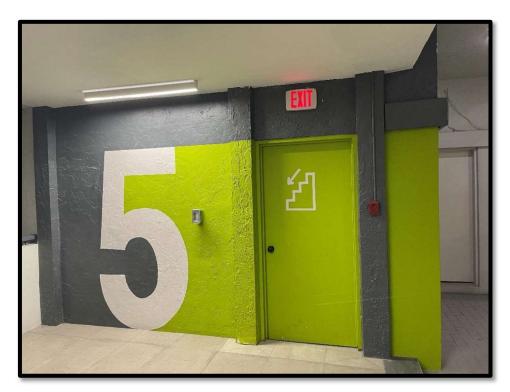
Photograph #190
Exit sign lights outdoor nighttime at 5th floors in the building in good working condition.

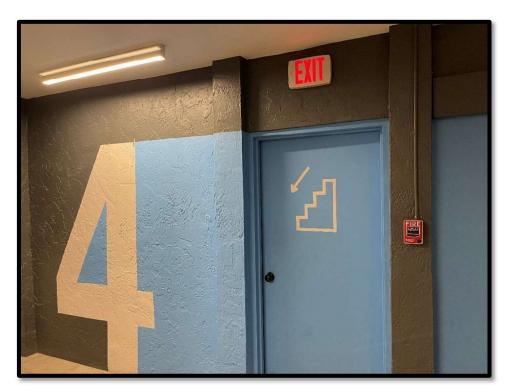
Photograph #192 Exit sign lights outdoor nighttime at 4th floors in the building in good working condition.

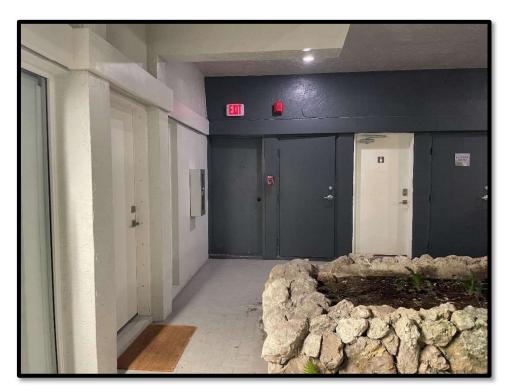
Photograph #194

Exit sign lights outdoor nighttime at 3rd floors in the building in good working condition.

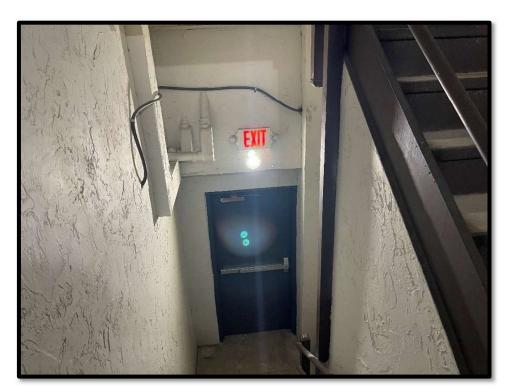
Photograph #195

Exit sign lights outdoor nighttime at 3rd floors to parking garage in the building in good working condition.

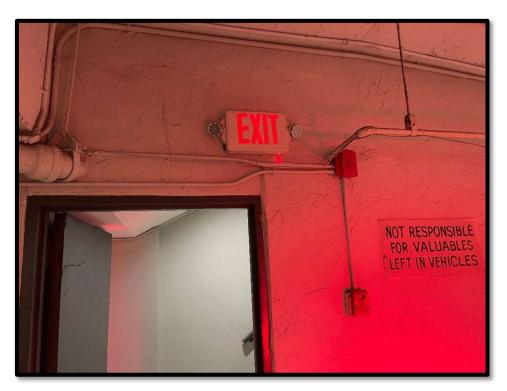
Photograph #196

Exit sign lights outdoor nighttime, access to parking garage in the building in good working condition.

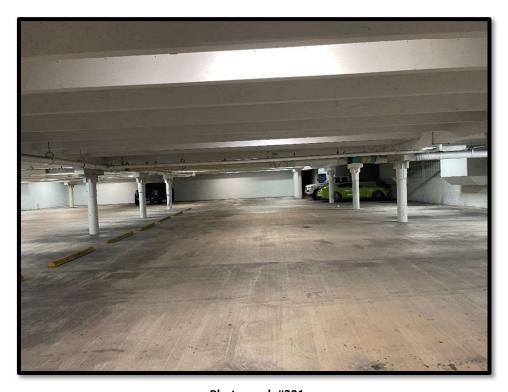
Photograph #201

Building interior parking garage illumination and lights in good working condition.

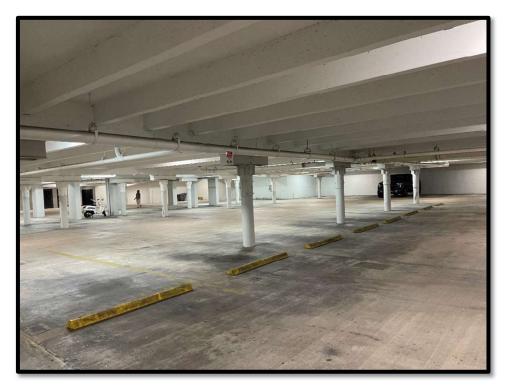
Photograph #202

Building interior parking garage illumination and lights in good working condition.

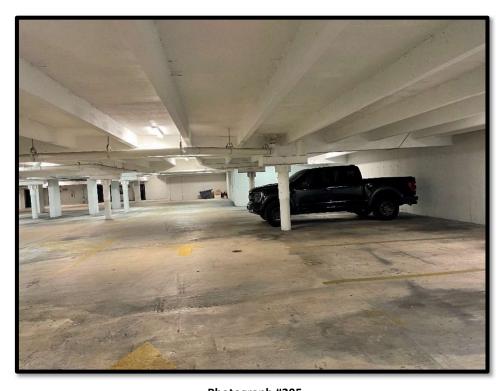
Photograph #205

Building interior parking garage illumination and lights in good working condition.

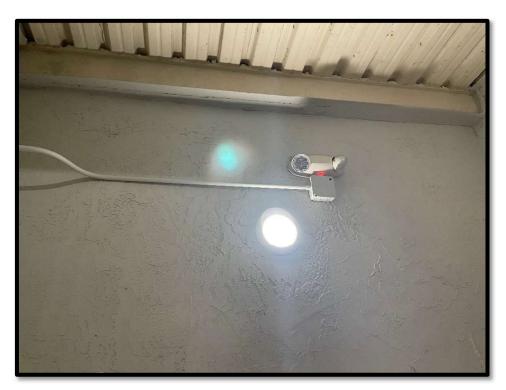
<u>Photograph #208</u> <u>Emergency light Properly installed and in good condition.</u>

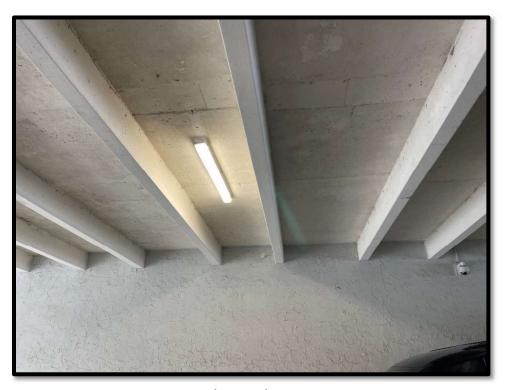
Photograph #213

Building interior parking garage good illumination and lamps in good working condition.

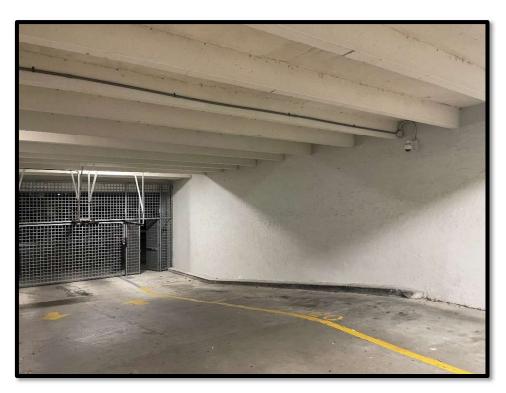
Photograph #214
Building interior parking garage good illumination and lights in good working condition.

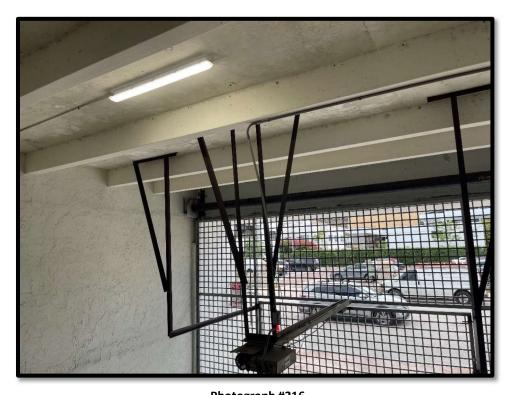
Photograph #216
Re-Inspection 05.20.2024.
Building interior parking garage good illumination and lamps in good working condition.

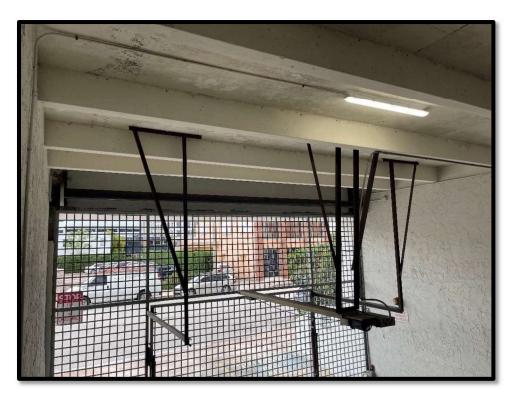
Photograph #217
Re-Inspection 05.20.2024.
Building interior parking garage good illumination and lamps in good working condition.

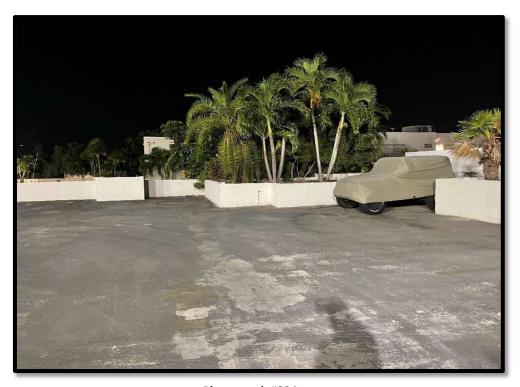
Photograph #224 Re-Inspection 05.26.2023.

<u>Parking Garage Exterior Light of the service good illumination and lamps in good working condition, in good standing at North, West, South and East side area, in all habitable and non-habitable areas.</u>

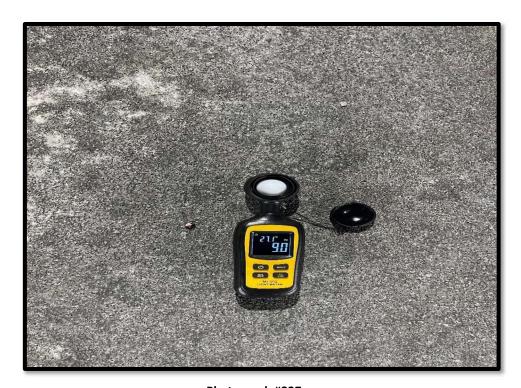
Photograph #227
Re-Inspection 05.26.2023.

Parking and non-enclosed areas under, or within, buildings shall be provided with a maintained minimum of 1.0 foot-candle of light on the walking and parking surfaces from dusk until dawn. This parking area is sufficiently illuminated.

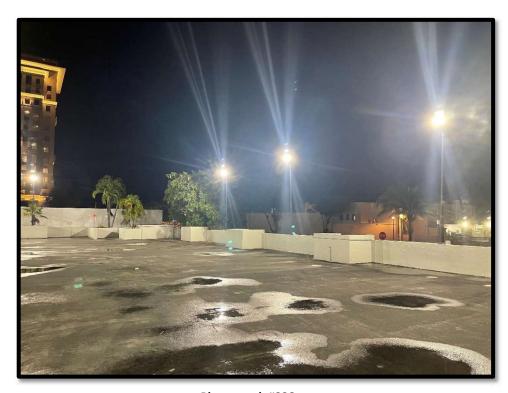
Photograph #228 Re-Inspection 05.26.2023.

<u>Parking Garage Exterior Light of the service good illumination and lamps in good working condition, in good standing at North, West, South and East side area, in all habitable and non-habitable areas.</u>
