**LISA H. HAMMER, RCA**  
*Horticultural Consultant*

March 31, 2025

RE: 737 Valencia Avenue  
Coral Gables, Florida 33134

We met at the above-referenced property on March 10, 2025, and again on March 26, 2025, where you requested that I evaluate the condition and relocation potential of six live oak trees (*Quercus virginiana*), #14, #20, #30, #41, #46 and #56, and one gumbo limbo tree (*Bursera simaruba*) #45, as shown on the Tree Survey/Disposition Plan you provided (de la Guardia Victoria Architects & Urbanists, Inc. Permit Set 11-25-24. Sheet LA-02). My report follows.

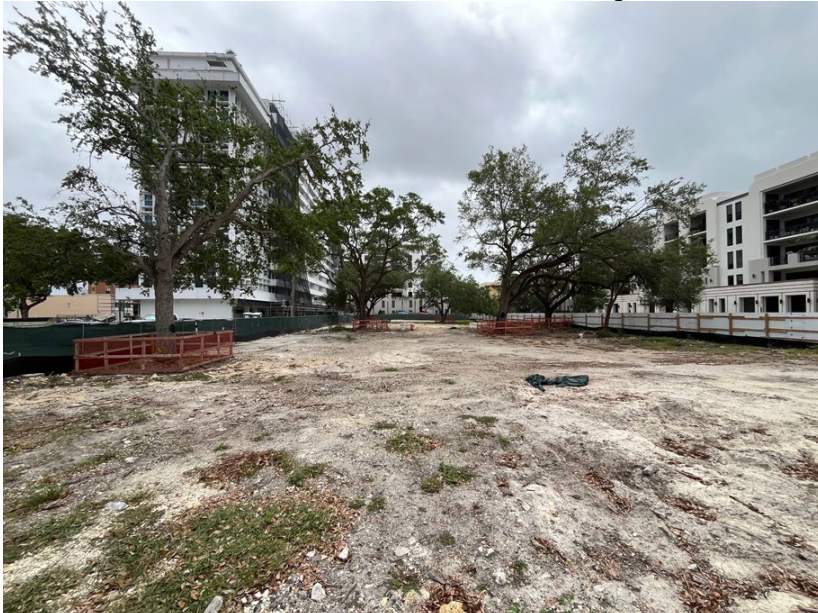
A photograph of current conditions of the property and the trees in question is below. Note that the trees have one-sided imbalanced crowns due to previous shading and crowding.

For the development to proceed as proposed, the trees cannot remain in their current locations. They cannot be relocated elsewhere on-site as there will not be “*a location that can accommodate the natural growth of the relocated tree.*” \*\*

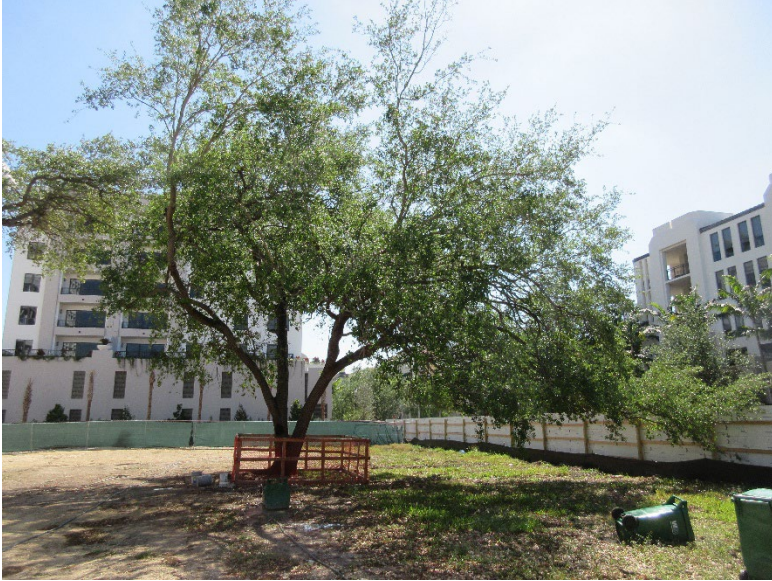
Tree #14 is a live oak with codominant leaders which diverge at a height of approximately 24 inches above grade. The north-side leader has a trunk diameter at breast height (DBH = 4.5 feet above grade) of 19.3 inches and the south side leader has a DBH of 15.8 inches. Below the divergent leaders, the trunk measures 28.1 inches in diameter. The tree is approximately 30 to 35 feet in overall height. Its crown spread is approximately 55 feet north-to-south and 57 feet east-to-west. The crown is imbalanced, with only about 15 feet of the north-south diameter on the north side, and 40 feet on the south side. The east-west diameter is 23 feet on the east side and 34 feet on the west side. A view of the tree from the west looking east is shown below.

Live oak tree #14 is generally in fair to good condition. However, its crown is severely imbalanced, and very low on the south side. It has codominant leaders within 24 inches of its base, with evidence of included bark between them. In addition, both leaders are divergent above, with included bark there as well.

This tree is not a good candidate for relocation due to its trunk and branching structure. It would be prone to splitting apart upon lifting, and its crown would need to be significantly reduced on the south side to balance its weight. It could not be moved off-site without severely pruning it to reduce its overall size.

For these reasons, it is my professional opinion that tree #14 should not be relocated.

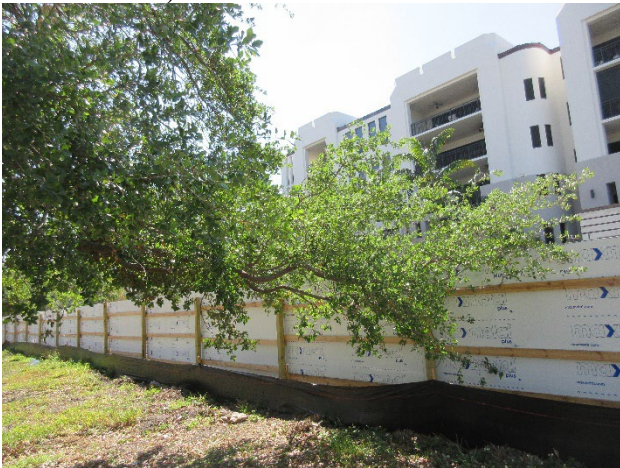
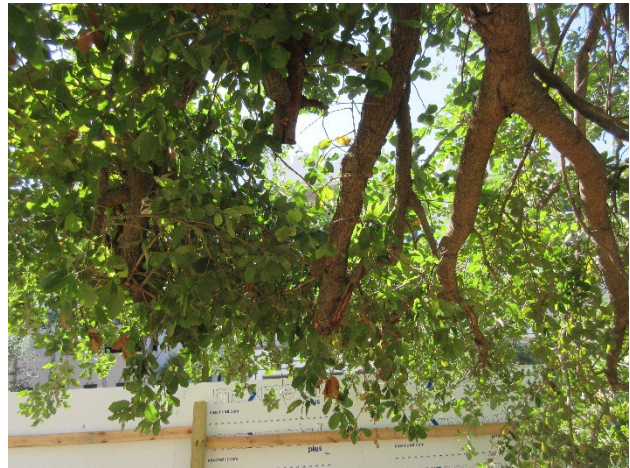
On the east side of the tree the branches are so low that they are touching and hanging over the construction fence. Some have previously been pruned using heading cuts (inappropriate cuts as per ANSI A-300) to raise them.

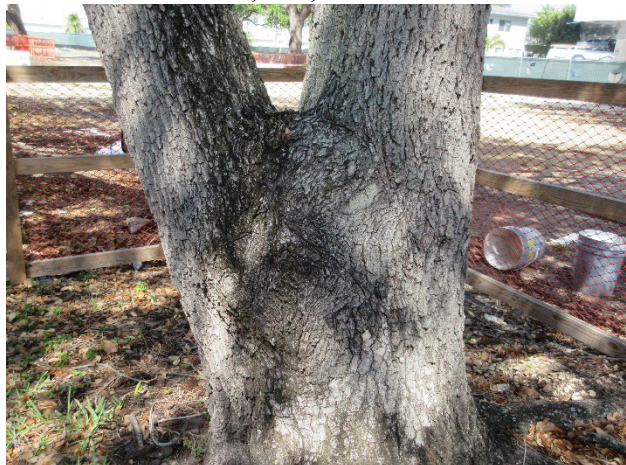
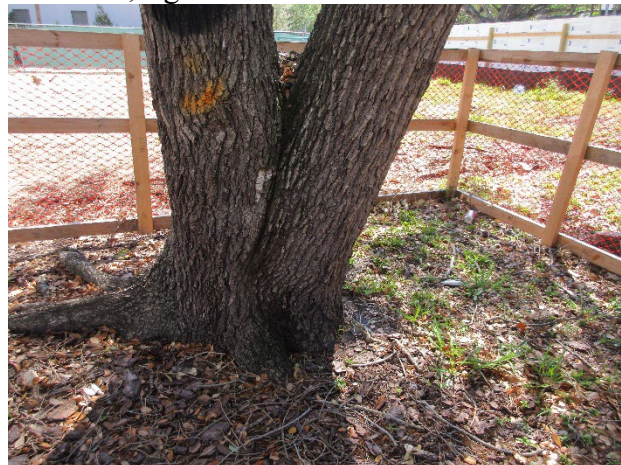
A view of the codominant leaders is shown below, from two opposite sides of the tree. The east side of the tree is below, left, and the west side of the tree is below, right.

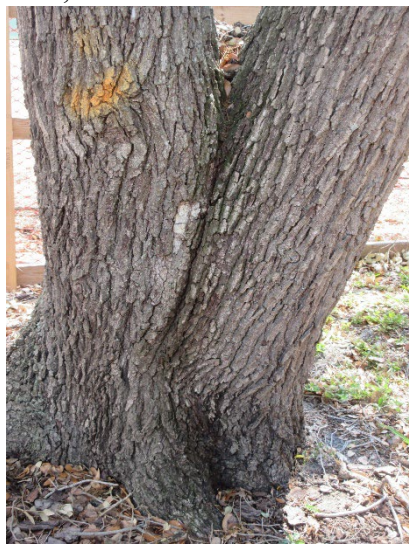
On the west side of the tree a split between the two leaders is apparent. This is a sign of included bark, an inherent structural defect that makes the trunk prone to splitting apart.

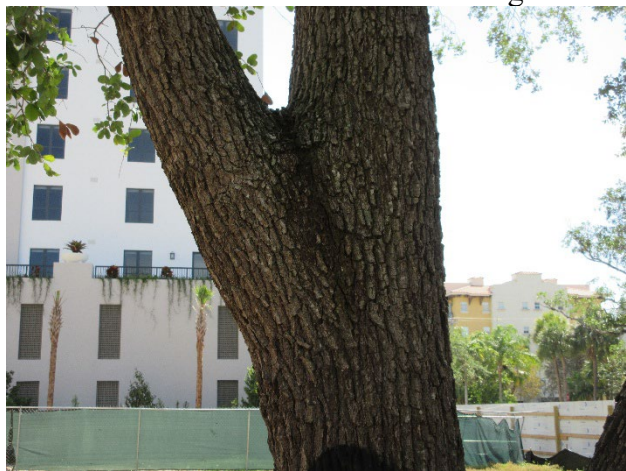
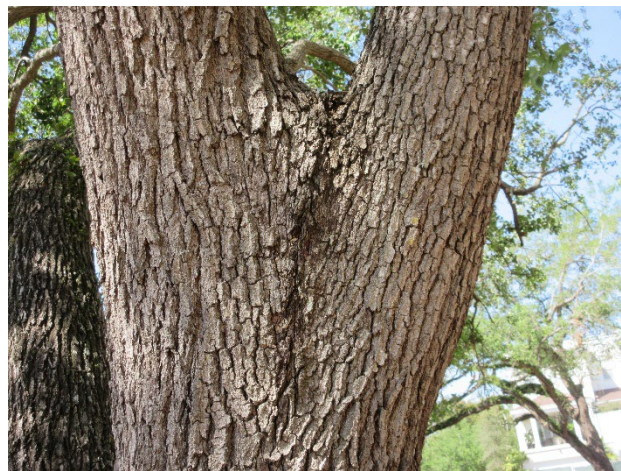
Each of the two leaders also have divergent stems above with included bark between them.

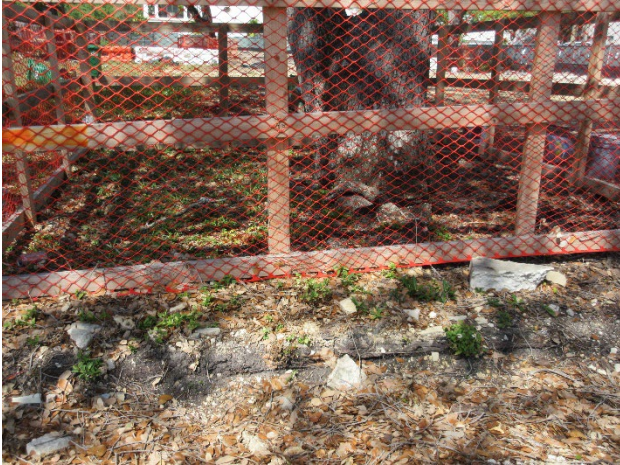
There is a linear grade change just outside the protective fencing on the east side of the tree, indicating the former presence of a structure near the tree.

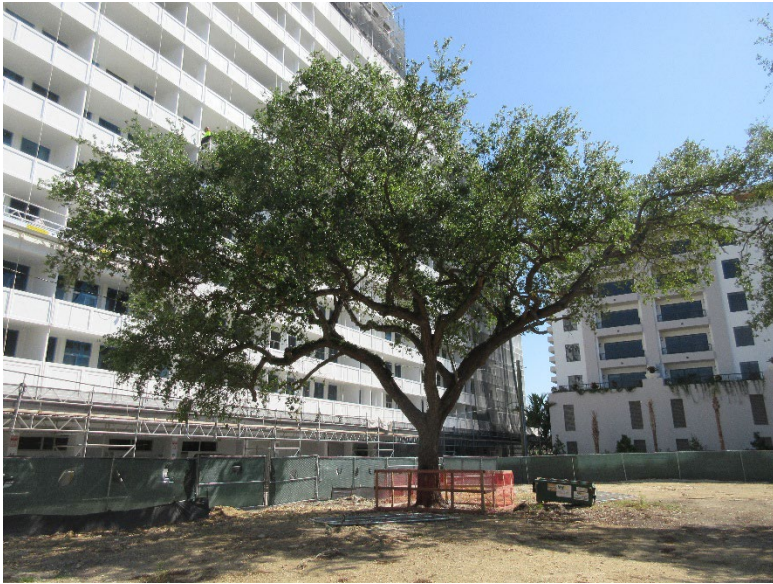
Tree #20 is a live oak with a DBH of 29.2 inches and is approximately 35 to 40 feet in overall height. Its crown spread is approximately 60 feet north-to-south and 50 feet east-to-west. The crown is imbalanced, with only about 14 feet of the east-west diameter on the east side, and 36 feet on the west side. The north-south diameter is approximately equal on both sides, about 30 feet on each side. A view of the tree from the southwest looking northeast is shown on the next page.

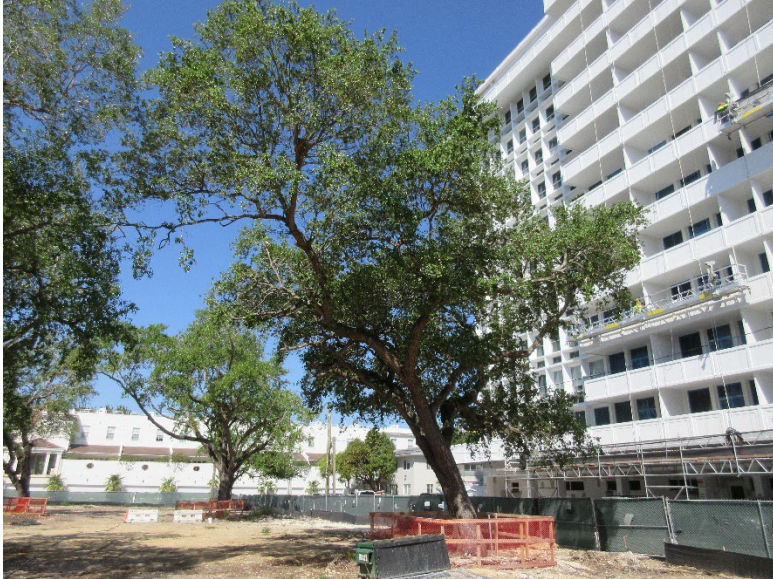
A view of the tree from the east looking west shows that it leans toward the south, with one leader on the south side significantly taller than the rest of the crown.

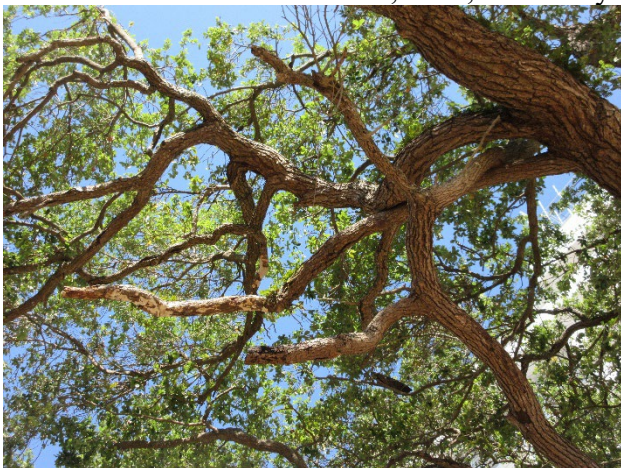
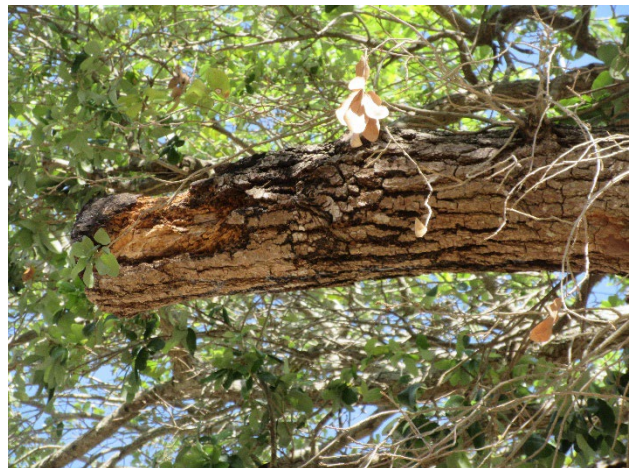
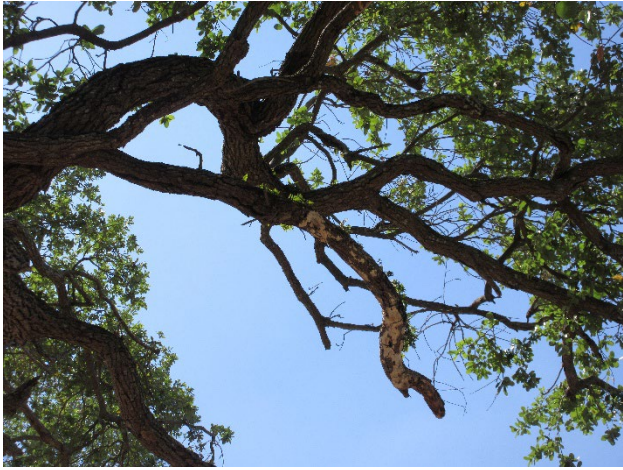
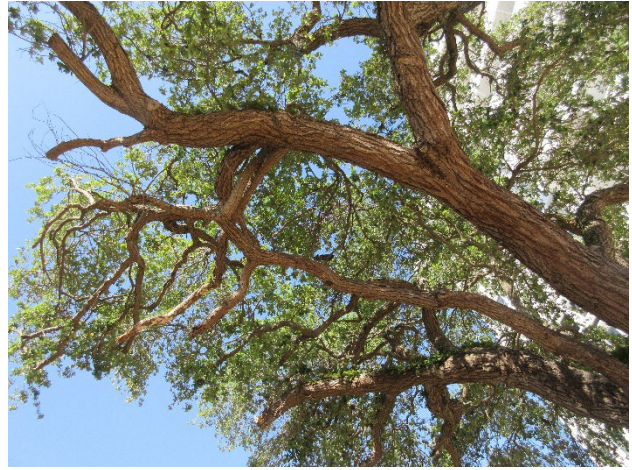
The tree has numerous broken, dead, and decayed branches.

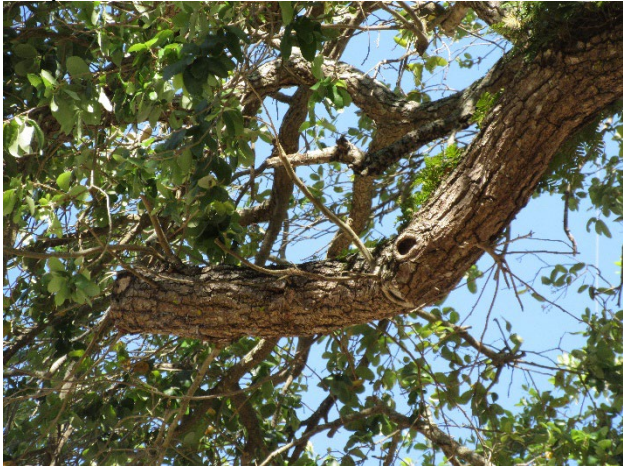
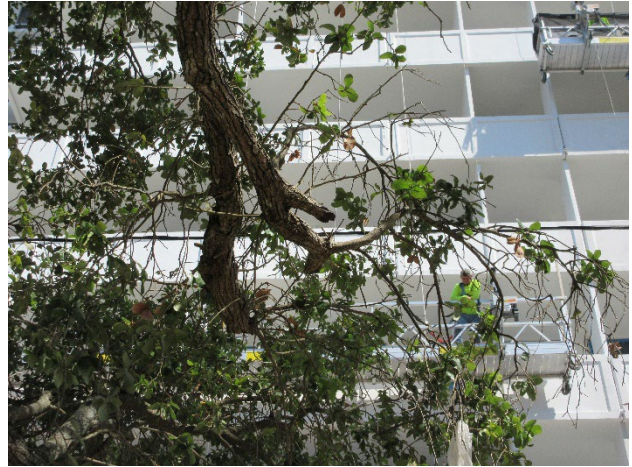
Many were previously pruned using [inappropriate] heading cuts, particularly on the north side near the powerlines.

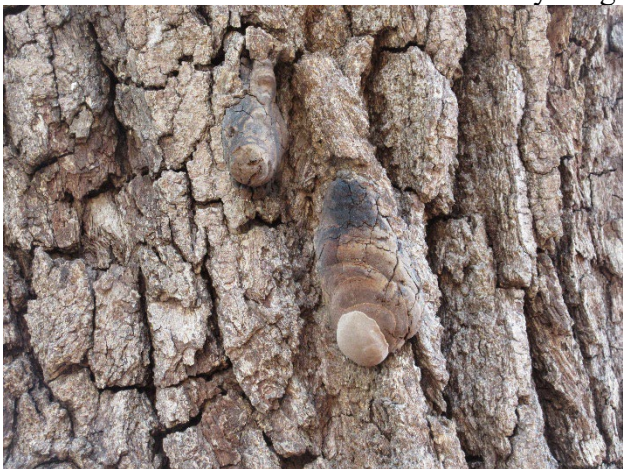
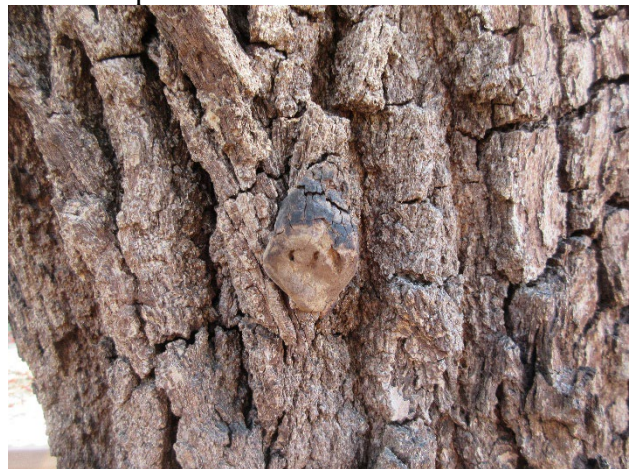
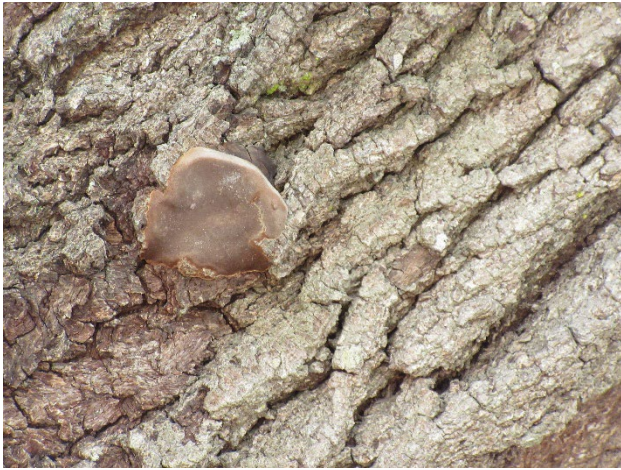
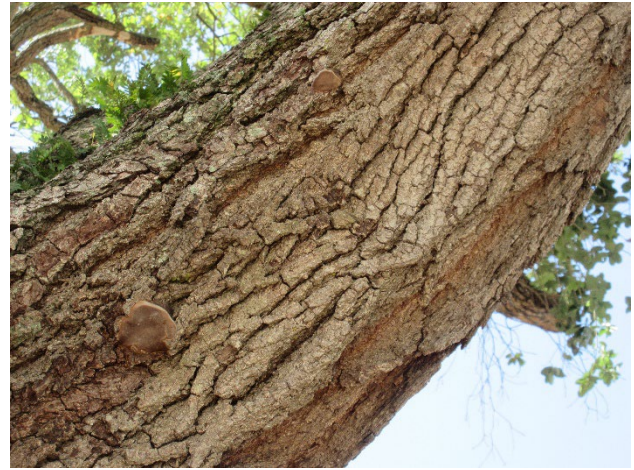
There are several conks of the wood decay fungus, *Phellinus* sp. on the main trunk.

Live oak tree #20 is generally in fair to poor condition. It has many dead branches and the crown is imbalanced. It is infected with a fungal wood decay disease which typically affects already-stressed trees. Although the disease generally progresses slowly, added stresses, i.e., relocation, could exacerbate its spread, causing faster tree decline. There is no effective cure or treatment for this disease.

This tree might initially survive relocation, but its long-term survival is questionable. Even with a stringent treatment program, the *Phellinus* fungus will likely progress. Following relocation, the tree's unbalanced crown would make it prone to toppling and it would need structural support for at least two to three years.

For these reasons, it is my professional opinion that tree #20 should not be relocated.

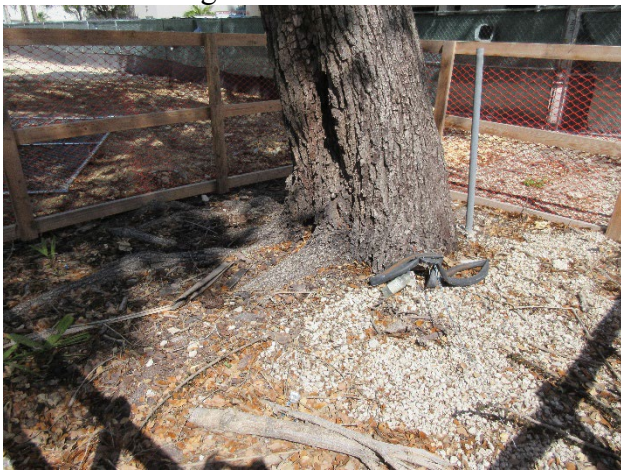
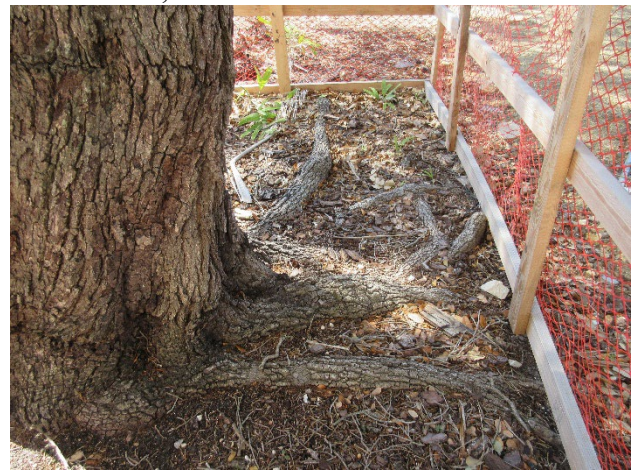
The tree has large surface roots on the southeast side of its trunk, the side to which it leans.

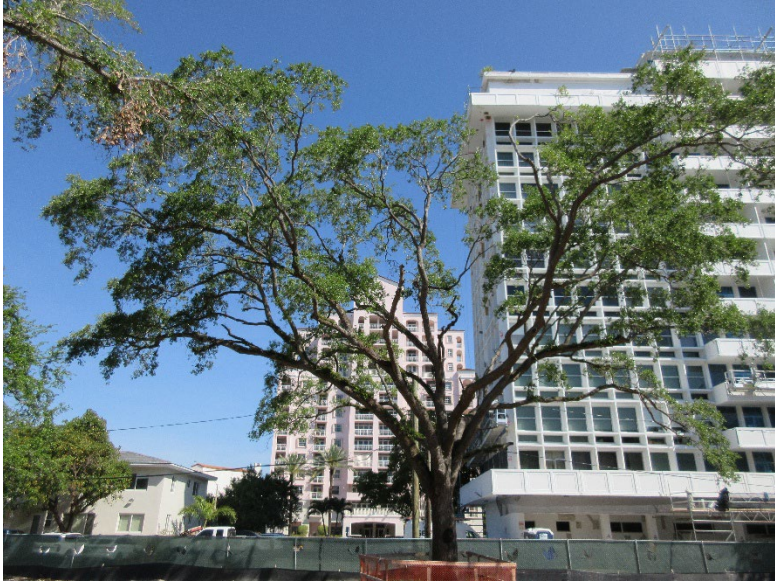
Tree #30 is a live oak with a DBH of 30.8 inches and is approximately 40 to 50 feet in overall height. Its crown spread is approximately 54 feet north-to-south and 72 feet east-to-west. The crown is slightly imbalanced, with about 32 feet of the north-south diameter on the north side, and 22 feet on

the south side. The east-west diameter is also slightly imbalanced, with about 30 feet on the east side and 42 feet on the west side. A view of the tree from the south looking north is shown below.

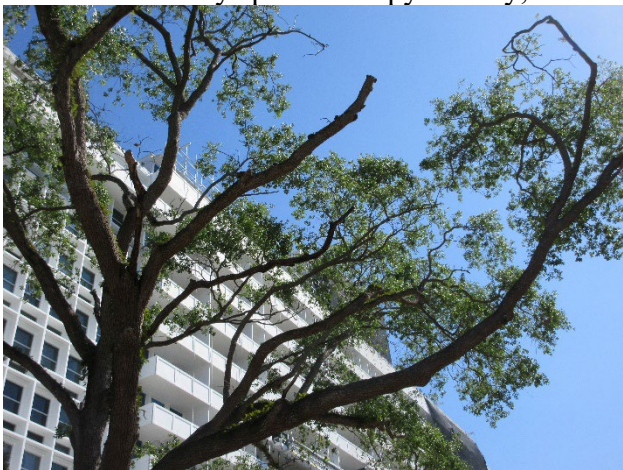
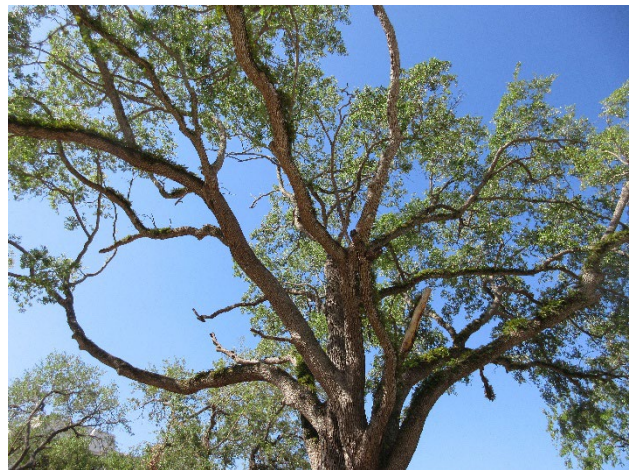
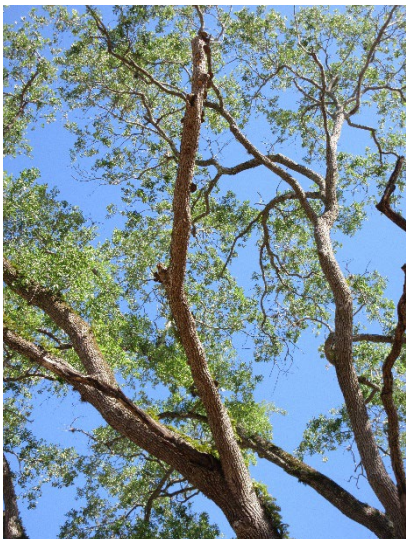
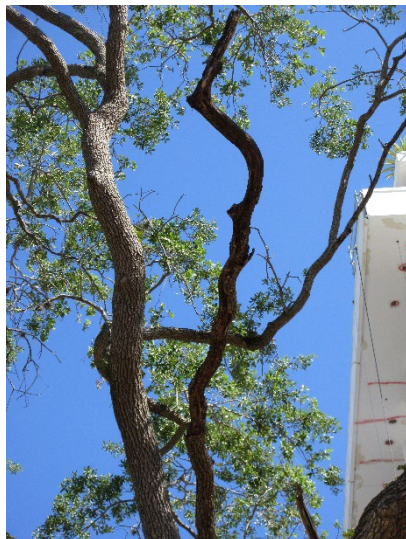
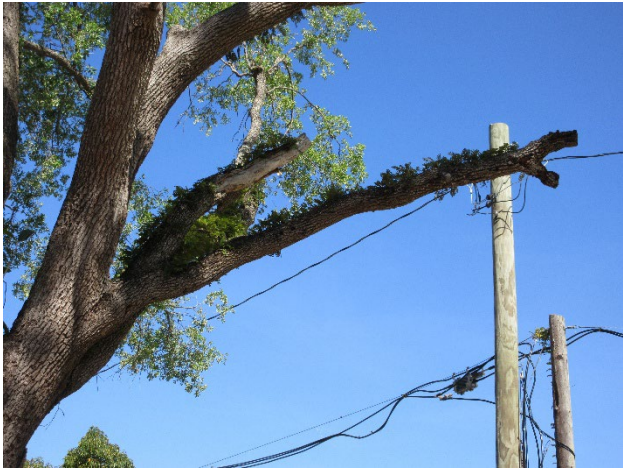
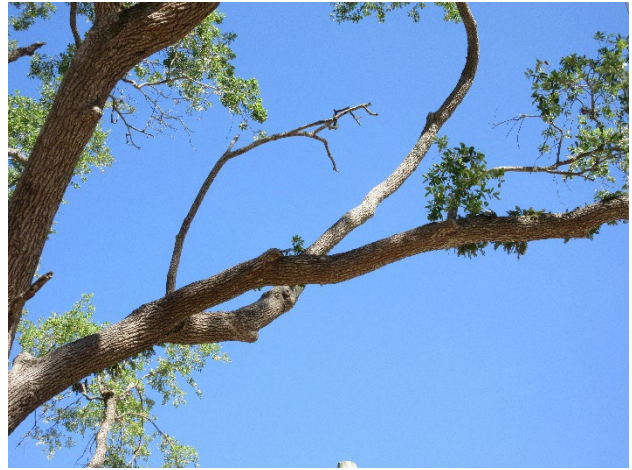
This tree has very sparse canopy density, with numerous dead branches.

Tree #30 is in poor condition, showing significant signs and symptoms of damage, stress, and decline. It is not like to survive relocation and therefore, it is my professional opinion that it is not a good candidate for relocation.

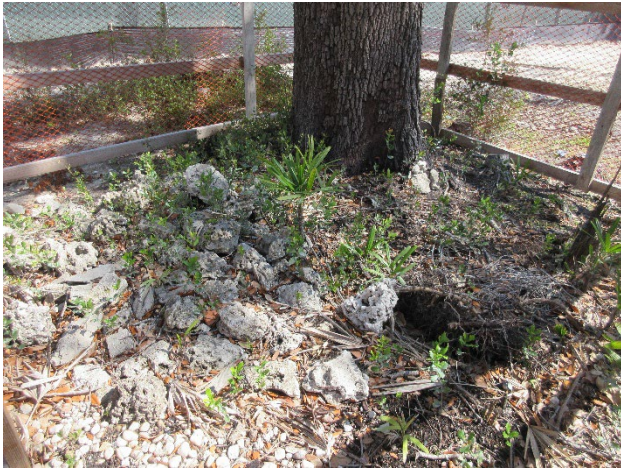
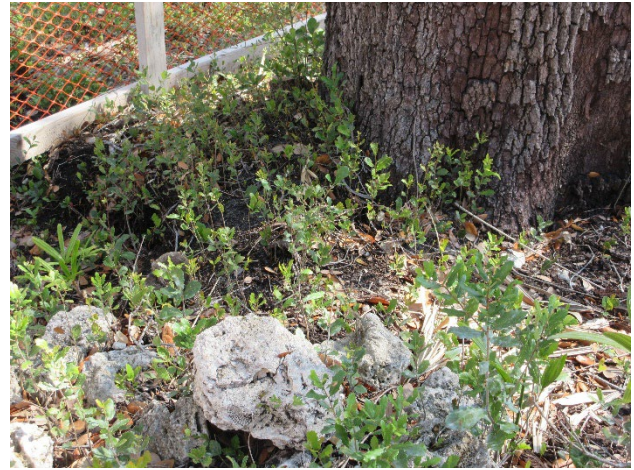
There is a pile of rocks near the base of the tree and it appears that there had been some type of structure or garden wall near the tree. The grade is uneven and there are root suckers present, an indicator of root damage or stress.

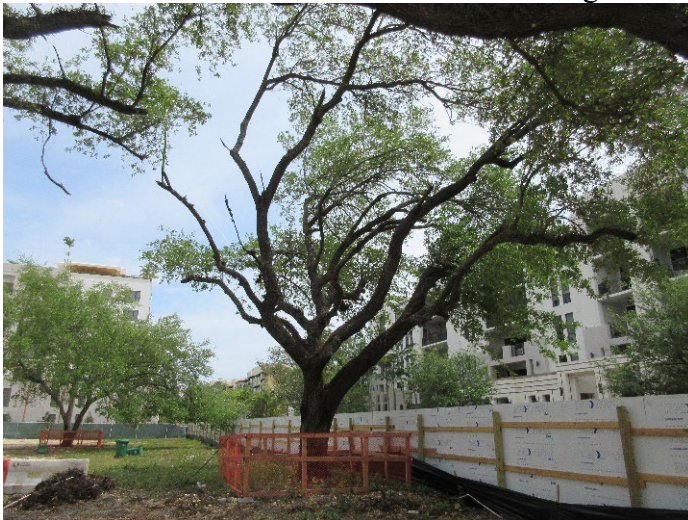
Tree #41 is a live oak with a DBH of 28.8 inches and is approximately 35 to 40 feet in overall height. Its crown spread is approximately 30 feet north-to-south and 50 feet east-to-west. The crown is imbalanced, with only about 8 to 10 feet of the north-south diameter on the north side, and 20 to 22 feet on the south side. The limbs on the north side are bent toward the south, probably due to past shading effects. The east-west diameter is approximately equal on both sides, about 25 feet on each side. A view of the tree from the west looking east is shown below.

Live oak tree #41 is generally in fair to poor condition. It has large dead branches and the crown is imbalanced. It has been improperly pruned on the south side. The presence of root suckers indicates root damage or stress. In its current condition, its potential for successfully surviving relocation would be marginal. For it to survive in a healthy condition, it would require an aggressive treatment program of irrigation, fertilization, and pest control beginning immediately and continuing for at least two to three years following relocation. Even with these treatments, its health might still be marginal.

It is my professional opinion that, while successful relocation of tree #41 may be possible, it is improbable. There are many challenges including its health, the need for an aggressive treatment program for several years, an unbalanced crown which poses a risk of toppling in a high-user area, limited space to place and cable the tree, and the need to remove/relocate up to four healthy, young

trees that already fit the space and have the potential of providing significant environmental and sociocultural benefits for many more years than tree #41. For these reasons, I recommend against relocation of tree #41.

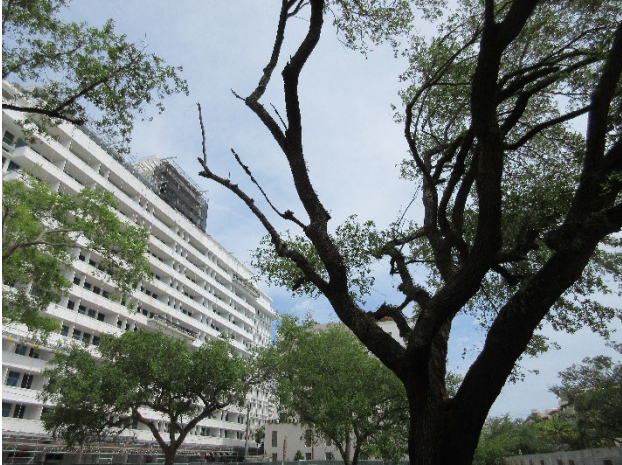
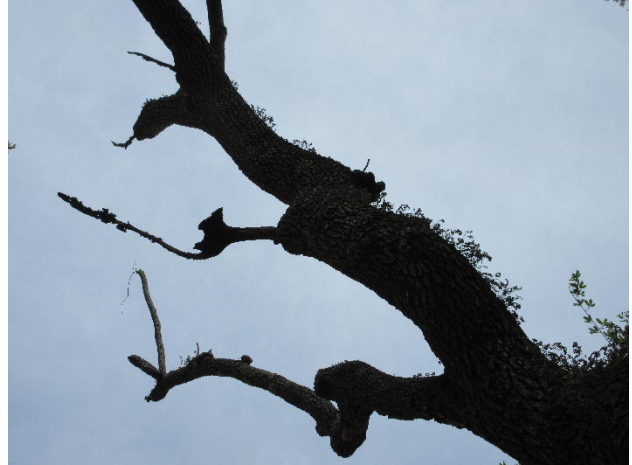
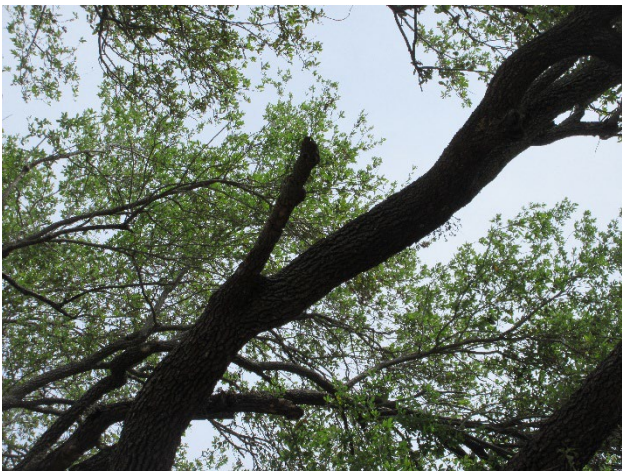
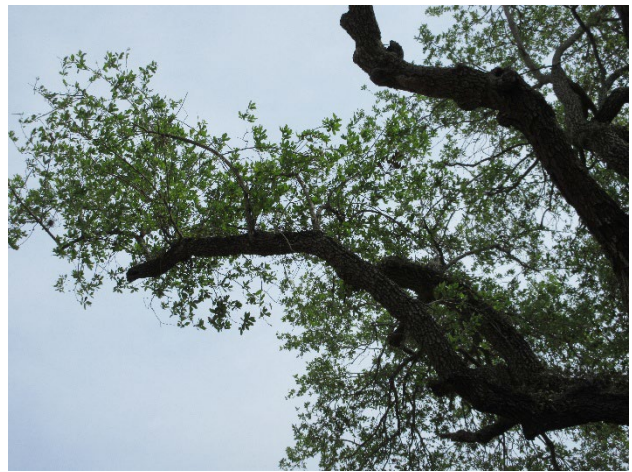
The tree has two large dead limbs on the north side and a dead limb through the center of the crown, growing toward the east.

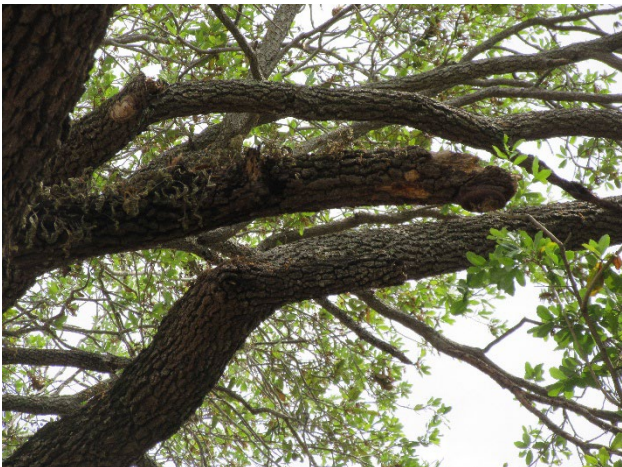
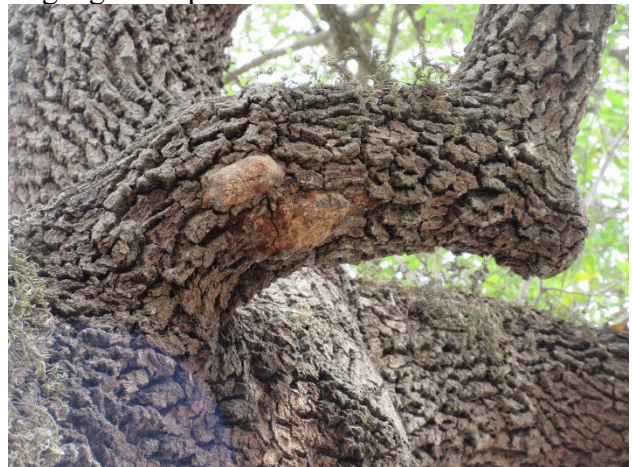
The dead limb in the center of the crown has active fungal growth present.

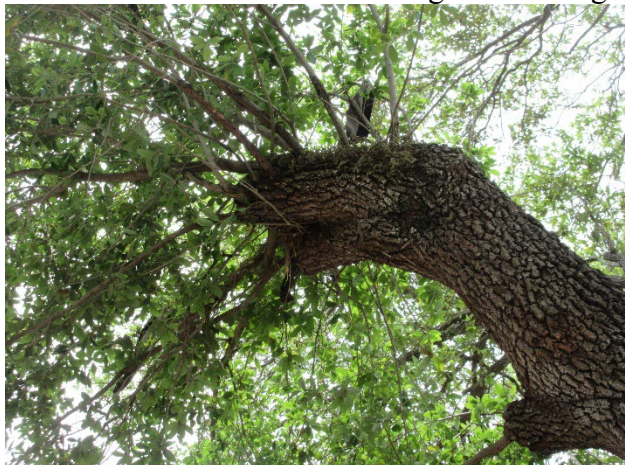
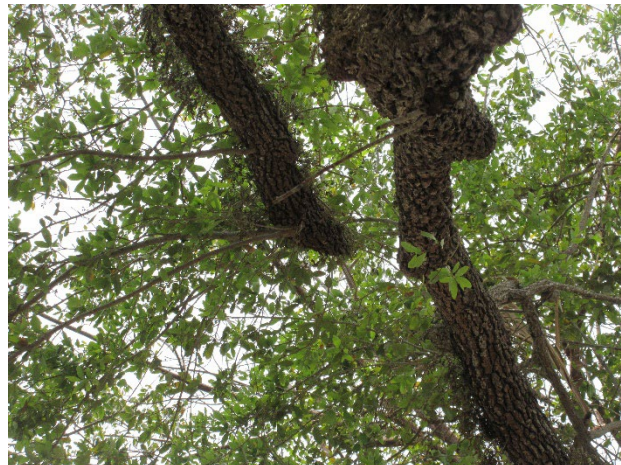
Several branches on the south side, near the street, have been pruned with [improper] heading cuts. There is now extensive “sucker” growth emerging from behind the cuts.

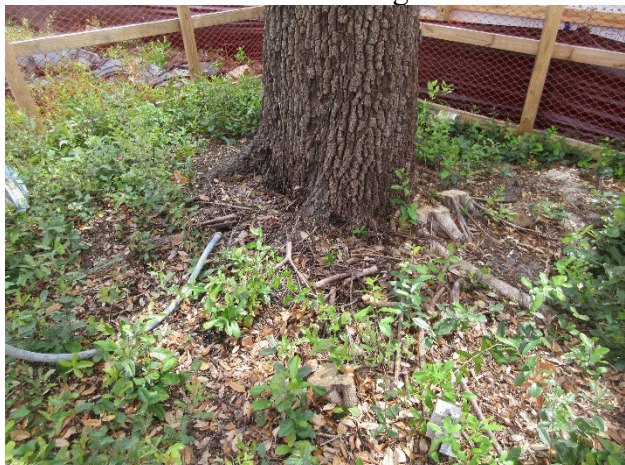
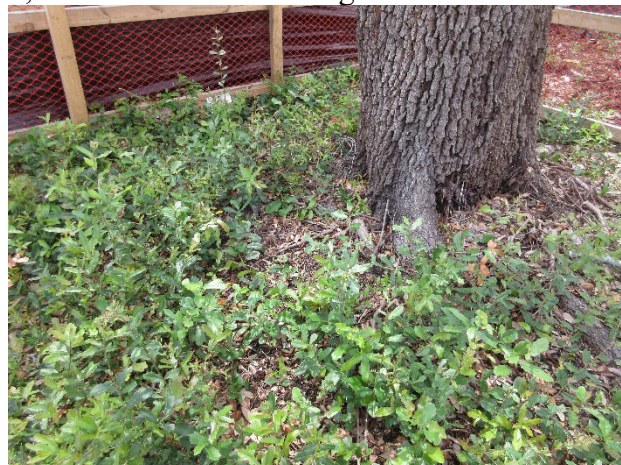
There is abundant root sucker growth beneath the tree, indicative of root damage or stress.

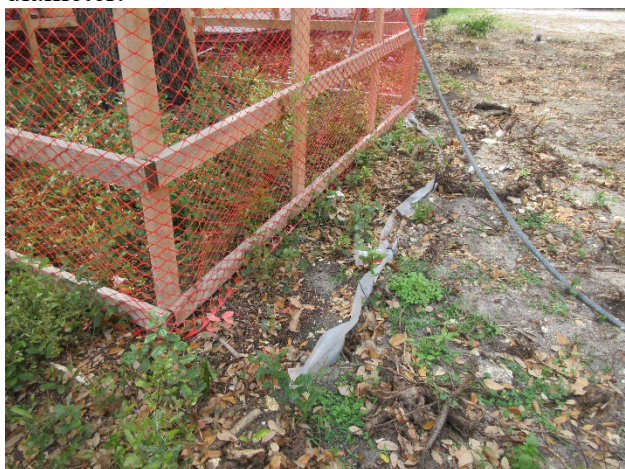
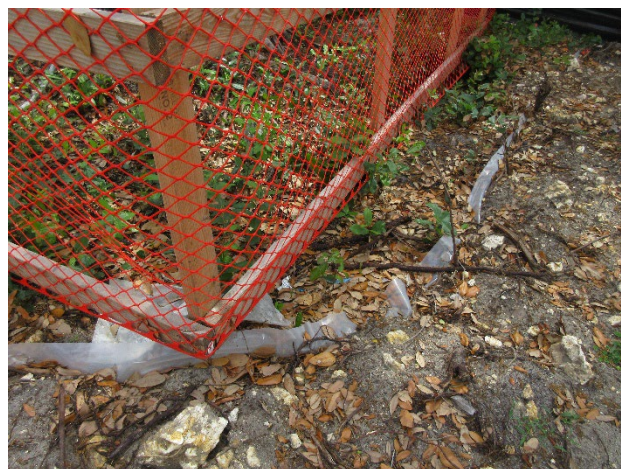
The tree was root-pruned on the north and west sides, reportedly done on January 6, 2025, and on the east side, reportedly on March 18, 2025. The root pruning cuts are approximately 12 to 15 feet in diameter.

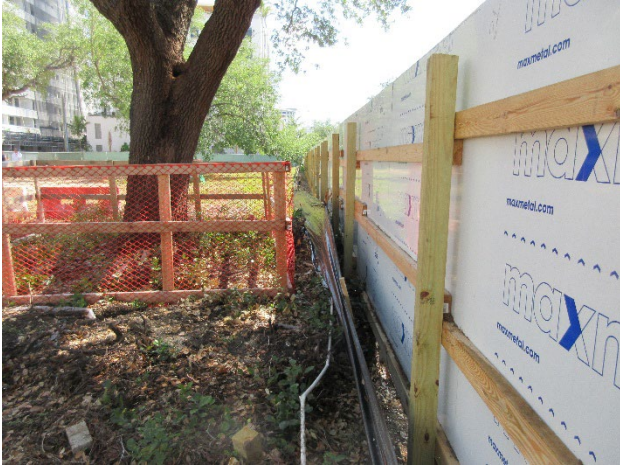
The tree is located about six feet from edge of trunk to the sidewalk on the south side, limiting the potential size of its rootball if relocated.

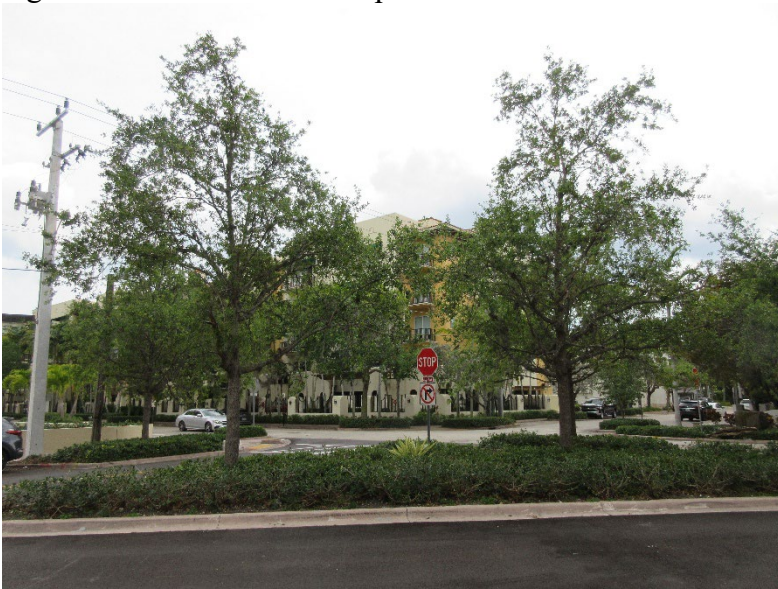
The proposed receiving site for this tree is in the triangular median located at the corner of Valencia Avenue and Cardena Street. In that triangle there are two existing live oak trees about 8 to 10 inches in trunk diameter, with Ficus ‘Green Island’ ground cover beneath. The trees are healthy and vigorous and have been root-pruned on four sides.

The proposed relocation plan calls for tree #41 to be moved to the triangular planter at the corner, which would necessitate removing the two young healthy live oak trees or relocating them elsewhere. The two live oak trees in the bump-out may also need to be removed or relocated in order to avoid a conflict with the crown of tree #41.

Although the four young root pruned trees in the triangle have already been root pruned in anticipation of relocation, they could be left in place “as is” without any significant impact on their long-term health, and it would be less stressful than relocating them elsewhere.

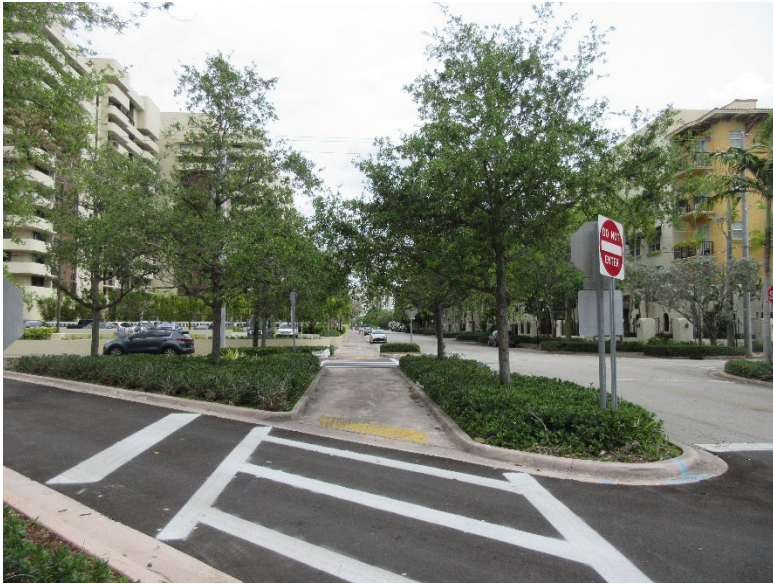
On the south side of the triangle is a sidewalk, with two healthy live oak trees, also about 8 to 10 inches in diameter, in the adjacent bump-out. They have been root-pruned on four sides. Their crowns are beginning to touch those of the two trees in the triangle, and starting to form a “tunnel” over the sidewalk. See photo next page.

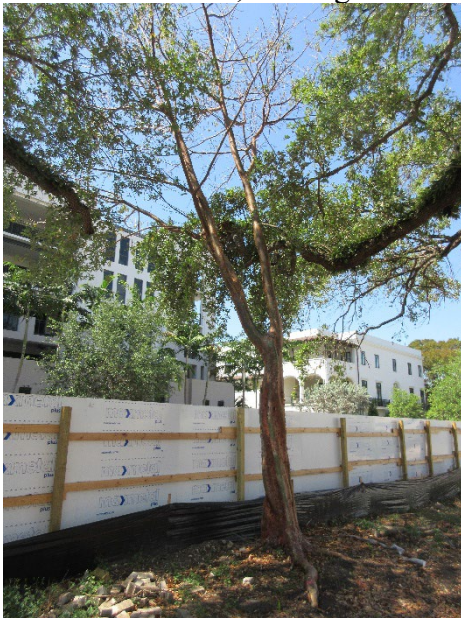
Tree #45 is a gumbo limbo (*Bursera simaruba*). Its trunk measures 14 inches in diameter and it is approximately 25 feet in overall height. Its crown spread is approximately 18 feet north-to-south and 15 feet east-to-west. The crown is imbalanced, with only about 6 feet of the north-south diameter on the north side and 12 feet on the south side. The east-west crown diameter is roughly equal. The tree can be seen below, looking from northeast to southwest.

The tree is currently dormant, but healthy. As a species, gumbo limbo is highly tolerant of relocation and due to its species, size, and condition, this tree is a good candidate for on- or off-site relocation.

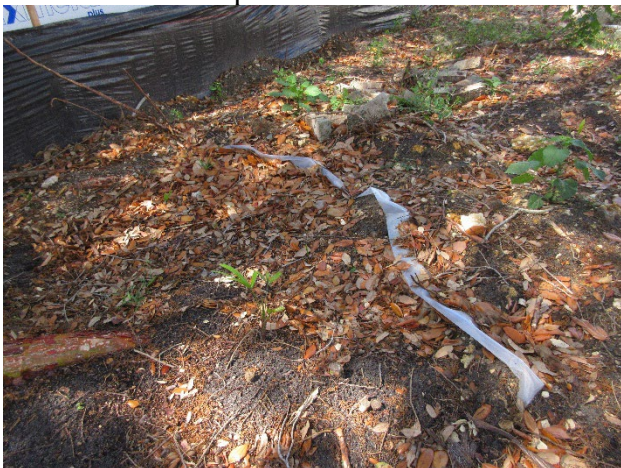
The tree was root pruned on the northeast side on January 6, 2025.

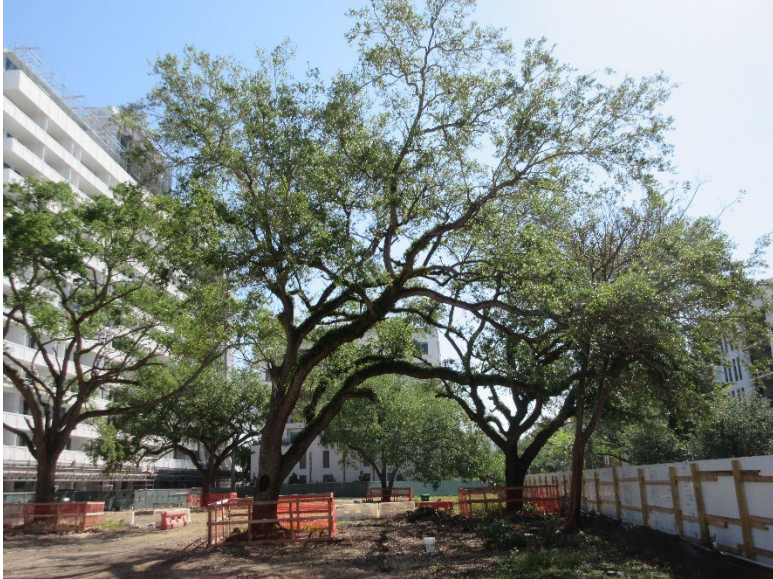
Tree #46 is a live oak with a DBH of 29.0 inches and is approximately 35 to 40 feet in overall height. Its crown spread is approximately 58 feet north-to-south and 50 feet east-to-west. The crown is imbalanced, with only about 10 feet of the north-south diameter on the north side, and 48 feet on the south side. The east-west diameter is approximately equal on both sides, about 25 feet on each side. A view of the tree from the west looking east is shown below.

Live oak tree #46 is generally in fair to poor condition. It has many dead branches and the crown is imbalanced. Its root system may have been compromised by growing in close proximity to structures. In its current condition, its potential for successfully surviving relocation would be marginal. For it to survive in a healthy condition, it would require an aggressive treatment program of irrigation,

For these reasons, it is my professional opinion that tree #46 should not be relocated.

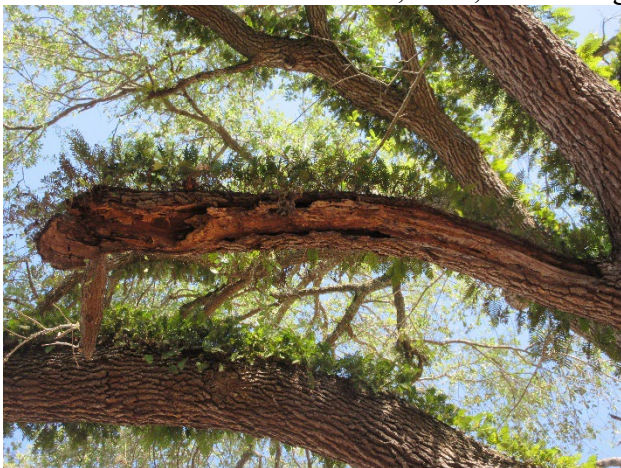
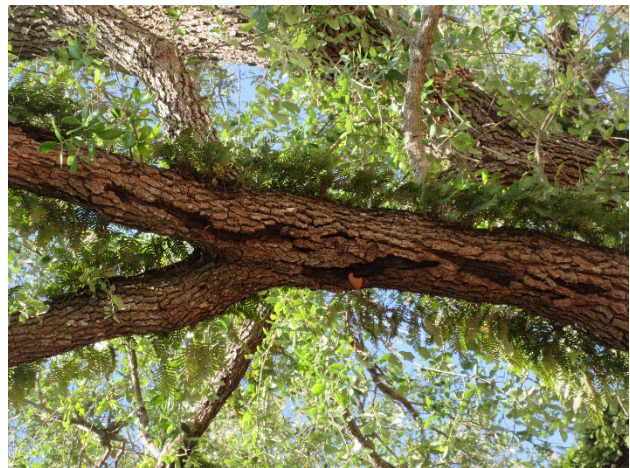
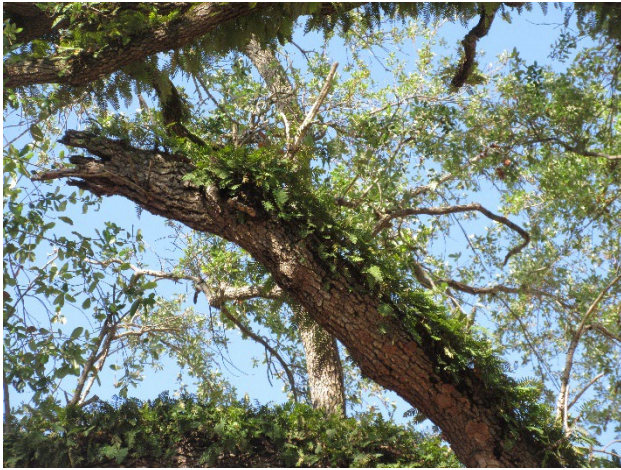
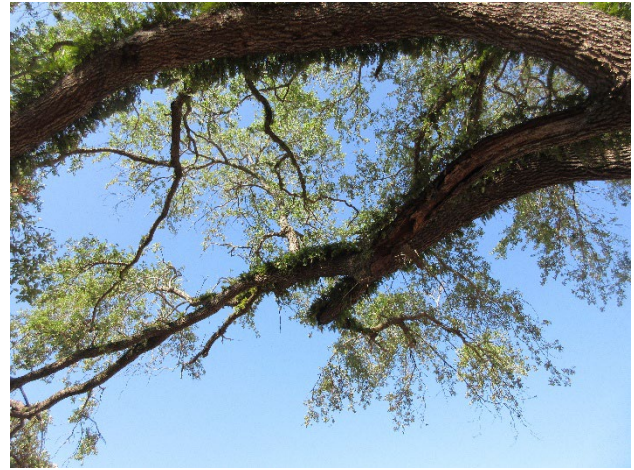
This tree has numerous broken, dead, and damaged limbs and branches.

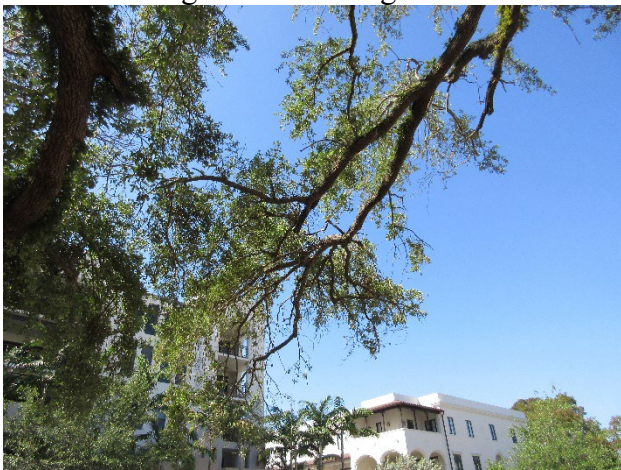
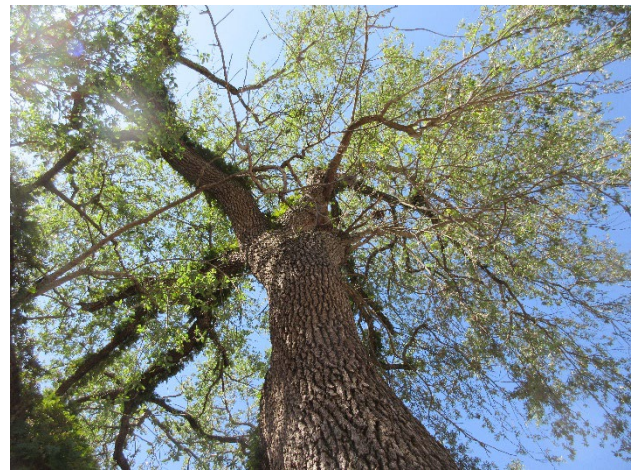
It also has twig dieback throughout the crown.

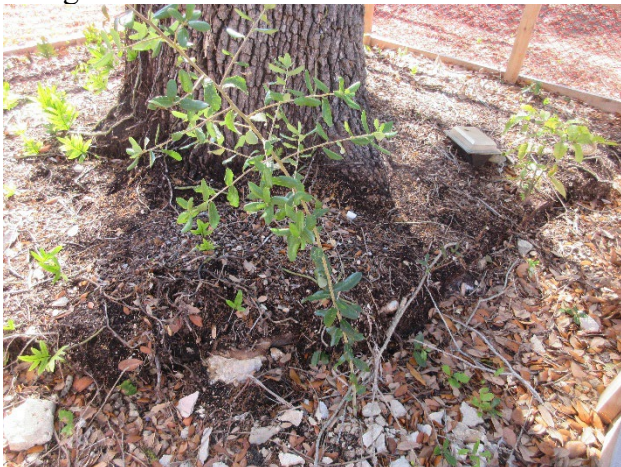
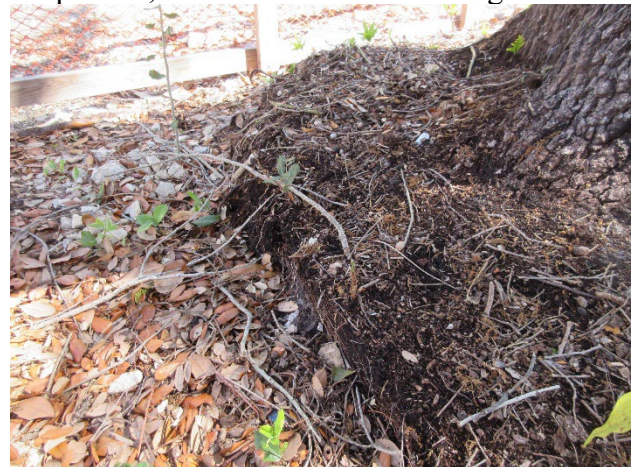
There appears to have been a structure immediately adjacent to its trunk, as there is a linear grade change on two sides of the tree. A few root suckers are present, an indicator of root damage or stress.

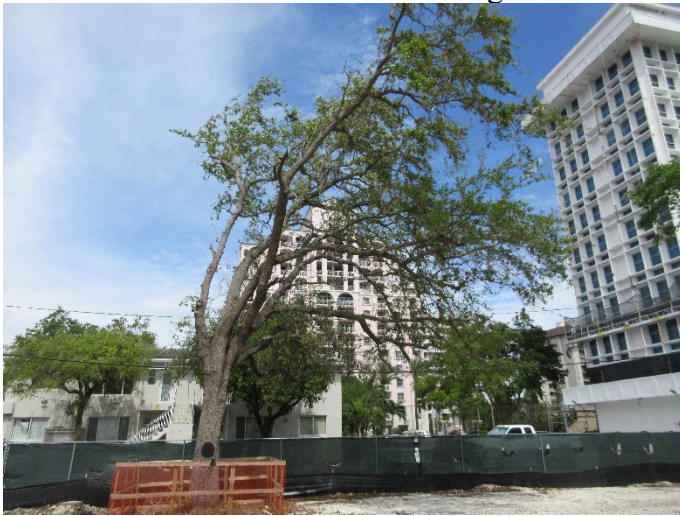
Tree #56 is a live oak with a DBH of 25.3 inches and is approximately 35 to 40 feet in overall height. Its crown spread is approximately 37 feet north-to-south and 32 feet east-to-west. The crown is imbalanced, with only about 6 to 8 feet of the east-west diameter on the west side, and 25 feet on the east side. The limbs on the west side are bent toward the east, probably due to past shading effects. The north-south diameter is approximately equal on both sides, about 18 to 20 feet on each side. A view of the tree from the south looking north is shown below.

Live oak tree #56 is generally in fair to poor condition. It has many dead branches and the crown is imbalanced. In its current condition, its potential for successfully surviving relocation would be marginal. For it to survive in a healthy condition, it would require an aggressive treatment program of irrigation, fertilization, and pest control beginning immediately and continuing for at least two to three years following relocation. Even with these treatments, its health might still be marginal.

For these reasons, it is my professional opinion that tree #56 should not be relocated.
