**LISA H. HAMMER, RCA**  
*Horticultural Consultant*

March 31, 2025

RE: 737 Valencia Avenue  
Coral Gables, Florida 33134

We met at the above-referenced property on March 10, 2025, and again on March 26, 2025, where you requested that I evaluate the condition and relocation potential of six live oak trees (*Quercus virginiana*), #14, #20, #30, #41, #46 and #56, and one gumbo limbo tree (*Bursera simaruba*) #45, as shown on the Tree Survey/Disposition Plan you provided (de la Guardia Victoria Architects & Urbanists, Inc. Permit Set 11-25-24. Sheet LA-02). My report follows.

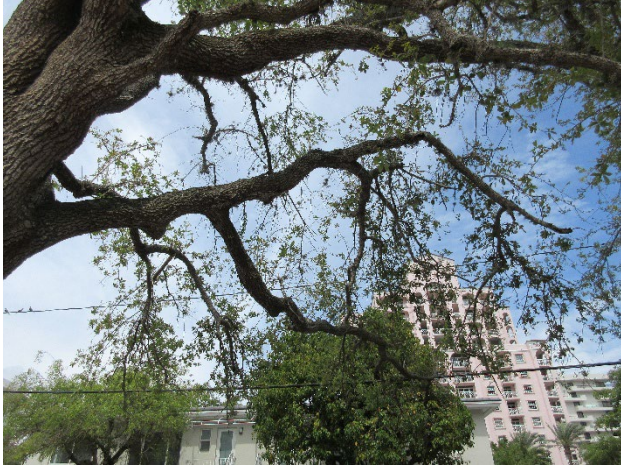
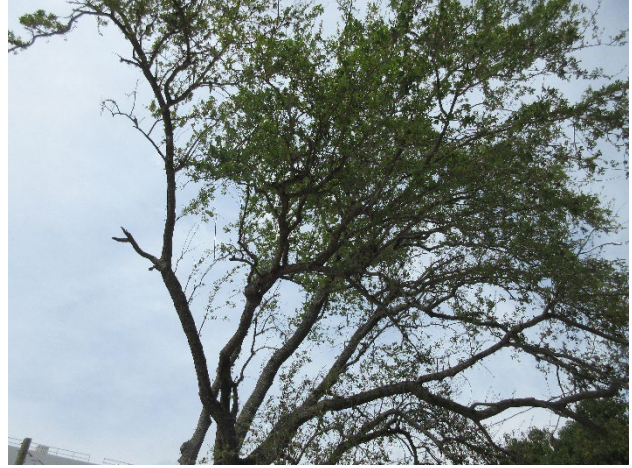
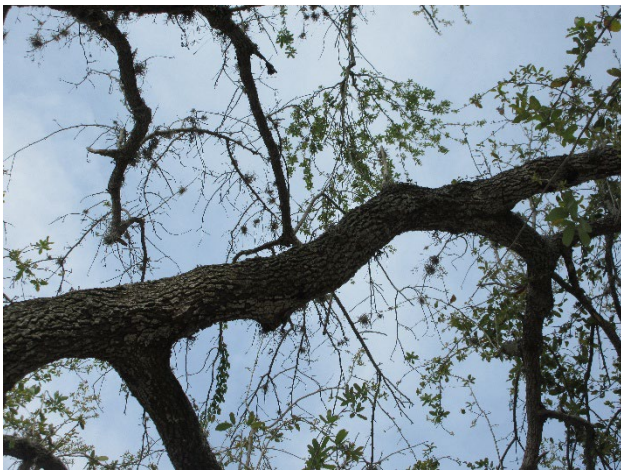
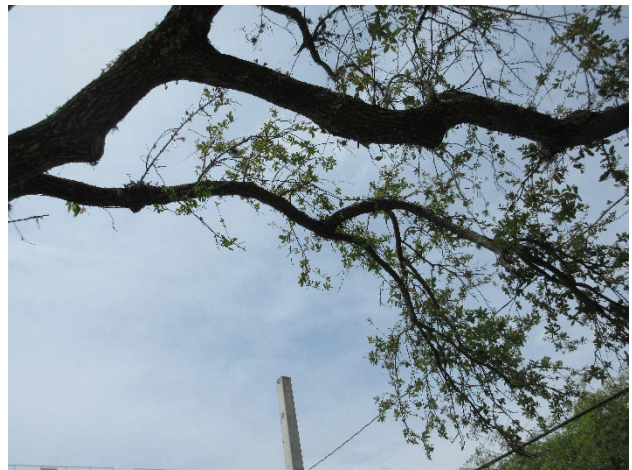
There are numerous dead branches and significant twig dieback.
