Subject: Structural Evaluation – Opinion Letter
1258 Obispo Avenue
Gable, Florida 33134

We are pleased to present this opinion letter regarding forensic engineering consulting services completed at the subject residence. This letter has been generated as requested by you and presents our opinion of the conditions of the following structural components at the subject residence.

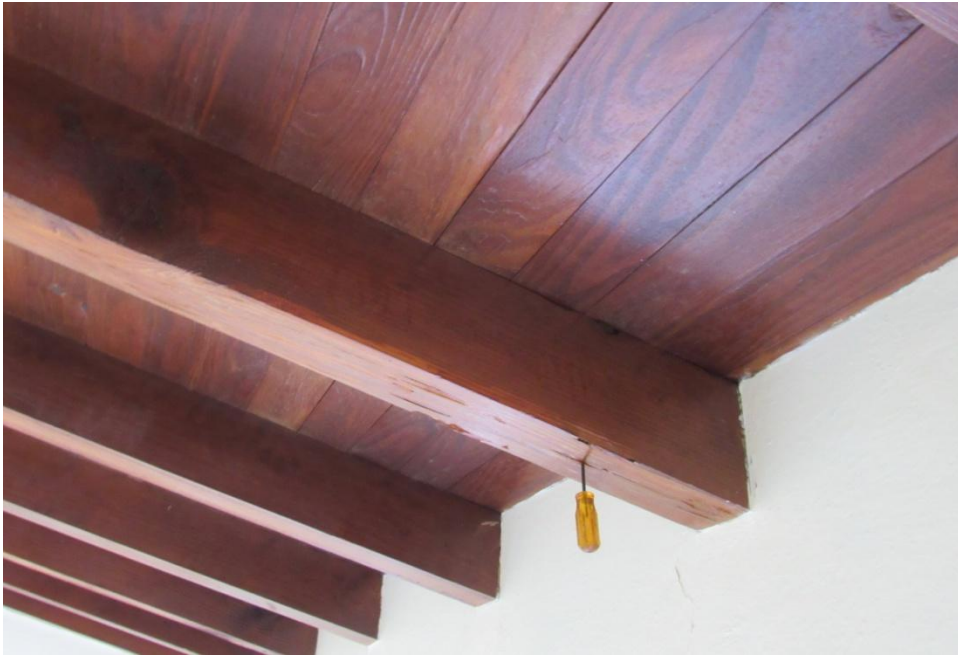
View of distressed roof joist due to termite infestation.

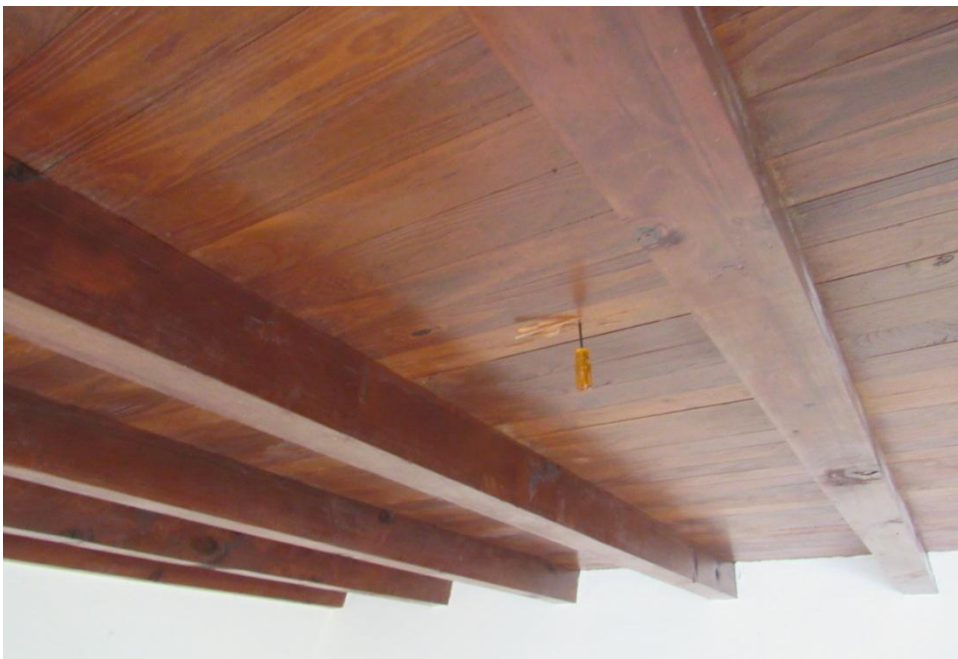
View of distressed roof plank due to termite infestation.

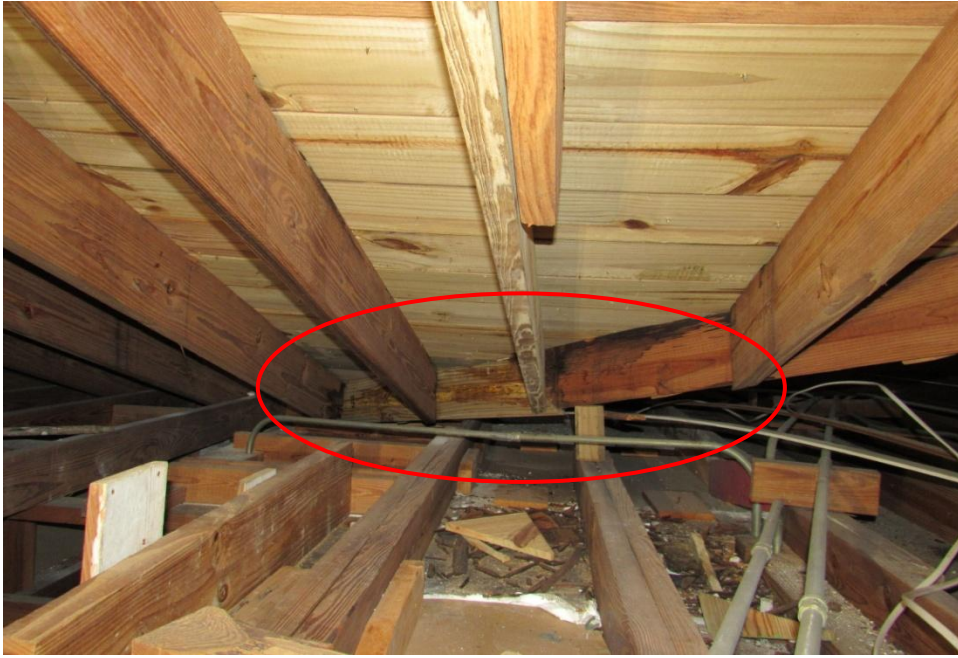
View of distressed rafter (local failure) due to water intrusion.

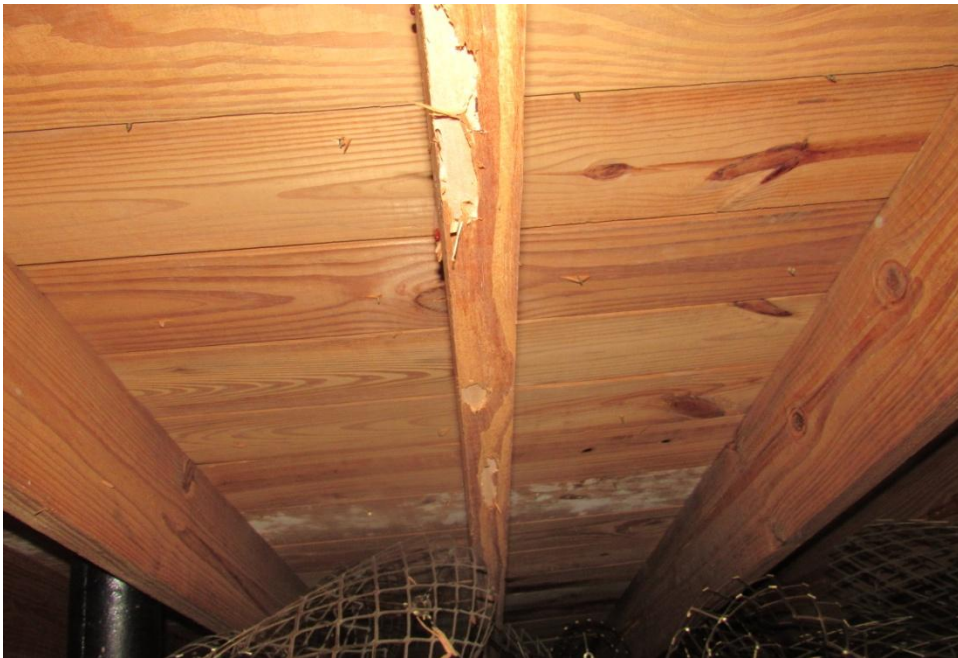
View of distressed roof joist due to termite infestation.

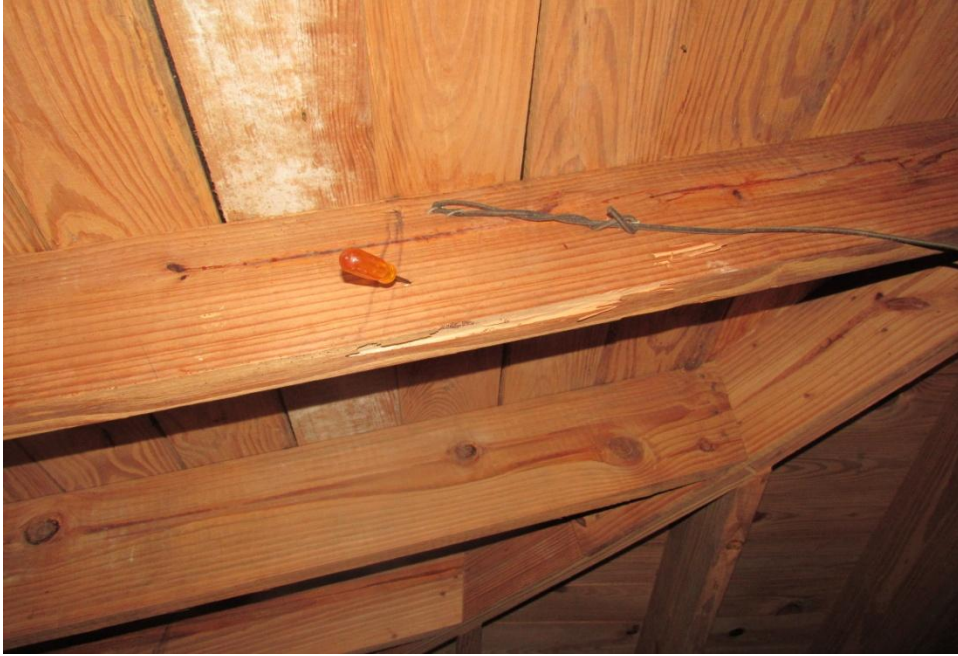
View of distressed roof joist due to termite infestation.

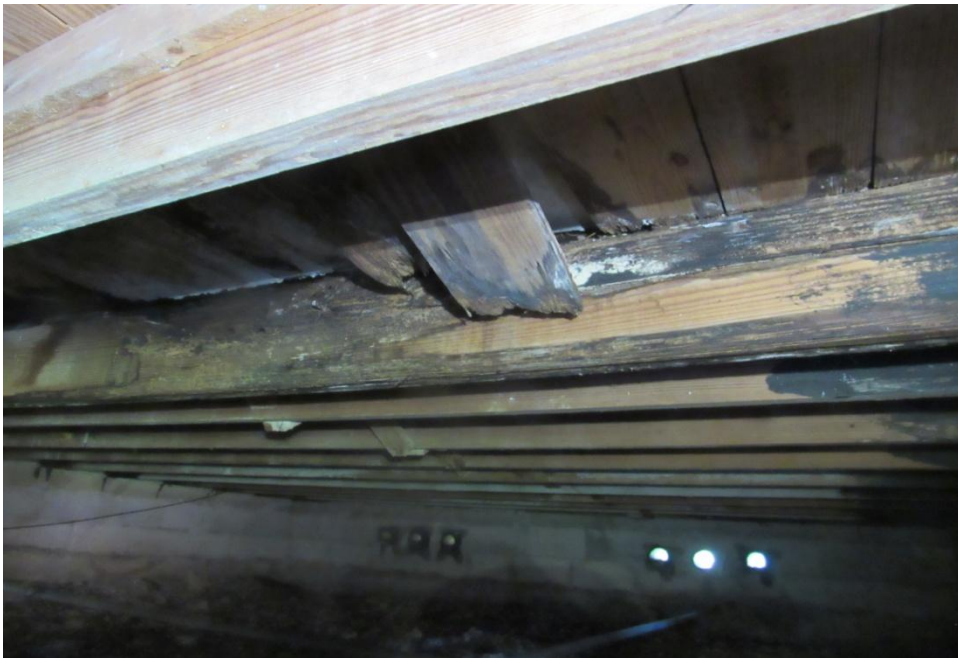
View of distressed (local failure) subfloor planks and joists due to water intrusion.

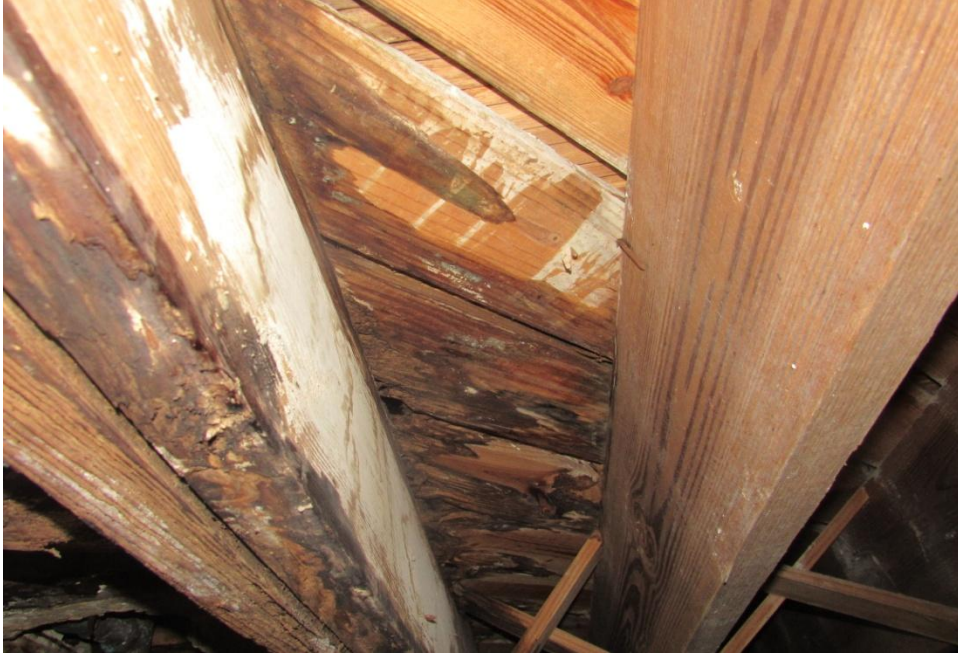
View of distressed (local failure) subfloor planks and joists due to water intrusion.

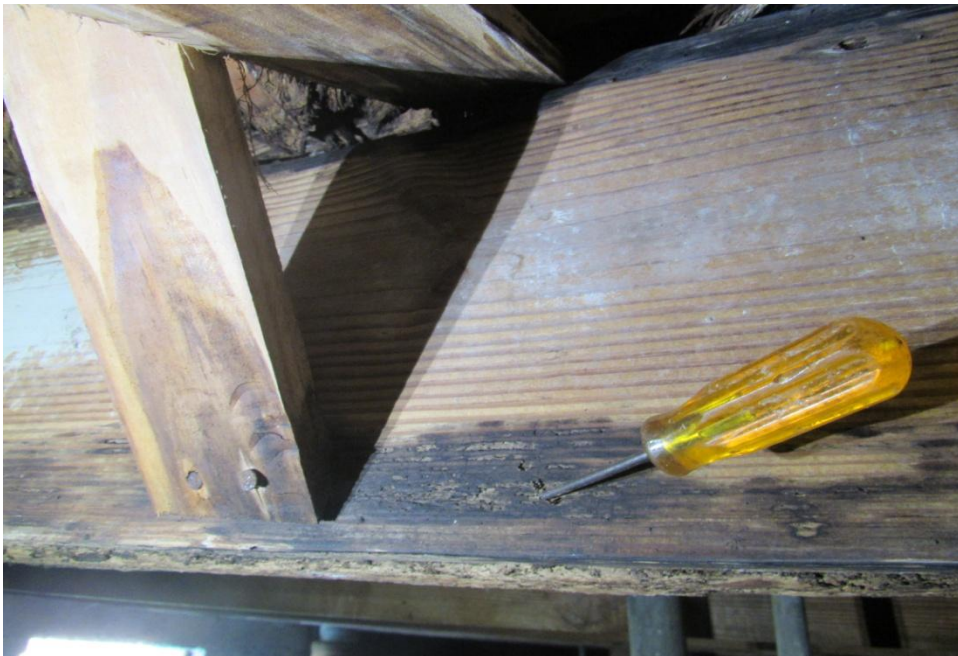
View of distressed subfloor joist due to termite infestation.

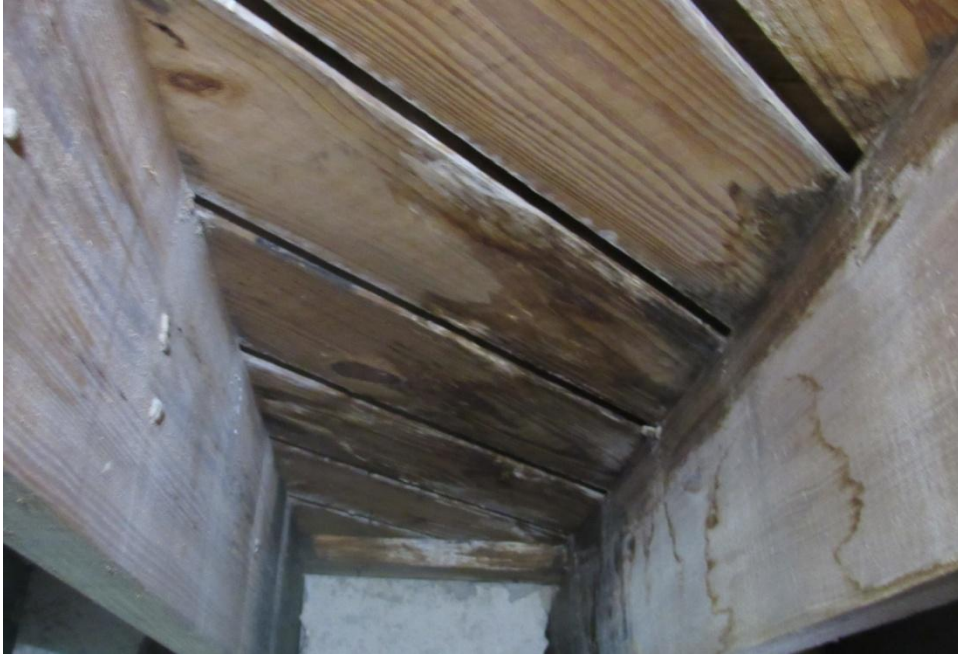
View of distressed subfloor planks and joists due to water intrusion.

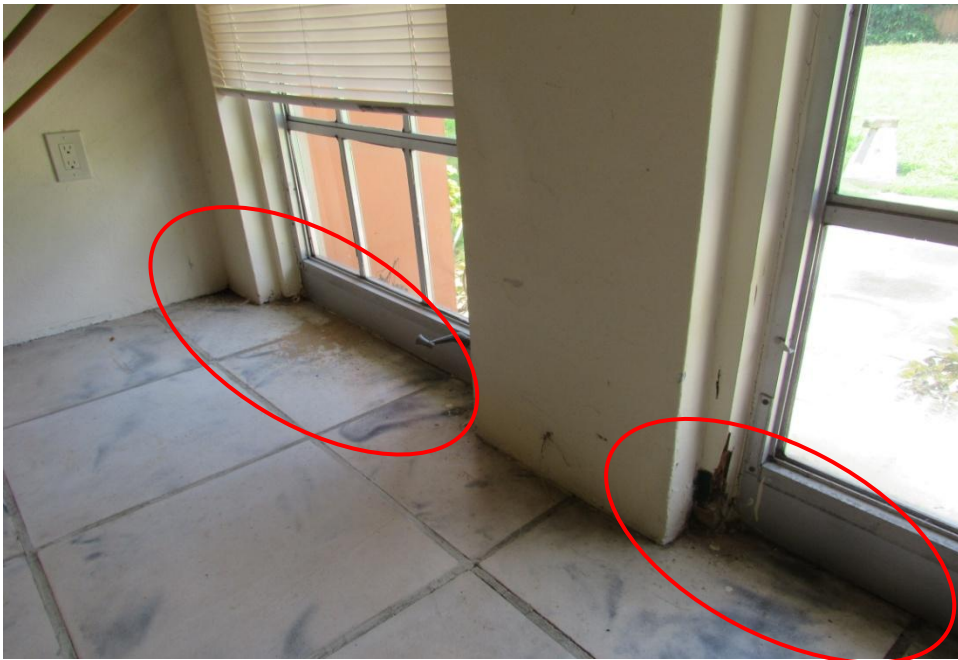
View of termite infestation evidence throughout the residence's interiors

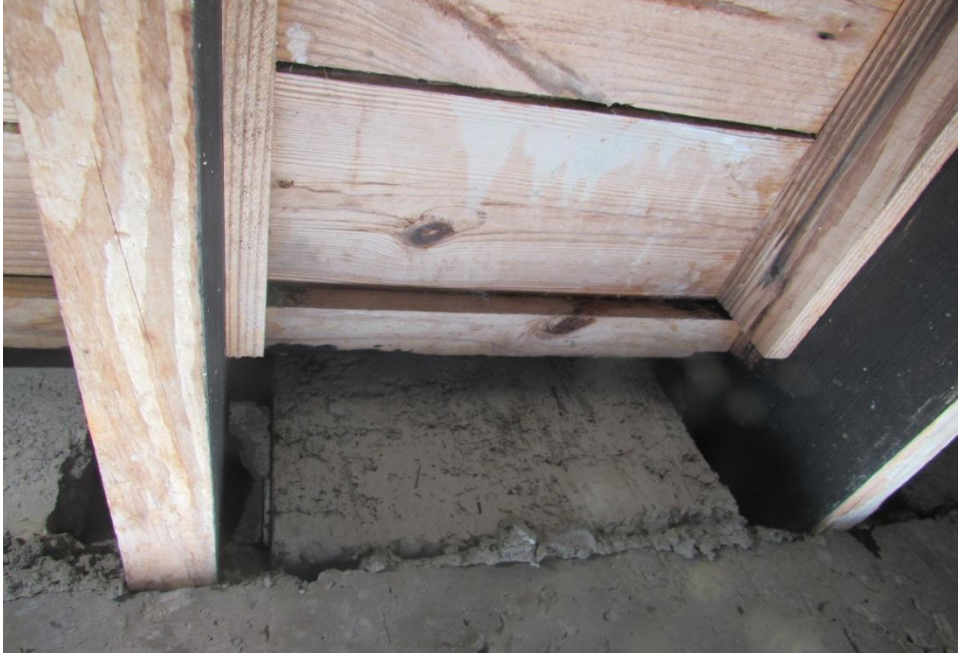
View of subfloor framing lacking structural connection to the foundation system.

In addition, during our investigation, we found that the subfloor framing was not connected to the foundation system of the residence. Typically, the subfloor framing structure acts as a diaphragm as part of the lateral-load resisting system of the residence structure. Therefore, it must be properly connected to the foundation system in order to transfer the lateral loads to the foundation system as well as adequately resist the uplift forces.

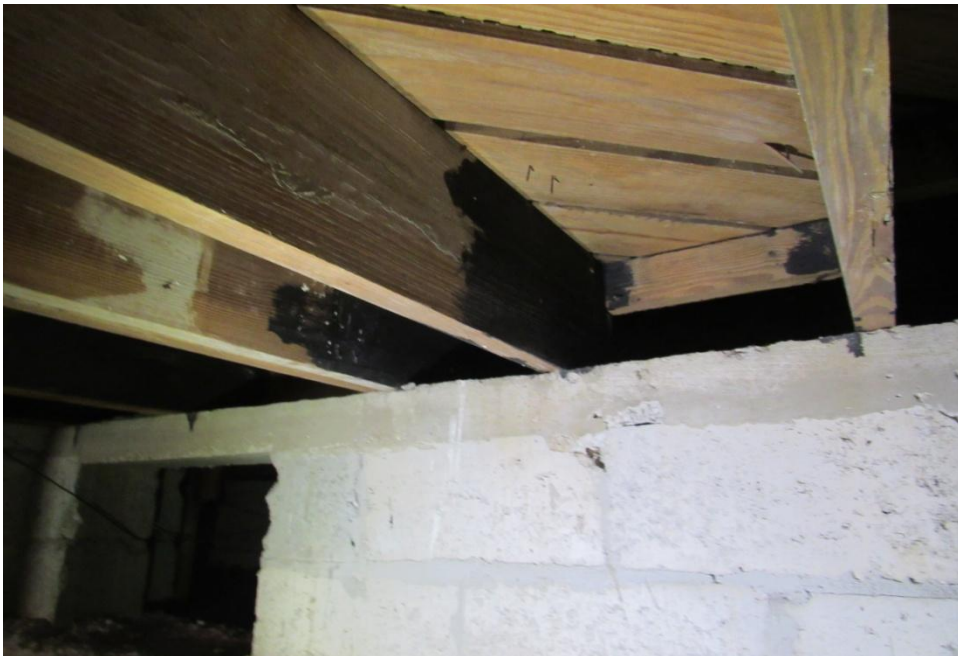
View of subfloor framing lacking structural connection to the foundation system.
