ISA ARBORIST, LLC

Arborist Report (Royal Poincianas)
1144 Milan Ave
Coral Gables, FL 33134

The purpose of this report is to provide the results of my examination/findings and condition rating for the (3) *Delonix regias*/Royal Poincianas located at 1144 Milan Ave, Coral Gables, FL 33134, Folio 03-4107-018-2950 during my onsite visit. This property is located within Miami-Dade County. This report is not intended to be a tree risk assessment report and should not be interpreted in any manner.

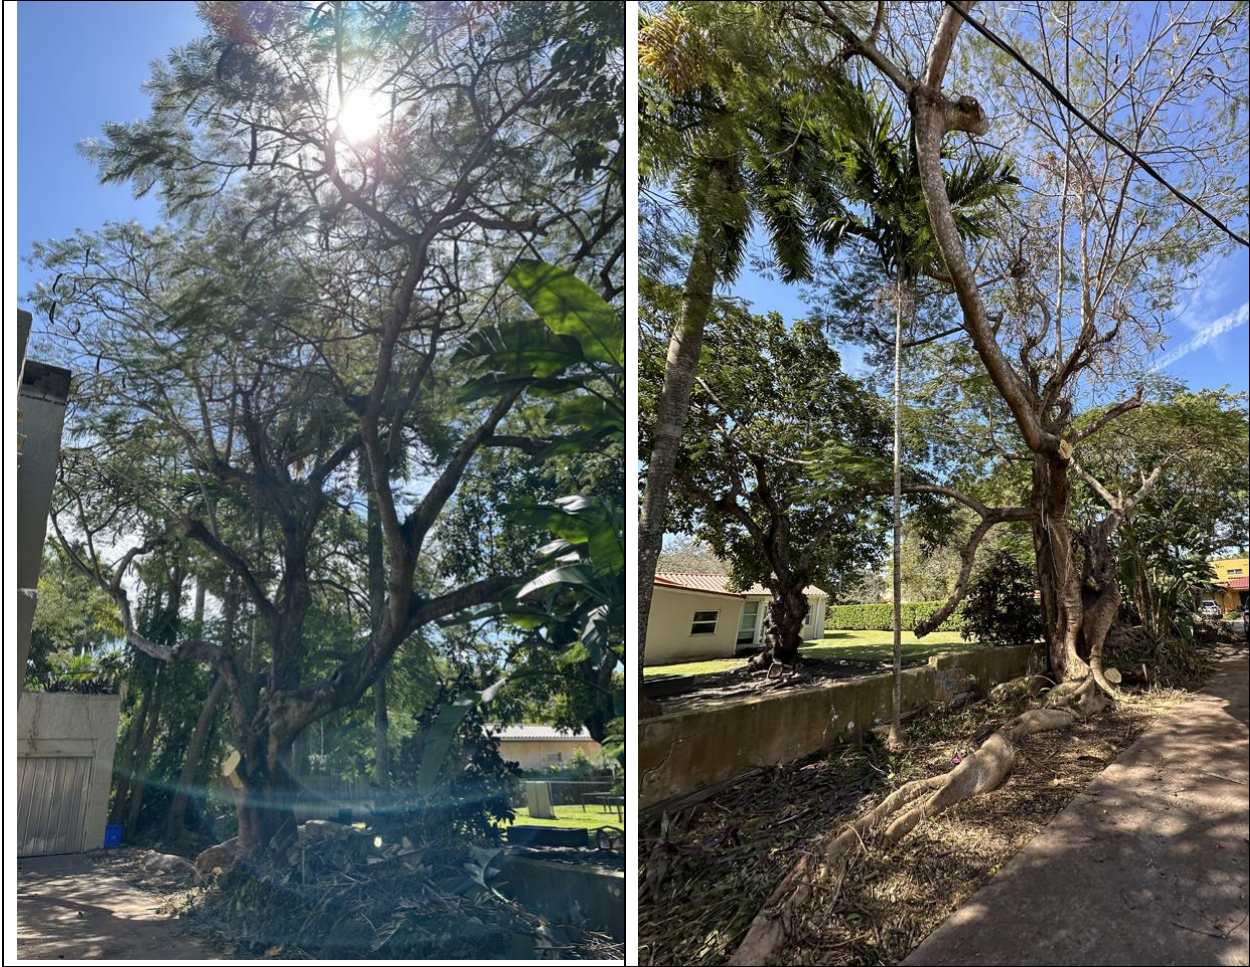
Tree #1 Royal Poinciana, 41 in DBH, 30 ft height, 55 ft canopy spread.

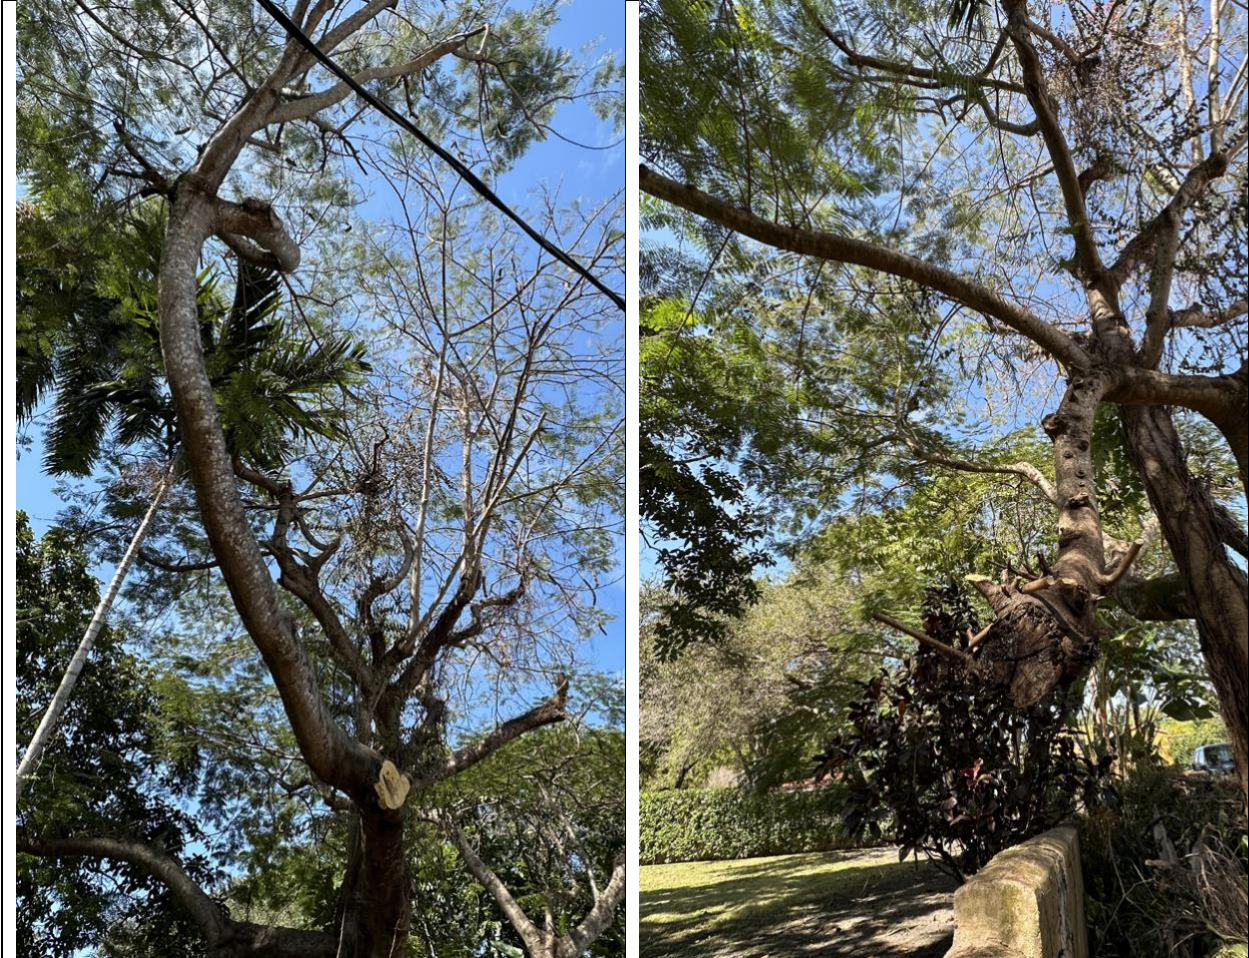
Approximate 6 in DBH lateral limb pruned (photo on left). Old pruning cuts and dead branches in upper canopy (photo on left). Water sprouts forming on old broken branch extending over into adjacent property. I did not access the neighboring property for better views and photos from West to East view.

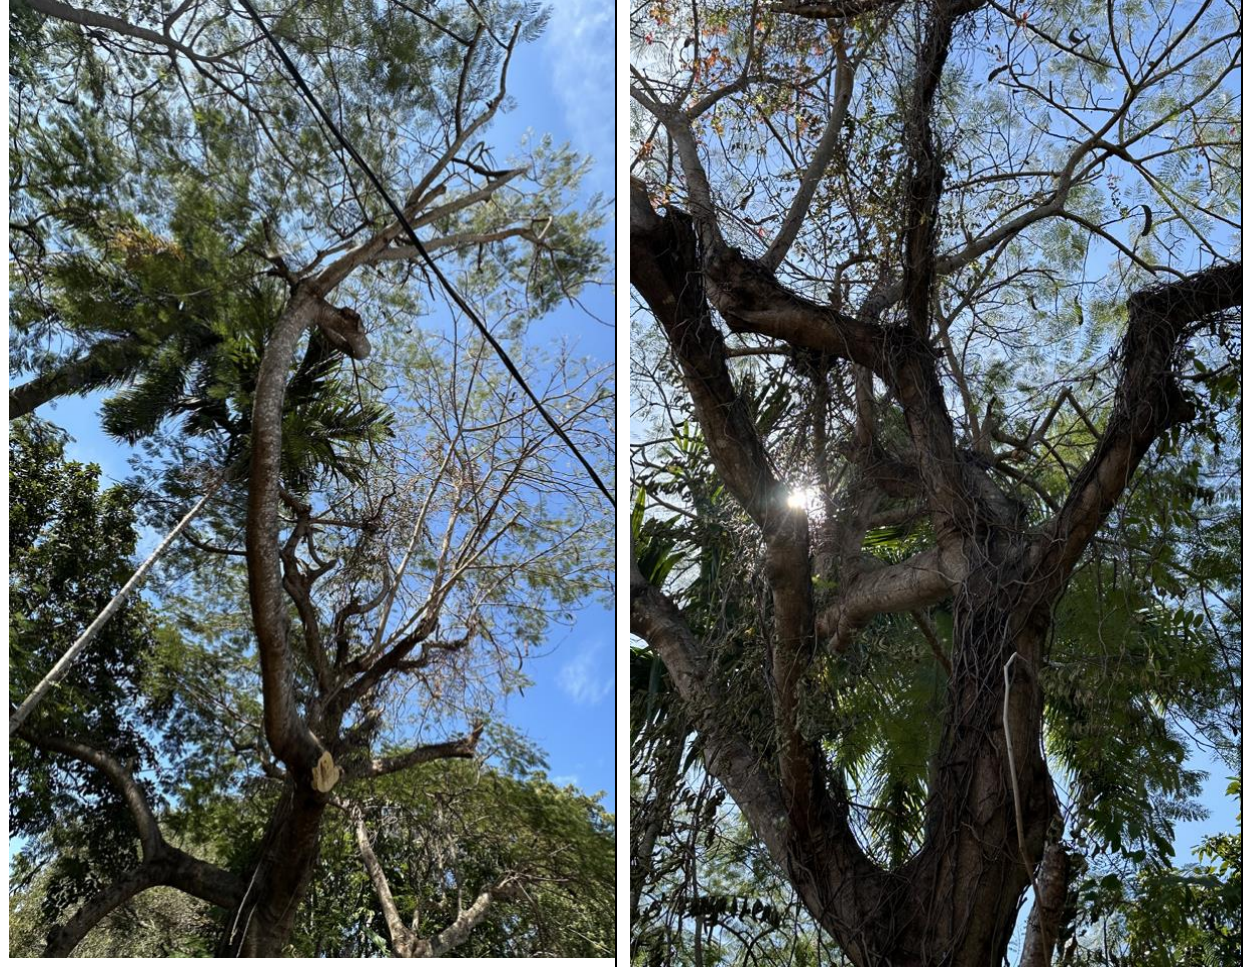
Thin, unbalanced canopy (photo on left). Broken lateral limb in upper canopy and areas of decay (photo on right).

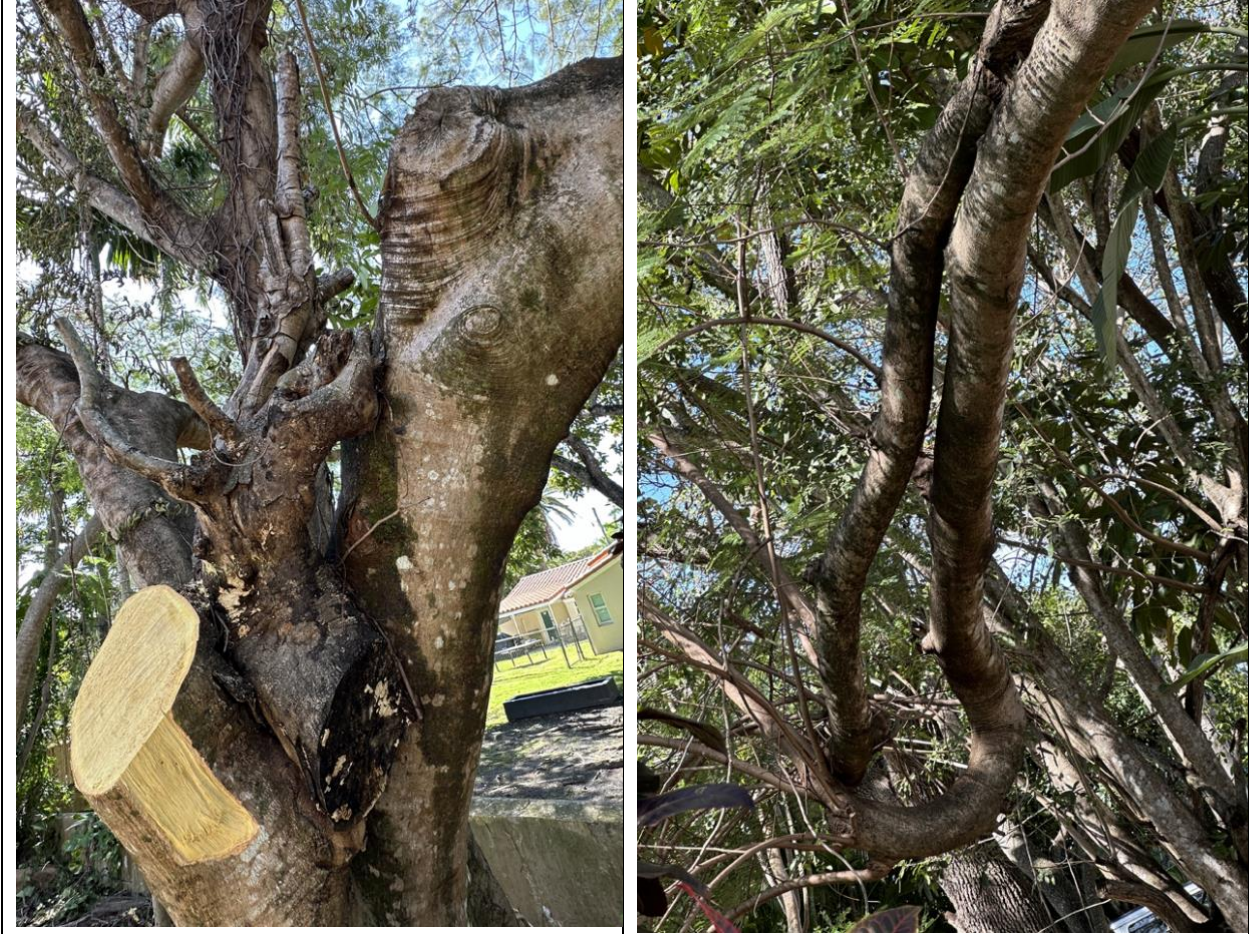
14 in DBH lateral limb that previously extended over driveway and house that was pruned (photo on left). Additional water sprouts on lateral limb extending over adjacent property to the West from previously broken branches.

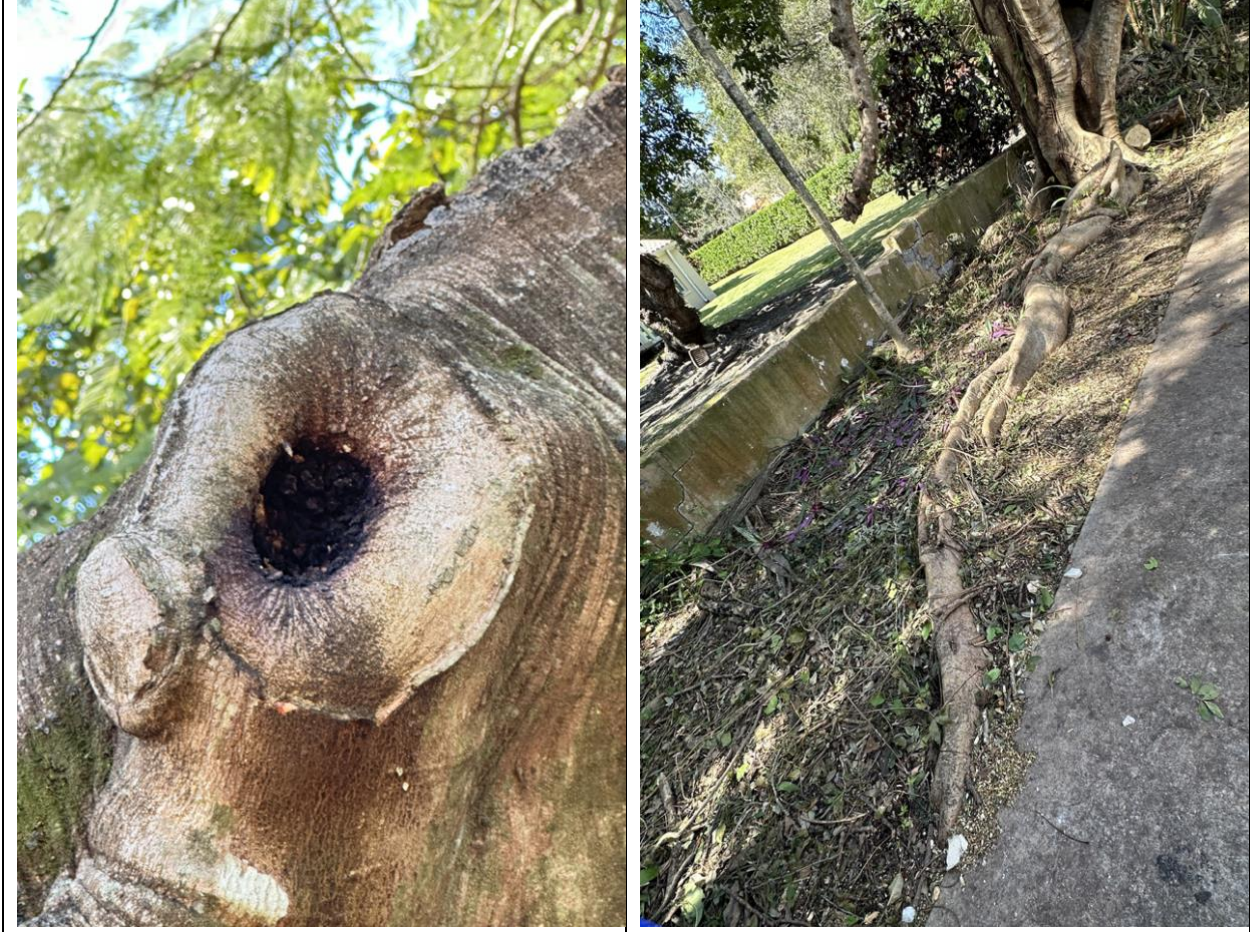
Dead wood on old pruning wound that did not heal over properly with some decay (photo on left). 23 ft Buttress root extended to garage (photo on right) and lifting driveway.

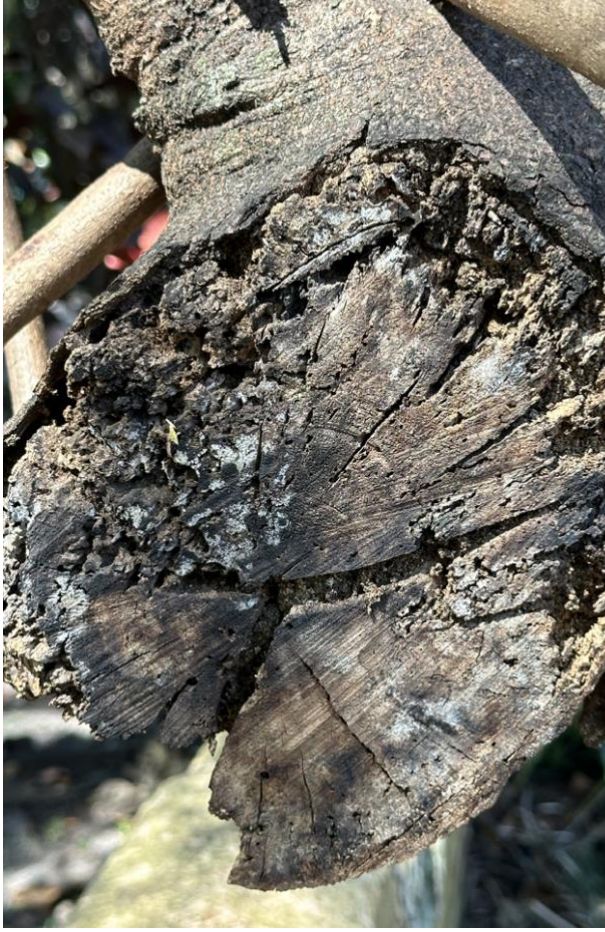
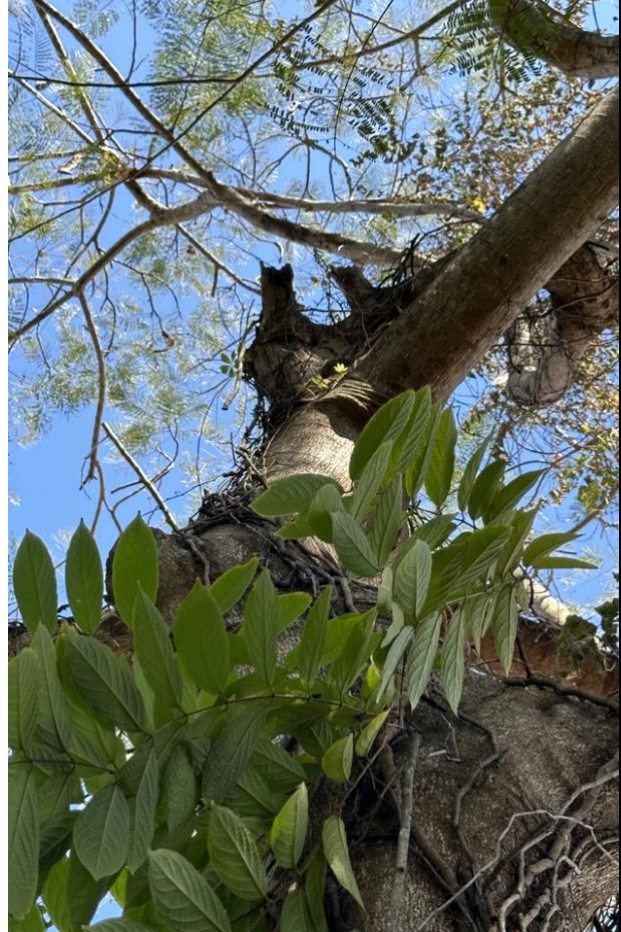
Old pruning cut that did not heal properly with area decay and evidence of termite damage (photo on left). Upper canopy with broken lateral limbs (photo on right).

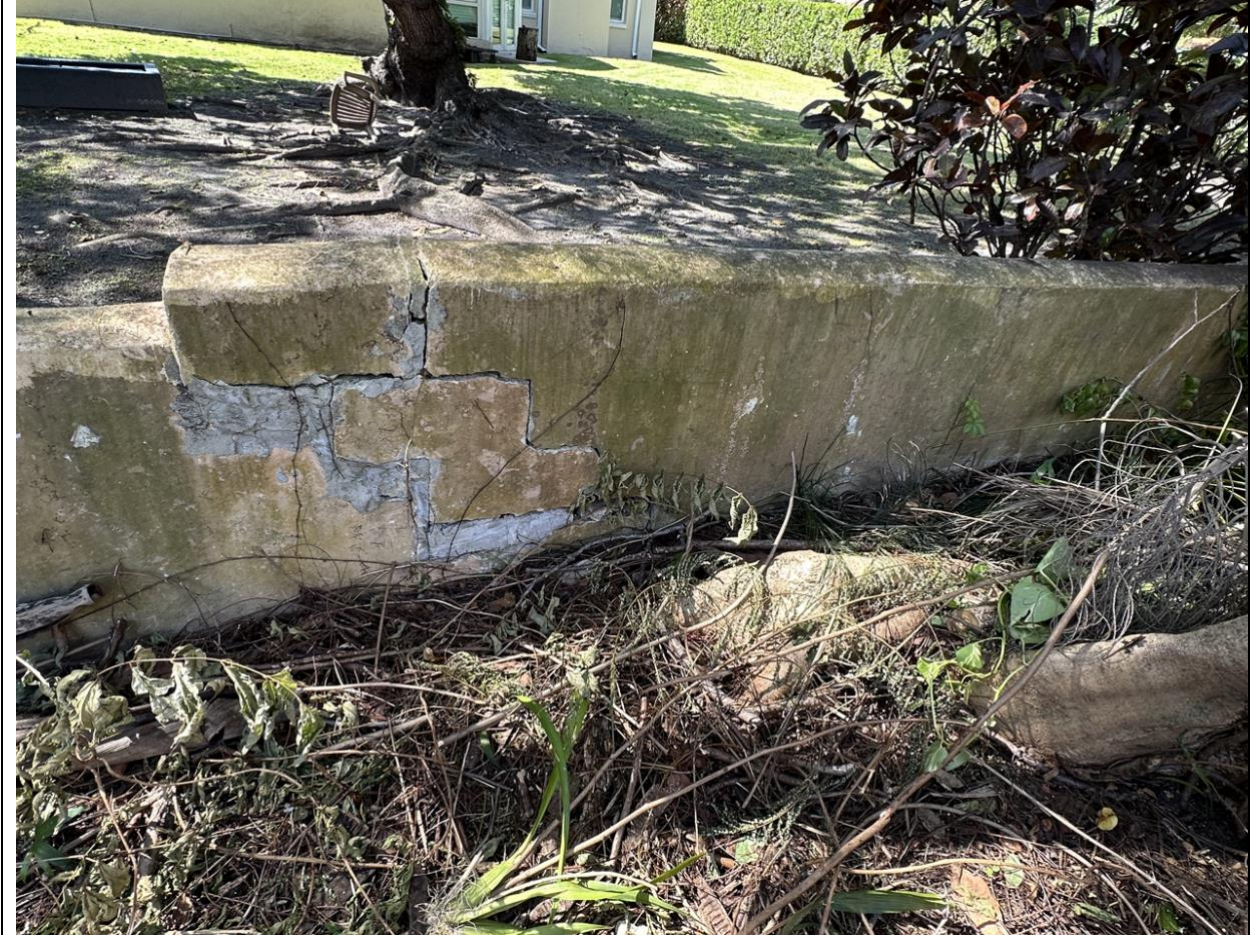
Large buttress root lifting and causing cracking in concrete wall.

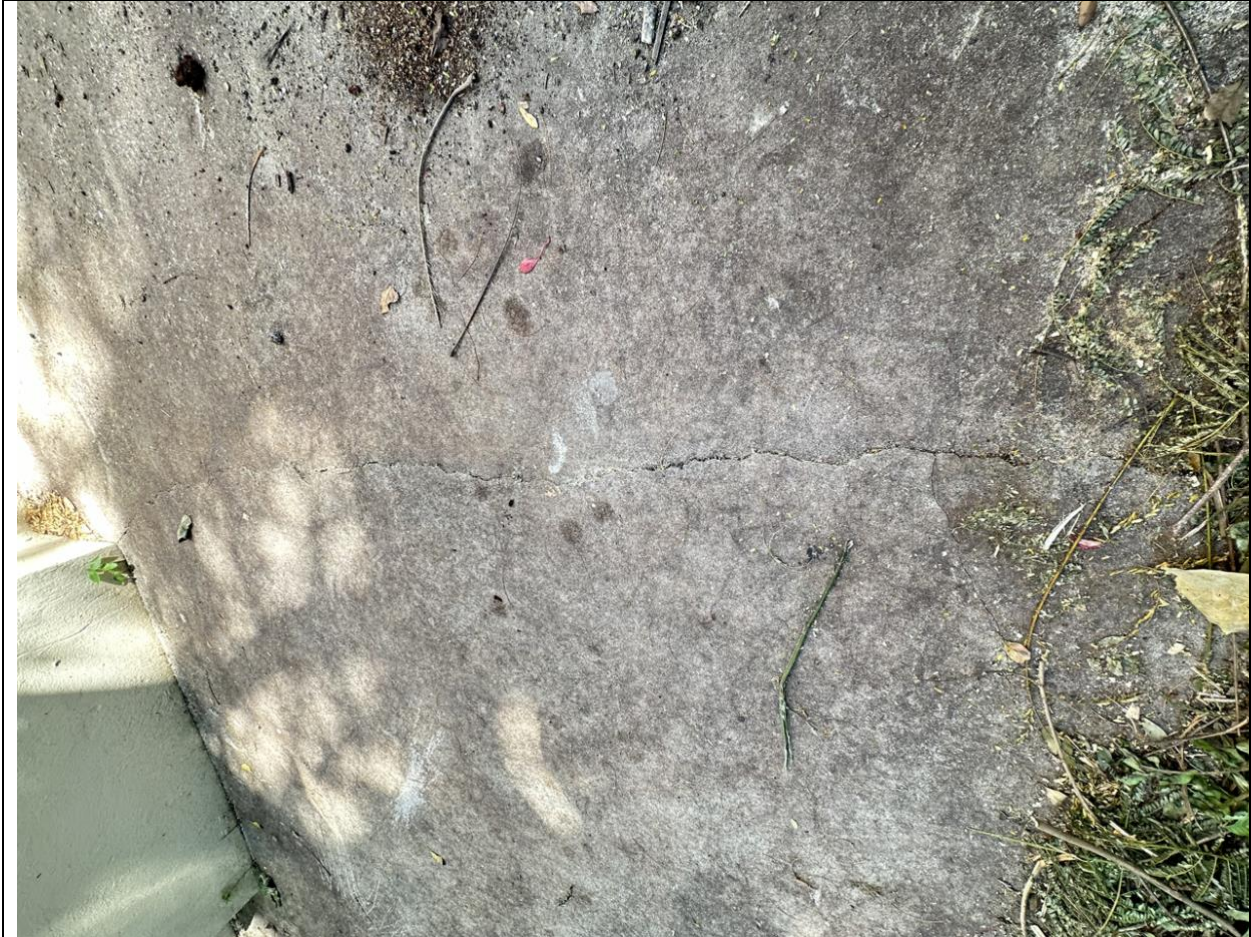
Crack that extends across the width of the driveway (approximately 9.5 ft wide driveway).

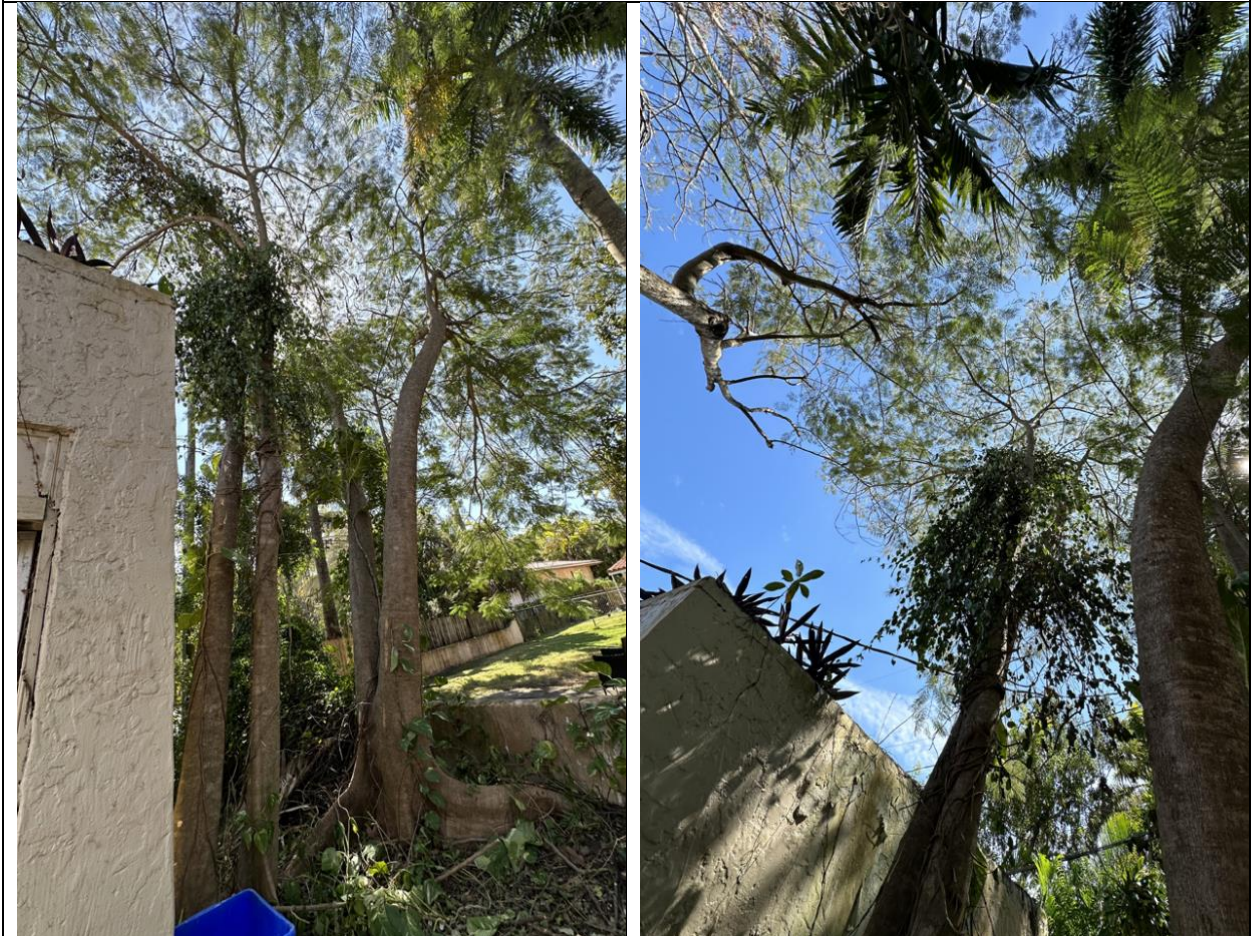
Tree #2 and #3 Royal Poincianas.

Tree #2 Royal Poincinana (tree on the left in both photos) has codominant leaders. One being 9.5 inches DBH and the other being 8.5 inches DBH.

Tree #3 Royal Poinciana (tree on right in both photos) has codominant leaders. One being 13 inches DBH and the other being 14 inches DBH and a third, smaller leader at 4 inches DBH.

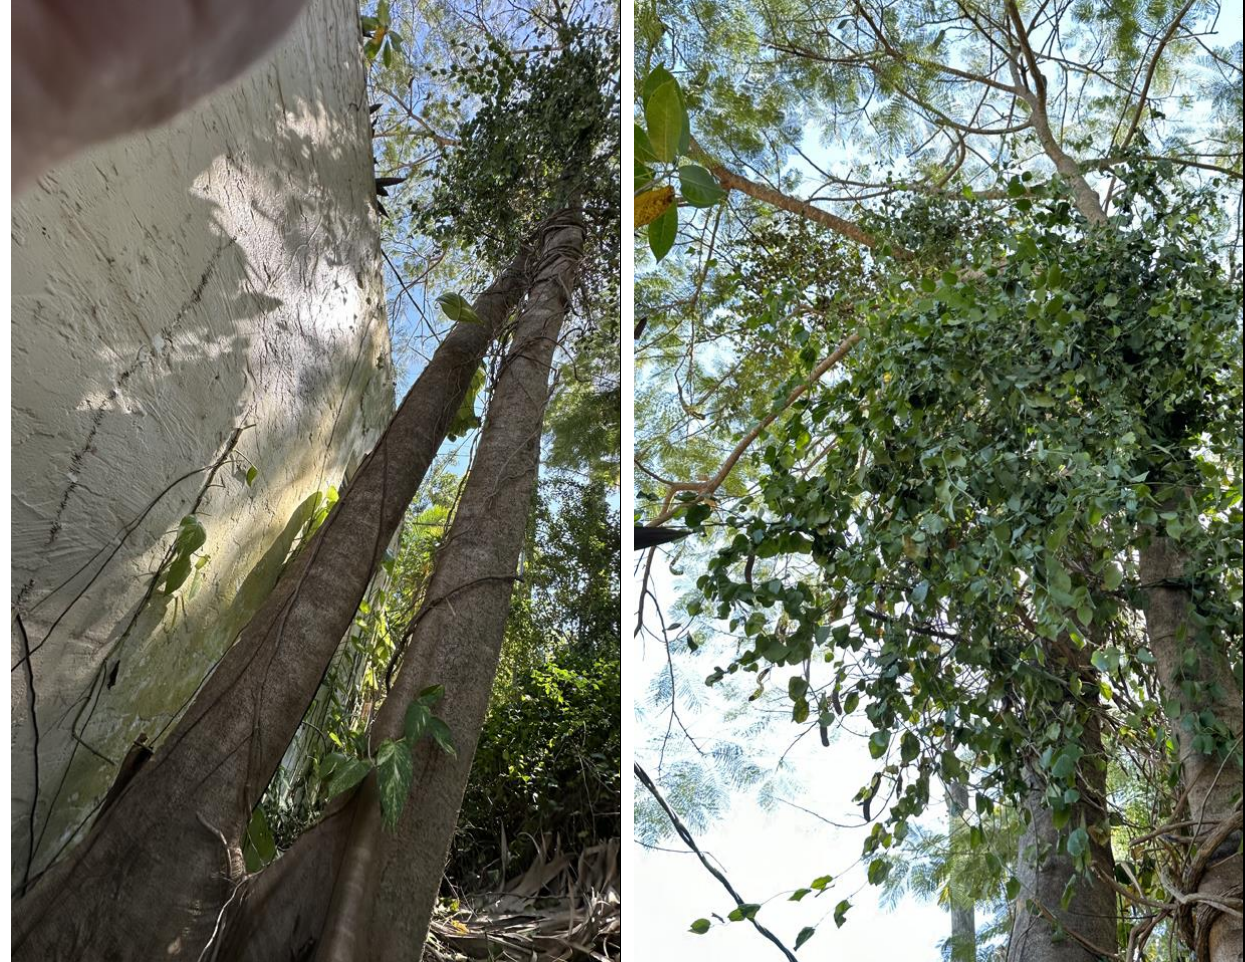
Tree #2, The tree (photo on left) is highly phototropic (penciling) as light is restricted in this area. Entire canopy is in the top 1/4th of the tree and is somewhat reduced in size. Reduced canopy and Cat's claw vine (photo on right) that should be removed.

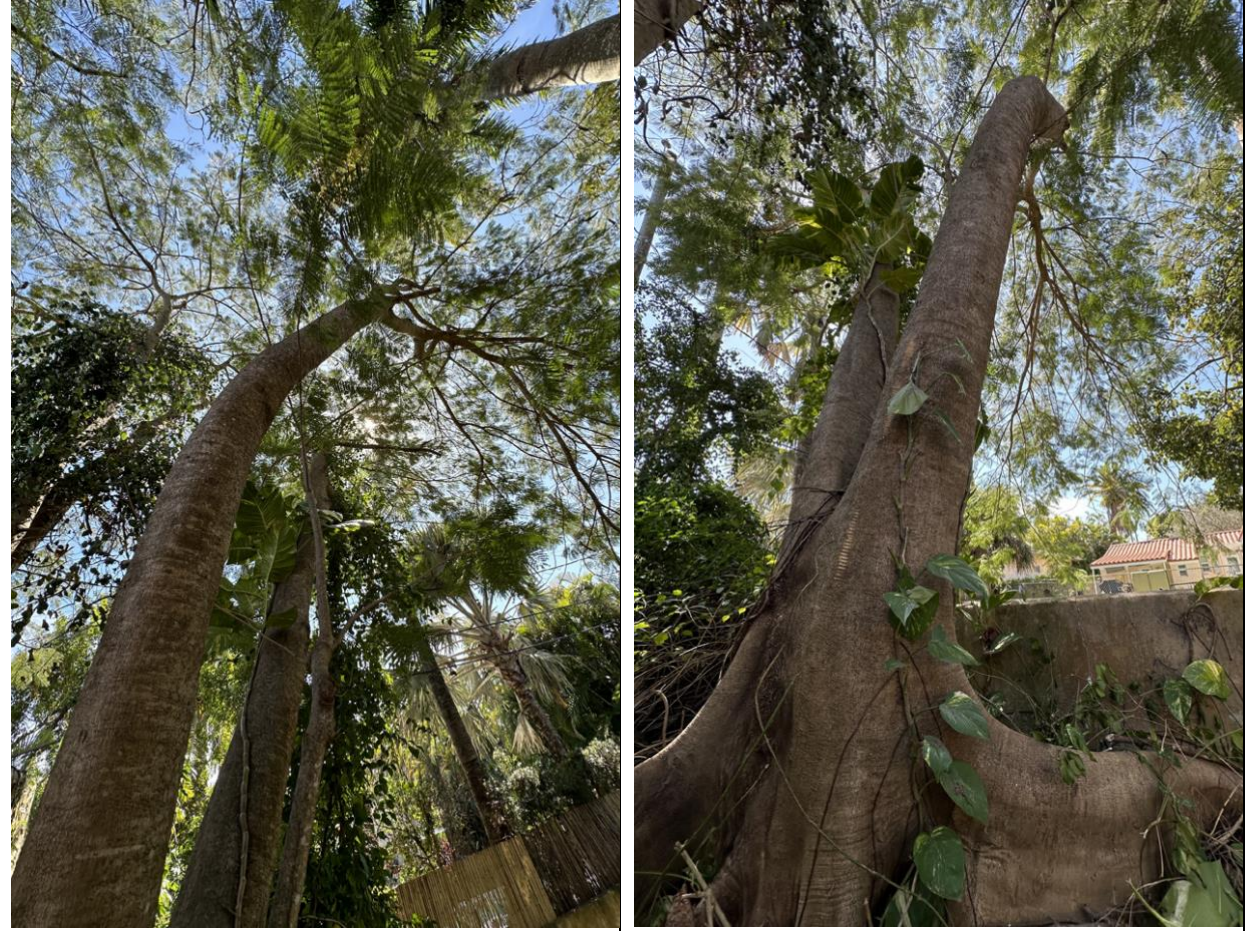
Tree #3, Tree has an approximate 15 degree lean over the adjacent property to the West and over 75% of the canopy extends over the neighboring property.

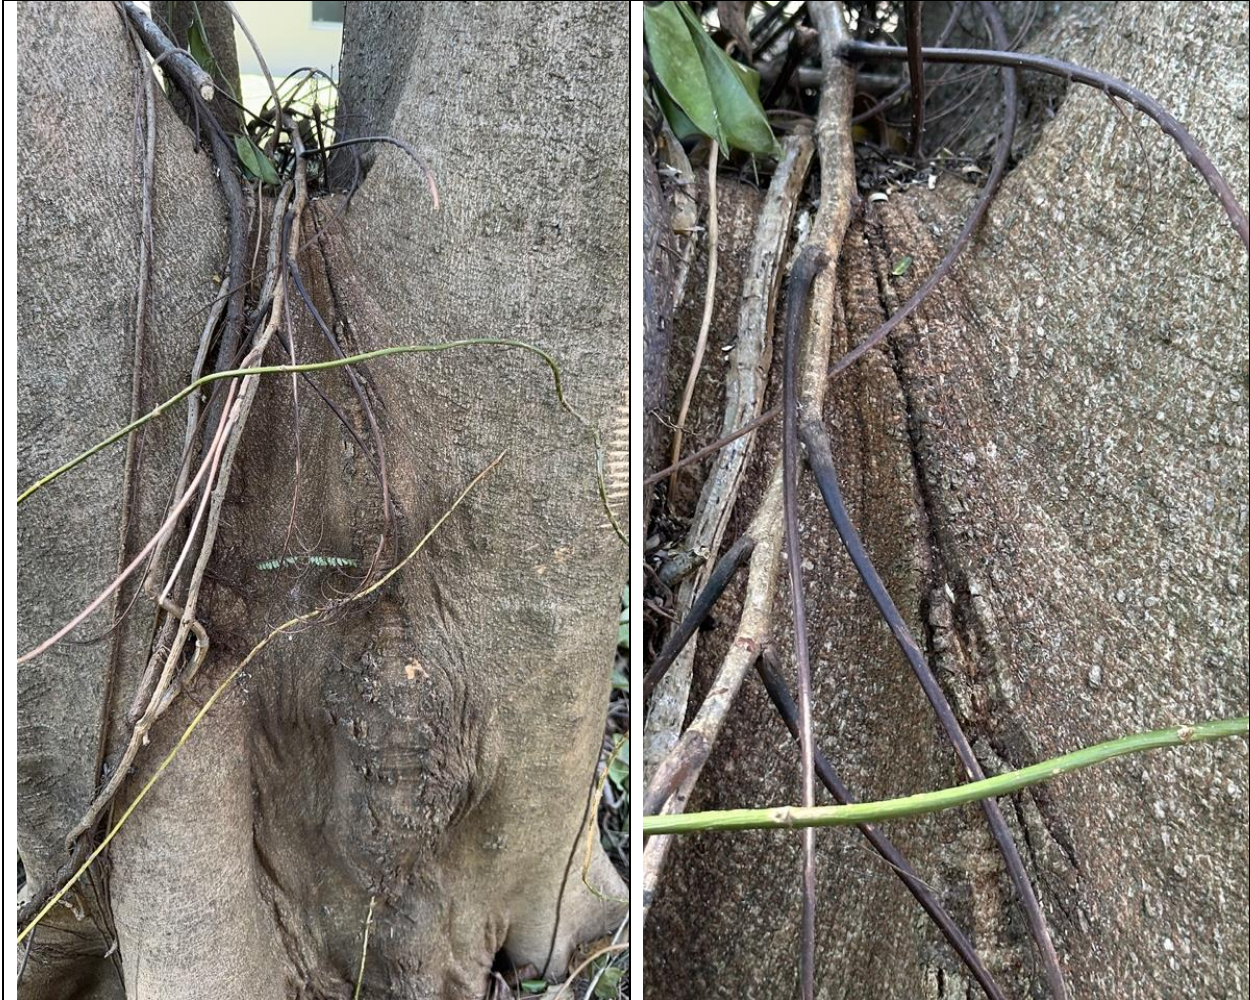
Tree #2, Codominant leaders with some bark inclusion where leaders join (both photos).

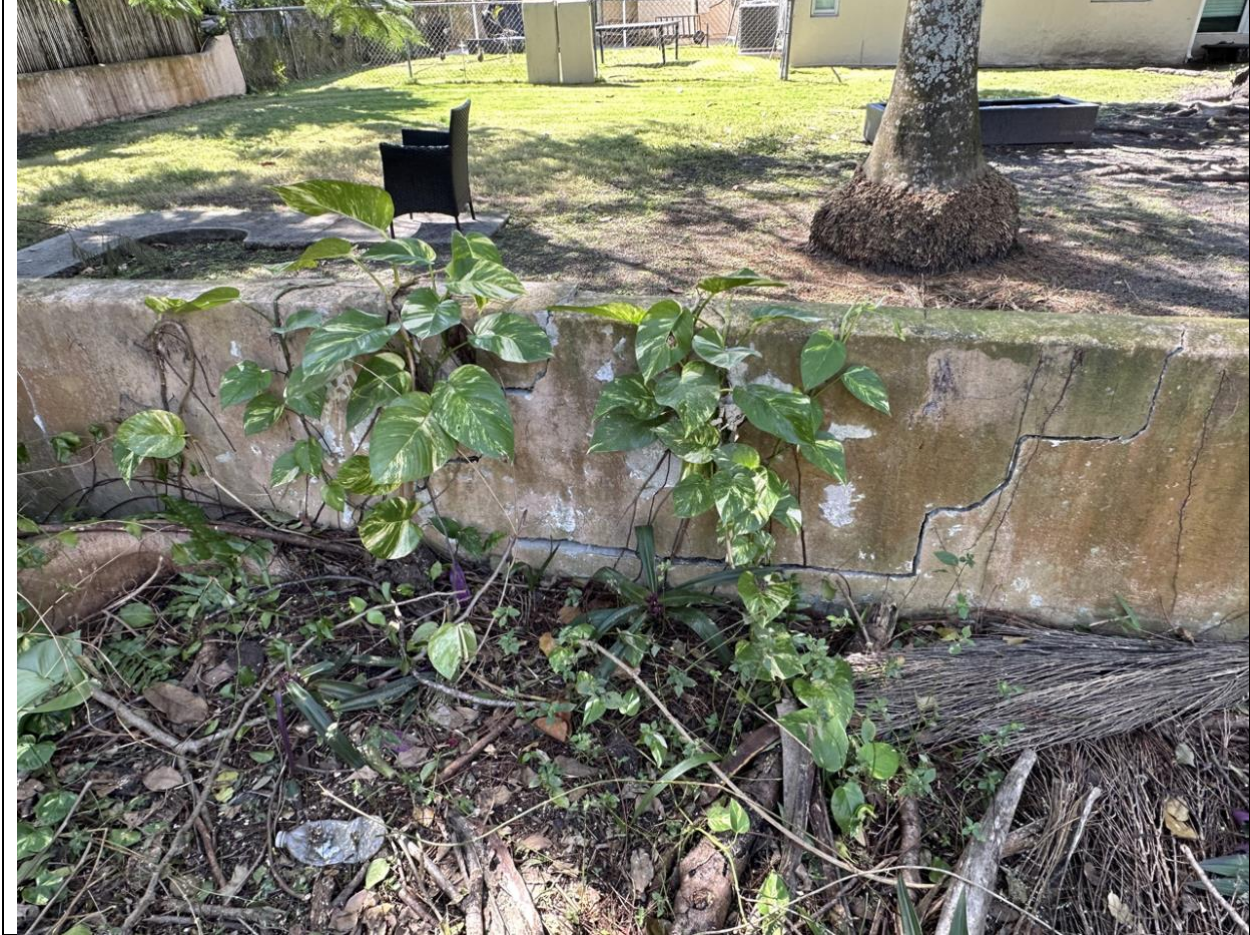
Tree #3, Roots of tree lifting and cracking concrete wall.
