HISTORIC PRESERVATION BOARD PRESENTATION

NOVEMBER 20, 2025

CORAL GABLES CITY HALL

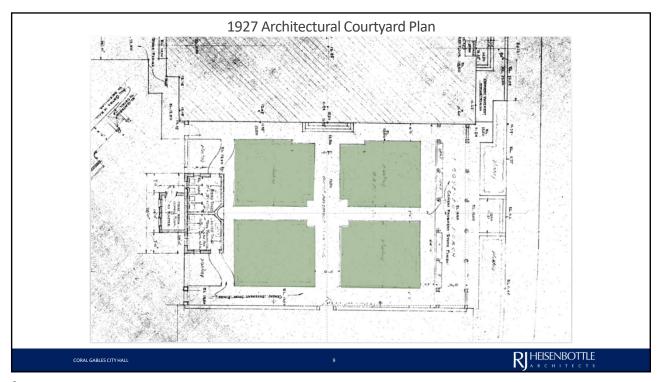
- $^{\circ}\,$ Mid-century addition disrupted symmetry and open
- o Original planting beds paved over in 90's
- \circ Courtyard's civic role diminished

- Remove the mid-century addition to the auxiliary building to restore bilateral symmetry and open space.
- Reinstate the planters as green areas to temper the bright sunlight and support rainwater infiltration.
- Remove abandoned septic tank.
- $\circ~$ Repave cracked walkways in keeping with historic design.
- Plant flowing trees at the perimeter to further cool the space and enhance its vitality.

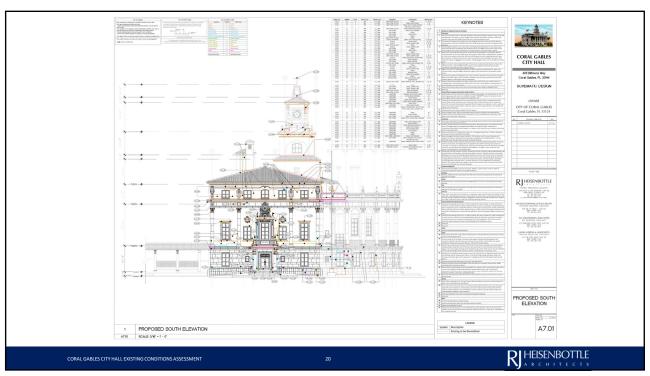
South Elevation Failures

- · Limestone
 - \circ $\;$ Cracking, spalling, incompatible patching at sill/anchors
- · Stucco
- Deterioration above cornices due to missing flashing
- Swirl marks from power-washing
- · Cast Stone
- Cracking
 Spalling
- Binder loss
- Corroded reinforcement and deteriorating balusters

- Remove incompatible limestone patches; repair with mortar or stone dutchmen
- Replace severely damaged limestone with matching new stone
- · Repoint all elevations
- $\circ\,$ Sound and repair stucco to matching original color, texture and finish
- Stabilize cast stone with crack injection, patching, and selective recasting
- $\circ\,$ Clean masonry gently; remove vegetation; apply new coatings
