Letter of Compliance for 40-Year Recertification

129-133 Sevilla Avenue Coral Gables, FL 33134-0000

# MINIMUM INSPECTION PROCEDURAL GUIDELINES FOR BUILDING STRUCTURAL RECERTIFICATION

#### **PICTURES OF INSPECTION:**

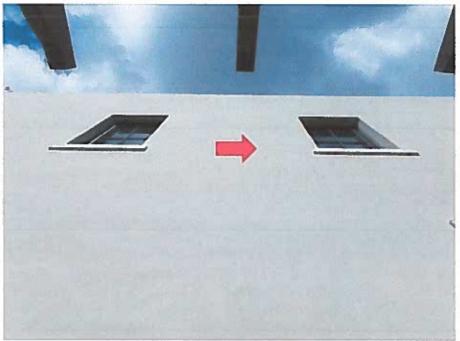
Upon visual inspection of the exterior of the property, it was noted that there are hairline cracks along the exterior walls. These cracks appear to have been previously patched. On the rooftop, the built-up roofing material over the rear stairwell was observed with water accumulating beneath surface of the roofing. This area of the roof was observed with a single scupper near the area of the observed water accumulation. It should also be noted that there was only one roof drain serving the main roof area and there were no secondary scuppers.

Stucco cracking may be attributed to several factors including stresses from cyclical loading, incorrect mix or application, movement of the underlying structure, the effects of temperature and shrinkage, and other reasons. Cracking throughout the structure may be defined as hairline (barely discernible), fine (<1 mm wide), medium (1mm - 2mm wide), and wide (>2 mm wide). These cracks can provide easy access for oxygen, moisture, and chlorides, and thus, create a condition in which cracking can be accelerated which may adversely affect the structure.

Patching observed at exterior wall

Isolated hairline and fine cracks shall be monitored periodically to observe for propagation of existing cracks and/or the formation of additional cracks. In the event that the cracks are exacerbated, the owner shall take necessary precautions and notify a professional engineer as immediate repair may be required. Cracks ranging from medium to wide, and all continuations of these cracks, shall be appropriately repaired based on the classification of each crack. Concrete crack repairs including routing and sealing, epoxy injection, stitching, and other such methods may be performed. All concrete repairs shall be performed in accordance with ACI 546 & ACI 562 to regain the structural integrity of damaged concrete. All required repairs shall re-establish or enhance the structural capacity the affected members.

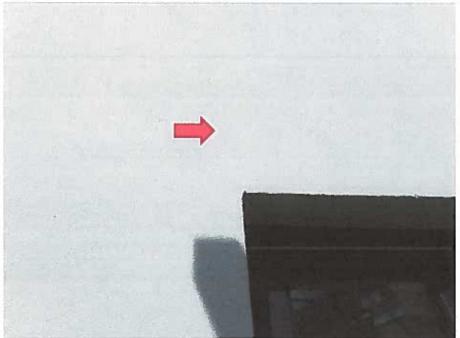
Patching observed near window opening

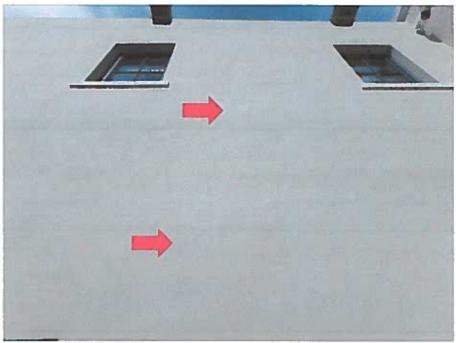
Patching observed at exterior wall

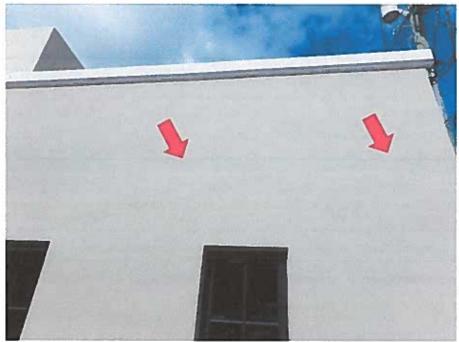
Patching observed at exterior wall

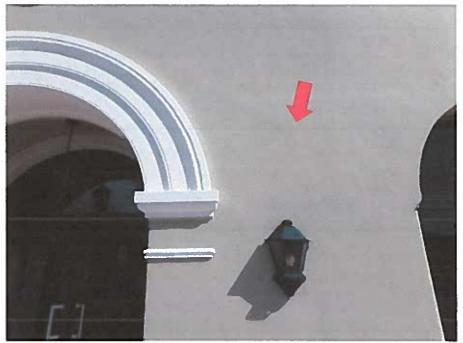
Patching observed at exterior wall

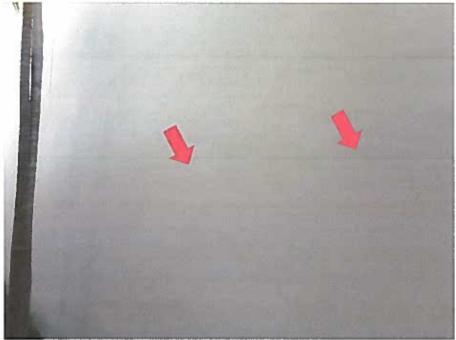
Patching observed at exterior wall

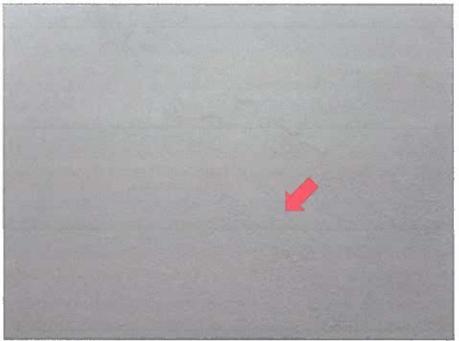
Close-up of patch with hairline crack

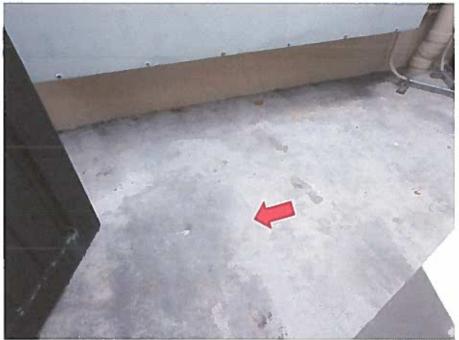
d. Cracks – note location in significant members. Identify crack size as HAIRLINE if barely discernible; FINE if less than 1 mm in width; MEDIUM if between 1 and 2 mm width; WIDE if over 2 mm.
Hairline cracks along exterior of west wall
Hairline crack observed at A/C equipment slab

Hairline crack at A/C equipment slab

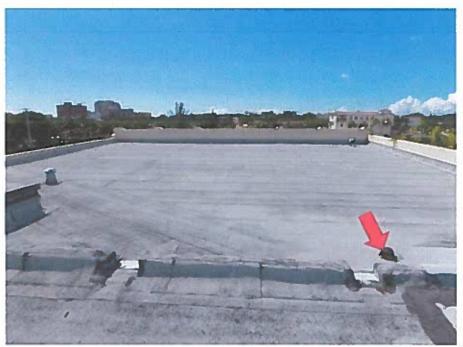
2.	Note water tanks, cooling towers, air conditioning equipment, signs, other heavy equipment and condition of support:
	None
3.	Note types of drains and scuppers and condition:
Scuppe	ers at rear of building, one roof drain for entire roof area, no secondary scuppers or drains observed

Overview of rooftop with single roof drain

Overall, the structural inspection has revealed the property to be in fair condition with exception to the aforementioned deficiencies. Continued observation of cracking is recommended in order to monitor for further propagation and the formation of new cracks. All structural load bearing members that are subject to damage shall be appropriately repaired to regain the integrity of the structure. Secondary drains and scuppers shall be added to the roof to prevent from water accumulation.

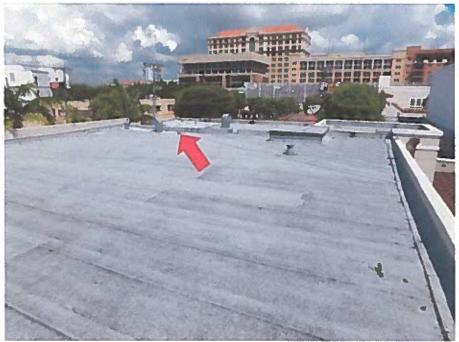
Overview of rooftop with single roof drain

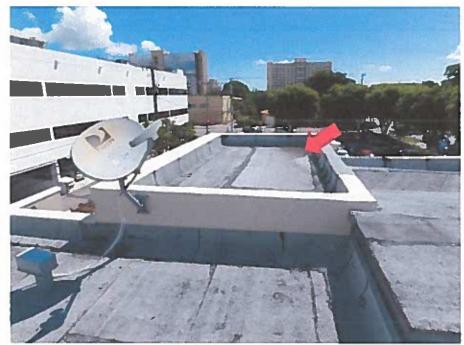
27.70 (W)
6. FLO	OR AND ROOF SYSTEM
a. Roof	willimm.
1.	Describe (flat, slope, type roofing, type roof deck, condition)
Flat ro	oof, built-up roofing, water accumulating beneath roofing above stairwell near scupper
	Tile roofing over front of building, 2:12 slope, good condition

Overview of rooftop over stairwell with water accumulation beneath roofing

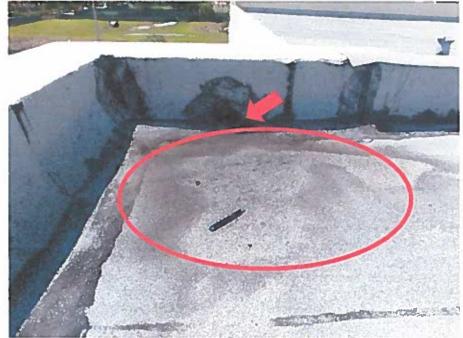
- c. Joints note if well fitted and still closed: No separation of joints observed
- d. Drainage note accumulations of moisture Accumulation of water at roof above exterior stairwell
- e. Ventilation note any concealed spaces not ventilated: N/A
- f. Note any concealed spaces opened for inspection:

Water accumulating beneath roofing over stairwell and single scupper

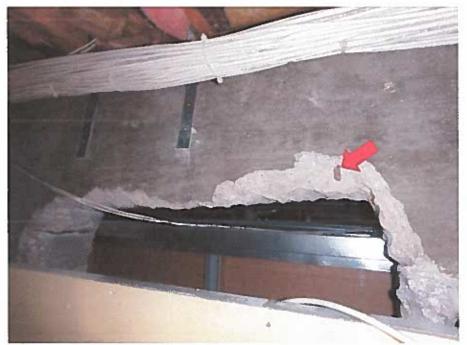
Concrete structures that have been damaged by the installation of penetrations should not have any exposed reinforcement. Steel reinforcement shall have the minimum prescribed concrete cover in all areas in order to protect the reinforcement from corrosion and to provide fire resistance. All areas subject to exposed reinforcement are required to be appropriately repaired. Similarly, where concrete is damaged at the support ends of steel framing members, repairs are also required to regain the integrity of the structure.

Overview of concrete beam with opening below and exposed reinforcement

All damaged structural members shall be repaired or replaced by a competent contractor. Each member shall be repaired/replaced individually and only one member shall be repaired/replaced for any given section at a time with adequate shoring provided. Methods of repair shall consider various parameters such as the extent of damage, constructability, accessibility, and any limitations imposed by the owner and/or tenant of the building. The contractor shall be knowledgeable, properly licensed, and must be relied upon to achieve proper installation of materials, material transitions, connections, etc. The contractor shall verify all dimensions and condition of the job site and report all discrepancies and unsafe conditions to the project engineer prior to proceeding with the work. Furthermore, as damage is evident at several areas of the structure, the contractor shall identify all members that are subject to damage and repair/replace them accordingly.

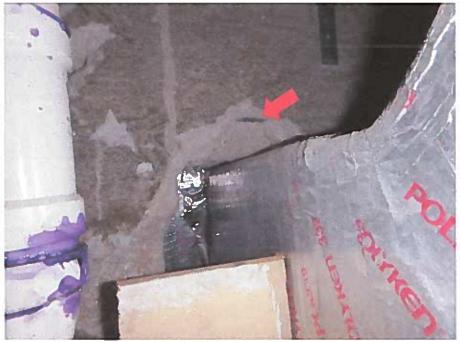
Overview of duct penetration with exposed reinforcement

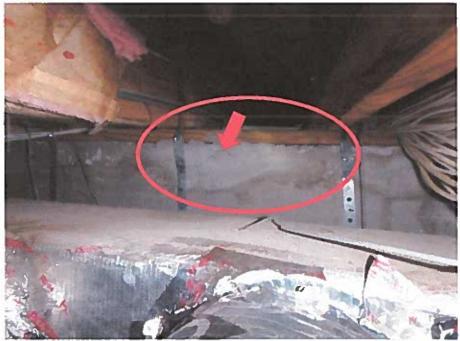
Cracking along concrete beam at previous repair location

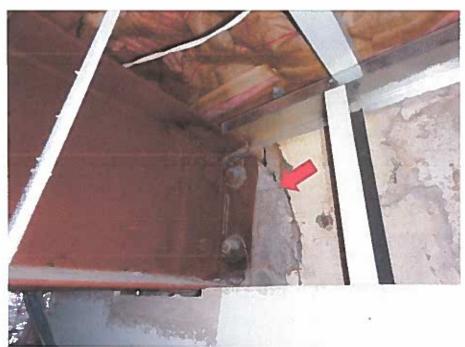
1. Bulging Good
2. Settlement Good
3. Deflections Good
4. Expansion Good
5. Contraction Good
b. Portion showing distress (Note, beams, columns, structural walls, floor, roofs, other)
Roofing material over rear stairwell has water accumulating beneath surface
Interior steel beam observed with cracked concrete near anchor bolt at clip angle connection
Concrete beams with exposed reinforcing at penetrations

Concrete cracking near bolt location at steel beam clip angle connection

# a. Date of notice of required inspection April 25, 2016 b. Date(s) of actual inspection September 16, 2016 c. Name and qualifications of individual submitting report: Nestor A. Cueto, P.E. (FL #71988) d. Description of laboratory or other formal testing, if required, rather than manual or visual procedures None required e. Structural repair-note appropriate line: 1. None required 2. Required (describe and indicate acceptance) Add secondary scuppers and drains at rooftop Repair damaged concrete at steel beam connection and where rebar is exposed
