PROPERTY APPRAISER OF MIAMI-DADE COUNTY

PROPERTY INFORMA	TION
Folio	03-4108-006-2040
Property Address	201 ALHAMBRA CIR CORAL GABLES, FL 33134-0000
Owner	EVELYN L GOLDBLOOM TRS & , GOLDBLOOM FAMILY LTD
Mailing Address	201 ALHAMBRA CIRCLE STE 514 CORAL GABLES, FL 33134-5105
Primary Zone	5005 MIXED-USE 3
Primary Land Use	1813 OFFICE BUILDING - MULTISTORY : OFFICE BUILDING
Beds / Baths /Half	0/0/0
Floors	13
Living Units	0
Actual Area	
Living Area	
Adjusted Area	447,478 Sq.Ft
Lot Size	51,762 Sq.Ft
Year Built	1973

The Falcon Group conducted a 50 Year Electrical Recertification of the referenced building in accordance with the requirements of section 8.11(f) of Miami Dade County Code. Please refer to the attached Electrical Recertification Report, the Illumination Letter, and the Thermography Report for this building. In summary, the Electrical Recertification is not approved as electrical repairs are necessary to meet current standards of safety. Please notice that we have not identified any condition that represents an imminent danger to the occupants of the building. Based on our evaluation, the building is electrically safe for its use and present occupancies at the time of our eval

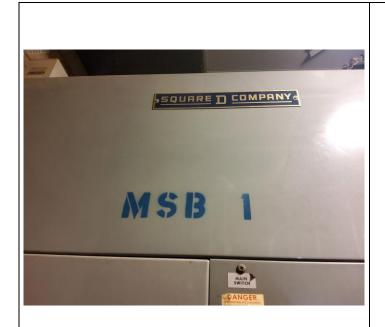
c. Condition: Good () Fair () Needs repair ())
Comments: Location: Main Electrical room
Repairs are required as follows:
a. Working space clearance violation. See Annex "A", photos #1, and 2.b. Main services must be identified as "Main 1 of 6". See Annex "A", photo #3.

Photo # 3. Item 3.1.b is depicted.

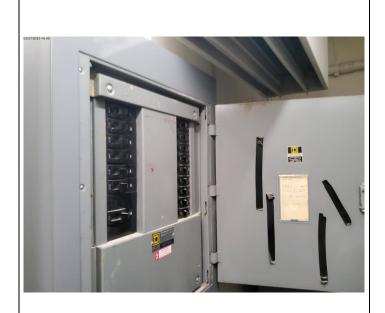
Photo # 16. Item 7.6 is depicted.

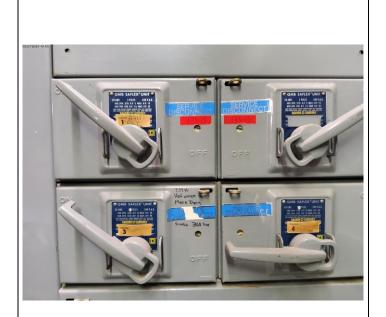
Photo # 18. Item 7.9.a is depicted.

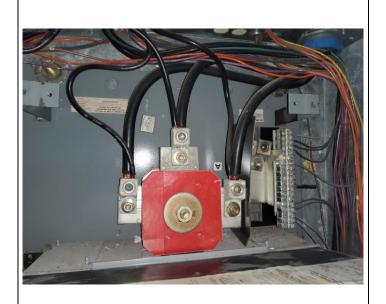
Photo # 20. Item 7.10.a is depicted.

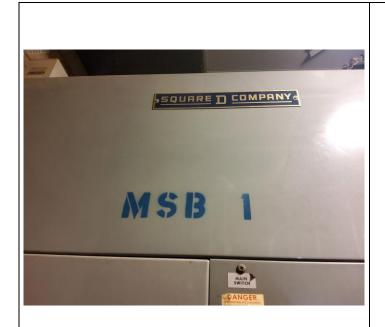
Photo # 3. Item 3.1.b is depicted.

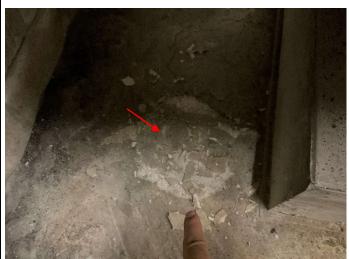
Photo # 5. Concrete spalling and exposed corroded rebar at roof (Generator Room).

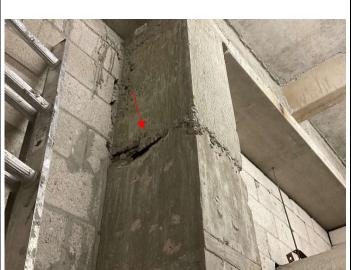
Photo # 6. Concrete spalling at roof (Generator Room).

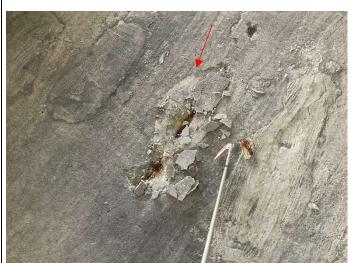
Photo #8. Concrete spalling at parking garage.

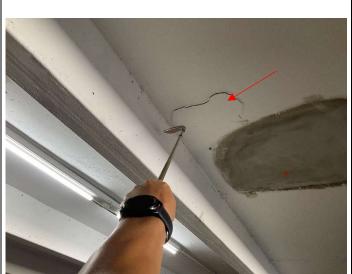
Photo # 9. Concrete spalling at ceiling of parking garage.

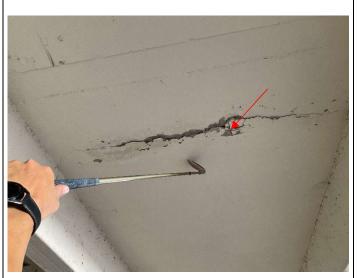
Photo # 10. Concrete spalling at joist beam of parking garage.

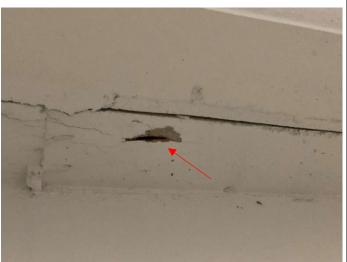
Photo # 11. Concrete spalling at ceiling of parking garage.

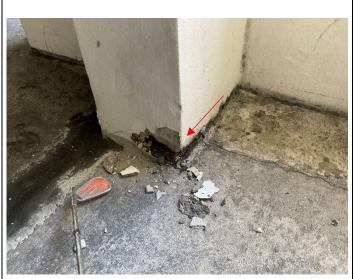
Photo # 12. Concrete spalling at ceiling of parking garage.

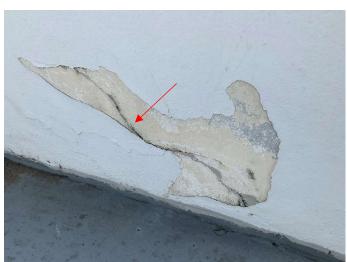
Photo # 21. Stucco delaminating at parking garage.

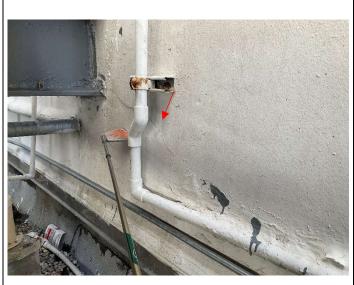
Photo # 22. Stucco crack at parking garage.

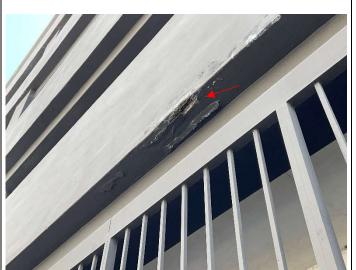
Photo # 25. Concrete spalling at slab edge of parking garage.

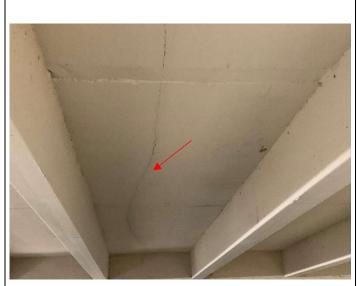
Photo # 26. Concrete crack at ceiling of parking garage.

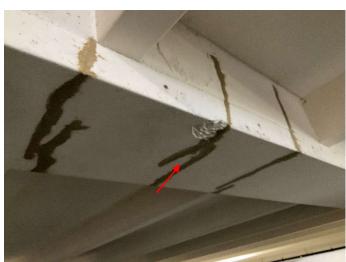
Photo # 29. Previously patched area at parking garage ceiling.

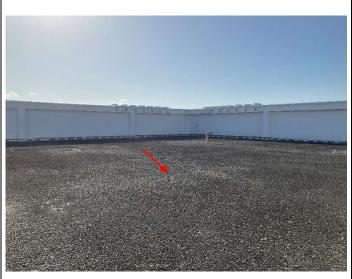
Photo # 31. Existing gravel Built-Up-Roof (BUR) system.

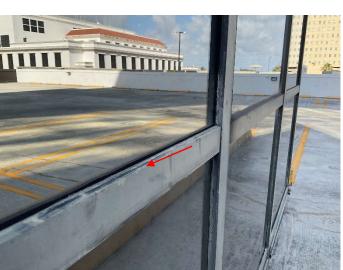
Photo # 52. Window sealant exhibiting typical dry condition.

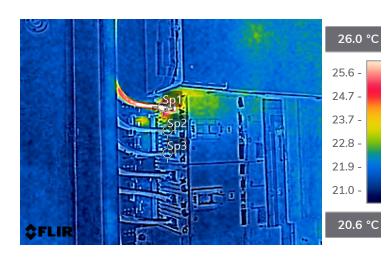
File name FLIR1128.jpg

Condition POSSIBLE DEFICIENCY

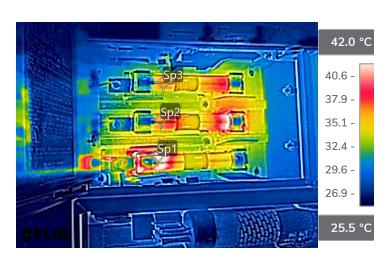
File name FLIR1216.jpg

Condition DEFICIENCY

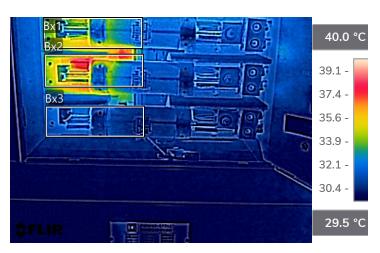
Thermogram index 103

File name FLIR1836.jpg
Condition DEFICIENCY

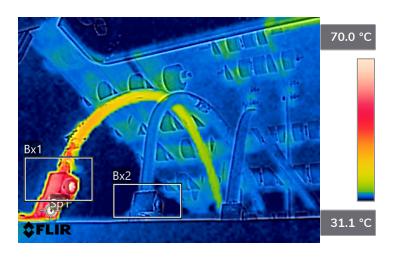
File name FLIR1870.jpg

Condition MAJOR DEFICIENCY

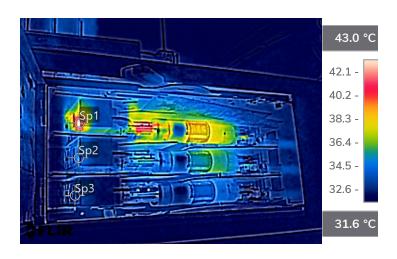
Thermogram index 107

File name FLIR1872.jpg
Condition DEFICIENCY
