POST-TRIMMING TREE REMEDIATION ARBORIST REPORT

The following is an arborist report for 190 Los Pinos Court, Coral Gables, Florida. The purpose of this report is to evaluate the condition of the canopies of 3 trees in the Right of Way (ROW). This report is not a risk assessment, but rather an assessment to determine if the trees have recovered post trimming. The One Tree Arborist LLC cannot be held liable for damage to the tree or damage caused by the tree. The owner has been informed of proper tree management and of any risk involving trees. Including safety during maintenance, and general risks involving having trees in close proximity to the property and people.

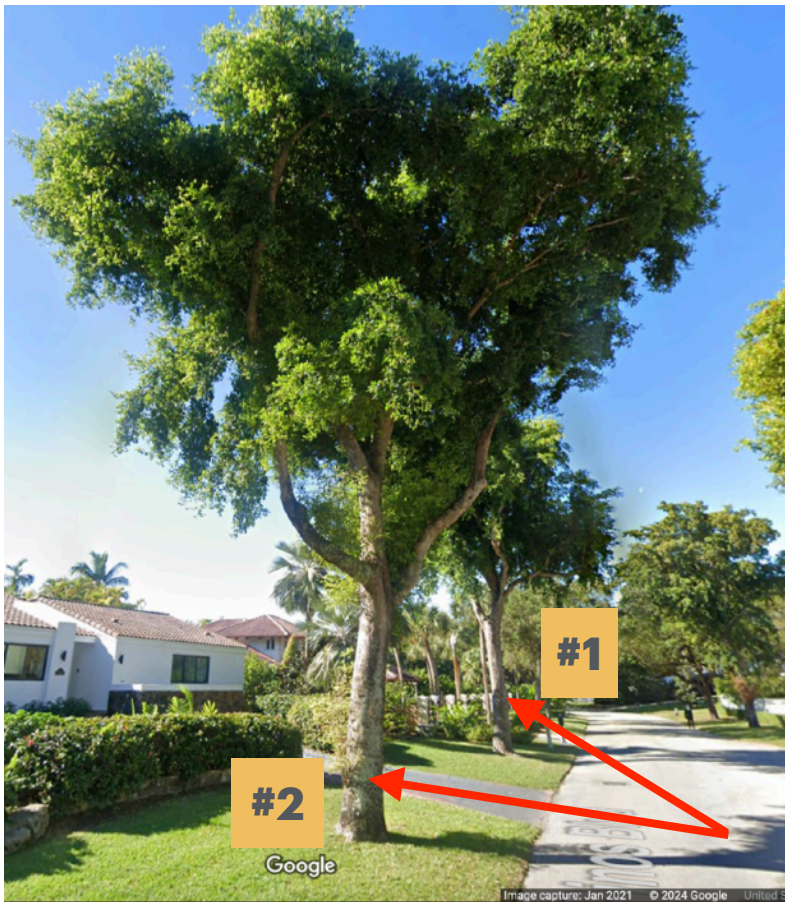
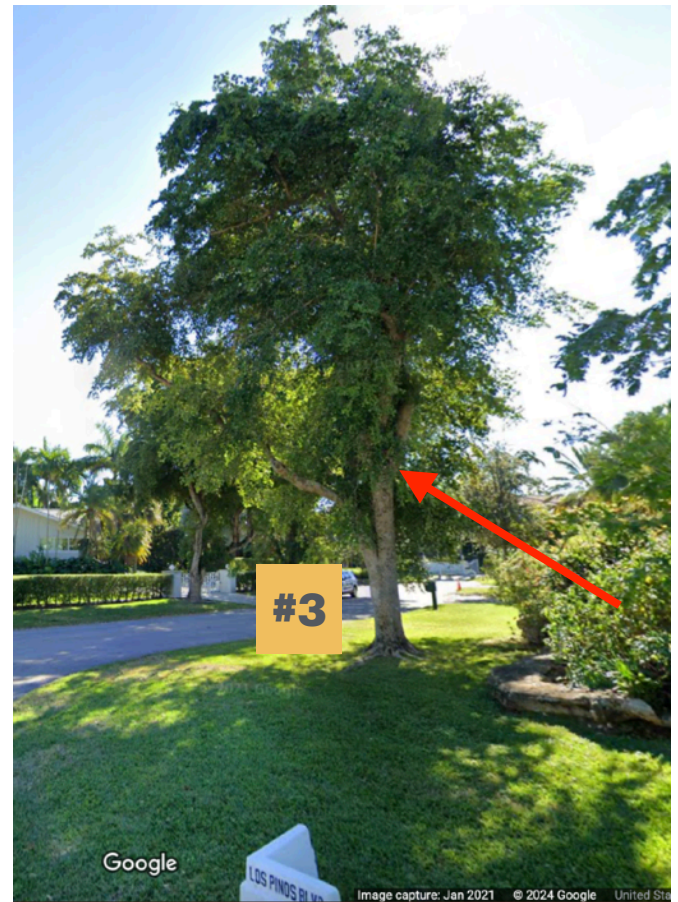
The images above are pre-trimming and have been sourced from Google street from Jan 2021. The estimated canopies of the trees #1, #2, and #3 were approximately 35-40FT.

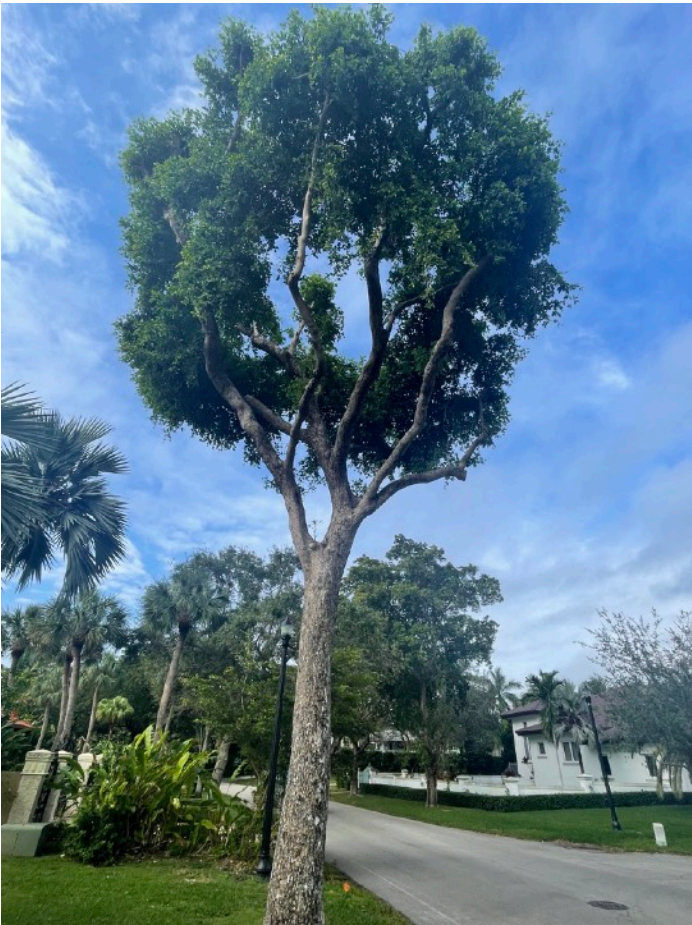
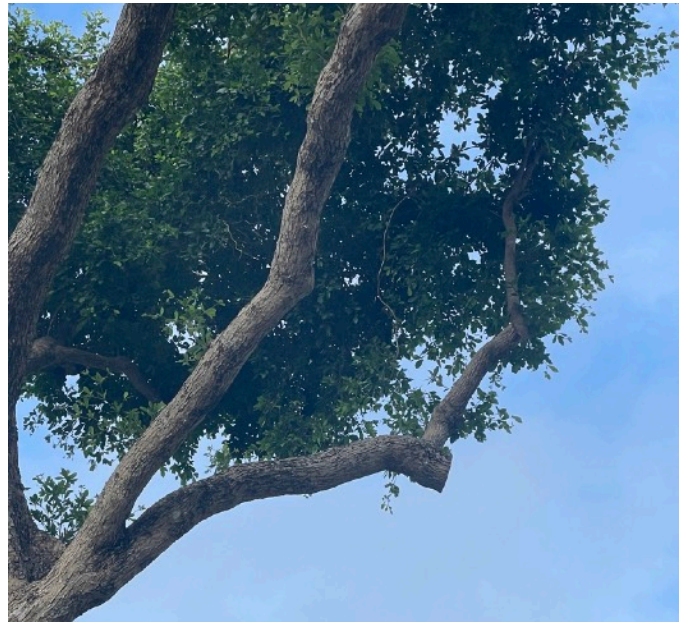
Black Olive Tree #1 (NW corner of 190 Los Pinos Ct)

The Black Olive (*Bucida brucea*) has a dbh of 40 inch, 35ft high, and 32 ft of canopy. The tree has lifted canopy and a routine trimming has been performed recently. The overall tree health is "Good". The trees branches have been reduced to a shorter branch by removing a stem back to a lateral branch that is large enough to resist extensive dysfunction and decay behind the cut. These types of cuts are recognized as a safest and healthiest trimming cuts to be performed. Mature trees are very sensitive to large trimming and can stress after removal of a large portion of the canopy. Most common symptom of stress in trees is waterspouts (vigorous, usually, upright shoots developing from dormant buds on the trunk or large branches of a tree.) As visible on the image above the tree does not display signs of stress. The canopy size has remained large (30ft as measured) post trim.

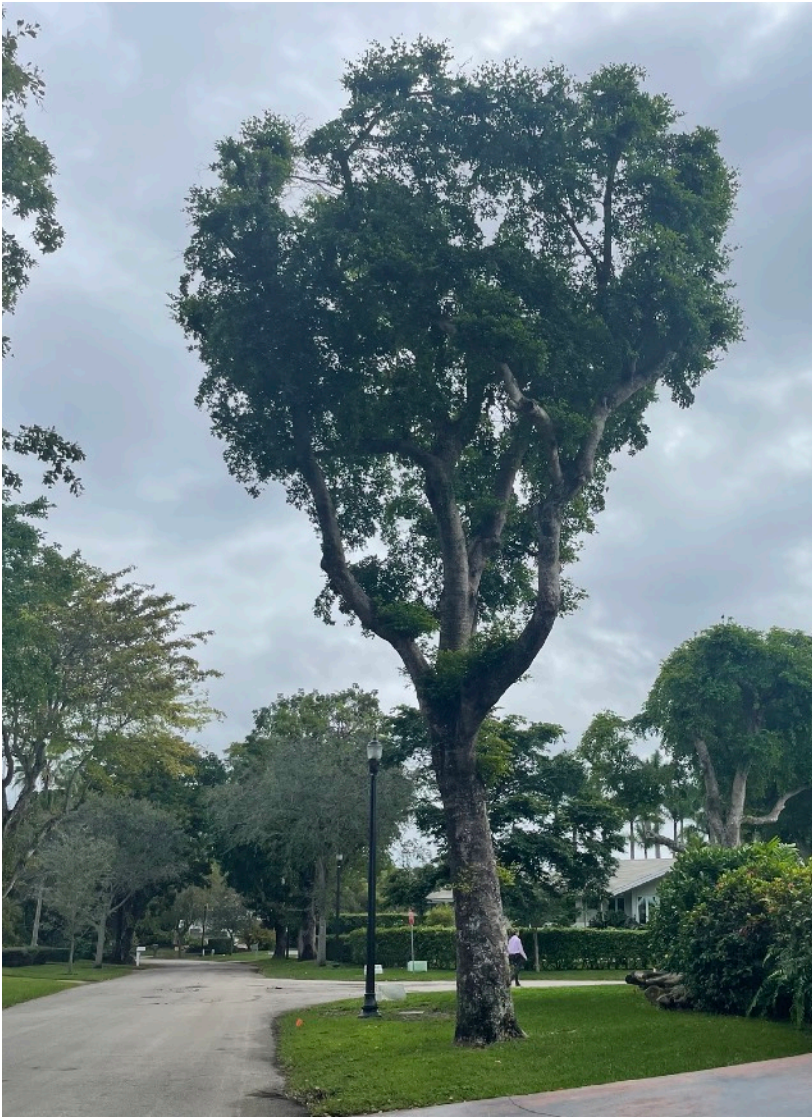
Black Olive Tree #2 (NE corner of 190 Los Pinos Ct)

The Black Olive (*Bucida bucerus*) has a DBH of 42 inch, 40ft high, and 30 ft of canopy. The tree has lifted canopy and a routine trimming has been performed recently. The overall tree health is "Good". The trees branches have been reduced to a shorter branch by removing a stem back to a lateral branch that is large enough to resist extensive disfunction and decay behind the cut. These types of cuts are recognized as a safest and healthiest trimming cuts to be performed. Mature trees are very sensitive to large trimming and can stress after removal of a large portion of the canopy. Most common symptom of stress in trees is waterspouts (vigorous, usually, upright shoots developing from dormant buds on the trunk or large branches of a tree.) As visible on the image above the tree does not display signs of stress. The canopy size has remained large (30ft as measured) post trim.

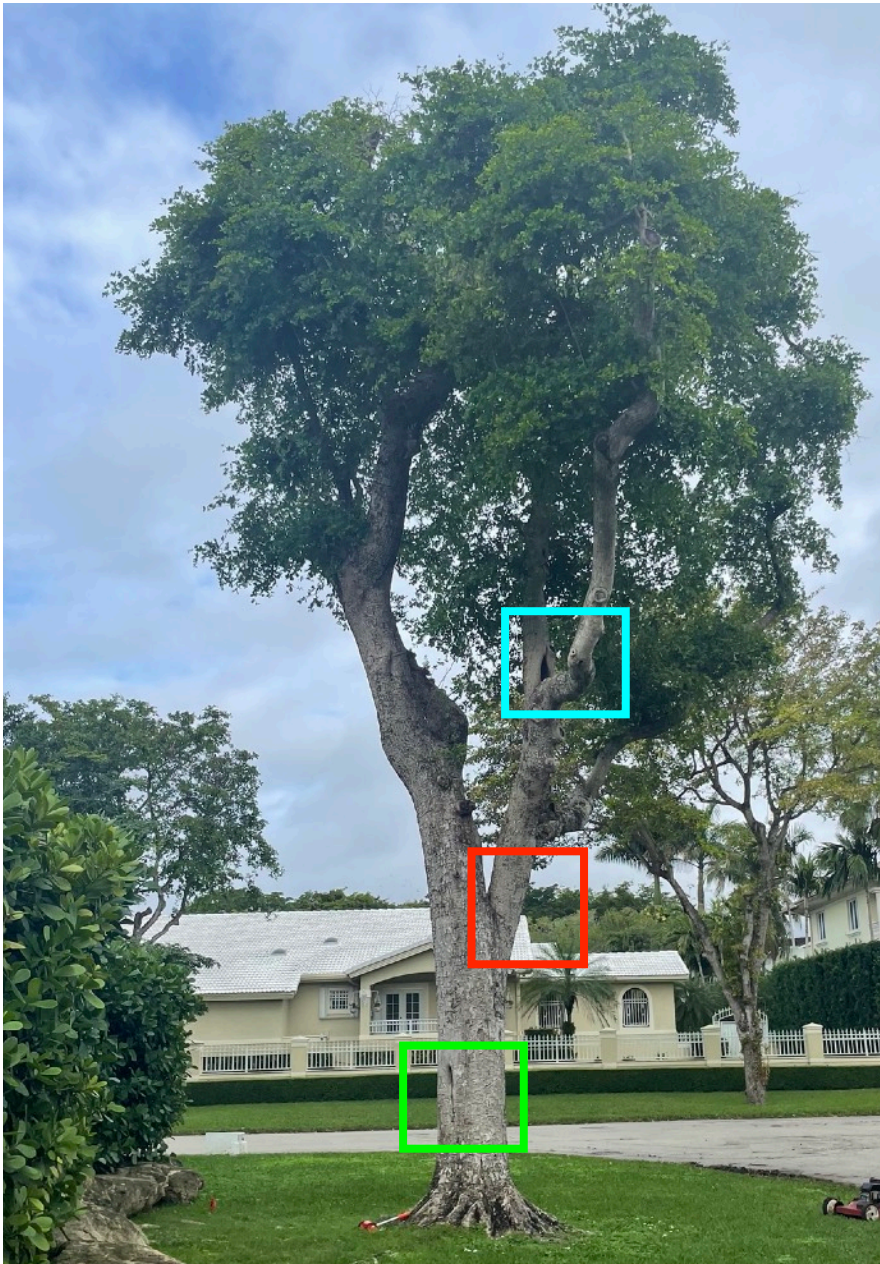
Black Olive Tree #3 (NS corner of 190 Los Pinos Ct)

The Black Olive (*Bucida brucea*) has a DBH of 38 inch, 35ft high, and 28 ft of canopy. The tree has grown into a Y shape. Such tree growing shape is common but not preferred due to possible split between the codominant limbs. The tree has lifted canopy and a routine trimming has been performed recently. The overall tree health is "Moderate". The trees branches have been reduced to a shorter branch by removing a stem back to a lateral branch that is large enough to resist extensive disfunction and decay behind the cut. These types of cuts are recognized as a safest and healthiest trimming cuts to be performed. **The tree has some signs of decay, and such limbs were removed, resulting in less canopy remaining post trim.**

Mature trees are very sensitive to large trimming and can stress after removal of a large portion of the canopy. Most common symptom of stress in trees is waterspouts (vigorous, usually, upright shoots developing from dormant buds on the trunk or large branches of a tree.) As visible on the image above the tree does not display signs of stress post trim. The canopy size has remained medium (28ft as measured) post trim.

(The cyan, red, and green rectangles correspond to the zoom in images provided on the next page.)

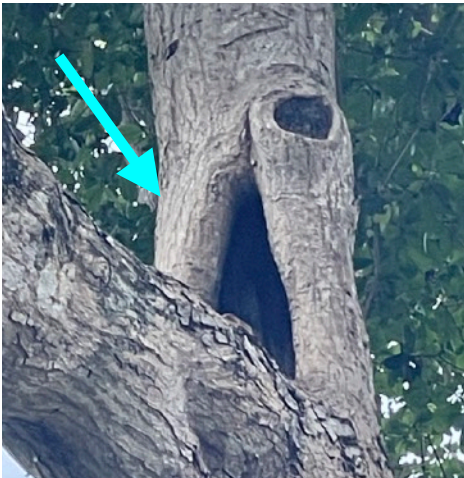
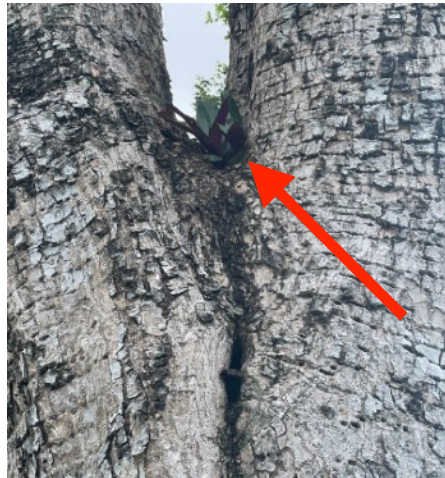
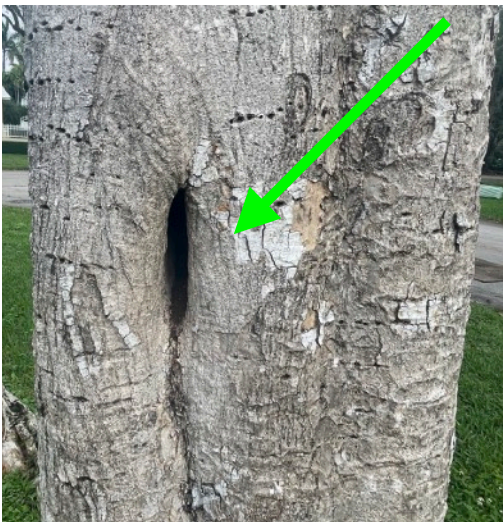
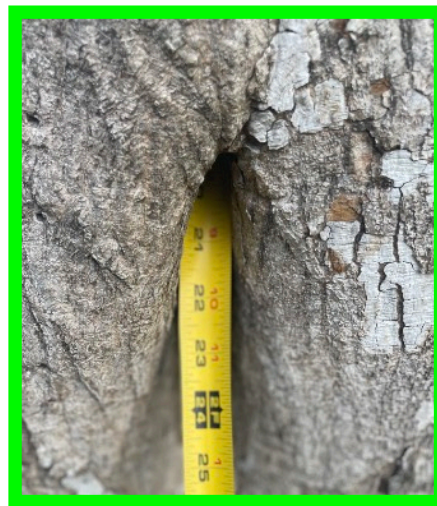
Signs of Potential Internal Decay

In the images (left) the tree shows signs of internal decay and rot. The cyan arrow in the image (left top corner) points to an opening and decaying limb. This type of wounds usually occur due to a split and are common to Black Olive species. The open cavity poses some risk exposing xylem and phloem of the tree to the natural factors. This can result in the decay of structural wood. The red arrow in image (right top corner) points to the cavity between codominant limbs. This tree shape is more likely to decay and to split in the crotch angle. It is important to keep the Y split free of plants or debris to try to prevent any decomposing material accumulating there. The green arrow in the image (lower left

corner) shows an open cavity under the tree's bark. The cavity poses a potential risk of decay spreading through the xylem. The structural integrity of the xylem might have been compromised. The tree bark located around the cavity is showing signs of compartmentalization, a process in which the tree stops or slows down the decay. During the site visit the cavity was not showing signs of the presence of the possible indicators of the decay, the carpenter ants, or any fruiting bodies or fungus. Overall the tree has some degree of structural damage in the lower area and also has some structural damage in the upper limbs, which was partially addressed during the trimming. The tree's health is rated as Moderate after a level 2 assessment, but without a level 3 assessment there is no way to determine the extent of potential decay. The tree has been trimmed to maintain its canopy and to mitigate some probable causes for it to fail and damage any property. This tree requires a more attentive care and monitoring. It is advised to conduct regular sorrow maintenance of this tree, and if any branches develop visible decay it is recommended to mitigate such limbs.
