## STRUCTURAL INSPECTION IN A SINGLE FAMILY RESIDENCE.

### REFERENCE: Inspection about Structural Conditions

To: Mr. Javier Avila.  
1258 Obispo Ave.  
Coral Gables, FL 33134

1258 OBISPO AVE.

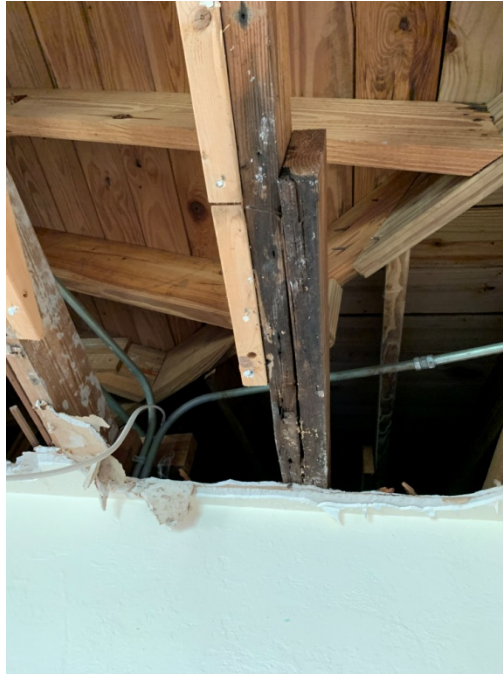
Picture 1

- In general the structural shell of the house is in extremely poor conditions. Can be observed water intrusion damage in the majority of the roof areas. In many places had been necessary to remove portions of the ceilings.

Area of the roof previously affected by water intrusion.

1-The roofing system and tiles, the roof plywood sheathing, and a big portion of the roof wood joists, the ceiling wood joists, must be removed and replaced. Also, we strongly recommend to cover the whole house with a tent and fumigate in order to eliminate any possibility of alive termites and avoid any future deterioration of the wood elements.

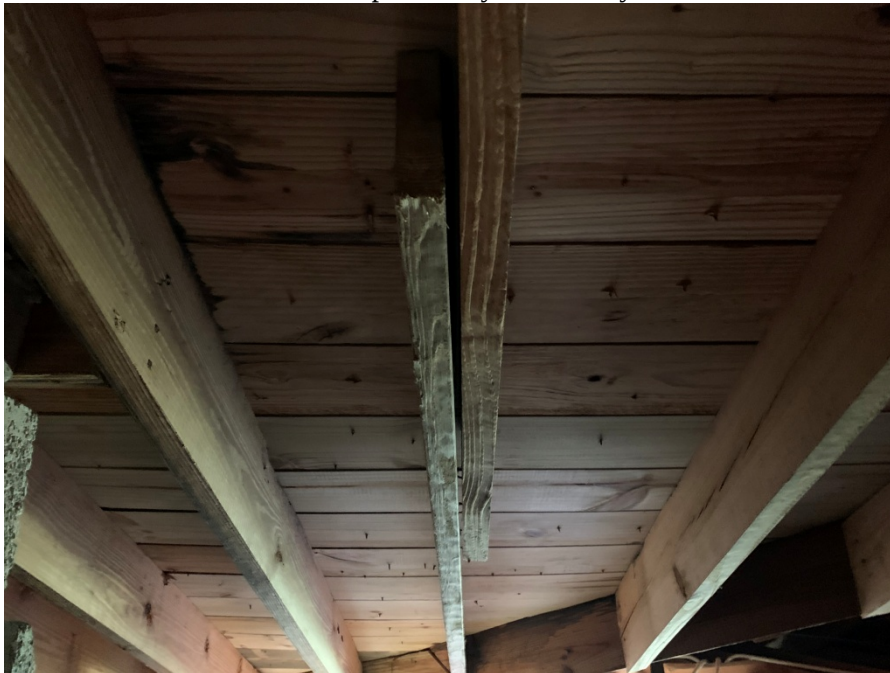
Picture 2

- Some previous wood joists repairs were done and do not comply with the minimum code requirements. The windows must be replaced.
- The exterior windows are in very bad conditions. The metal frames are rusted and some glass panel broken. The windows must be replaced.

Roof joists not properly repaired

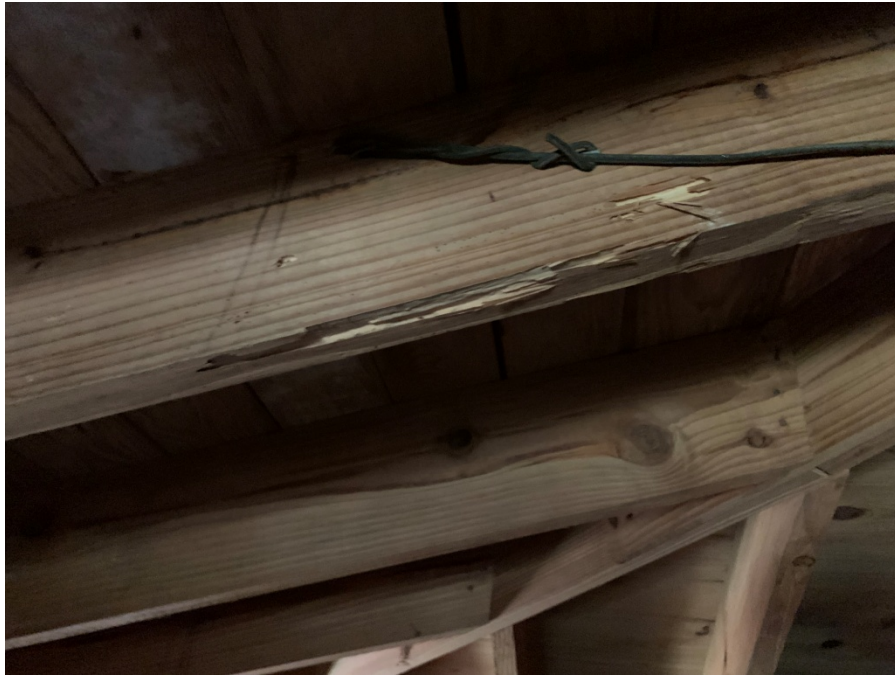
- The house was infested by termites. It was observed in many places traces of termites. For example wood ceiling joists, wood joist or rafters, wood floors planks, wood floor joists, and windows and doors wood framings.

Picture 3  
Roof joists damaged by termites.

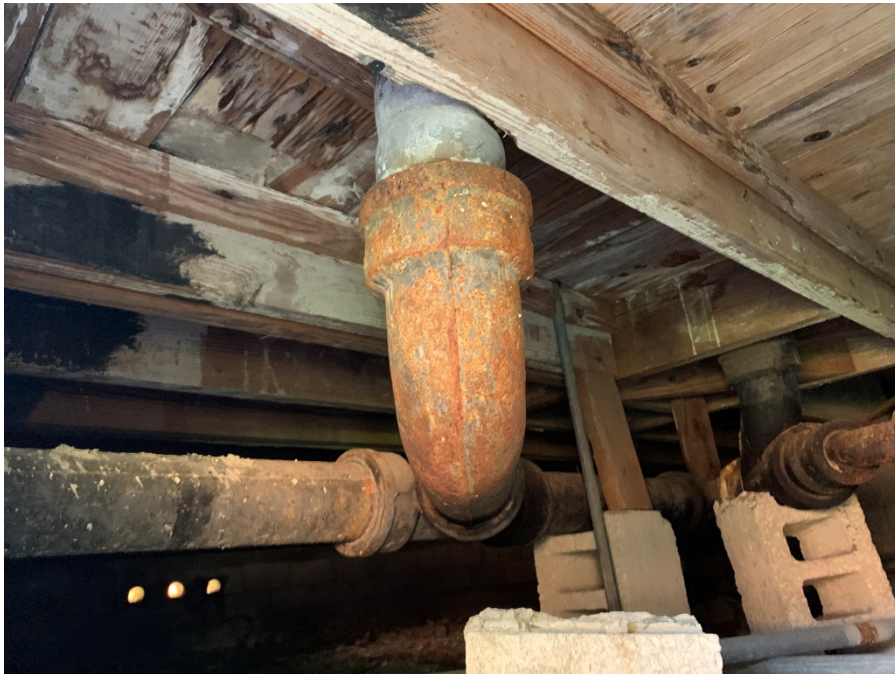
Picture 4  
Previously damaged wood floor by water intrusion, not properly repaired. Wood joists supported by unstable blocks and wood posts

2-The wood floor and subfloor and maybe a significant portion of the wood joists at ground floor need to be replaced, also we recommend to brace the exterior CMU walls to the ground floor wood joists (above the crawl space) w/ some connectors, in order to reduce the wall slenderness for lateral wind suction.

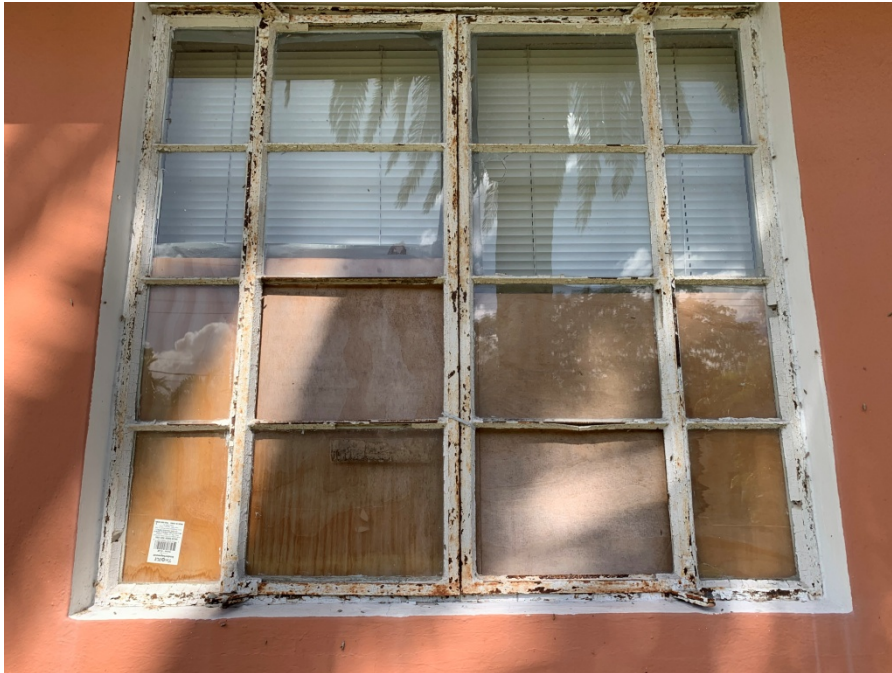
Picture #5  
Exterior window rusted and glass panel broken.

3-All the exterior windows and doors must be replaced.

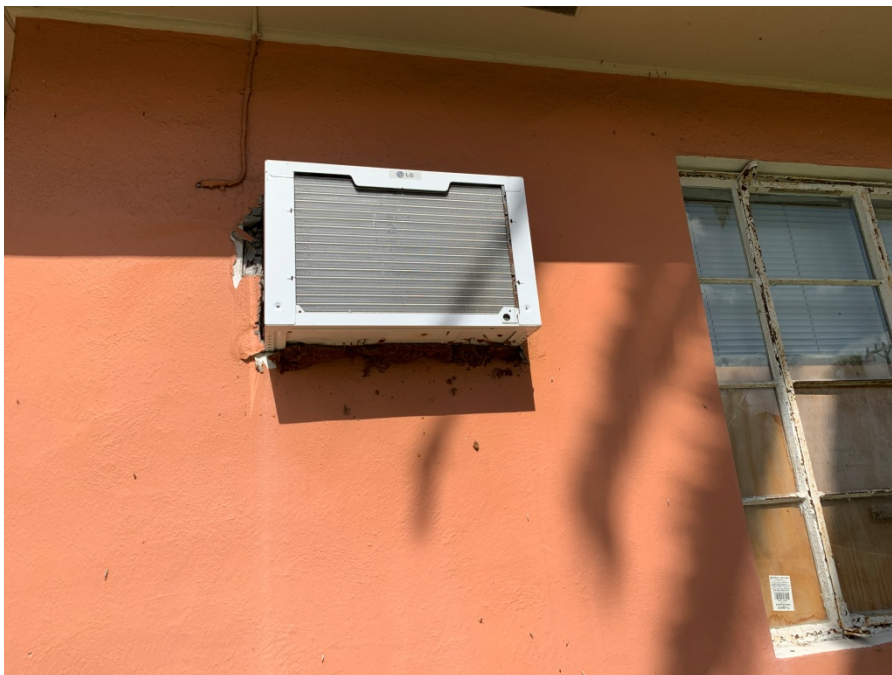
Picture #6  
A/C unit not properly encased into the wall.

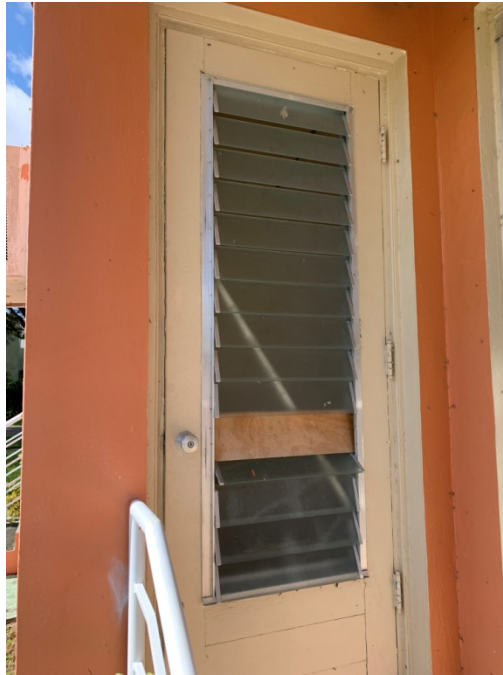
Picture #7 Exterior door very damaged

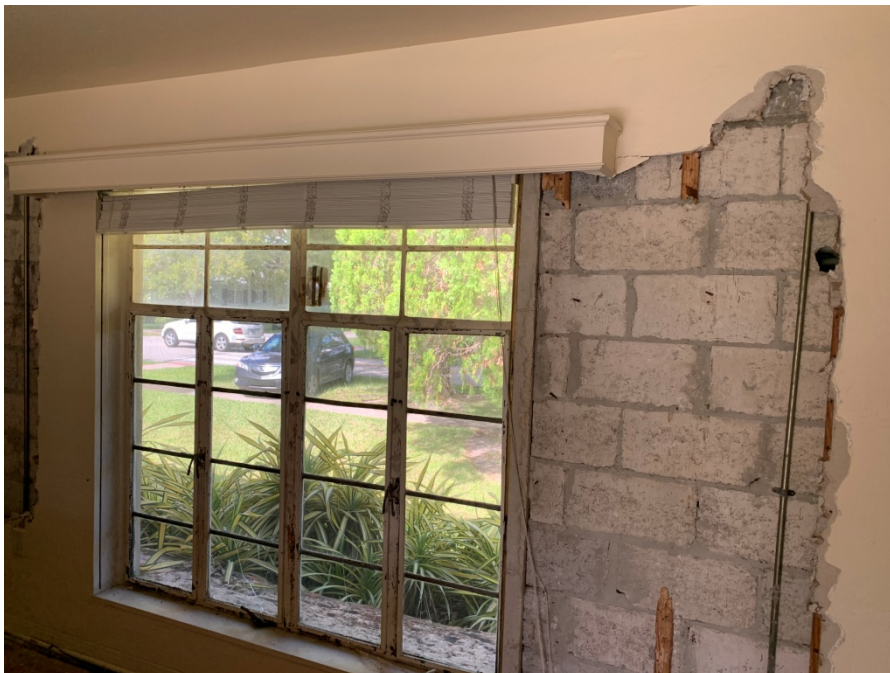
Picture #8 Front widow, very damaged

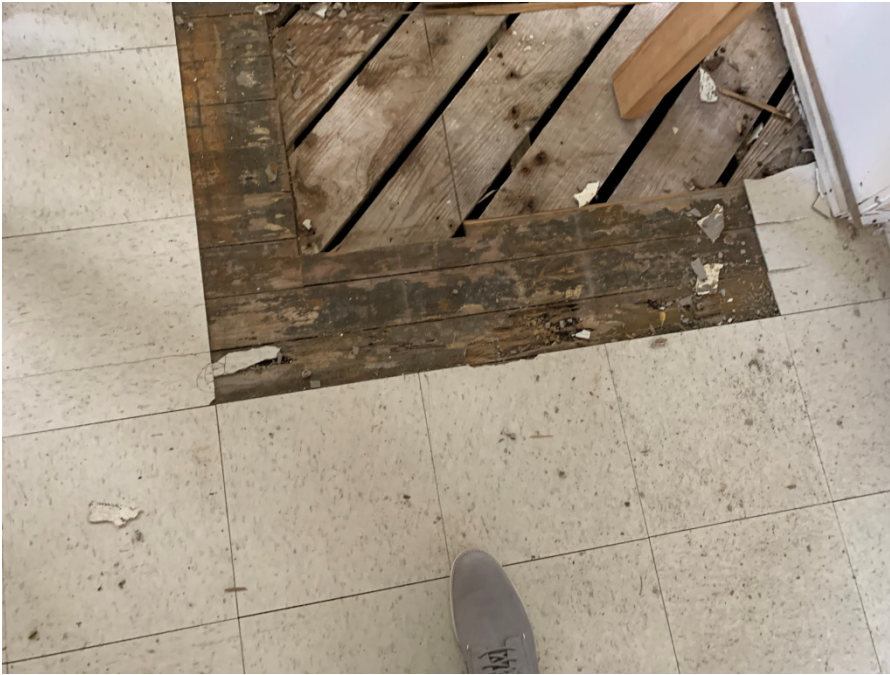
Picture #9 Wood floor damaged by termites.

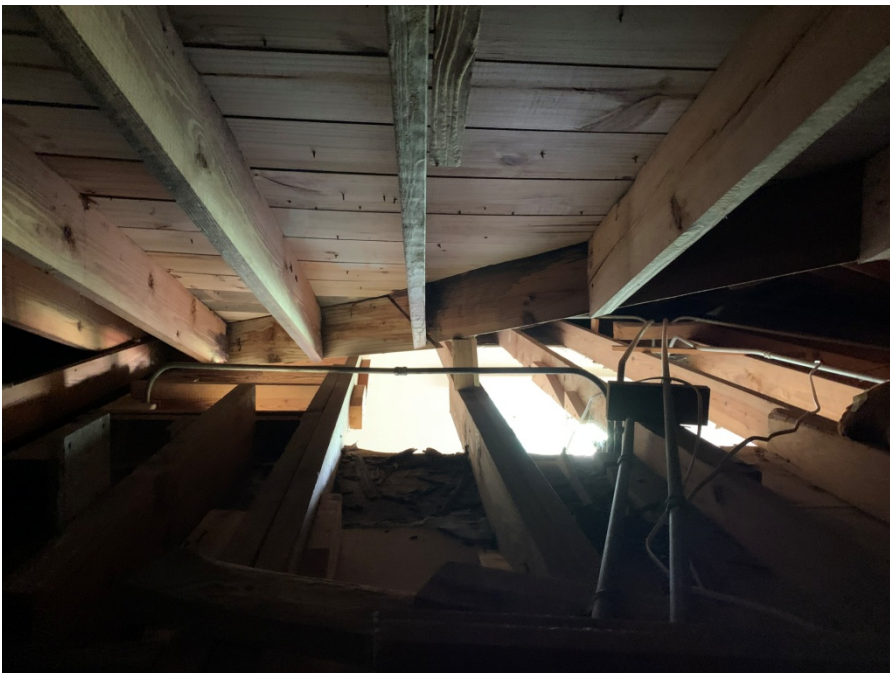
Picture #10 Ridge joist broken.
