**LISA H. HAMMER, RCA**  
*Horticultural Consultant*

June 11, 2014

RE: 6801 Granada Boulevard  
Coral Gables, Florida

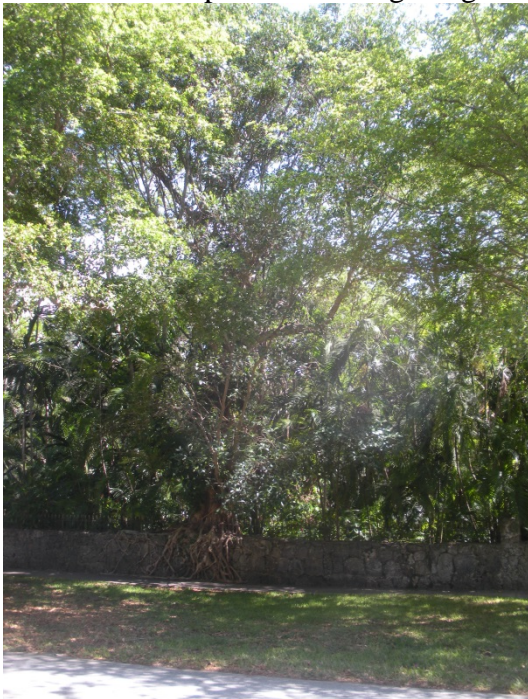
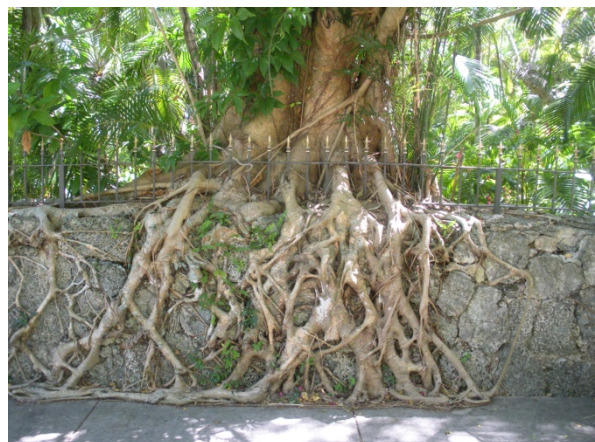
### Tree #17

Tree #17 is a strangler fig (*Ficus aurea*), a native *Ficus* species. It is growing on top of the rock wall with a trunk diameter above the wall of approximately 36 inches. The tree is about 60 feet in height, with a 50-foot crown spread. It is in good general condition but dependent on the wall for support.

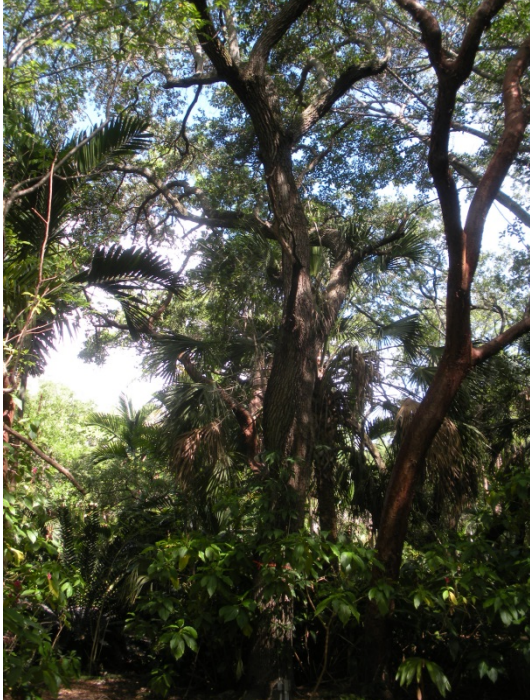
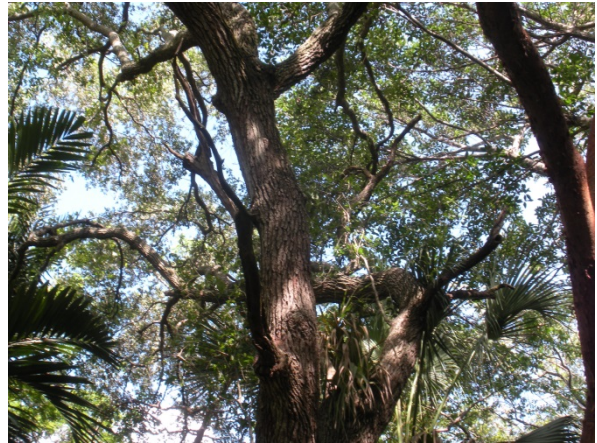
**Tree #95**

Tree #95 is a live oak (*Quercus virginiana*). Its trunk diameter is 22.5 inches, overall height 40 feet, and crown spread of 40 feet. It has a high crown which is slightly sparse, with dead branches up to 4 inches in diameter. The tree is generally in fair to good condition.

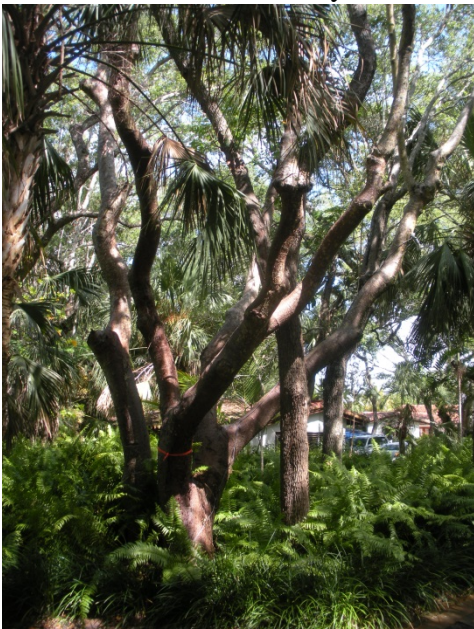
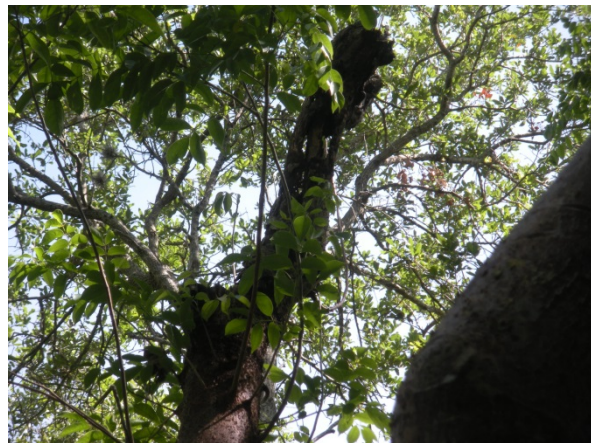
**Tree #119**

Tree #119 is a gumbo limbo (*Bursera simaruba*). Its trunk diameter is 24 inches measured below its double leaders. The leaders measure 15.5 and 16 inches, respectively. The tree is about 40 feet in overall height with a 35-foot crown spread. It has a high crown which is slightly sparse, and one main branch is broken and decayed. The tree is generally in fair to good condition.

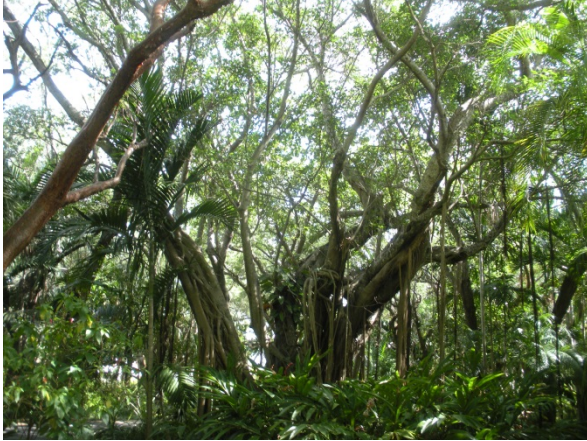
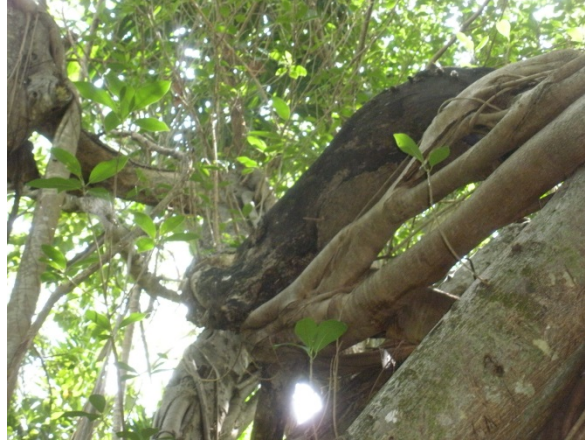
**Tree #144**

Tree #144 is a strangler fig (*Ficus aurea*), a *Ficus* species native to South Florida. Its trunk diameter measures approximately 52 inches and includes numerous trunks and trunk-like aerial root structures. It is about 35 feet in overall height with a 55-foot crown spread. With the exception of one dead/decaying limb lying laterally through the center of the crown, the tree is in very good condition.

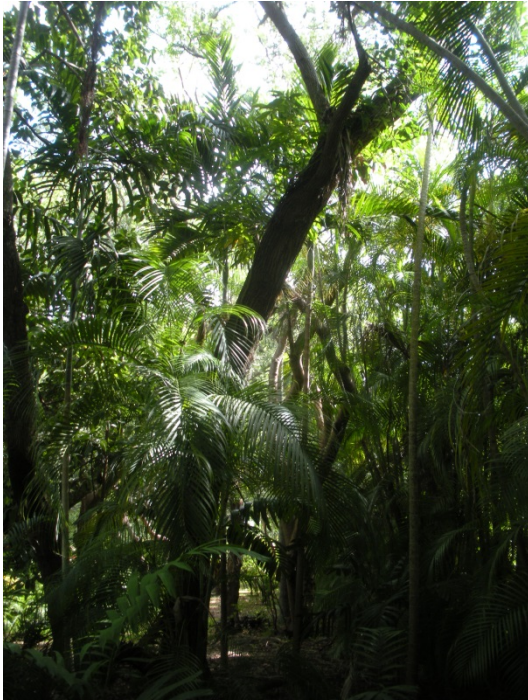
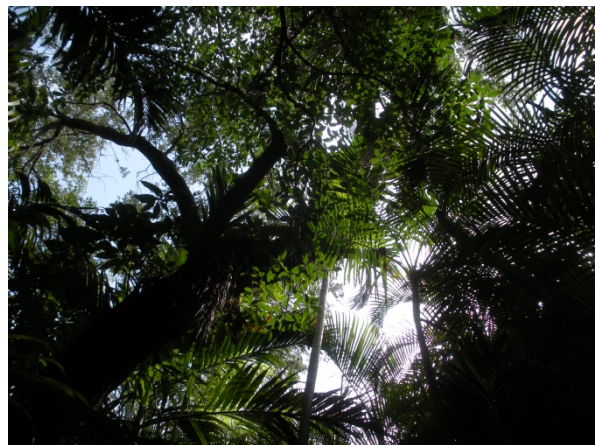
**Tree #173**

Tree #173 is a live oak. Its trunk diameter is 19.5 inches. It is approximately 40 feet in overall height, with a 30-foot crown spread. Its crown is high and sparse, and has been pruned at the property line. The tree is generally in fair condition.

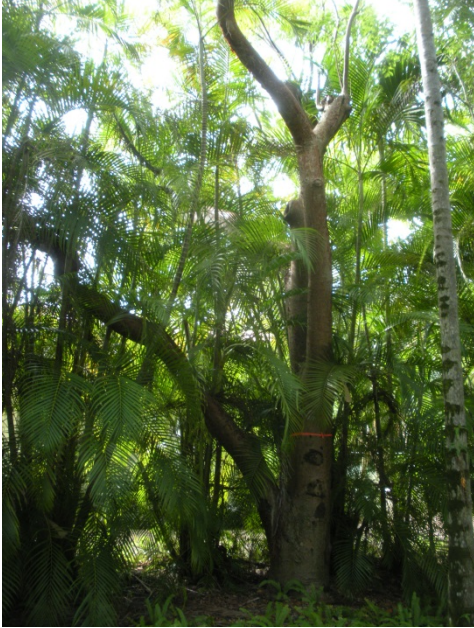
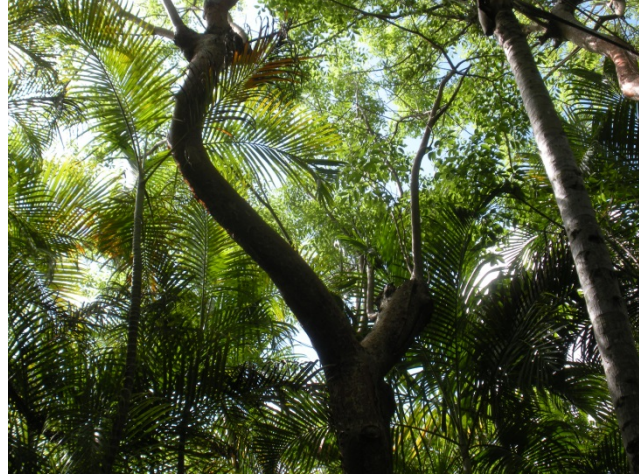
**Tree #186**

Tree #186 is a gumbo limbo. Its trunk diameter is 24 inches, height 35 feet, and crown spread 25 feet. It has some old topping cuts and is generally in fair to good condition.

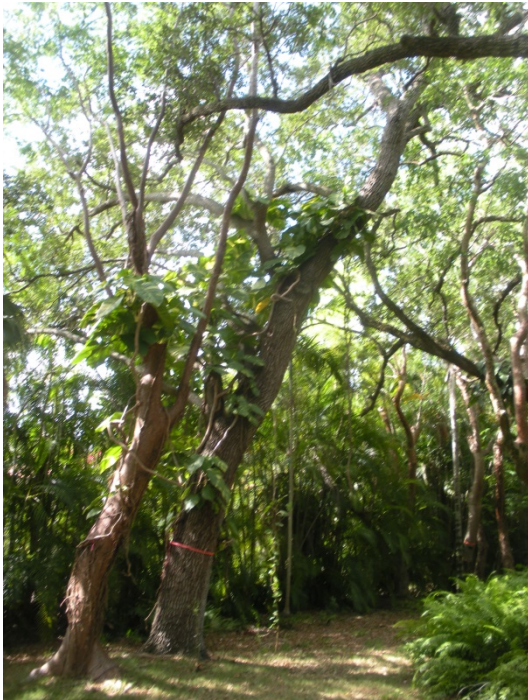
**Tree #196**

Tree #196 is a live oak (*Quercus virginiana*). It has a trunk diameter of 26 inches, an overall height of approximately 50 feet, and a 50-foot crown spread. It is in good general condition (seen below with orange tag).

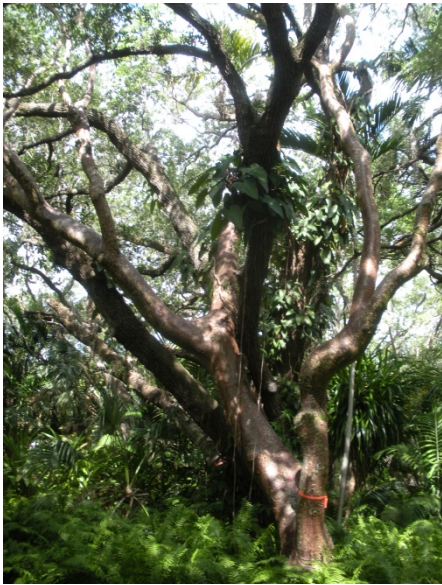
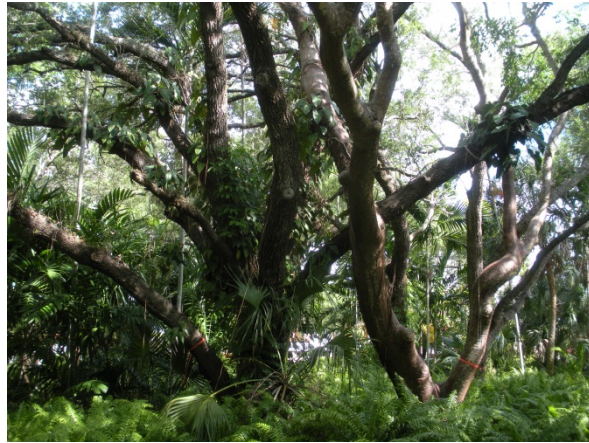
**Tree #198**

Tree #198 is a gumbo limbo. It has a trunk diameter of 28 inches and an overall height of about 30 feet. It has two main leaders that are widely-spread, resulting in a total crown spread of about 50 feet. Its crown is slightly sparse due to shade. It is very close to live oak #200 (seen behind). The tree is generally in fair to good condition.

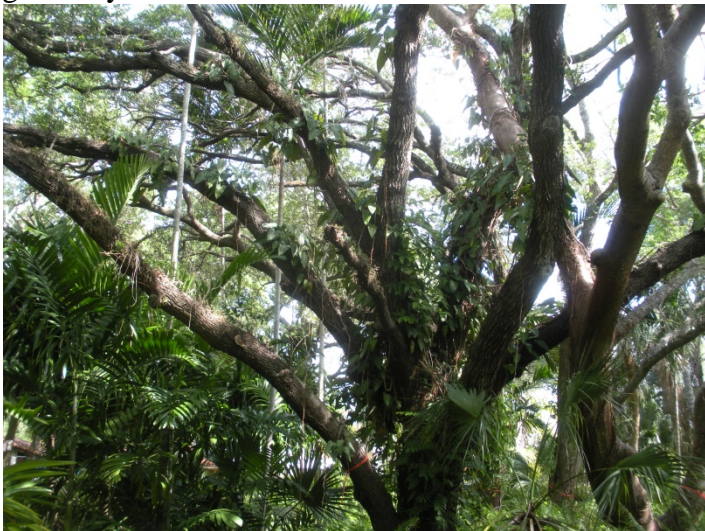
**Tree #200**

Tree #200 is a live oak with a 36-inch trunk diameter. It is about 30 feet in height with a 50-foot crown spread. Its crown is sparse and it has one dead limb about 12 inches in diameter (the one with the orange tag). It has numerous other dead branches up to 6 inches in diameter. The tree is generally in fair condition.

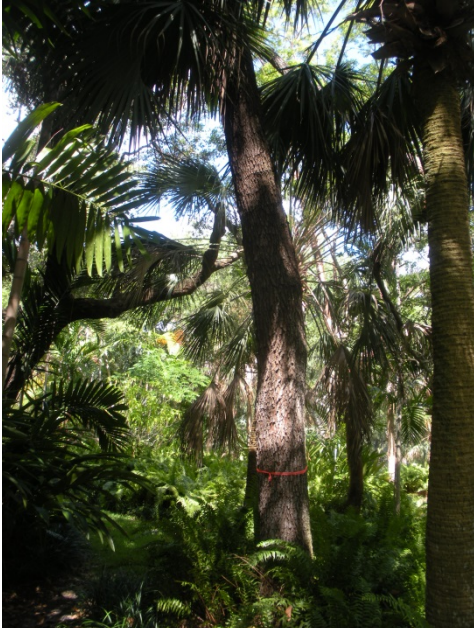
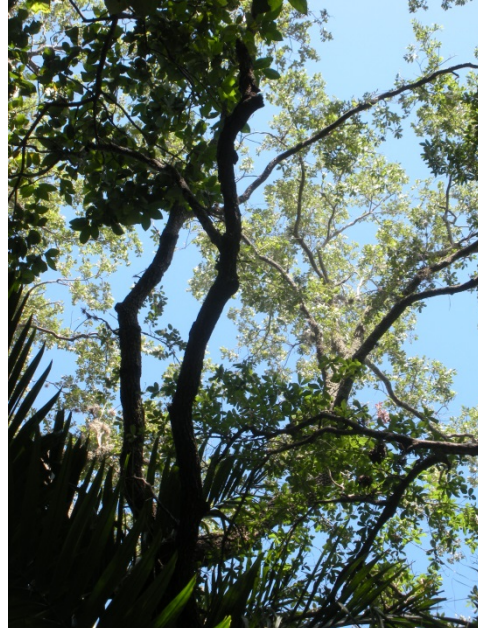
**Tree #211**

Tree #211 is a live oak with a trunk diameter of 18.8 inches. It is about 45 feet in height with a 35-foot crown spread. It is tall, thin, and sparse, with dead branches up to 6 inches in diameter. This tree is in fair to poor condition.

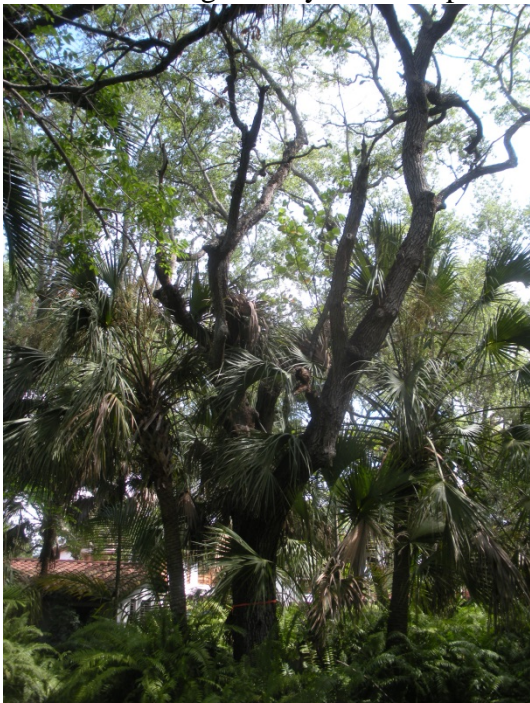
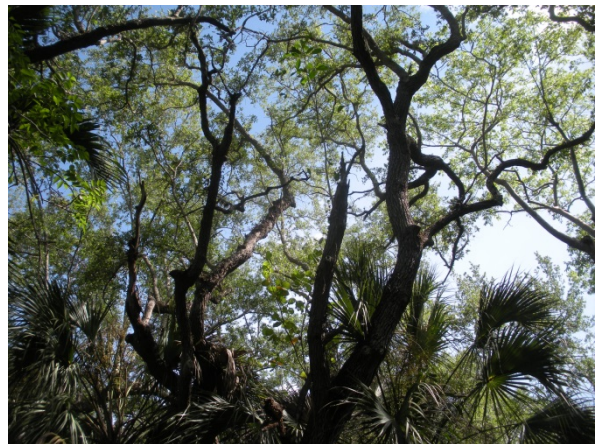
**Tree #216**

Tree #216 is a live oak with a trunk diameter of 23.8 inches. It is about 40 feet in height with a 30-foot crown spread. The crown is very sparse with numerous dead branches up to 10 inches in diameter. This tree is generally in fair to poor condition.

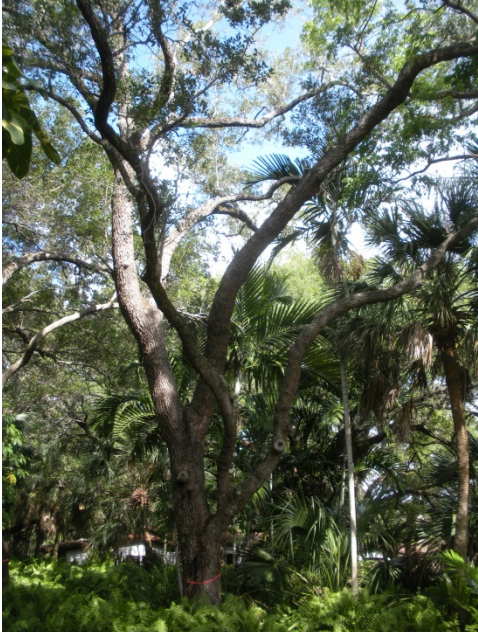
**Tree #226**

Tree #226 is a live oak with a 27-inch trunk diameter. It is approximately 50 feet in overall height with a 35-foot crown spread. Its crown is slightly sparse and it has dead branches up to 8 inches in diameter. It is generally in fair condition.

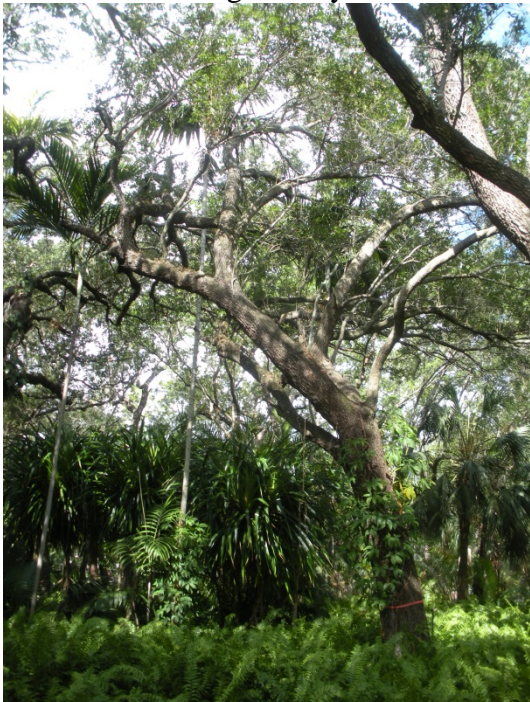
**Tree #228**

Tree #228 is a live oak with a trunk diameter of 23 inches. It is approximately 40 feet in overall height with a 30-foot crown spread. Its crown is slightly sparse and has dead branches up to 6 inches in diameter. The tree is generally in fair condition.

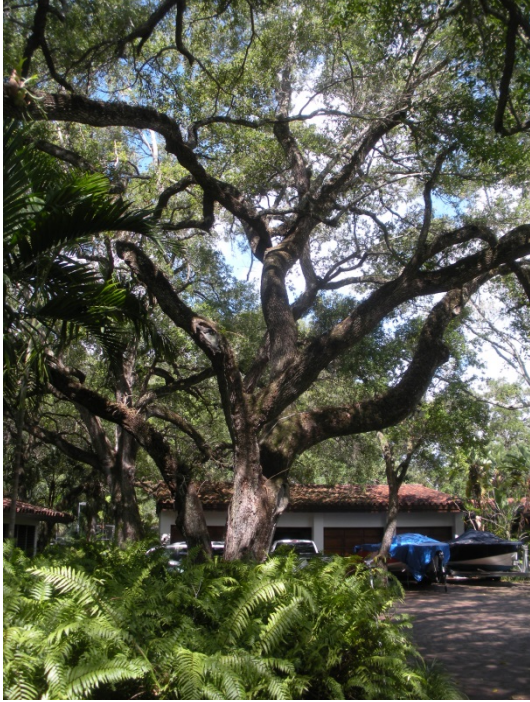
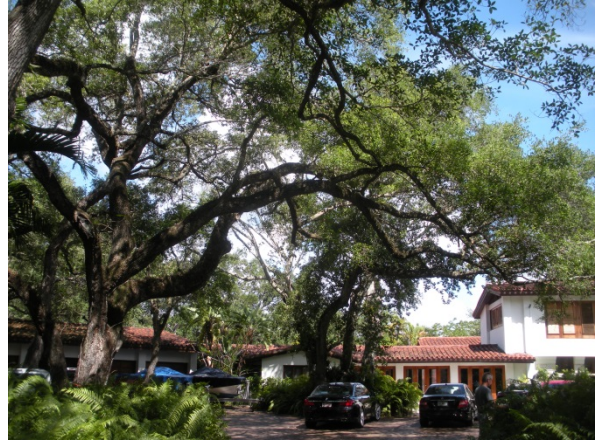
### **Tree #312**

Tree #312 is a live oak with a 27.5-inch diameter trunk. It is about 40 feet in overall height with a 45-foot crown spread. It has one dead leader 14.5 inches in diameter (seen on left side of tree). This tree is in fair to good condition.

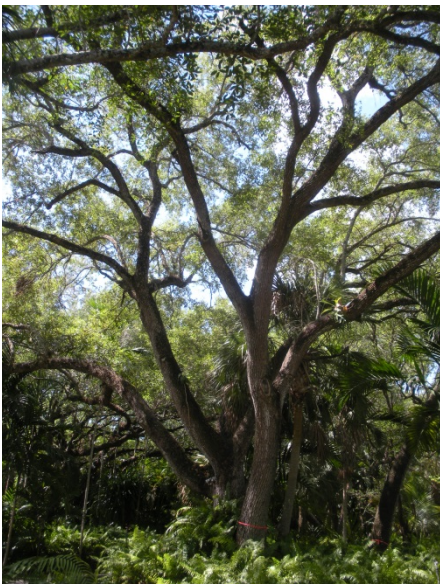
### **Trees #313 and #314**

Trees #313 and #314 are both live oaks, growing close to one another near the driveway where they have had ample space and sunlight. Tree #313 has a trunk diameter of 23.5 inches. It is approximately 50 feet in height with a 40-foot crown spread. Tree #314 is a live oak. Its trunk measures 31 inches in diameter. It is approximately 50 feet in overall height, with a 50-foot crown spread. Both trees are generally in good condition. In the photo below tree #313 is in the front and #314 is behind it.

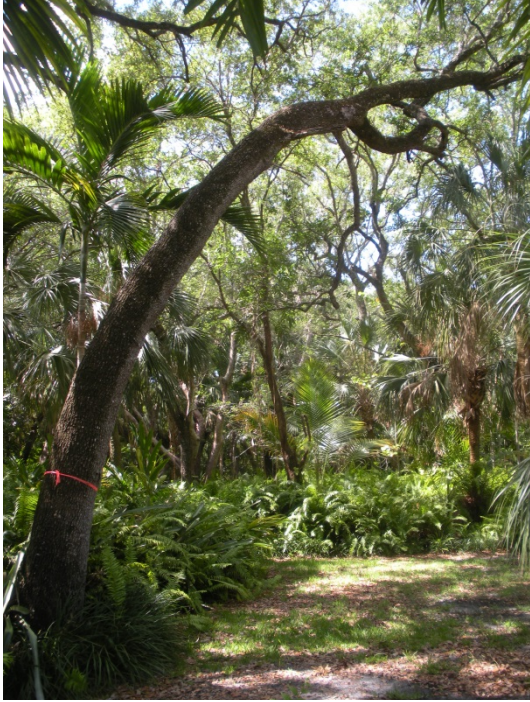
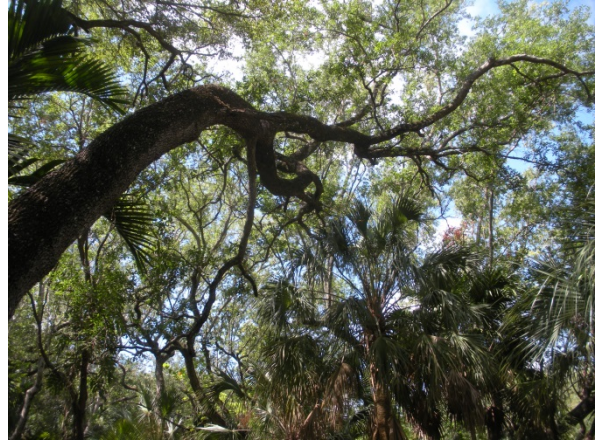
**Tree #315**

Tree #315 is a live oak. Its trunk diameter is 20.3 inches and the trunk is leaning/bent under the shade of other trees. It is about 35 feet in height with a 30-foot crown spread that is one-sided. The tree is in fair to good condition.

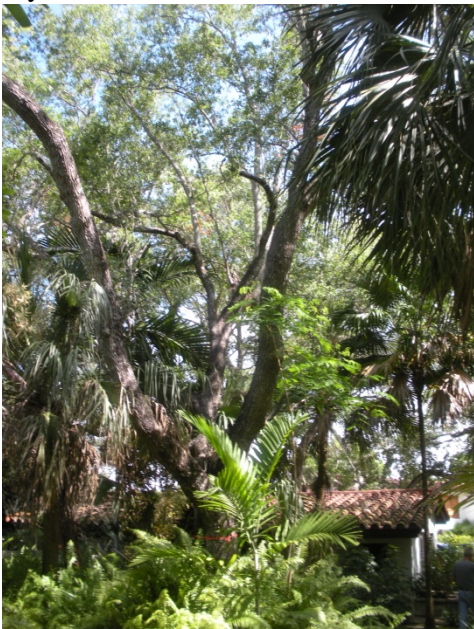
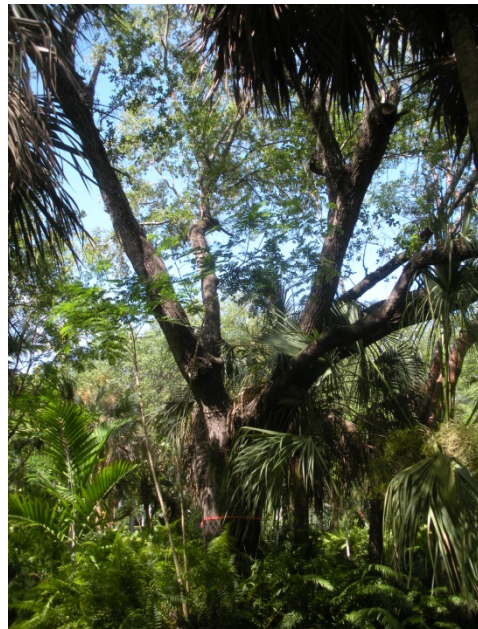
**Tree #322**

Tree #322 is a live oak with a trunk diameter of 25 inches. It is approximately 40 feet in overall height, with a crown spread of 40 feet. Its crown is slightly sparse with a little twig dieback. It is generally in fair condition.
