Big Ron's Tree Service

Arborist Report

Address: 5307 Orduna Drive Coral Gables Fl 33146

Date: January 15th, 2025

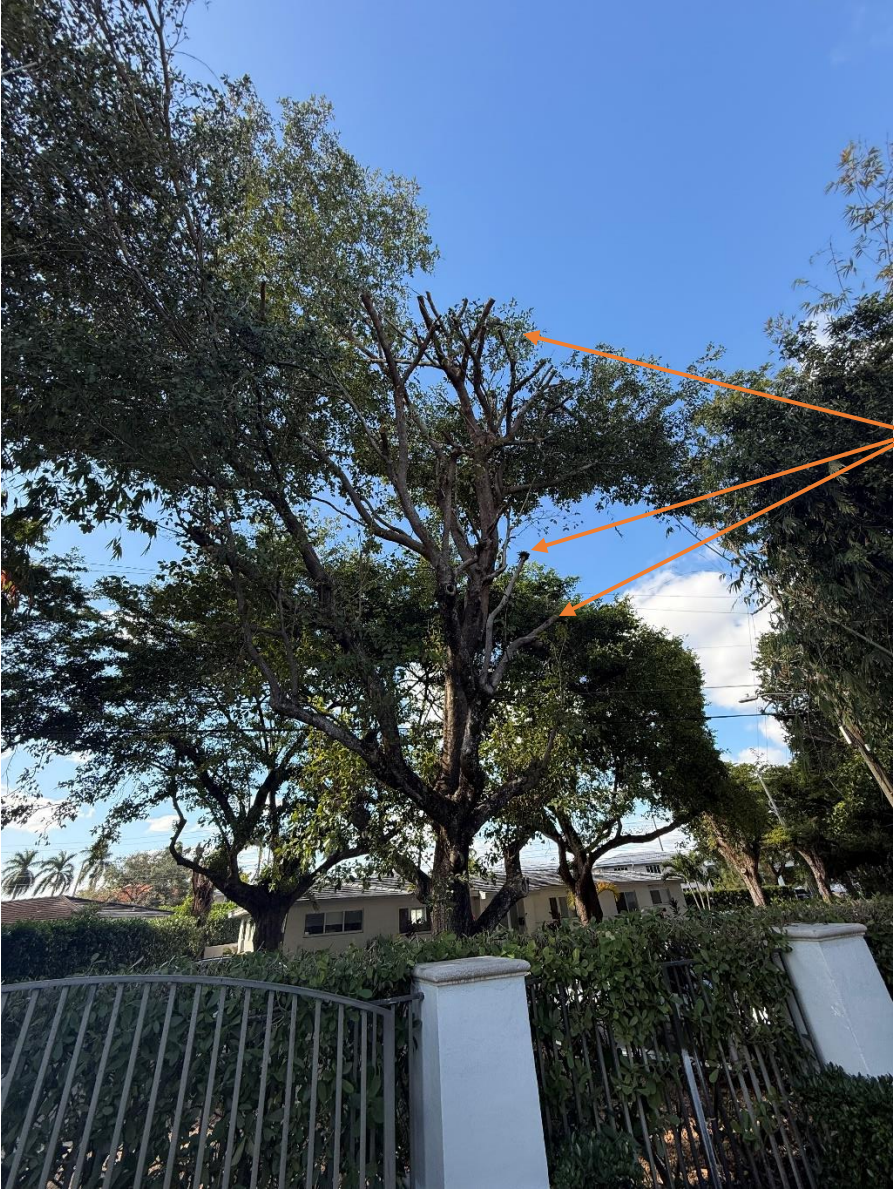
This tree has been pruned without a permit as per the notice of violation. The tree was trimmed back from the property. Not all pruning cuts were done as per ANSI A-300 standards. The following restorative actions should be taken:

Stubs to be corrected by bringing back to the main leader.

1. **Remove Stubs:** Stub cuts should be corrected, that is as per ANSI A-300 standards. This should be supervised by an ISA certified Arborist. In my professional opinion the tree stands a fair chance of recovery if the stubs are removed. Removing them will avoid the tree going into stress mode. I will also recommend the removal of the stubs below the Utility lines. See pic below. Though the client isn't at fault for this, there is a lot of adventitious growth on it and if left alone it will grow back faster than before and the utility company will improperly prune it again in the future, leading to additional unwanted stress to the tree.
2. **Follow-up Arborist assessment:** After 12 months an arborist assessment must be done to determine if the tree is healing and re-growing as it should, and its overall condition. No additional pruning should be done during the 12 month period.

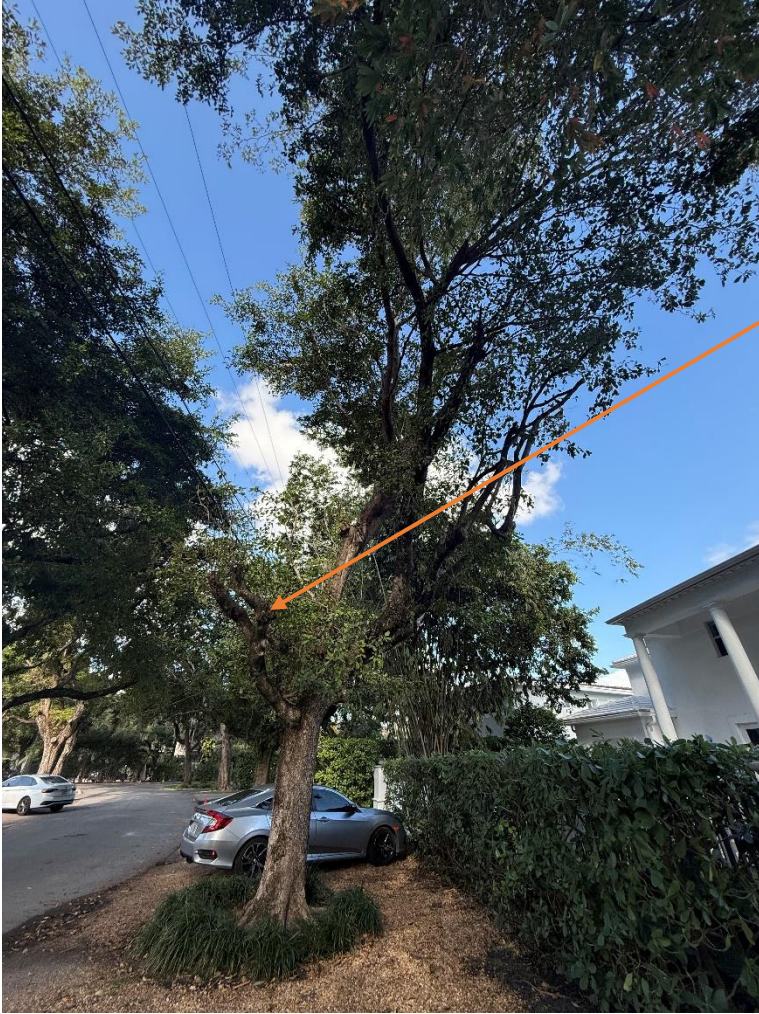
Though this tree was trimmed without a permit, it is still in fair condition. It appears that this tree was utility trimmed as well which usually leaves stubs.

3 Stubs to be removed from under the Utility lines. This should be brought back to the main trunk.
