5040 NW 7TH STREET, SUITE 820, MIAMI, FL 33126

305.461.3450 | O-N.COM

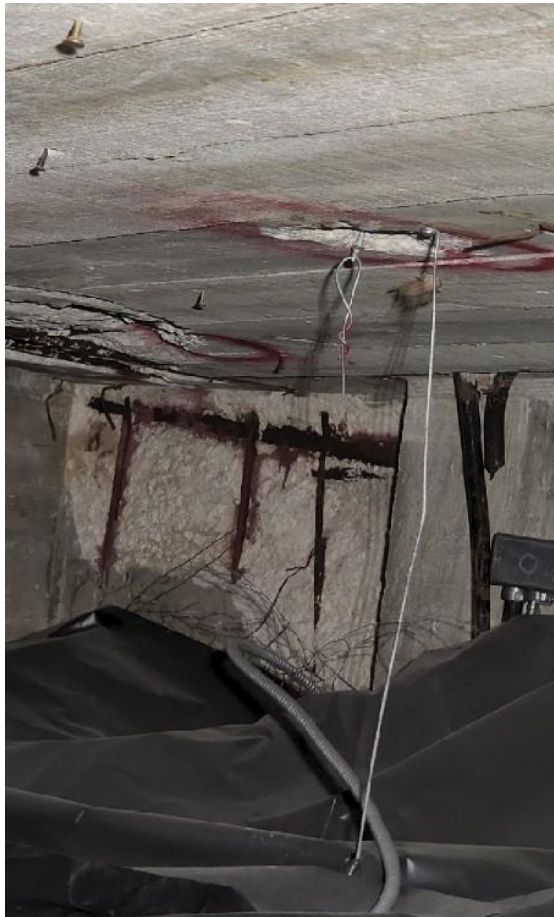
PHOTOGRAPH 6 - EXAMPLE OF SPALLING AT EXTERIOR TIE BEAM ABOVE FINANCE DEPARTMENT

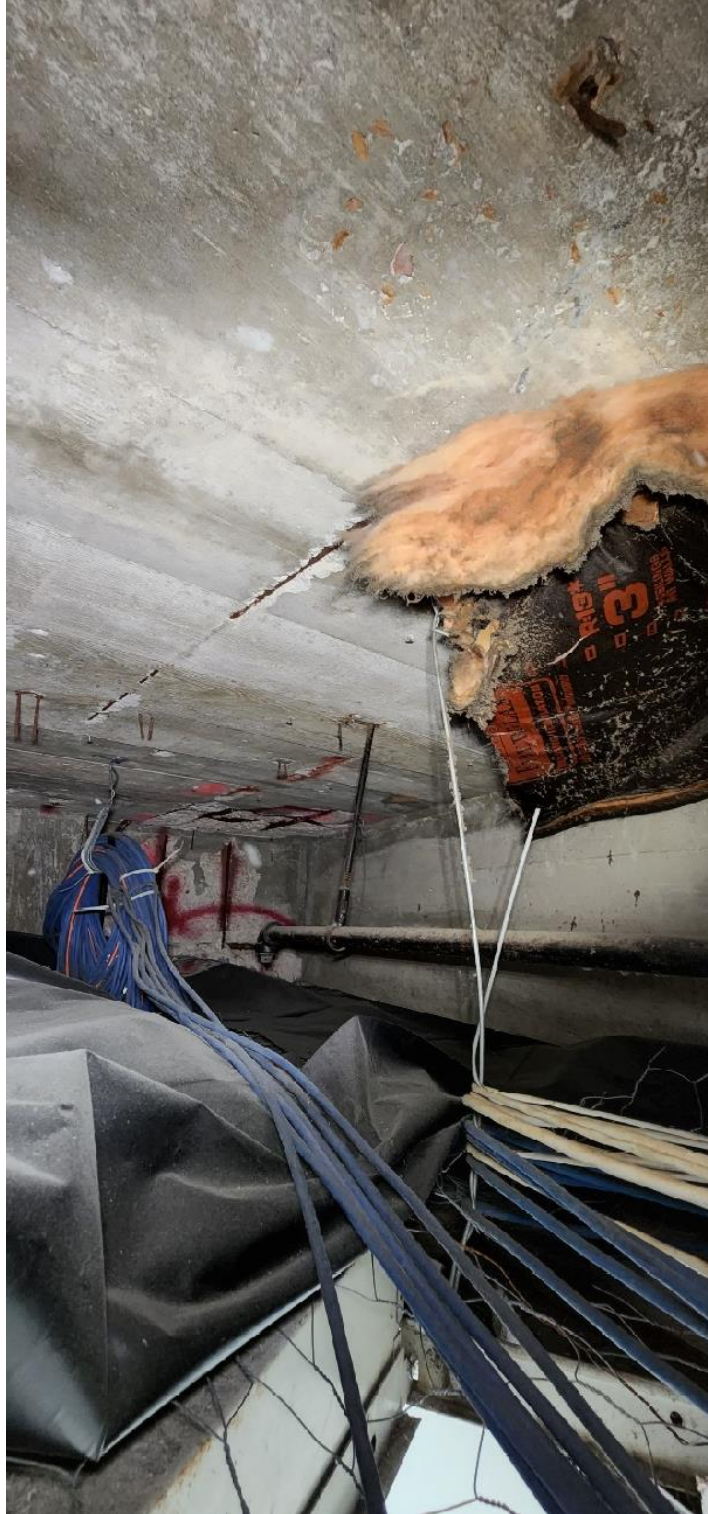
PHOTOGRAPH 7 - EXAMPLE OF SPALLING AT EXTERIOR TIE BEAM AND SLAB ABOVE FINANCE DEPARTMENT

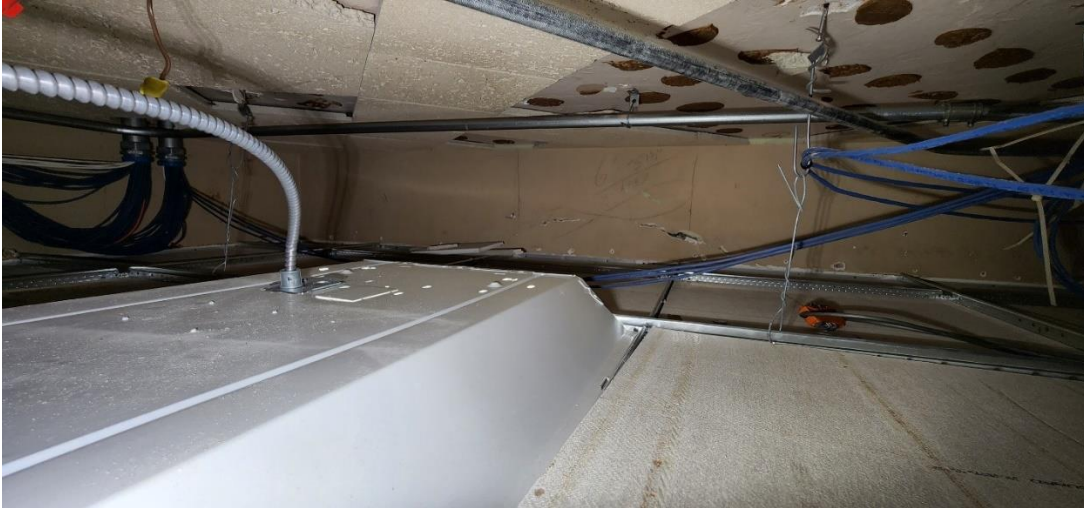
PHOTOGRAPH 10 - SPALLING AT BEAM ABOVE CITY MANAGERS'S DEPARTMENT

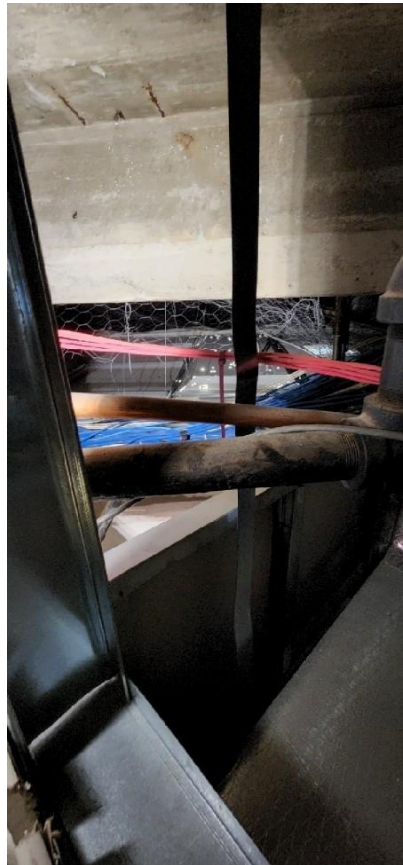
PHOTOGRAPH 12 - SPALLING AT SLAB ABOVE CITY MANAGERS DEPARTMENT CEILING

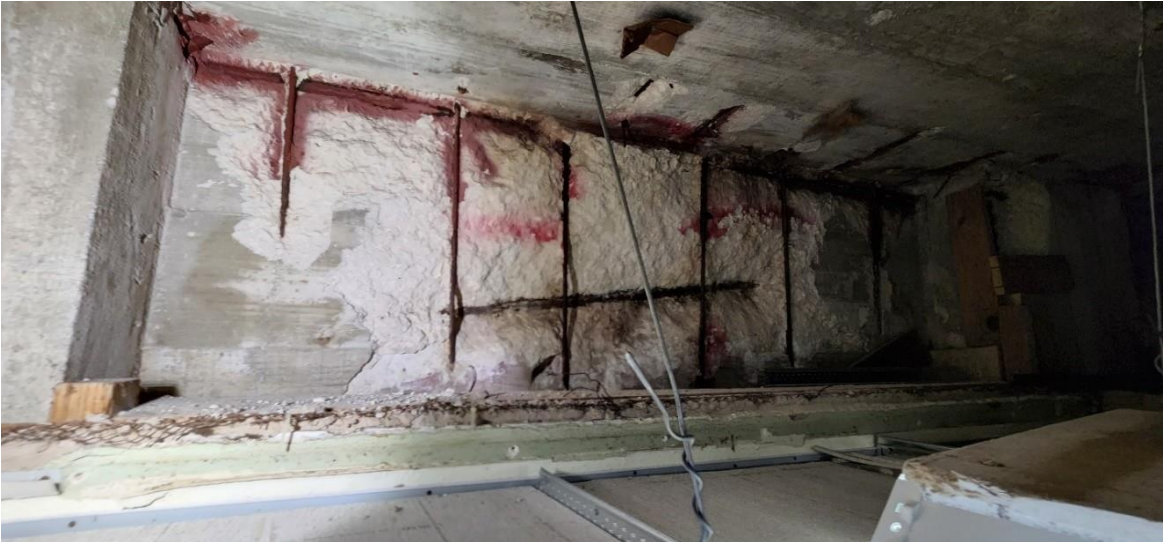
PHOTOGRAPH 13 - SPALLING AT EXTERIOR BEAM ABOVE CITY MANAGER'S CEILING

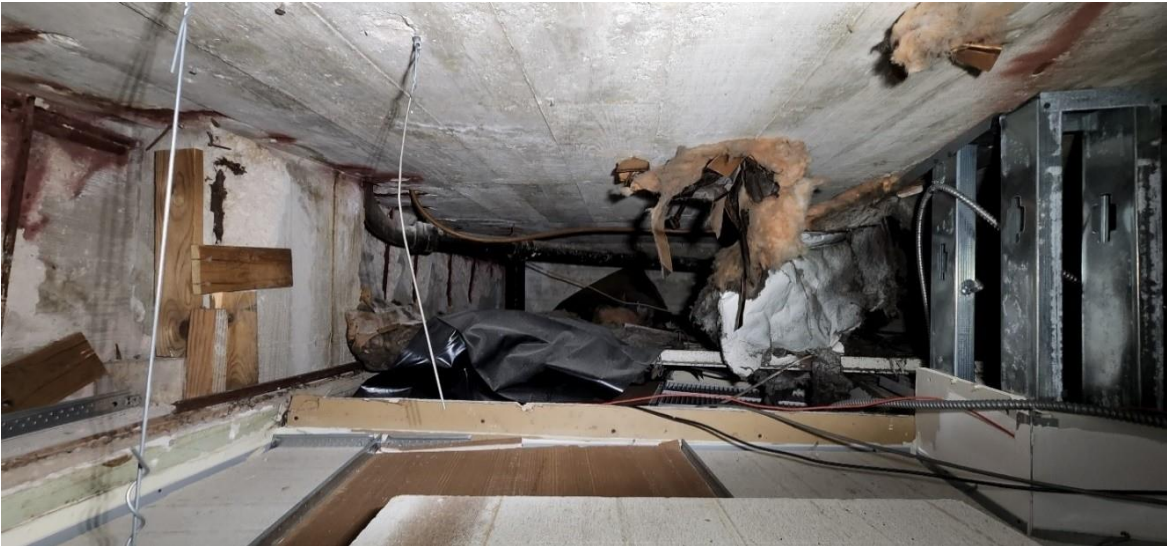
PHOTOGRAPH 14 - SPALLING AT EXTERIOR BEAM ABOVE CITY MANAGER'S CEILING

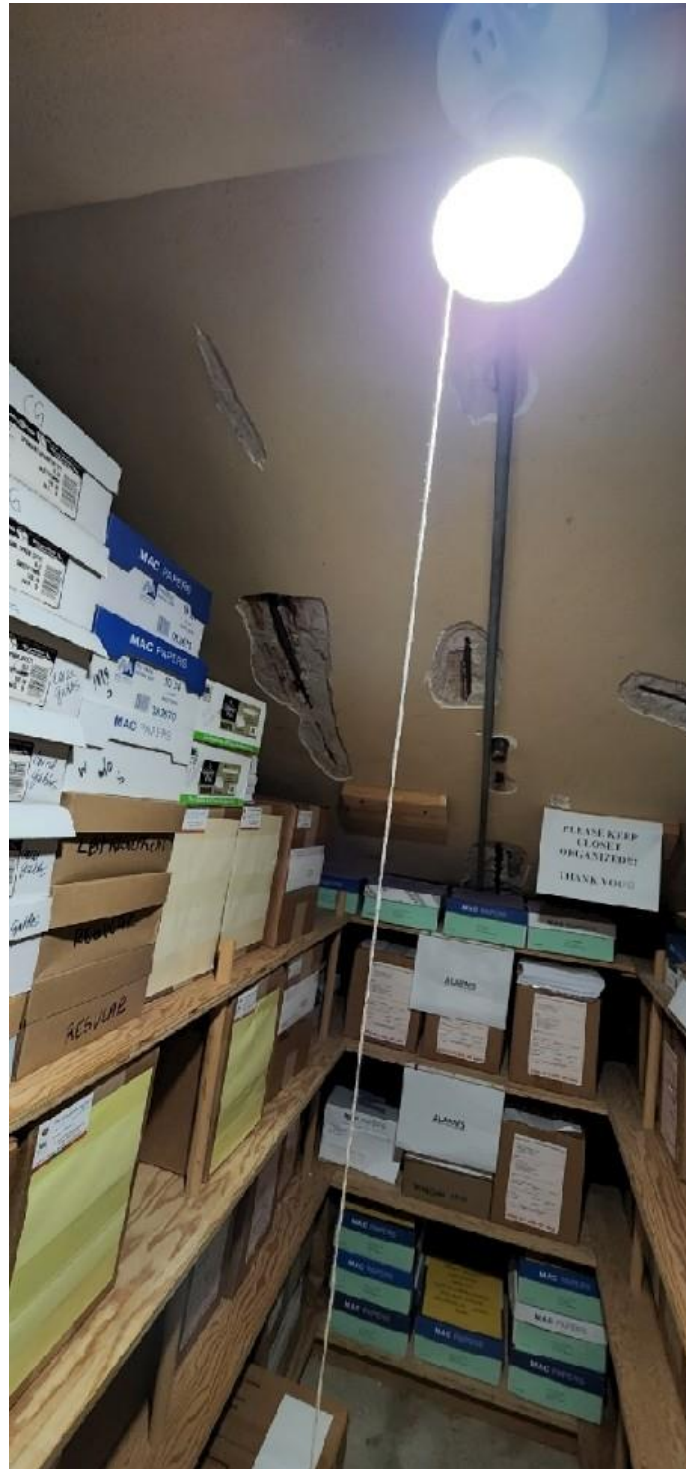
PHOTOGRAPH 5 - SPALLING BELOW MAIN STAIRCASE

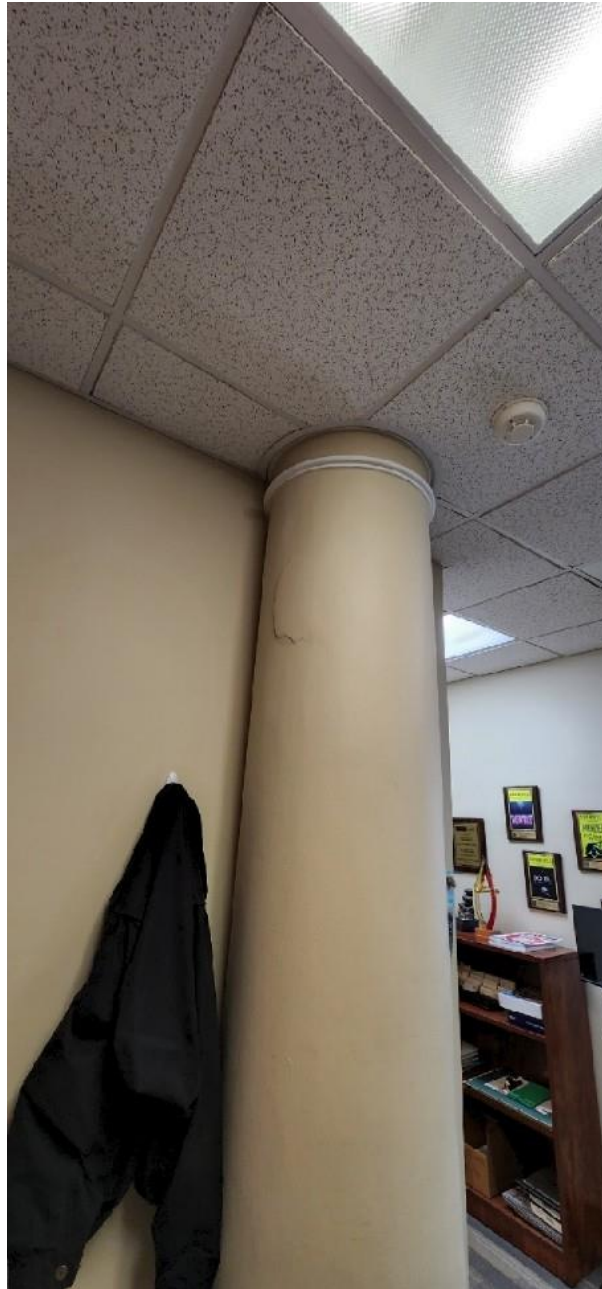
PHOTOGRAPH 11 - SPALLING AT CONCRETE COLUMN IN CITY MANAGER'S DEPARTMENT

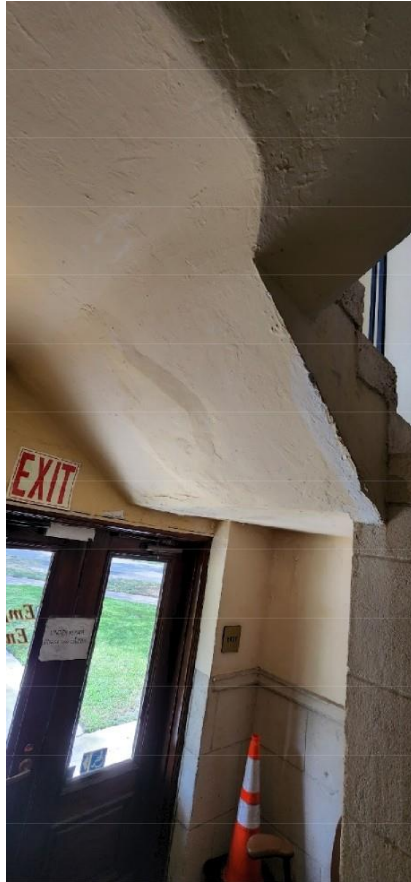
PHOTOGRAPH 1 - BULGING SPALL AT AUXILIARY STAIRCASE

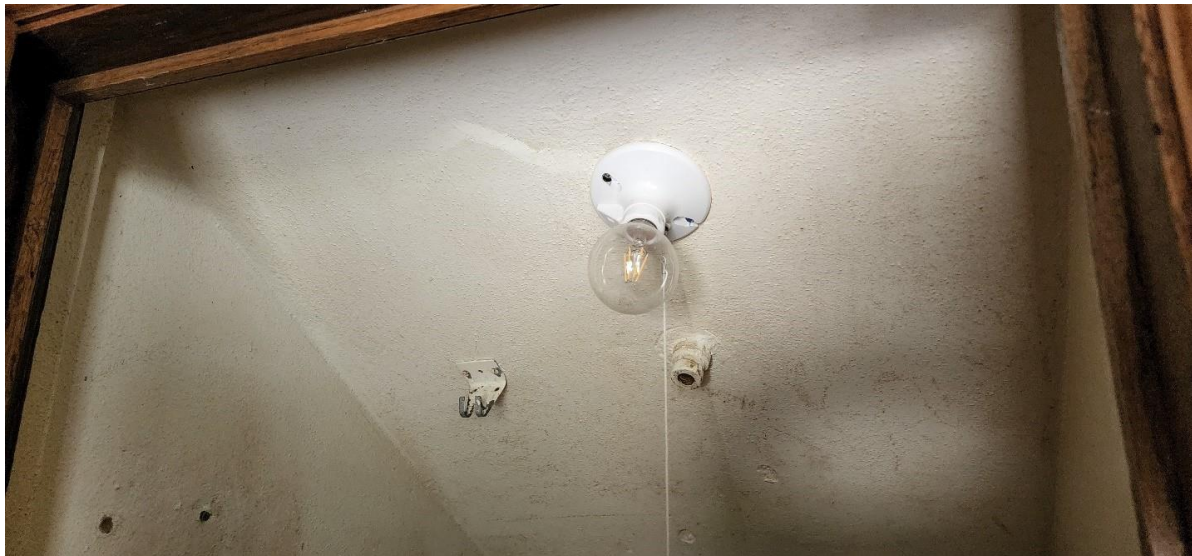
PHOTOGRAPH 25 - EXAMPLE OF SPALL UNDER AUXILIARY STAIRWAY

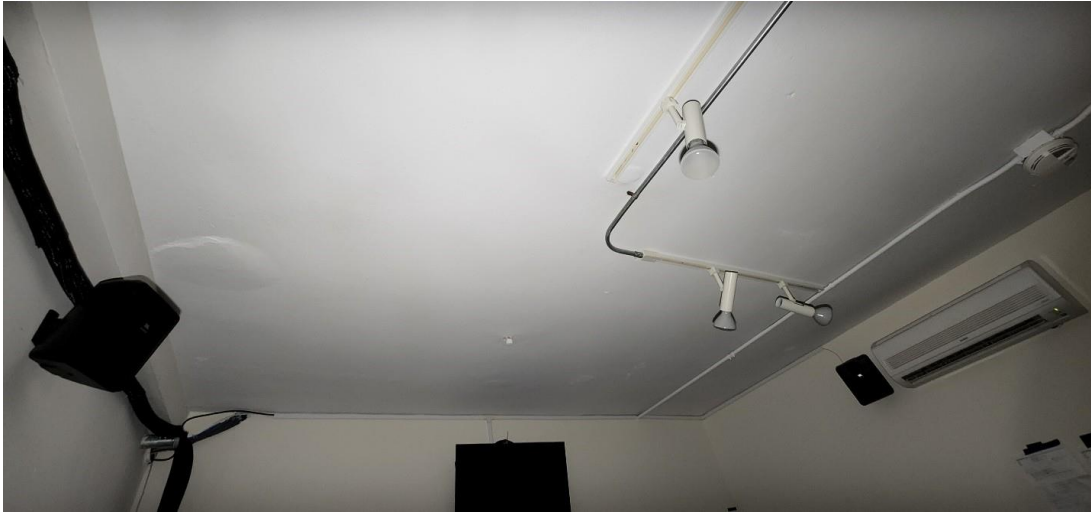
PHOTOGRAPH 38 - EXAMPLE OF CEILING SPALL AT MEDIA CONTROL ROOM

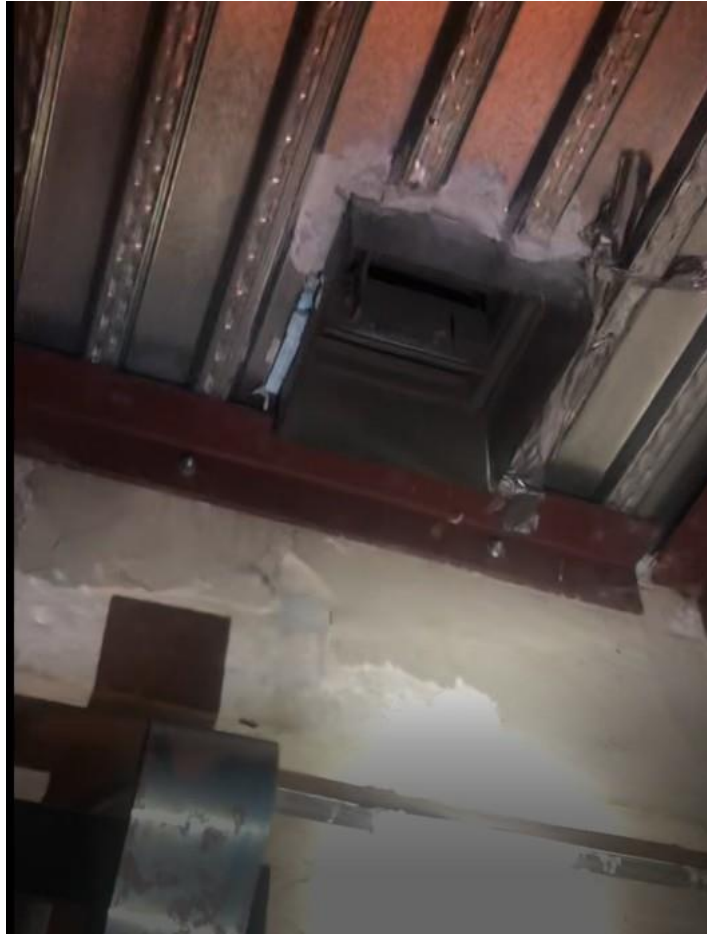
PHOTOGRAPH 45 - EXAMPLE OF SPALLING AT ELEVATOR CHASE WALLS

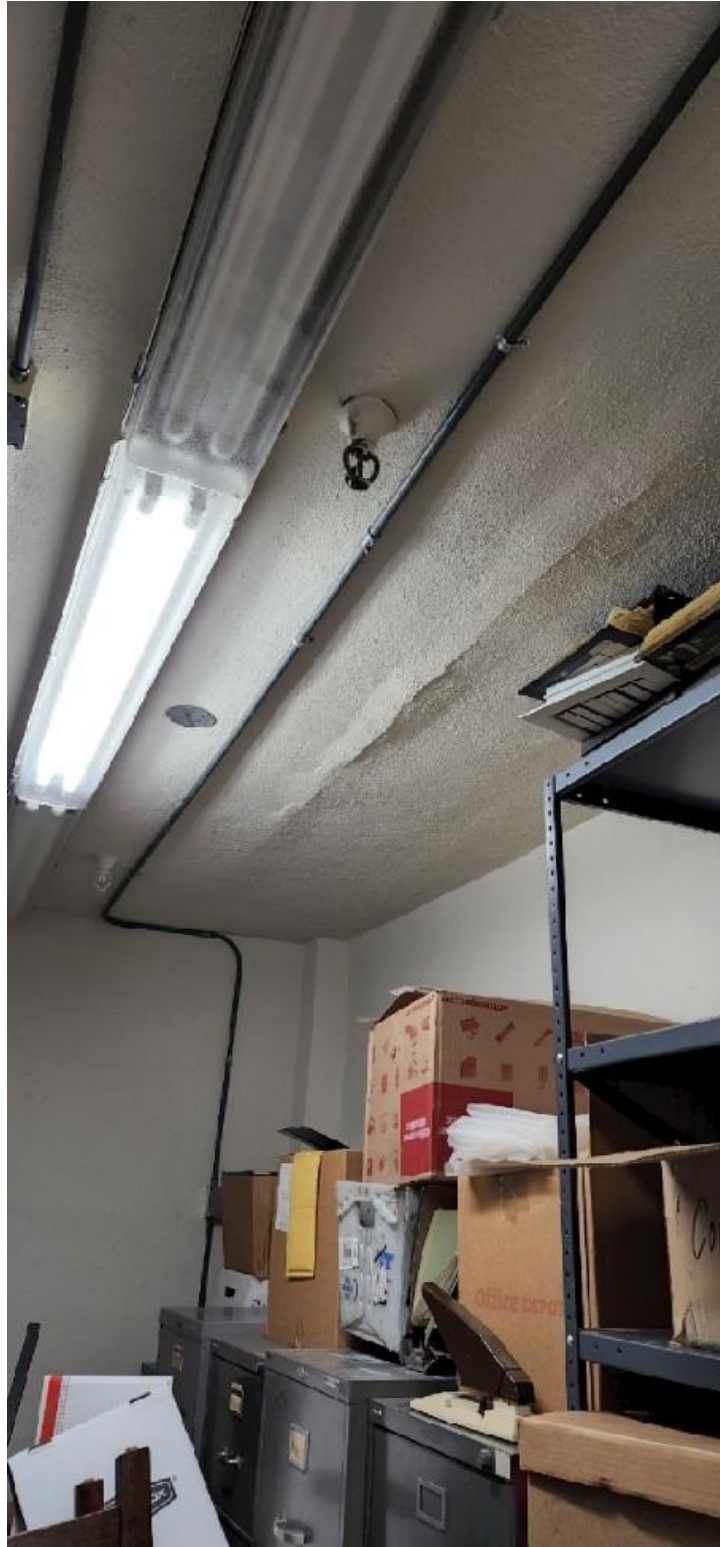
PHOTOGRAPH 48 - EXAMPLE OF SPALLING IN MICROFILM DEPARTMENT.

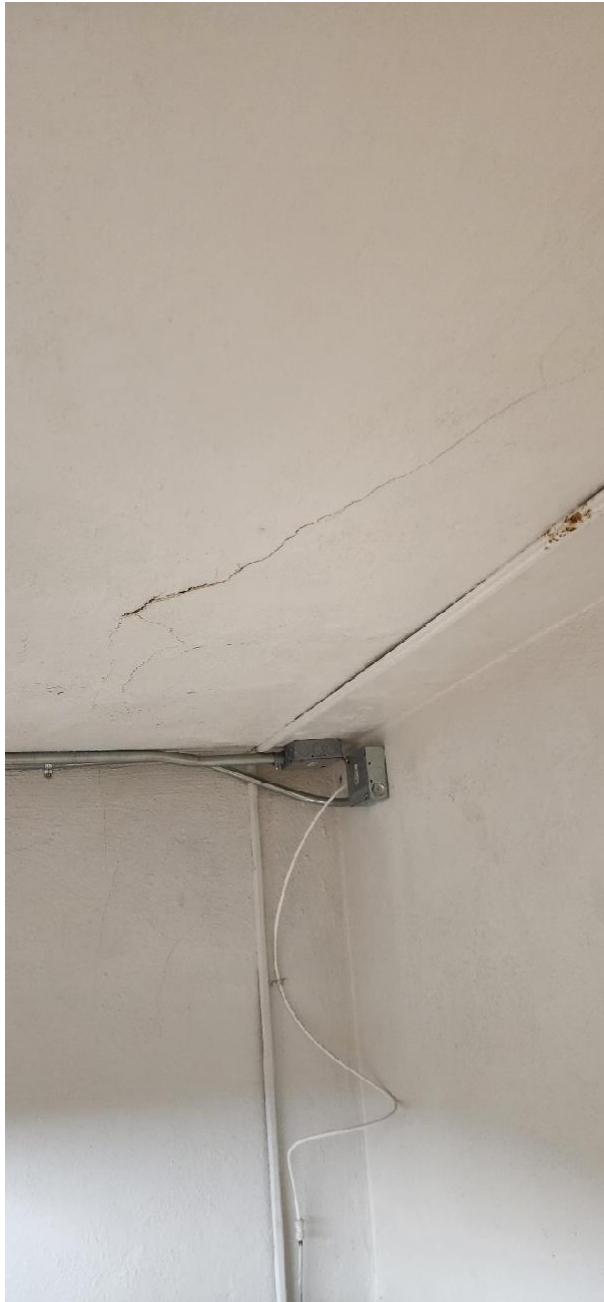
PHOTOGRAPH 16 – SPALLING IN CEILING AND WALL CRACKS AT HISTORICAL SAFE IN CITY MANAGER'S DEPARTMENT

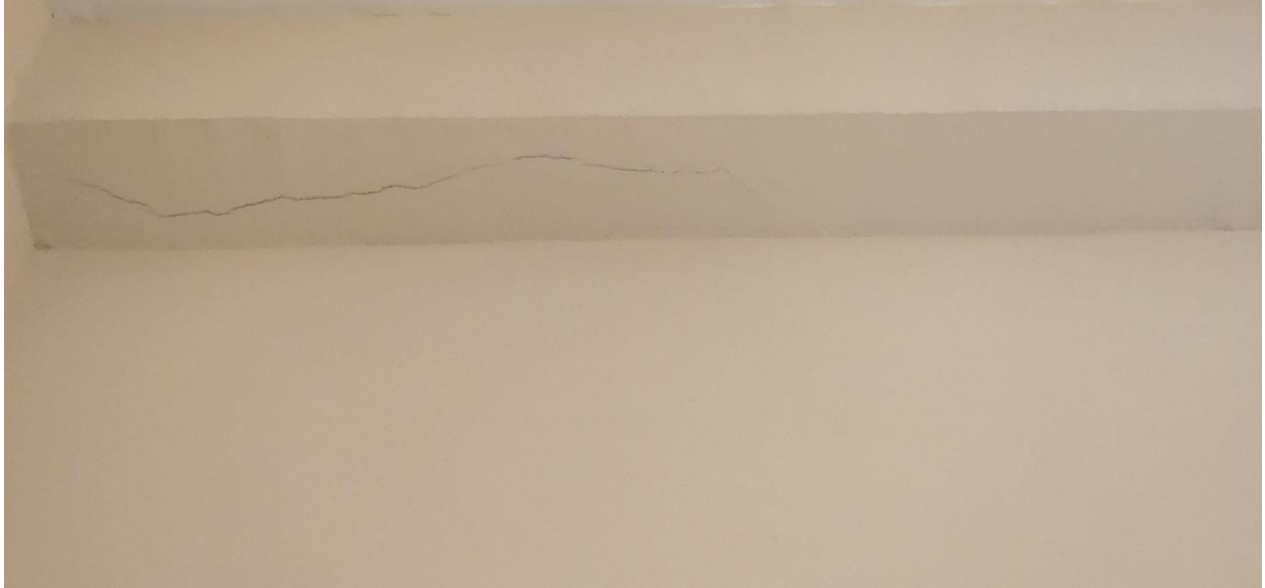
PHOTOGRAPH 17 - SPALLING AT BEAM IN CITY MANAGER'S OFFICE HISTORIC SAFE

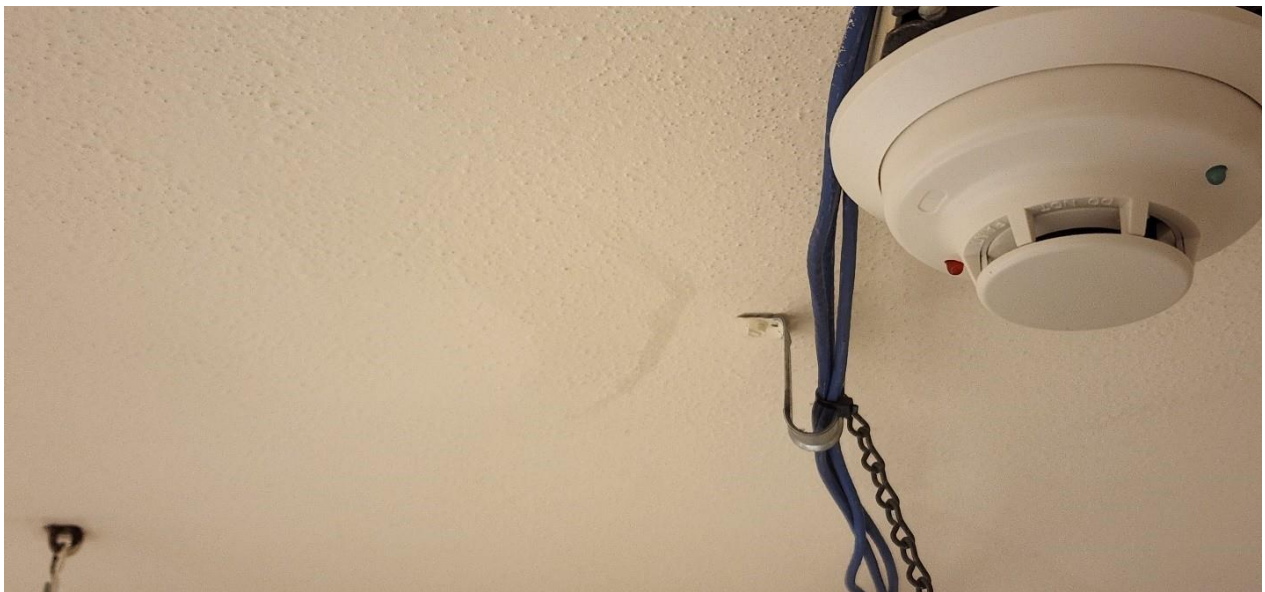
PHOTOGRAPH 19 - SPALL AT CEILING IN HISTORICAL SAFE IN CITY CLERK DEPARTMENT

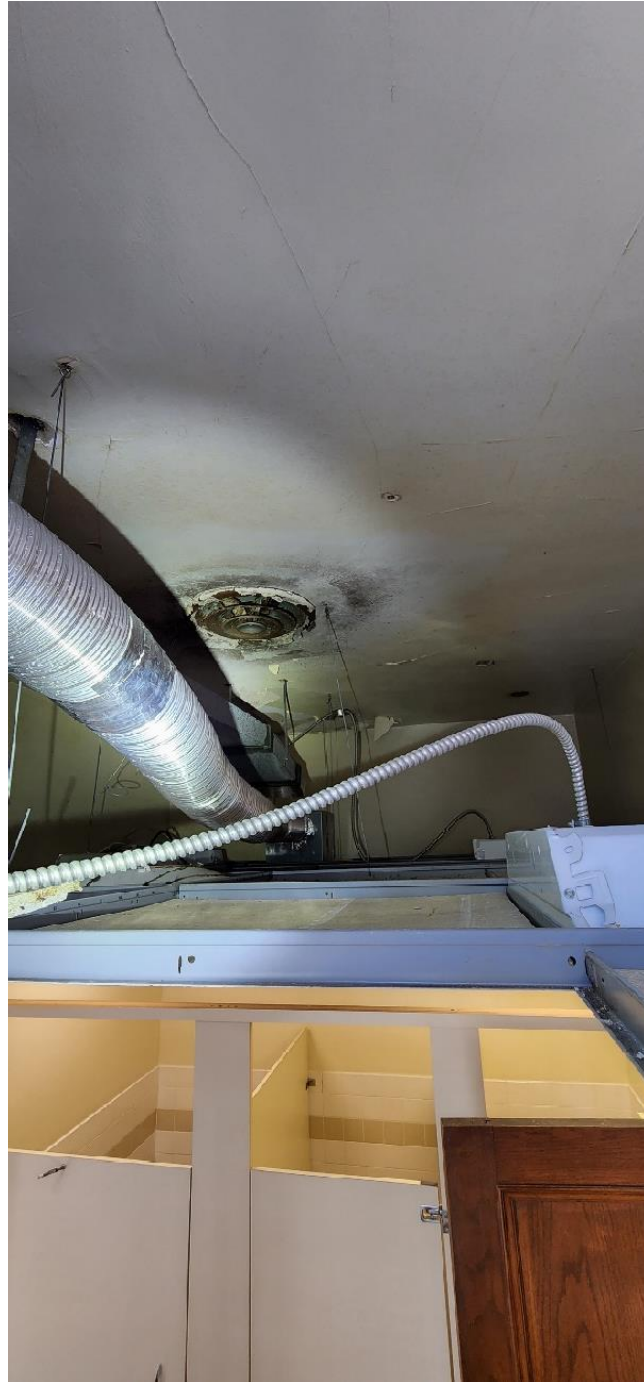
PHOTOGRAPH 47 - EXAMPLE OF EFFLORESCENCE AND CRACKING ABOVE CEILING IN WOMEN'S RESTROOM

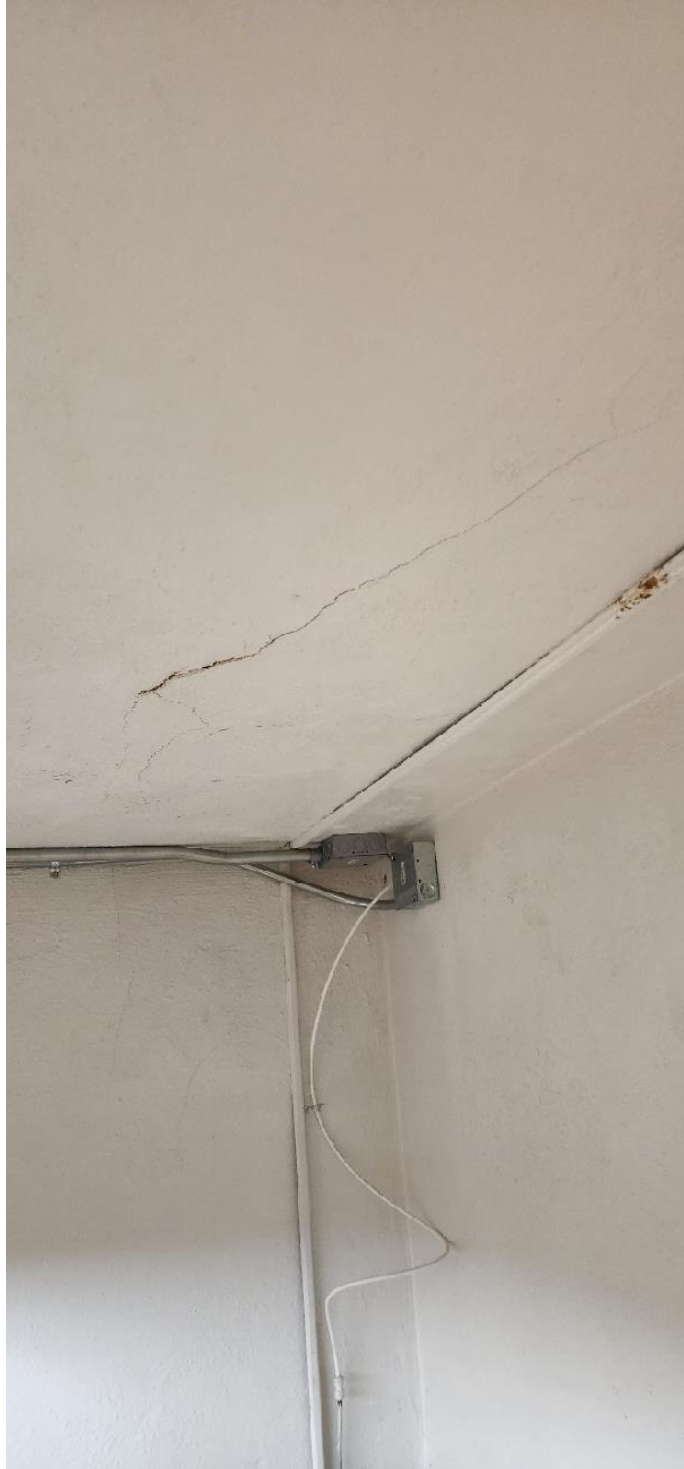
PHOTOGRAPH 16 - SPALLING CEILING AND WALL CRACKS OF HISTORICAL SAFE IN

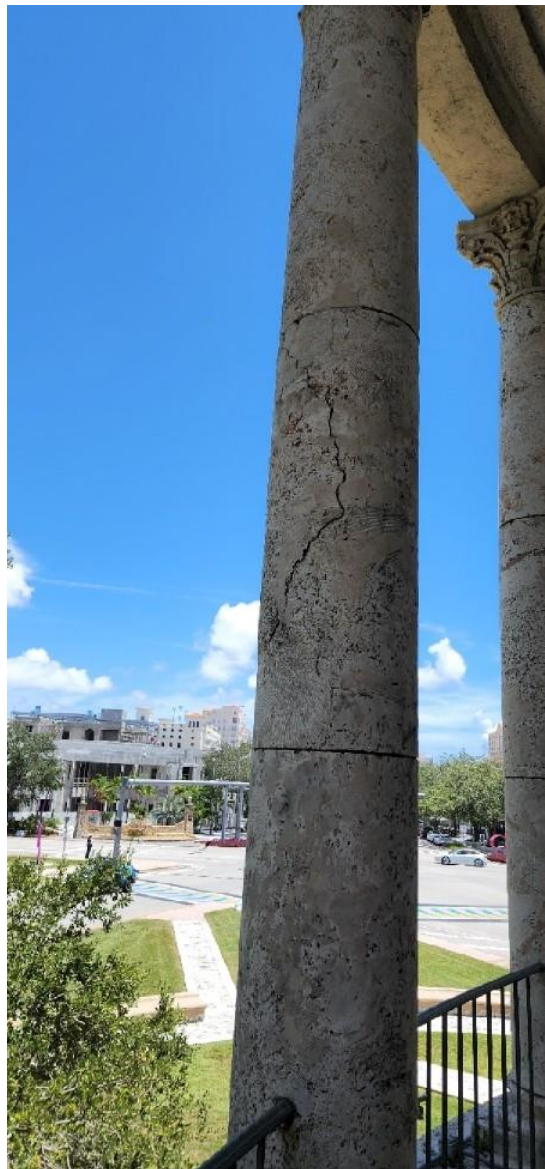
PHOTOGRAPH 32 - EXAMPLE OF SPALLING OF CLADDING AT EXTERIOR COLUMN

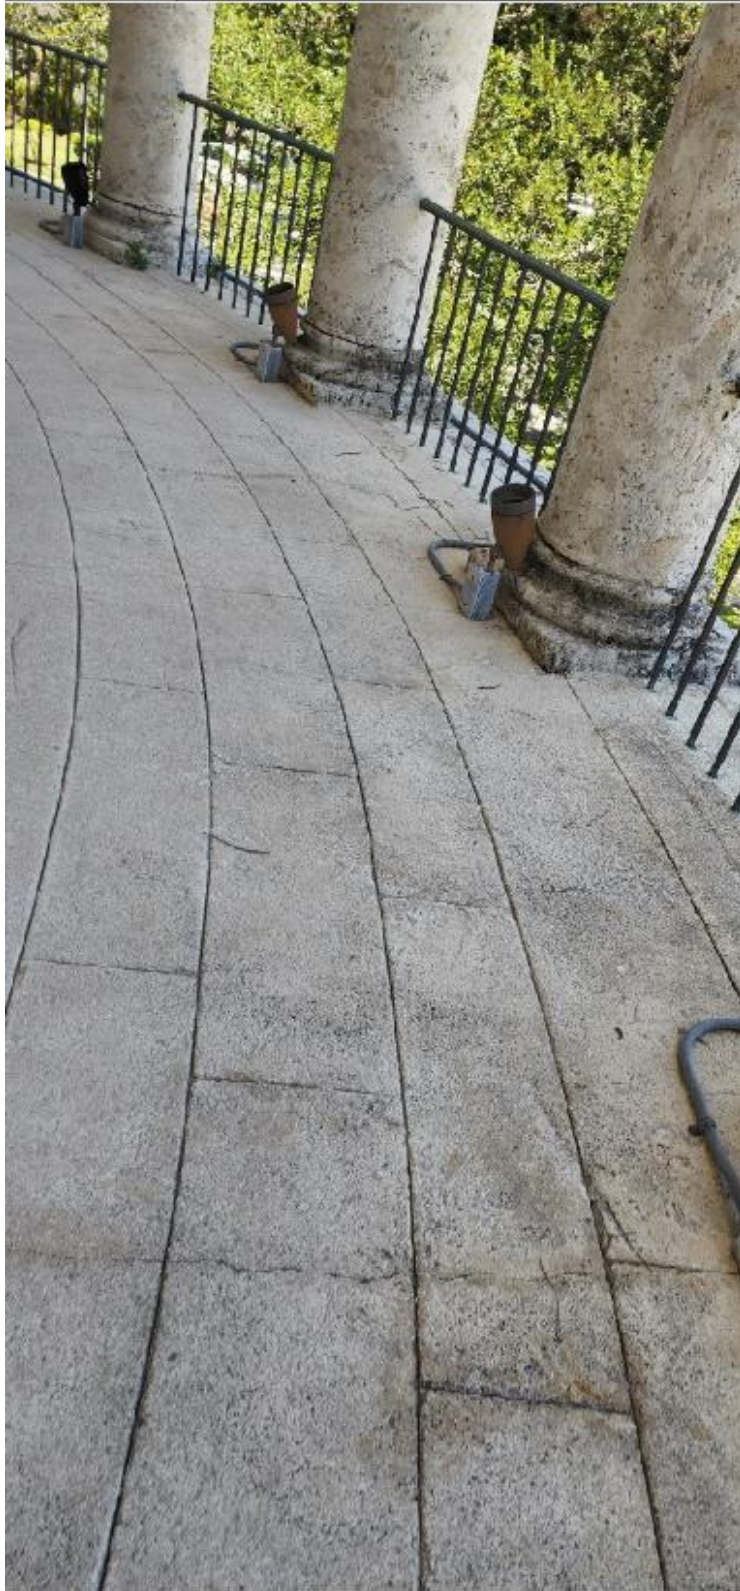
PHOTOGRAPH 33 - LOOSE BALCONY TOP RAILING

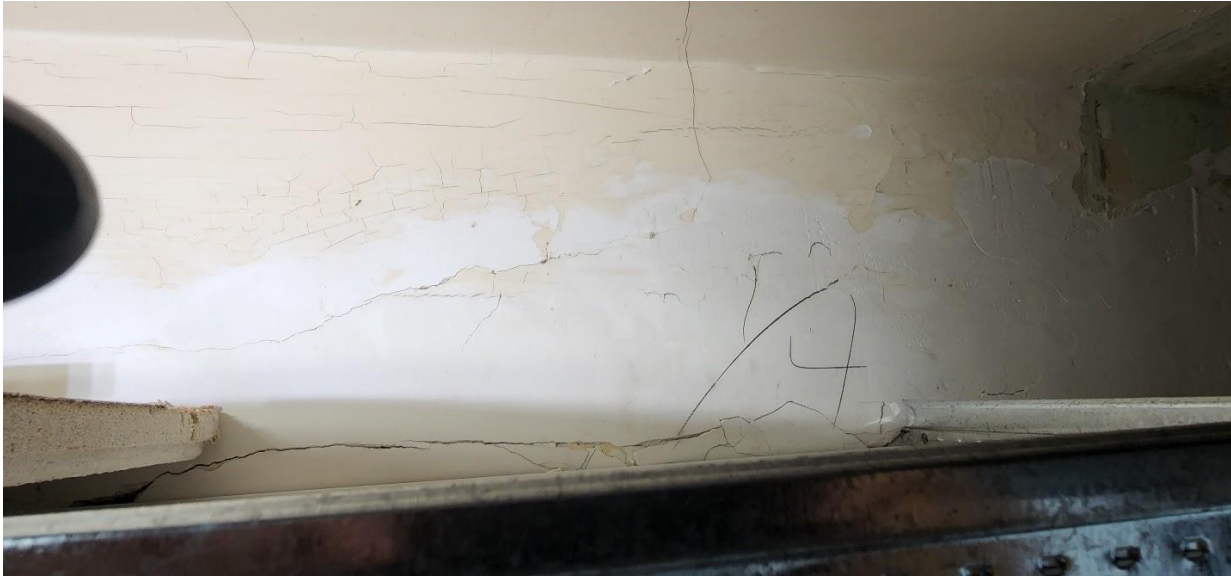
PHOTOGRAPH 40 - EXAMPLE OF CRACKING IN 3<sup>RD</sup> FLOOR CITY ATTORNEY'S OFFICE

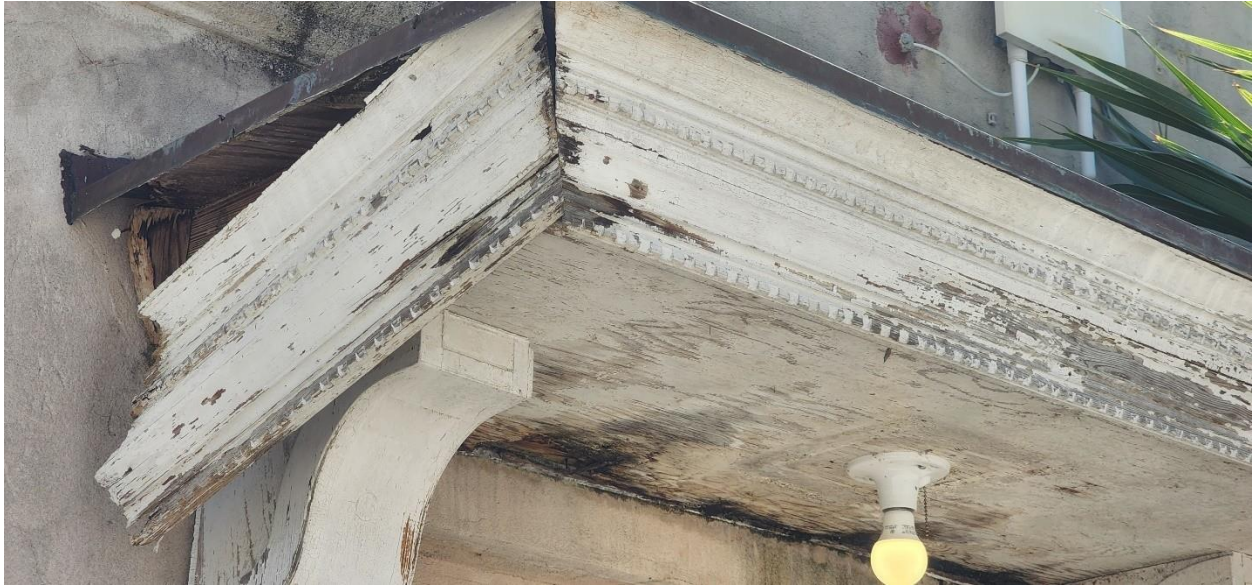
PHOTOGRAPH 66 - EXTERIOR CANOPY ROOF DETERIORATION ABOVE DOORWAYS AROUND ANNEX
