A.J. Odilon
3406 Granada Blvd.
Coral Gables, FL 33134

On March 7th, 2025 A.J. Odilon contacted Bartlett Tree Experts to inspect three black olives (*Terminalia busceras*) located at 3406 Granada Blvd. The trees had recently been pruned and were found to be in violation of Coral Gables Code of Ordinance Section 82-3 (b) – Defacement of tree, shrubs, vines, etc., in public placed prohibited without a permit, and Section 82-29 (c) – Tree Abuse – Permits generally. The city required that the tree be evaluated for overall condition to determine if the tree could be retained.

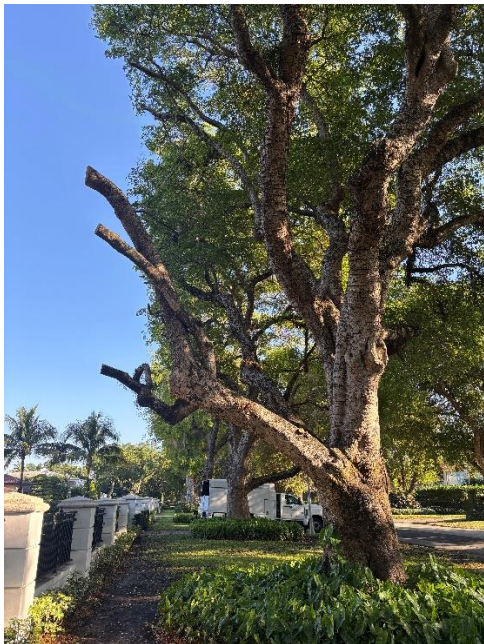
Figure 1 Large defoliated limb on southernmost tree, facing the property

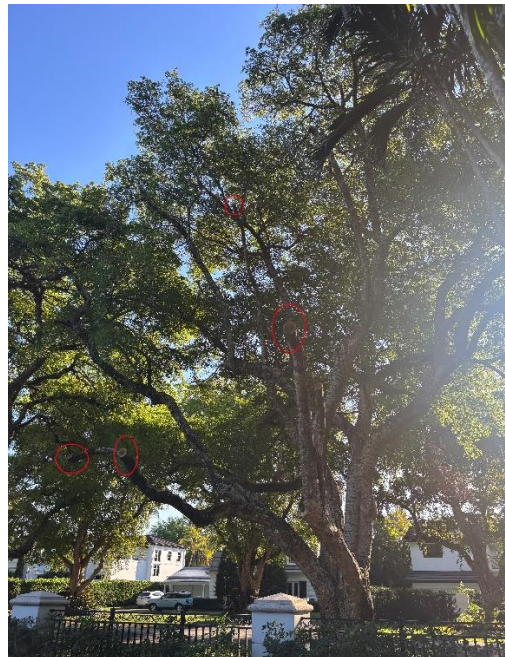
The recent pruning consisted of multiple heading cuts ranging from approximately 2" to 10" in diameter in the crown facing the property. (See photo below). Heading, or "topping" cuts is a sub-standard practice that has long been understood to be detrimental to tree health and structure. Heading cuts can promote decay in the retained part of the branch.

Figure 2 Looking from property towards street, large heading cuts are observed

- Fertilize the tree every four months with a controlled release fertilizer based on the results of a soil sample.
- Prune the tree properly. Branches that were headed should be reduced back to a lateral and/or removed back to the branch collar. Pruning should be performed by an ISA Certified Arborist who is competent in this work.

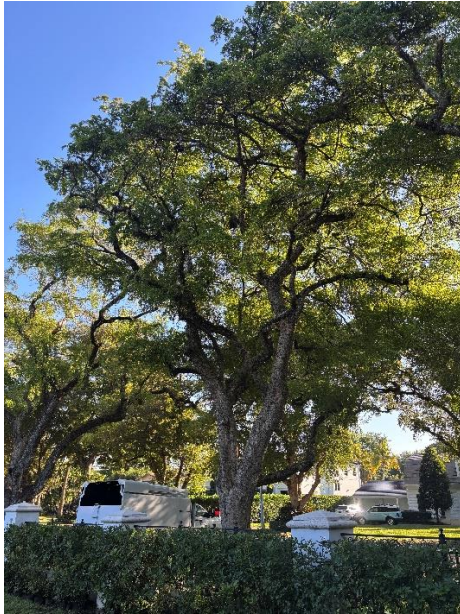
Figure 3 center tree with 2-4" heading cuts in the upper canopy

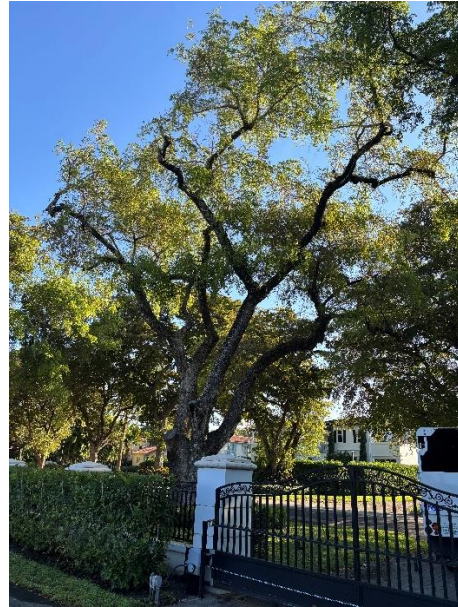
Figure 4 Northernmost tree with heading cuts in the upper canopy and large deadwood in the crown
