Arborist Tree Survey/Level-2, Basic visual assessment
Violation of Section 82-29 (d) "Pruning of limbs 10" diameter or greater"

Prepared for: The City of Coral Gables

Property location: 740 Tibidabo Avenue

Ticket: #25-10-21653, issued 10/22/25

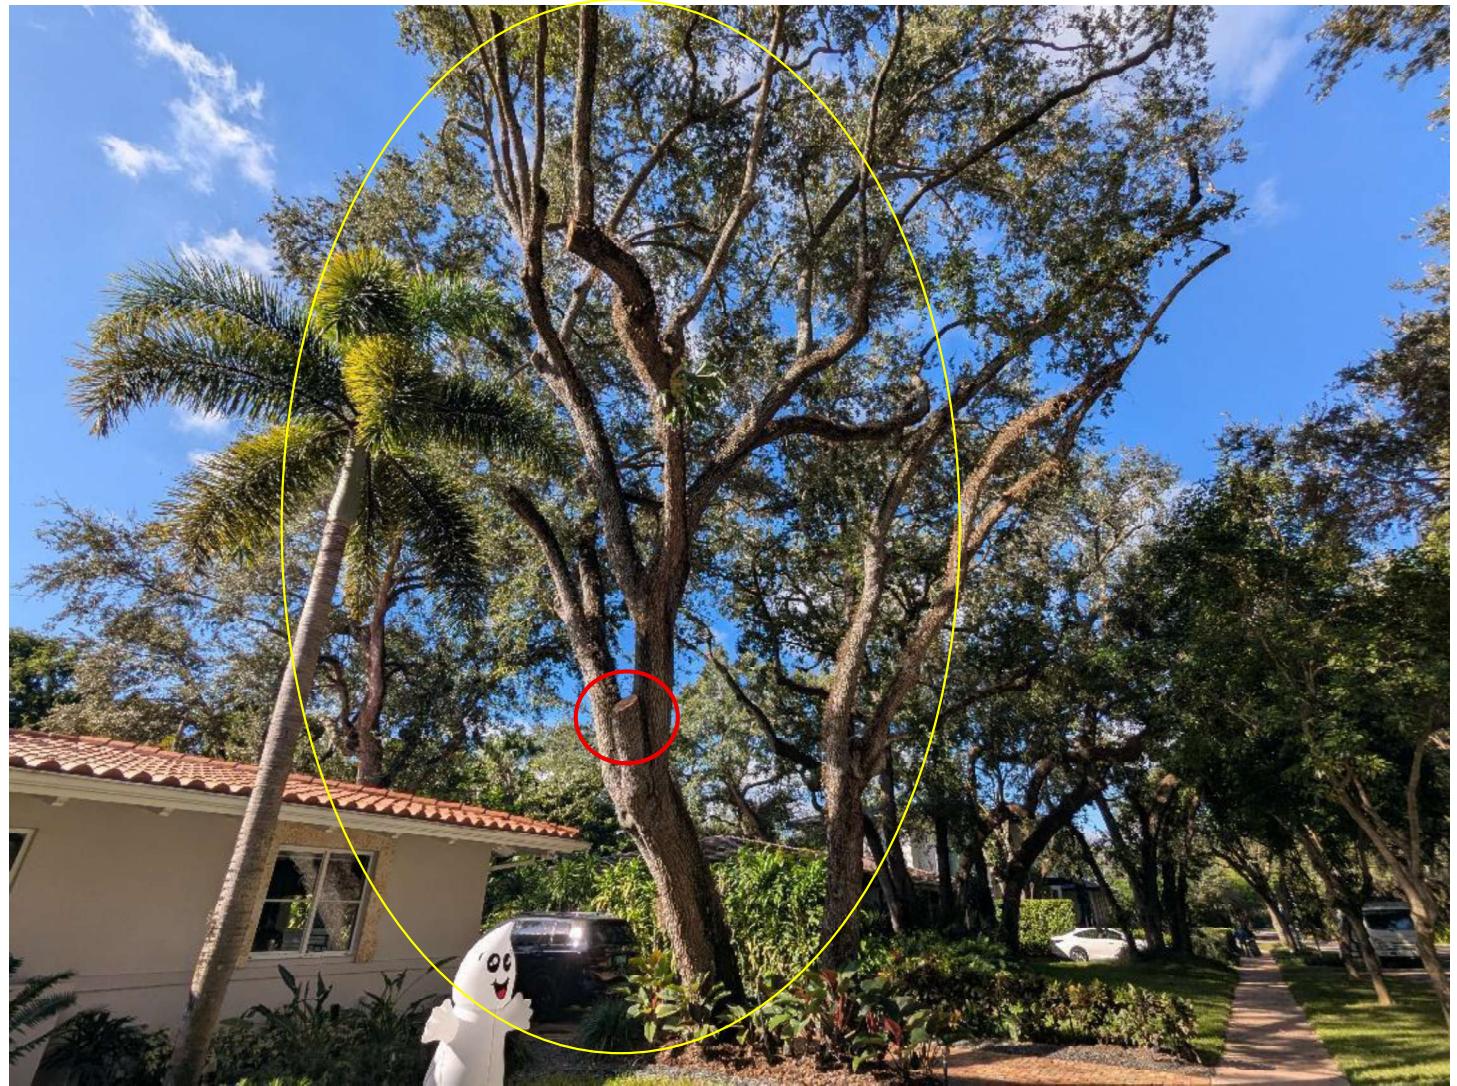
The tree in question is circled in yellow in the image above. It is a 2x, specimen Live oak (with the west codominant trunk stem being obscured in the image by the east trunk, at the angle provided). It is growing extremely close to a sister tree to its north. Both trees offer sparse canopies along with an appearance of questionable health status. The north tree is underdeveloped, over pruned and barely sustaining. I have a suspicion that both trees were adversely affected by past driveway construction whereby a high likelihood of aggressive root cutting would have been required to accommodate the driveway. This process would explain the start of an accelerated decline in their condition

The removal of the 13” diameter first order stem, that was emerging from the primary union of the east growing codominant trunk stem (circled in red), along with the maintenance pruning recently conducted did not negatively impact the tree or change its condition. Although done in violation of City code because a permit was not secured in advance of the work, I suggest the decision to remove the seriously decaying 13” diameter branch (following its partial failure) was a prudent and safety minded arboricultural decision.

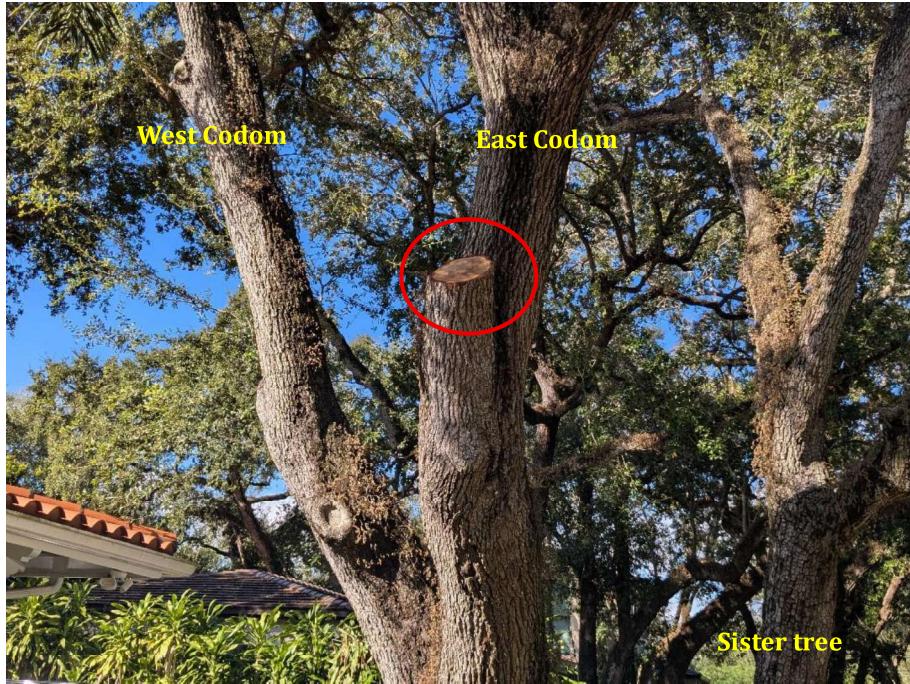
After questioning the tree contractor who performed the removal of the 13” diameter branch I was explained that the end of the branch had already failed prior to their arrival and after an assessment of the remaining portion of the branch it was decided that based on its location and recent history of branch failures, the safest solution was to reduce the remaining portion of the branch to healthy, solid, wood and then secure an after-the-fact permit. As documented in the images below, the branch had an unacceptable degree of internal decay throughout its length that appropriately resulted in a branch removal, as opposed to a reduction. The option allowing any of the branch to remain attached would have required a heading cut and only a few feet of healthy, lateral wood (a stub) protruding.

Close-up of branch removal wound

I see no need for any additional, corrective or restorative to be done at this time.

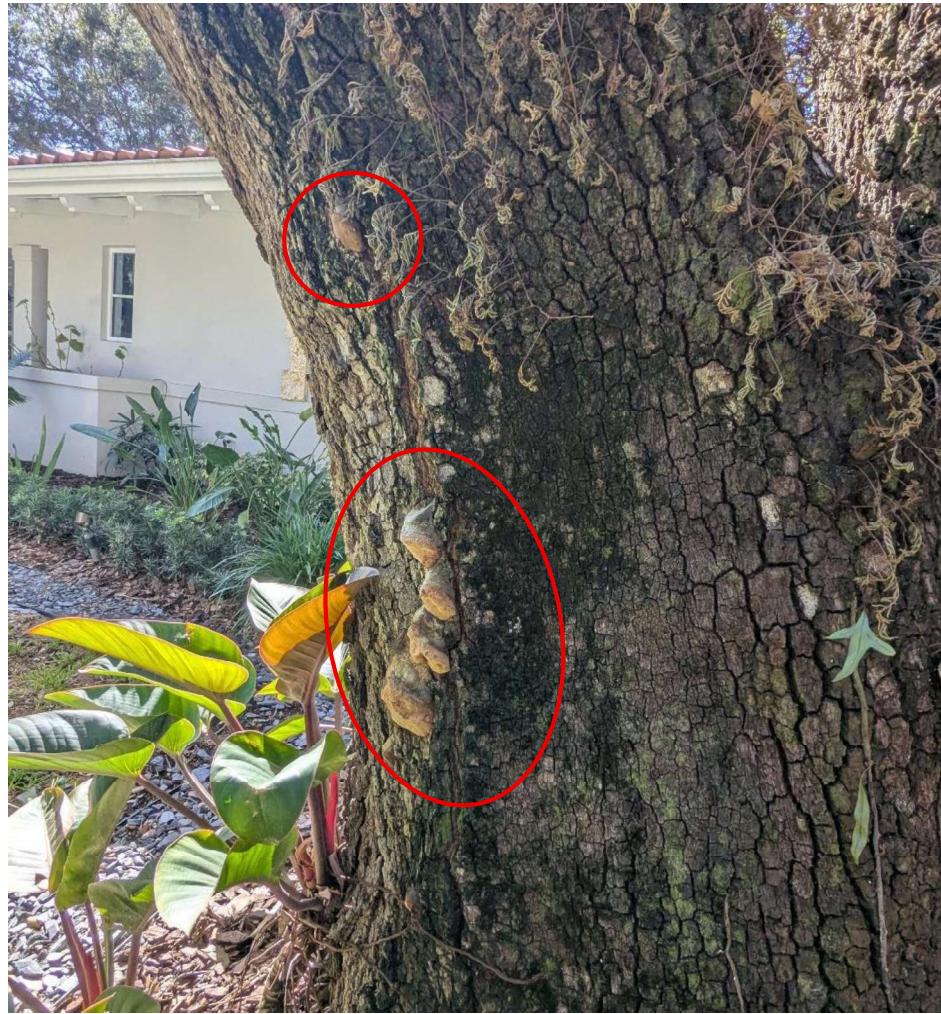
The tree appears to be surviving in an advanced state of decline, again, not exacerbated by the large diameter branch removal. The tree is not thriving as a healthy, good condition oak would reflect. The tree exhibits a sparse canopy as expected from a tree in stress, including a large volume of old branch removal wounds (some decaying, some hardened) throughout the lower half of the crown and is also contending with a *Fomitiporia dryophila* fungal infection as evidenced by 4 active fungal basidiocarps (a.k.a., conks) located along the lower, north face of the east trunk stem. This fungi is known to cause white rot in the heartwood of Live oaks (image below).

Close-up of 4 wood rot producing fungal pathogens on the north trunk face supporting survival in a stressed mode with a concern of advancing decline in overall condition

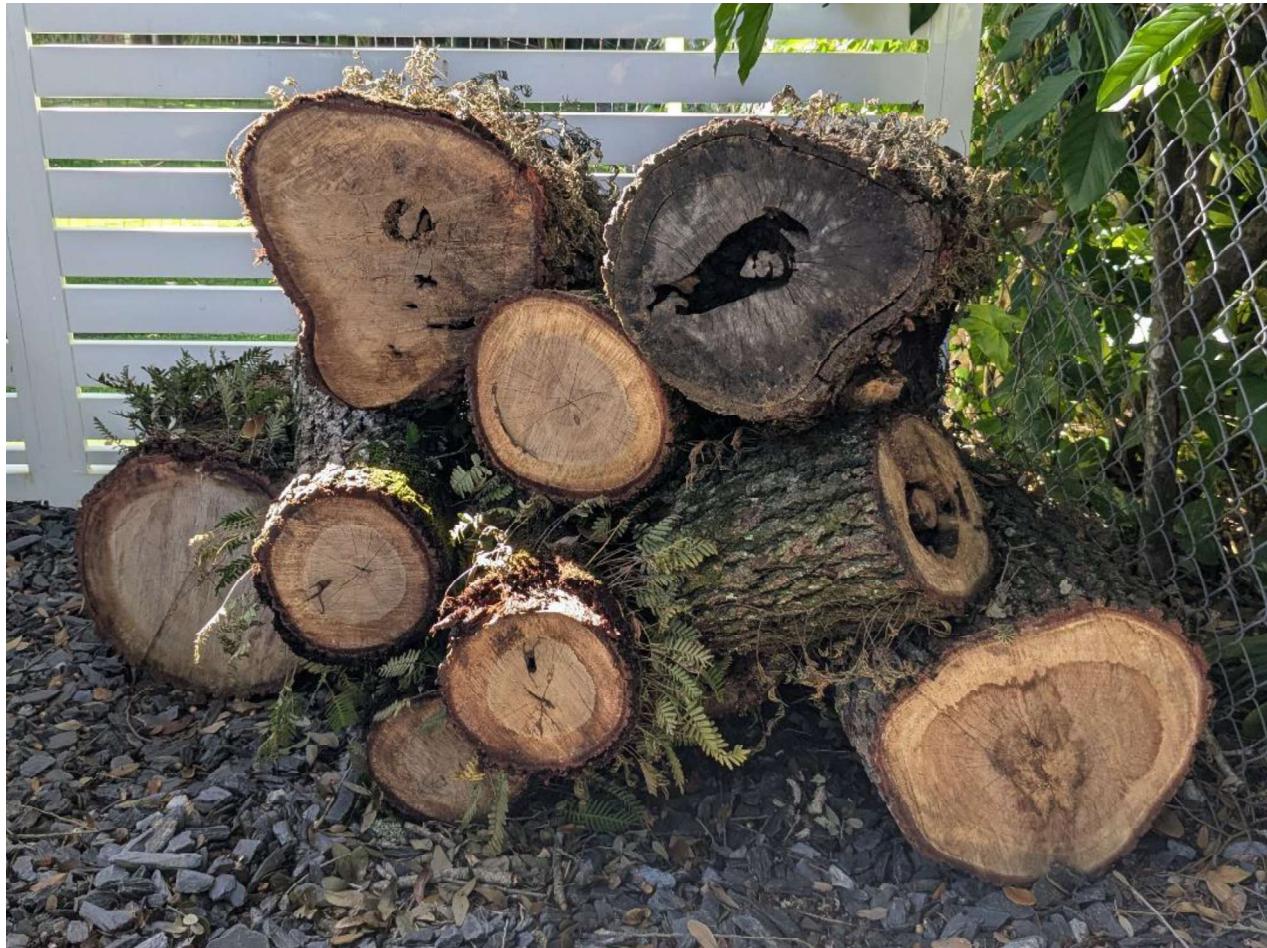
Fortunately, the tree contractor saved and stacked the cut wood sections (image below) from the 13" diameter branch they removed. The extent of the internal decay throughout sections of the branch is apparent and supports and justifies the decision to remove the entire branch.
