**Almeria Park Condominium
357 Almeria Avenue
Coral Gables, FL 33134**

Testing Report

Re: Moisture Scanning

The primary purpose was to find the source of leaks on the bathroom of the unit located at the SE corner of the building at the fifth floor level. Testing and Investigation followed ASTM E2128 Standard Guide for Evaluating Water Leakage of Building Walls.

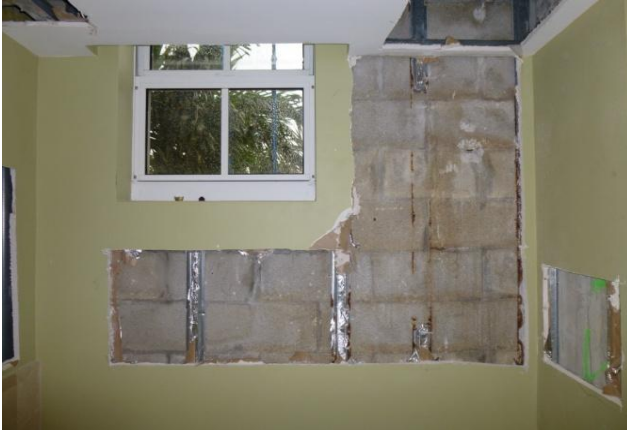
Picture 1

| Pic | Location | Findings |
|---|---|---|
| 1 | Bathtub's Wall | Concrete block with metal furring paneling was removed prior to the inspection |

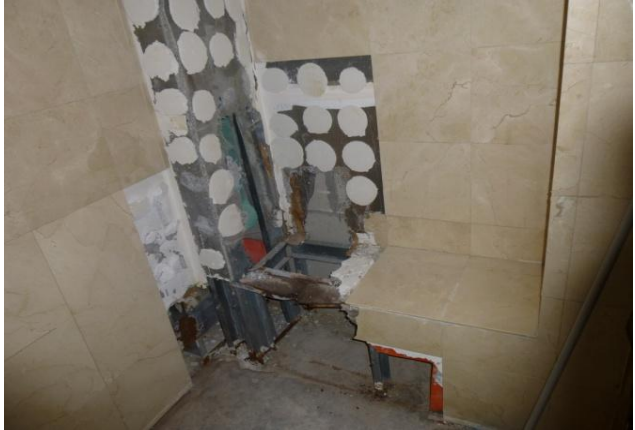
Picture 2

| Pic | Location | Findings |
|---|---|---|
| 2 | Bathroom Shower Wall | Rusted metal furring. However, at the time of the test no moisture was found on concrete block wall |

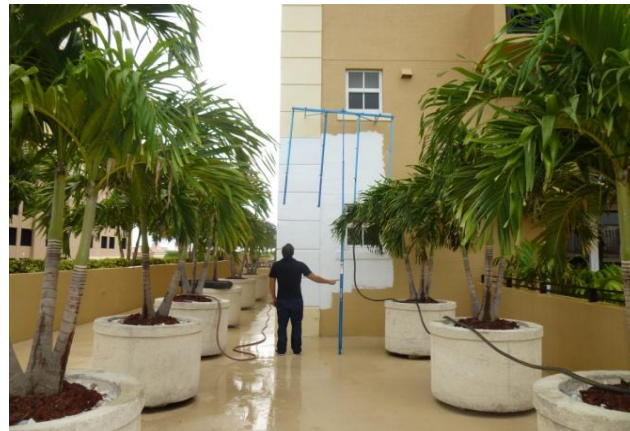
Picture 3

| Pic | Location | Findings |
|---|---|---|
| 3 | Exterior wall | Setting the spray rack for deluge test |

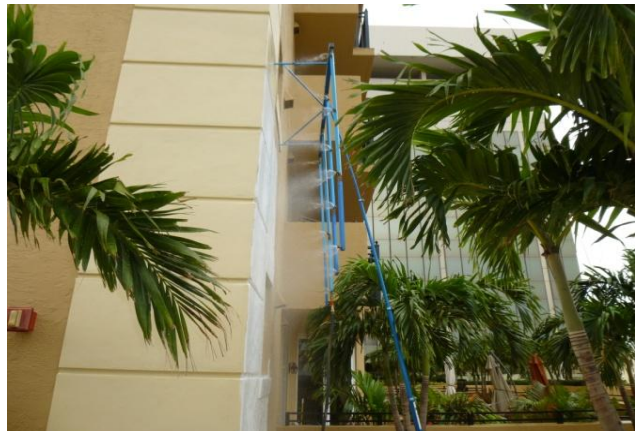
Picture 4

| Pic | Location | Findings |
|---|---|---|
| 4 | Exterior wall | Water sprayed on the white coated area of the exterior side of the wall |

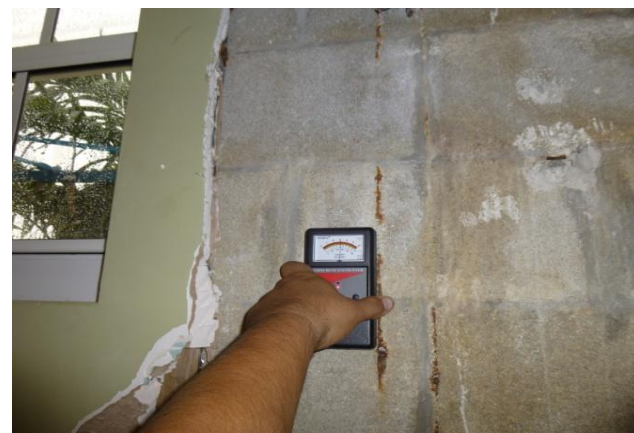
Picture 5

| Pic | Location | Findings |
|---|---|---|
| 5 | Bathroom Wall next to window | 60 % of moisture tested on the inside after applying spray water on the exterior side of the wall |

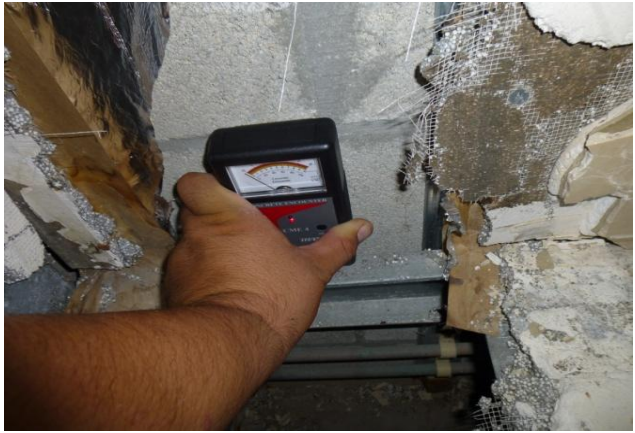
Picture 6

| Pic | Location | Findings |
|---|---|---|
| 6 | Bathroom Shower Wall | No moisture shown after spraying water on this area |

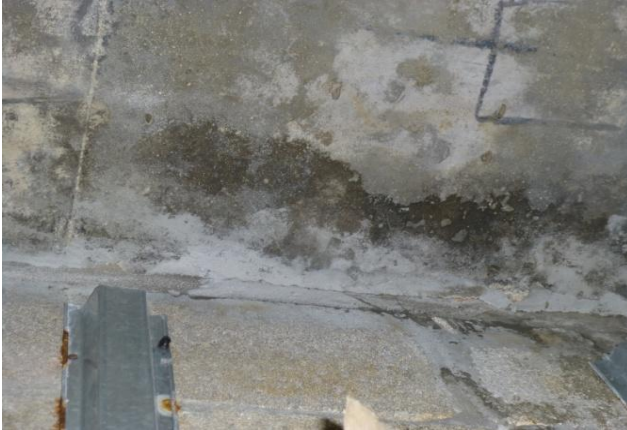
Picture 7

| Pic | Location | Findings |
|---|---|---|
| 7 | Bathroom's Ceiling | Visible moisture on the underside of the concrete slab of the unit above |

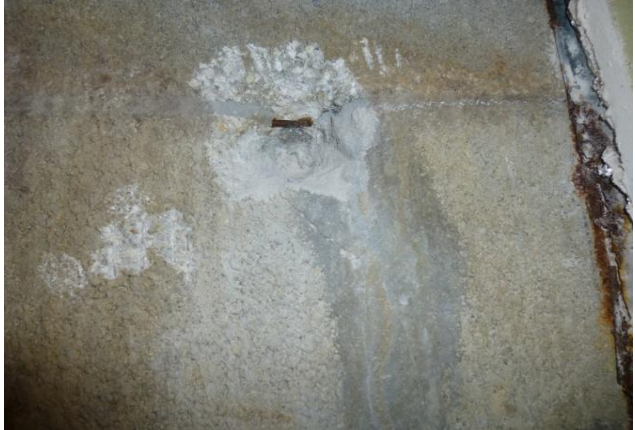
Picture 8

| Pic | Location | Findings |
|---|---|---|
| 8 | Bathtub's Wall | Rusted rebar and concrete spall |

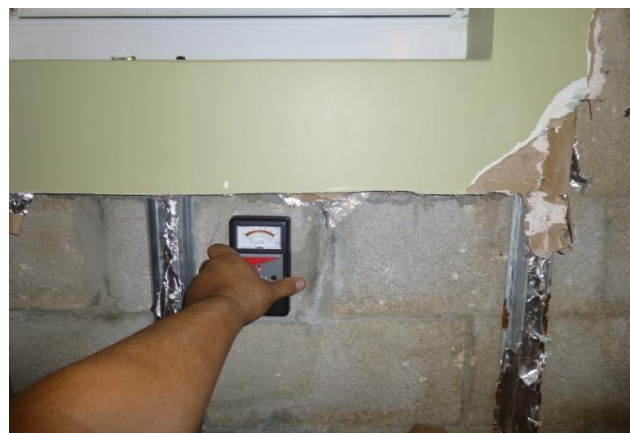
Picture 9

| Pic | Location | Findings |
|---|---|---|
| 9 | Bathroom Wall under window sill | No moisture Tested after spraying water on the exterior |

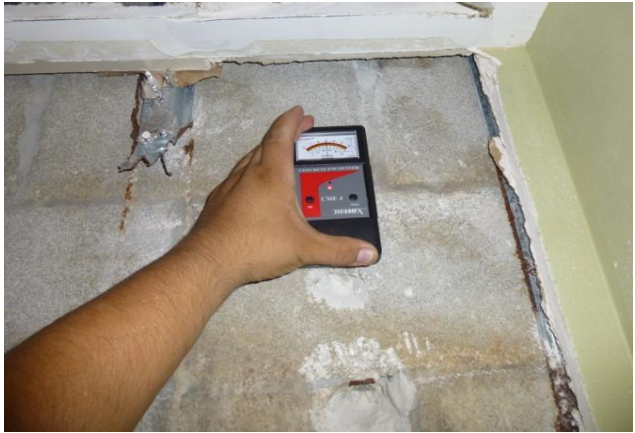
Picture 10

| Pic | Location | Findings |
|---|---|---|
| 10 | Bathtub's Wall | We found 60 % of moisture on the concrete blocks surface |

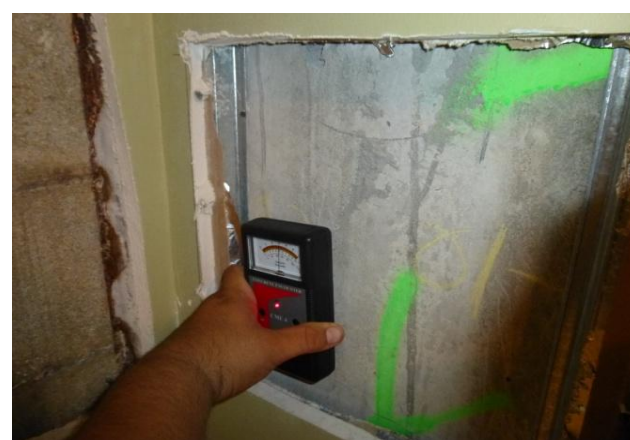
Picture 11

| Pic | Location | Findings |
|---|---|---|
| 11 | Column | 50 % of moisture was tested on the concrete column at the corner of the unit |

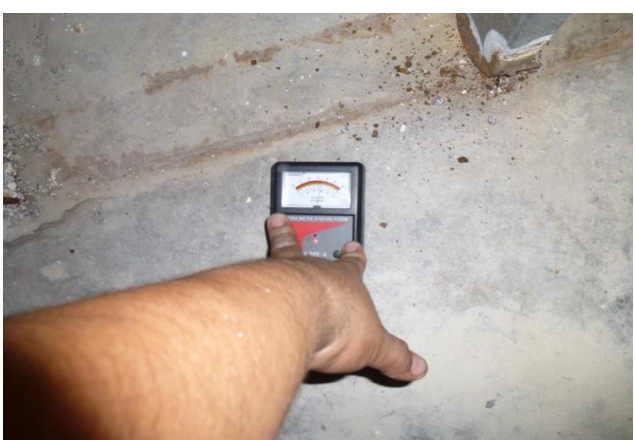
Picture 12

| Pic | Location | Findings |
|---|---|---|
| 12 | Bathroom Shower Floor | Dial shows 60 % of moisture on the shower's floor. |

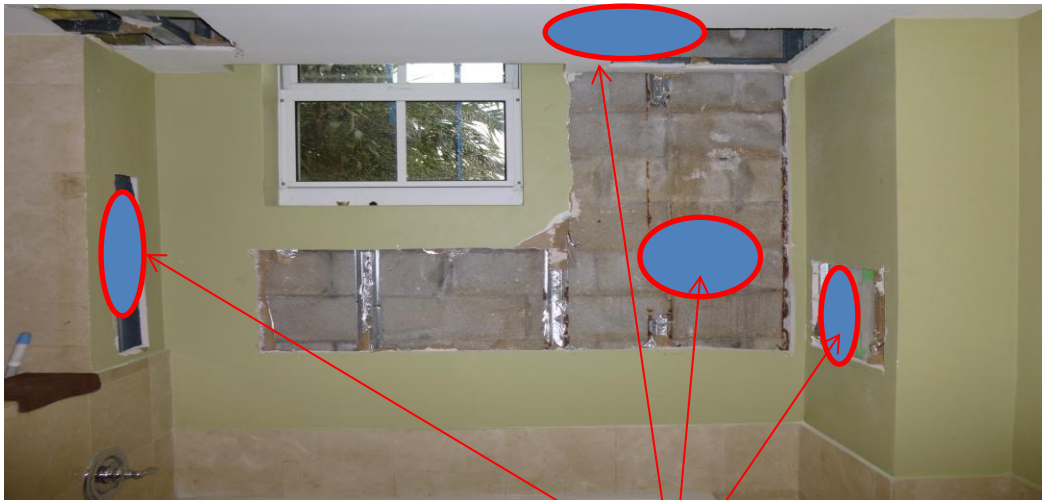
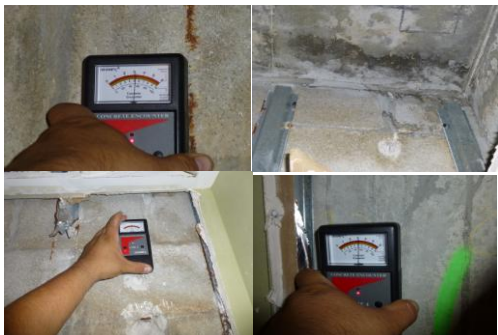
60% Moisture on Concrete block Wall
