Jun 2, 2025

Please find below my Certified Arborist Report for 2 Southern Live Oak trees, *Quercus virginiana* in response to a notice of violation by the City of Coral Gables, case #:NOVI-25-05-10100 at 8245 Los Pinos Cir, Coral Gables, FL 33143.

SUMMARY

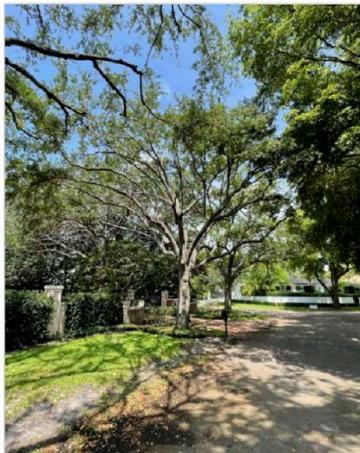
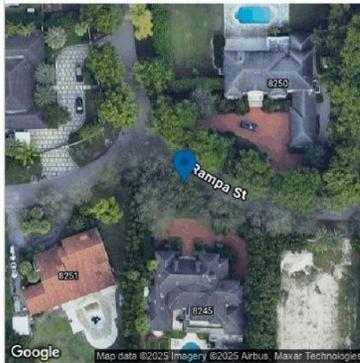
Quercus virginiana ID# 1
Southern Live Oak
Height: 42' DBH: 21"
Health: 80% - Good

Canopy Spread 54'

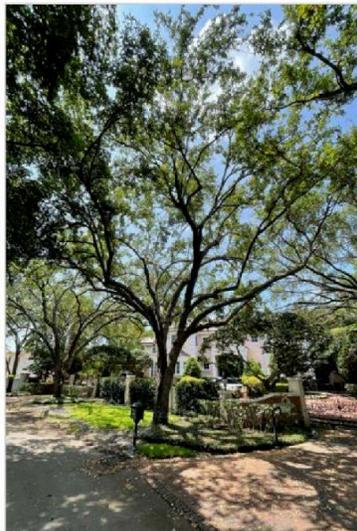
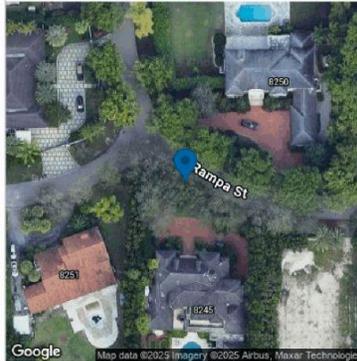
Quercus virginiana ID# 1
Southern Live Oak
Height: 42' DBH: 21"
Health: 80% - Good

Canopy Spread 54'

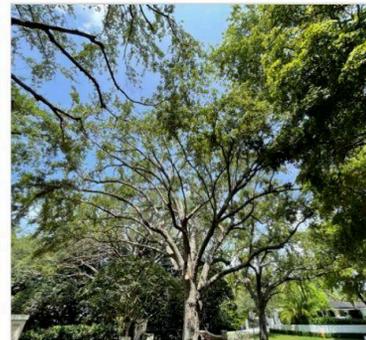
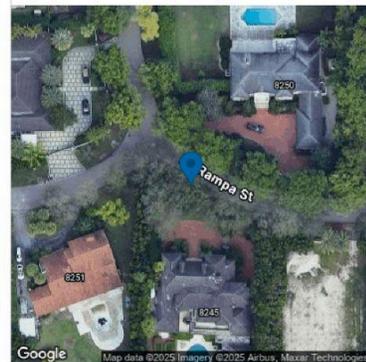
Quercus virginiana ID# 1
Southern Live Oak
Height: 42' DBH: 21"
Health: 80% - Good

Canopy Spread 54'

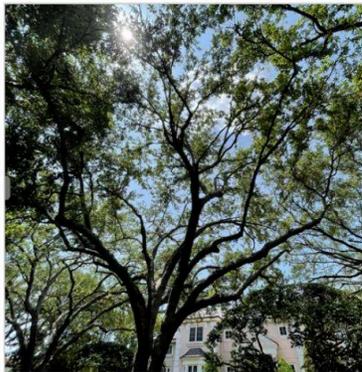
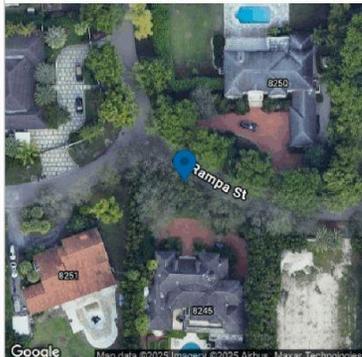
Quercus virginiana ID# 1
 Southern Live Oak
 Height: 42' DBH: 21"
 Health: 80% - Good

Canopy Spread 54'

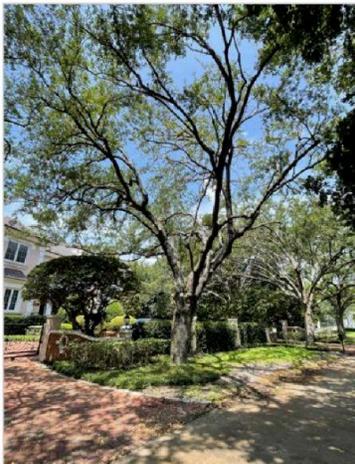
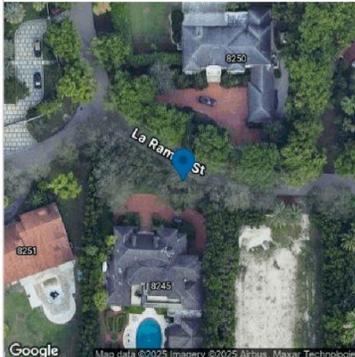
Quercus virginiana ID# 2
 Southern Live Oak
 Height: 41' DBH: 26"
 Health: 80% - Good

Canopy Spread 60'

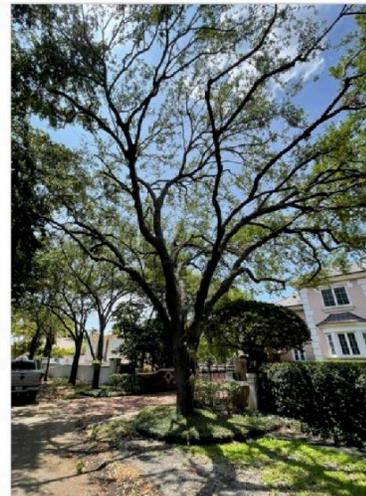
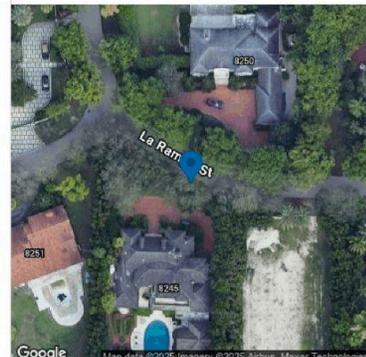
Quercus virginiana ID# 2
 Southern Live Oak
 Height: 41' DBH: 26"
 Health: 80% - Good

Canopy Spread 60'

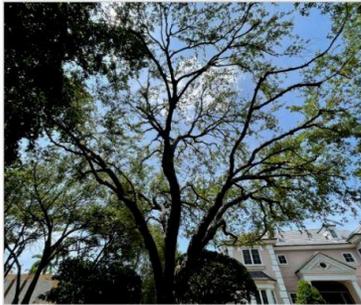
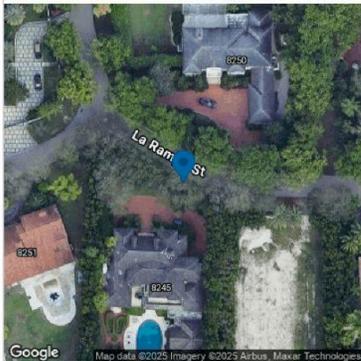
Quercus virginiana ID# 2
Southern Live Oak
Height: 41' DBH: 26"
Health: 80% - Good

Canopy Spread 60'

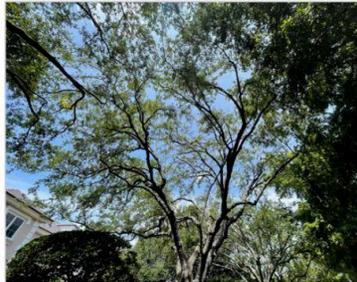
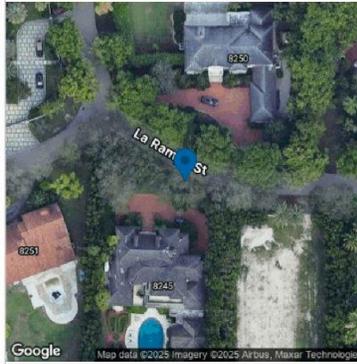
Quercus virginiana ID# 2
Southern Live Oak
Height: 41' DBH: 26"
Health: 80% - Good

Canopy Spread 60'
