Jun 2, 2025

**Mark Moore**  
**Member of International Society of Arboriculture**  
**ISA Certified Arborist # FL-9818A**  
**ISA Tree Risk Assessment Qualification**  
**(305) 323-6444**  
[yourarboristreport@gmail.com](mailto:yourarboristreport@gmail.com)

Please find below my Certified Arborist Report for 2 Southern Live Oak trees, *Quercus virginiana* in response to a notice of violation by the City of Coral Gables, case #:NOVI-25-05-10100 at 8245 Los Pinos Cir, Coral Gables, FL 33143.

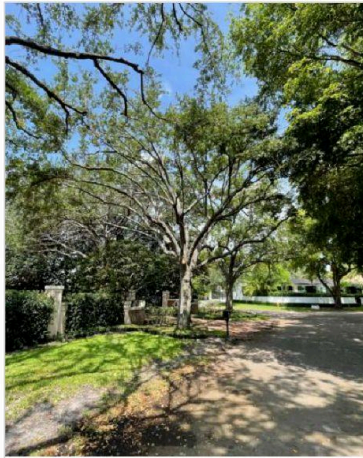
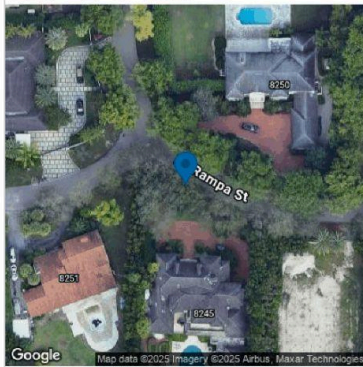
*Quercus virginiana* ID# 1  
Southern Live Oak  
Height: 42' DBH: 21"  
Health: 80% - Good

Canopy Spread 54'

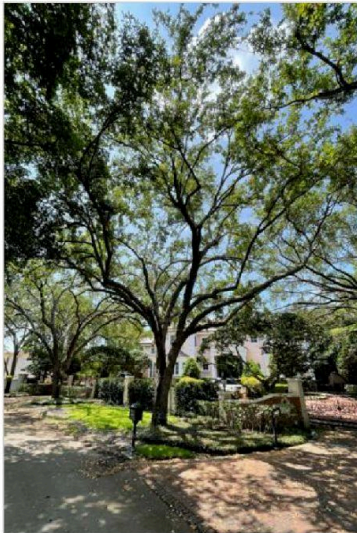
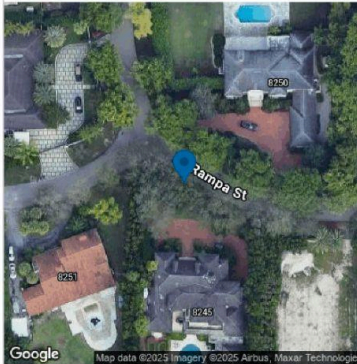
*Quercus virginiana* ID# 1  
Southern Live Oak  
Height: 42' DBH: 21"  
Health: 80% - Good

Canopy Spread 54'

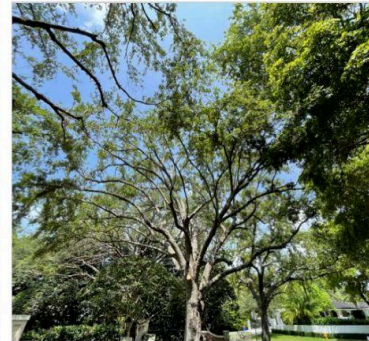
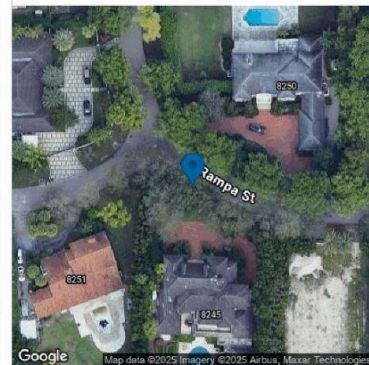
*Quercus virginiana* ID# 1  
Southern Live Oak  
Height: 42' DBH: 21"  
Health: 80% - Good

Canopy Spread 54'

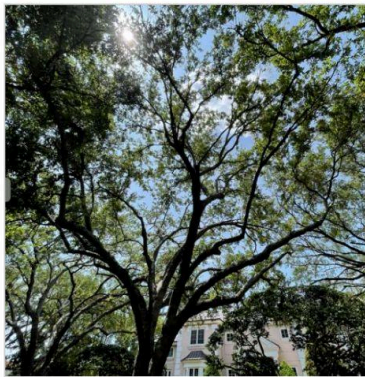
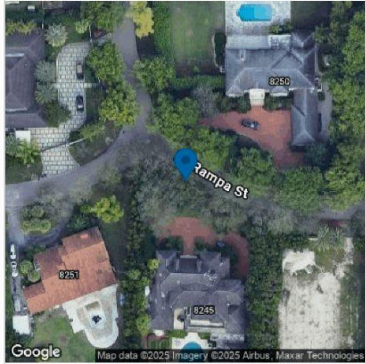
*Quercus virginiana* ID# 1  
Southern Live Oak  
Height: 42' DBH: 21"  
Health: 80% - Good

Canopy Spread 54'

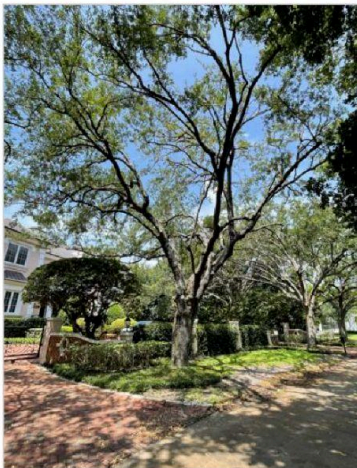
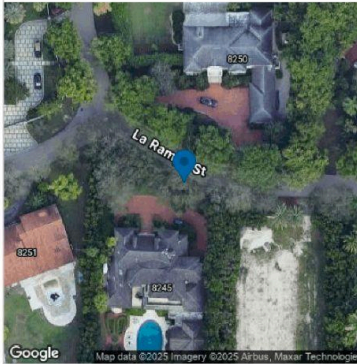
*Quercus virginiana* ID# 2  
Southern Live Oak  
Height: 41' DBH: 26"  
Health: 80% - Good

Canopy Spread 60'

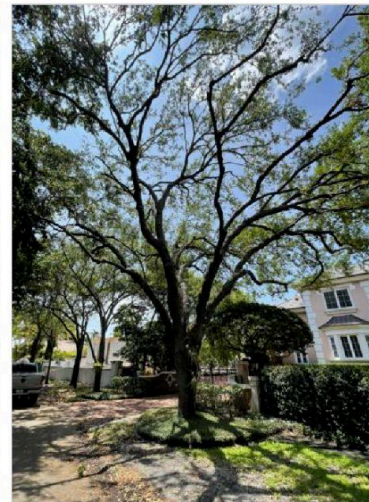
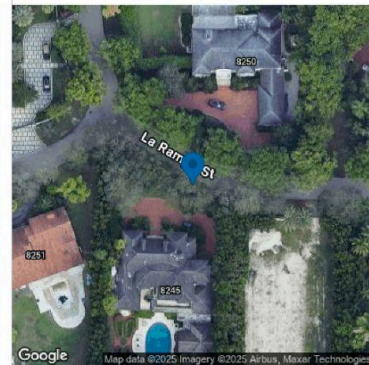
*Quercus virginiana* ID# 2  
Southern Live Oak  
Height: 41' DBH: 26"  
Health: 80% - Good

Canopy Spread 60'

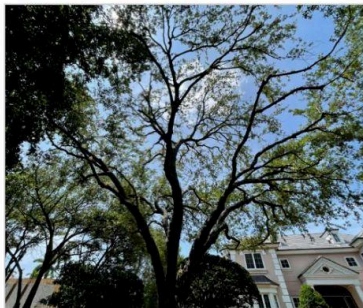
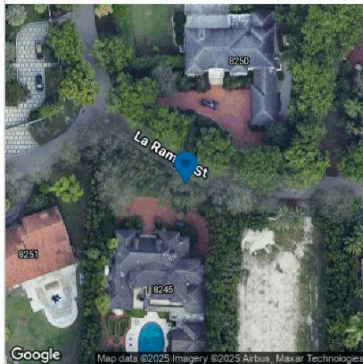
*Quercus virginiana* ID# 2  
Southern Live Oak  
Height: 41' DBH: 26"  
Health: 80% - Good

Canopy Spread 60'

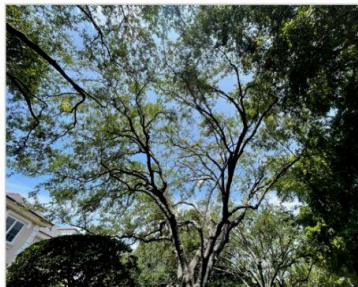
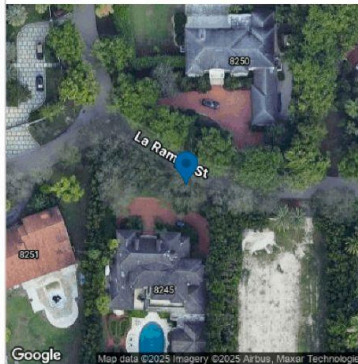
*Quercus virginiana* ID# 2  
Southern Live Oak  
Height: 41' DBH: 26"  
Health: 80% - Good

Canopy Spread 60'
