STRUCTURAL INSPECTION REPORT

REFERENCE: Inspection about Structural Conditions of a residence.
Property of: Mr. Anthony Vinciguerra.
134 Florida Ave.
Coral Gables, FL 33133

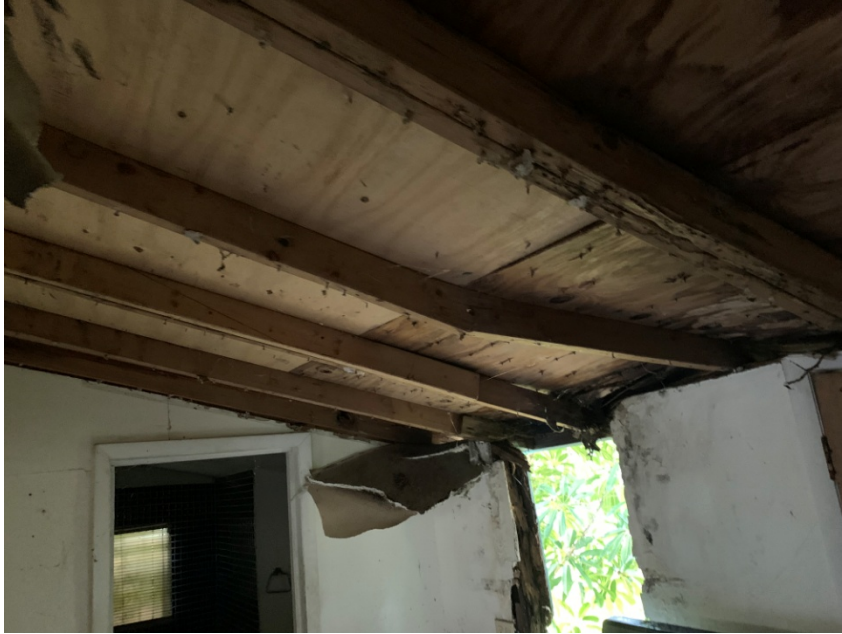
Picture 1

- The house is infested by termites. It was observed in many places traces of termites. For example wood ceiling joists, wood joist or rafters, wood floors planks, wood floor joists, exterior wood panels and windows and doors wood framings.

Area of the house very damaged. Broken joists and termite infection

1- We strongly recommend to cover the whole house with a tent and fumigate in order to eliminate any possibility of alive termites, and avoid any future deterioration of the existing wood joists, sheathing (floor and roof) and the existing wood partitions.

2-All the structural elements that has been damaged in more than 25 % of its cross section area (wood joist, wood studs, wood beams) must be immediately replaced. The wood floor and subfloor, and maybe a significant portion of the wood joists, at ground floor and roof, need to be replaced.

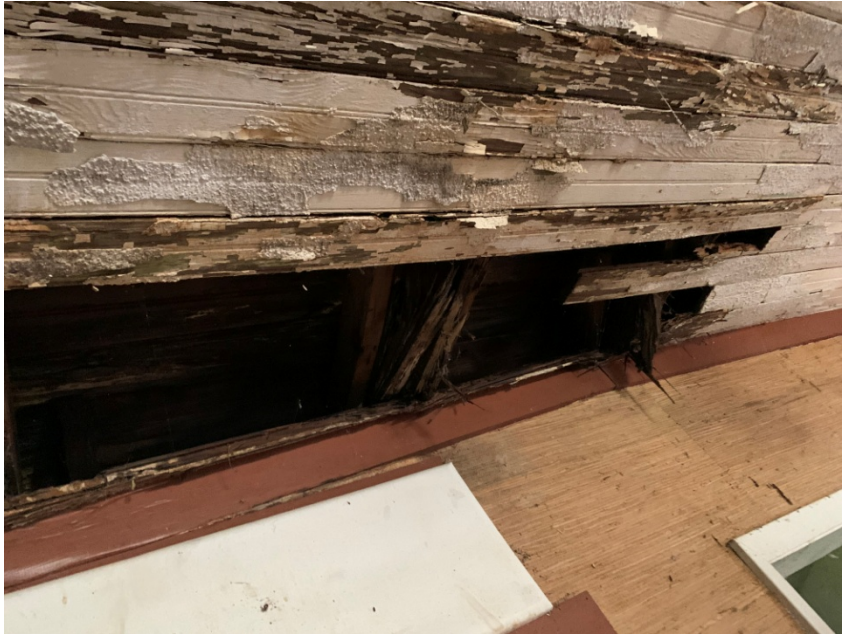
Picture 2

- In general the structural shell of the house is in very bad conditions. Can be observed severe damage to the shell elements all around the property.
- Water intrusion damage is observed in some roof areas. In many places can be observed the ceilings damaged. Also water filtration on the floor and partitions walls around the kitchen area and the bathroom area by problems w/ the pipes of the house that are in very bad conditions too.

Wood ceiling rotten by water filtration

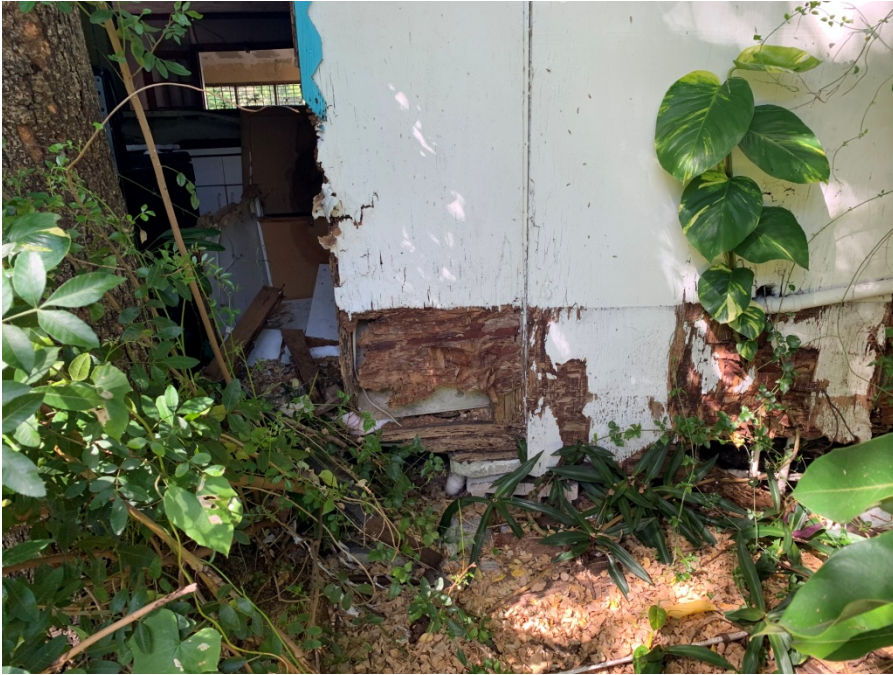
Picture #3

Severe damage on the exterior wood panels walls (back of the house)

3-Of course, all the exterior windows and wood panels that are not there, most be re-built and reinstalled.

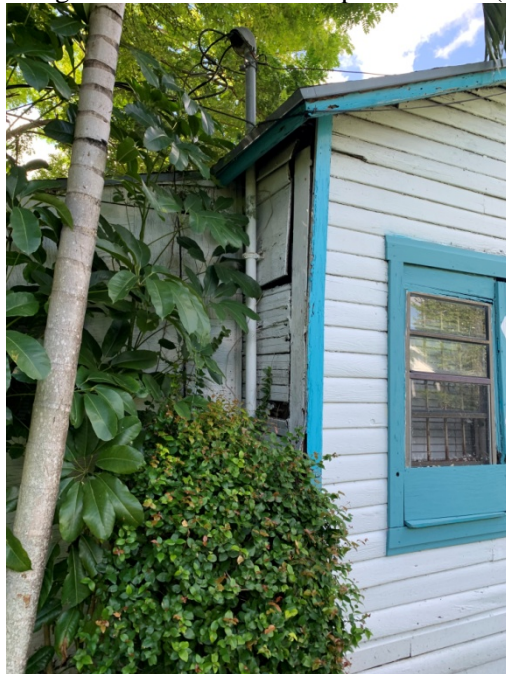
Picture #4

Another exterior wall area in bad conditions

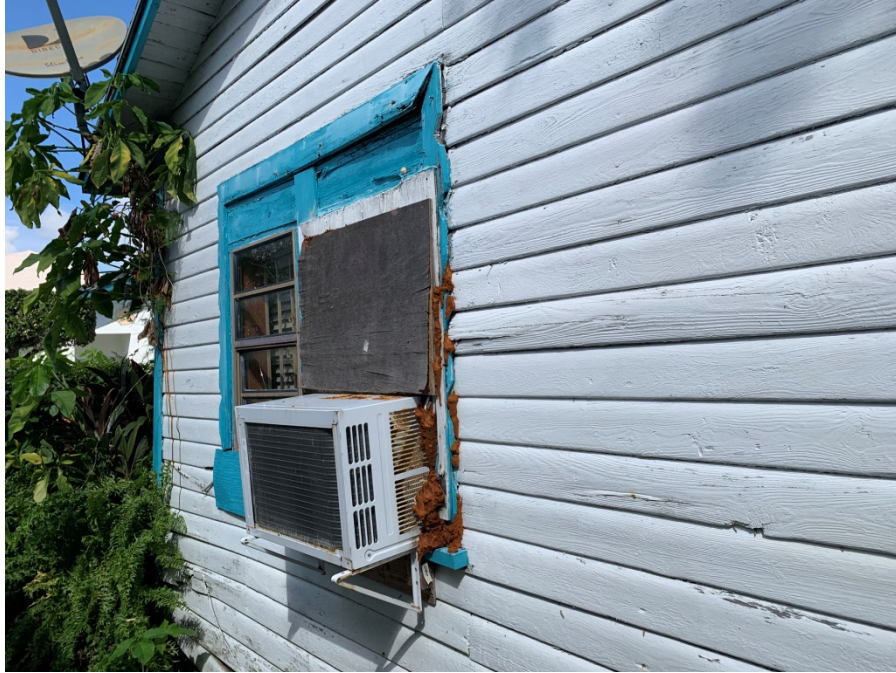
Picture #5

A/C unit not properly encased into the windows. The windows is damaged

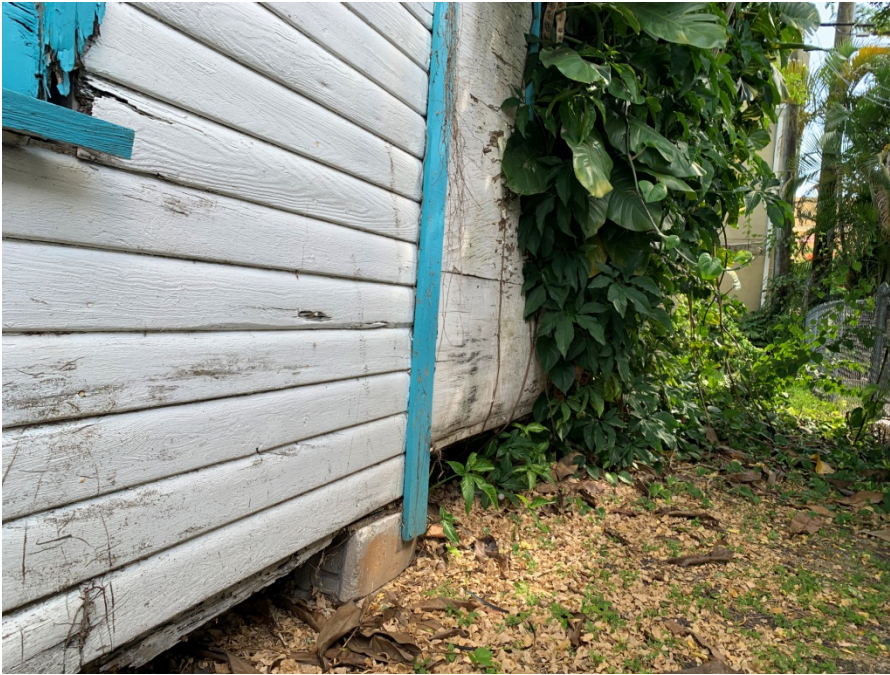
Picture #9 Another support example.

4-We strongly recommend to brace the house to the foundation. Replace the CMU block pedestals that are without any connection to the foundation and the ground floor, by concrete pedestals (attached to the foundation and the ground floor wood joists) w/ some connectors, in order to control the lateral stability of the house.

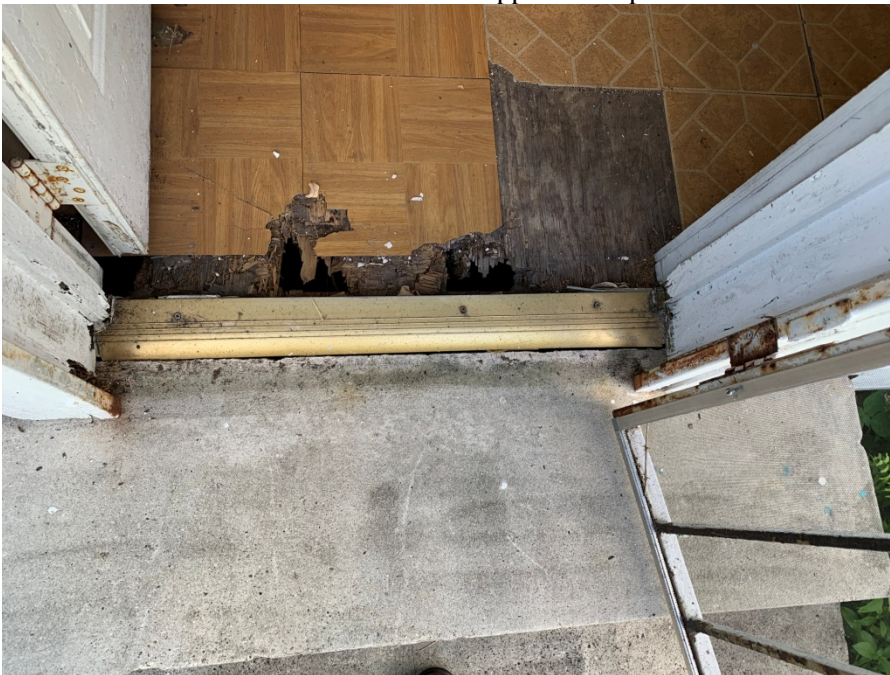
Picture #10 The wood floor is rotten in some areas.
