# PROPERTY APPRAISER OF MIAMI-DADE COUNTY

### NOTICE OF UNSAFE STRUCTURE VIOLATION FOR FAILURE TO RECERTIFY AND NOTICE OF HEARING

# GABLES LAROC CONDOMINIUM – THERMAL SCANS

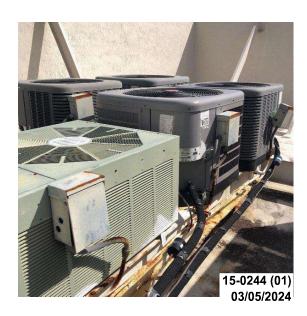
# 1.2 Corroded/Deteriorated Equipment

m2e observed some electrical equipment, raceways, fittings, and supports corroded and deteriorated. Some of the equipment and raceways were abandoned and inoperative during the site visit.

Repair corroded parts and apply corrosion-resistant coating as per the manufacturer's instructions. Remove equipment if is not in use and abandoned. Replace highly corroded equipment with equivalent corrosion-resistant units as required per the manufacturer's recommendations.

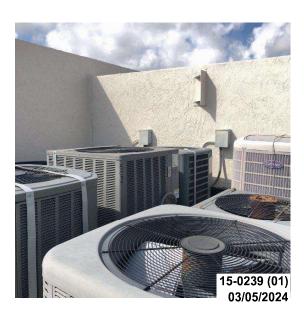
# 1.3 Missing/Improper Circuits Identification

Electrical equipment (panelboards and disconnecting means) were not properly identified. All disconnecting means must be legibly marked to identify its intended purpose of use unless located and arranged so the purpose of use is evident. Additionally, the installed circuit breakers were found to be uncoordinated with the circuit directory that is affixed to the panelboard.

Provide a typed and laminated label for the electrical panelboards, and disconnecting means identifying its name and from where it is fed. Additionally, provide an updated and accurate circuit directory with all circuits legibly identified indicating their purpose or use.

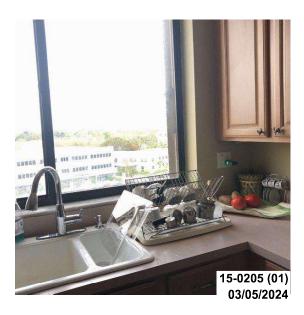
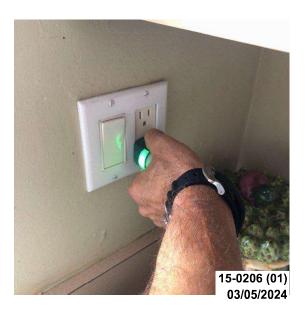
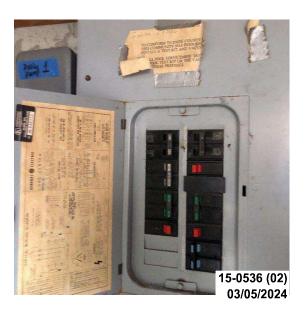
# 1.4 Missing GFCI Protection

m2e observed some receptacles located in a water-prone (wet/damp) are not Ground Fault Circuit Interrupter (GFCI) type. Additionally, m2e recommends providing GFCI protection for the pool and spa motor circuits (pump, jet, etc.) per the current code although this was not a requirement at the time the property was built. This situation poses a potential electric shock hazard and should be addressed promptly to ensure the safety of the residents.

Perform a full inventory of all apartment units with this condition. Replace existing receptacles with GFCI-type ones. Provide Class A GFCI breakers for the pool and spa motor circuits and any equipment related to pool water recirculation.

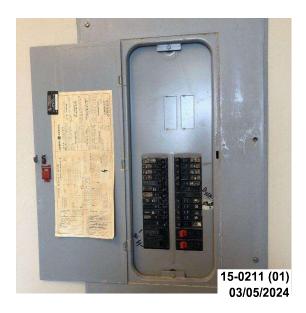
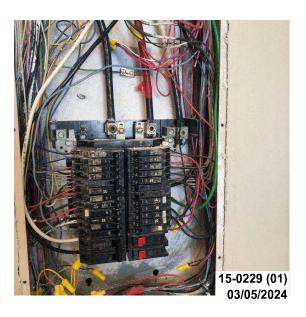
# 1.5 Improper Grounding Connection

m2e observed a grounding conductor improperly connected to the neutral bar of the electrical panel. In subpanels, it's essential that neutral and ground wires are isolated to prevent neutral current from flowing through the ground system. This separation is crucial for preventing potential electric shock and ensuring that fault currents have a clear, uninterrupted path to the earth ground, enhancing overall electrical safety.

Perform a full inventory of all electrical panels with this condition. Remove the grounding conductors from the neutral bars and reconnect them to the proper grounding bars in each subpanel.

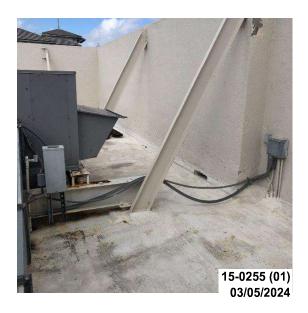
# **1.6 Improperly Supported Raceways**

m2e observed some Liquidtight Flexible Nonmetallic Conduit (LFNC) improperly supported on the roof.

Where installed in lengths exceeding 1.8 m (6 ft), the conduit shall be securely fastened at intervals not exceeding 900 mm (3 ft) and within 300 mm (12 in.) on each side of every outlet box, junction box, cabinet, or fitting.

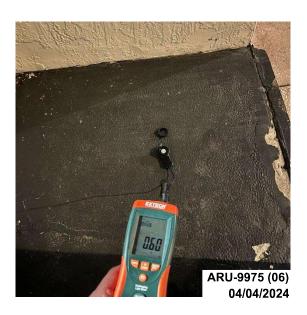
m2e measured the illumination levels at the parking and means of egress locations and noted values below the one ft-candle requirement for those areas.

Repair damaged or provide new light fixtures to the areas with a lack of illumination. Coordinate with a lighting consultant and licensed engineer for the design and permit plans as needed.

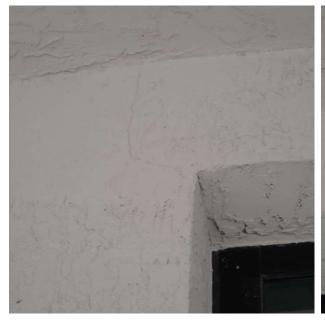
Photo # 1 Stucco crack at pool entrance door Photo # 2 Stucco crack at pool entrance door

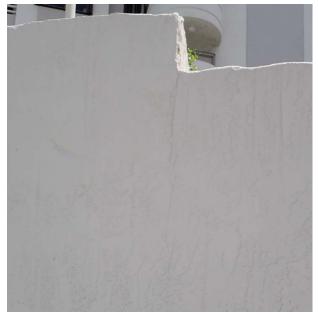
Photo # 3 Cracked stucco at entrance planter wall

Photo # 4 Closeup of Photo # 3

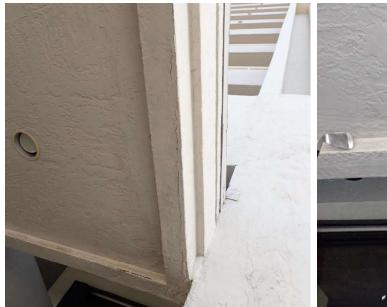
Photo # 7 Cracked stucco at entrance canopy

Photo # 8 Closeup of Photo # 7

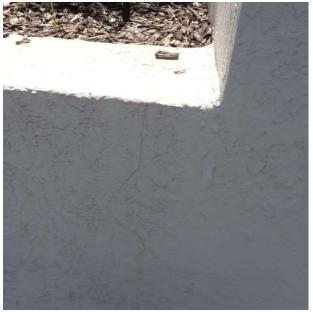
Photo # 11 Cracked stucco at entrance planter wall

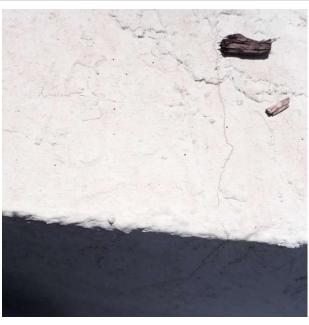
Photo # 12 Closeup of Photo # 11

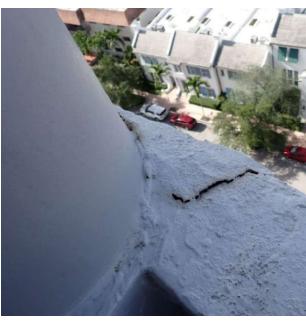
Photo # 16 Spalling stucco at penthouse balcony

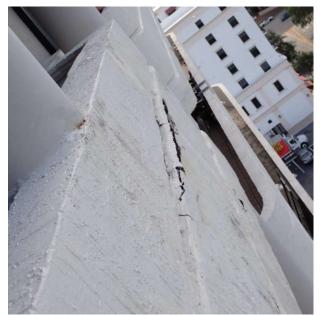
Photo # 17 Cracked stucco at penthouse balcony

Photo # 18 Closeup of Photo # 17

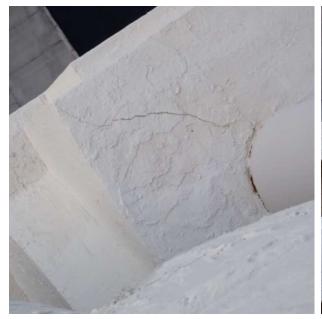
Photo # 19 Cracked stucco at bottom of column

Photo # 20 Cracked balcony on lower floor

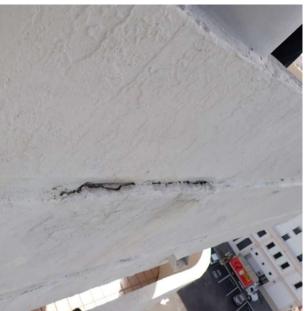
Photo # 22 Balcony crack at penthouse level

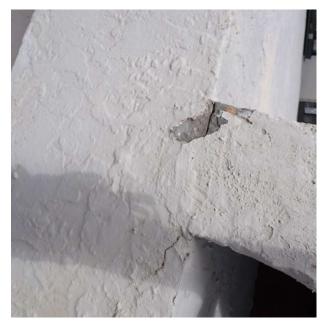
Photo # 25 Cracked balcony wall at penthouse level

Photo # 26 Closeup of Photo # 25

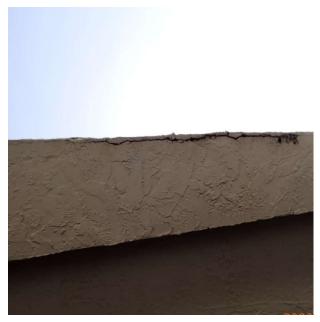
Photo # 27 Cracked stucco at penthouse level railing

Photo # 28 Crack in stucco at penthouse level

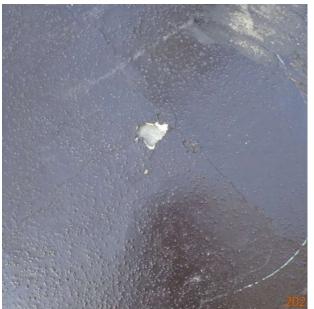
Photo # 31 Driveway cracked and spalled

Photo # 32 Driveway cracked and spalled at west ramp

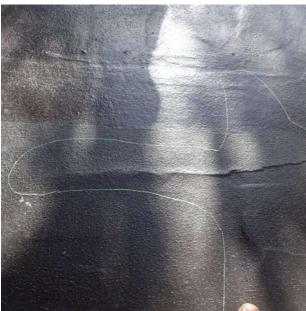
Photo #34 Driveway cracked and spalled

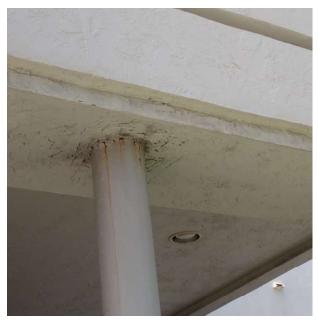
Photo # 35 Column rusting at lobby level at entrance

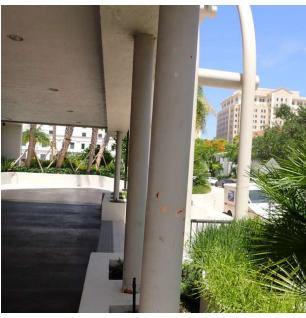
Photo # 36 Rust spots on column at building entrance

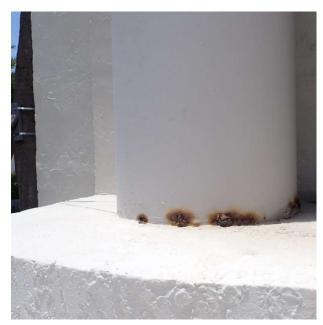
Photo # 37 Corroded column bottom at pool

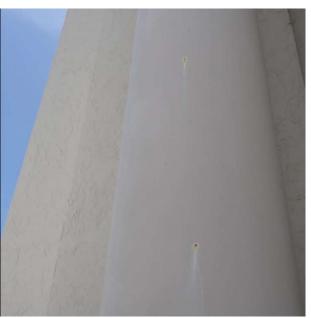
Photo # 38 Corrosion spots on column by pool

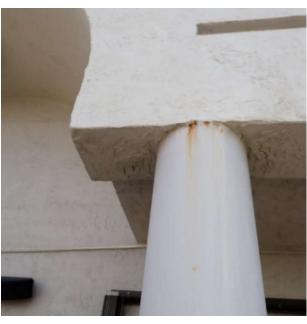
Photo # 40 Corrosion spots on column by pool

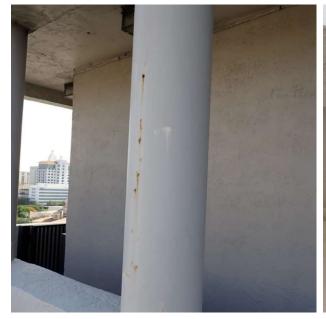
Photo #41 Corroded column at penthouse

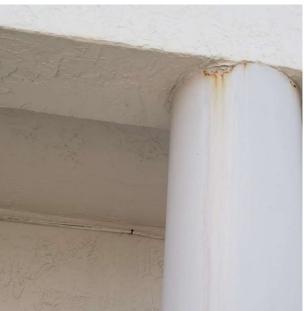
Photo # 42 Corroded column at penthouse

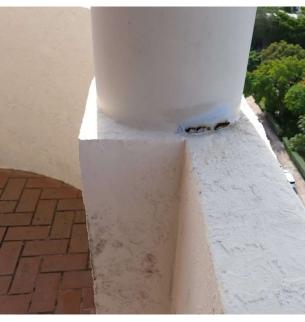
Photo # 44 Corroded column at penthouse

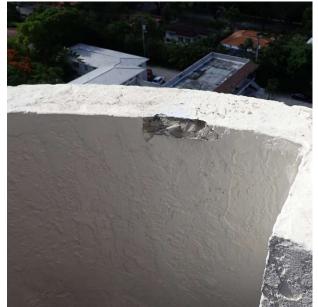
Photo # 45 Corroded column at penthouse

Photo #46 Corroded column at penthouse

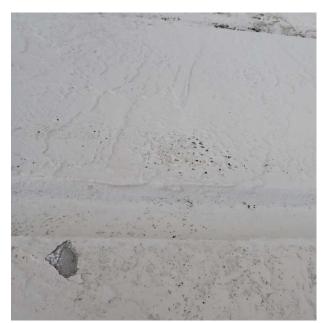
Photo # 47 Spalled stucco on balcony unit 1202

Photo # 48 Cracked stucco on balcony unit 1102

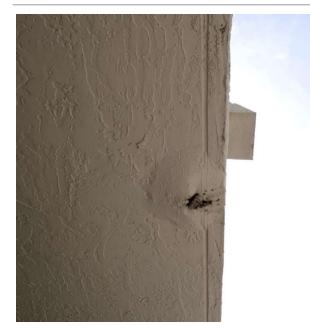
Photo # 49 Water bubble up on balcony above 1102

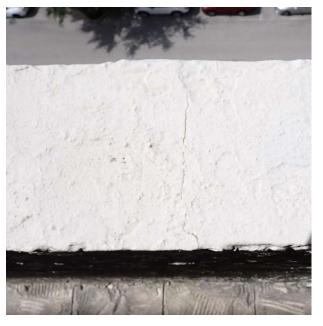
Photo # 50 Cracked balcony stucco in unit 1102

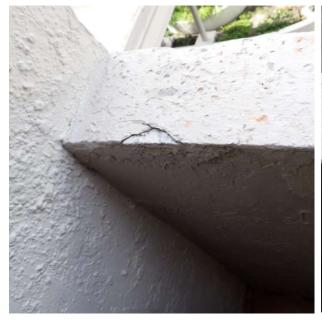
Photo # 51 Spalled stucco on balcony unit 201 Photo # 52 Chipped paint on balcony unit 201

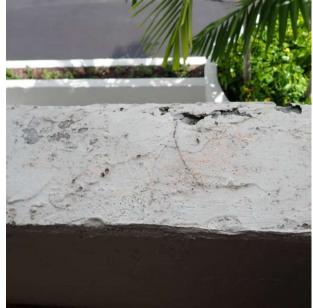
Photo # 53 Spalled stucco on balcony unit 201

Photo # 54 Cracked stucco on balcony unit 201

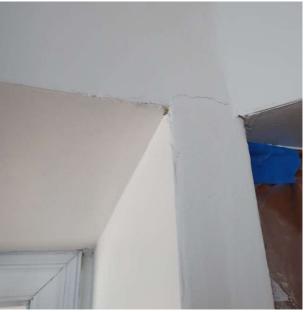
Photo # 56 Wall crack at door in penthouse

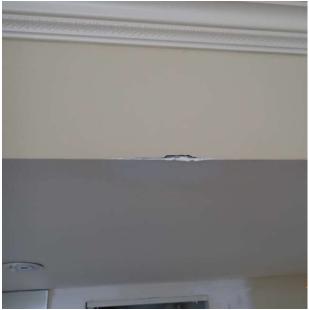
Photo #57 Wall crack at door in penthouse

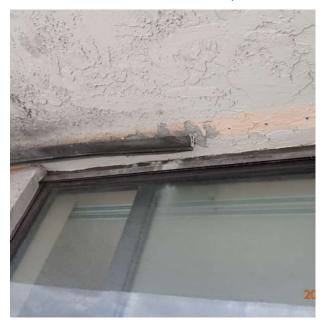
Photo # 59 Previous hurricane shutter bolt holes in unit 1102

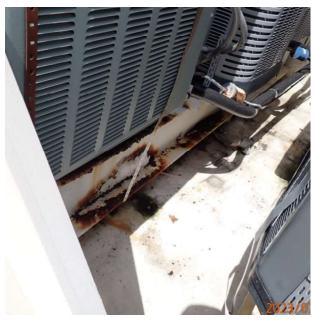
Photo # 61 Corroded machine support members

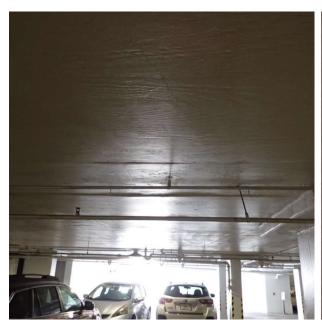
Photo # 66 Crack in garage ceiling

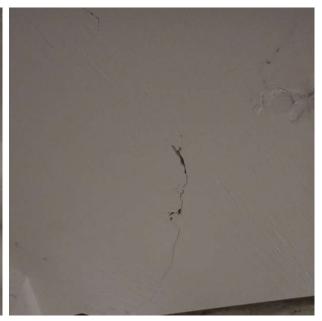
Photo # 71 Wall crack

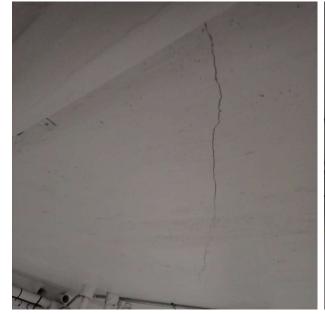
Photo # 72 Crack in garage ceiling

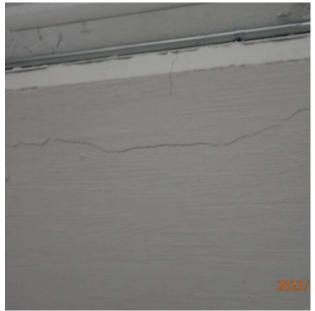
Photo # 75 Crack in garage beam and ceiling

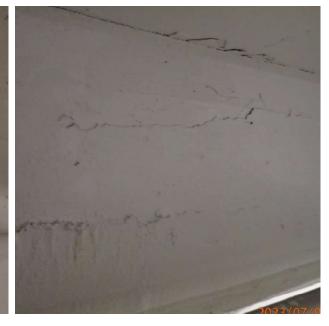
Photo # 76 Spalling concrete in the ceiling

Photo # 77 Spalling concrete in ceiling and wall

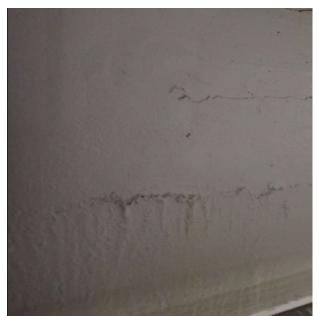
Photo # 78 Sign of water intrusion in garage wall

Photo # 79 Sign of water intrusion

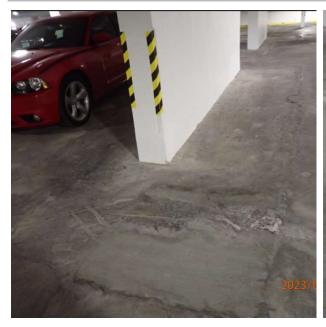
Photo # 80 Crack in garage floor, seemingly around the outline of the footer

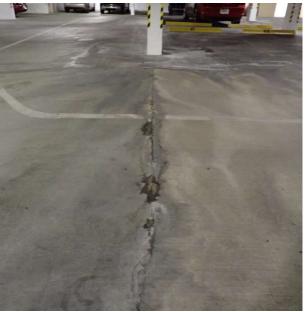
Photo #81 Crack in garage floor

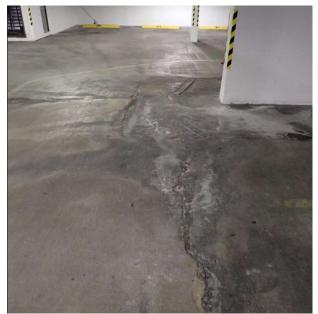
Photo # 82 Crack in garage floor, seemingly around the outline of the footer

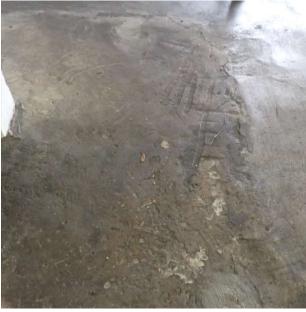
Photo # 83 Crack in garage floor around outline of footer
