Arborist Report - Tree Inventory/Evaluation

Address: 420 Barbarrosa Ave, Coral Gables Fl Date: 7/2//2025

Subject: Large black olive (Bucida burseras) growing between the street and sidewalk, and next to future driveway construction.

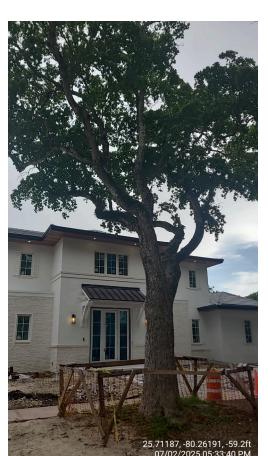
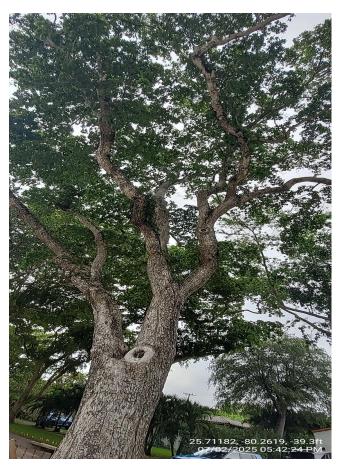
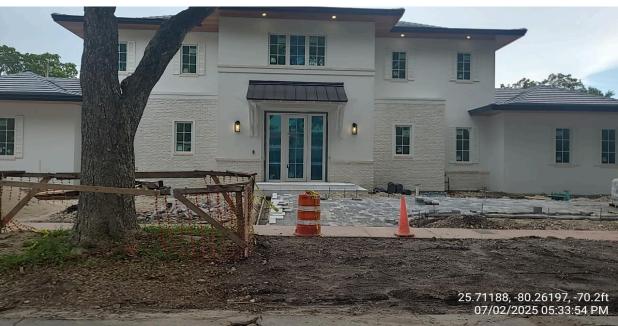
Size: DBH: 32". Height, 35' overall. Spread: 30'

Structure: Tree has two main co-dominanct trunks without included bark. Pruning history indicates more aggressive than recommended lifting. There is evidence of large pruning cuts that appear to be sealing well. No recent flush cuts were evident.

Tree health: Tree appears healthy and actively growing.

Construction is currently on-going at the residence. All trees in the construction zone are protected with wooden tree protection barriers. A new paver driveway is being installed which involves the further excavation of approximately 6 inches of soil. This would result in disturbance to the tree's root zone. Excavation would be the closest at 6.5 feet from the base of the tree. Since excavation would be tangent to the tree's radius, every other point would be further from the trunk.

Recommendations from the University of Florida say that pruning tree roots should ideally be no closer than 3X the trunk diameter. In this case that would be 8 feet. However, further guidance also suggests that no more than one third of a tree's roots should be trimmed. Beyond that there could be stability issues and tree health issues. In this case, the percentage of roots proposed to be trimmed would be around 10-15 percent.

Conclusion: I'm confident that driveway excavation will not kill this tree. However, due to the root pruning occurring slightly closer to the trunk than ideal, I recommend that the tree's canopy be trimmed so that the loss in canopy is proportional to the loss of roots. This helps with tree stability as well as to maintain a healthy canopy. The reduction should NOT be from bottom limbs but should be from the top and outside of the canopy to reduce weight and make the tree more wind-resistant.

Ensure the final cut of root pruning leaves a clean cut. Frayed or torn root ends will not re-grow well. Ensure that the cut root surface is quickly buried after excavation and not left exposed.
