STRUCTURAL INSPECTION REPORT

REFERENCE: Inspection about Structural Conditions of a residence.
Property of: Mr. Anthony Vinciguerra.
134 Florida Ave.
Coral Gables, FL 33133

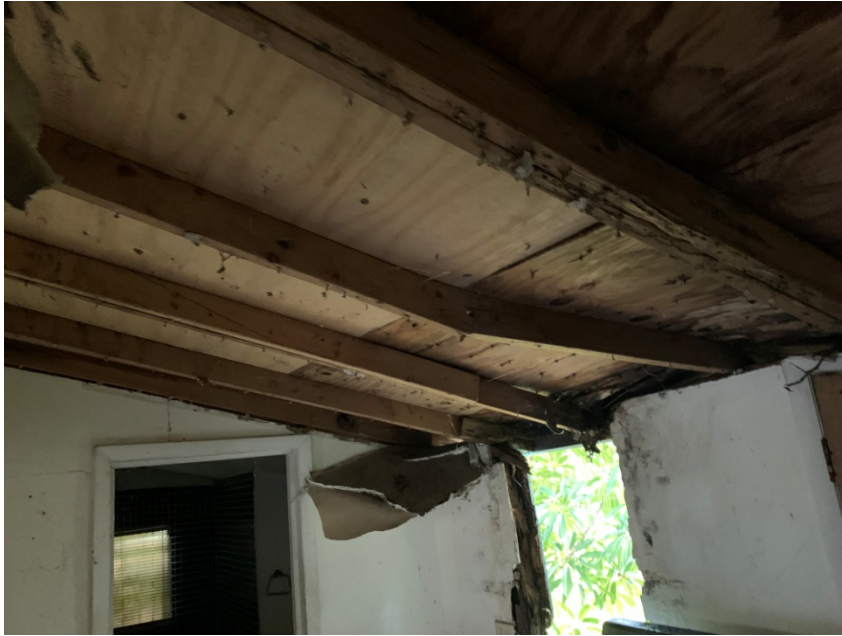
Picture 1

- The house is infested by termites. It was observed in many places traces of termites. For example wood ceiling joists, wood joist or rafters, wood floors planks, wood floor joists, exterior wood panels and windows and doors wood framings.

Area of the house very damaged. Broken joists and termite infection

1- We strongly recommend to cover the whole house with a tent and fumigate in order to eliminate any possibility of alive termites, and avoid any future deterioration of the existing wood joists, sheathing (floor and roof) and the existing wood partitions.

2-All the structural elements that has been damaged in more than 25 % of its cross section area (wood joist, wood studs, wood beams) must be immediately replaced. The wood floor and subfloor, and maybe a significant portion of the wood joists, at ground floor and roof, need to be replaced.

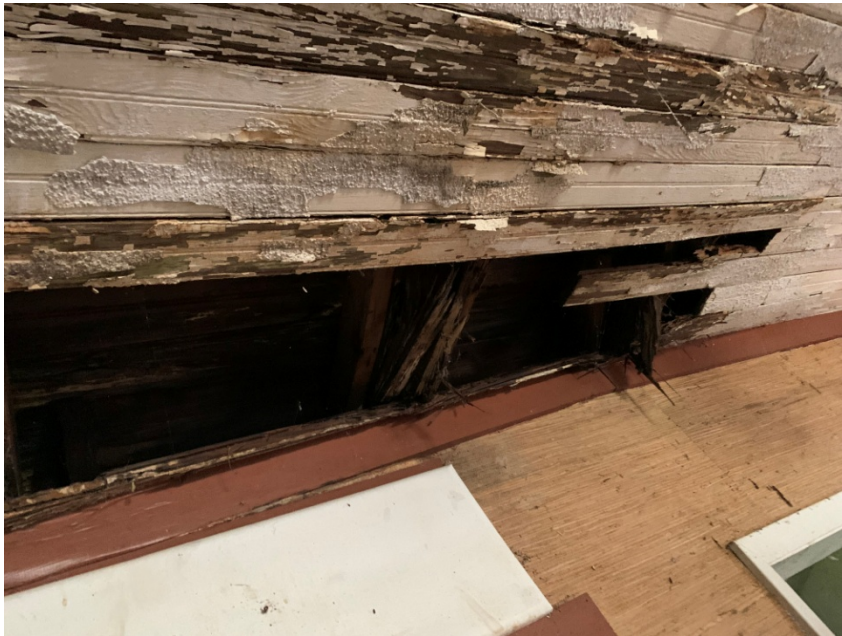
Picture 2

Wood ceiling rotten by water filtration

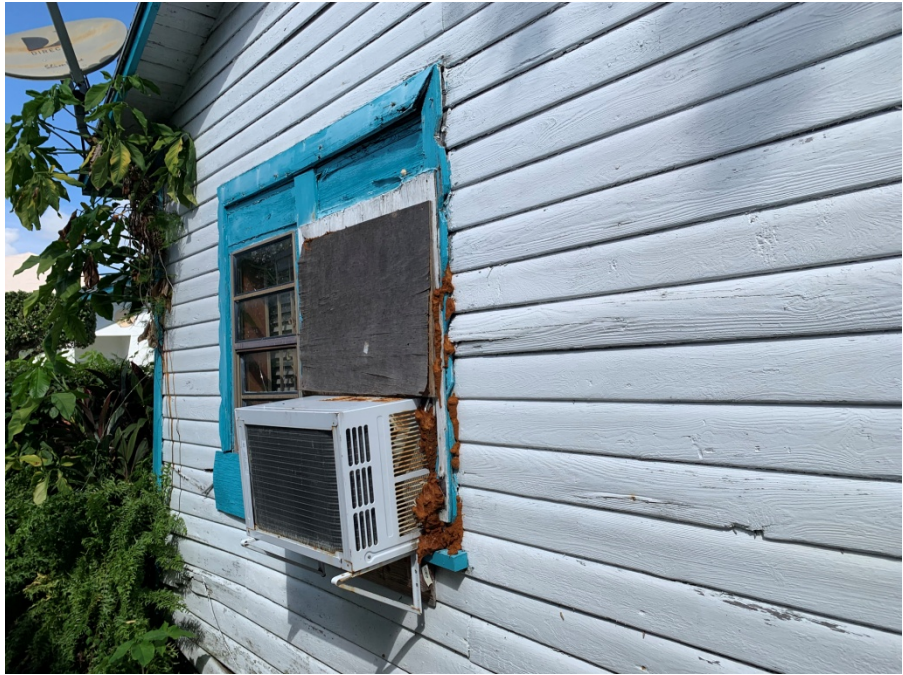
Picture #5

A/C unit not properly encased into the windows. The windows is damaged

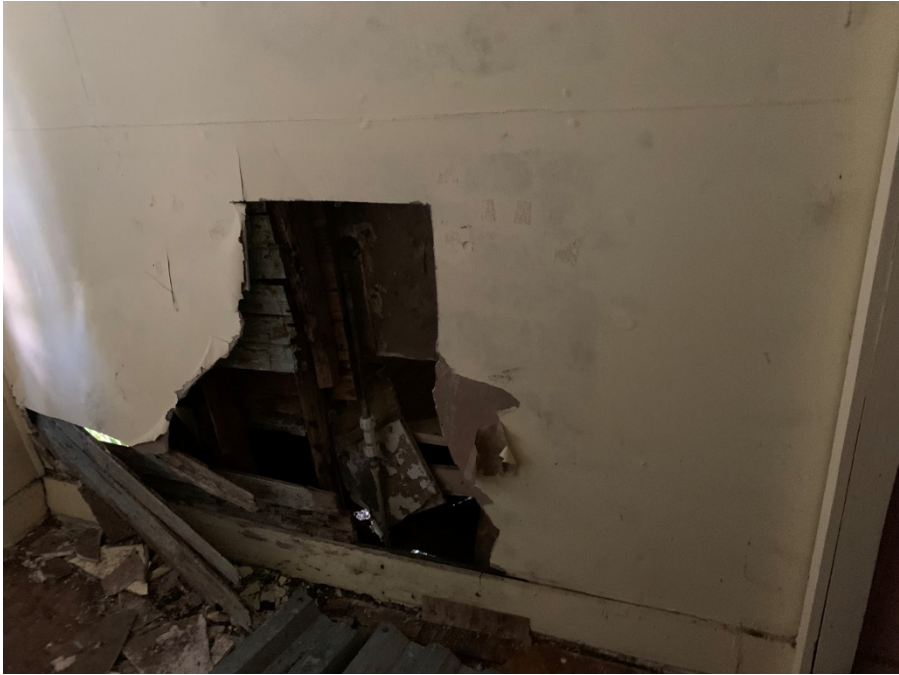
Picture #7
Wood partition rotten inside the house.

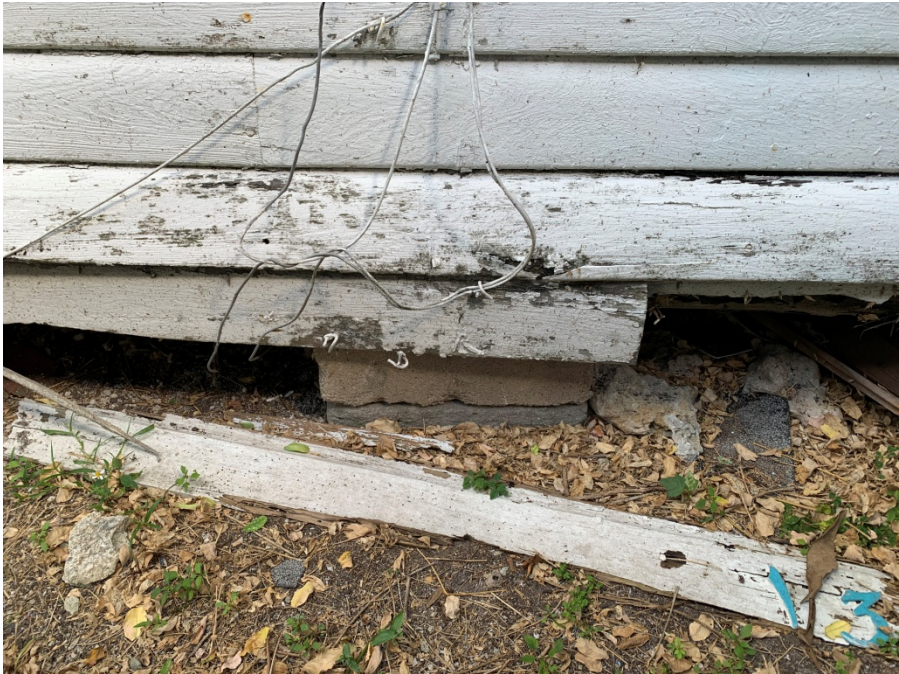
- Some exterior windows are in very bad conditions. Some metal frames are rusted and some glass panel are cracked. Also, there are some windows missing.
- The exterior wall wood panels and the floor wood joists are not braced at ground floor. In others words, the house doesn't have a mechanical connection to transmit and guarantee a lateral stability. In some places the house is resting un blocks without any connection to a footing into the grade.

Picture #8
The house is on a crawl space supported by block pedestal without any structural connection

4-We strongly recommend to brace the house to the foundation. Replace the CMU block pedestals that are without any connection to the foundation and the ground floor, by concrete pedestals (attached to the foundation and the ground floor wood joists) w/ some connectors, in order to control the lateral stability of the house.

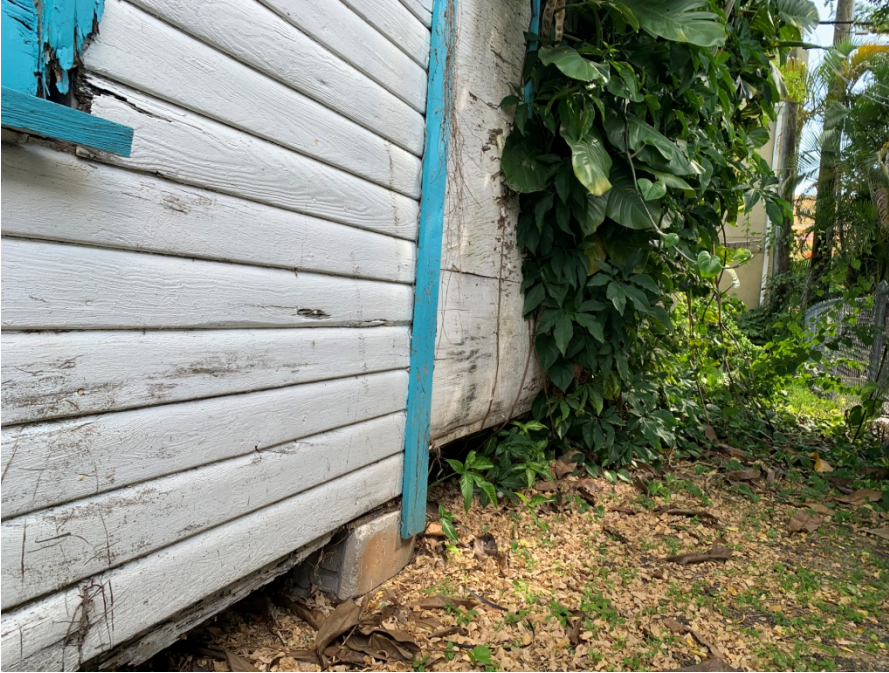
Picture #9 Another support example.

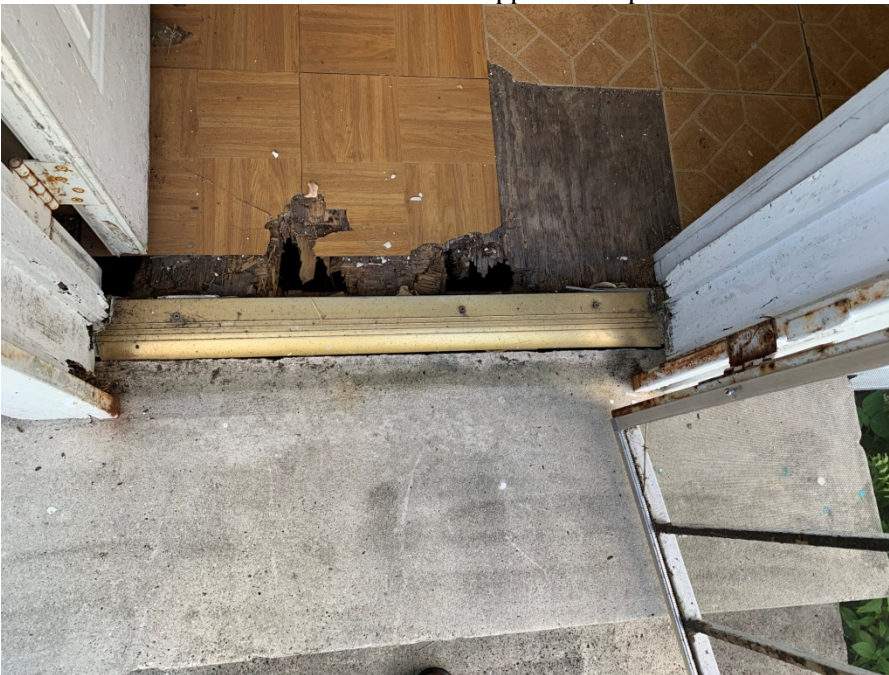
Picture #10 The wood floor is rotten in some areas.
