721 Biltmore Way

NOTICE OF UNSAFE STRUCTURE VIOLATION FOR FAILURE TO RECERTIFY AND NOTICE OF HEARING

Aerial of the Property Identifying the Building Being Certified

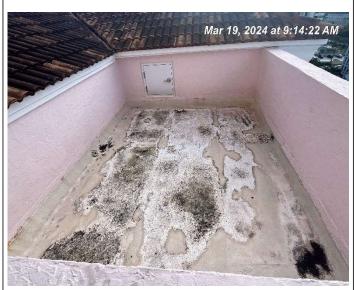
Photo # 18. Water ponding at the lower flat roof.

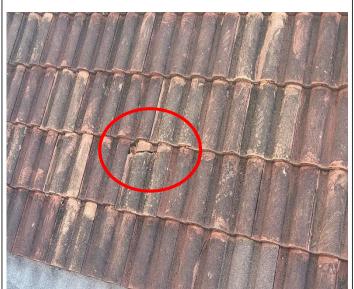
Photo # 22. Cracked clay barrel tile at the PH floor roof.

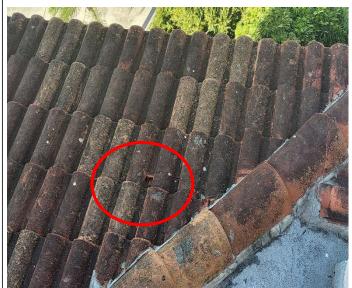
Photo # 23. Cracked clay barrel tile at the PH floor roof.

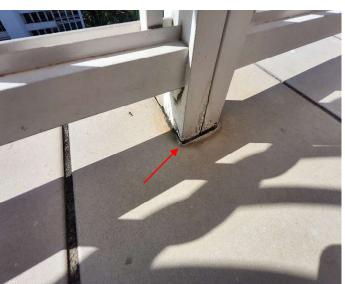
Photo # 29. Cracked tile at the balcony and missing sealant/grout at the railing post throughout.

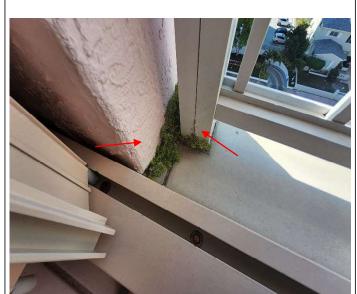
Photo # 30. Pitting corrosion at the balcony railing post throughout.

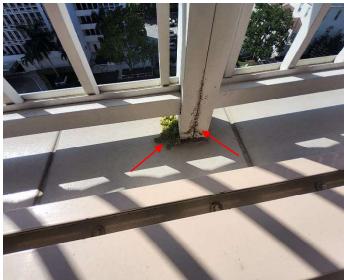
Photo # 31. Biological growth and pitting corrosion at the balcony railing post.

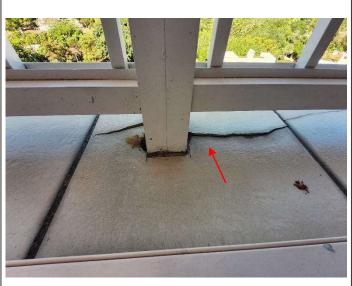
Photo # 32. Biological growth and pitting corrosion at the balcony railing post.

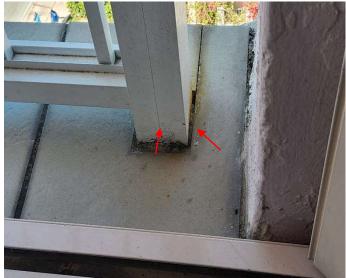
Photo #33. Cracked tile around the railing post.

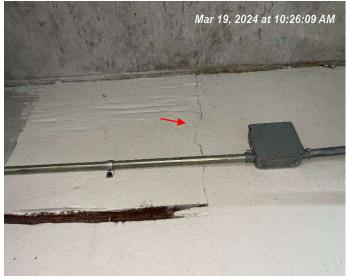
d. Cracks: Note location in significant members. Identify crack size as HAIRLINE if barely discernible; FINE if less than 1 mm in width; MEDIUM if between 1- and 2-mm width; WIDE if over 2 mm.
Medium (1 - 2 mm) Concrete cracks in parking garage's structural members varied from fine to
medium at structural walls, columns, beams, and slabs. See Annex C.

Photo # 35. Concrete crack at the ceiling slab of the basement garage.

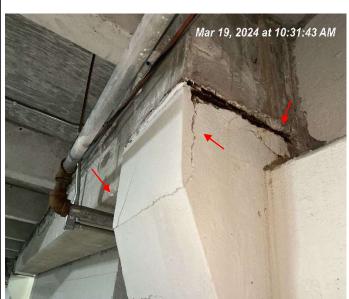
Photo # 37. Concrete crack with water stains and efflorescence at the ceiling slab of the basement garage.

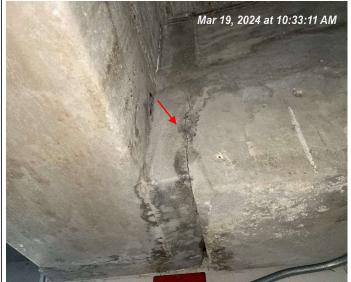
4. Significant (structural repairs required) Concrete cracks and spalling with exposed corroded rebar were noted at the parking slabs, and at the generator & fire pump room's slab.	garage's walls, columns, beams, and

Photo # 39. Spalled concrete with exposed corroded rebar at the beam of the parking garage.

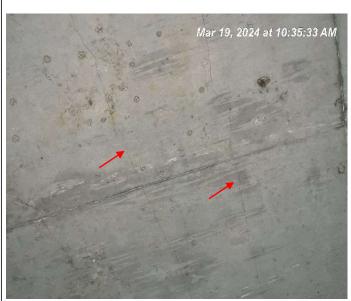
Photo # 41. Concrete crack with water stains and efflorescence at the ceiling slab of the basement garage.

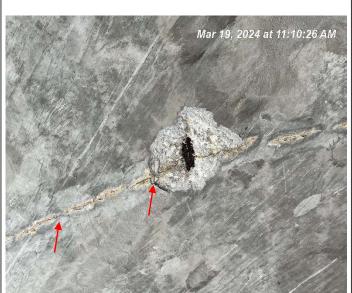
Photo # 42. Concrete cracks at the ceiling slab of the basement garage.

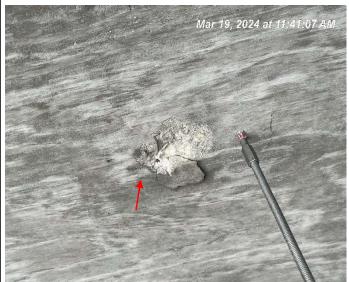
4. Ramps: indicate location, framing type, material, and condition: N/A:	PROVIDE PHOTO 7b4
Ramps are located at the parking garage (East and West side) and are reinforced concrete fair condition, with localized concrete cracks and spalling with exposed corroded rebar at the Annex C.

Photo # 43. Cracked and spalled concrete with exposed corroded rebar at the ramp ceiling slab (East Side)

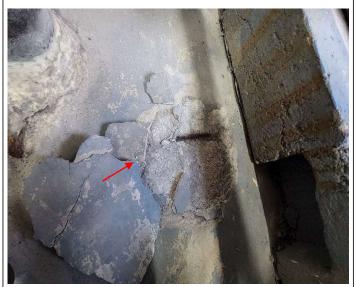
Photo # 44. Cracked and spalled concrete at the ramp ceiling slab (West Side)

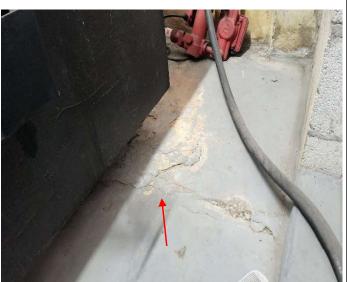
Photo # 45. Cracked and spalled concrete with exposed corroded rebar at the Generator & Fire Pump Room.

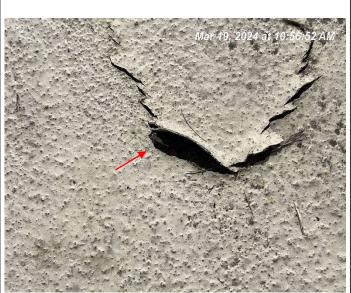
Photo # 46. Cracked and spalled concrete at the Generator & Fire Pump Room.

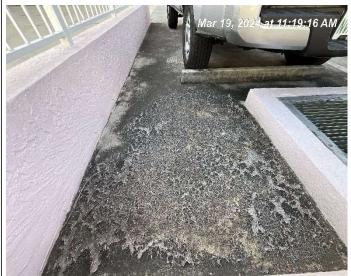
Photo # 47. Delaminated waterproofing coating at the parking deck.

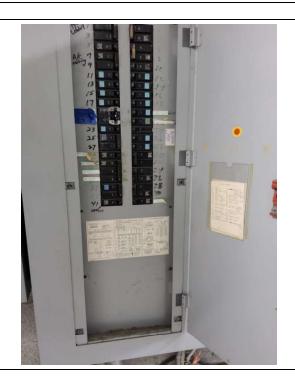
Photo # 10. Item 7.4.a. Meter Electrical Room. Panelboard HOUSE. Missing proper circuit identification.

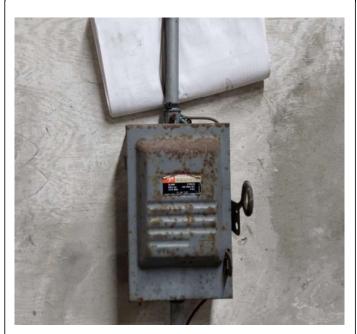
Photo # 24. Item 26.a. Pool equipotential bonding: Failed test between pumps and metal parts.

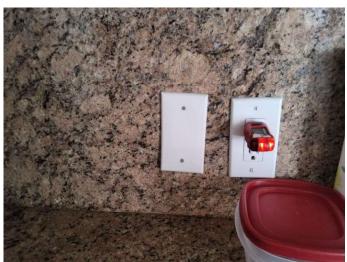
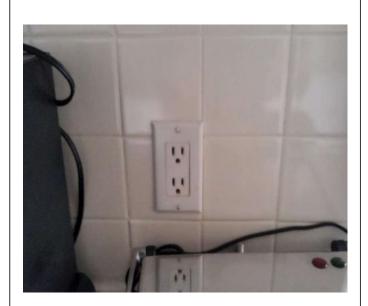
Photo # 29. Item 28.1. Missing GFCI protection for receptacles in the kitchen.

Photo # 30. Item 28.1. Missing GFCI protection for receptacles in the kitchen.

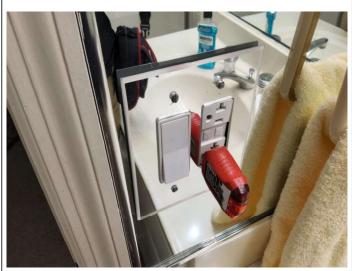
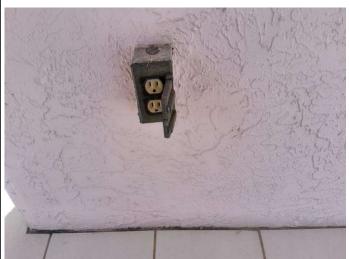
Photo # 32. Item 28.2. Missing GFCI protection for receptacles in the bathroom- test fail.

Photo # 33. Item 28.2 Missing GFCI protection for receptacles in the bathroom- test fail.

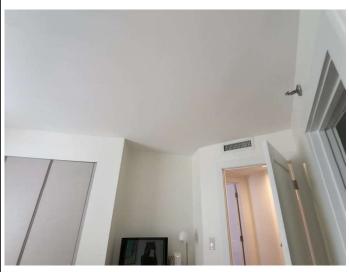
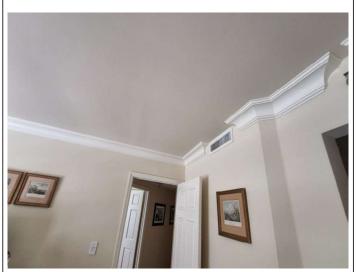
Photo # 36. Item 28.5. Missing smoke alarm inside the sleeping rooms.

Photo # 37. Item 28.3. Missing smoke alarm inside the sleeping rooms.

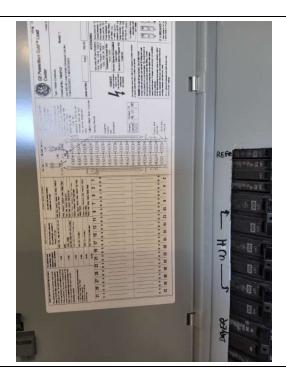
Photo # 39. Items 28.7. Electrical panel missing or incomplete proper circuit directory.

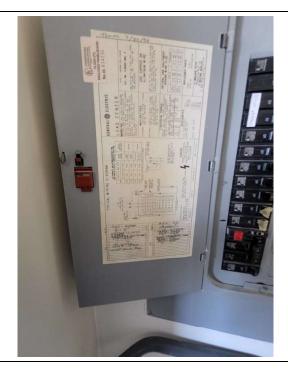
Photo # 40. Item 28.7. Electrical panel missing or incomplete proper circuit directory.

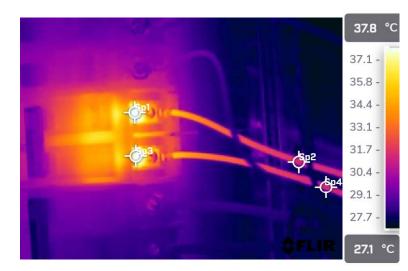
File name FLIR1519.jpg

Condition POSSIBLE DEFICIENCY
