STRUCTURAL INSPECTION REPORT

REFERENCE: Inspection about Structural Conditions of a residence.
Property of: Mr. Anthony Vinciguerra.
134 Florida Ave.
Coral Gables, FL 33133

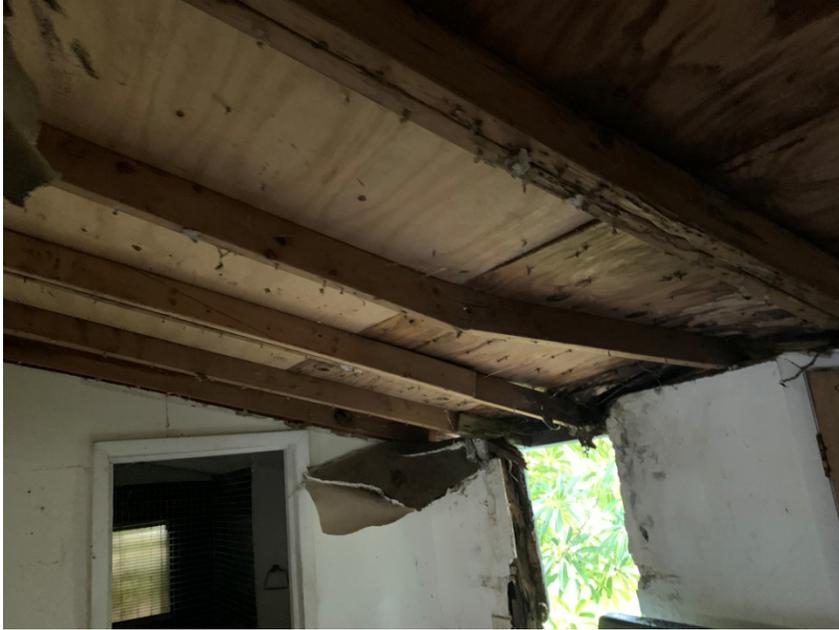
Picture 1

- The house is infested by termites. It was observed in many places traces of termites. For example wood ceiling joists, wood joist or rafters, wood floors planks, wood floor joists, exterior wood panels and windows and doors wood framings.

Area of the house very damaged. Broken joists and termite infection

1- We strongly recommend to cover the whole house with a tent and fumigate in order to eliminate any possibility of alive termites, and avoid any future deterioration of the existing wood joists, sheathing (floor and roof) and the existing wood partitions.

2-All the structural elements that has been damaged in more than 25 % of its cross section area (wood joist, wood studs, wood beams) must be immediately replaced. The wood floor and subfloor, and maybe a significant portion of the wood joists, at ground floor and roof, need to be replaced.

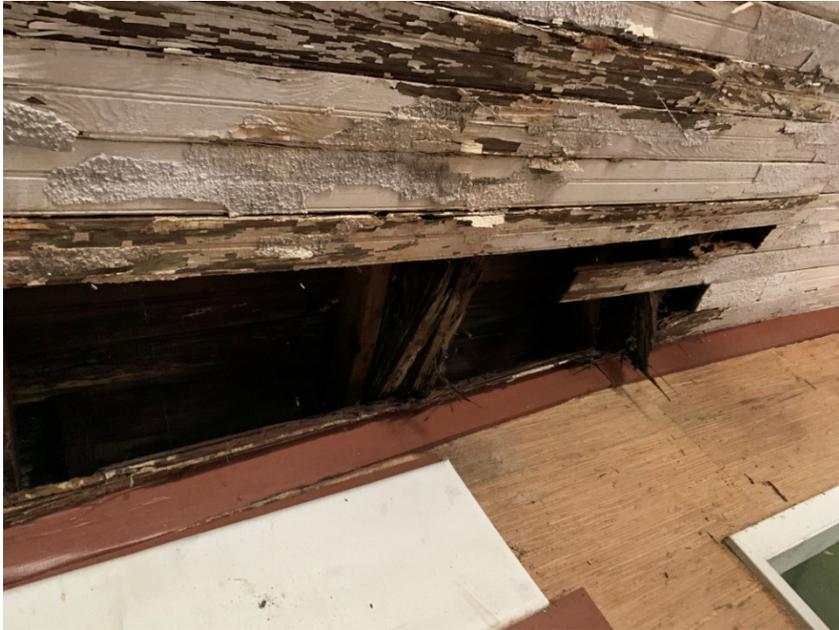
Picture 2

Wood ceiling rotten by water filtration

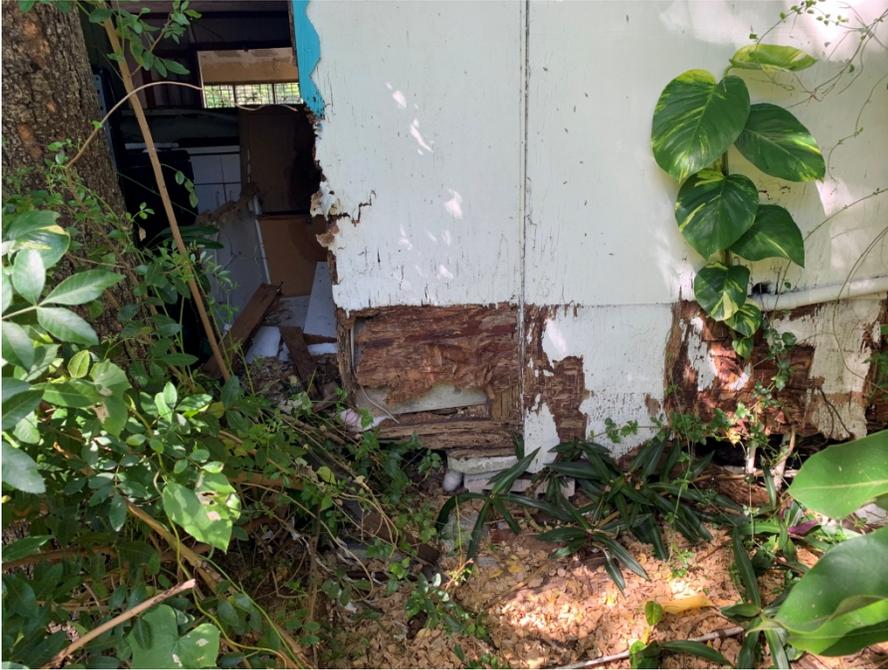
Picture #3

Severe damage on the exterior wood panels walls (back of the house)

3-Of course, all the exterior windows and wood panels that are not there, most be re-built and reinstalled.

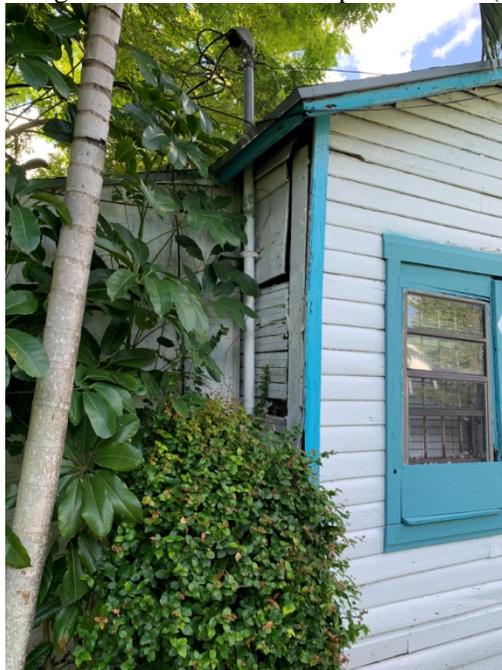
Picture #4

Another exterior wall area in bad conditions

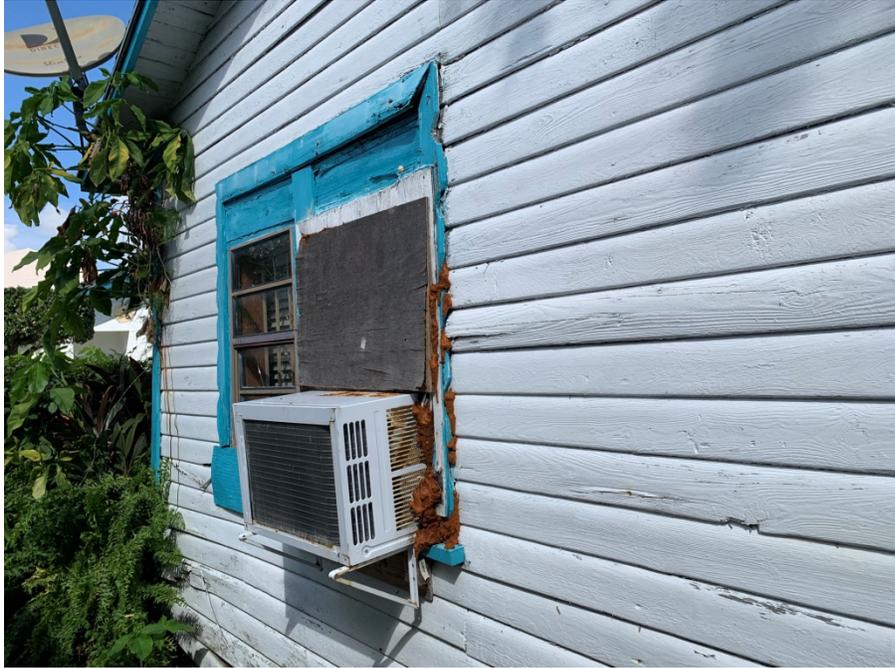
Picture #5

A/C unit not properly encased into the windows. The windows is damaged

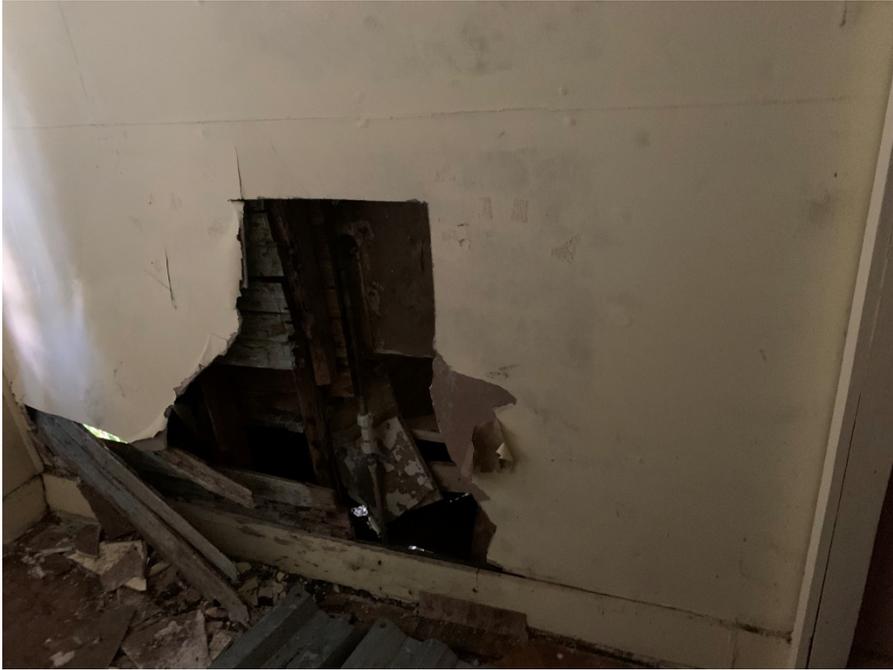
Picture #7
Wood partition rotten inside the house.

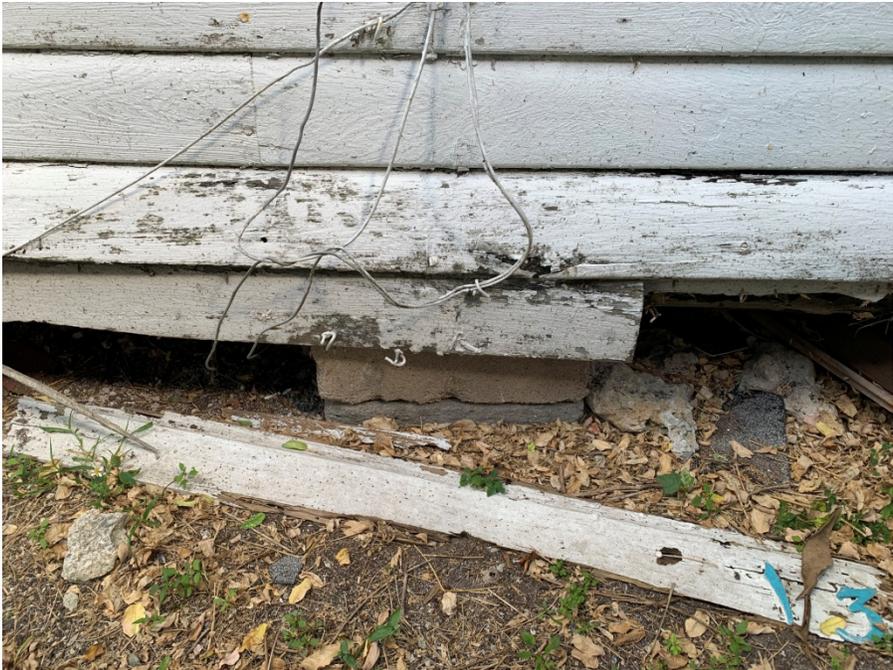
- Some exterior windows are in very bad conditions. Some metal frames are rusted and some glass panel are cracked. Also, there are some windows missing.
- The exterior wall wood panels and the floor wood joists are not braced at ground floor. In others words, the house doesn't have a mechanical connection to transmit and guarantee a lateral stability. In some places the house is resting un blocks without any connection to a footing into the grade.

Picture #8
The house is on a crawl space supported by block pedestal without any structural connection

4-We strongly recommend to brace the house to the foundation. Replace the CMU block pedestals that are without any connection to the foundation and the ground floor, by concrete pedestals (attached to the foundation and the ground floor wood joists) w/ some connectors, in order to control the lateral stability of the house.

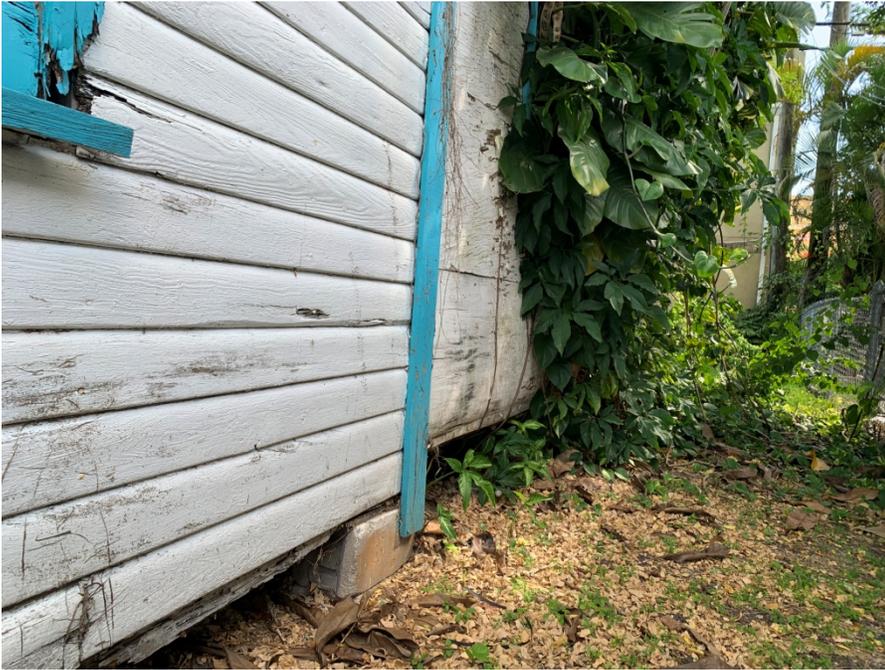
Picture #9 Another support example.

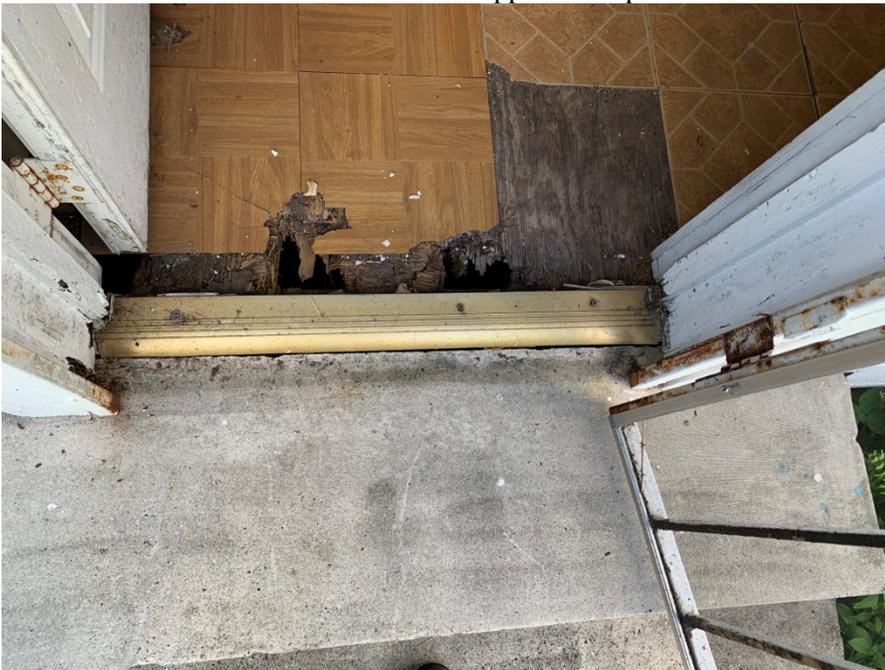
Picture #10 The wood floor is rotten in some areas.
