AFTER PHOTOS

EXTERIOR ARCHITECTURAL FEATURES

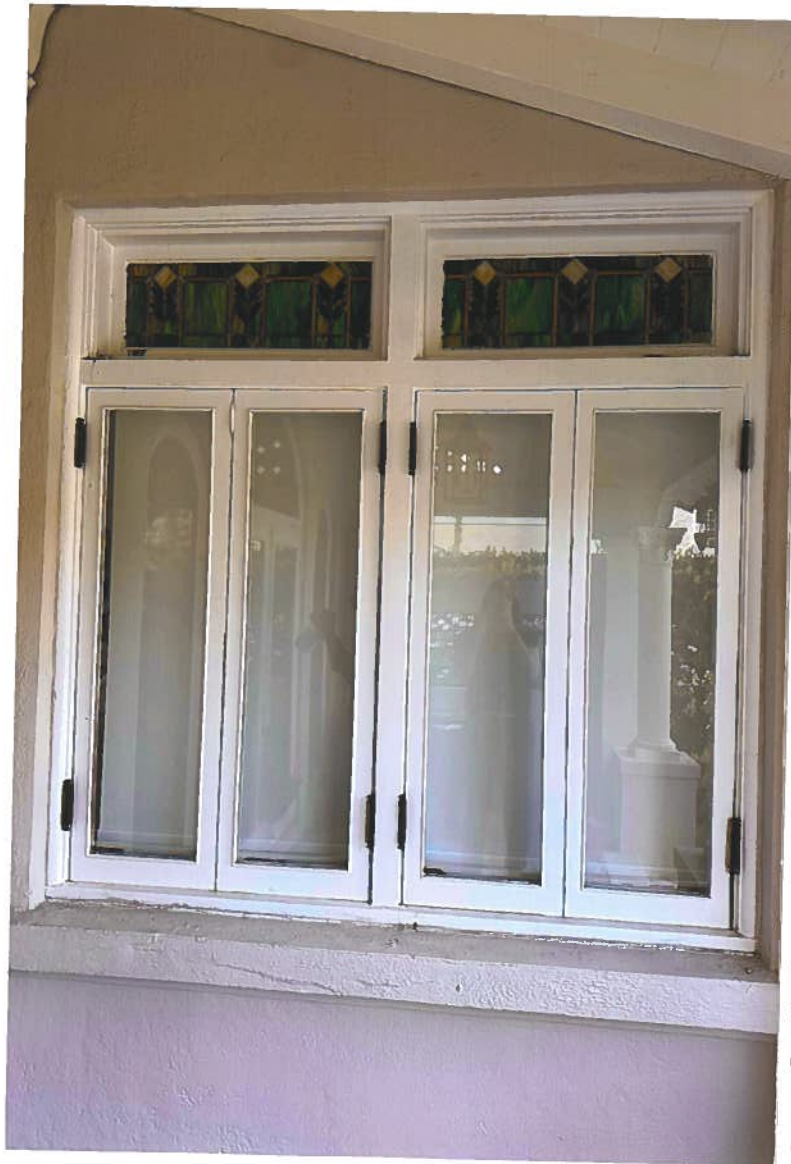
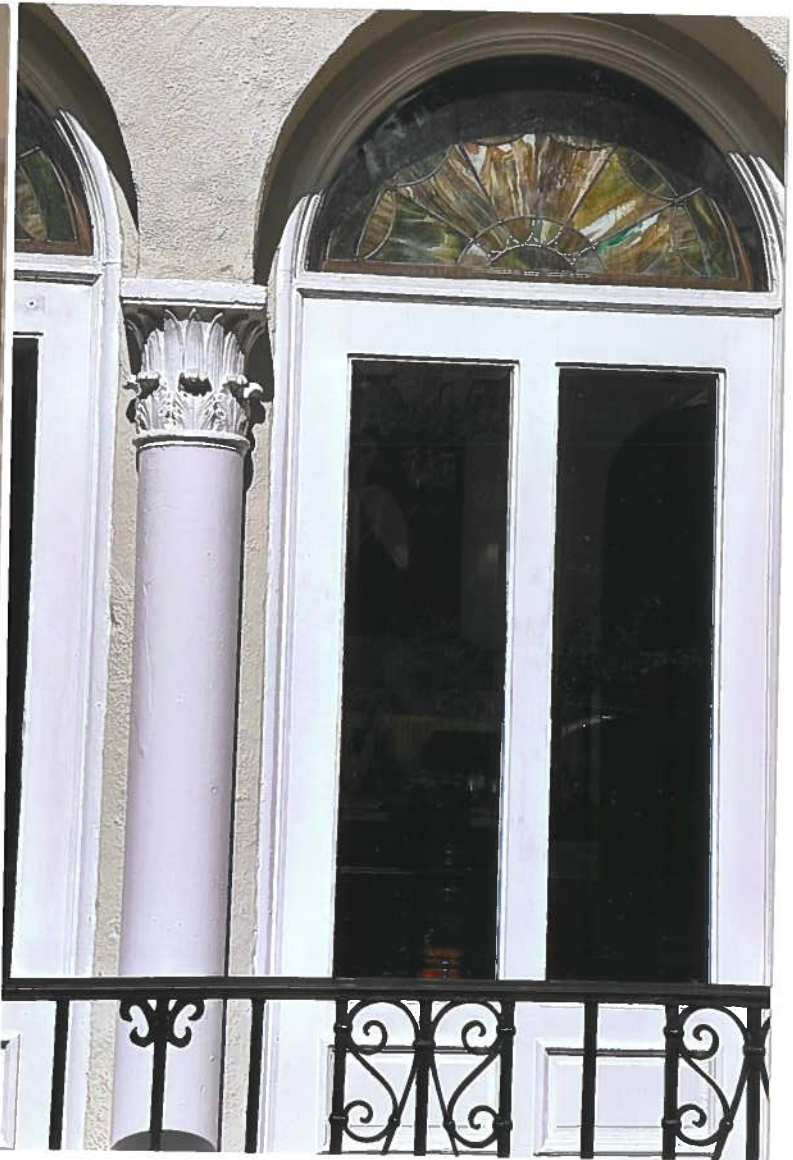
FEATURE # 1: ORIGINAL WINDOWS WITH STAINED GLASS -  
REPAIRED & RESTORED

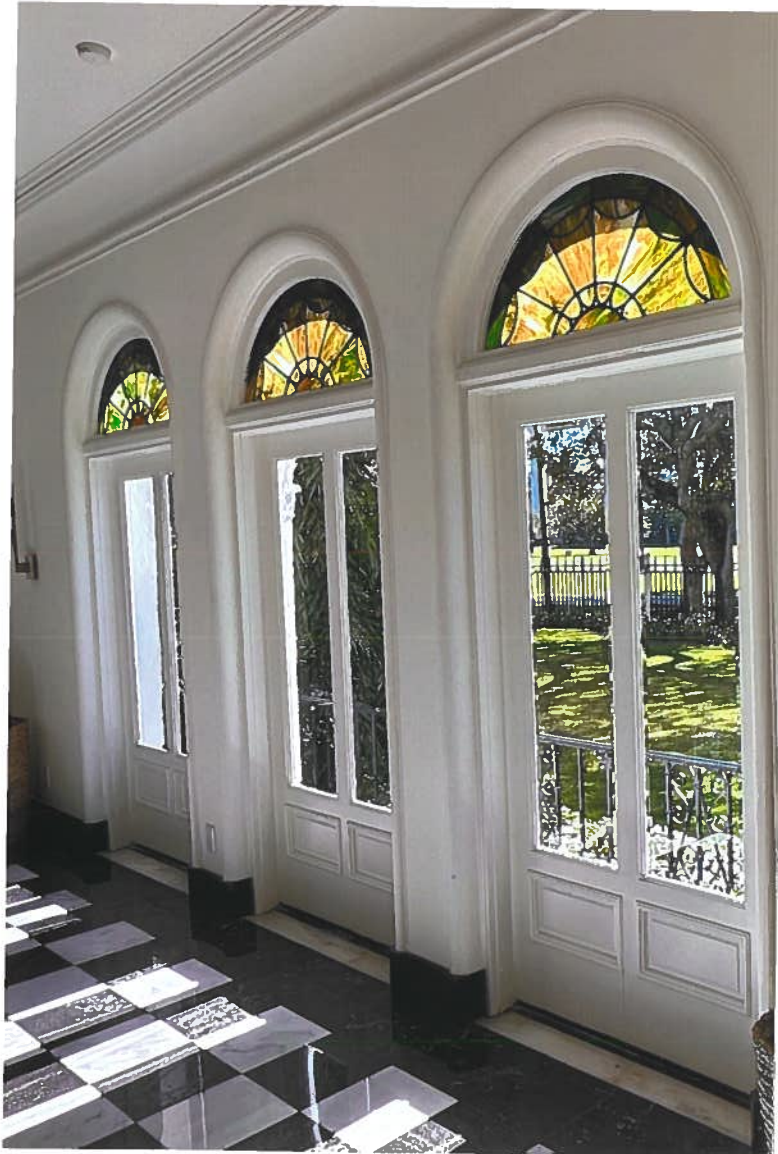
#### FEATURE # 1: ORIGINAL WINDOWS WITH STAINED GLASS - REPAIRED & RESTORED (CONTINUED)

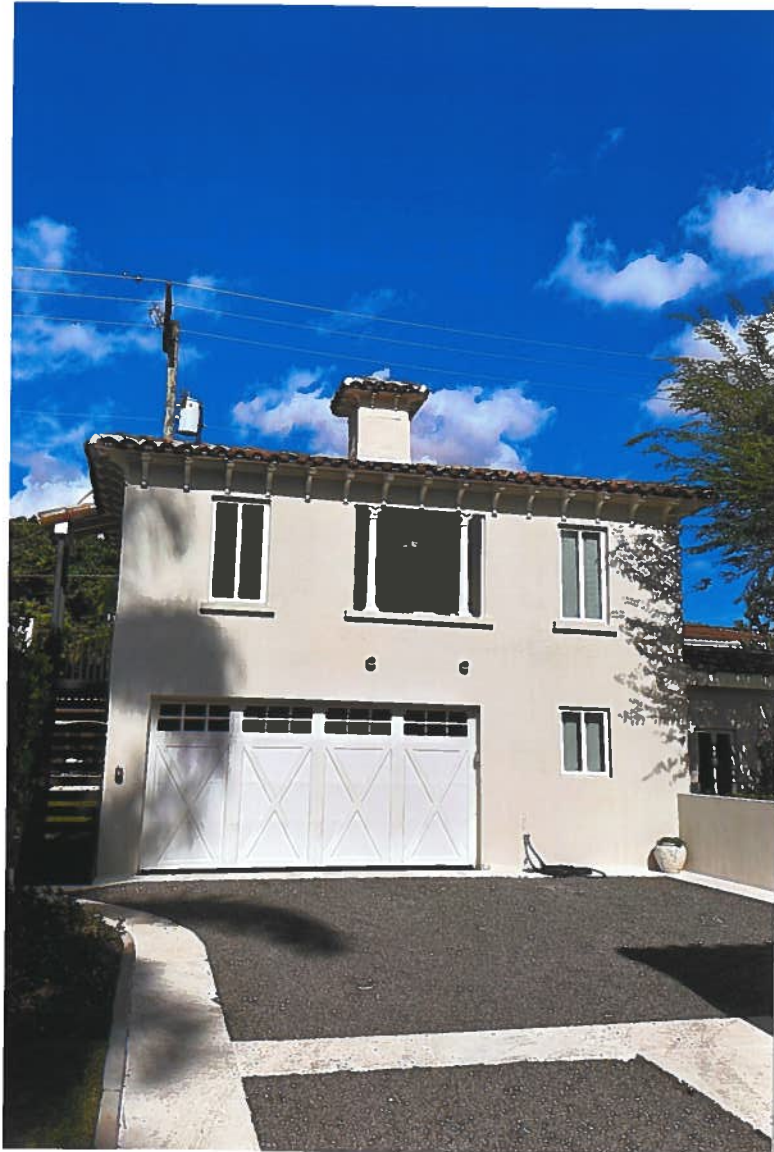
#### FEATURE # 3: RE-ESTABLISHING ORIGINAL GARAGE

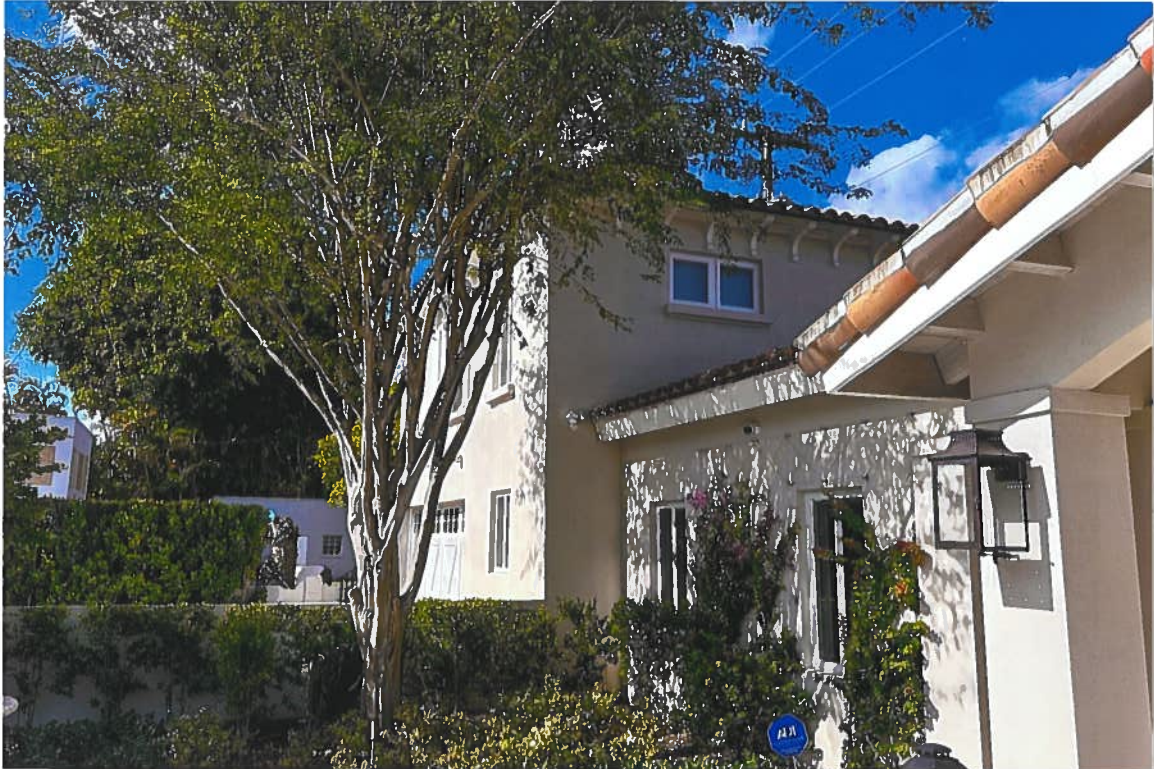
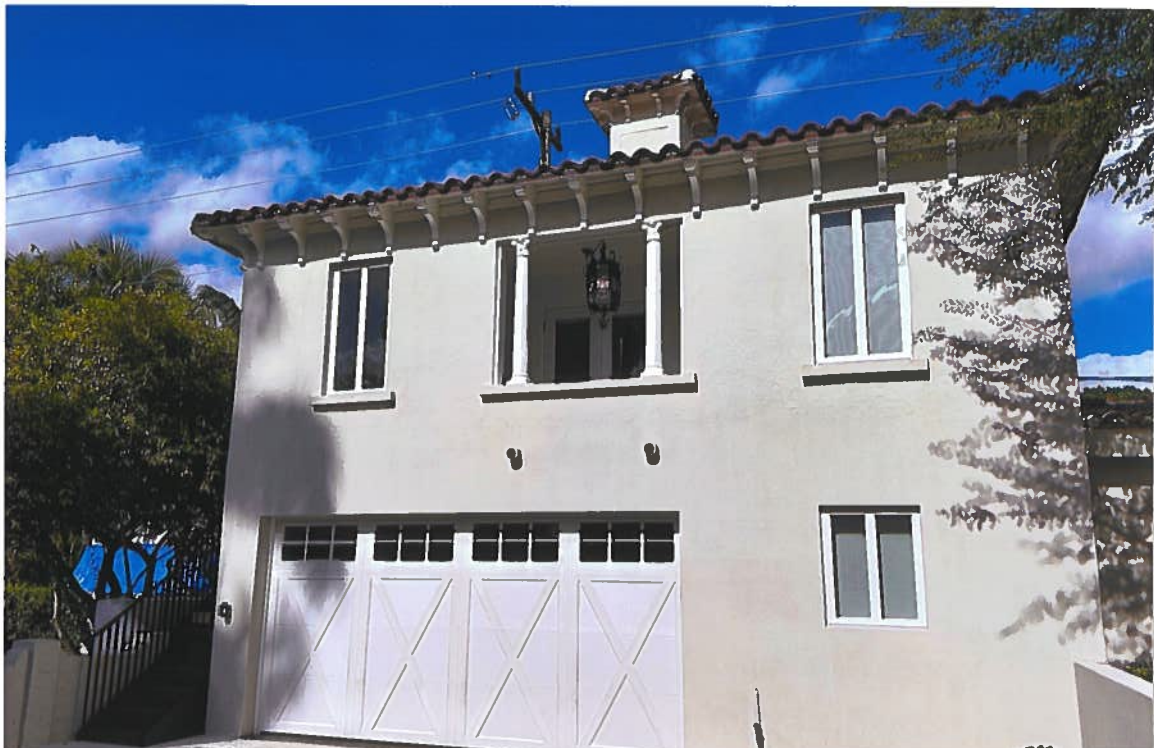
FEATURE # 3: RE-ESTABLISHING ORIGINAL GARAGE -

(CONTINUED)

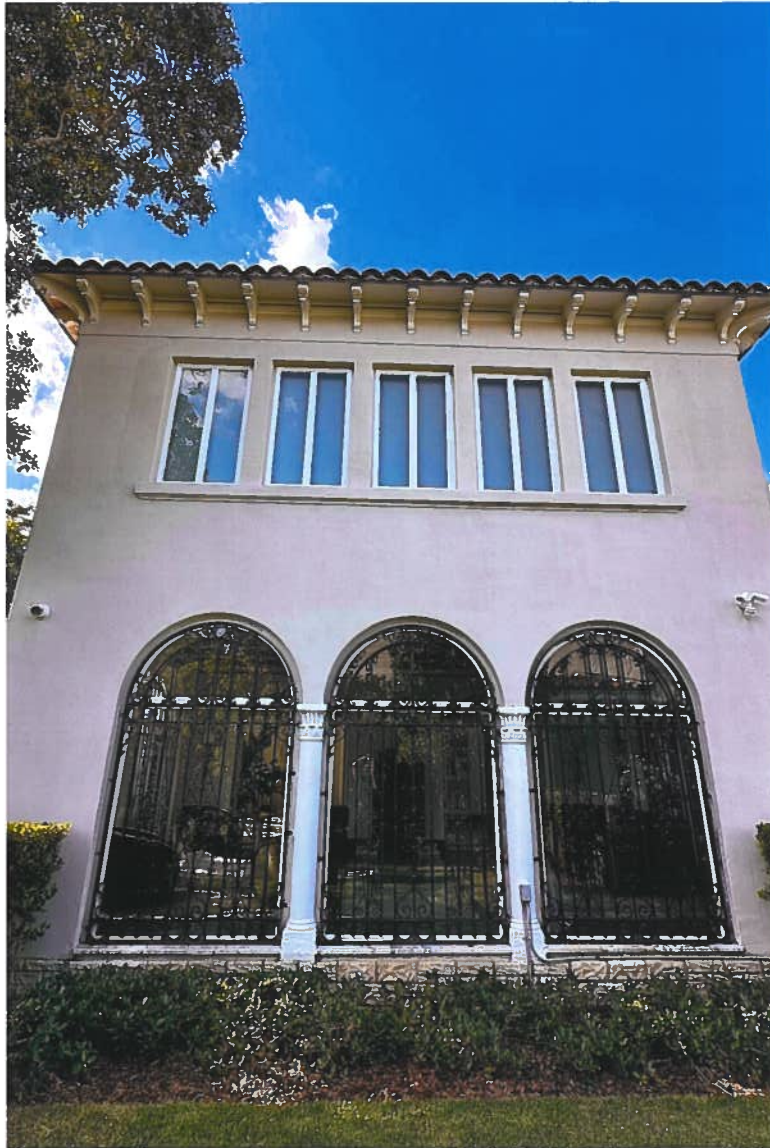
#### FEATURE # 4: RE-ESTABLISHING REMOVED WINDOWS

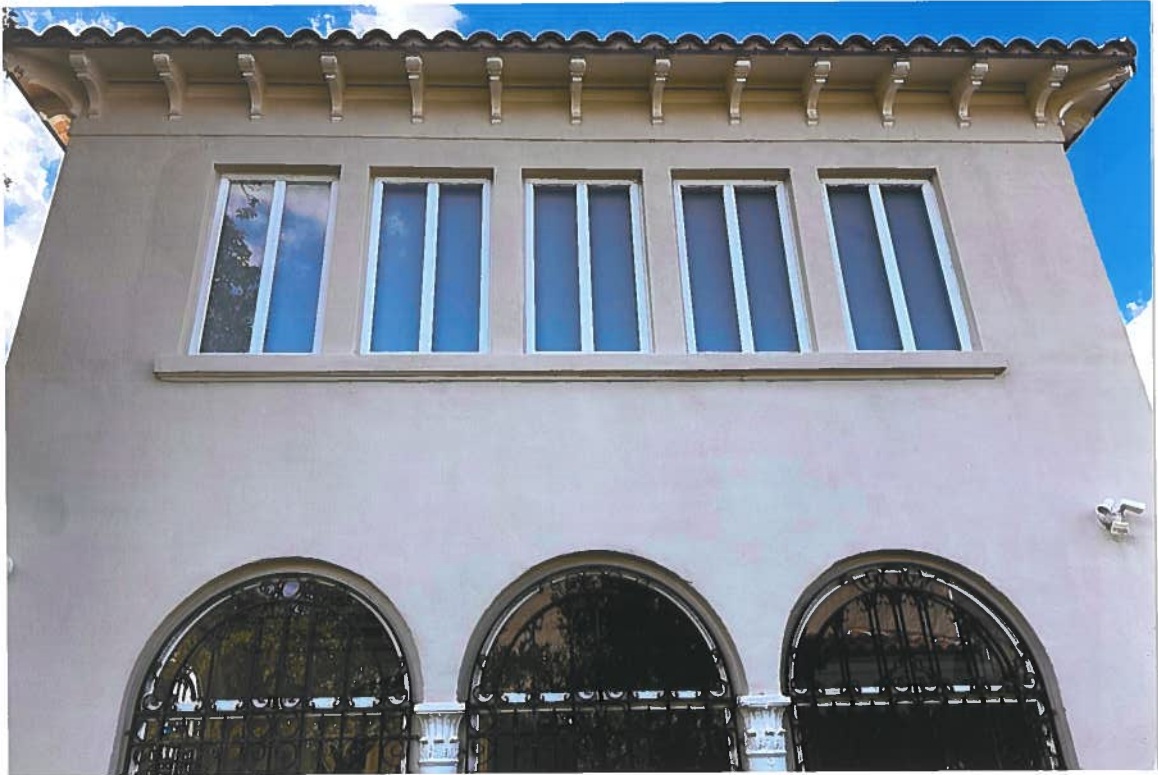
FEATURE # 4: RE-ESTABLISHING REMOVED WINDOWS

(CONTINUED)
