PROPERTY APPRAISER OF MIAMI-DADE COUNTY

1960 Douglas Rd

**NOTICE OF UNSAFE STRUCTURE VIOLATION FOR FAILURE TO RECERTIFY
AND NOTICE OF HEARING**

AERIAL IMAGES

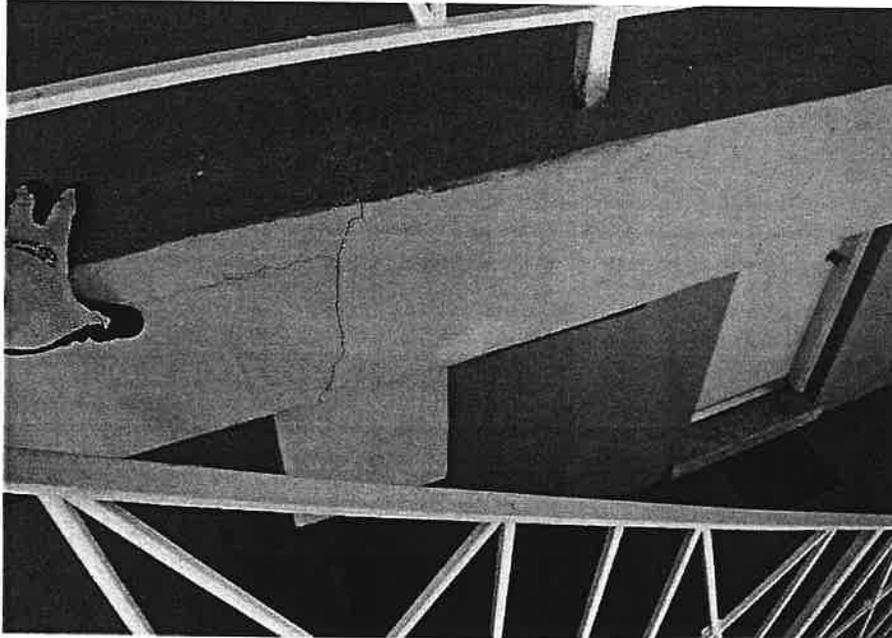
Photo(s) 5d:

d. Cracks: Note location in significant members. Identify crack size as HAIRLINE if barely discernible; FINE if less than 1 mm in width; MEDIUM if between 1- and 2-mm width; WIDE if over 2 mm.	PROVIDE PHOTO 5d
Fine (Less than 1 mm)	Fine cracks in the 2nd-floor slab's edge and joint at the north portion of the building's west side. Hairline to fine stucco cracks around the interface between the northwest stair and ground-floor CMU enclosure.

Cracked 2nd-floor, pre-cast concrete slab at the north portion of the west edge

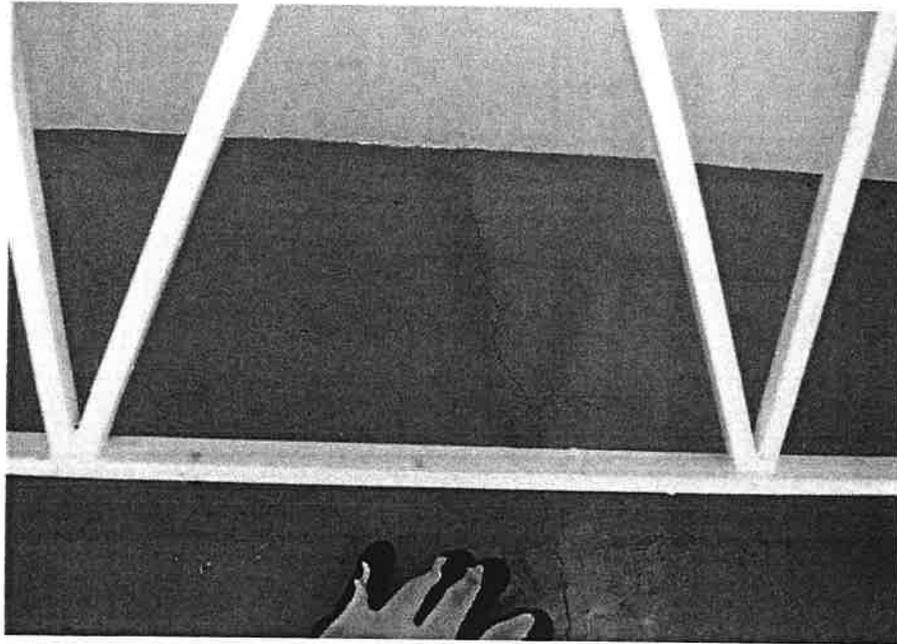
Typical cracked joints between the 2nd-floor pre-cast concrete slab along the west continuous balcony

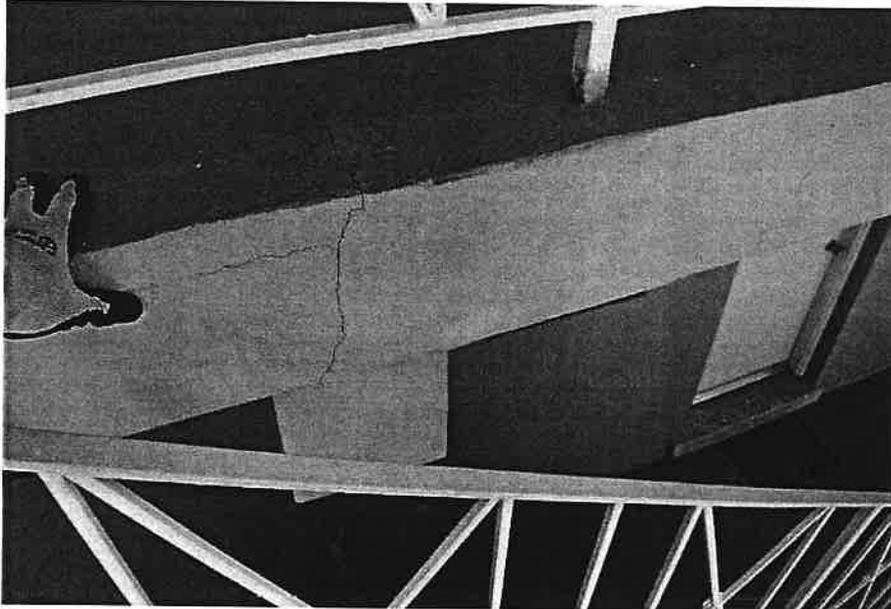
Photo(s) 5e:

e. General extent of deterioration: Cracking or spalling of concrete or masonry, oxidation of metals; rot or borer attack in wood.	PROVIDE PHOTO 5e
Fine cracks in the 2nd-floor slab's edge and joint at the north portion of the building's west side.

Cracked 2nd-floor, pre-cast concrete slab at the south portion of the west edge

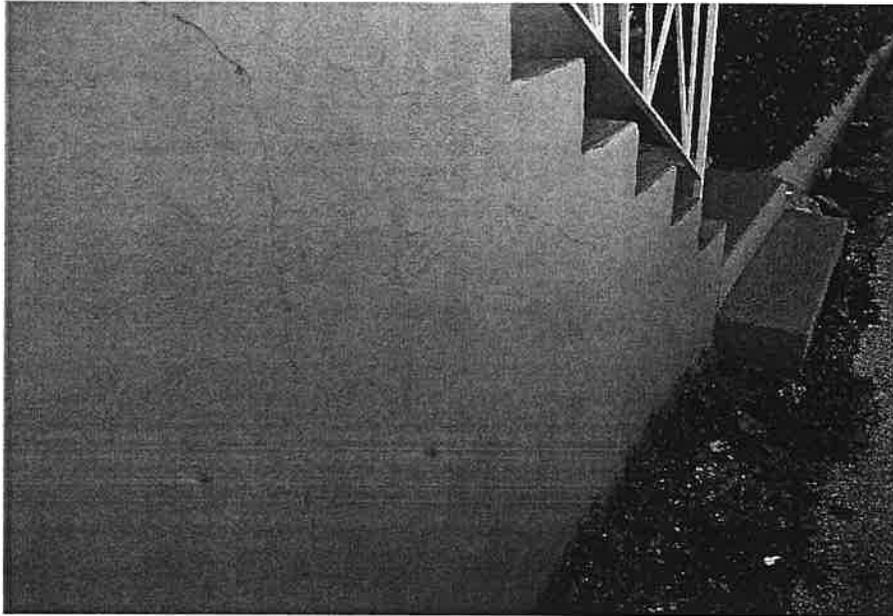
Continuous stucco cracks along the interface between the southwest stair and its ground-floor CMU enclosure

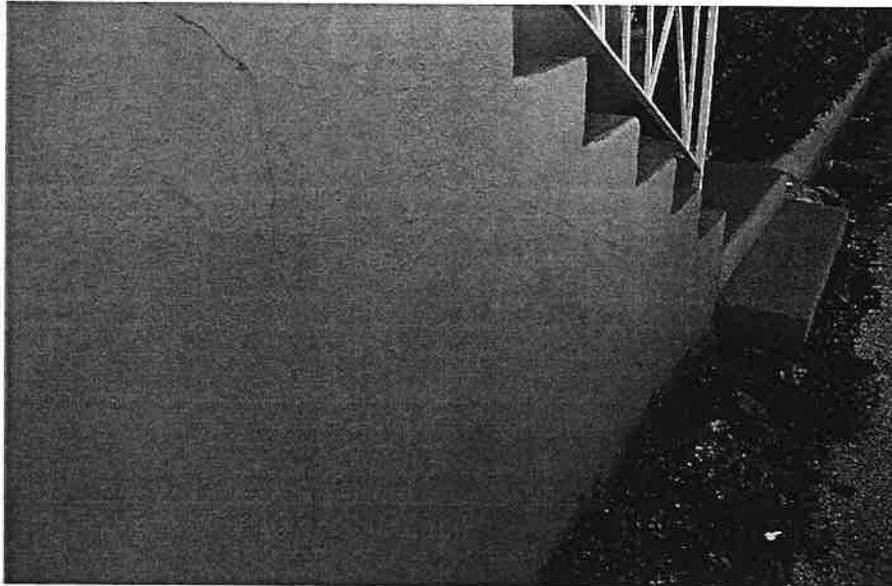
Photo(s) 6i:

Fine cracks in the 2nd-floor slab's edge and joint at the north portion of the building's west side. Hairline to fine stucco cracks around the interface between the northwest stair and ground-floor CMU enclosure.

Continuous cracks along the interface between the southwest stair and its ground-floor CMU enclosure

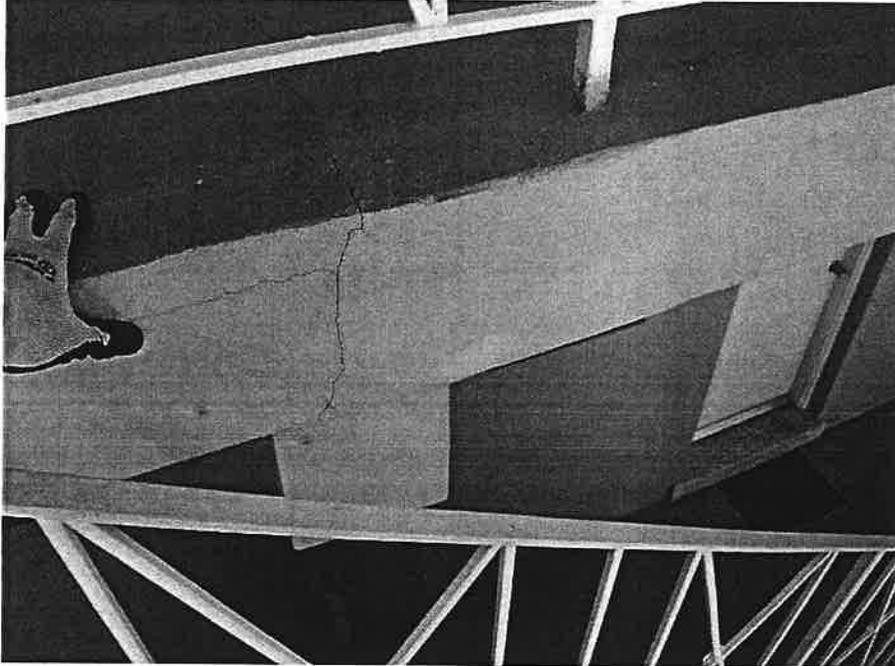
Photo(s) 9b:

Cracked 2nd-floor, pre-cast concrete slab at the south portion of the west edge

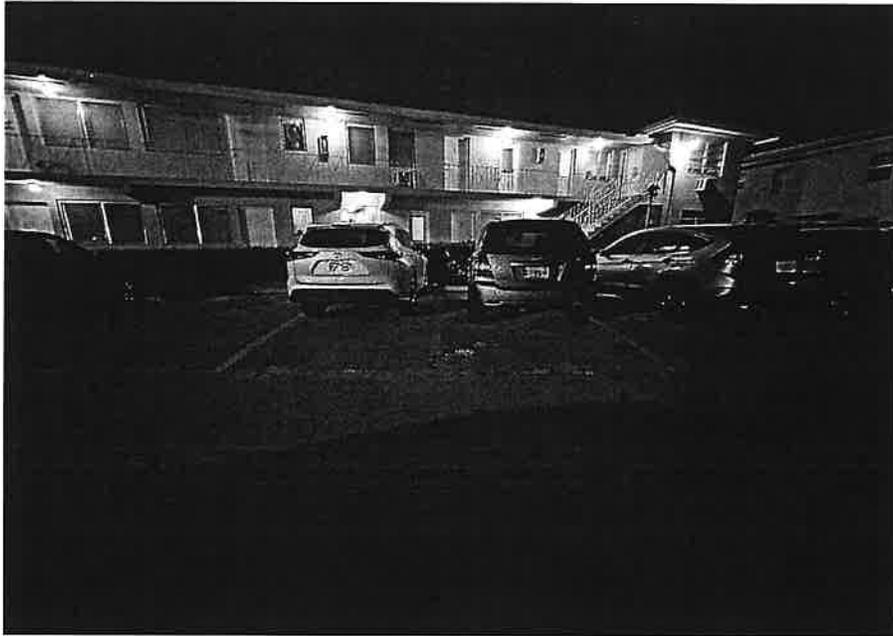
Lighting Levels Low in Parking Lot -

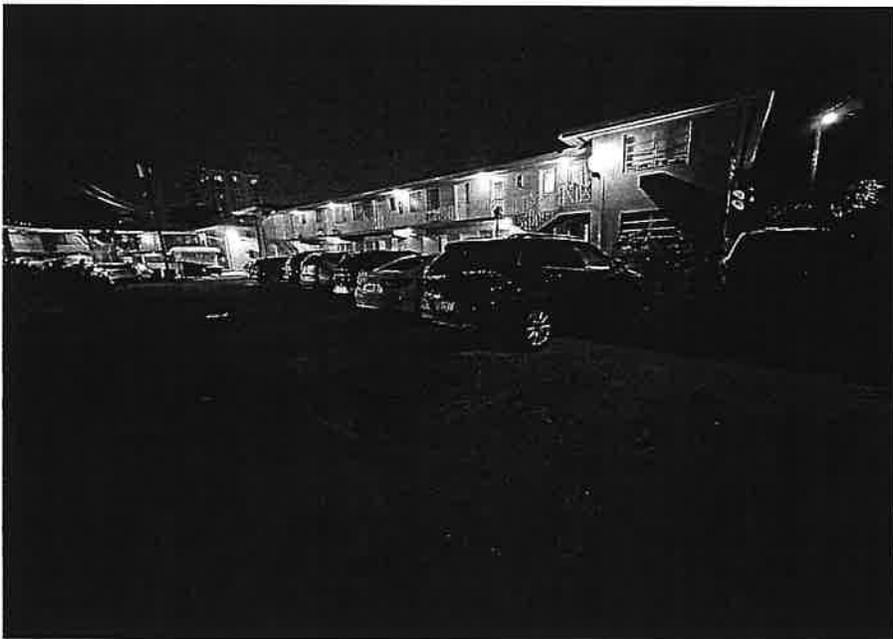
Lighting Levels Low in Parking Lot -

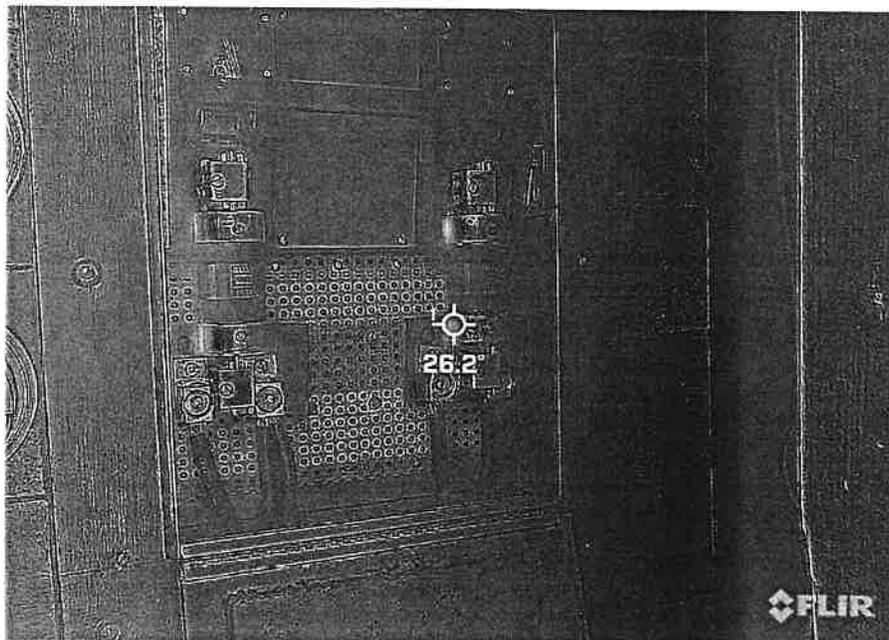
Item 1: Main 1 of 1 at 26.2C (delta 4.2C)

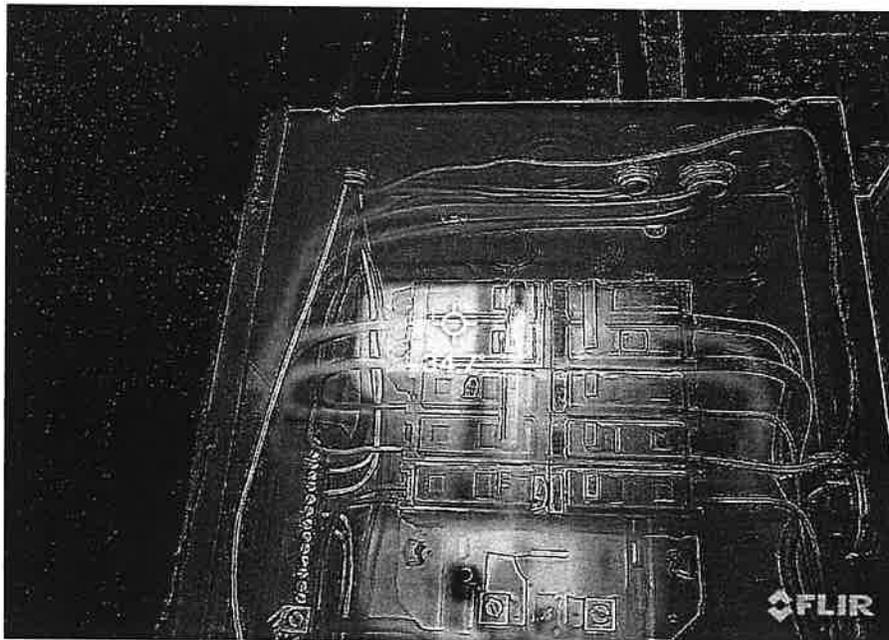
Item 2: Panel H at 34.7C (delta 12.7C)

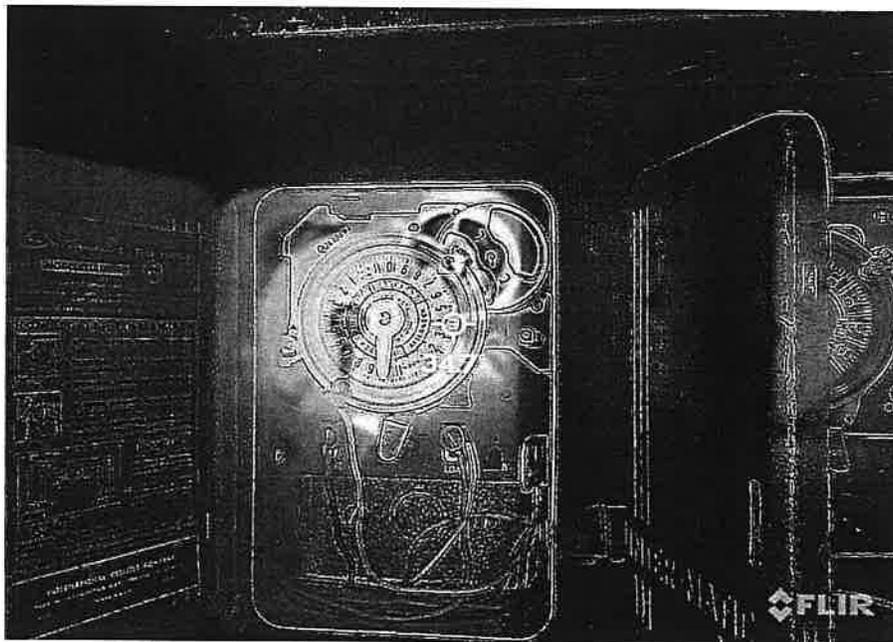
Item 3: Time Clock at 34.7C (delta 12.7C)

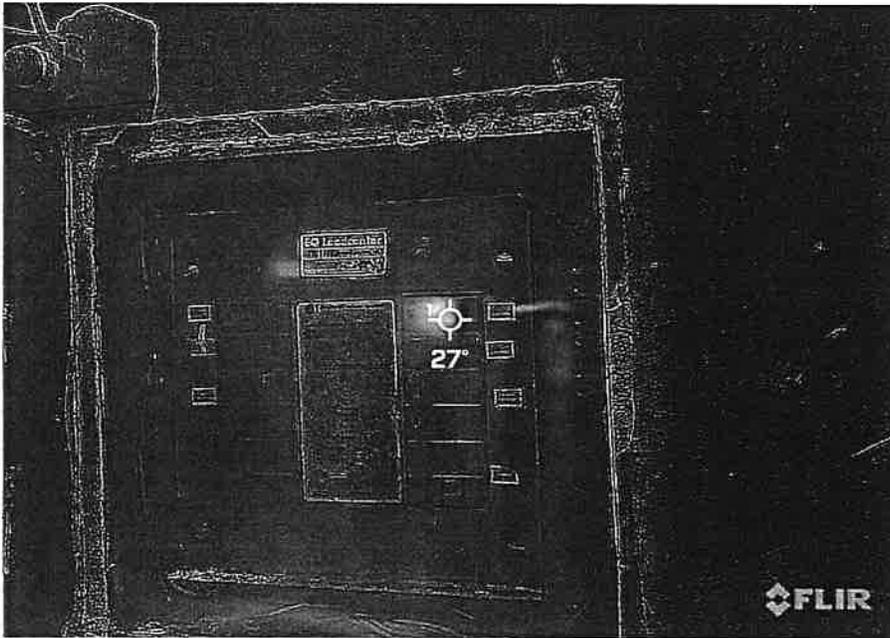
Item 4: Typical Panel at 27.0C (delta 5.0C) -

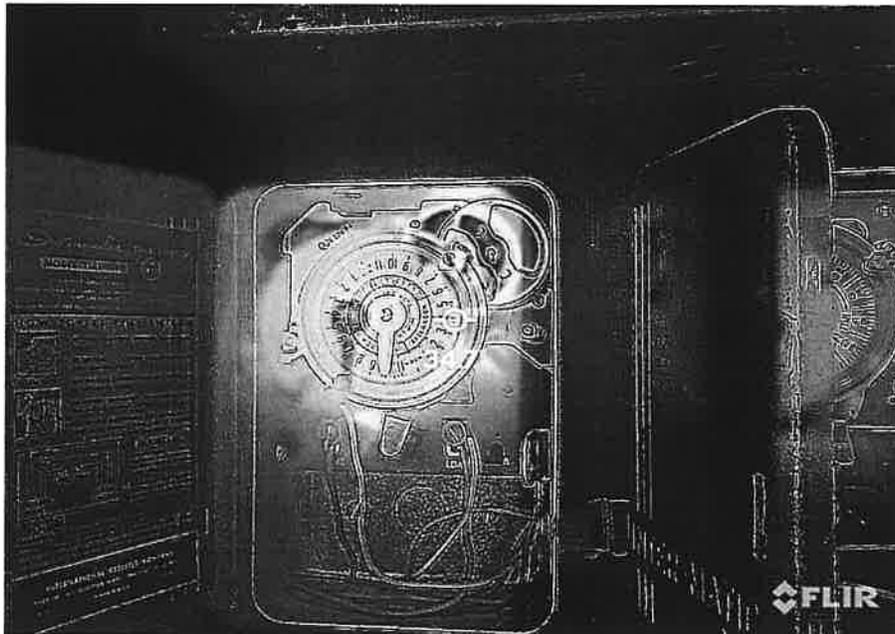
Item 3: Time Clock at 34.7C (delta 12.7C)
