**City of Coral Gables
Development Services Department**

**UNSAFE STRUCTURES BOARD HEARING
CASE RESUME**

BUILDING ADDRESS: 600 Biltmore Way

FORTY-YEAR INSPECTION

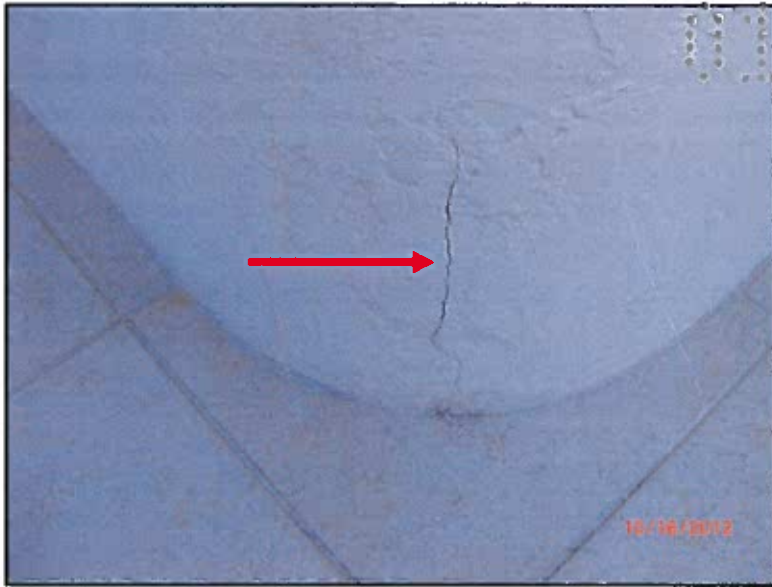
1. The building structure is generally in good condition.
2. The interior walls of balconies are in good condition overall. Minor cracking was observed on interior balcony wall and building wall (photo #1, photo #2 and photo #3) location.

PHOTO # 1: Vertical cracking on building wall located at balcony Unit #219

The walls of the balcony slabs are typically in good condition, the inspected residential units' exhibit cracking at balconies. This is an indication of moisture intrusion into the block wall, with subsequent delamination of stucco. If left unabated, the stucco at the balcony block wall will eventually spall off, creating a falling debris and life safety hazard for residents and pedestrians below. We recommend the balcony walls be repaired where there are sign of cracking and

delamination. In addition, we also recommend that all balcony block walls be surveyed to document similar conditions.

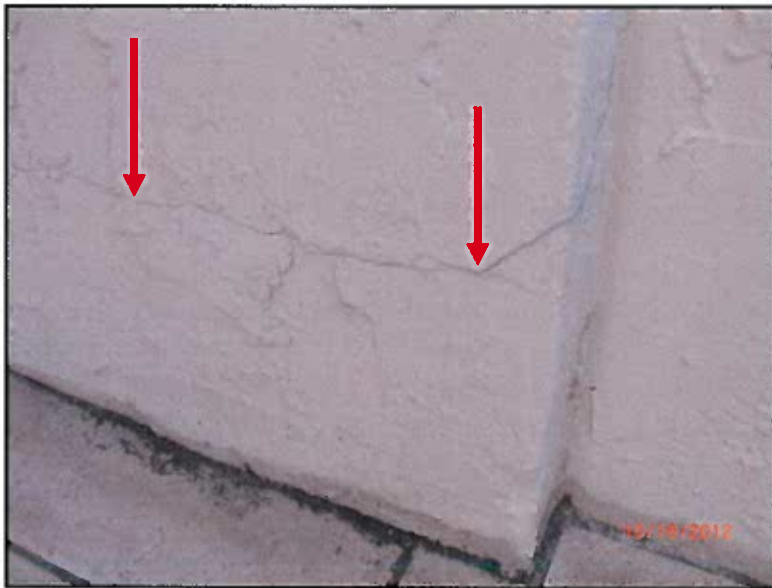
PHOTO # 2: Horizontal cracking/delaminated stucco at balcony wall Unit #219

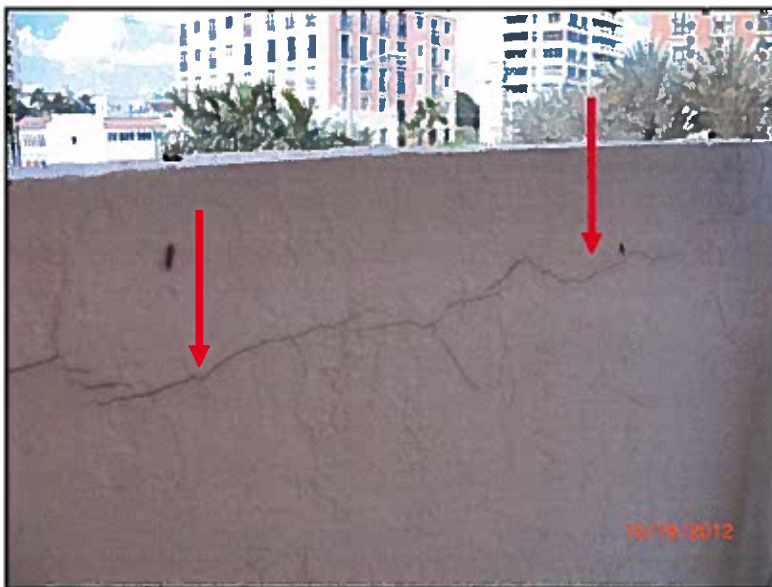
PHOTO # 3: Horizontal cracking on balcony block wall concrete cap at Unit #219

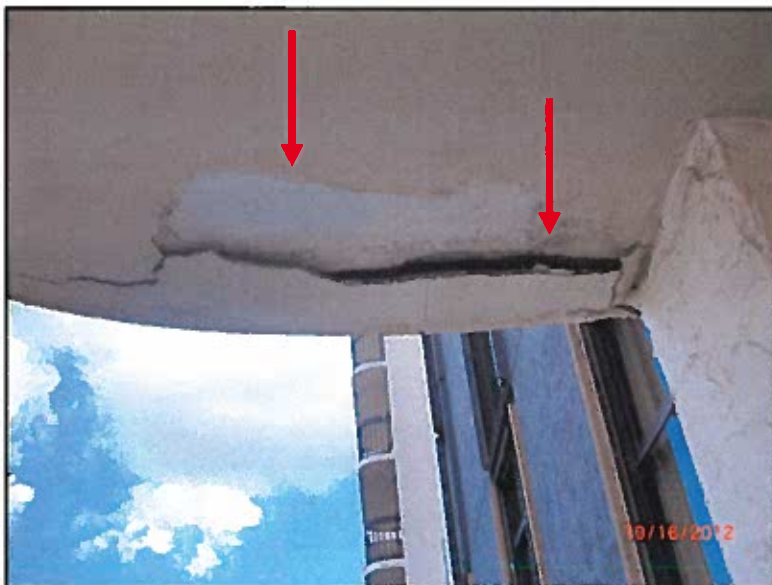
3. The balcony slabs are in fair condition. Spalled concrete with corroded reinforcing steel was noted on the balcony ceilings of Units 219 and 416 (photo #4 and photo #5).

PHOTO # 4: Concrete spalling/exposed steel rebar at balcony ceiling at Unit #219

Although the edges of the balcony slabs are typically in fair condition, some units exhibit cracking and concrete spalling at the slab edge and at the underside of slab above. This is an indication of moisture intrusion into the concrete, with subsequent corrosion of the reinforcing steel. If left unabated, the concrete at the edges of balconies will eventually spall off, creating a falling debris and life safety hazard for residents and pedestrians below. It's recommended that balcony edges be repaired where there are signs of cracking and concrete spalling. In addition, we also recommend that all balconies be surveyed to document similar conditions.

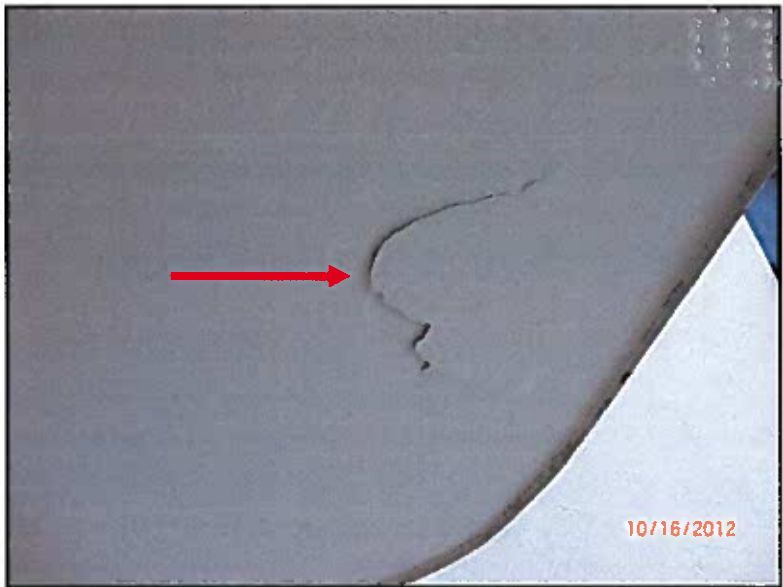
PHOTO # 5: Concrete spalling at balcony ceiling at Unit #416

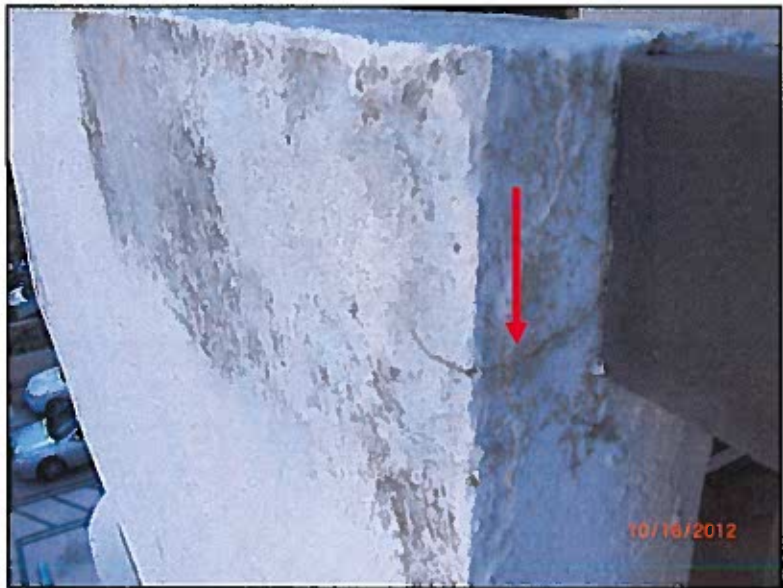
4. Minor stucco cracking at balcony railing connection to block wall of Unit 407 (photo #6).
5. We observed stucco cracking along balcony's edge of Unit 407 (photo #7) and connection between block wall and building column of Unit 219 (photo #8).

PHOTO # 6: Cracking stucco at balcony railing connection at Unit #407

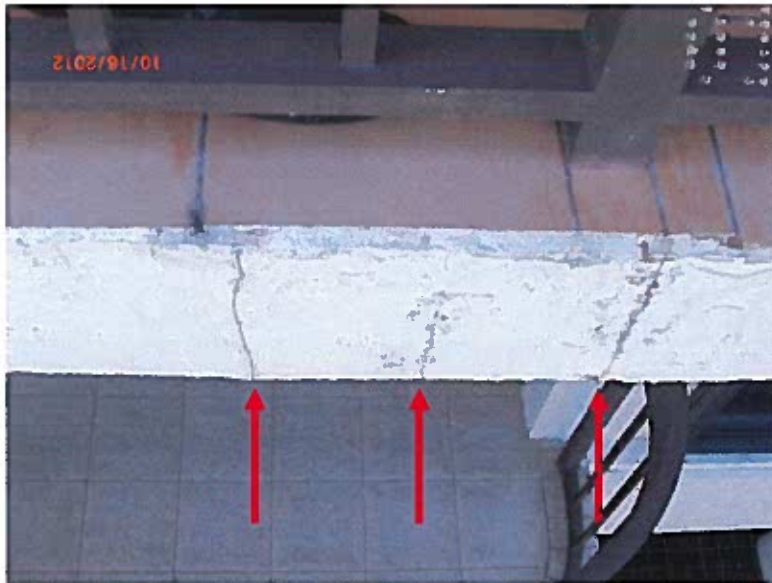
PHOTO # 7: Cracking/delaminated stucco on balcony slab edge at Unit #407

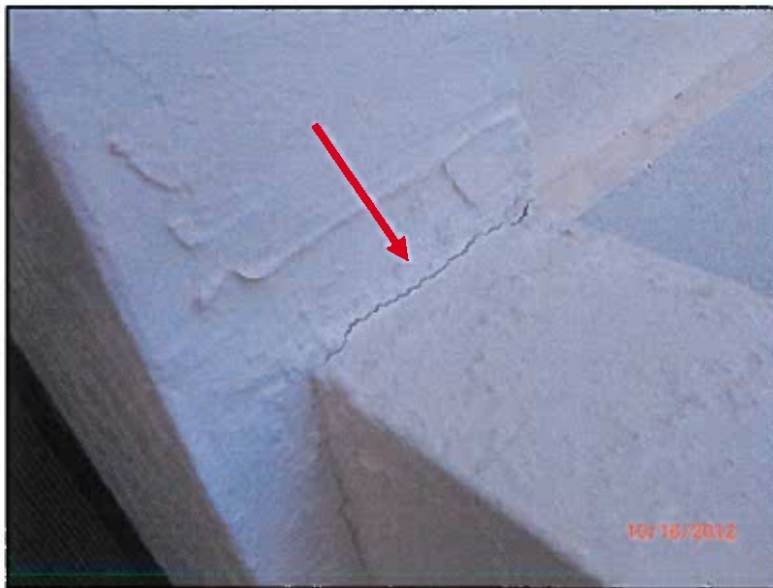
PHOTO # 8: Cracking at connection between balcony wall and bldg. column at Unit #219

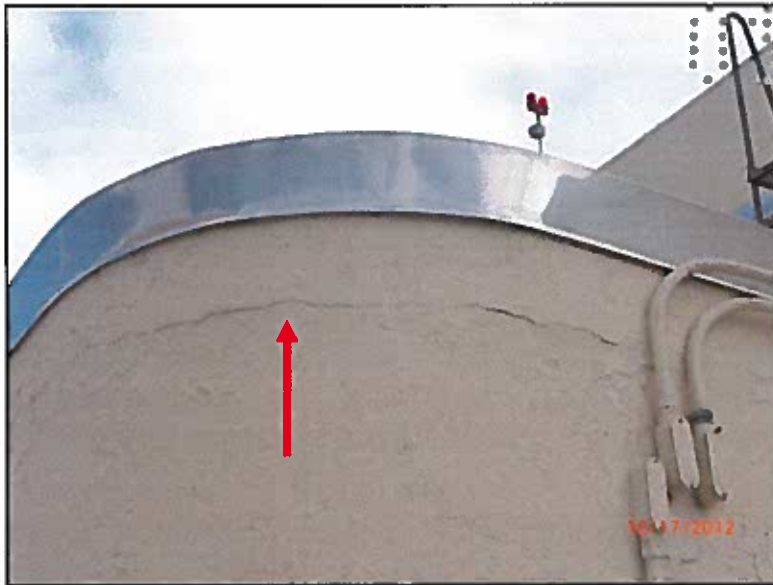
6. The roof edges of the Generator Room (photo #9) and East Elevator Machine Room (photo #10) at Roof Area have fine horizontal cracks which exhibit signs of water infiltration.

PHOTO # 9: Delaminated/cracking stucco at exterior of Generator Room at roof area

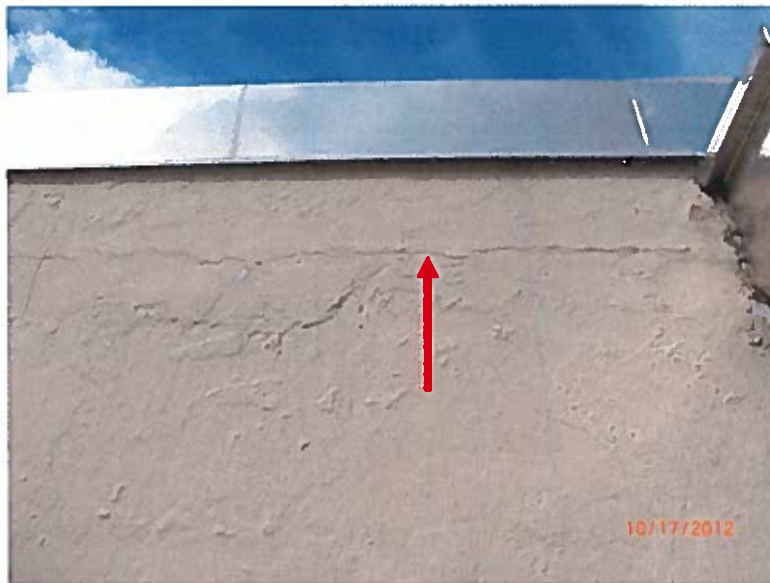
PHOTO # 10: Delaminated/cracking stucco at exterior of east Elevator Machine Room at Roof Area

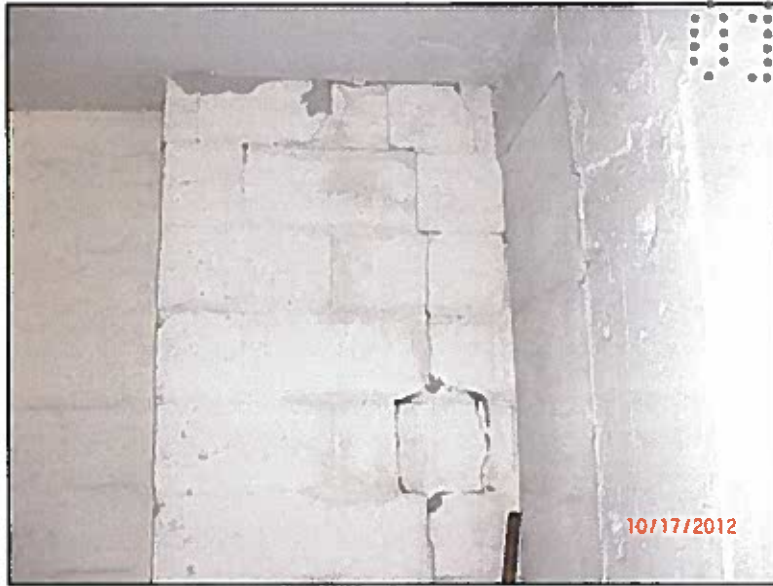
7. The interior block wall at the east side of the Elevator Machine Room at the Roof Area was observed with step cracking (photo #11).
8. The roof edge of the Penthouse exterior wall (photo #12) was noted with fine horizontal cracks which exhibit signs of water infiltration.

PHOTO # 11: Step cracking at corners of east side Elevator Machine Room

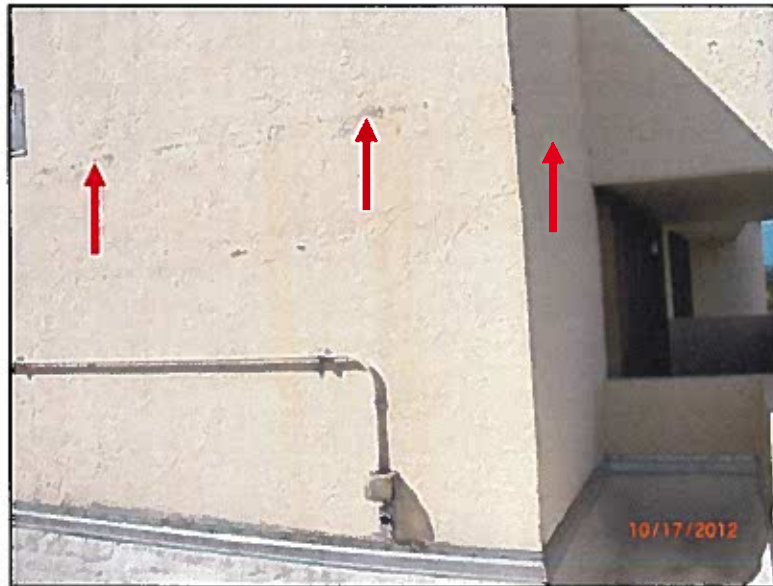
PHOTO # 12: Horizontal cracking at PH exterior wall

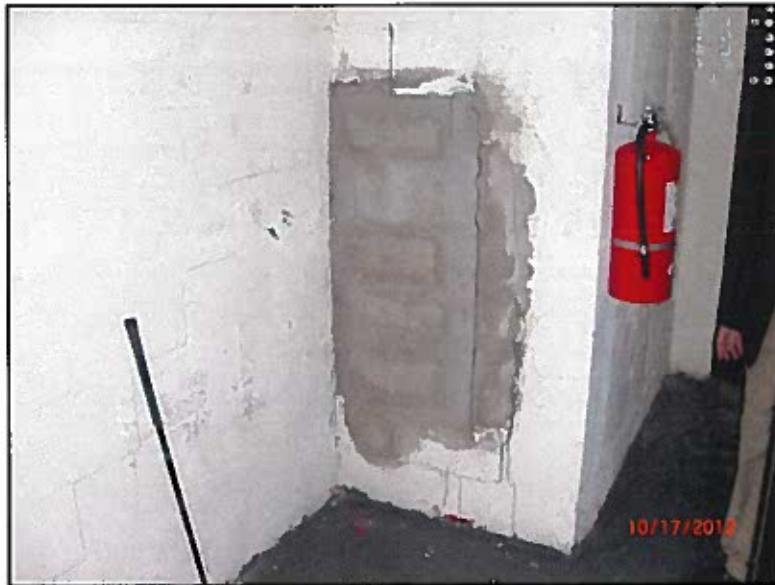
9. The interior block wall at the West Elevator Machine Room is not mortared properly at patched area (photo #13).
10. Hair Line cracking across column drop panel next to Parking Space No. 267 (photo #14 and photo #15).

PHOTO # 13: Cracks on block wall at inside of West Elevator Machine Room

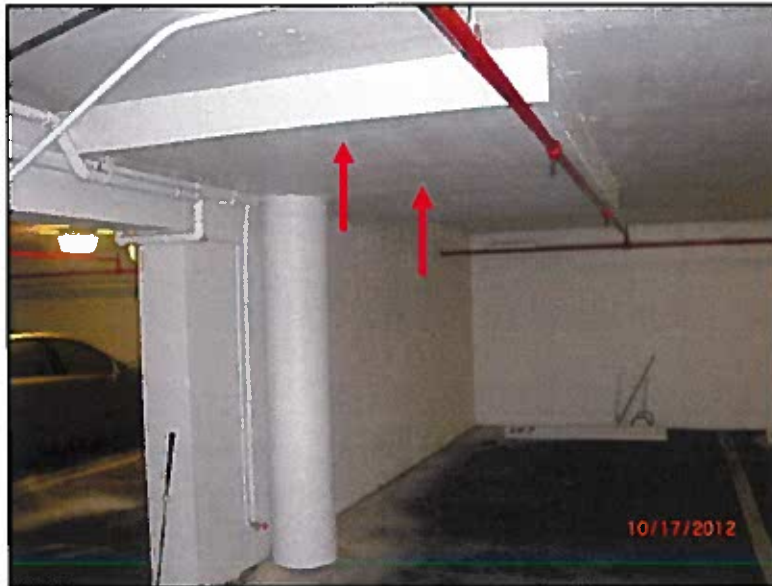
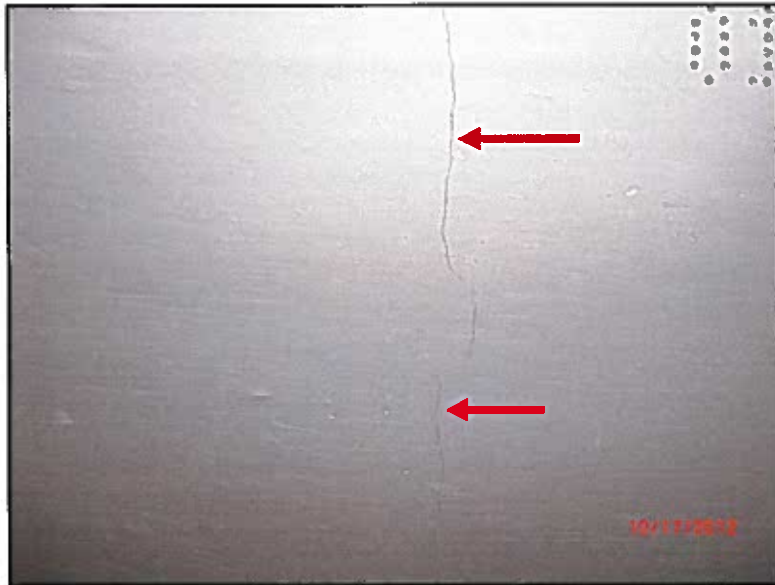
PHOTO # 14: slab cracking at column drop panel next to Parking Space No. 267

PHOTO # 15: slab cracking at column drop panel next to Parking Space No. 267

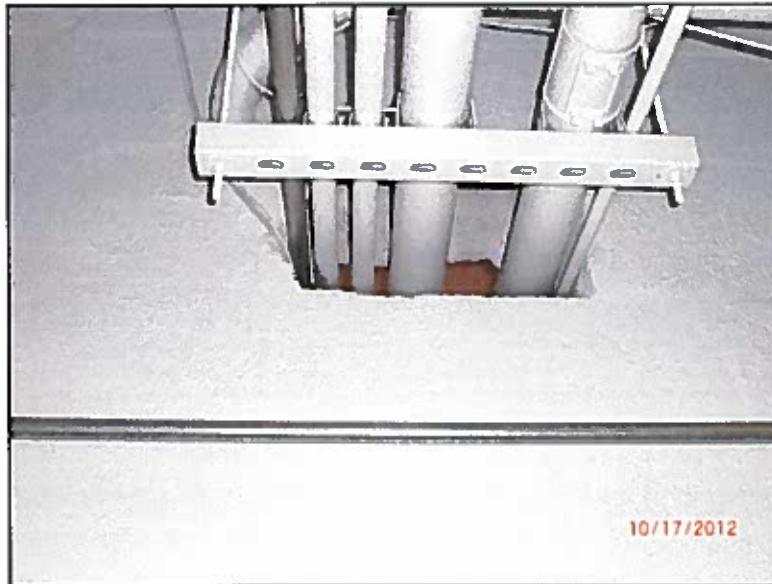
11. Unsealed wall pipe penetration at fire rated separation (2hr Fire rate assembly) (photo #16).
12. Hair line cracking on slab and beam was noted next to Parking Space No. 210 (photo #17 and photo #18).

**PHOTO # 16: Unsealed wall, pipe penetration at Fire rated assembly (2hr fire rated assembly)
Paint Storage Room**

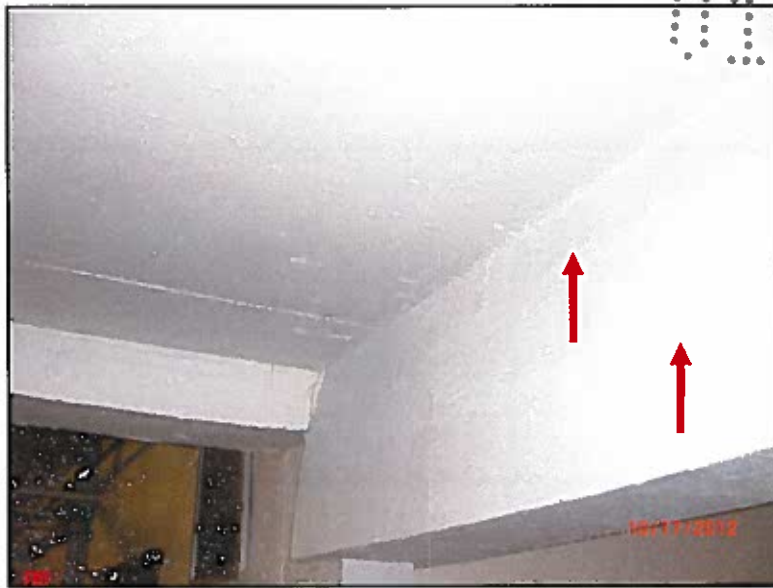
PHOTO # 17: slab cracking and beam cracks next to Parking Space 210

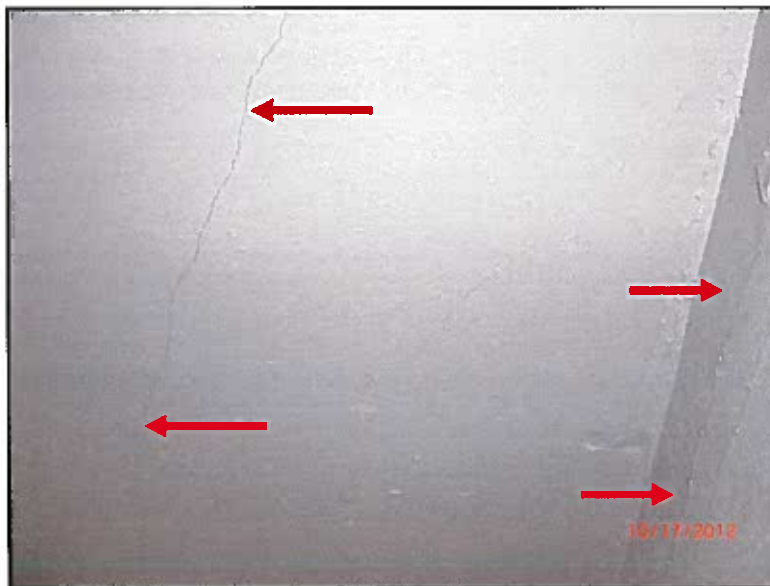
PHOTO # 18: slab cracking at column drop panel next to Parking Space 210

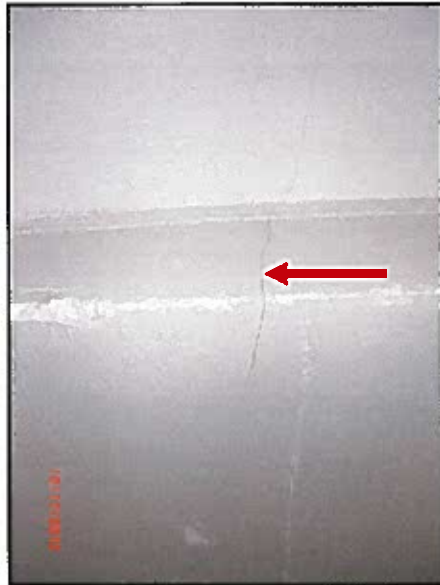
13. Hair line cracking across column drop panel between Parking Space No. 248 & 249 (photo #19).
14. Hair Line cracking at column drop panel corner between Parking Space No. 245 & 246 (photo #20).

PHOTO # 19: slab cracking at column drop panel between Parking Spaces 248 & 249

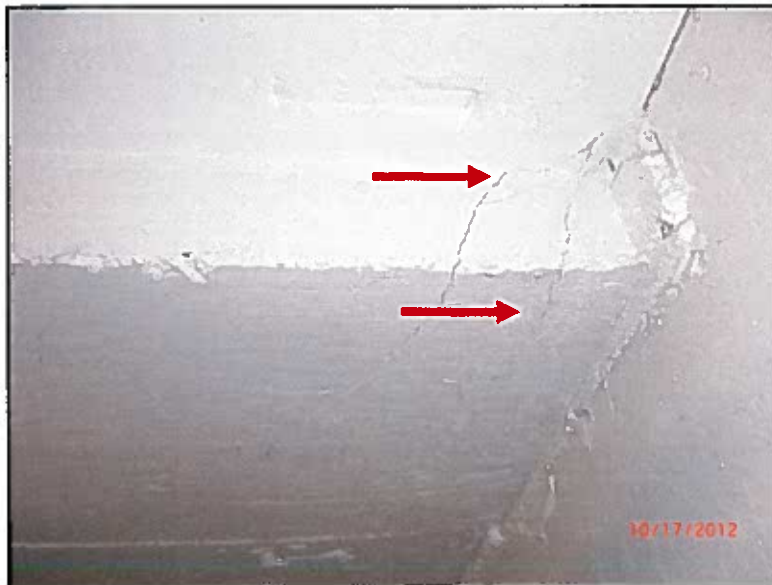
PHOTO # 20: slab cracking at column drop panel between Parking Spaces 245 & 246

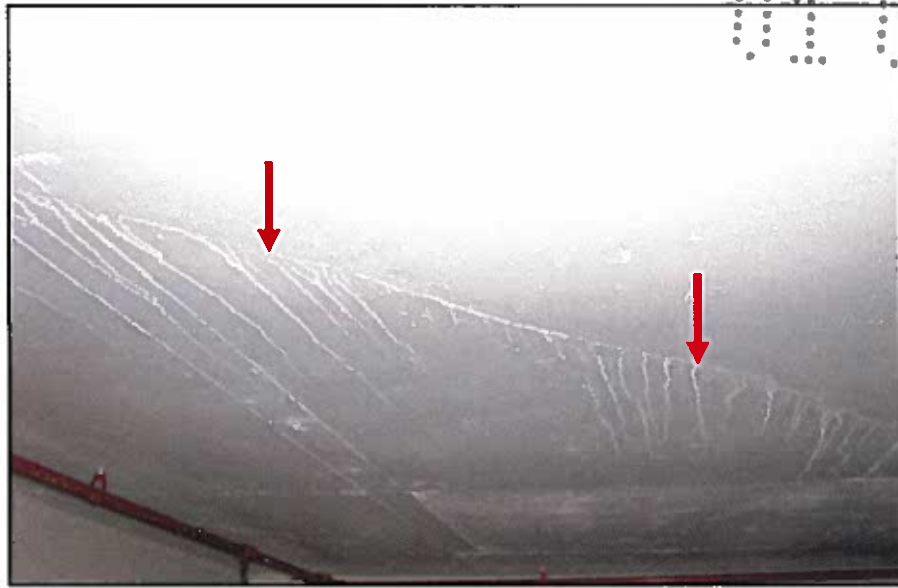
15. Trench drain drop ceiling opening over flows at opening between Parking Spaces No. 314 & 327 (photo #21 and photo #22).
16. Surface cracking and water intrusion was noted at underside of ramp on front of Parking Space No. 61 (photo #23).

PHOTO # 23: cracking and water intrusion at underside of ramp in front of Parking Space 61

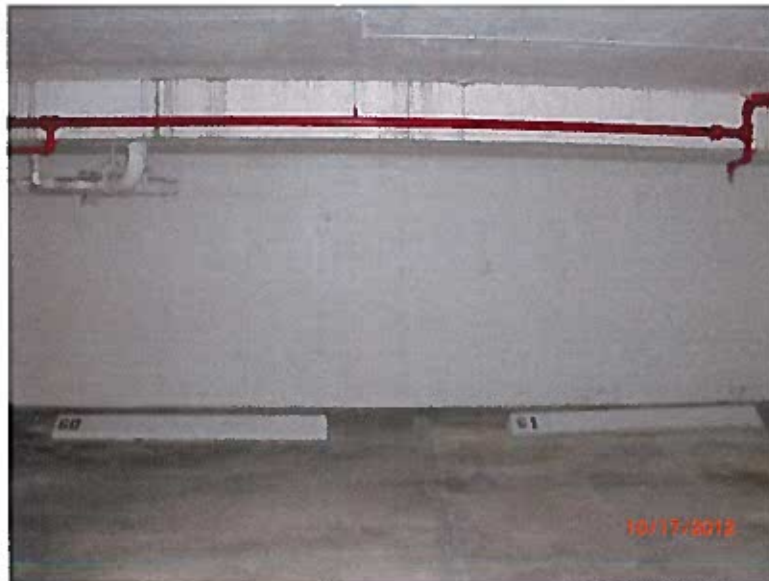
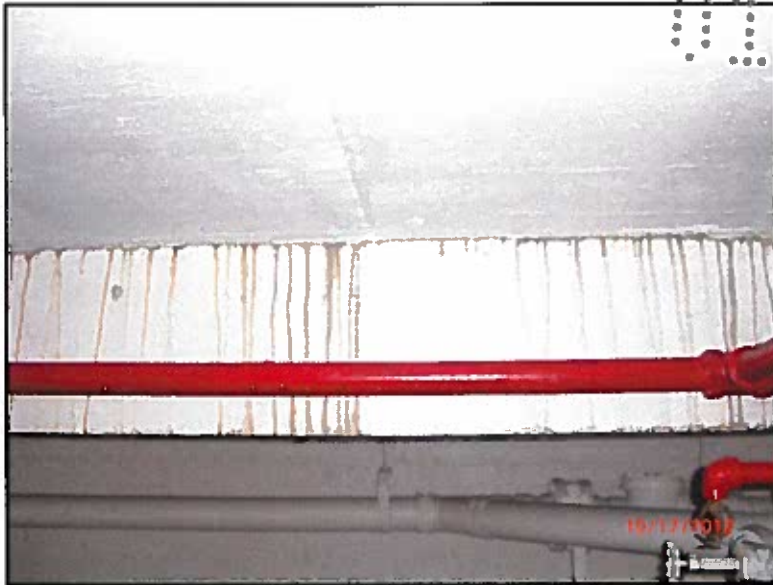
17. Trench drain drop ceiling opening over flows at opening between Parking Space No. 52 & 61 (photo #24 and photo #25).
18. The East end of the Parking Garage wall exhibits hair line cracking next to Parking Space No. 51 (photo #26).

PHOTO # 24: trench drain drop ceiling between Parking Spaces 52 & 61

PHOTO # 25: trench drain drop ceiling between Parking Spaces 52 & 61

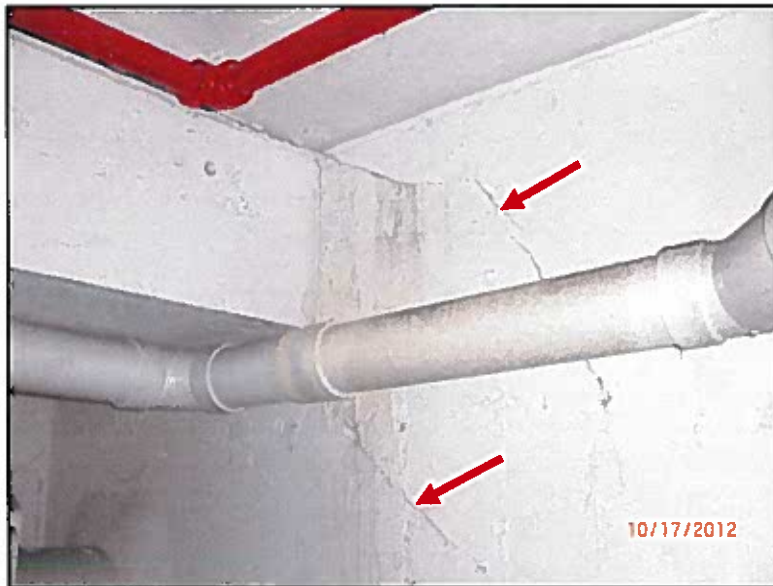
PHOTO # 26: cracking on wall next to Parking Space 51

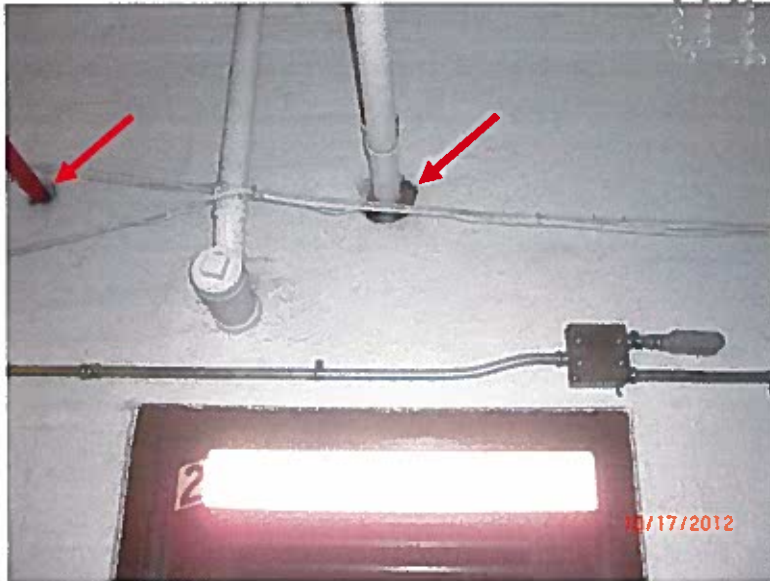
19. Unsealed wall pipe penetration at fire rated separation (2hr Fire rate assembly) above Fire Pump Room door (photo #27).
20. Hair Line Cracking on Overhang at West side (photo #28).

**PHOTO # 27: Unsealed wall, pipe penetration at Fire rated assembly (2hr fire rated assembly)
Paint Storage Room**

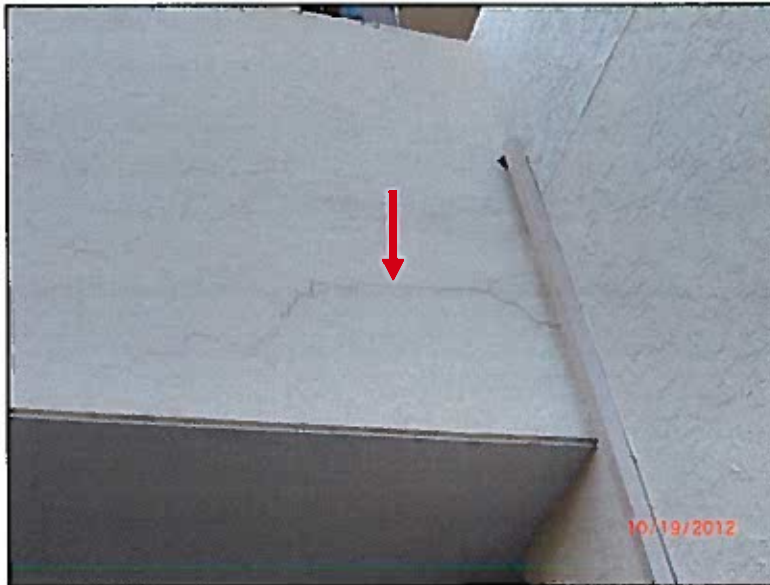
PHOTO # 28: cracking on overhang at West side

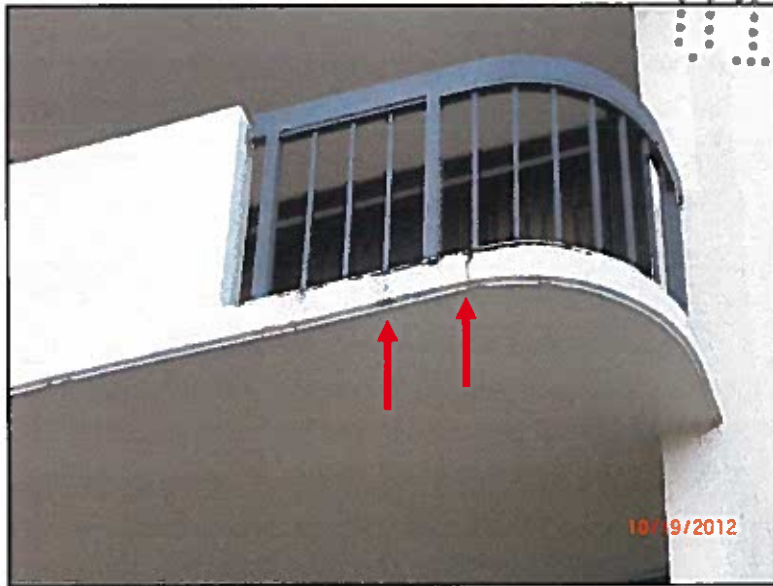
21. Hair Line Cracking and staining on balcony edge at Third level on north side (photo #29).
22. Blistering and underside cracking was observed at Overhang (photo #30).

PHOTO # 29: cracking and staining on balcony edge

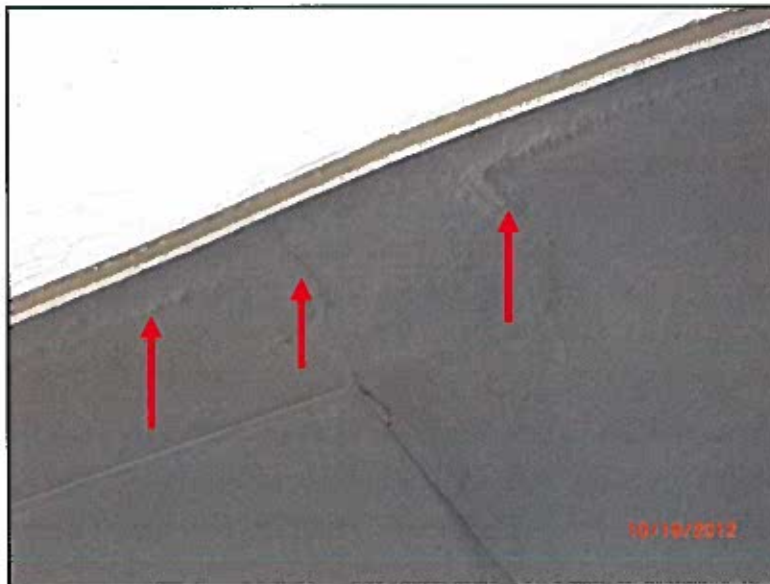
PHOTO # 30: cracking & blistering at underside of overhang edge

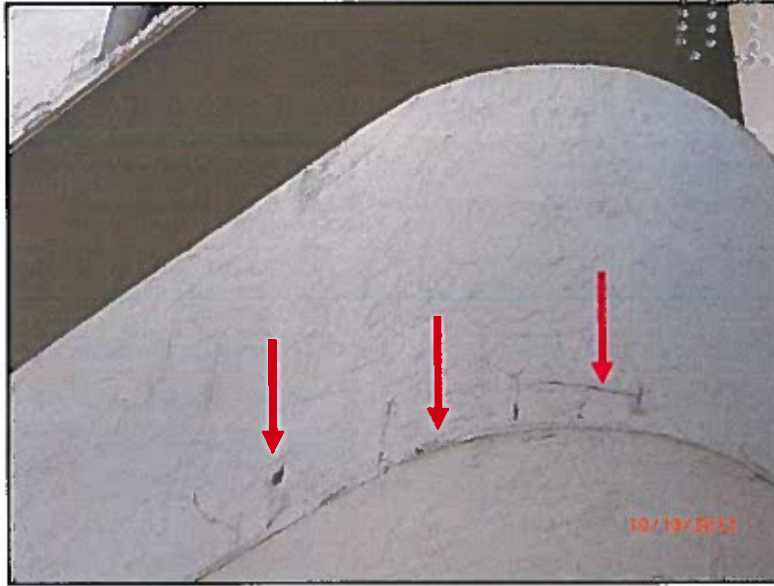
23. Cracking at bottom of balcony wall was noted (photo #31).
24. Crack along tiled pedestrian ramp east of main entrance was observed (photo #32).
25. Delaminated stucco and cracking at bottom of fourth floor balcony wall on east (photo #33).

PHOTO # 31: stucco cracking at bottom of third floor balcony wall on East side

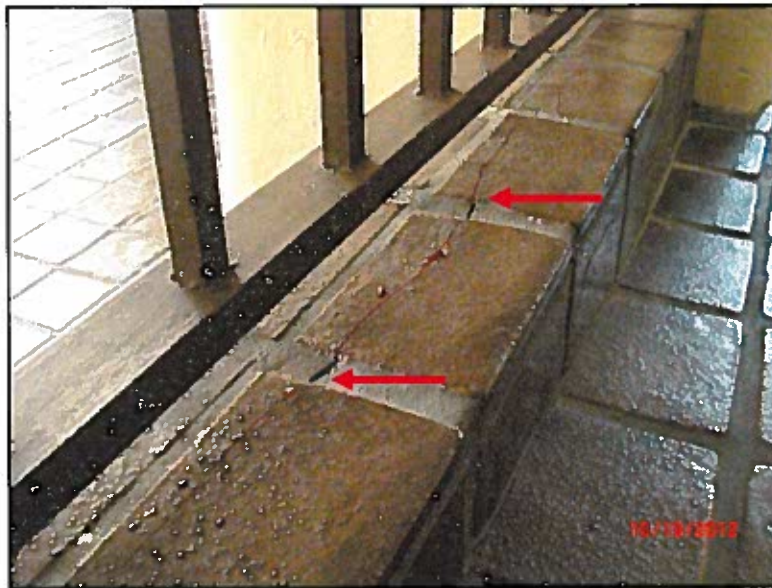
PHOTO # 32: crack along tiled ramp east of main entrance

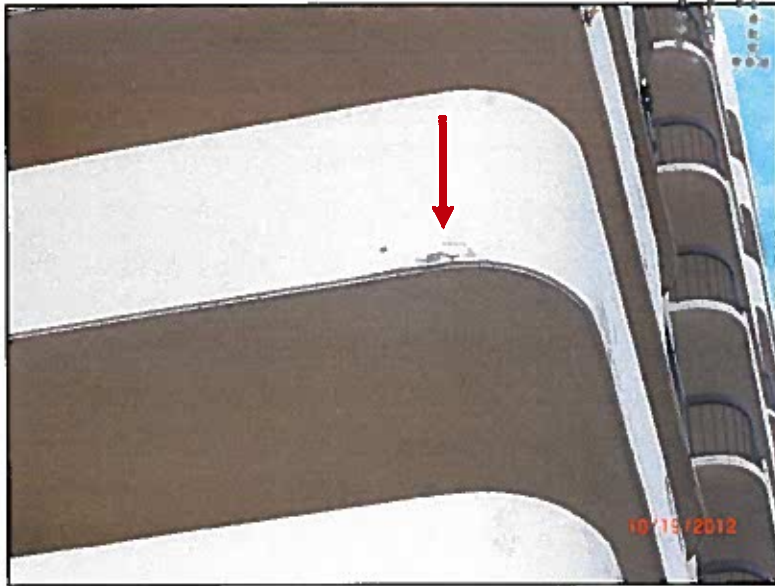
PHOTO # 33: cracking and staining at bottom of fourth floor balcony wall on east

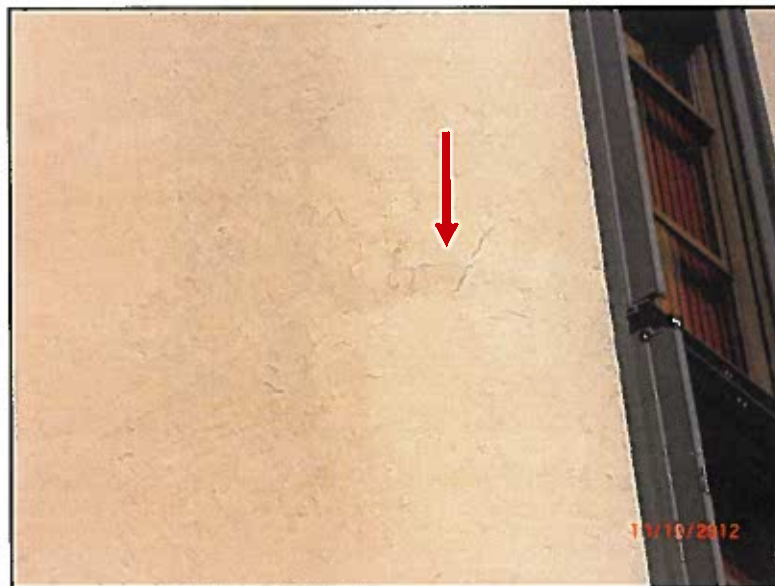
26. Surface cracks on building shear wall next to window shutter next to east stairs tower (photo #34).
27. Spider web cracking on exterior face at first balcony on East side (photo #35).

PHOTO # 34: stucco cracking on building wall next to east stairs tower

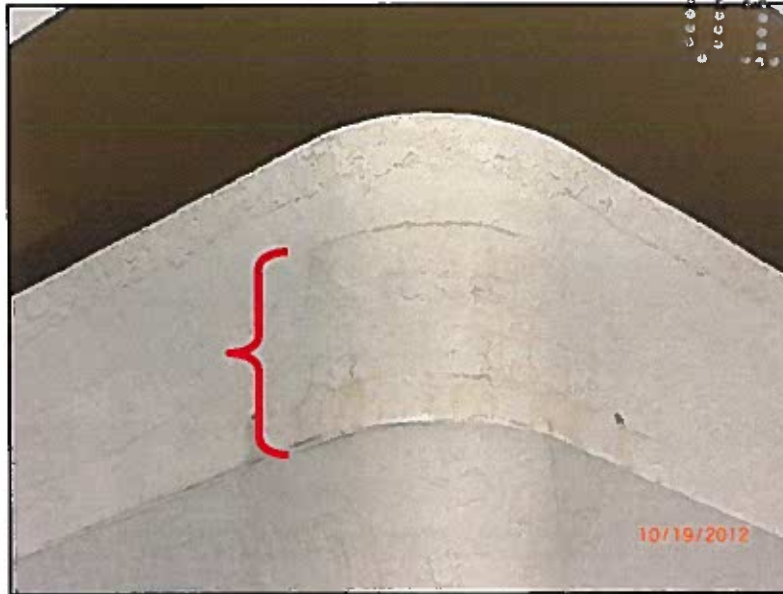
PHOTO # 35: spider web cracking on exterior face at second floor balcony on East side

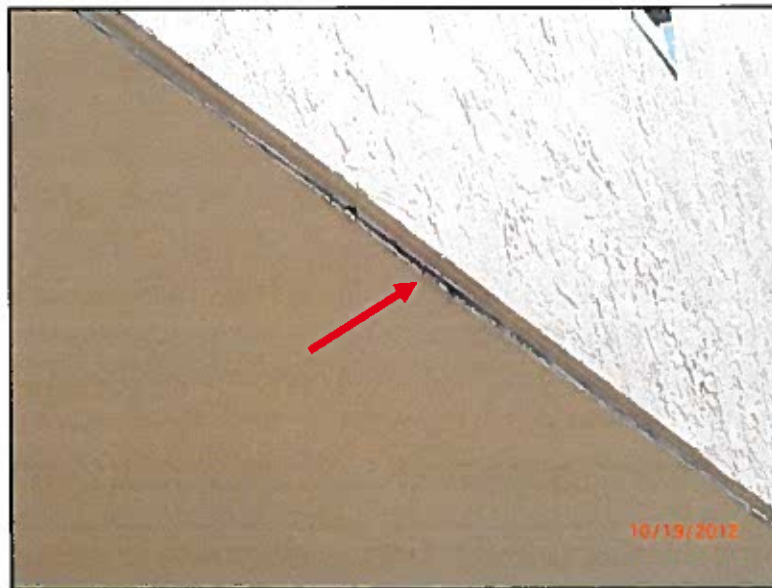
28. Ceiling panel separation at edge of South overhang (photo #36).
29. Stucco cracking on East side of building corner at Pool Deck Area (photo #37).

PHOTO # 36: ceiling separation at edge of South overhang

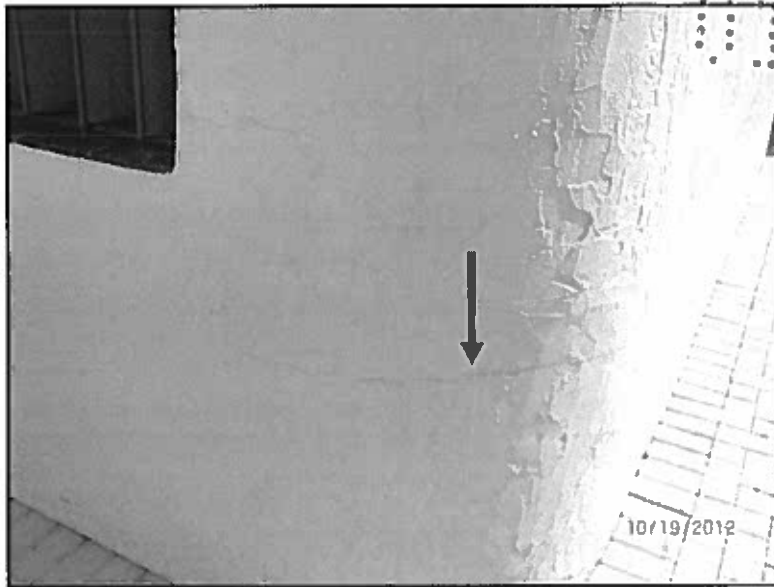
PHOTO # 37: stucco cracking on East side of building corner at pool deck area
