## STRUCTURAL INSPECTION IN A TOWN HOME.

**REFERENCE:** Inspection about Structural Conditions

1258 OBISPO AVE.

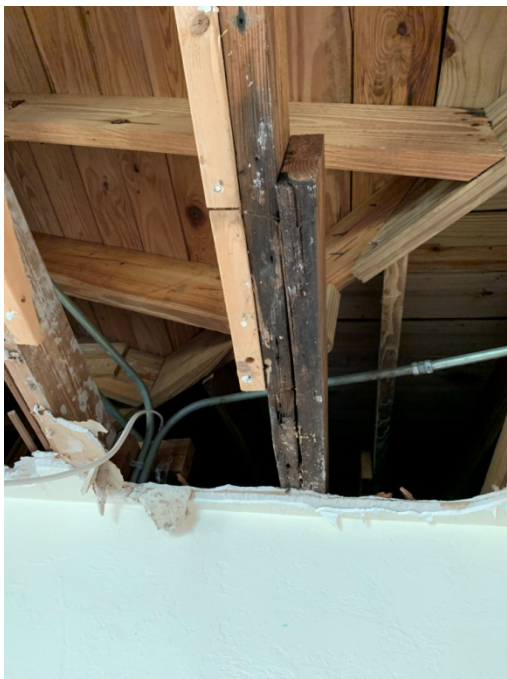
- In general the structural shell of the house is in poor conditions. Can be observed water intrusion damage in some roof areas. In many places had been necessary to remove portions of the ceilings.

Picture 1  
Area of the roof previously affected by water intrusion.

1-The roofing system and tiles, the roof plywood sheathing, and around the 50% of the roof wood joists, the ceiling wood joists, must be removed and replaced. Also, we strongly recommend to cover the whole house with a tent and fumigate in order to eliminate any possibility of alive termites and avoid any future deterioration of the wood elements.

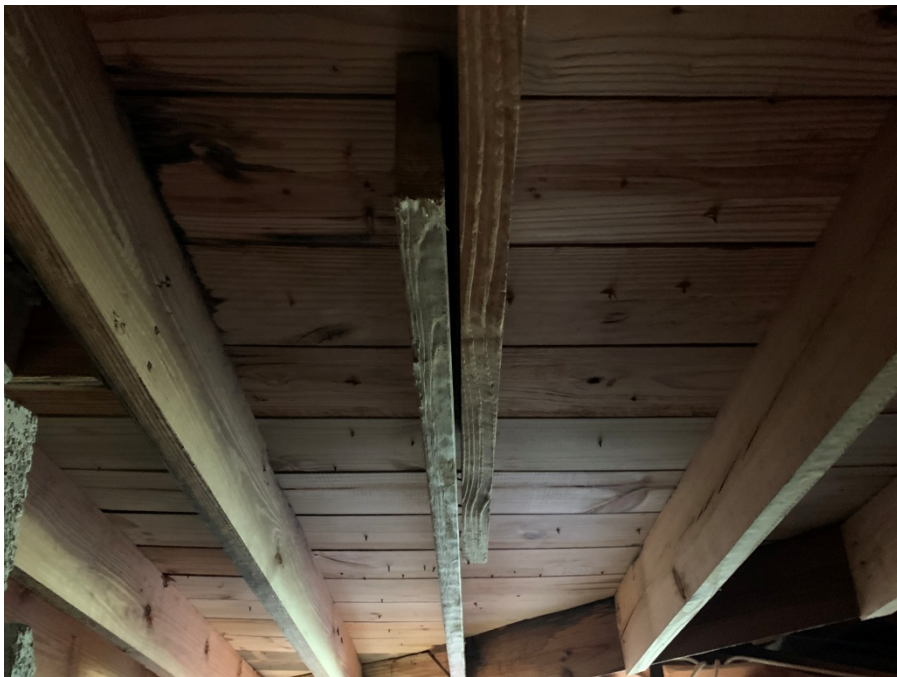
Picture 2

- Some previous wood joists repairs were done there without comply with the minimum code requirements.
- The exterior windows are in very bad conditions. The metal frames are rusted and some glass panel broken.

Roof joists not properly repaired

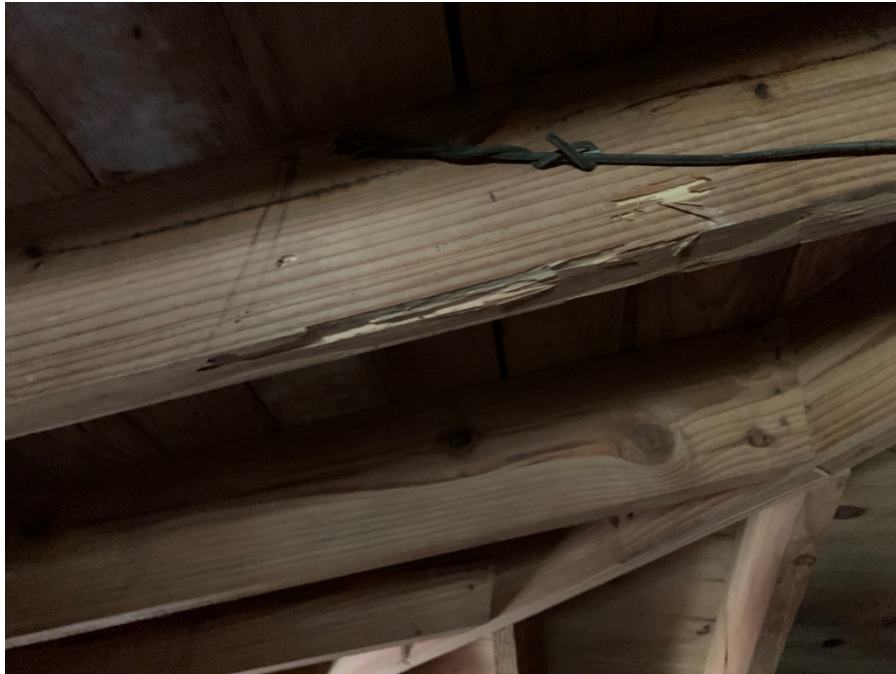
- The house was infested by termites. It was observed in many places traces of termites. For example wood ceiling joists, wood joist or rafters, wood floors planks, wood floor joists, and windows and doors wood framings.

Picture 3  
Roof joists damaged by termites.

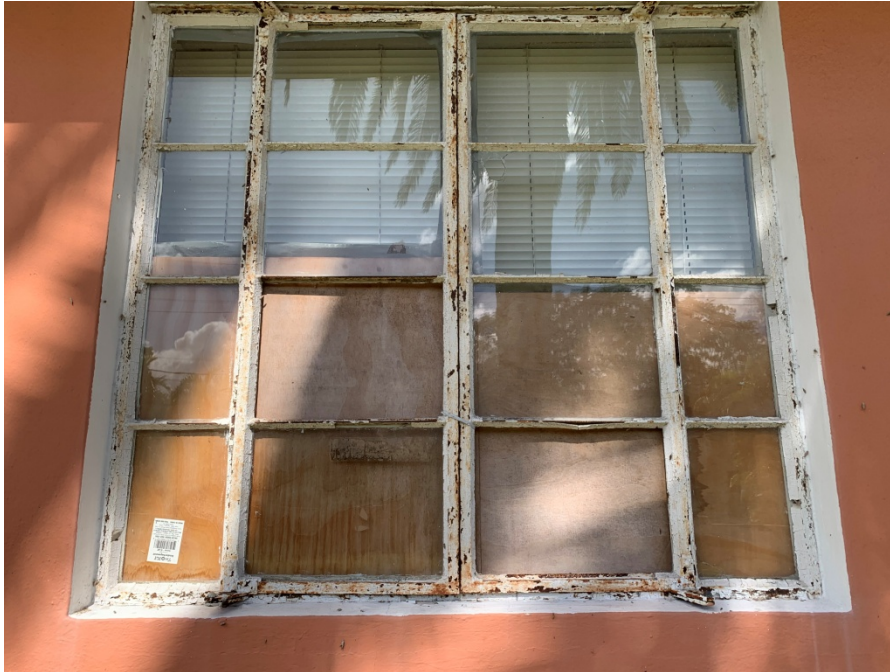
Picture #5  
Exterior window rusted and glass panel broken.

3-All the exterior windows and doors must be replaced.

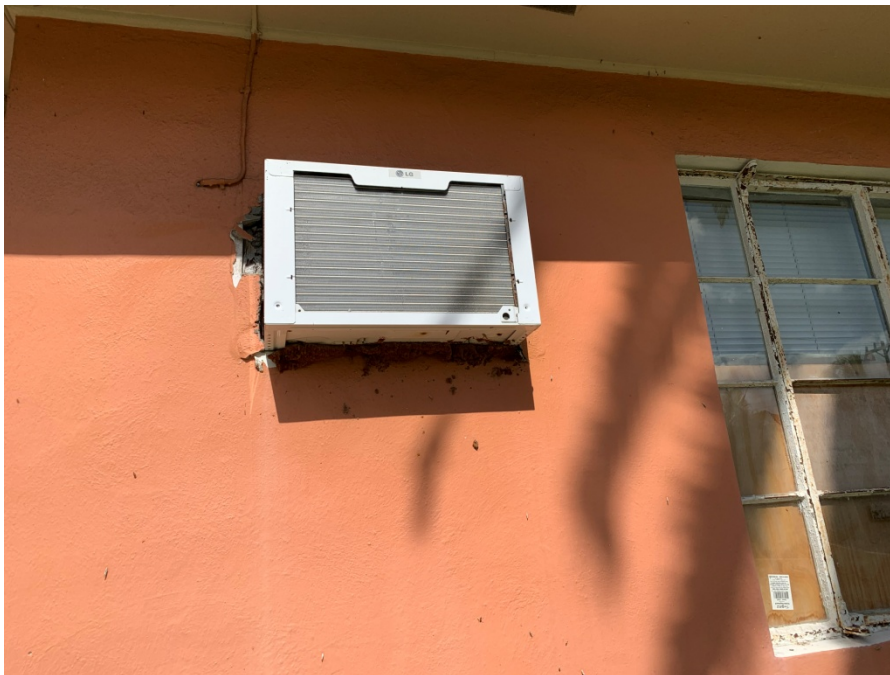
Picture #6  
A/C unit not properly encased into the wall.

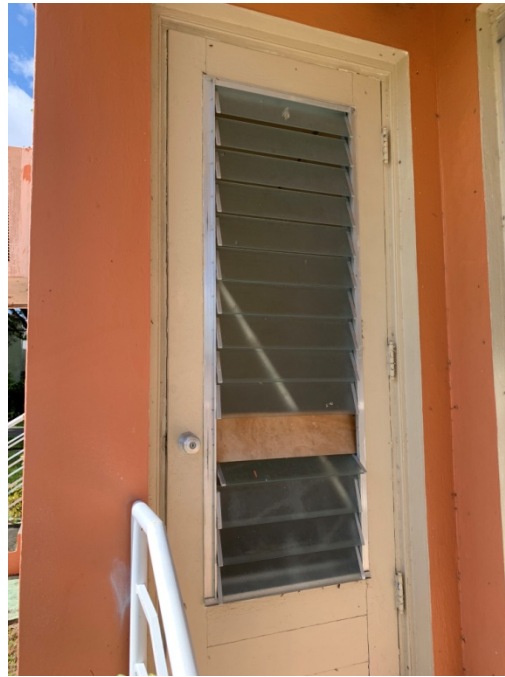
Picture #7 Exterior door very damaged

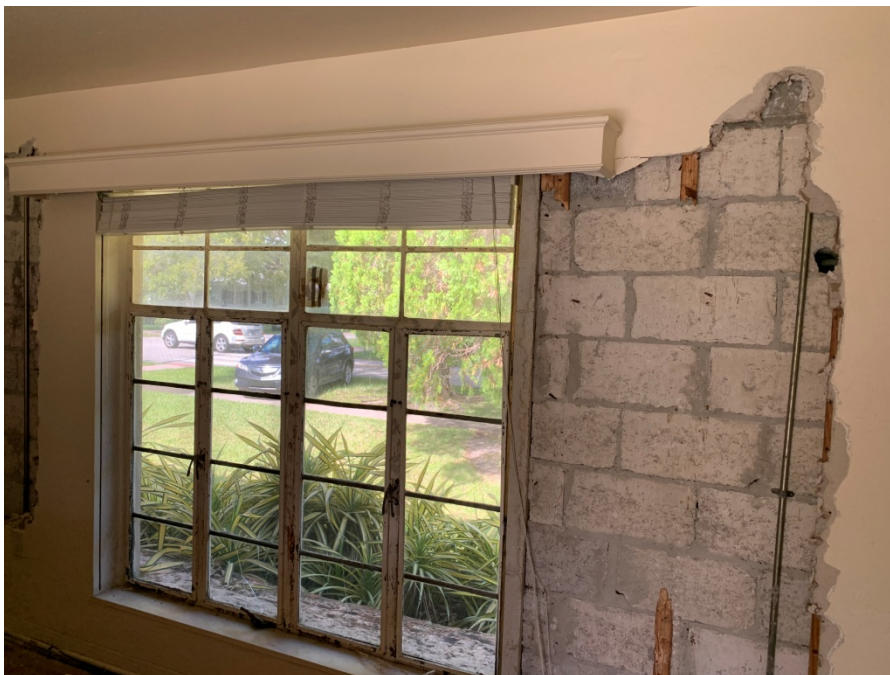
Picture #8 Front widow, very damaged

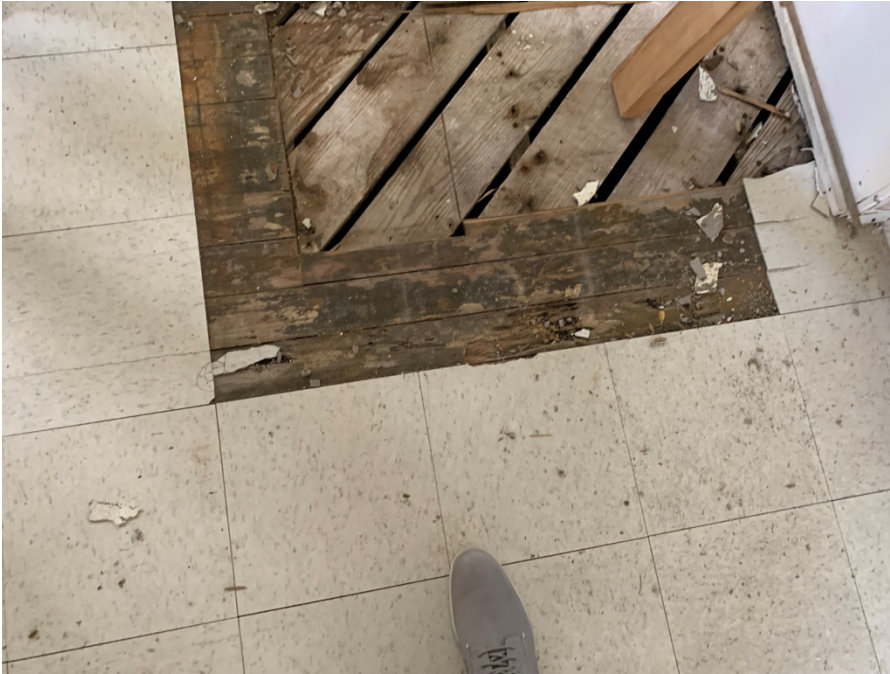
Picture #9 Wood floor damaged by termites.

2-The wood floor and subfloor and maybe a significant portion of the wood joists at ground floor need to be replaced, also we recommend to brace the exterior CMU walls to the ground floor wood joists (above the crawl space) w/ some connectors, in order to reduce the wall slenderness for lateral wind suction.

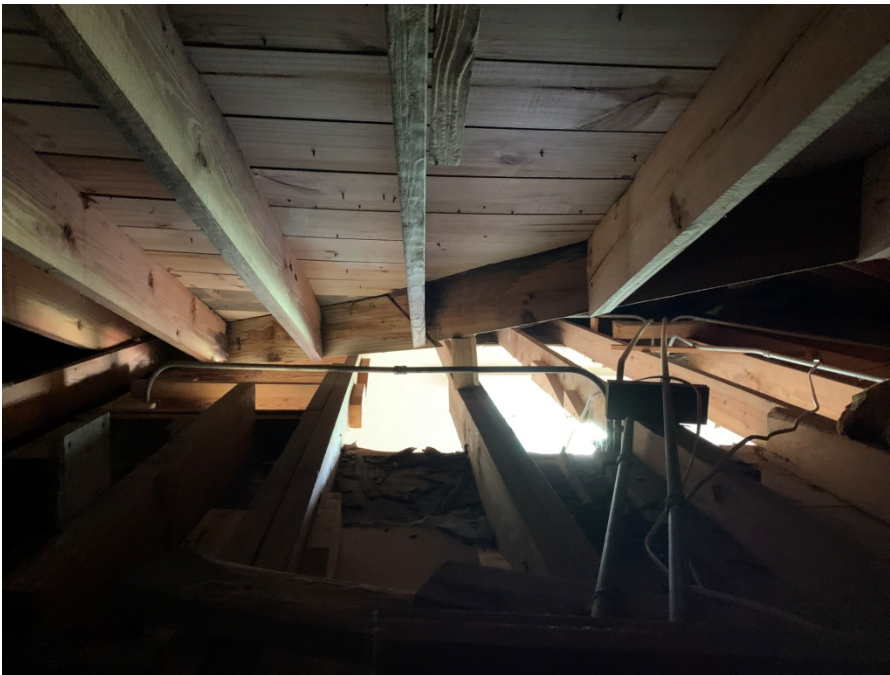
Picture #10 Ridge joist broken.
