STRUCTURAL INSPECTION IN A TOWN HOME.

REFERENCE: Inspection about Structural Conditions

1258 OBISPO AVE.

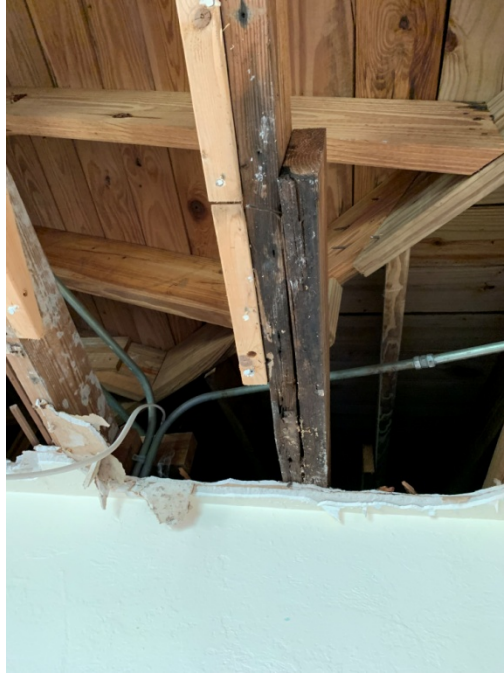
- In general the structural shell of the house is in poor conditions. Can be observed water intrusion damage in some roof areas. In many places had been necessary to remove portions of the ceilings.

Picture 1
Area of the roof previously affected by water intrusion.

1-The roofing system and tiles, the roof plywood sheathing, and around the 50% of the roof wood joists, the ceiling wood joists, must be removed and replaced. Also, we strongly recommend to cover the whole house with a tent and fumigate in order to eliminate any possibility of alive termites and avoid any future deterioration of the wood elements.

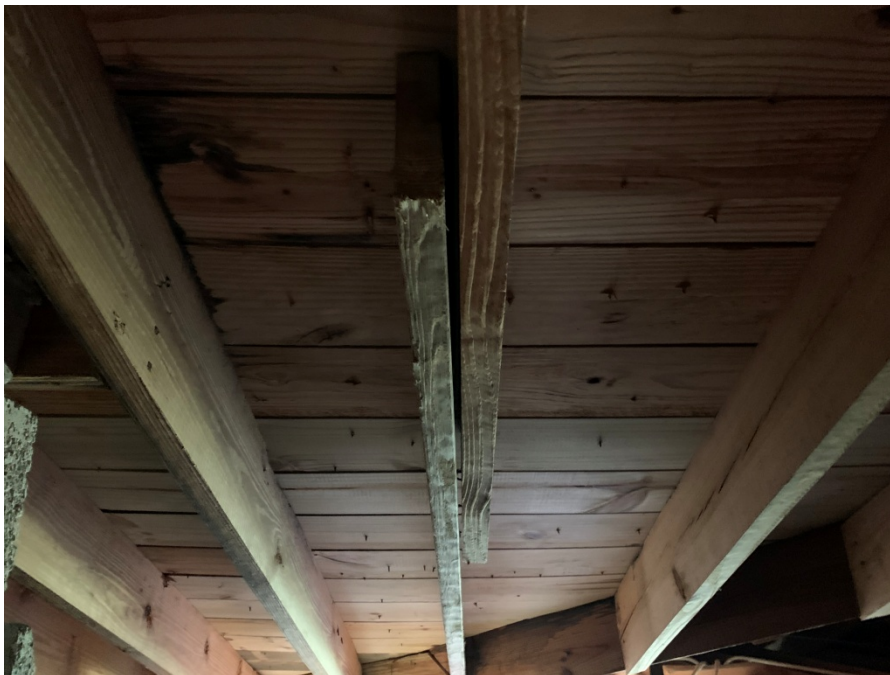
Picture 2

- Some previous wood joists repairs were done there without comply with the minimum code requirements.
- The exterior windows are in very bad conditions. The metal frames are rusted and some glass panel broken.

Roof joists not properly repaired

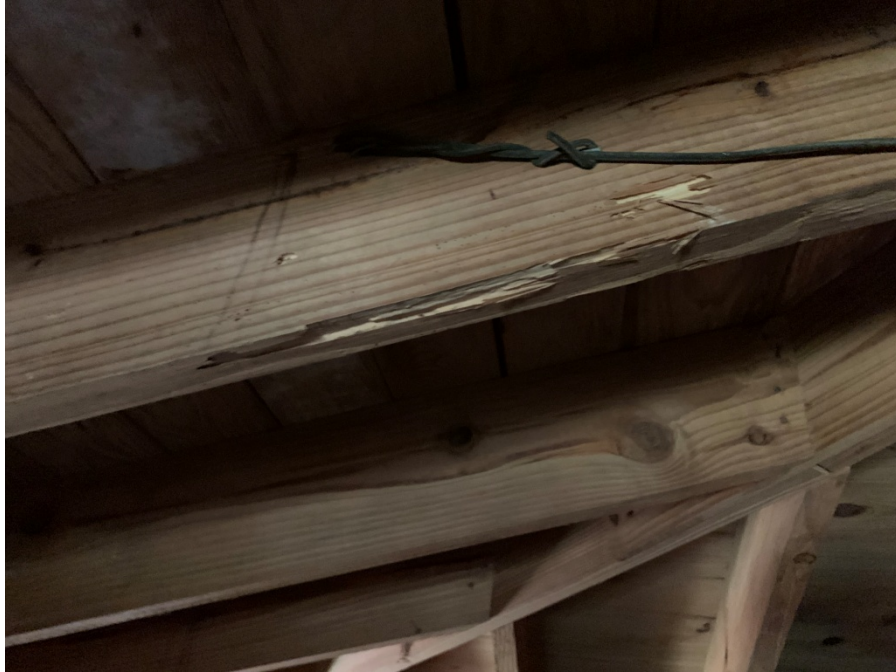
- The house was infested by termites. It was observed in many places traces of termites. For example wood ceiling joists, wood joist or rafters, wood floors planks, wood floor joists, and windows and doors wood framings.

Picture 3
Roof joists damaged by termites.

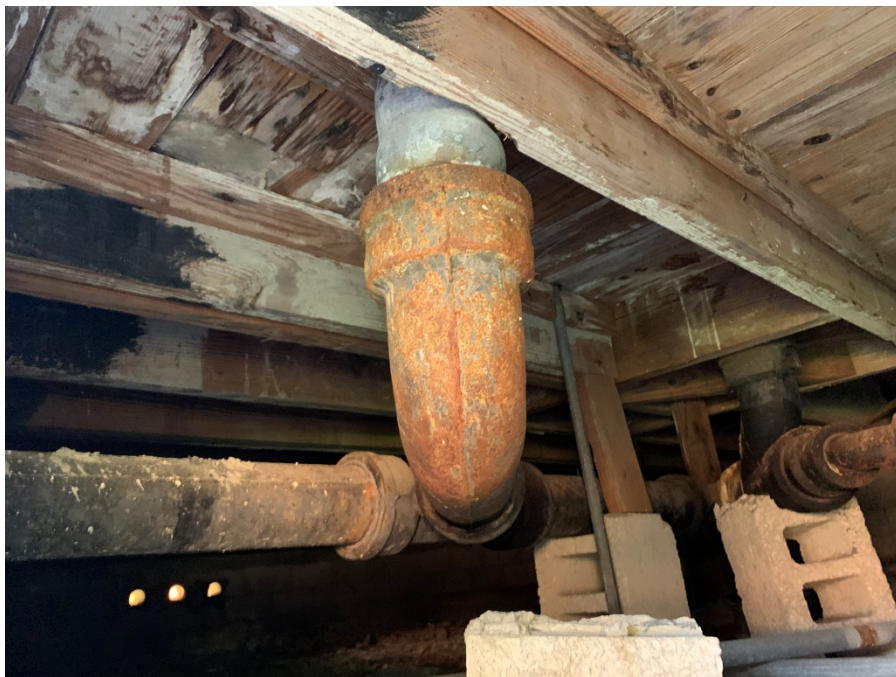
Picture 4
Previously damaged wood floor by water intrusion, not properly repaired. Wood joists supported by unstable blocks and wood posts

2-The wood floor and subfloor and maybe a significant portion of the wood joists at ground floor need to be replaced, also we recommend to brace the exterior CMU walls to the ground floor wood joists (above the crawl space) w/ some connectors, in order to reduce the wall slenderness for lateral wind suction.

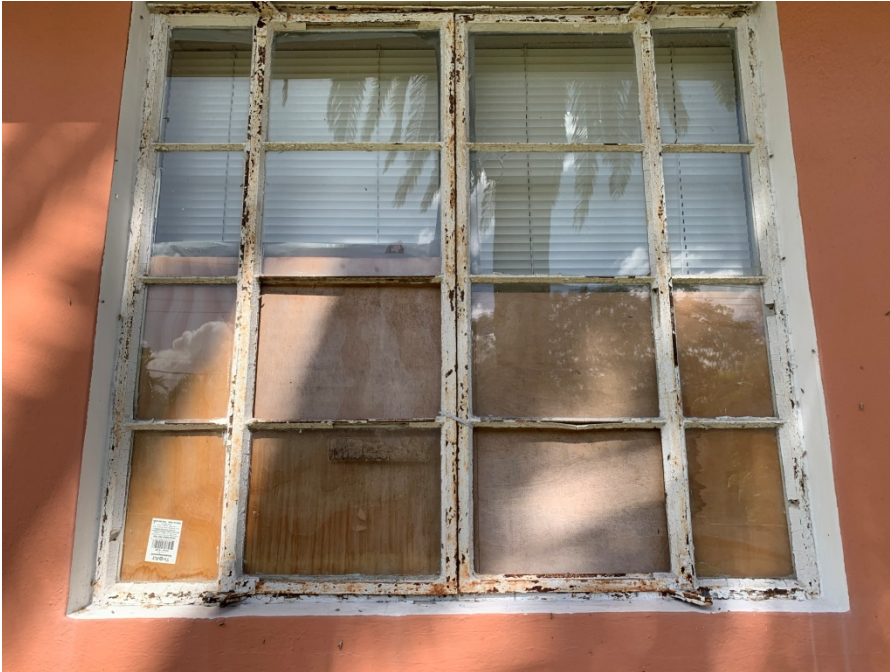
Picture #5
Exterior window rusted and glass panel broken.

3-All the exterior windows and doors must be replaced.

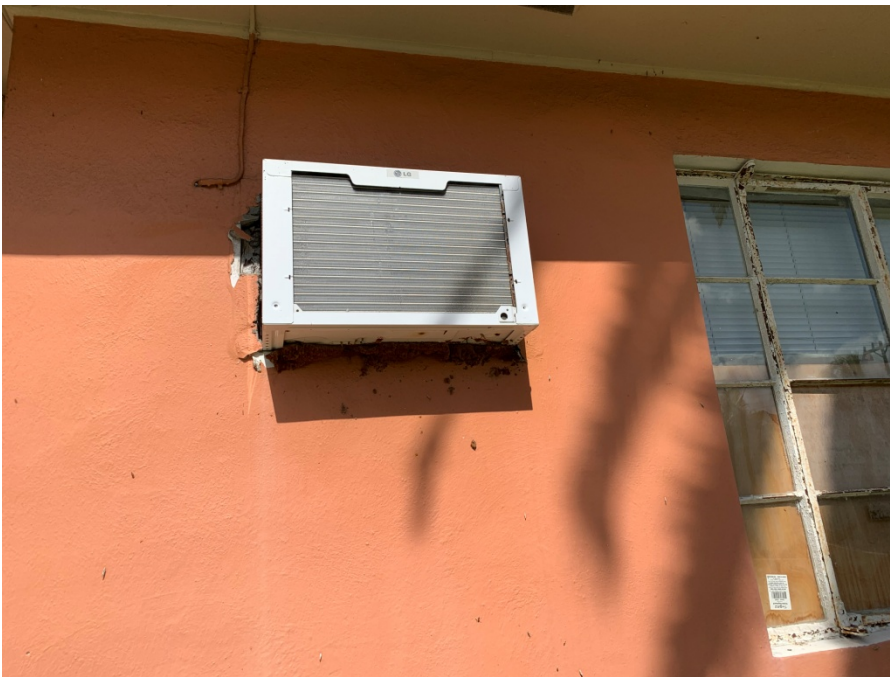
Picture #6
A/C unit not properly encased into the wall.

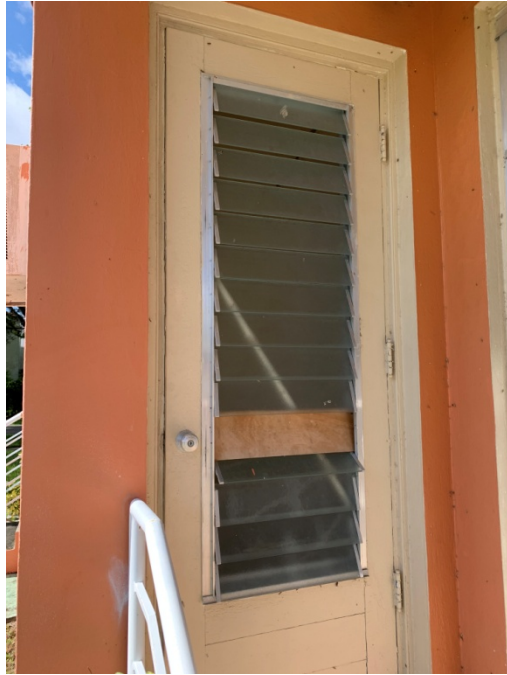
Picture #7 Exterior door very damaged

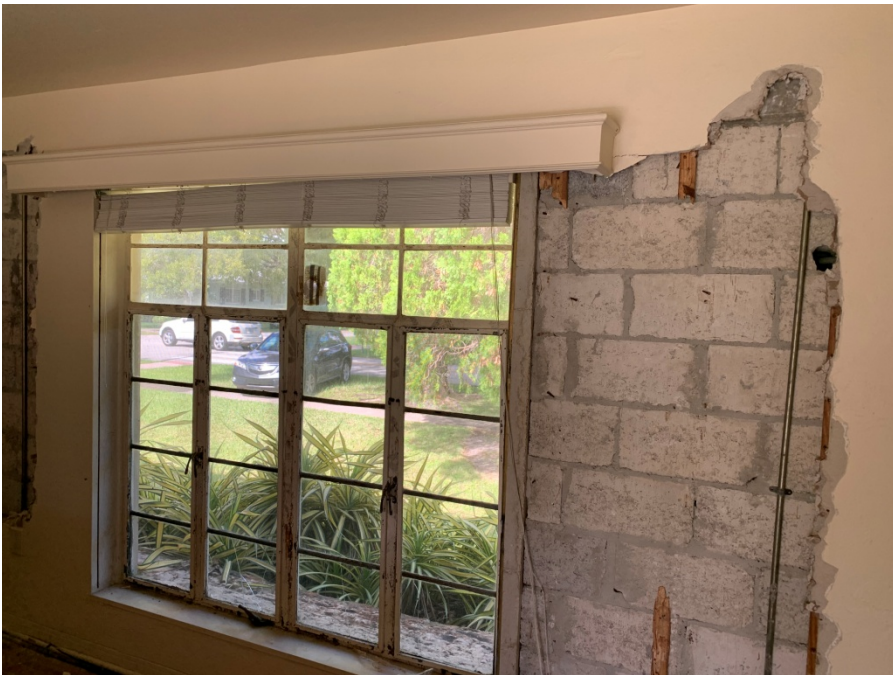
Picture #8 Front widow, very damaged

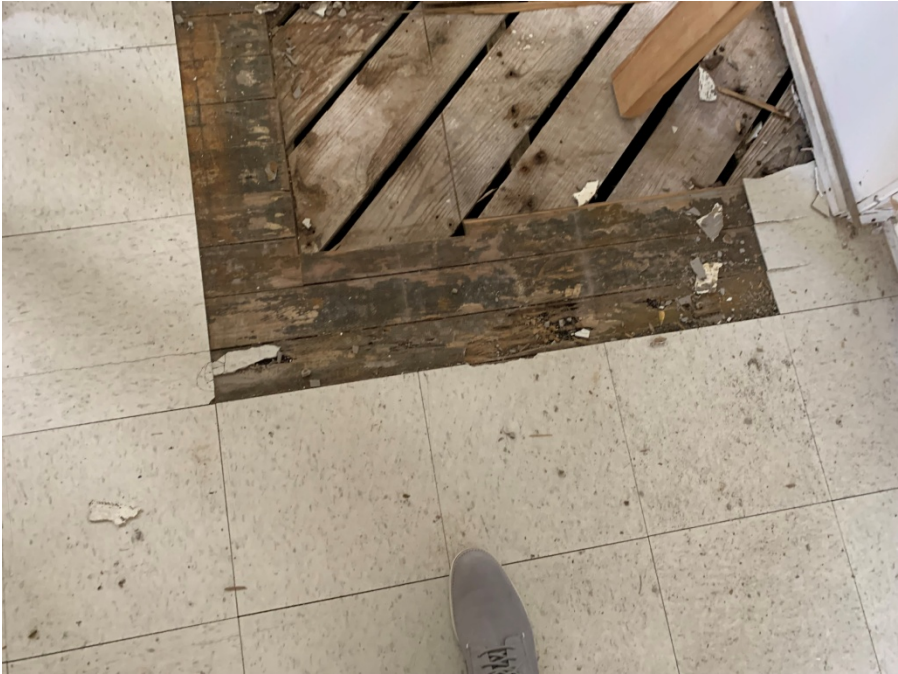
Picture #9 Wood floor damaged by termites.

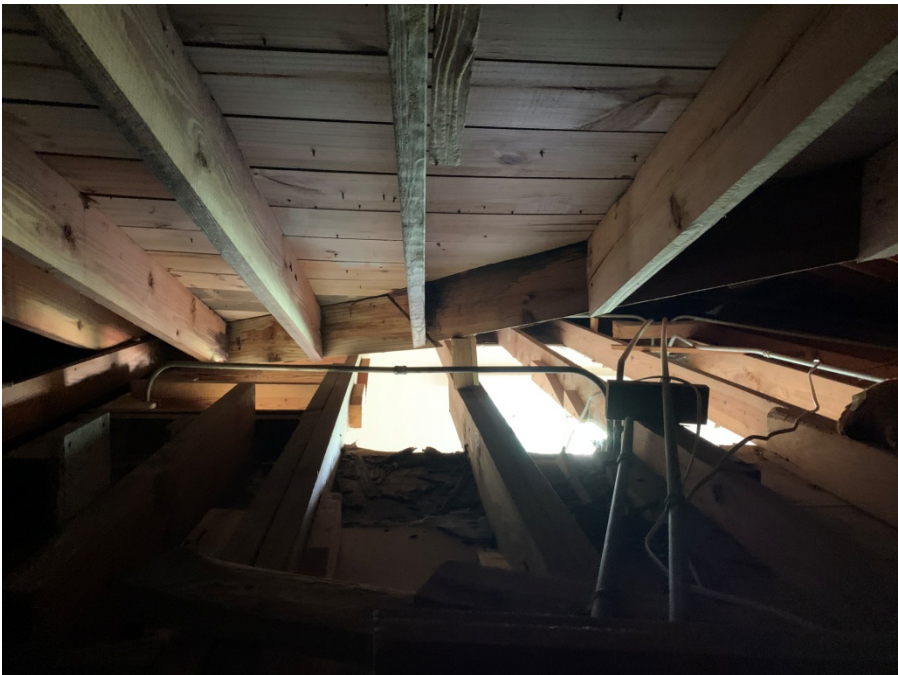
Picture #10 Ridge joist broken.
