MIAMI-DADE COUNTY  
HISTORIC PRESERVATION AD-VALOREM TAX EXEMPTION

**PART 2 – REQUEST FOR REVIEW OF COMPLETED WORK**

Property Name: 1223 LISBON ST CORAL GABLES FL  
Folio Number: 03-4107-018-6380  
Street Address: 1223 LISBON ST.

**1223 LISBON ST CORAL GABLES FL 33134**

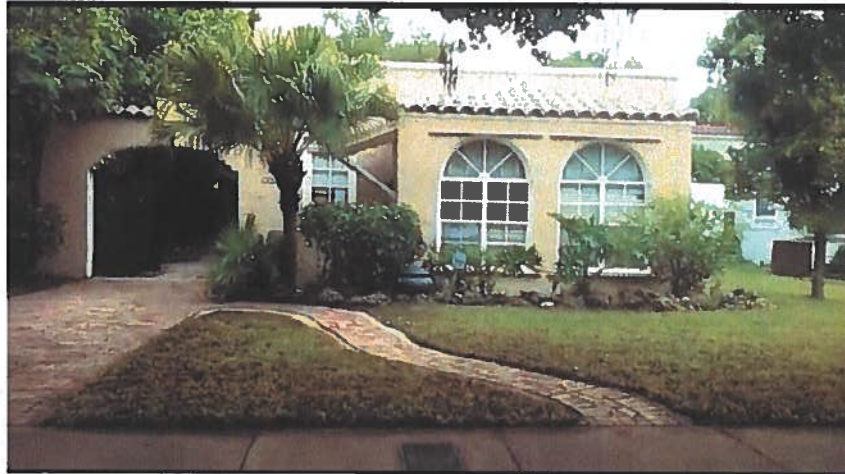
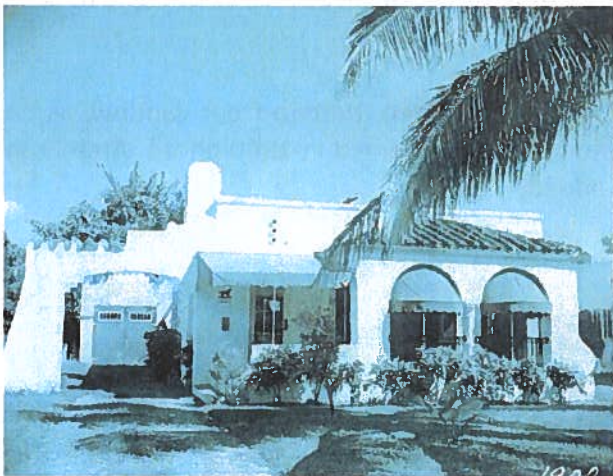
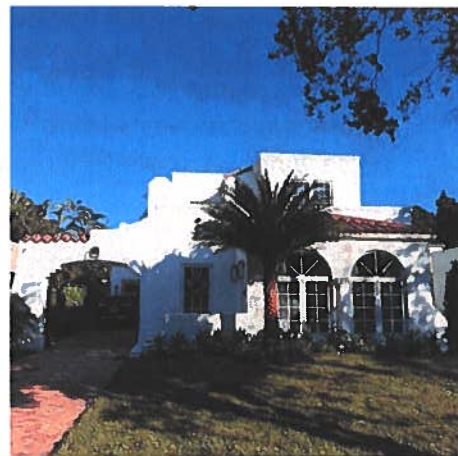
**I- EXAMPLES OF CONSTRUCTION ELEMENTS OF PRESERVATION, AND/OR RESTORATION TO ORIGINAL (IMAGE AVAILABLE FROM 1940).**

- a. As per project approved by BOA and HPB, the house architecture style character was preserved or restored . The house was completely repainted in white, restoring original color, as per 1940 photo. All hurricane shutters support was removed, new true barrel tiles installed, metallic front gate removed and simplified gate following historic style installed as per HPB request and restoring original look and style.

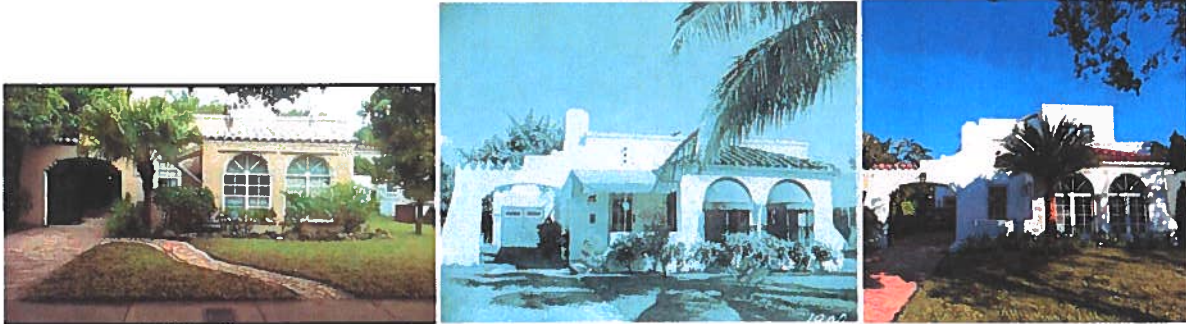
- b. Approx. 75% of original stucco was preserved. Some existing areas of the house required structural work per plans and, as a result, much of the stucco which was already cracked or spalling needed repair. Many areas of existing stucco received only skim-coats to blend in the areas that were needing more attention.
- c. A front column was added externally to foyer , between the two-front window, as per project and requests from HPB, and restoring style observed in 1940 photo. Arch Front Case windows as per HPB request were added.

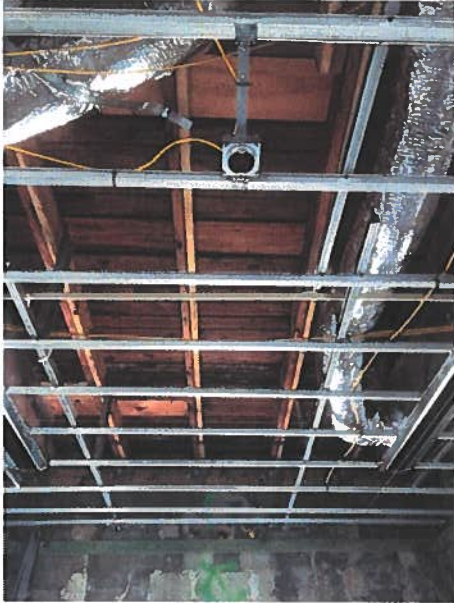
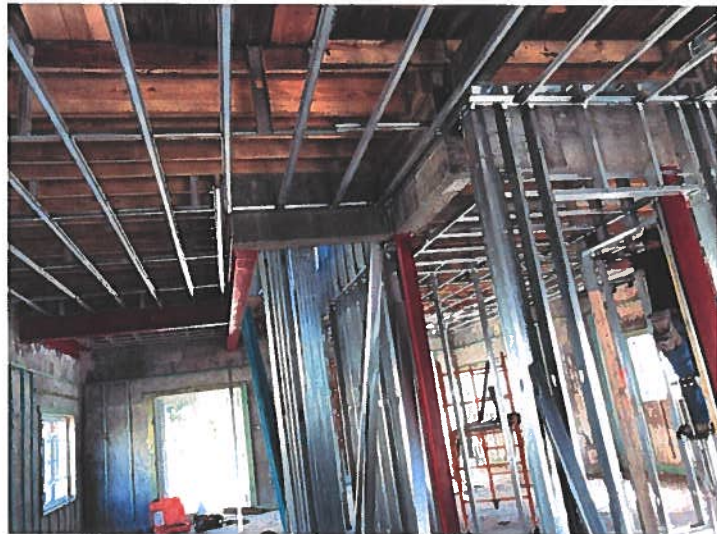
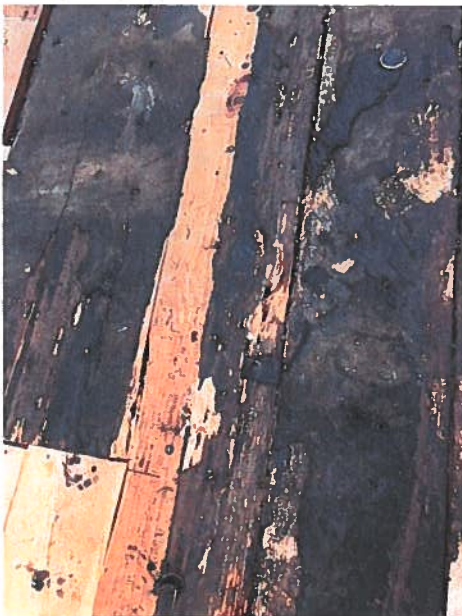
- d. The 1<sup>st</sup> floor Living room and guest room Roof was completely preserved in original condition, as per HPB new request, during one of our meetings. This request required us to redesign and update of initial proposed and approved roof structural calculation and developed a special reinforcement solution, in order to comply with existing hurricane safety. This incurred in a change vs original project approve to comply with HPB requested and generated a \$7.5K additional cost just to preserve that structure.

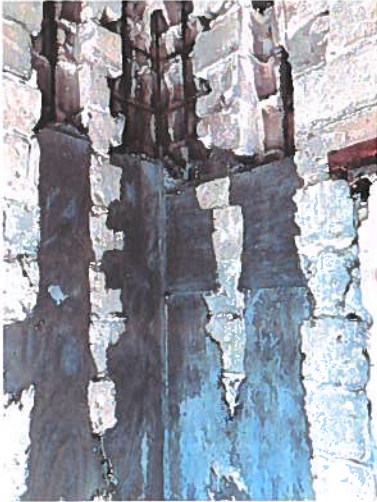
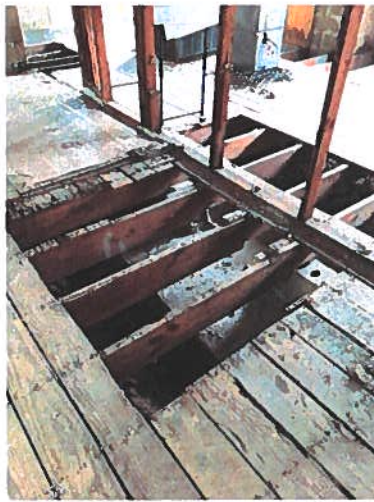
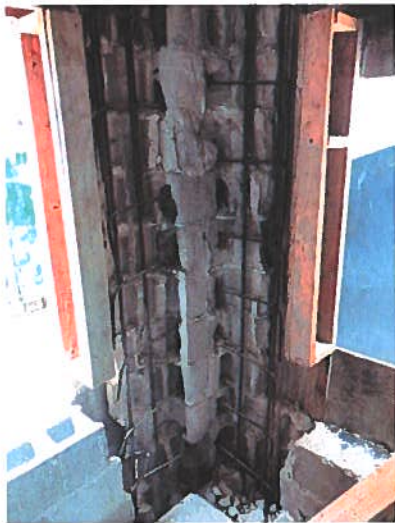
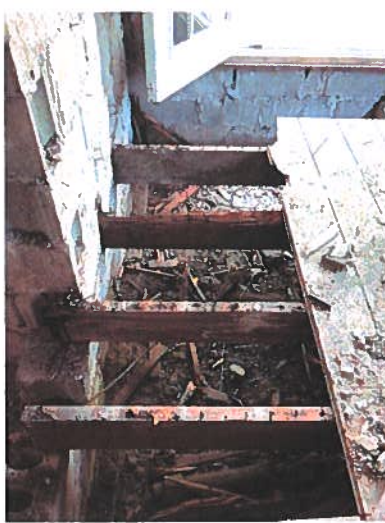
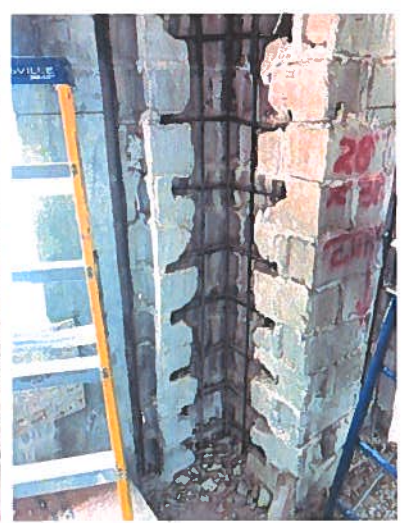
- e. Floor joists (aprox 85%) were preserved and reinforced to adjust and support new structure and project plans. Structural reinforcement as per project plans built from inside to preserve external structure and stucco as much as possible, which incurred in additional work and costs.

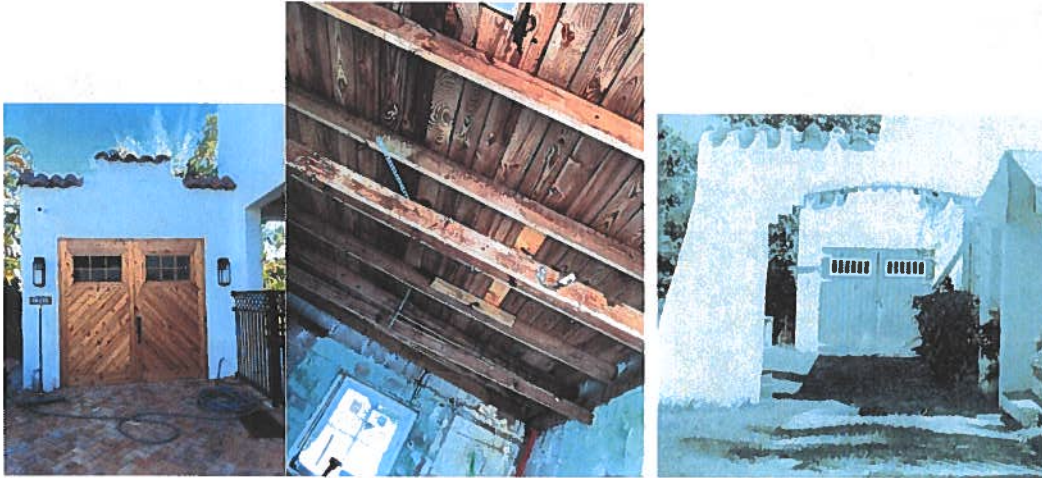
- f. Garage structure returned to original function (previous owner had remodeled into a guest bedroom, and it was in a very bad condition). Added Wood door, similar style to 1940 photo. Garage roof was preserved to original, added structural reinforcement had also incurred additional work and costs.

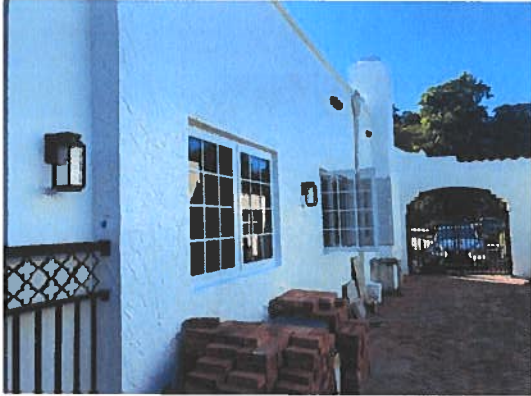
**PHOTO 5**

**2. ALL WINDOWS AND DOORS HAD TO BE REPLACED, NEW TRUE CASEMENTS WINDOWS TO BE INSTALLED ALIGNED WITH ORIGINAL HISTORIC STYLE**

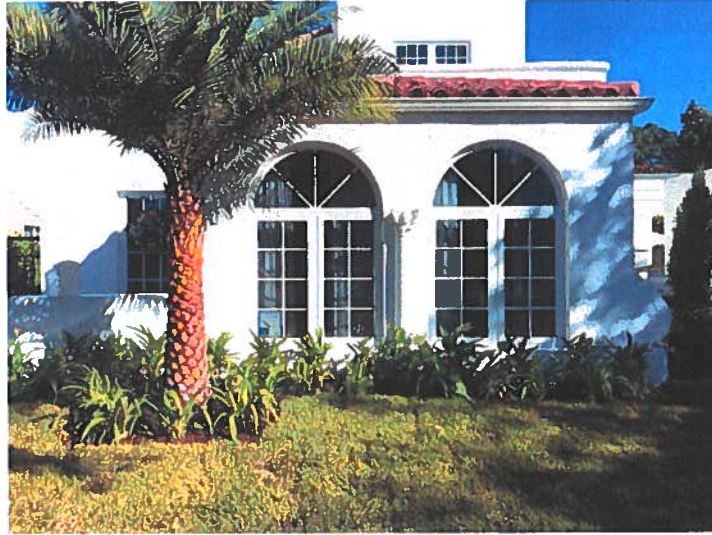
PHOTO 9

3. PROJECTING BAY ON FRONT HAD PART OF STRUCTURED CONVERTED INTO A BEDROOM CLOSED. IT HAD RETURN TO ORIGINAL 1940 CLOSED PORCH FUNCTION. A HISTORIC COLUMN DECORATIVE SHOWED ON 1940 PHOTO WILL BE RESTORED. CURRENT S-ROOF TILES REPLACED BY ORIGINAL TRUE-BARREL. FOYER ROOF WITH STRUCTURAL DAMAGE DUE TERMITES

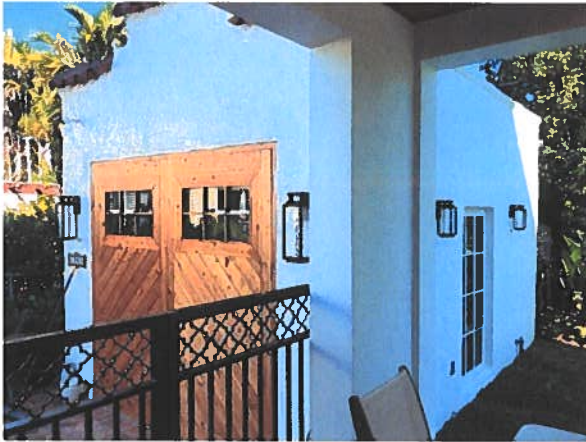
**PHOTO 11**

**4. GARAGE, CAR PATHWAY AND LANDSCAPE :**  
**PREVIOUSLY GARAGE WAS CONVERTED INTO A GUEST APARTMENT, FRONT DOOR CLOSED AND A DECORATIVE WOOD INSTALLED (NOT REAL DOOR), THERE IS AN ENTRY DOOR INSTALLED ON WEST ELEVATION. CAR PATH CHICAGO BRICKS REMOVED OR DAMAGED, LANDSCAPE NOT EXISTING OR IN A BAD CONDITION.**  
**GARAGE WAS REESTABLISHED TO ORIGINAL FUNCTION. CAR PATH REDONE AND RECOVERED TO ORIGINAL HISTORIC STYLE WITH WOOD DOOR INSTALLED, SIMILAR STYLE TO 1940'S ORIGINAL PHOTO; COMPLETELY NEW LANDSCAPE EXECUTED.**
