City of Coral Gables

Development Services

To Whom It May Concern,

On December 18, 2025, an arboricultural inspection was conducted on behalf of Alex Echvarria at 5800 Granada Blvd, Coral Gables, Florida, to assess three specimen trees (identified as Tree 1, Tree 2, and Tree 3). The subject trees are Black Olives (*Bucida buceras*). The inspection was prompted by recent pruning activities intended to mitigate litterfall (leaves, fruit, and tannic exudate) and address sidewalk infrastructure interference.

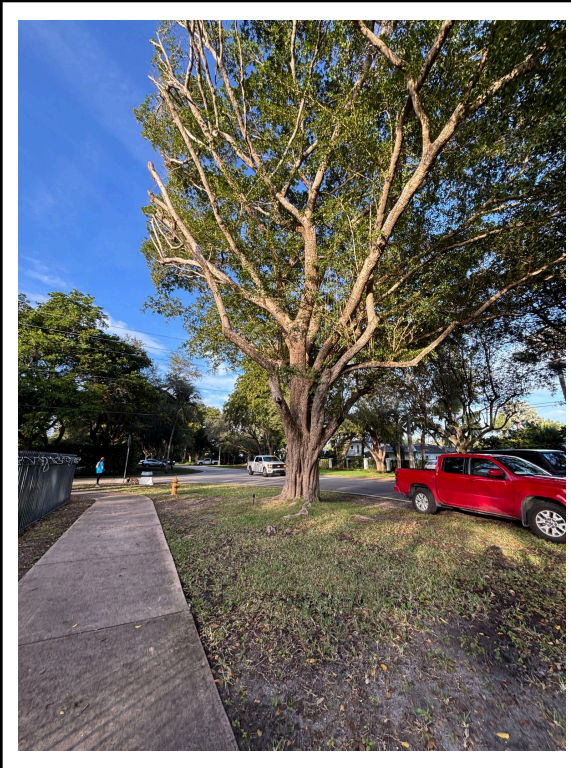
1

The recent maintenance performed on the subject trees utilized vertical clearing (shearing) rather than industry-standard reduction cuts. Contrary to ANSI A300 standards, which dictate pruning back to lateral nodes or adhering to a 3:1 branch-to-stem diameter ratio, a vertical plane was established. This resulted in each branch being severed along a uniform line parallel to the tree row, regardless of individual branch anatomy or the presence of appropriate heading cuts.

As established by Dr. Edward Gilman in *Structural Pruning: A Guide for the Green Industry*, structural integrity must be cultivated early in a tree's developmental life cycle. Because these specimens have lacked consistent structural training since planting, they currently exhibit low-reaching limbs with excessive end-weight. The failure to establish the lowest permanent branch has left these limbs structurally compromised and aesthetically degraded. Furthermore, the removal of interior lateral foliage has eliminated natural mass damping, significantly increasing the risk of limb failure during wind events.

Corrective Cuts: Existing stubs and stripped branches should be pruned back to the parent stem or to a suitable lateral branch (reduction cut) to encourage proper wound-wood formation where possible.

Crown Restoration: Future management should focus on thinning the outer canopy to reduce spread and litterfall, rather than stripping the interior.
