# PROPERTY APPRAISER OF MIAMI-DADE COUNTY

| PROPERTY INFORMATION | |
|---|---|
| Property Address | 13637 DEERING BAY DR<br>CORAL GABLES, FL 33158-0000 |

**NOTICE OF UNSAFE STRUCTURE VIOLATION FOR FAILURE TO RECERTIFY  
AND NOTICE OF HEARING**

☒ Initial Inspection Report ☐ Amended Inspection Report after completion of repairs

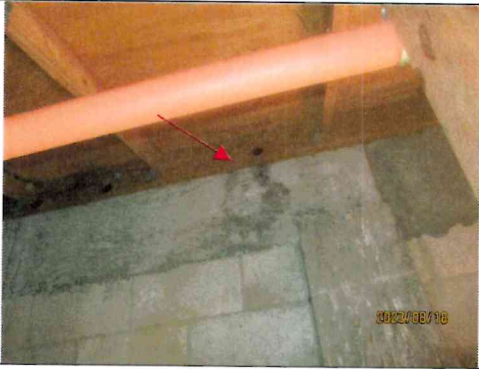
| <p><i>Photo-3: Water intrusion stains on the tie beam inside attic at east tower.</i></p> | <p><i>Photo-4: Water stains at overhead sheathing inside attic of north tower.</i></p> |

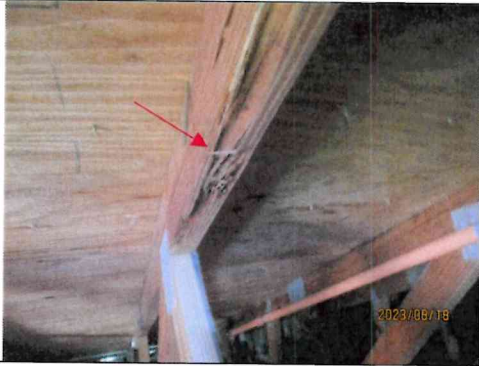
| <p><i>Photo-5: Damaged top chord inside west tower attic.</i></p> | <p><i>Photo-6: Gap in between truss top chord and the plywood sheathing inside west tower attic.</i></p> |

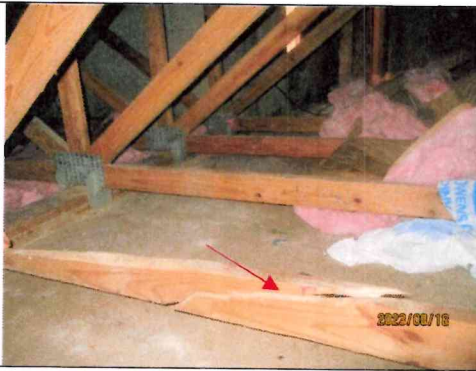
*Photo-7: Cracked web support member inside south tower attic.*

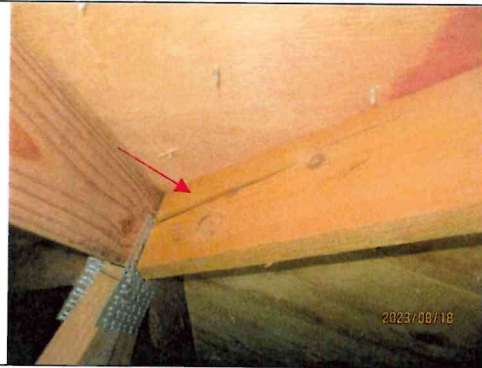
*Photo-8: Cracked top chord support member inside west tower attic.*

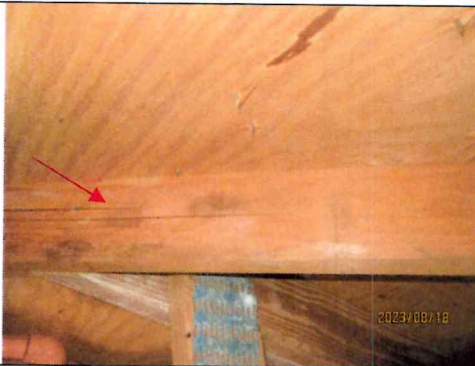
*Photo-9: Cracked top chord support member inside west tower attic inside east tower attic.*

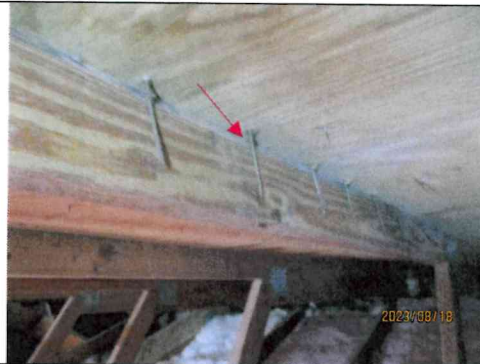
7. Inadequately installed nails missing the top chord of the truss at multiple locations inside the north tower attic are visible. Refer to photograph #10.

*Photo-10: Nails are not inserted in the top chord of truss inside north tower attic.*

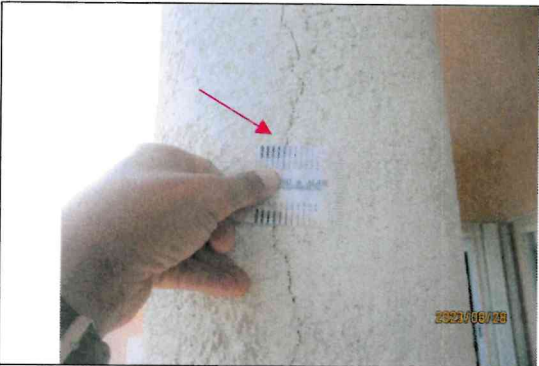
| <p><i>Photo-11: Crack in the column at balcony of Unit 293.</i></p> | <p><i>Photo-12: Crack in the column at balcony of Unit 285.</i></p> |

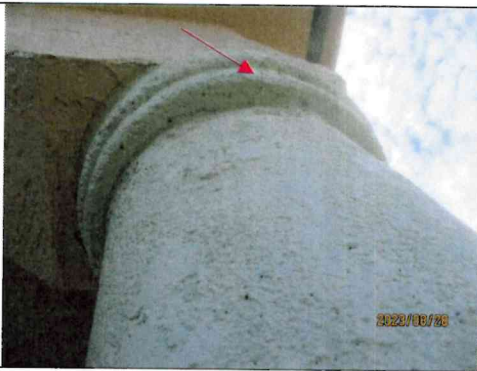
*Photo-13: Crack in the column at balcony of Unit 294.*

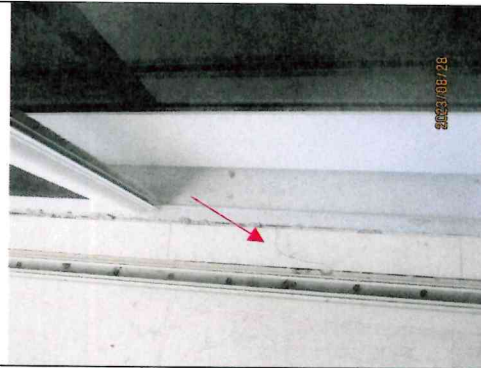
*Photo-14: Crack in the tile adjacent to the shutter in the balcony of Unit 243.*

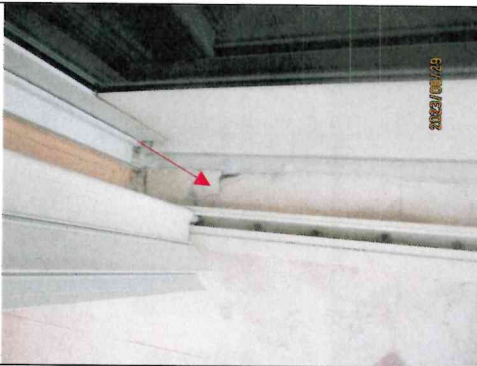
*Photo-15: Crack in the tile adjacent to the shutter in the balcony of Unit 258.*

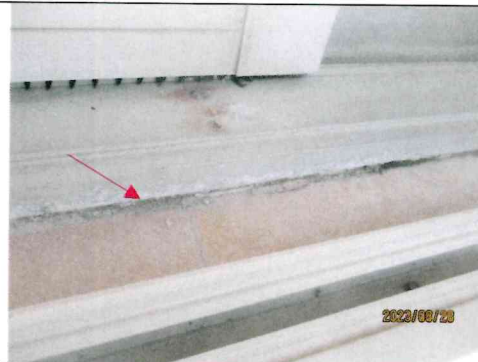
*Photo-16: Damaged concrete below the sliding glass door frame in the balcony of Unit 293.*

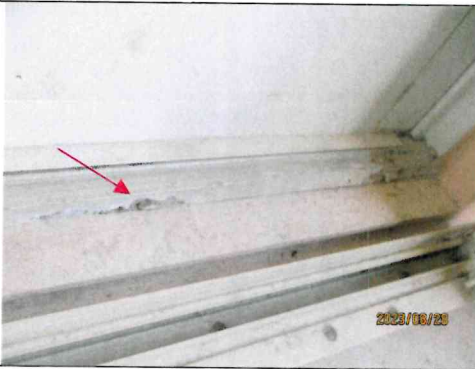
**Photo-17:** Damaged concrete adjacent to the sliding glass door frame in the balcony of Unit 244.

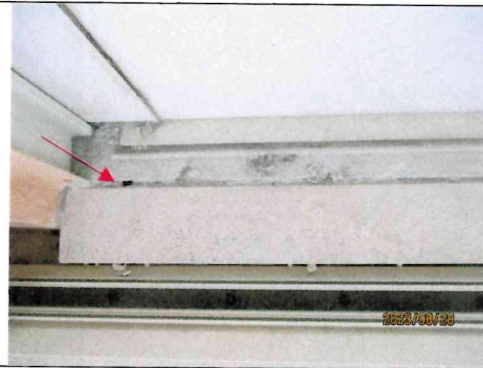
**Photo-18:** Void in the concrete adjacent to the sliding glass door frame in the balcony of Unit 243.

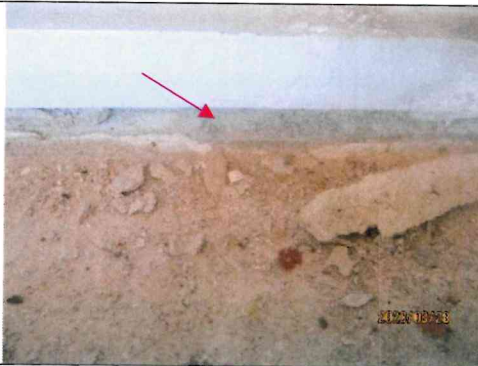
**Photo-19:** Damaged concrete below the sliding glass door frame in the balcony of Unit 293.

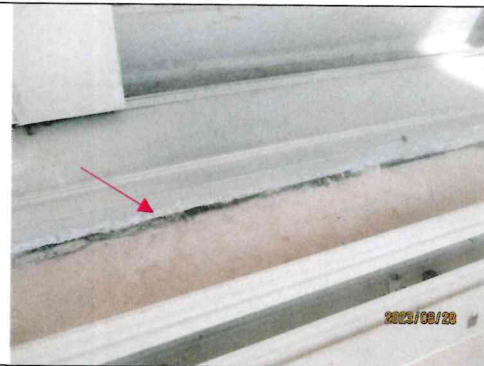
**Photo-20:** Damaged concrete below the sliding glass door frame in the balcony of Unit 293.

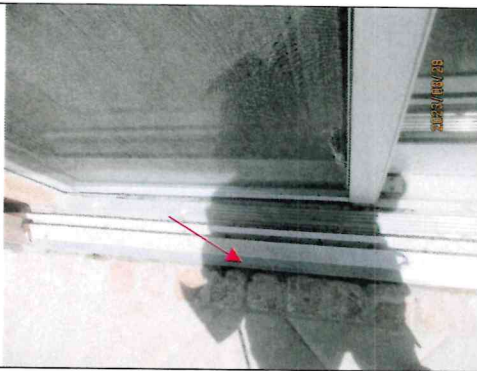
*Photo-21: Water ponding adjacent to the shutter in the balcony of Unit 294.*

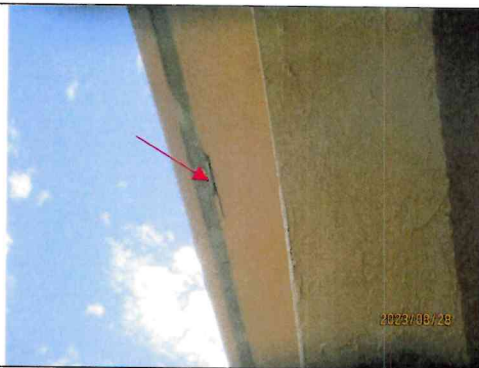
*Photo-23: Damaged soffit in the roof of Unit 294.*

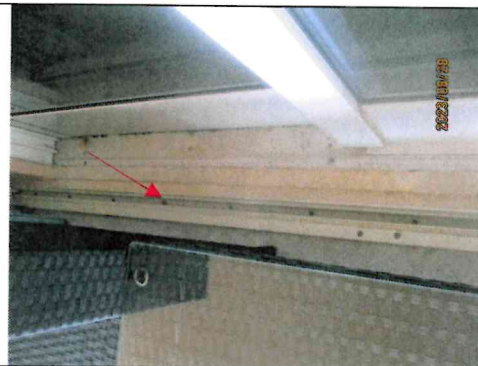
*Photo-24: Corroded shutter fasteners anchored to the floor slab in the balcony of Unit 244.*

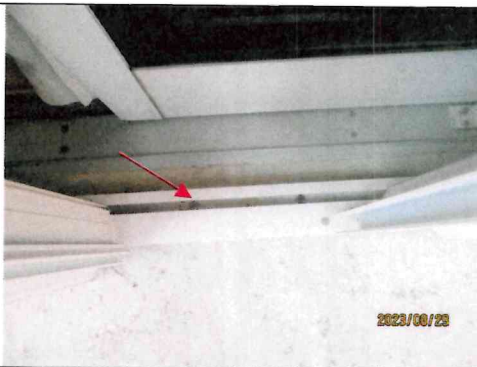
*Photo-25: Corroded shutter fasteners anchored to the floor slab in the balcony of Unit 257.*

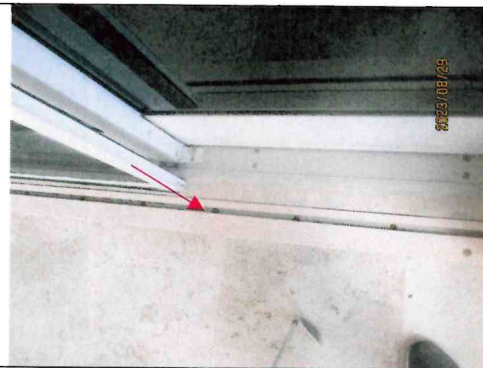
*Photo-26: Corroded shutter fasteners anchored to the floor slab in the balcony of Unit 261.*

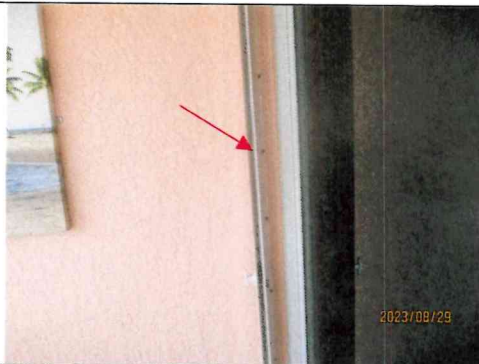
7. Corroded shutter fasteners are anchored to the wall on the balconies of Unit 252 and Unit 258. Refer to photographs #27 and #28.

*Photo-27: Corroded shutter fasteners anchored to the wall in the balcony of Unit 252.*

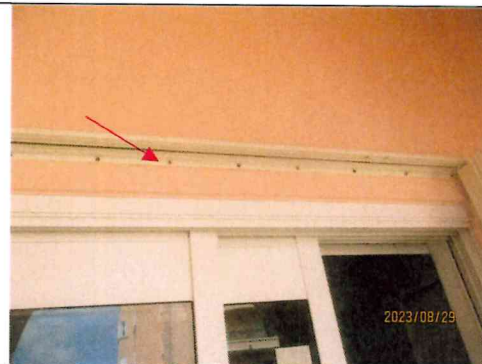
*Photo-28: Corroded shutter fasteners anchored to the wall in the balcony of Unit 258.*

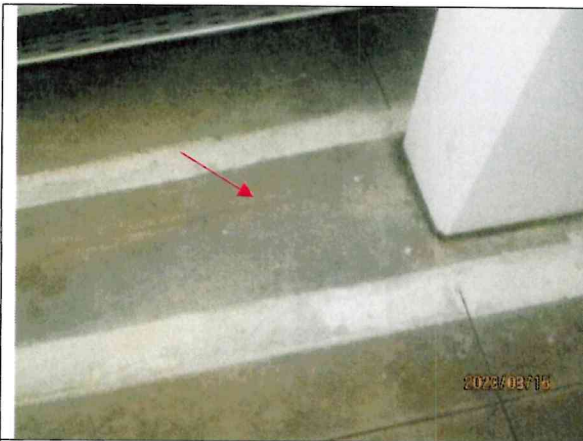
*Photo-30: Crack in the floor slab at the ground level parking garage.*

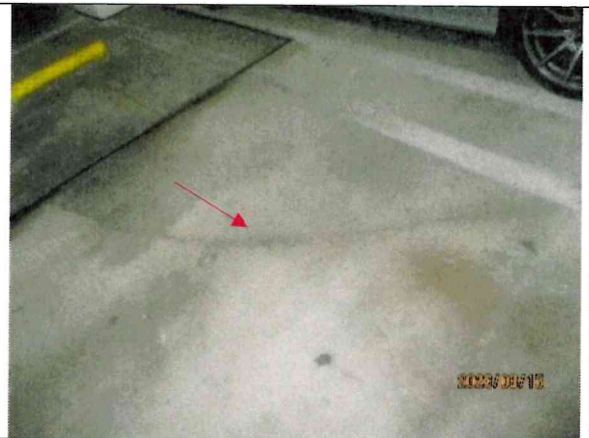
*Photo-31: Crack in the floor slab at the ground level parking garage.*

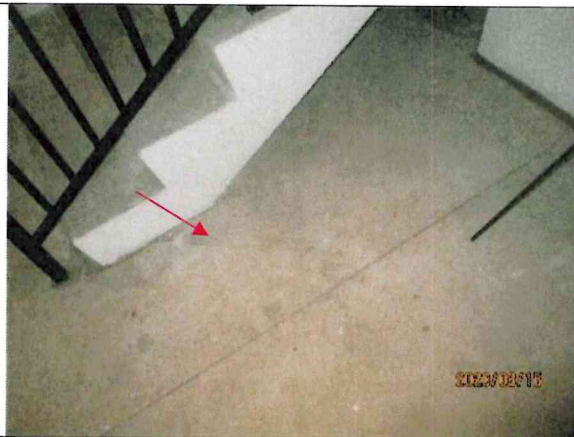
*Photo-32: Crack in the floor slab at the ground level parking garage.*

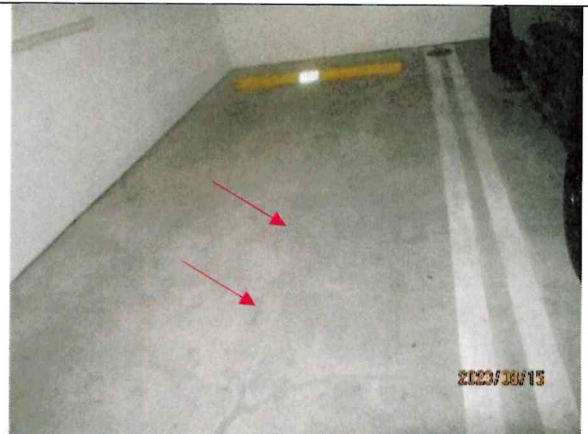
*Photo-33: Cracks in the floor slab at the ground level parking garage.*

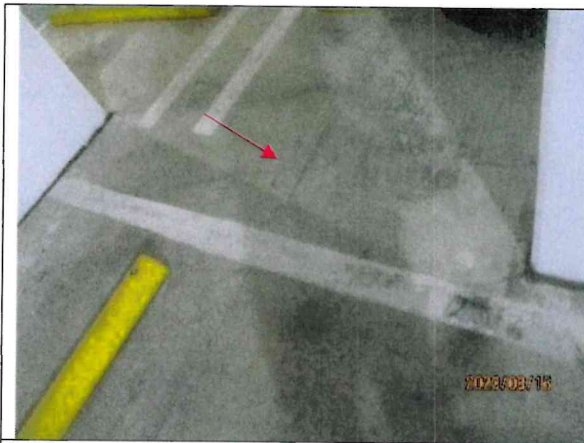
*Photo-34: Crack in the floor slab at the ground level parking garage.*

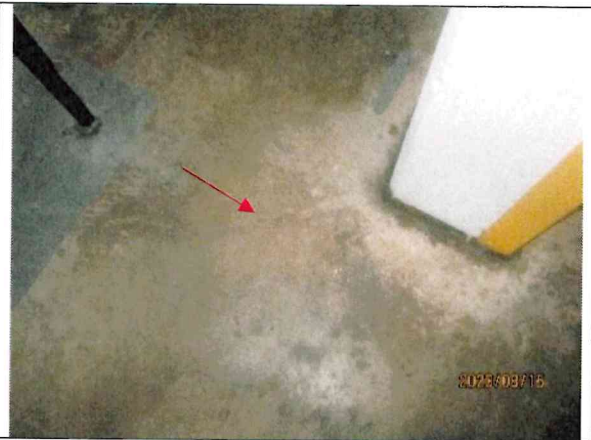
*Photo-35: Crack in the floor slab at the ground level parking garage.*

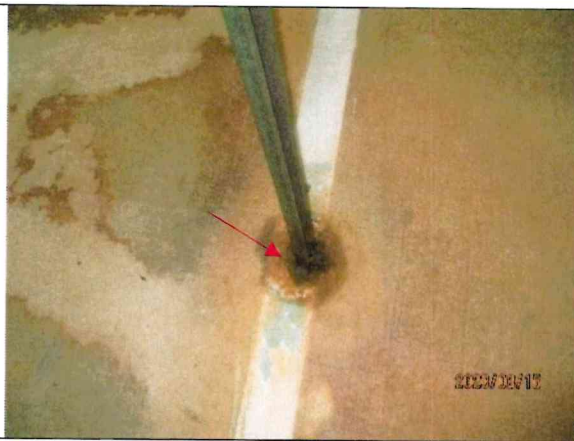
*Photo-36: Corrosion stains on the floor slab at the signboard post located at ground level parking garage.*

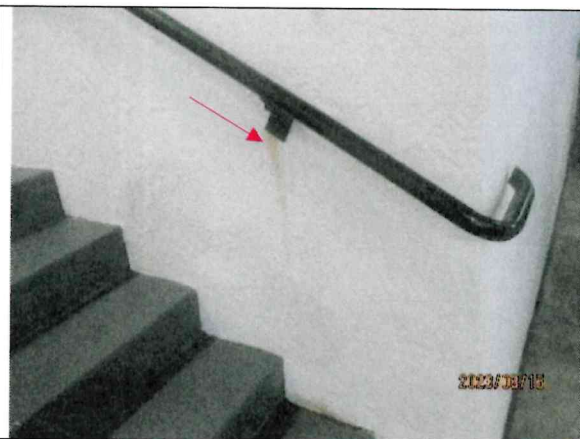
*Photo-37: Corrosion stains on the wall at the staircase handrail located at ground level parking garage.*

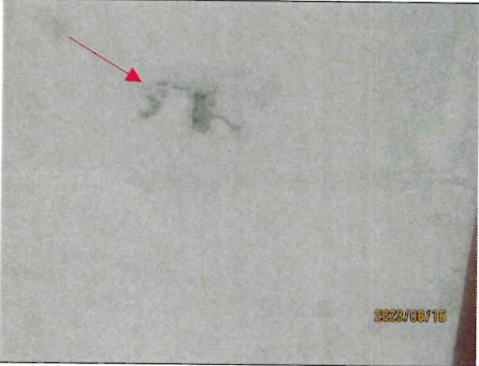
| <p><i>Photo-40: Spalling concrete in the stair ceiling of elevator room floor at north tower.</i></p> | <p><i>Photo-41: Cracks in the slab at south tower at the garage floor.</i></p> |

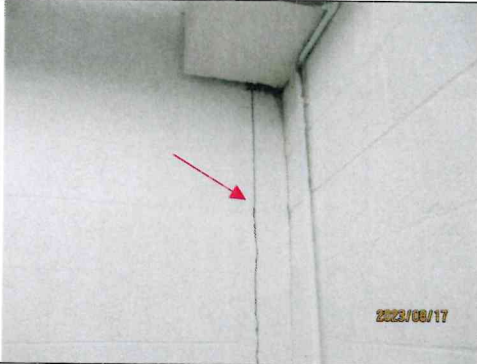
| <p><i>Photo-46: Crack in the C.M.U. wall inside trash room of north tower.</i></p> | <p><i>Photo-47: Crack in the C.M.U. wall inside trash room of south tower.</i></p> |

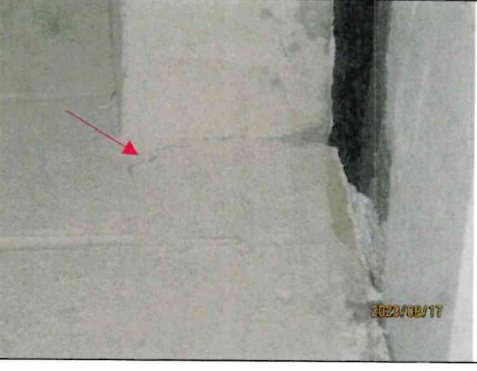
| <p><i>Photo-48: Crack in C.M.U. wall inside trash room of east tower.</i></p> | <p><i>Photo-49: Crack in the floor slab of electrical room at west tower.</i></p> |

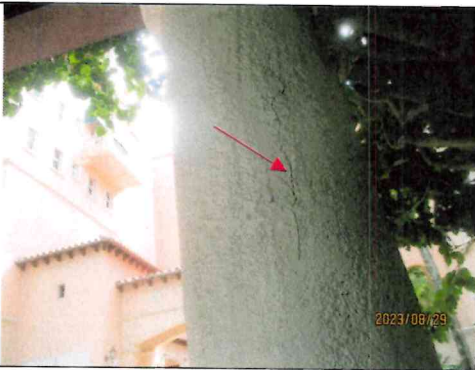
*Photo-52: Crack in column in the west tower.*

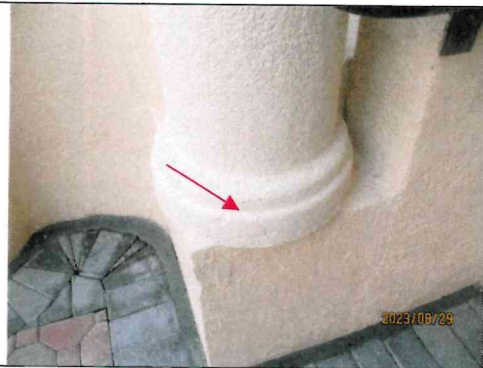
*Photo-53: Crack at column base in the east tower.*

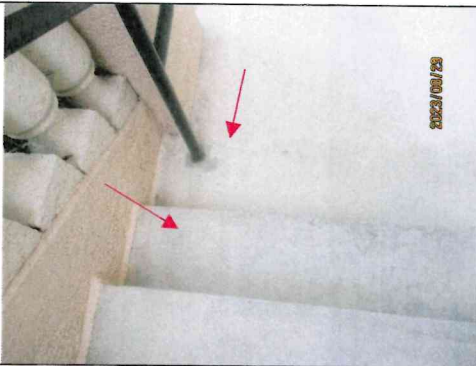
*Photo-54: Crack in stairs in the north tower.*

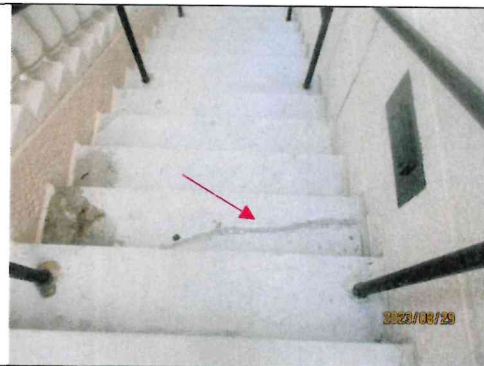
*Photo-55: Crack in stairs in the north tower.*

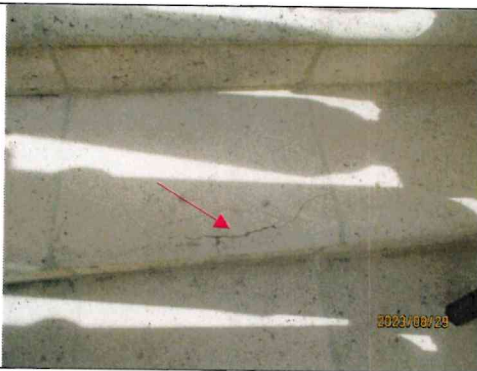
*Photo-56: Crack in stair in the east tower.*

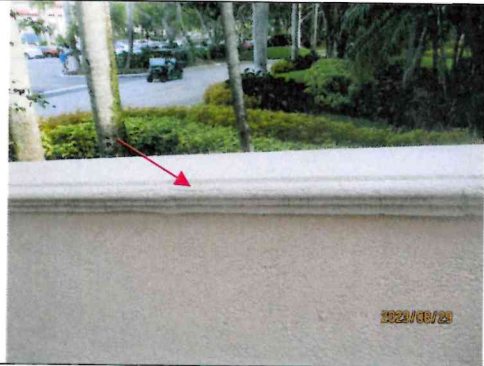
*Photo-57: Crack in cap beam at the wall in the north tower.*

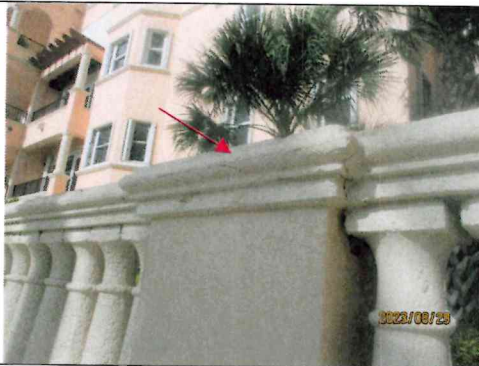
*Photo-58: Crack in guardrail cap at the east tower.*

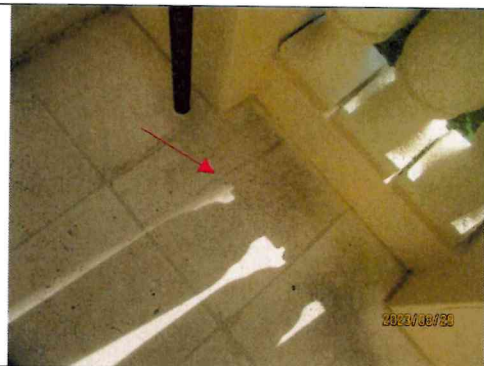
*Photo-59: Crack in floor tile at the east tower.*

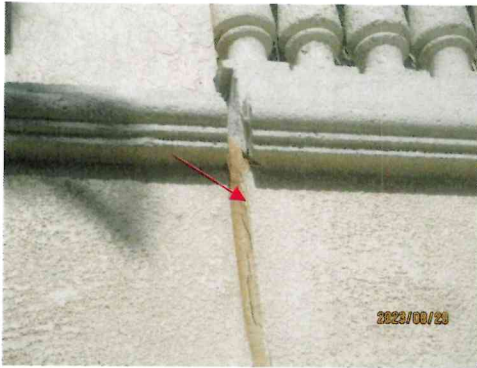
*Photo-60: Crack in expansion joint at the east tower.*

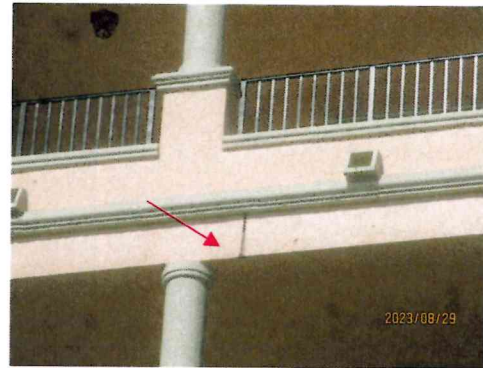
*Photo-61: Water/organic stain from curb in the east tower.*

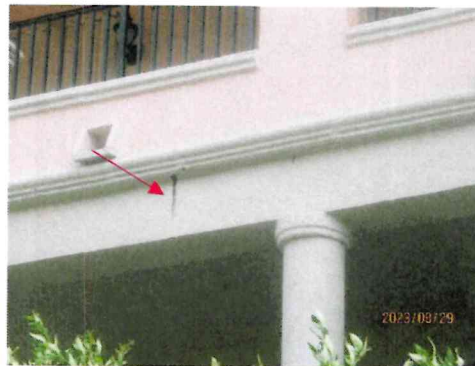
*Photo-62: Water/organic stain from curb in the south tower.*
