Arborist Report for residential property at 1019 Mariposa Ave, Coral Gables, FL 33146

I visited the above-mentioned property on 10/26/2023 to evaluate eight trees, verify condition, take photographs. Please see attached map overlay with the trees labeled and numbered, health condition and notes. The Live Oak trees are located outside the property line in the neighboring property to the west and some of the data collection was only visual estimates because the trees were not fully accessible.

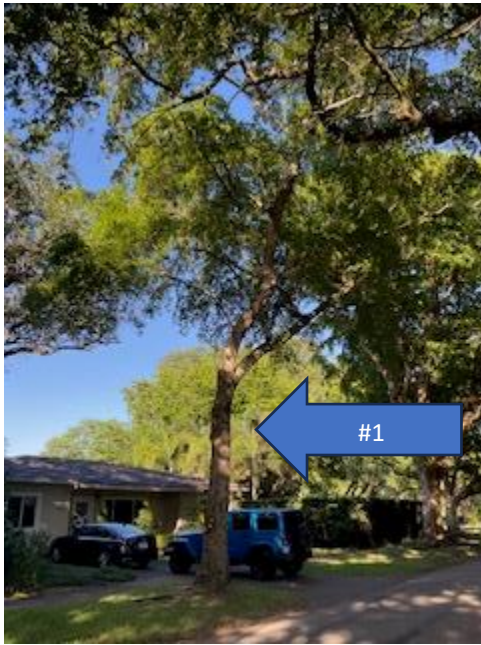
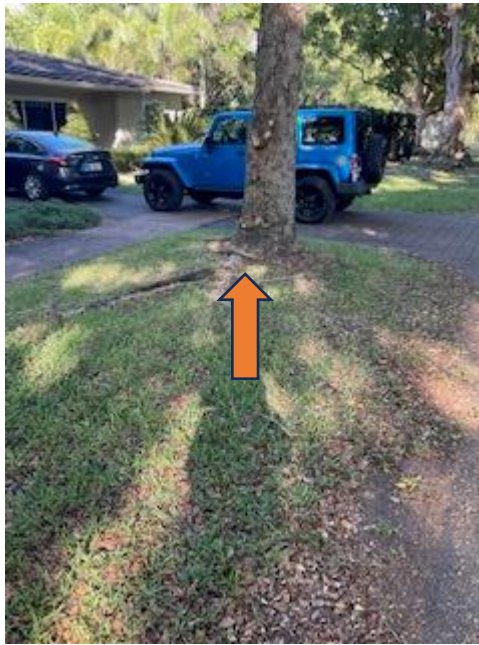
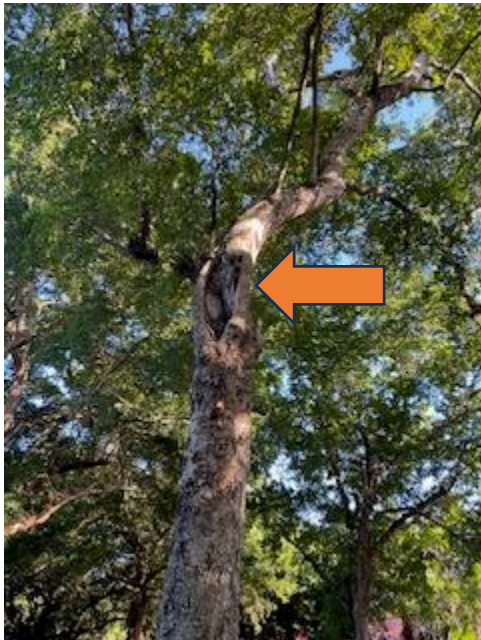
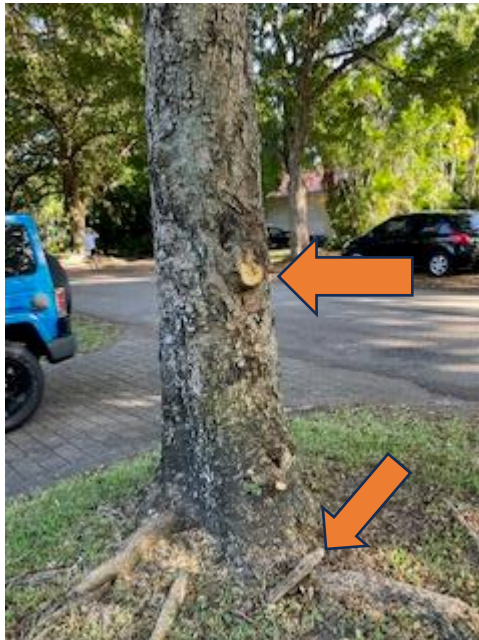
#1 This Black Olive trees (*Terminalia buceras*) is in overall poor condition. Some issues with this tree include a large cavity in the upper trunk at 18', confined roots from hardscape sidewalk and circling roots at root collar. This tree has recently had sucker growth pruned away from sidewalk. Monitor cavity with follow up inspection in one year.

**#1 LARGE CAVITY IN THE UPPER TRUNK AT 18', CONFINED ROOTS FROM HARDSCAPE SIDEWALK AND CIRCLING ROOTS AT ROOT COLLAR. THIS TRIM HAS RECENTLY HAD SUCKER GROWTH PRUNED AWAY FROM SIDEWALK.**

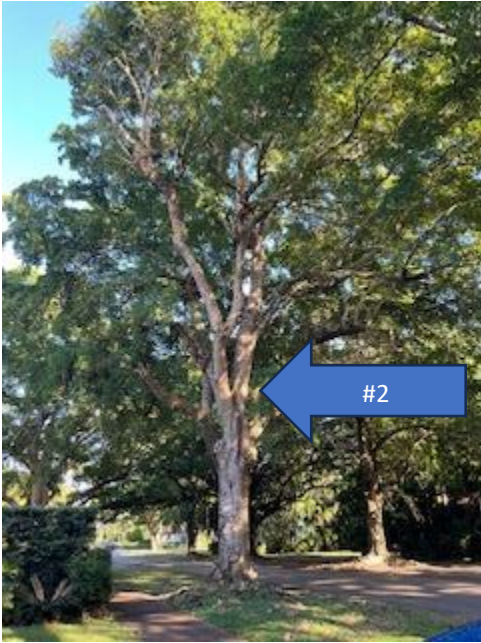
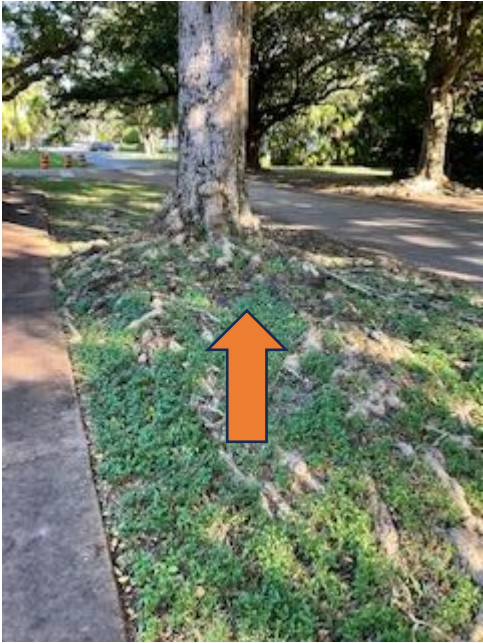
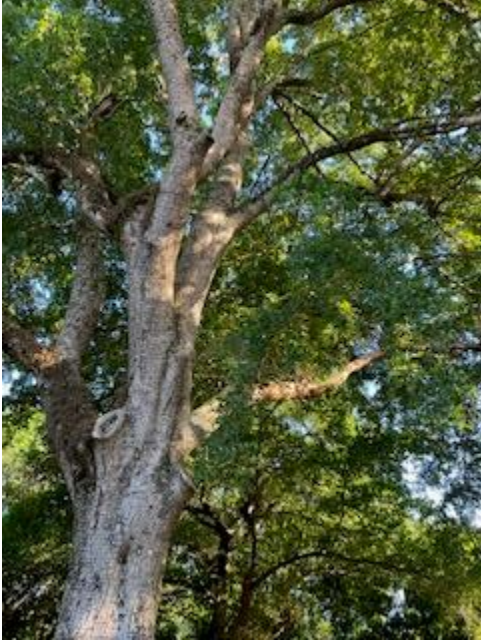
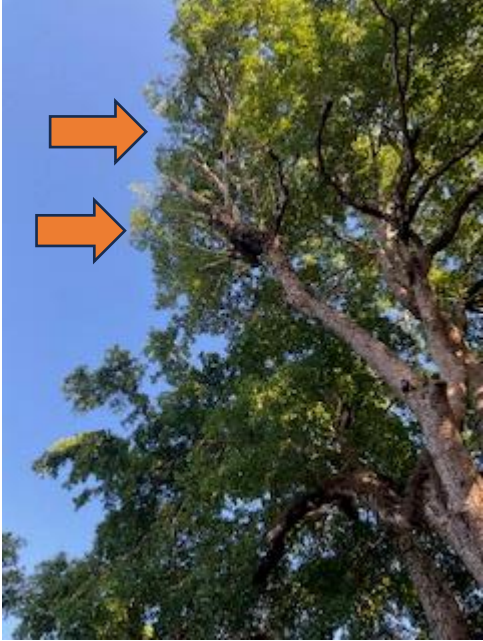
#2 This Black Olive trees (*Terminalia buceras*) is in overall fair condition. Some issues with this tree include recent heading cuts to reduce canopy from growing towards mentioned home, confined roots from hardscape sidewalk and exposed surface roots. This tree has recently had canopy reduction that includes heading cuts resulting in an unbalanced canopy. Recommendations are to allow re growth and have canopy inspected in one year.

**#2 HEADING CUTS TO REDUCE CANOPY FROM GROWING TOWARDS MENTIONED HOME, CONFINED ROOTS FROM HARDSCAPE SIDEWALK AND EXPOSED SURFACE ROOTS. THIS TREE HAS RECENTLY HAD CANOPY REDUCTION THAT INCLUDES HEADING CUTS RESULTING IN AN UNBALANCED CANOPY.**

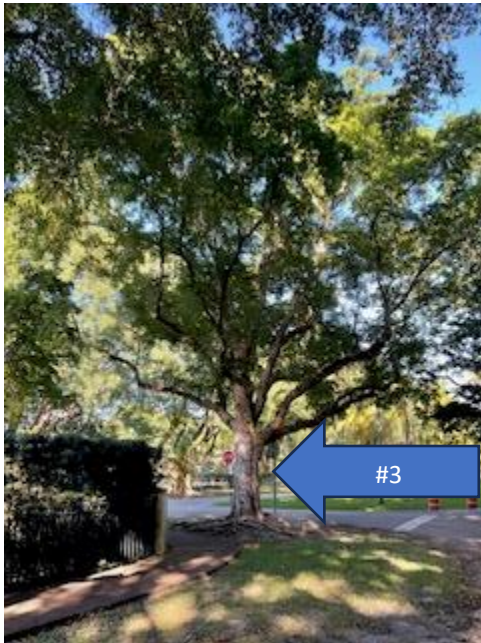
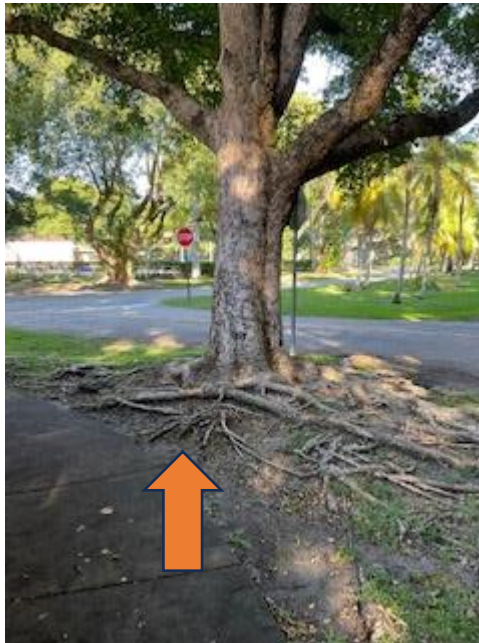
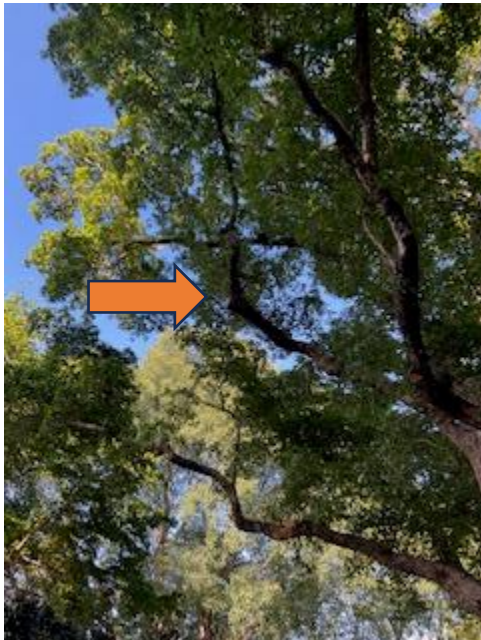
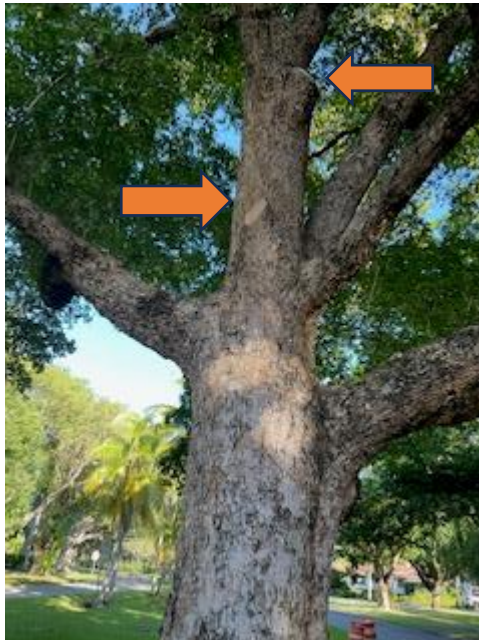
#3 This Black Olive trees (*Terminalia buceras*) is in overall fair condition. Some issues with this tree include confined roots from hardscape sidewalk and circling roots at root collar. This tree has recently had sucker growth pruned away from sidewalk and reduction cuts for dead wood removal. Recommendations are to allow re growth and have canopy inspected in one year.

**#3 CONFINED ROOTS FROM HARDSCAPE SIDEWALK AND CIRCLING ROOTS AT ROOT COLLAR. THIS TREE HAS RECENTLY HAD SUCKER GROWTH PRUNED AWAY FROM SIDEWALK AND REDUCTION CUTS FOR DEAD WOOD REMOVAL.**

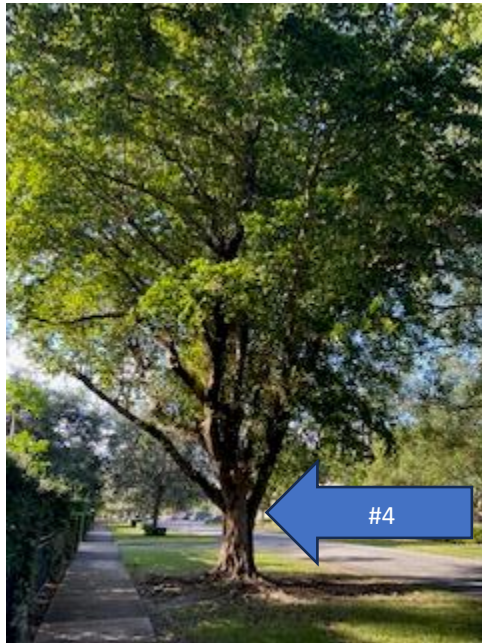
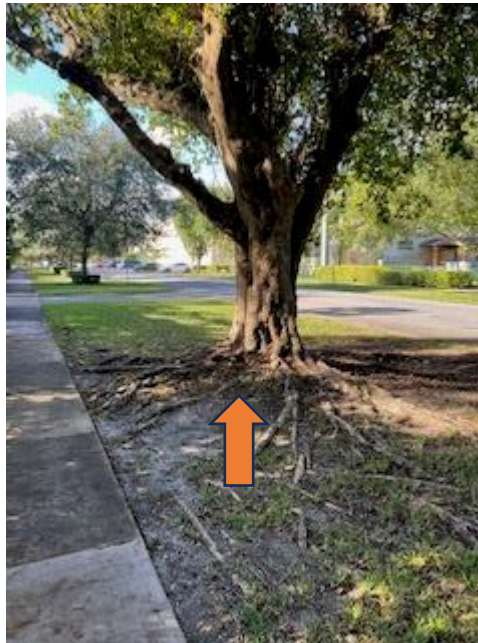
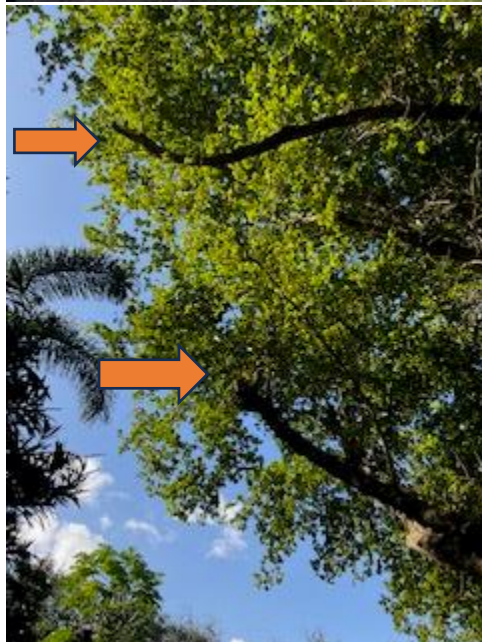
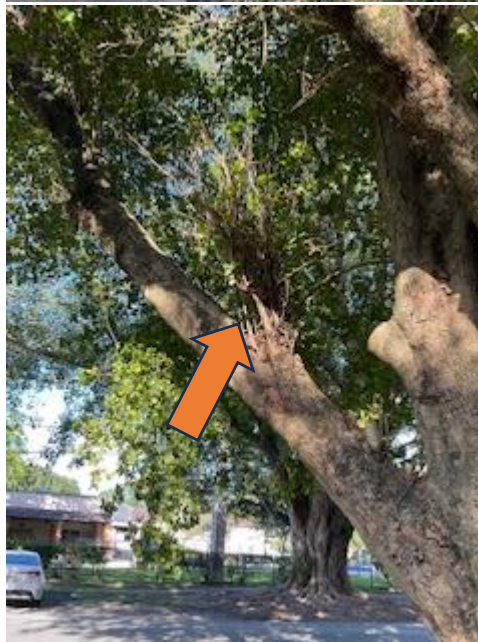
#4 This Black Olive trees (*Terminalia buceras*) is in overall fair condition. Some issues with this tree include confined roots from hardscape sidewalk. This tree has recently had sucker growth pruned away from sidewalk and reduction cuts for dead wood removal. Lions tail pruning found on west side of tree on main branch growing towards mentioned property. Recommendations are to allow re growth and have canopy inspected in one year.

**#4 CONFINED ROOTS FROM HARDSCAPE SIDEWALK. THIS TREE HAS RECENTLY HAD SUCKER GROWTH PRUNED AWAY FROM SIDEWALK AND REDUCTION CUTS FOR DEAD WOOD REMOVAL. LIONS TAIL PRUNING FOUND ON WEST SIDE OF TREE ON MAIN BRANCH GROWING TOWARDS MENTIONED PROPERTY.**

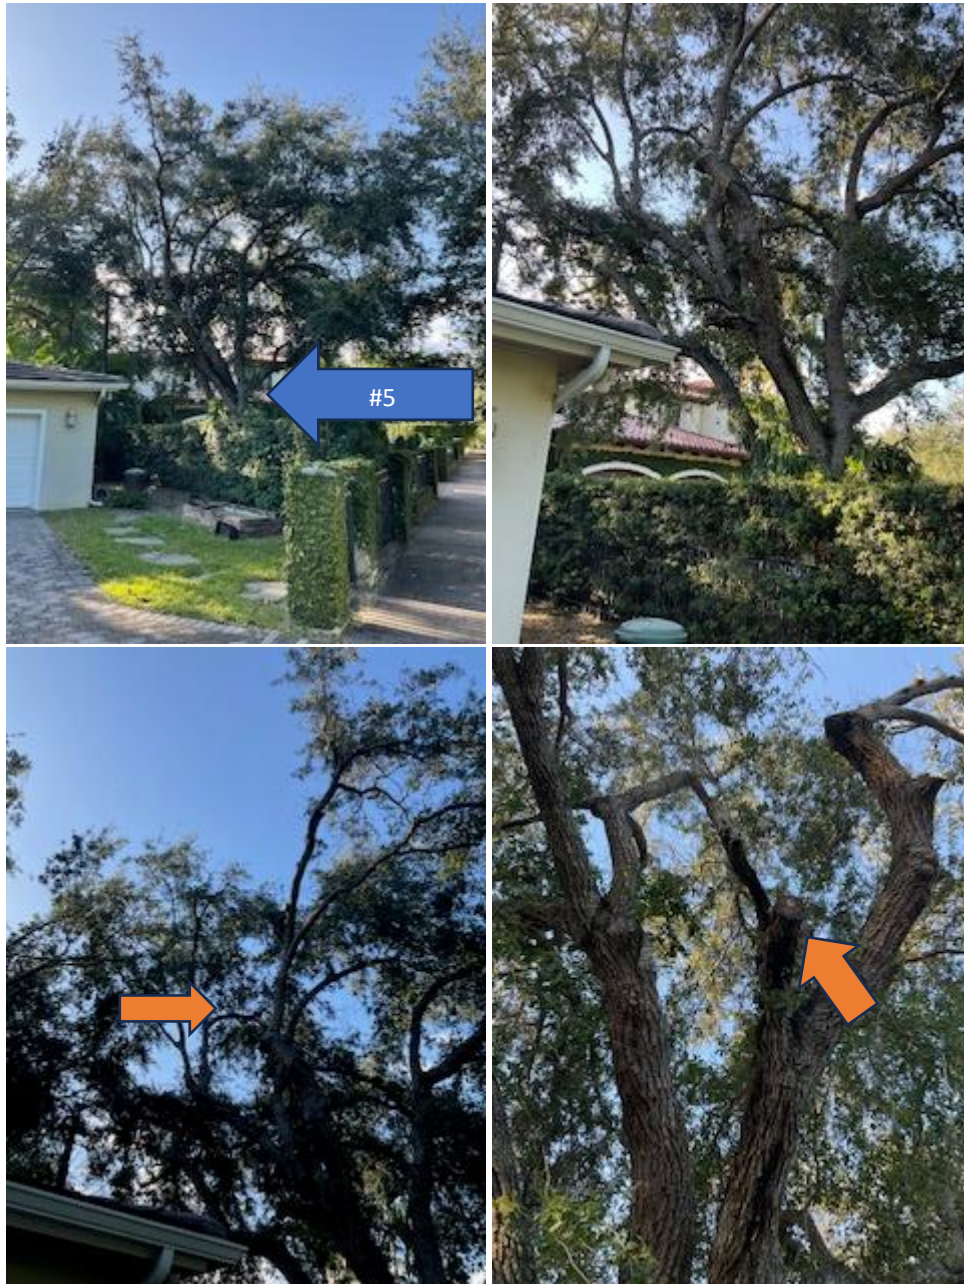
#5 This Live Oak (*Quercus virginiana*) is in overall good condition. Some issues with this tree include canopy growing over roof of mentioned property. This tree has recently had canopy reduction pruning resulting in an unbalanced canopy. Recommendations are to allow re growth and have canopy inspected in one year.

**#5 CANOPY GROWING OVER ROOF OF MENTIONED PROPERTY. THIS TREE HAS RECENTLY HAD CANOPY REDUCTION PRUNING RESULTING IN AN UNBALANCED CANOPY.**

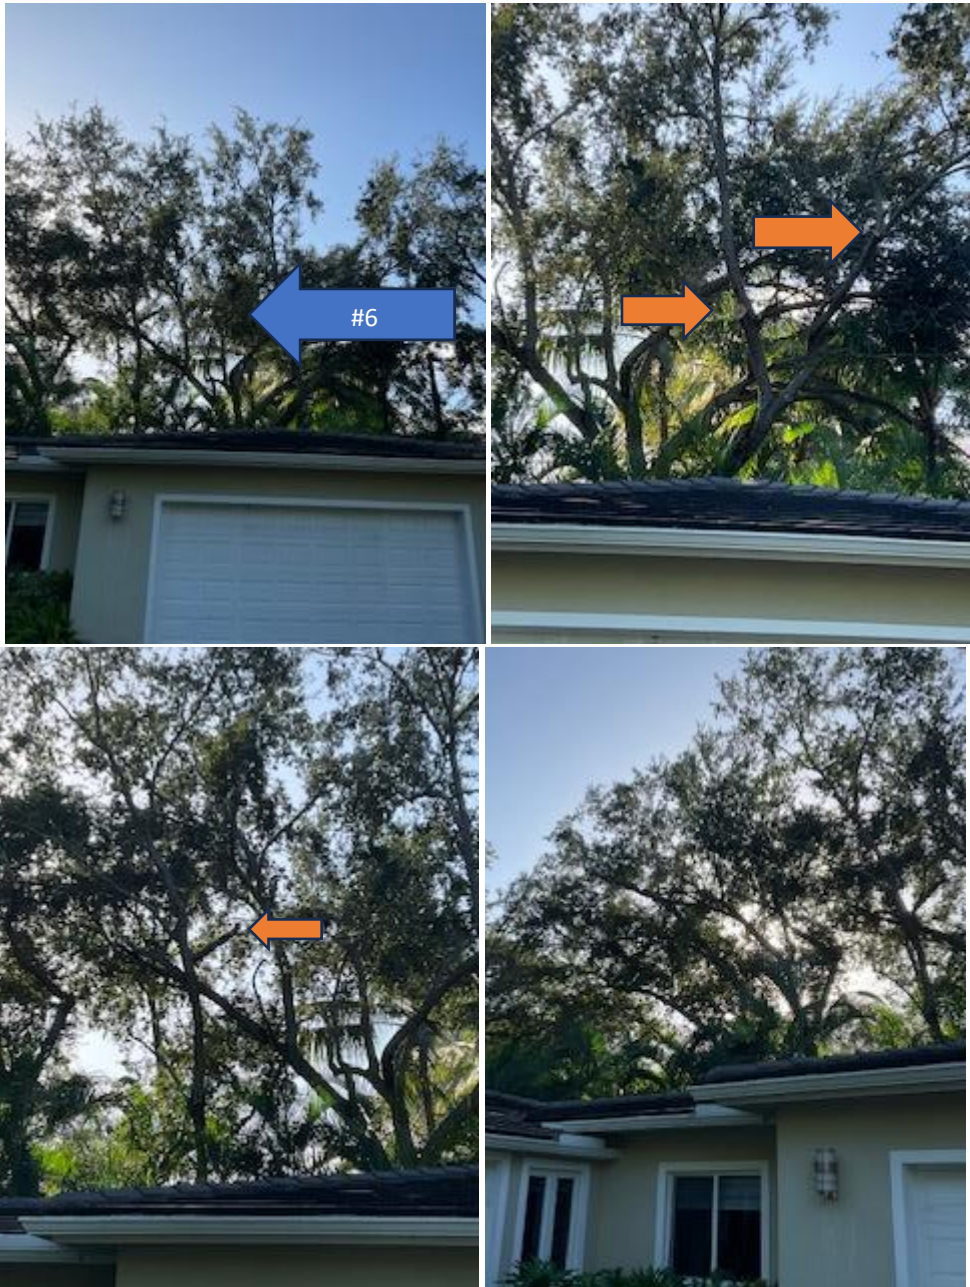
#6 This Live Oak (*Quercus virginiana*) is in overall good condition. Some issues with this tree include canopy growing over roof of mentioned property. This tree has recently had canopy reduction pruning resulting in an unbalanced canopy. Recommendations are to allow re growth and have canopy inspected in one year.

**#6 INCLUDE CANOPY GROWING OVER ROOF OF MENTIONED PROPERTY. THIS TREE HAS RECENTLY HAD CANOPY REDUCTION PRUNING RESULTING IN AN UNBALANCED CANOPY.**

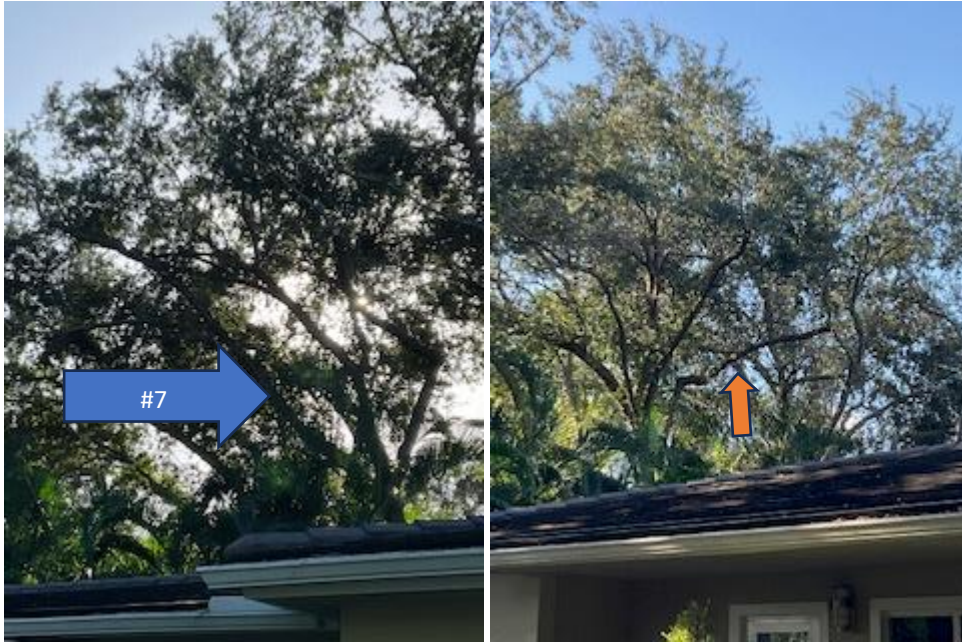
#7 This Live Oak (*Quercus virginiana*) is in overall good condition. Some issues with this tree include canopy growing over roof of mentioned property. This tree has recently had canopy reduction pruning resulting in an unbalanced canopy. Recommendations are to allow re growth and have canopy inspected in one year.

**#7 INCLUDE CANOPY GROWING OVER ROOF OF MENTIONED PROPERTY. THIS TREE HAS RECENTLY HAD CANOPY REDUCTION PRUNING RESULTING IN AN UNBALANCED CANOPY.**

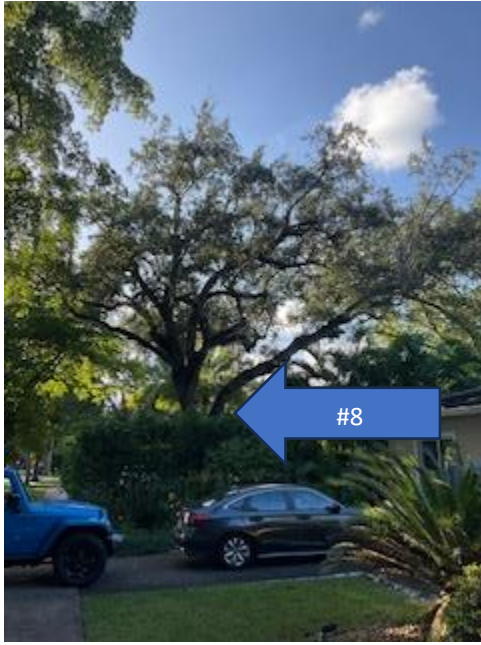
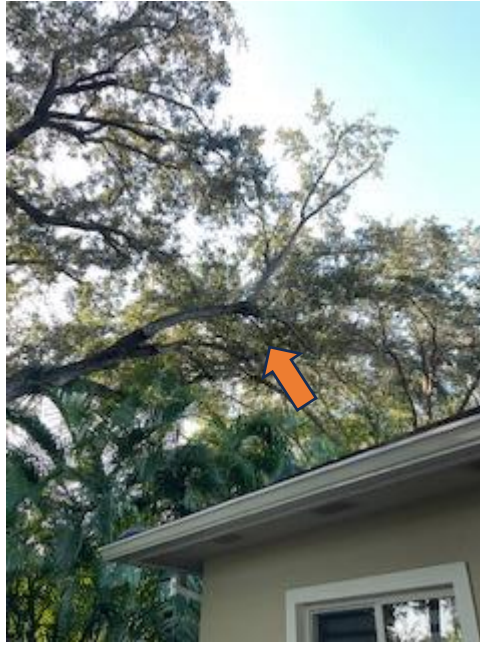
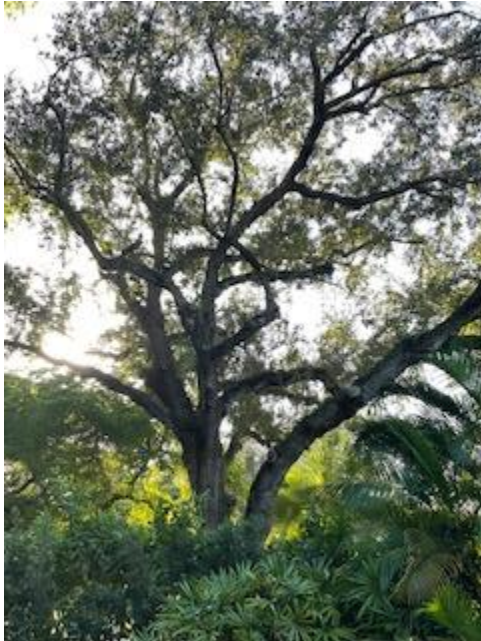
#8 This Live Oak (*Quercus virginiana*) is in overall good condition. Some issues with this tree include canopy growing over roof of mentioned property. This tree has recently had canopy reduction pruning resulting in an unbalanced canopy. Recommendations are to allow re growth and have canopy inspected in one year.

**#8 INCLUDE CANOPY GROWING OVER ROOF OF MENTIONED PROPERTY. THIS TREE HAS RECENTLY HAD CANOPY REDUCTION PRUNING RESULTING IN AN UNBALANCED CANOPY.**

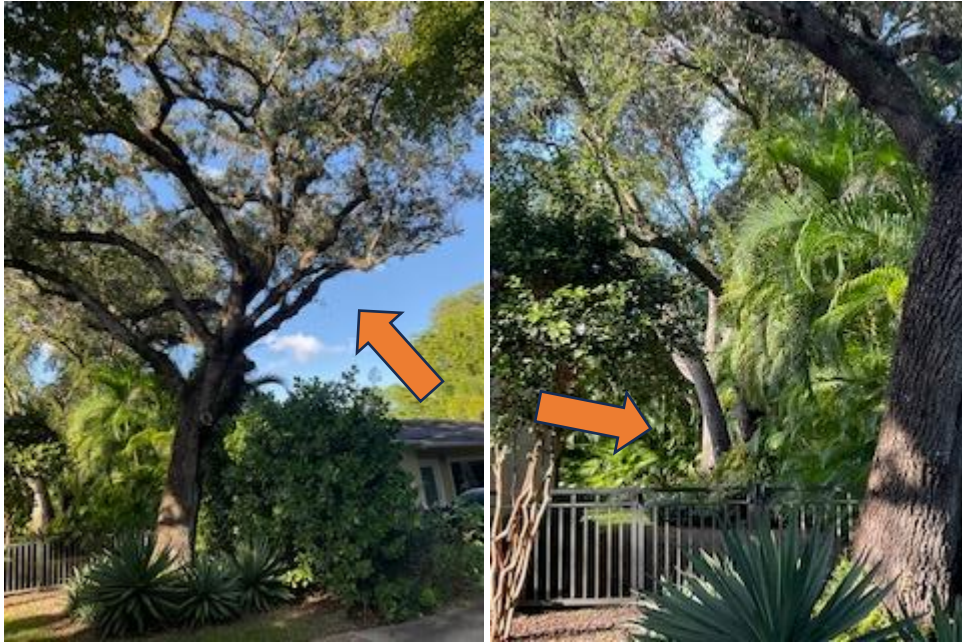
**FACING NORTH SHOWING CANOPY OVER ROOF AND FENCE LINE WITH LIMITED VISUAL ACCESS TO OAK TREES.**
