HISTORIC PRESERVATION AD-VALOREM TAX EXEMPTION

PART 2 – REQUEST FOR REVIEW OF COMPLETED WORK

**Request for Completed Work
Ad-Valorem Application Package for:
Historical Restoration, Addition, and Alteration to:
(Submitted June 2, 2014)**

Olivera Residence

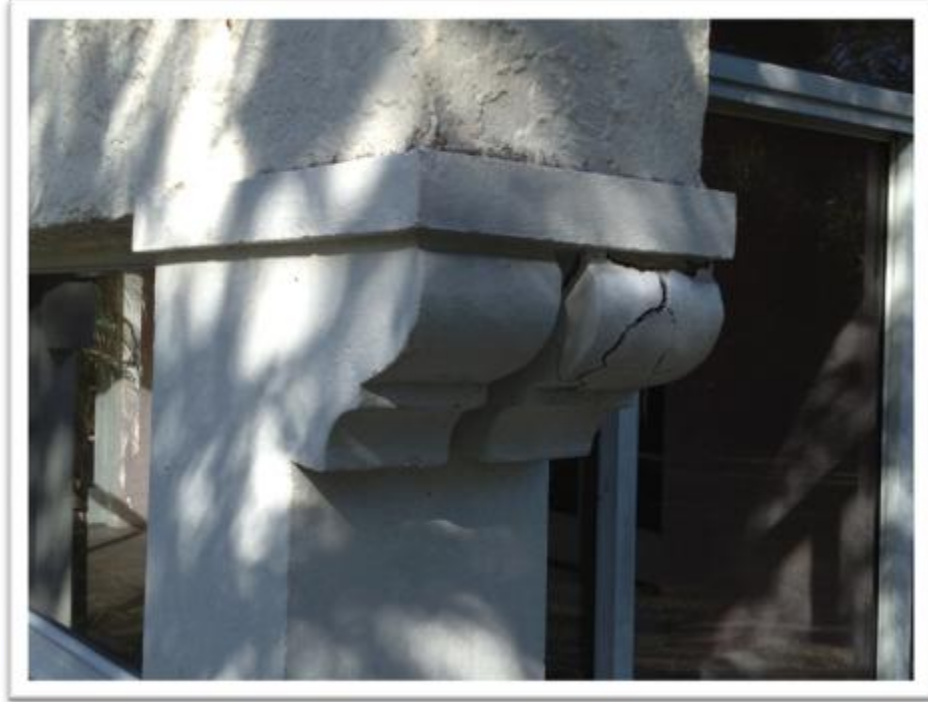
Photo Number: Image 21 (Before)

Plan Number: **Stucco Detail View of Porch Column Capitals**

Describe Work and Impact on Existing Feature: Repair stucco cracks at Column Capital, New Paint

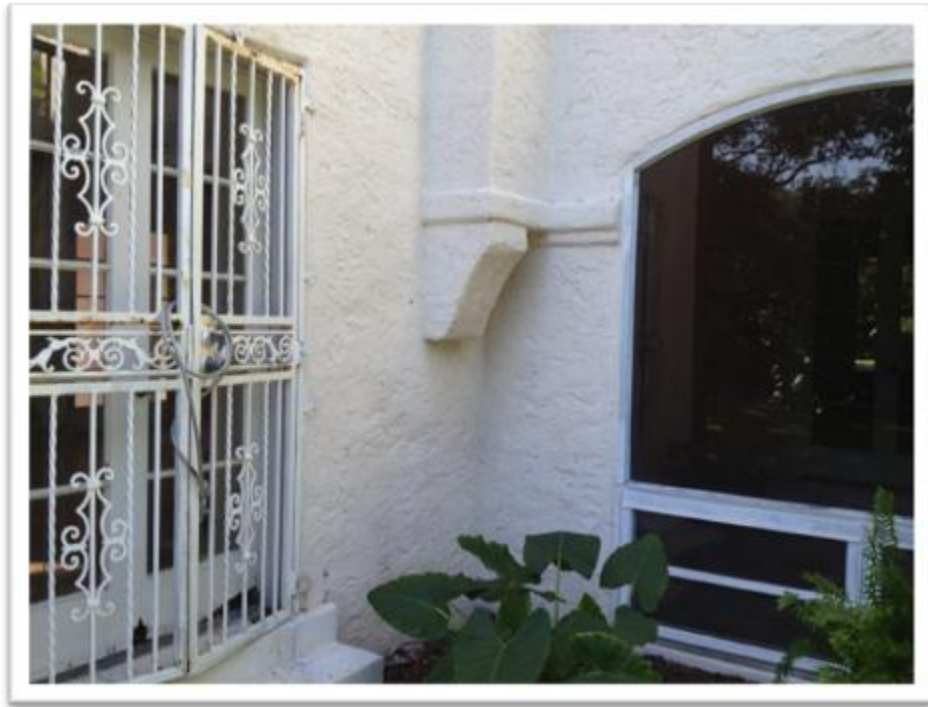
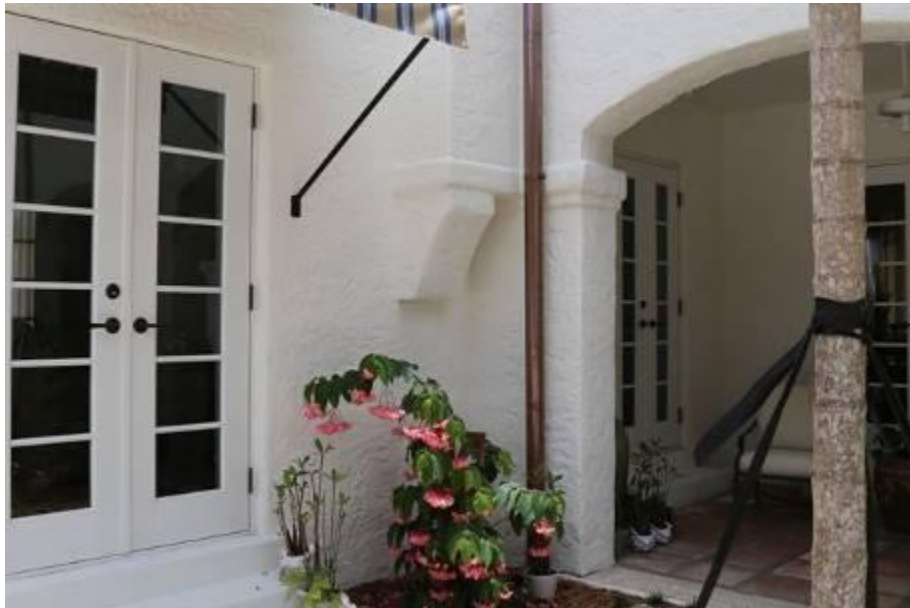
Photo Number: Image 22 (Before)

Stucco Detail View at Chimney Base

Describe Work and Impact on Existing Feature: New Impact Doors and remove existing window for new open terrace, remove security grillwork

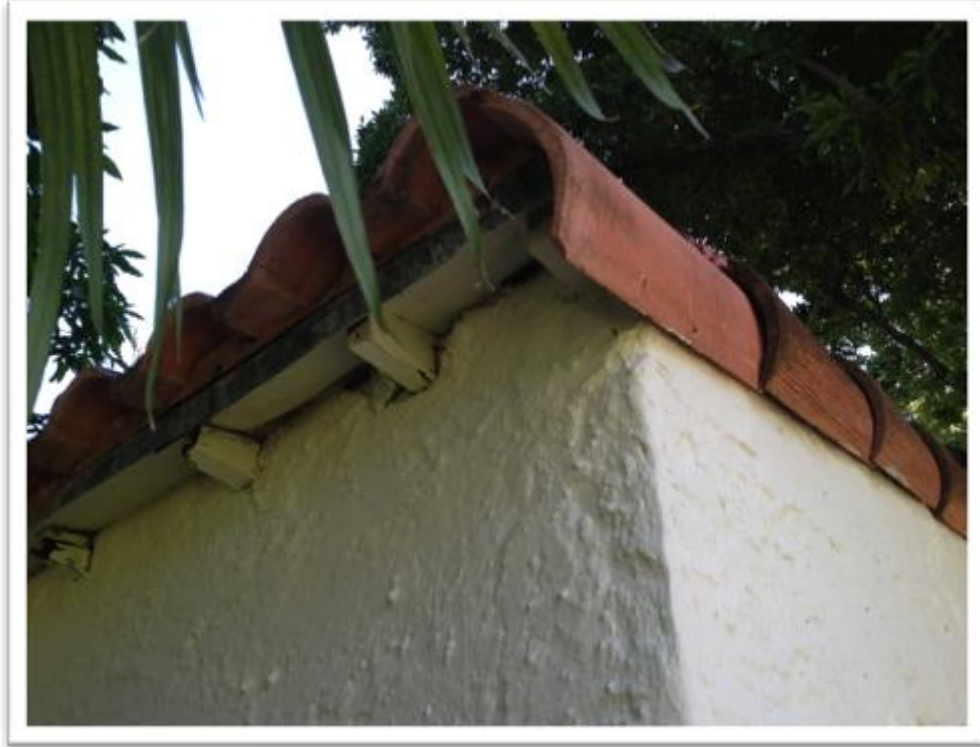
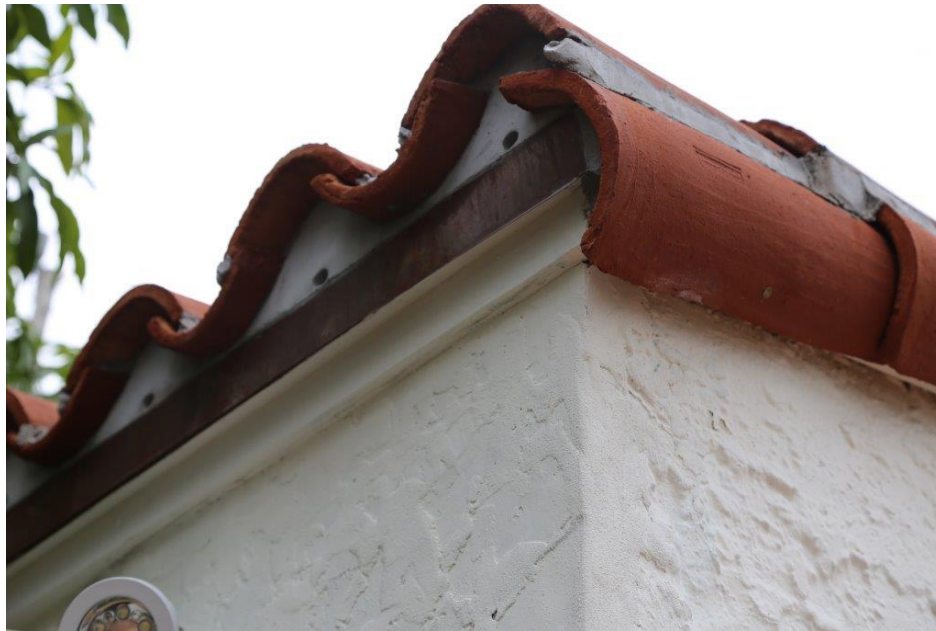
Photo Number: Image 23 (Before)

Detail View of Typical Roof Overhang

Describe Work and Impact on Existing Feature: New Barrel Roof Tile, Repair Wood Overhang, New Paint

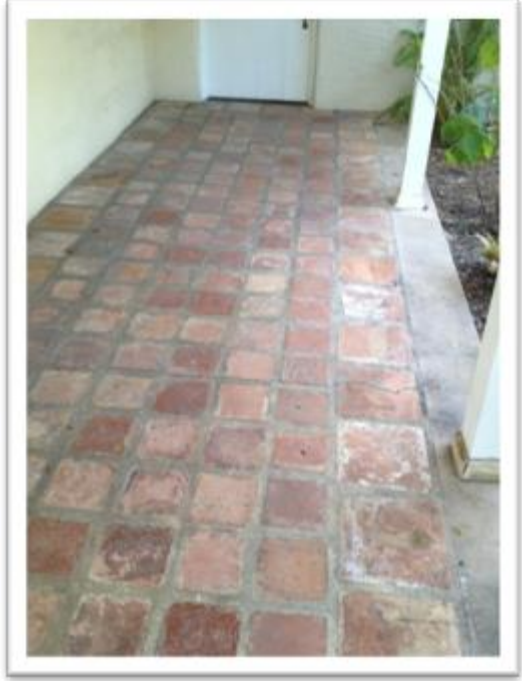
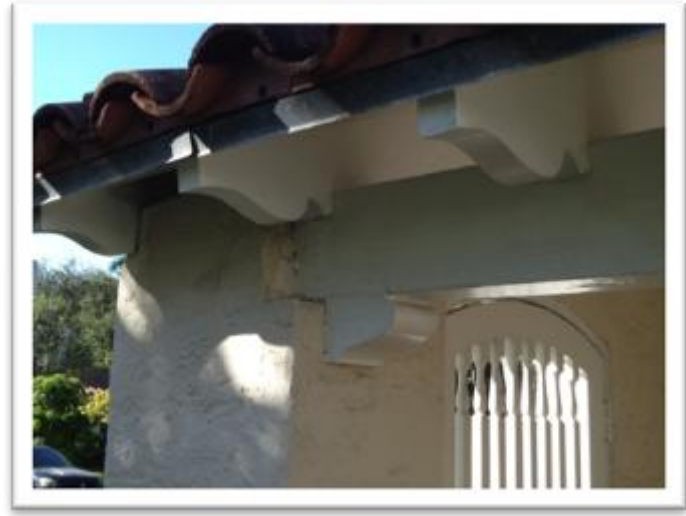
Photo Number: Image 24 & 25 (Before)

Detail View of Floor Tile at Courtyard, View of Beam & Outriggers at Courtyard

Describe Work and Impact on Existing Feature: Clean and Repair visible cracks in wood beam, New Paint
