40 YEAR INSPECTION

RE: 40 YEAR RECERTIFICATION

RE: Case No.: NOTE: No Parking Lot / Street Parking only
Property Address: 119 Menores Ave. Coral Gables, FL 33134
Building Description: 2 story CBS, Wood Frame FL/RF, 16 units

**40 YEAR INSPECTION - STRUCTURAL
ATTACHEMENTS TO REPORT PREPARED FOR 119 MENORES AVENUE, CORAL GABLES, FL**

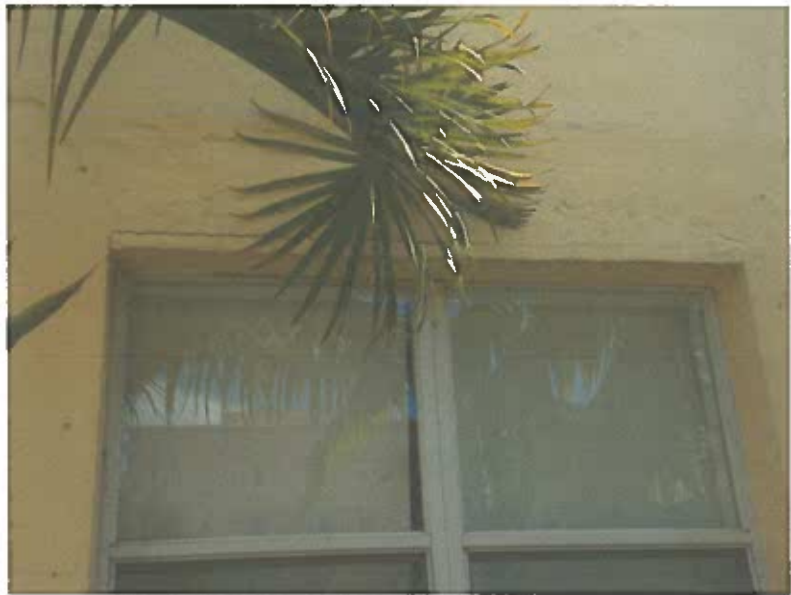
CRACKS IN ELEMENTS LISTED ABOVE ARE GENERALLY HAIRLINE TO MEDIUM. ONE CRACK ABOVE EAST SIDE 1ST FLR WINDOW IS WIDE.

4. EXPANSION CRACK ABOVE WINDOW

RECOMMEND REPAIRS TO EXTERIOR CRACKS TO AVOID FURTHER MOISTURE PENETRATION AND DETERIORATION OF REINFORCING. ROOFING IN CURRENT NEED OF REPAIR AND REPLACEMENT WITHIN THE NEXT 2 TO 3 YEARS.

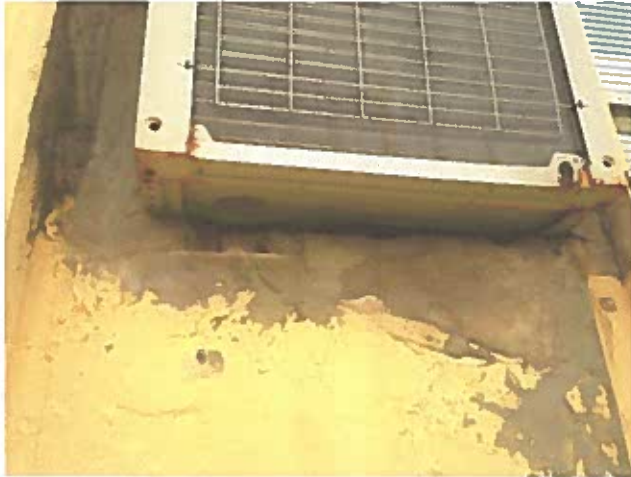
STUCCO CRACKS AS PER ABOVE. ALSO SIGNS OF MOISTURE PENETRATION IN ROOF STRUCTURE. RECOMMEND ROOF REPAIR OR REPLACEMENT WITHIN THE NEXT 2 YEARS. MOISURE PENETRATION NOTED THRU PARAPET AND AROUND THRU-WALL AIR CONDITIONERS.

5. AIR CONDITIONING INSTALLATION

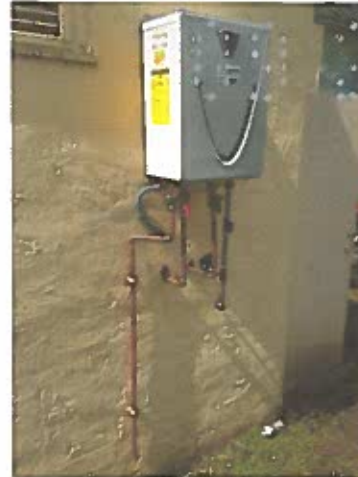
g. Masonry finishes - exterior	
1. Stucco	FAIR
2. Veneer	N/A
3. Paint only	GOOD
4. Other(describe)	OPENINGS AROUND AIR CONDITIONERS AND PIPE PENETRATIONS IN NEED OF REPAIR

6. PENETRATION OPENINGS @ WH

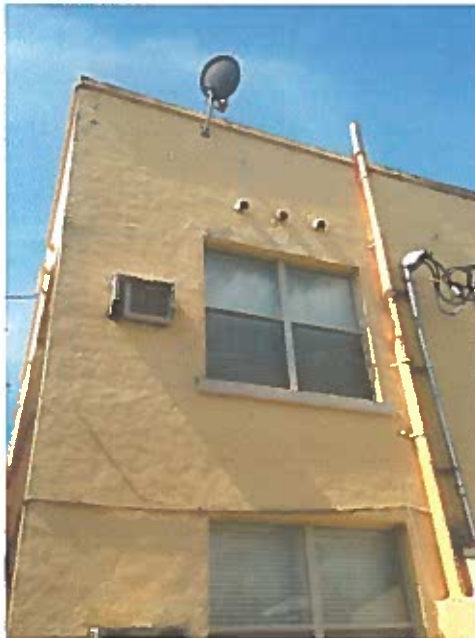
PARAPET HAS BOTH HORIZONTAL AND VERTICAL CRACKS IN NEED OF REPAIR.

7. PARAPET CRACKS (REAR)

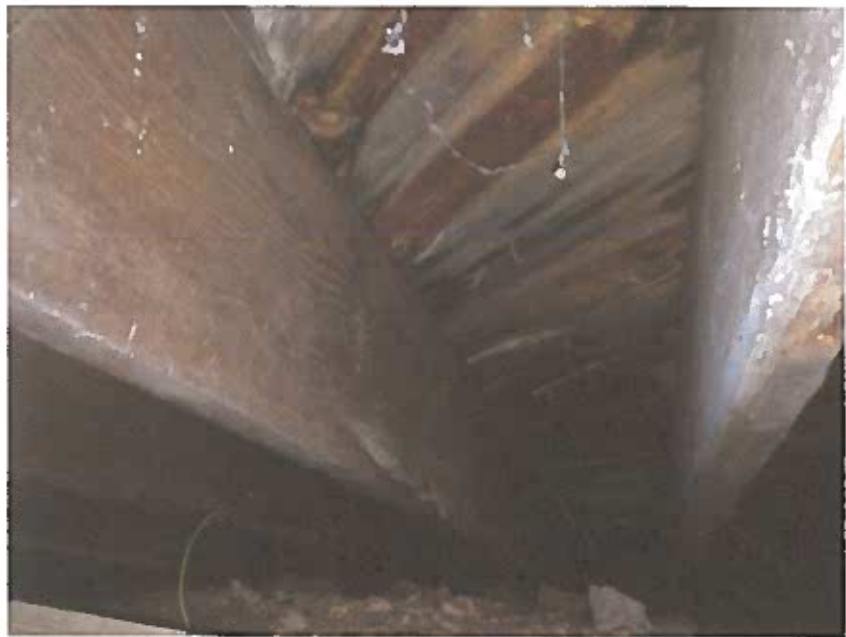
c. Inspection – note exposed areas available for inspection, and where it was found necessary to open ceilings, etc. for inspection of typical framing members.
ROOF FRAMING VISIBLE THRU CEILING ACCESS PANEL
1ST FLOOR FRAMING VISIBLE FROM ACCESS OPENINGS. NO DISTRESS OF 2ND FLOOR FRAMING VISIBLE IN FINISHES.

8 FIRST FLOOR FRAMING (EAST SIDE)

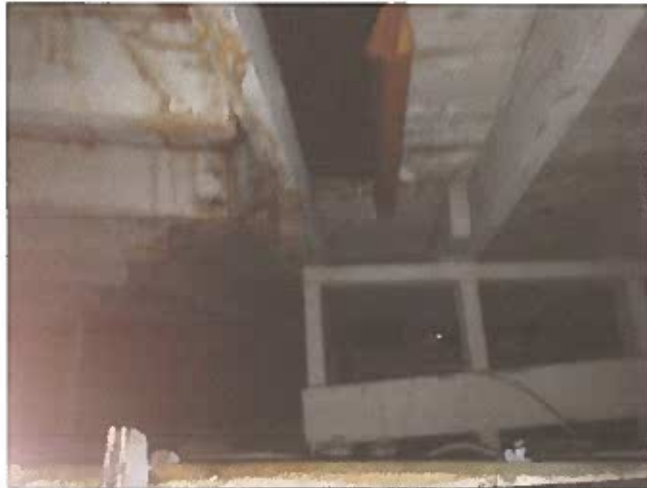
a. Roof:
1. Describe (flat, slope, type roofing, type roof deck, condition).
LOW SLOPE WITH BUILT UP MEMBRANE ROOFING ON 1X6 WOOD PLANKS. FAIR CONDITION. RECOMMEND REPAIR (IMMEDIATE) OR REPLACEMENT IN NEXT 2-3 YEARS.

9. ROOF FRAMING
PAGE 2 OF 3

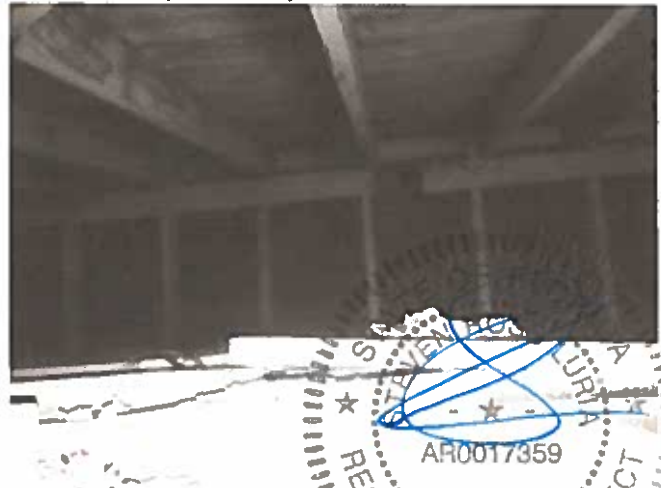
10. ROOF FRAMING

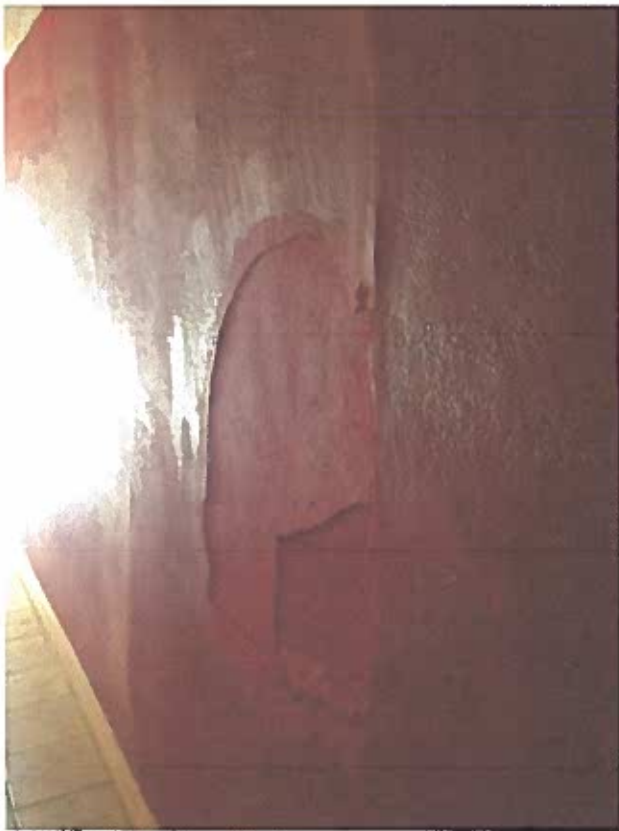
h. Masonry finishes - interior	
1. Vapor barrier	GOOD
2. Furring and plaster	FAIR. HALLWAY PLASTER IN NEED OF REPAIR
3. Paneling	N/A
4. Paint only	GOOD
5. Other (describe)	N/A

13. 2ND FLOOR HALLWAY
