CITY OF CORAL GABLES

- MEMORANDUM -

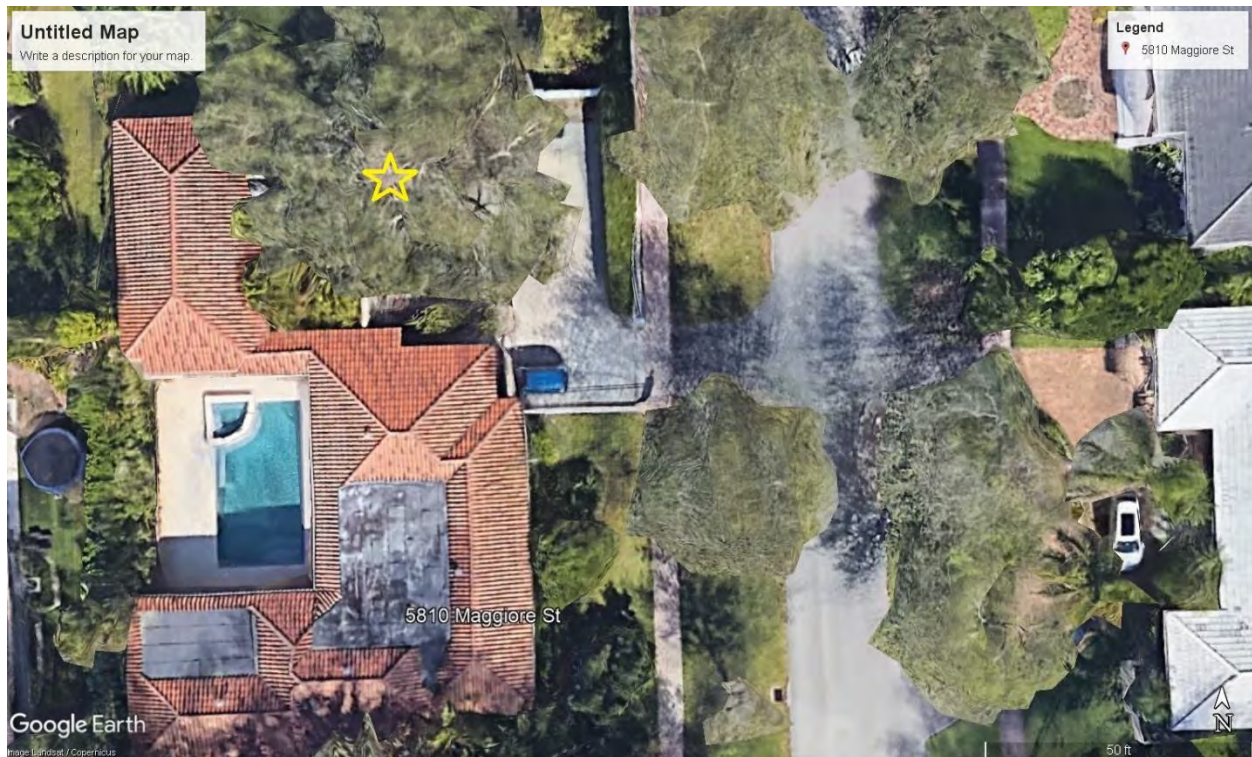
Please see the satellite image marked with the approximate tree location and pictures below.

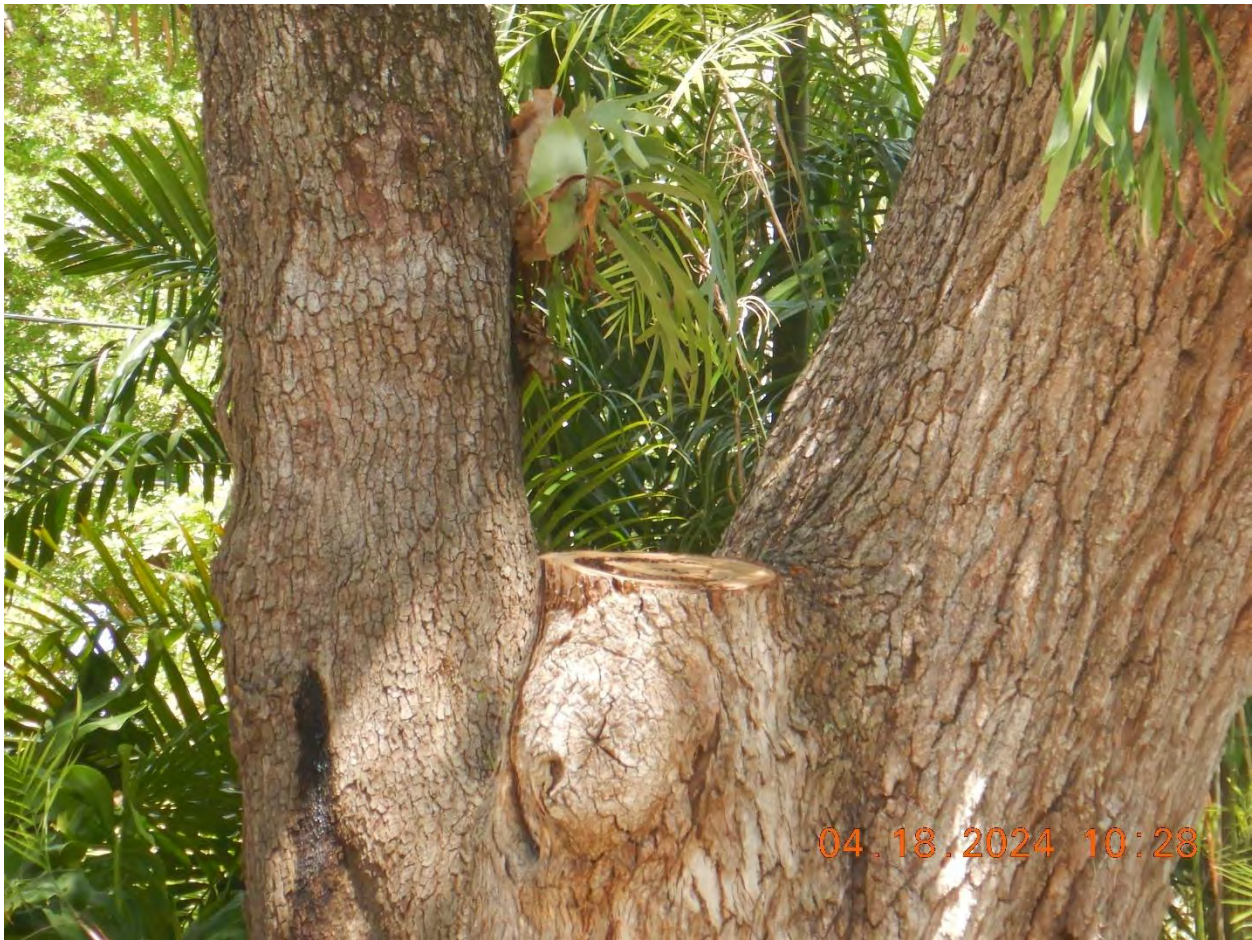
Decay in main fork where branch was removed.

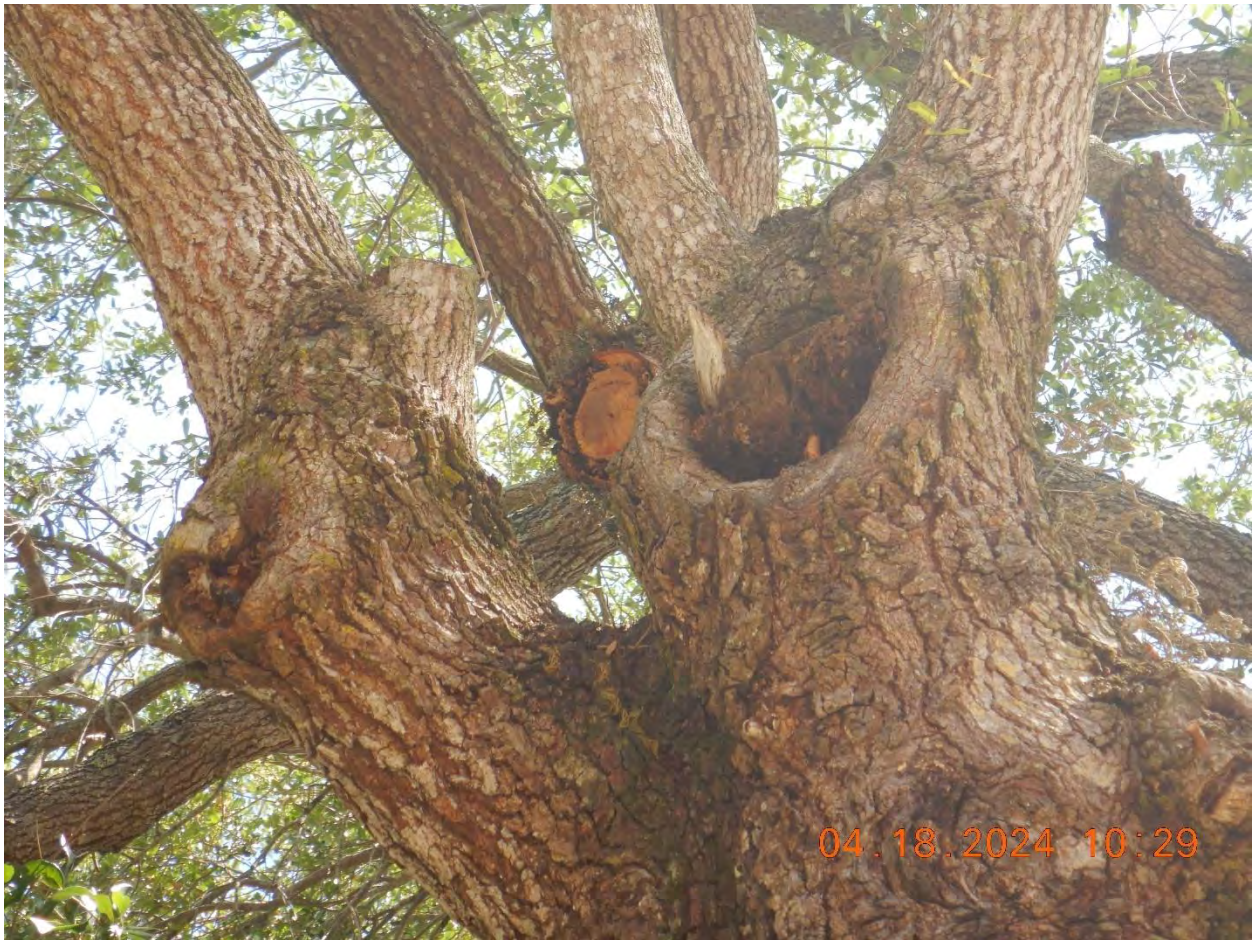
Decay where branches were removed.

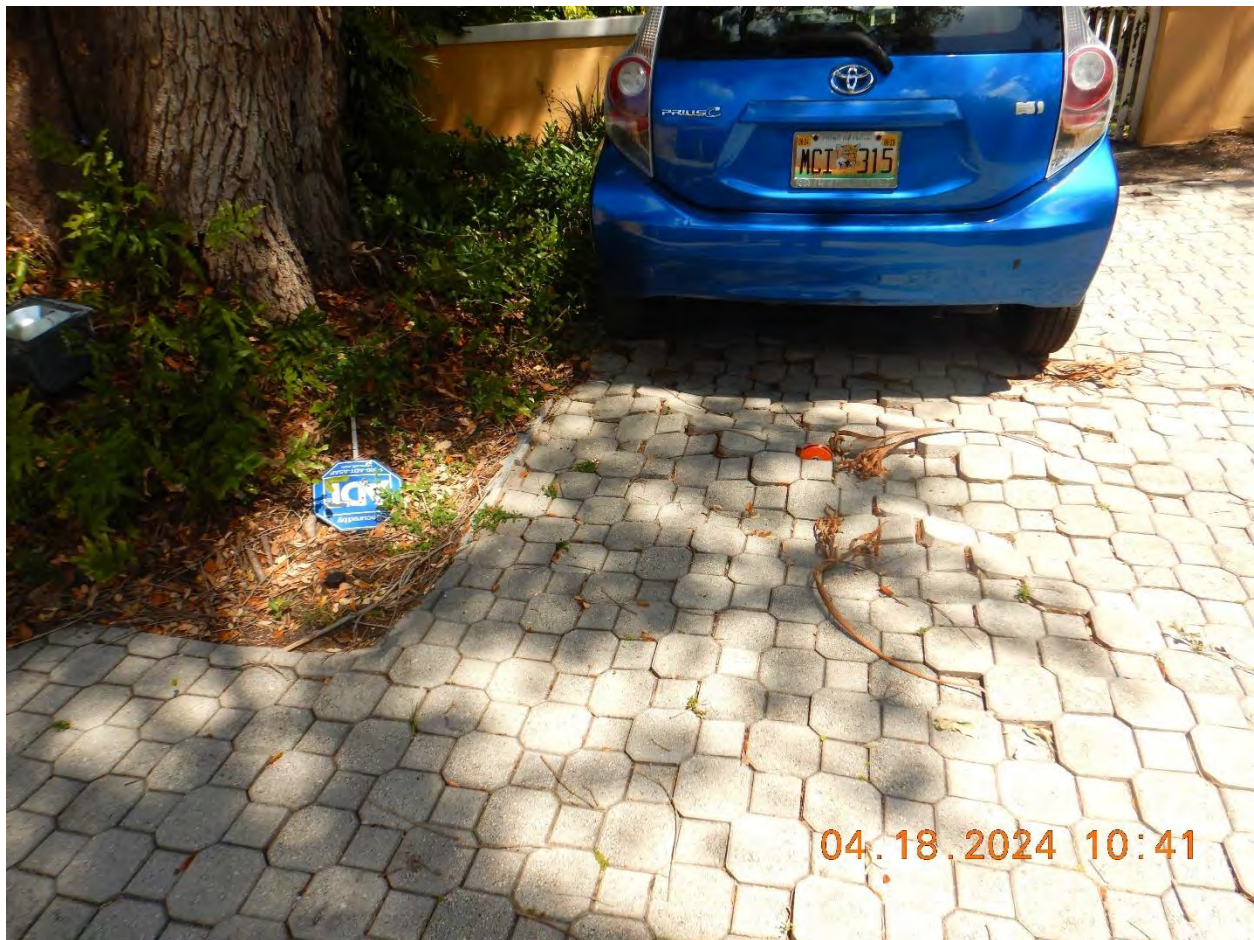
Pavers lifted due to roots.

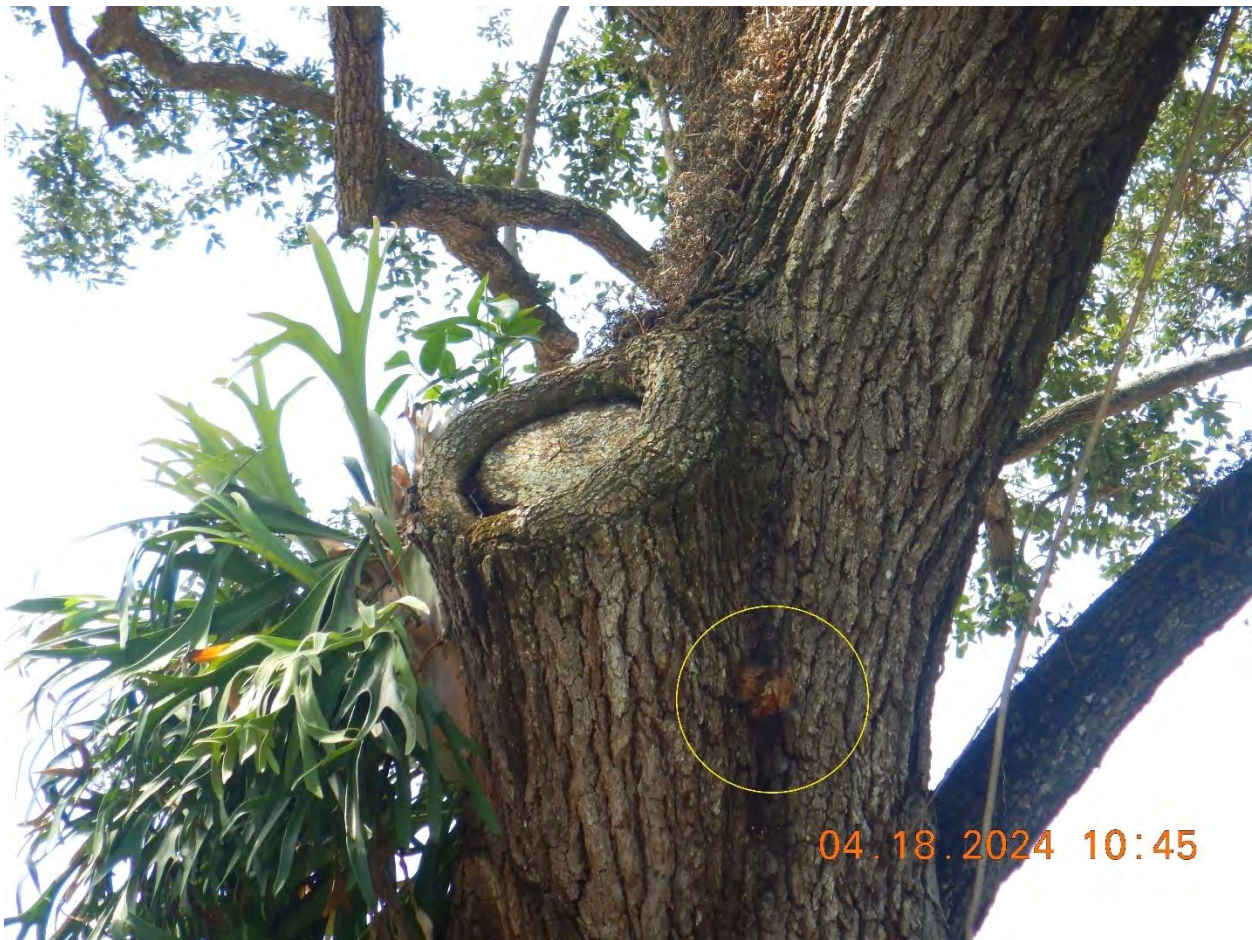
Decay where branch was removed, circle is a heart rot fungal growth.

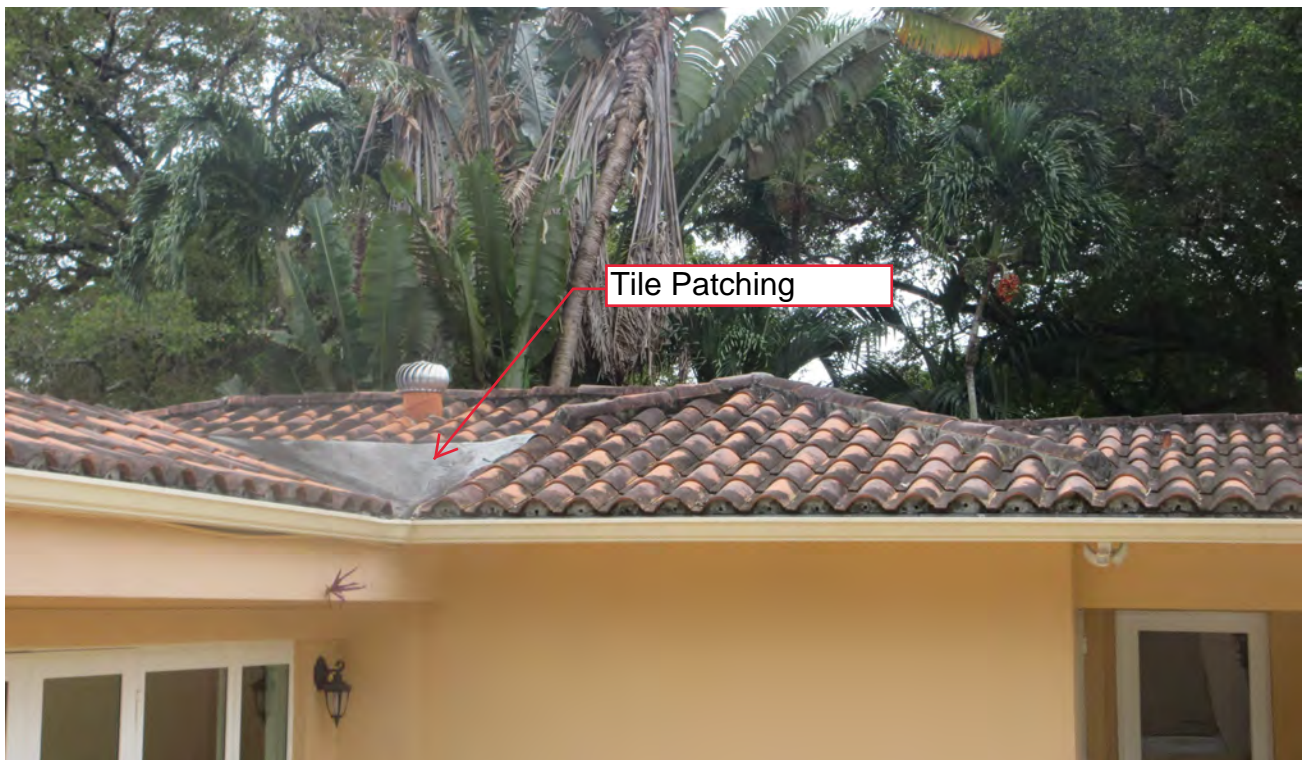
Roof- Degradation of Tiles/Patching

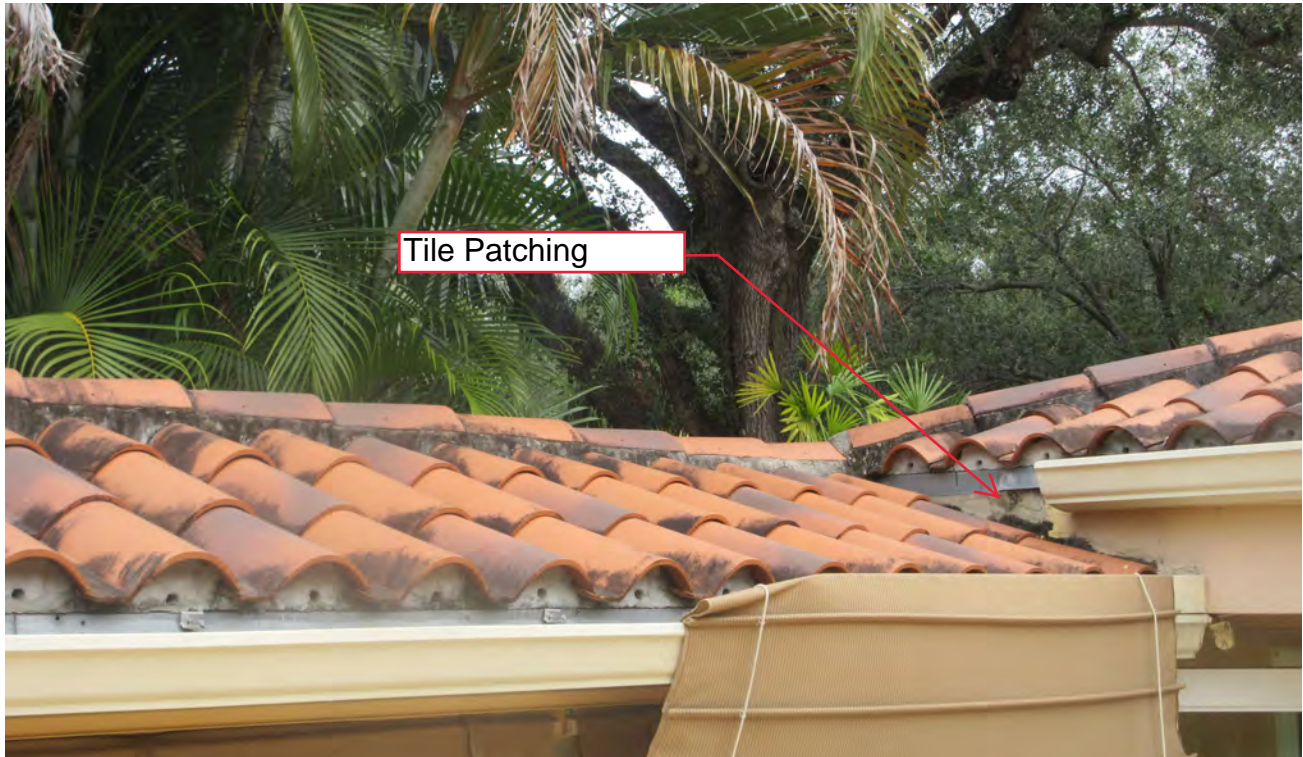
Roof-Degradation of Tiles

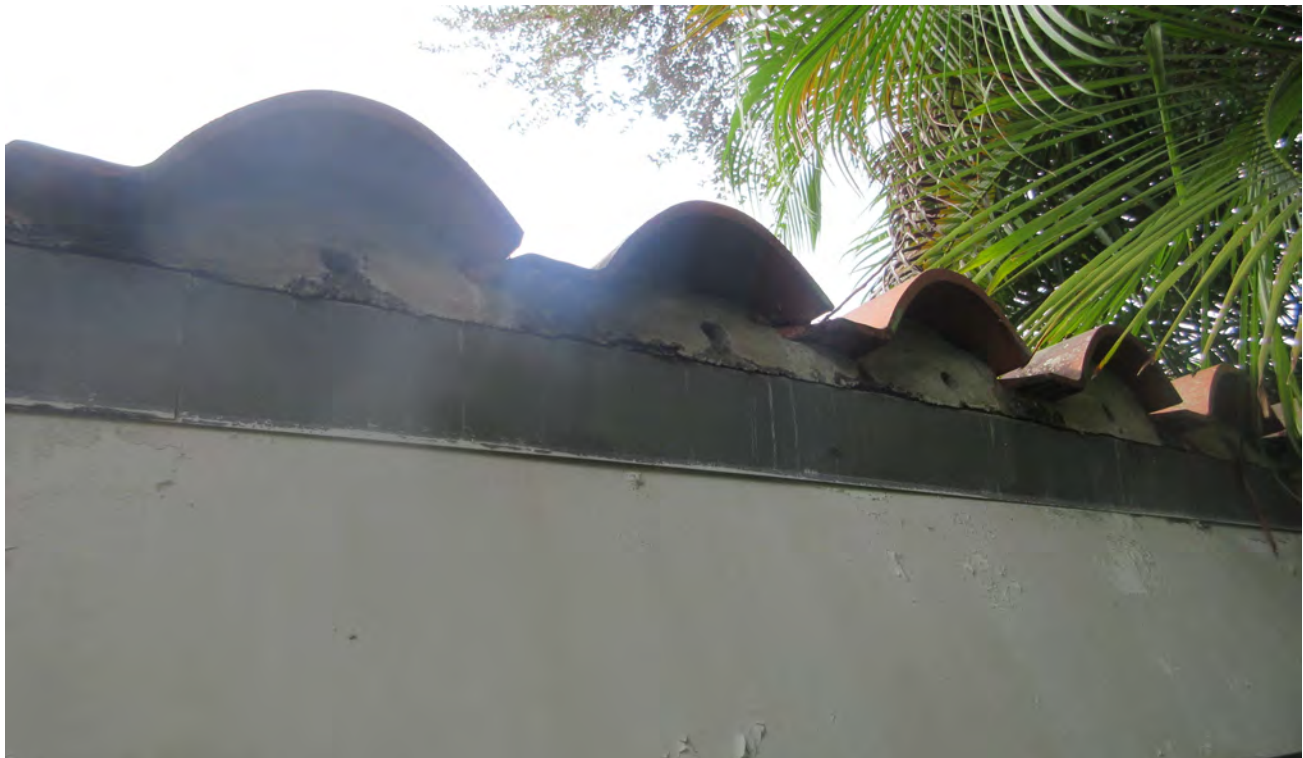
Roof- Degradation of Tile

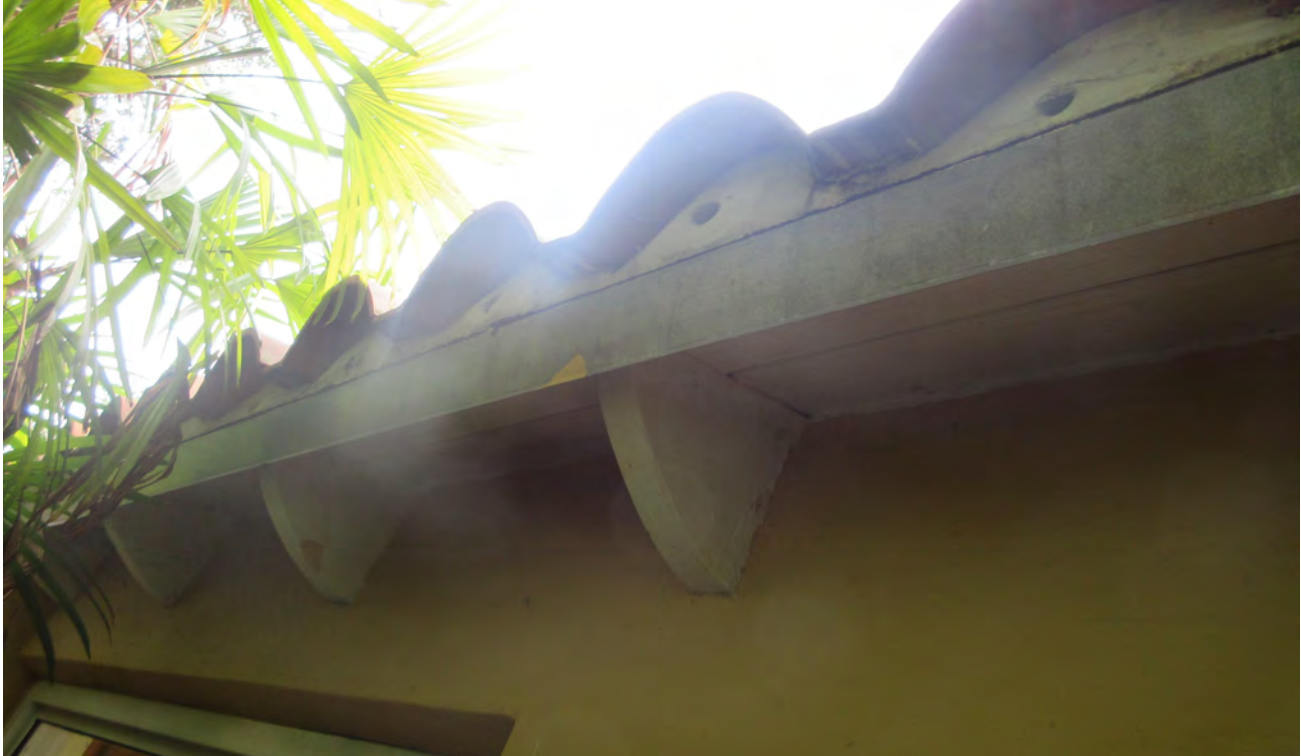
Roof- Degradation of Soffit

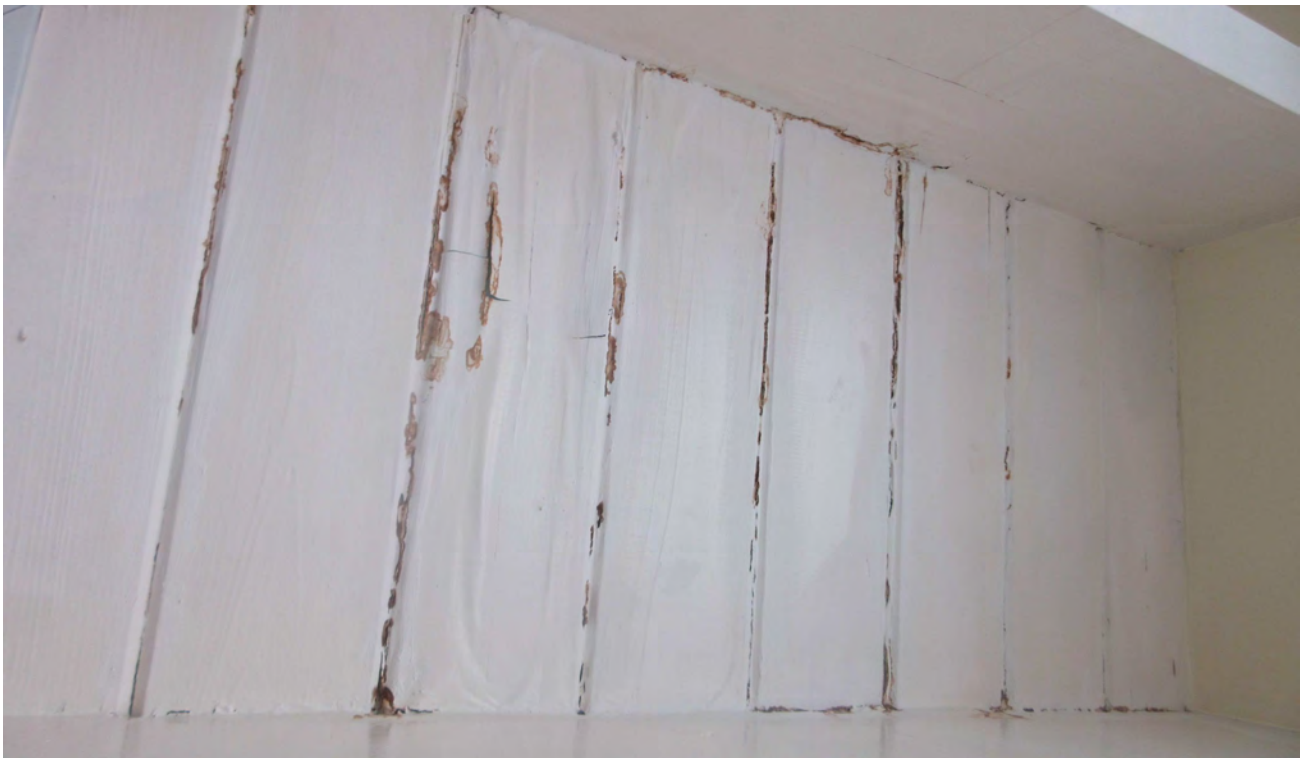
Interior Ceiling- Degradation/Leaks

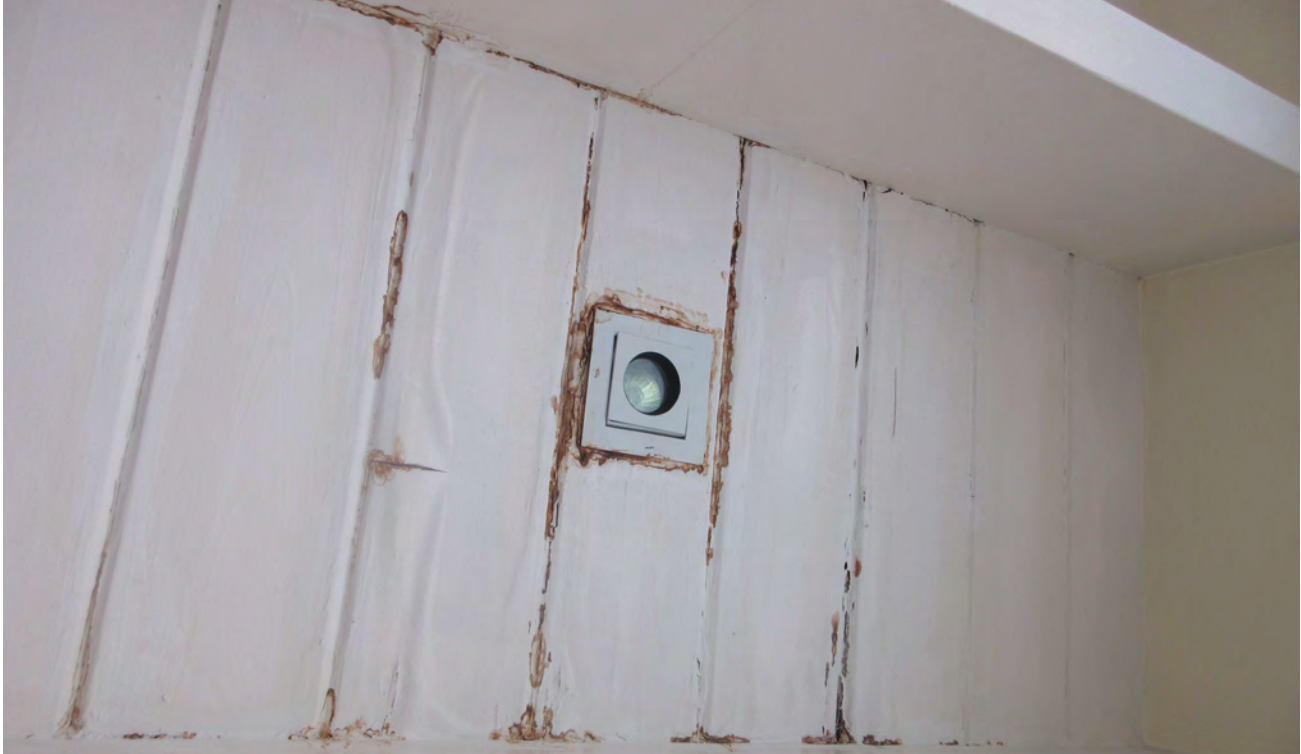
Interior Ceiling- Water Damage and Leaks

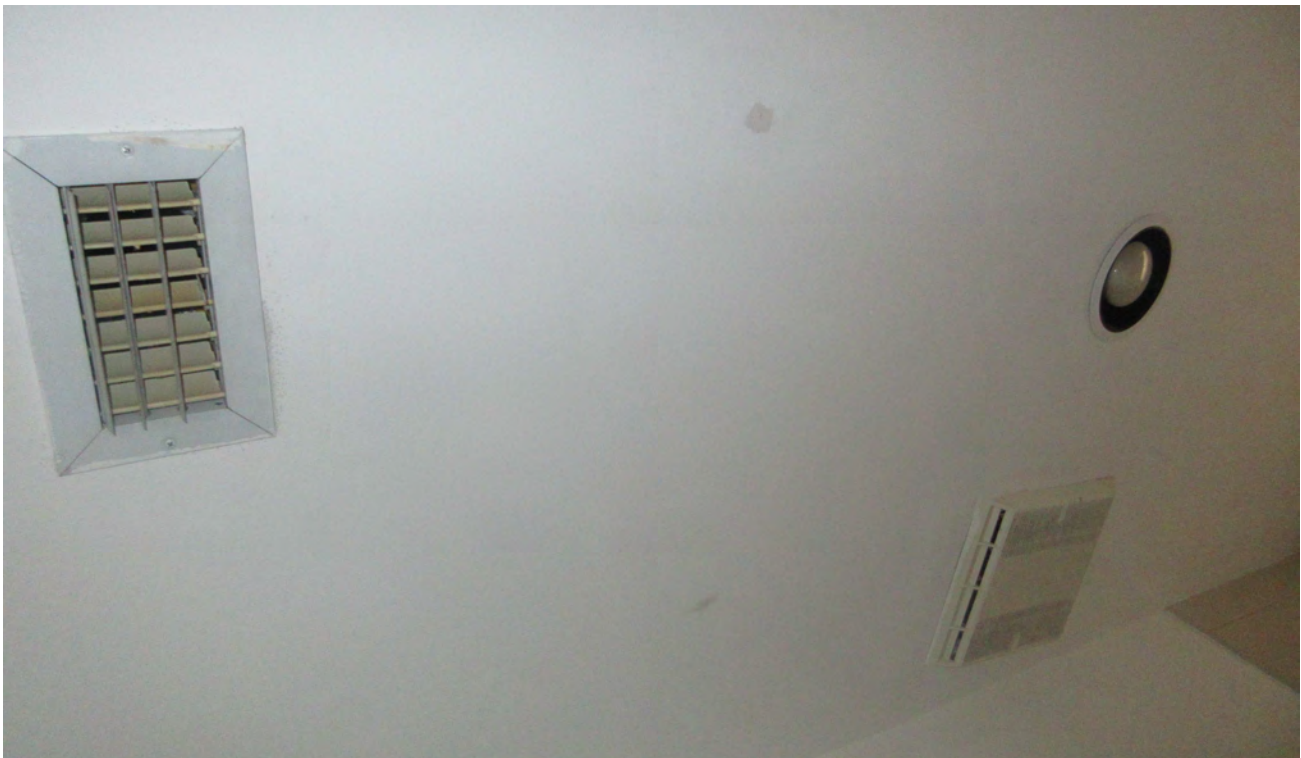
Interior Ceiling- Water Stains

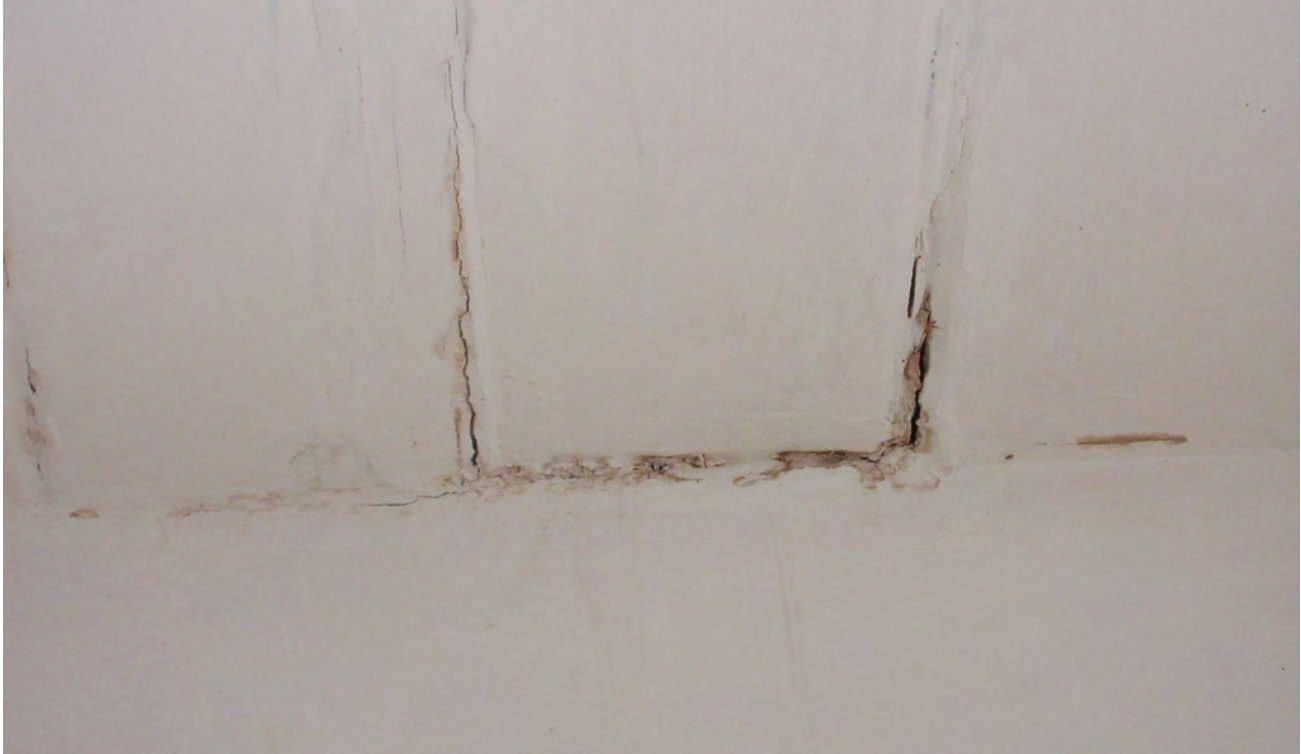
Ceiling- Water Staining

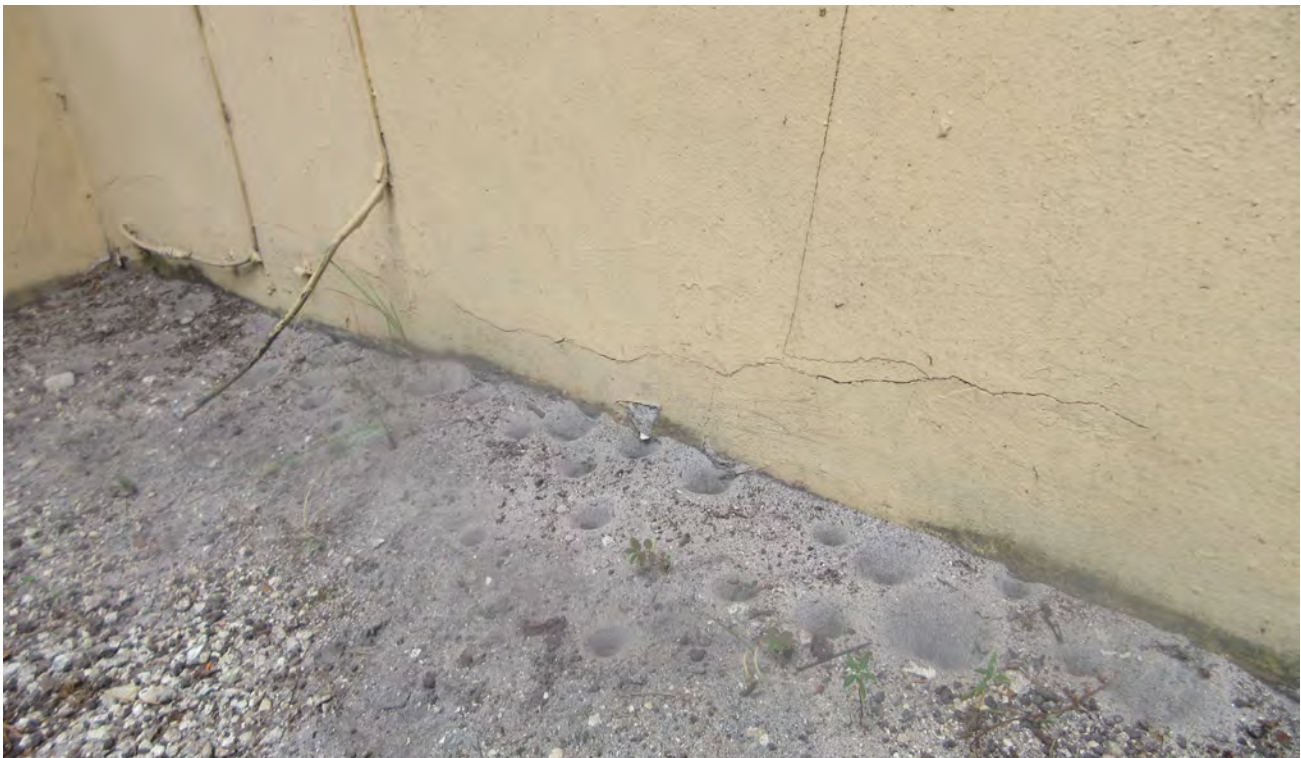
Exterior Wall Cracking - Foundation Failure

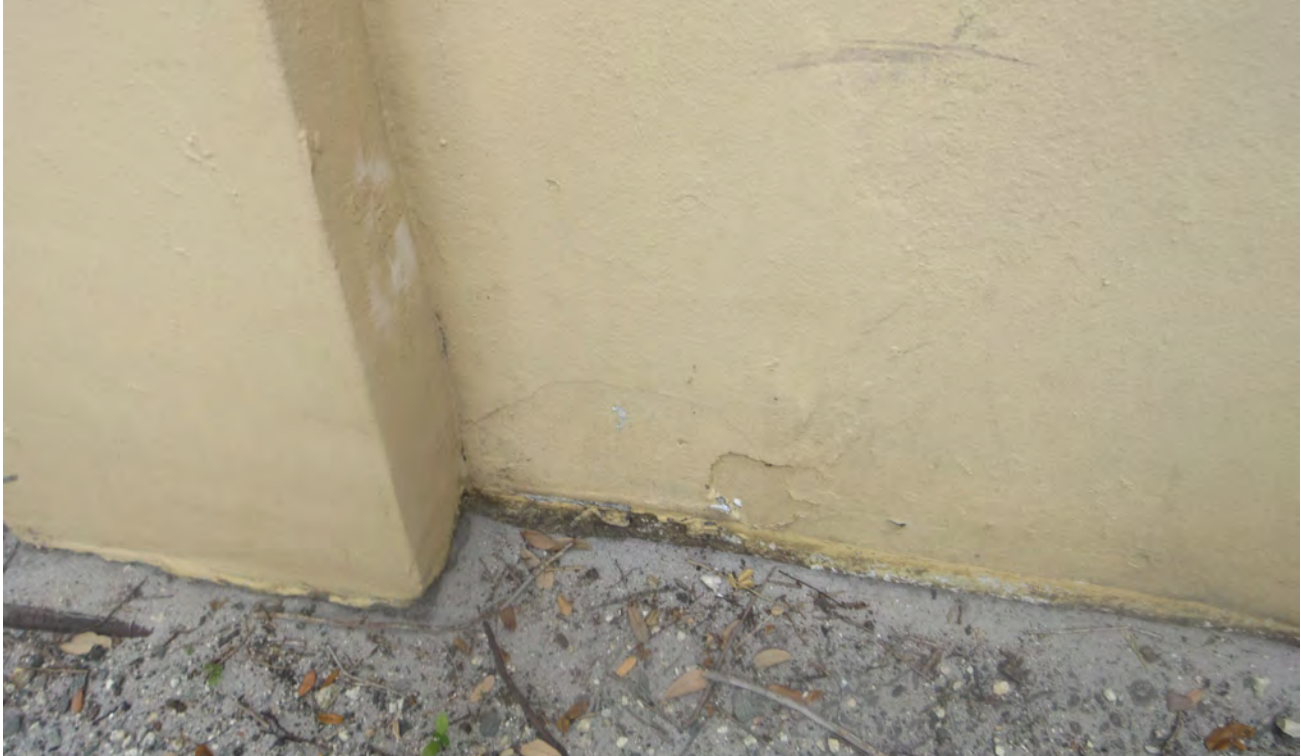
Exterior Walls- Cracking

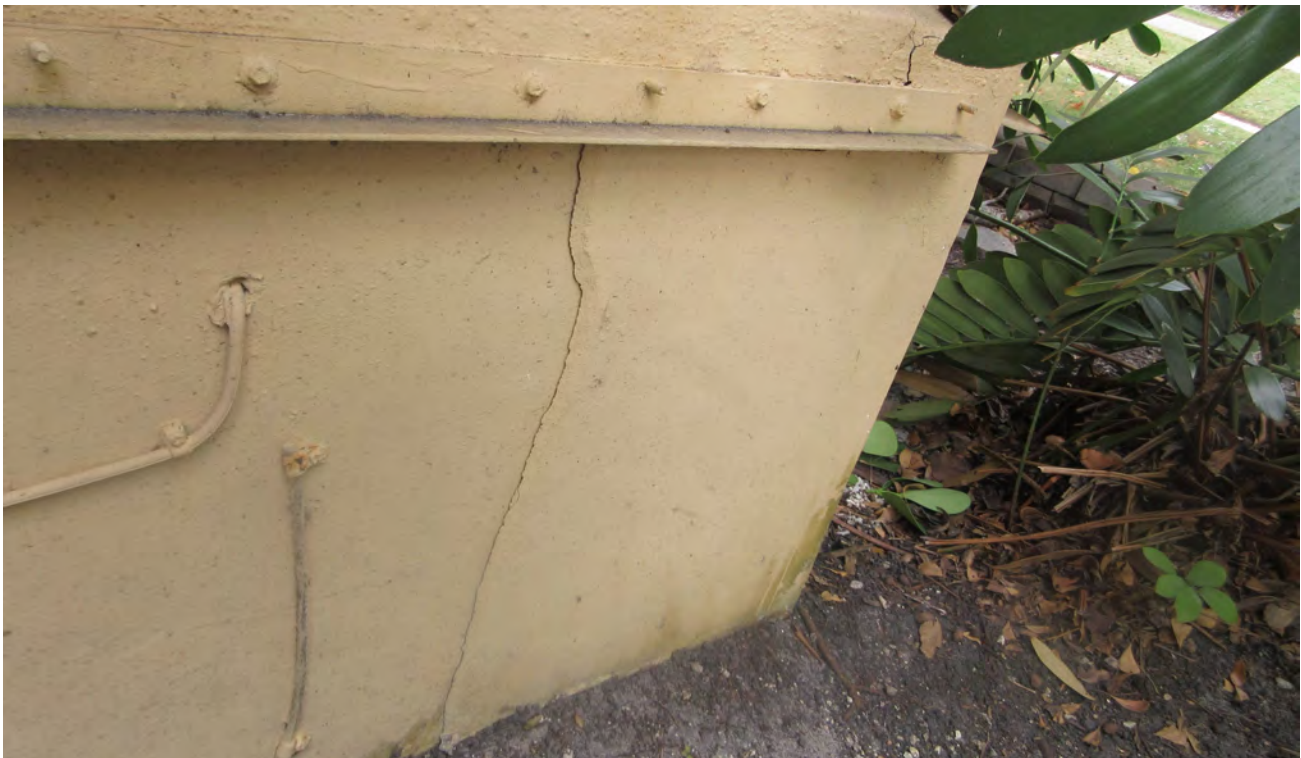
Exterior Wall Cracking - Foundation Failure

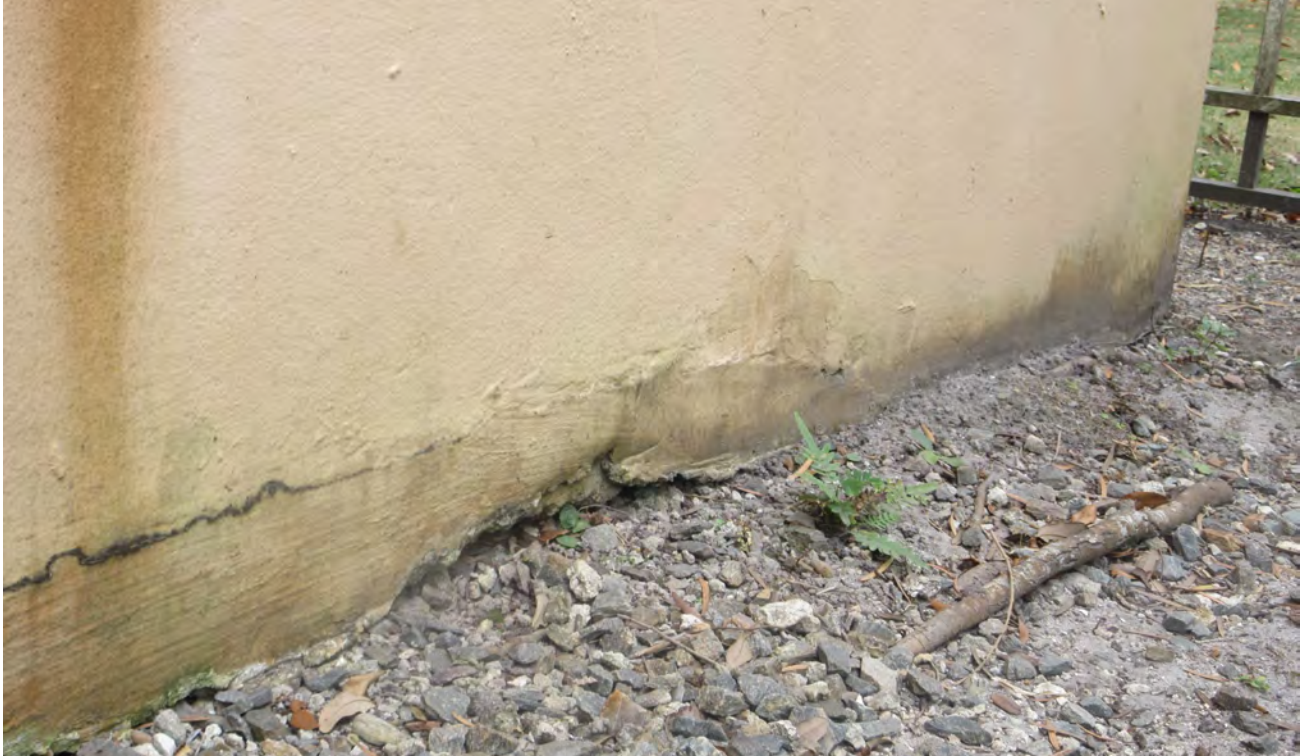
Erosion/Spalling of Foundation

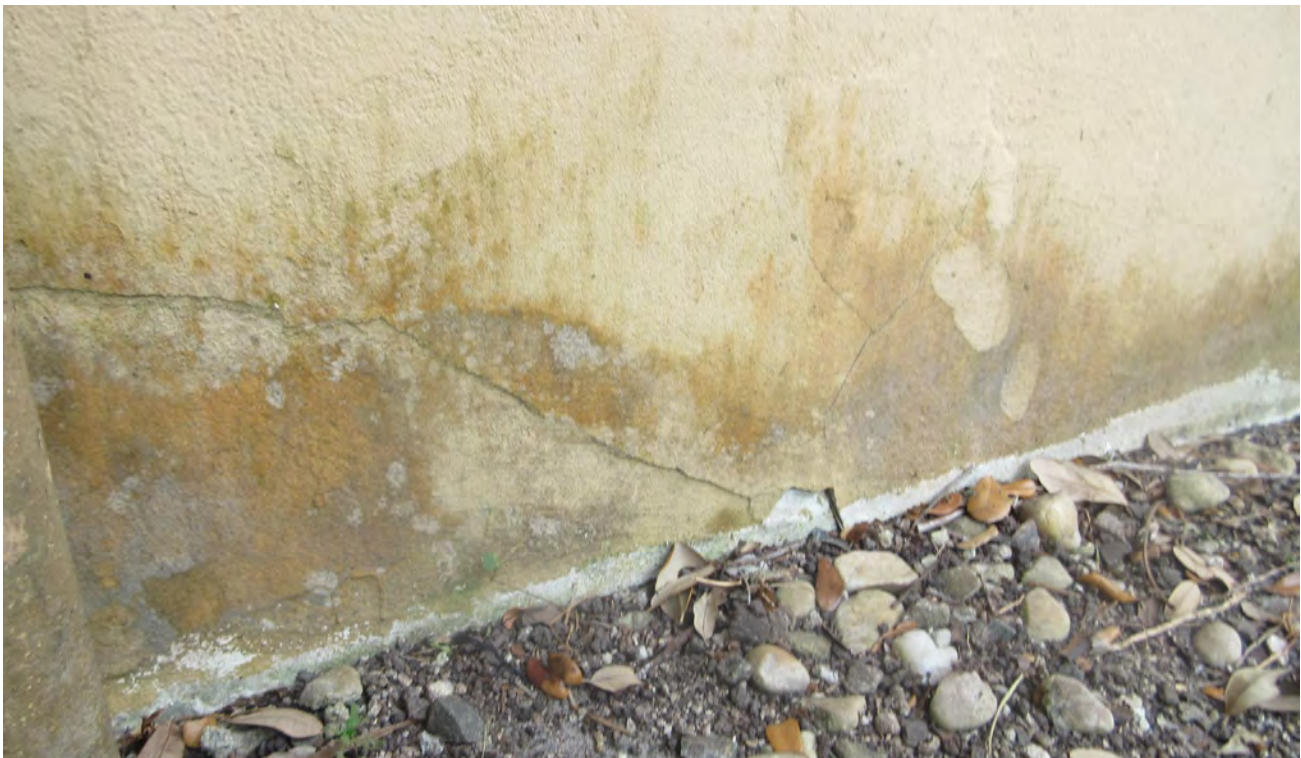
Foundation- Cracking

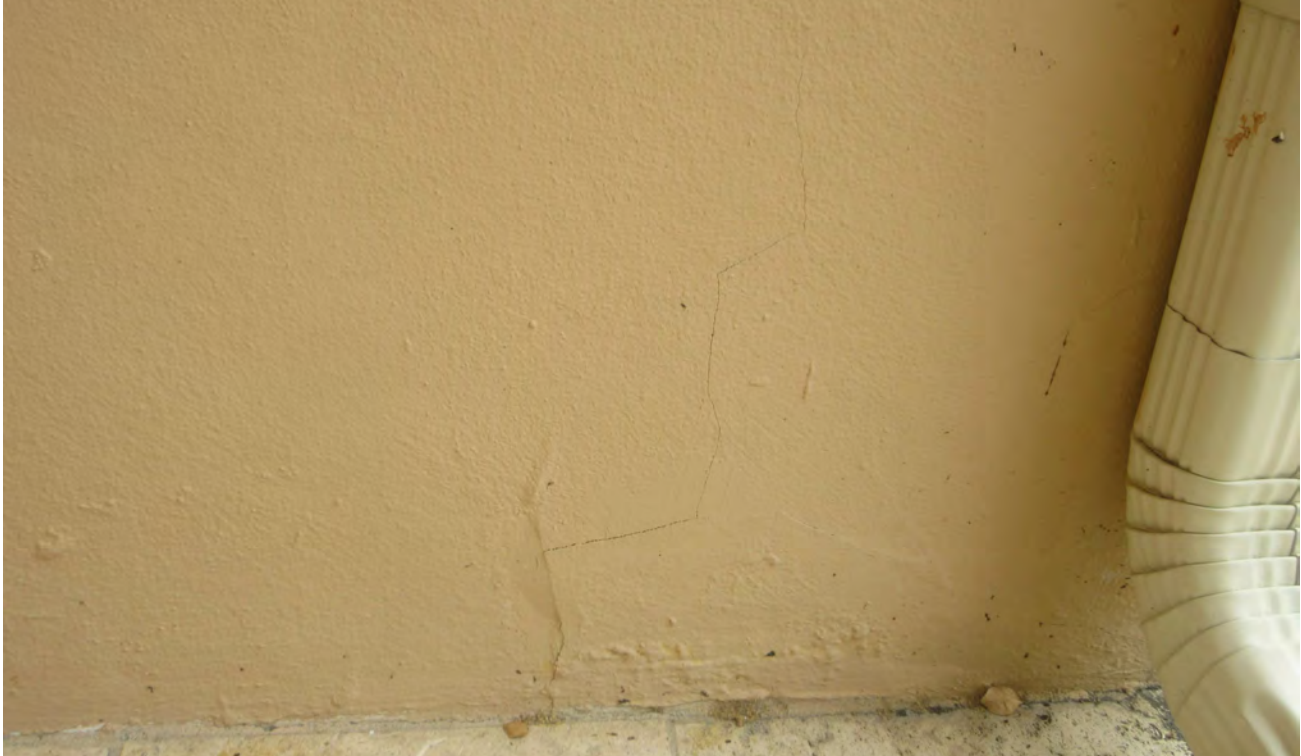
Exterior Wall- Cracking

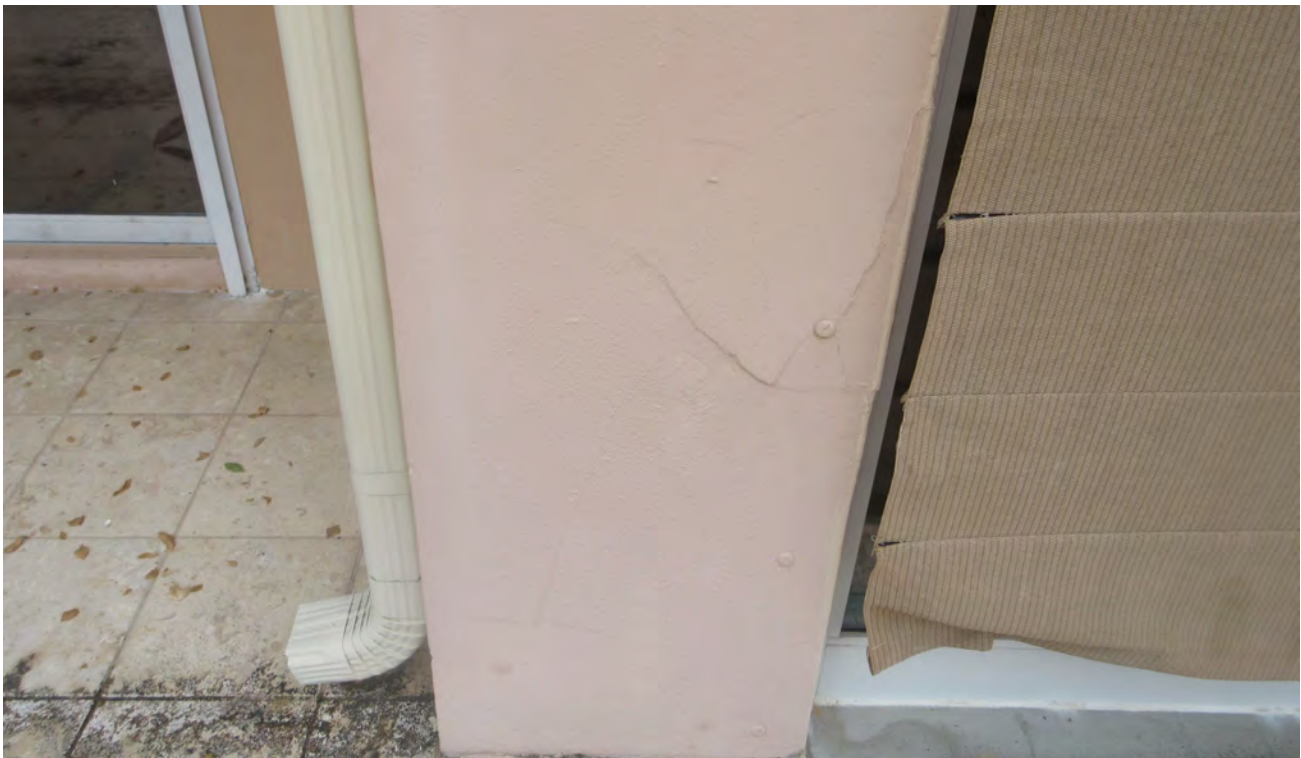
Exterior Wall- Cracking

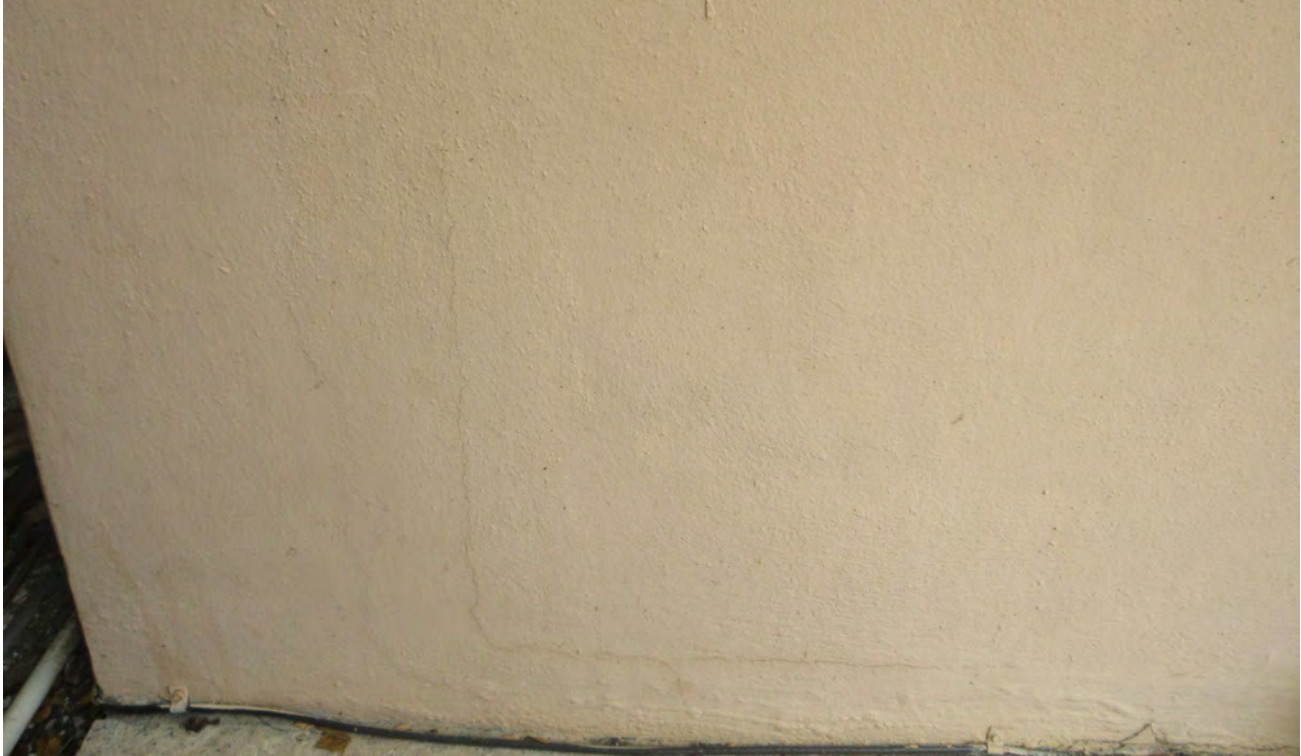
Exterior Walls- Cracking

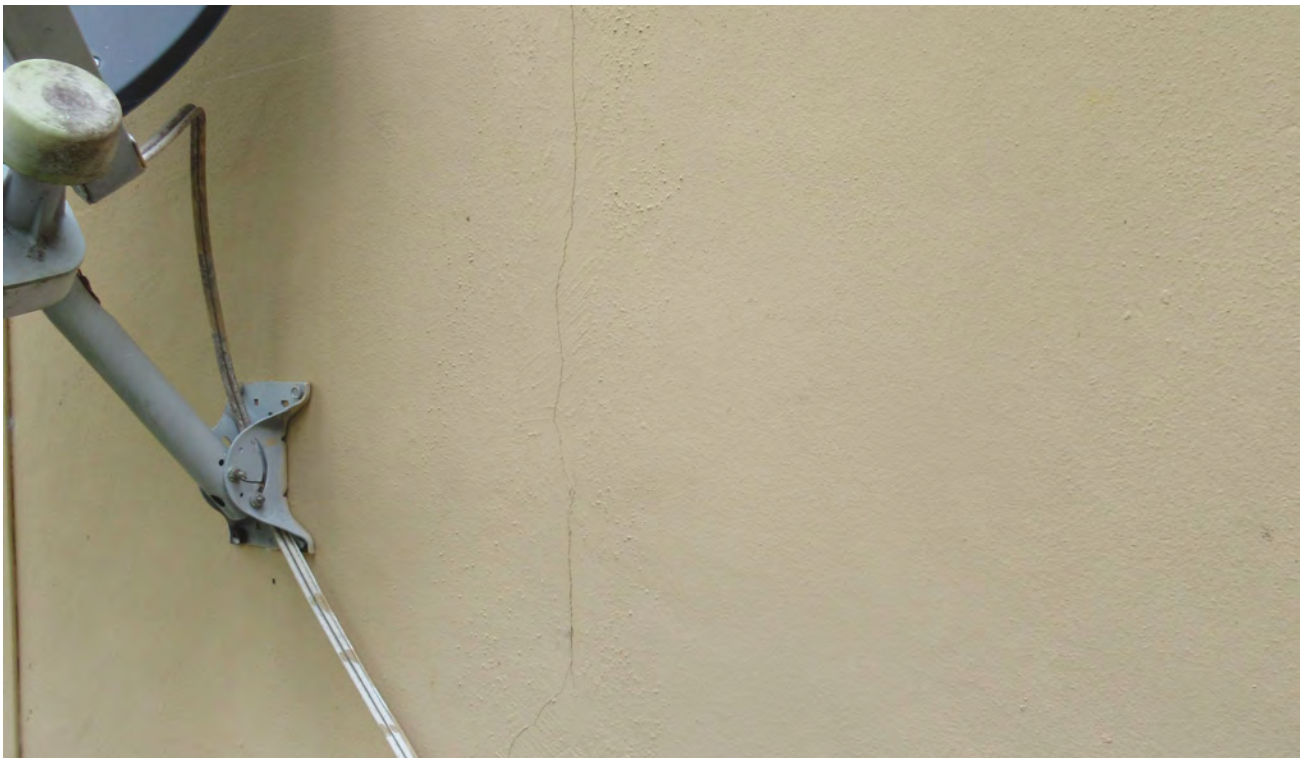
Exterior Walls- Cracking
