CITY OF CORAL GABLES

- MEMORANDUM -

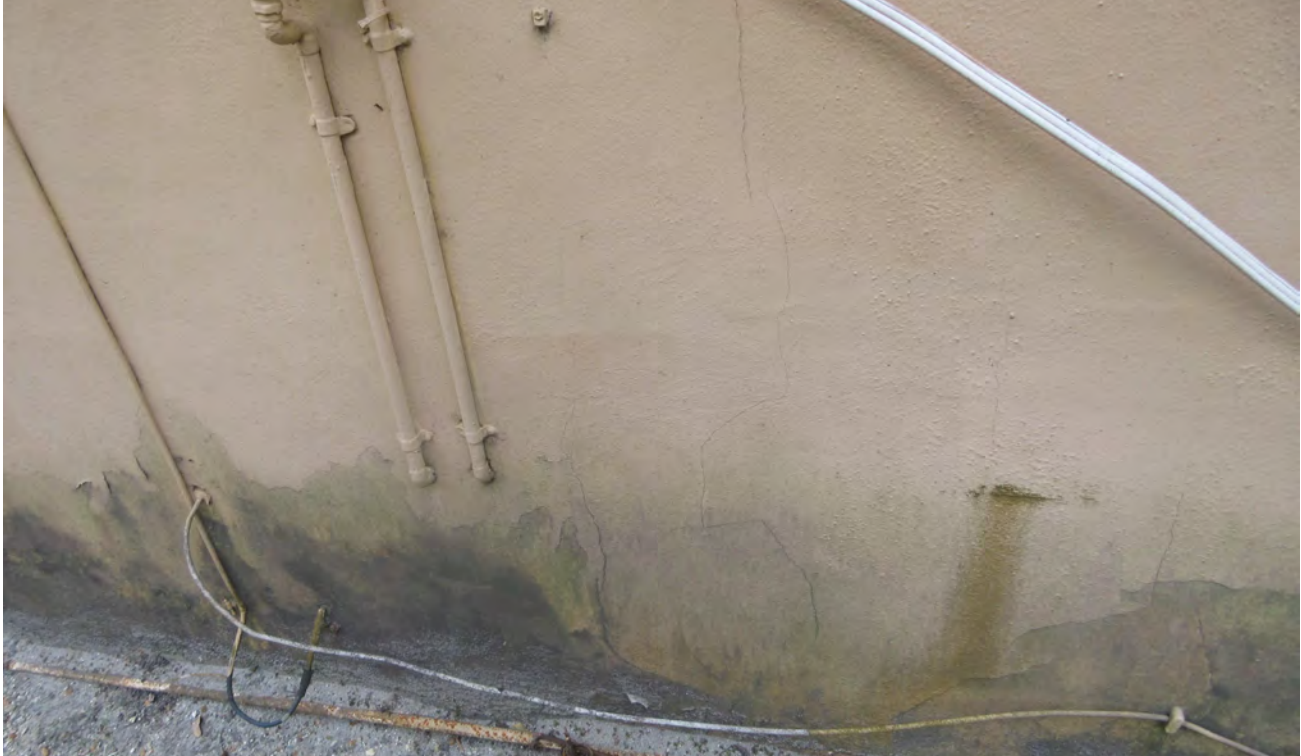
Exterior Walls- Degraded Stucco

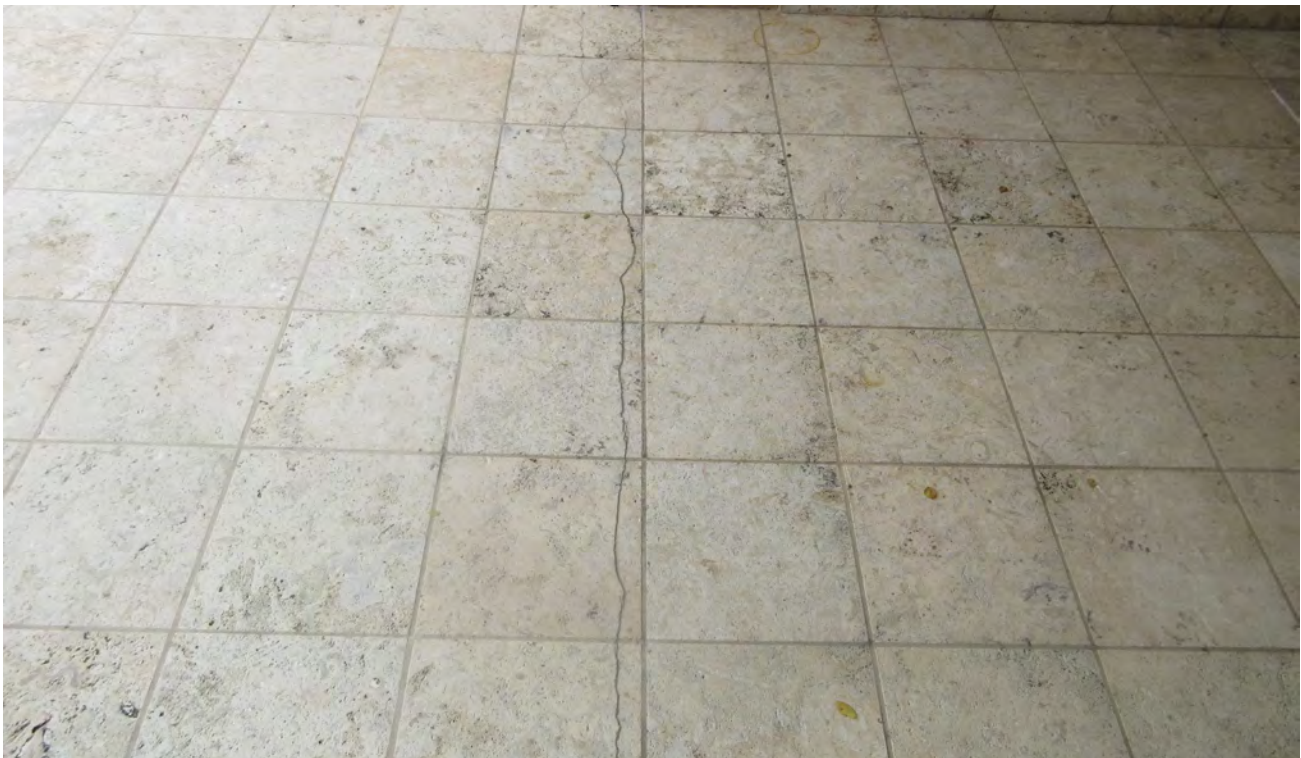
Floor Tile- Cracking

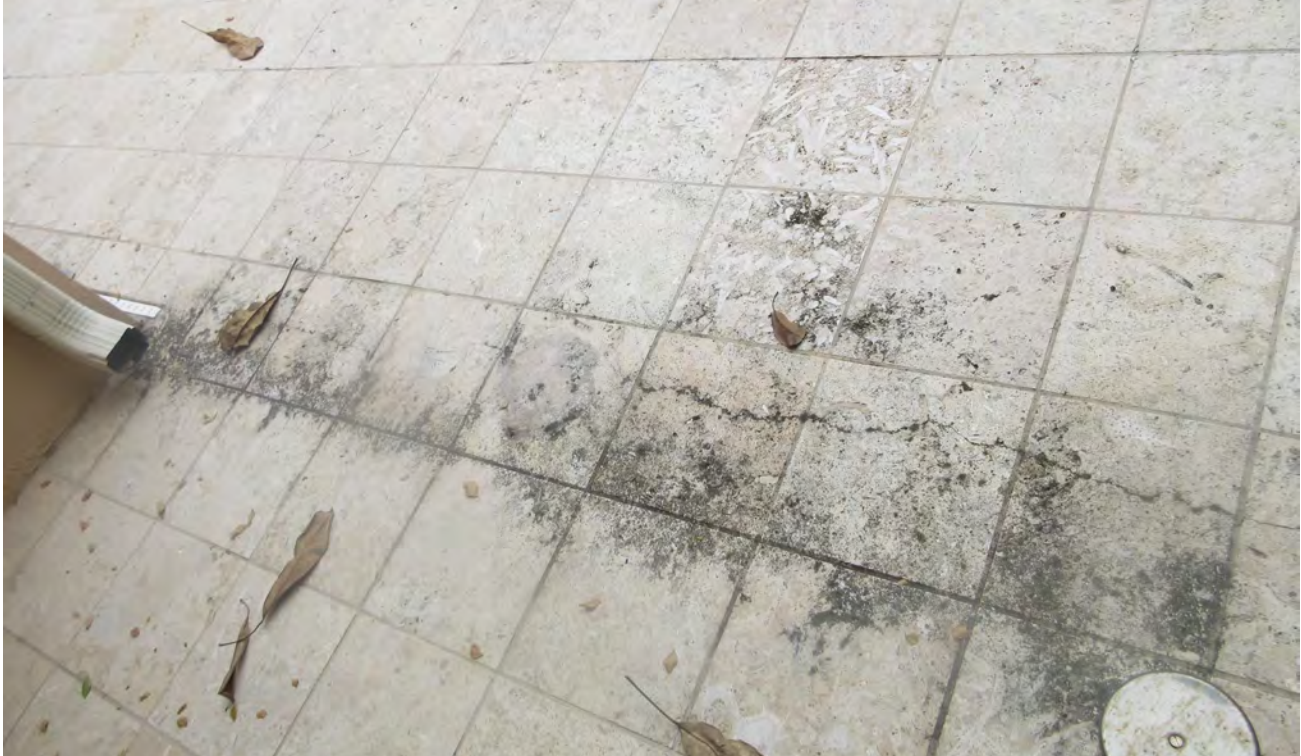
5810 Maggiore Street Coral Gables, FL 33146

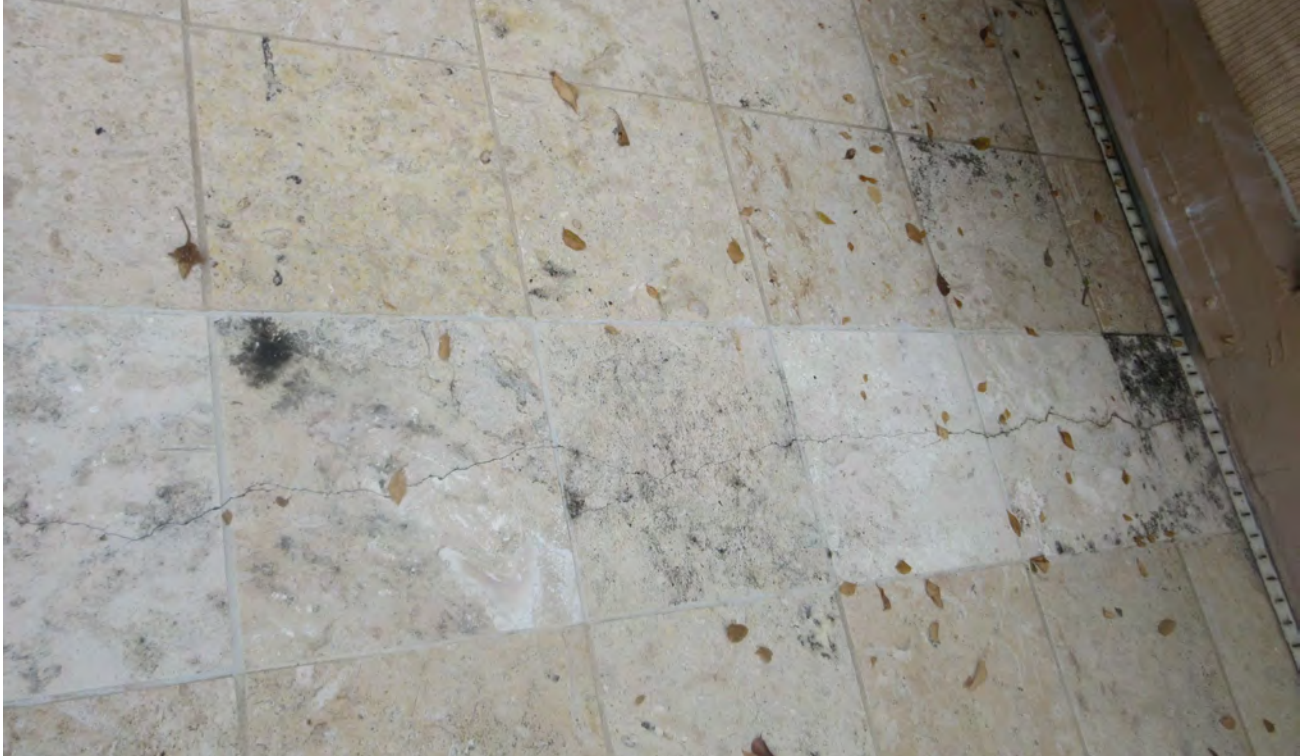
5810 Maggiore Street Coral Gables, FL 33146

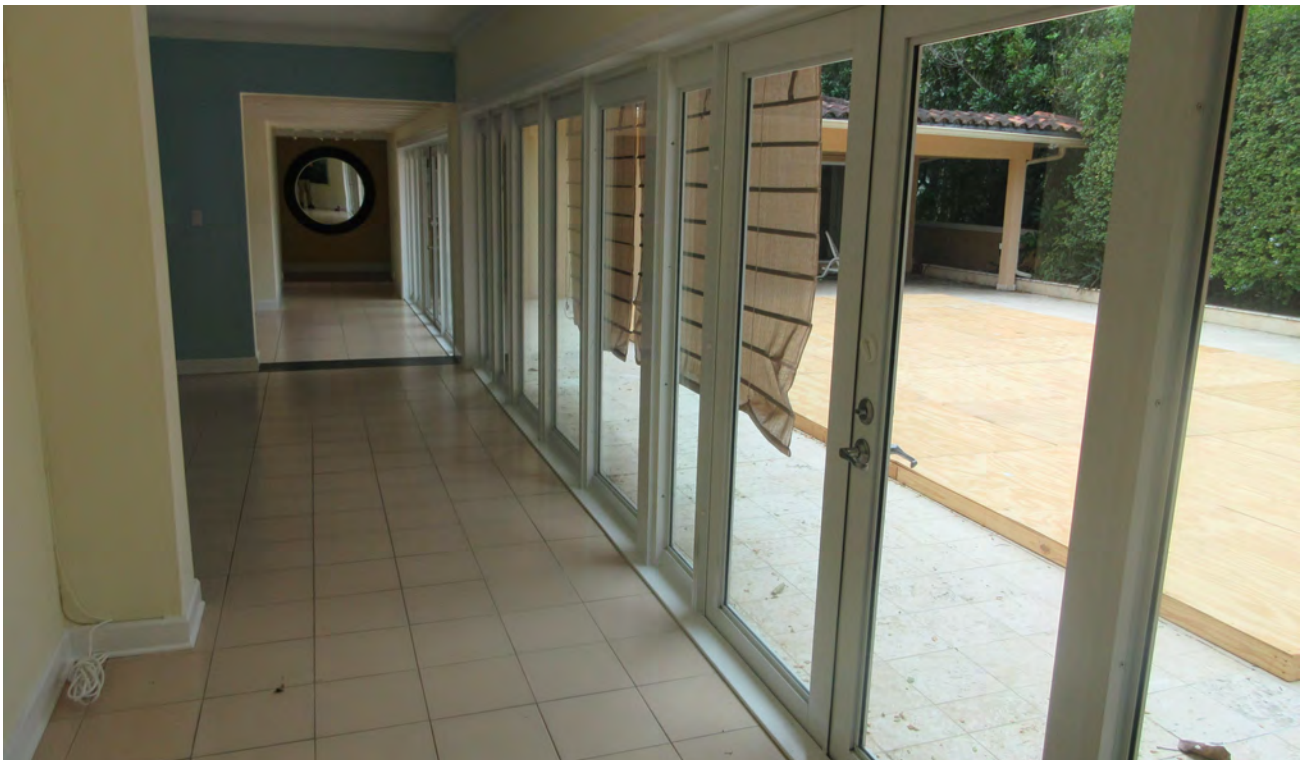
Non-Functional Glass Doors

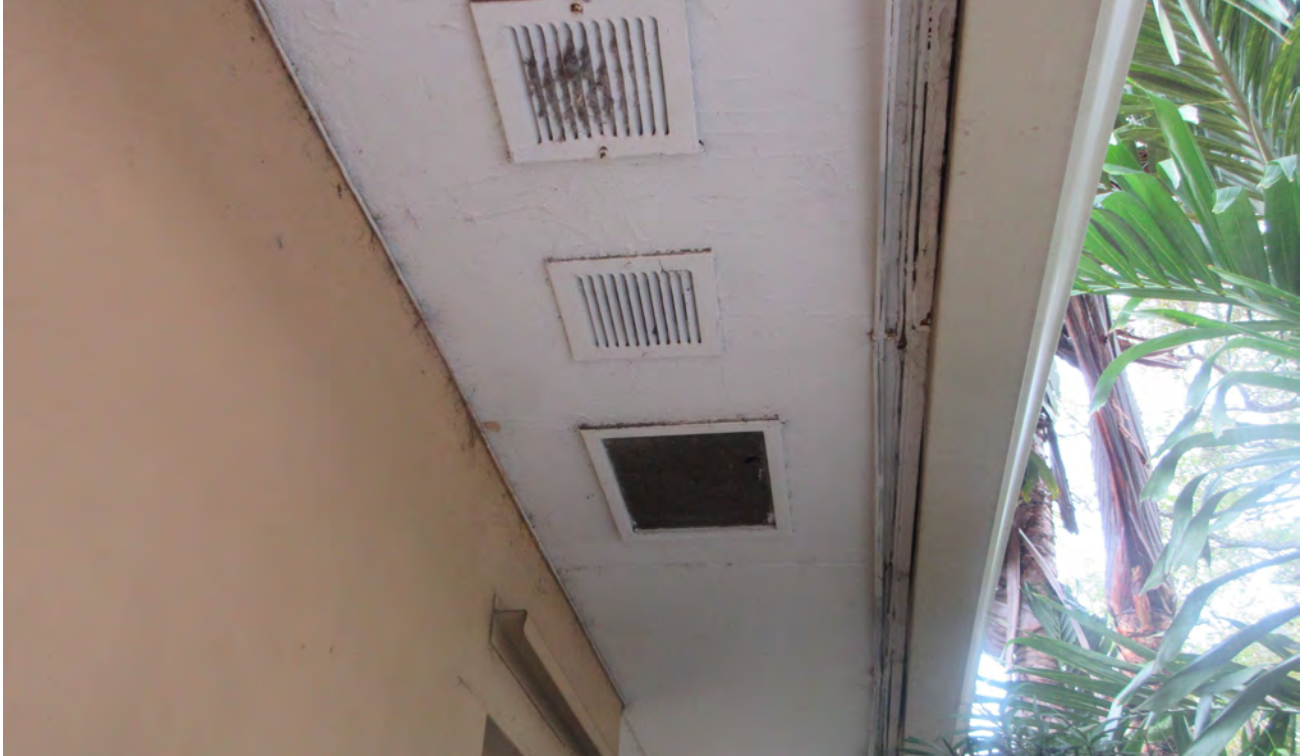
5810 Maggiore Street Coral Gables, FL 33146

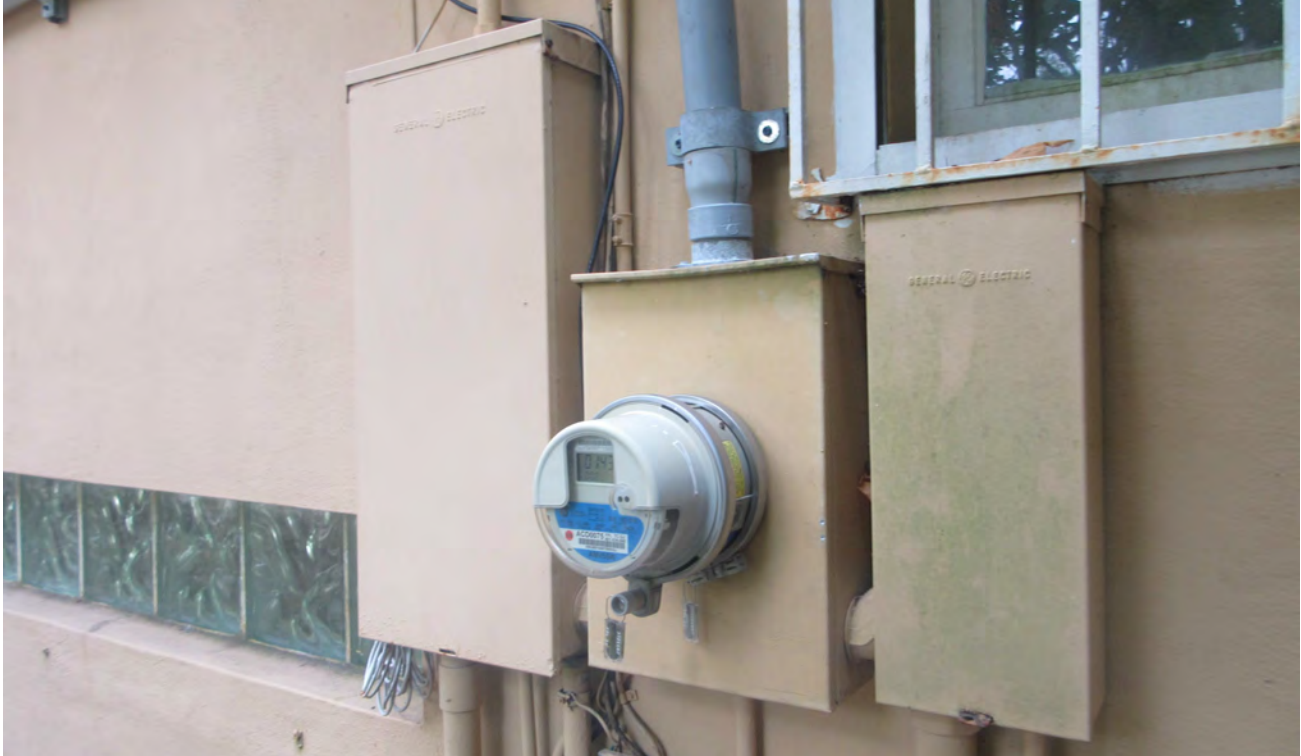
5810 Maggiore Street Coral Gables, FL 33146
