**Almeria Park Condominium  
357 Almeria Avenue  
Coral Gables, FL 33134**

## **Testing Report**

**Raul Schwerdt, P.E.  
RAS Engineers and Consultants, Inc.**

**Re: Moisture Scanning and Stucco Testing**

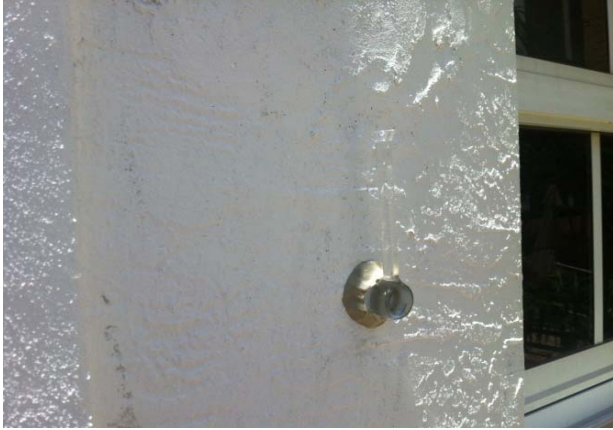
Picture 1

The testing results during the second visit showed coincidentally high water permeability see pictures 1, 2, and 3. Also, there is hollow stucco in two locations, see pictures 5 and 6. Thereafter, the stucco was cut and grinded to reach the masonry blocks surface. See holes cut on picture 9 on the 8/14/2013 picture album. A large crack on the stucco was previously repaired, see picture 4. The crack is located on the final coat of the stucco. We have

Pic	Location	Findings
1	5th Floor By East South Wall between column and window	Masonry Absorption Test
2	5th Floor By East South column	Water intrusion on Masonry Wall
3	Wall next to window	Water intrusion on Masonry Wall
4	Wall next to window	Visible Large Crack repaired behind the paint
5	Wall next to window	No Alkali silica reaction was observed at the time of the test
6	5th Floor By East South side	Hollow Column with moisture inside
7	column	1 inch stucco on column and 1/4 in plastic trim mold
8	5th Floor By East South	the exploratory inspection was at 10 feet up to the 6 th floor slab
9	5th Floor By East South	Exploratory holes cover with provisory cement

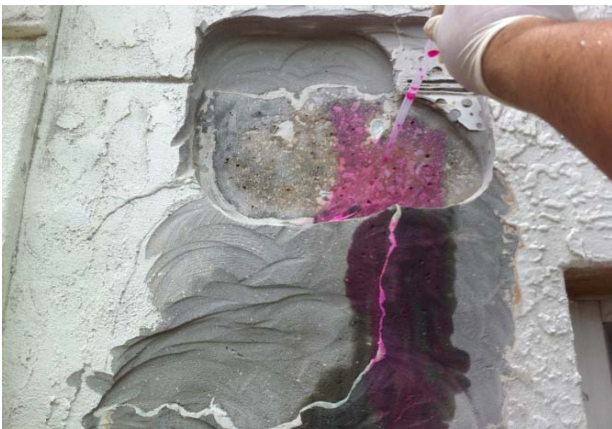
Picture 5

performed alkali-silica reaction test to determine any adverse reaction from the aggregates, see picture 5. As result, we determined that alkali-silica reaction is not a detrimental factor for the deficiency.

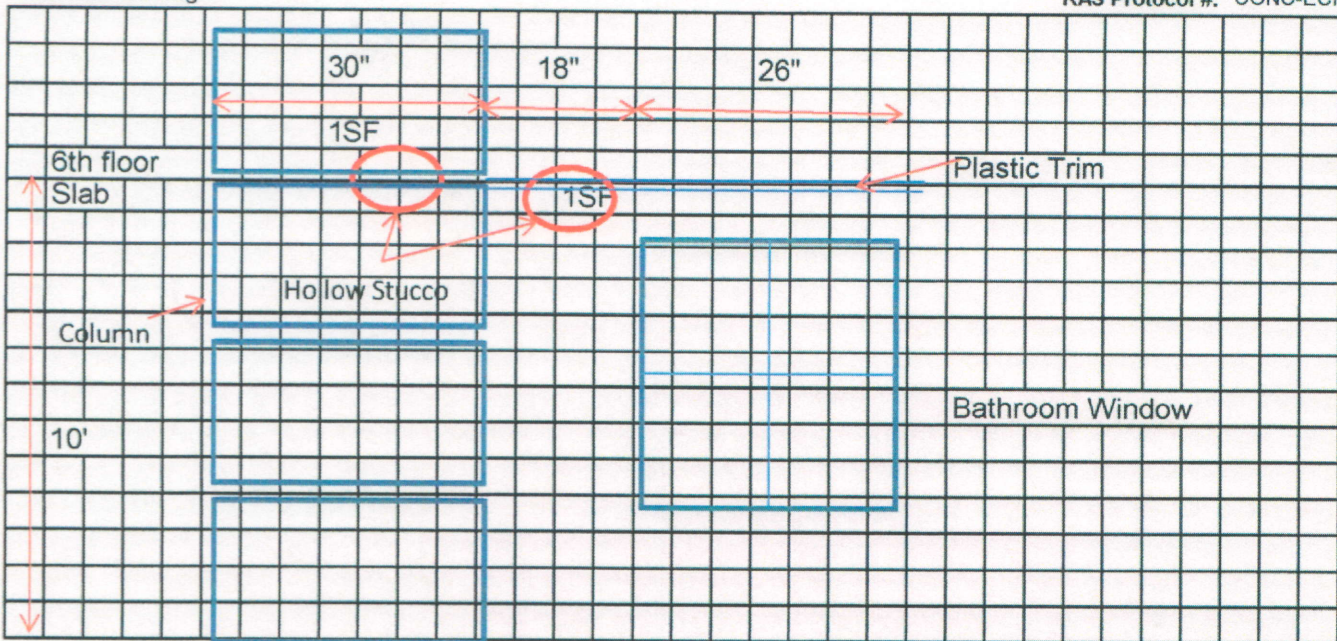
TEST N*	1	2	3	Comments
Location	5th Floor			
Structural member	Wall			
Area of the Structural member (SF)	100			
Area delaminated (SF)	2			
% of the Structural member delaminated	2

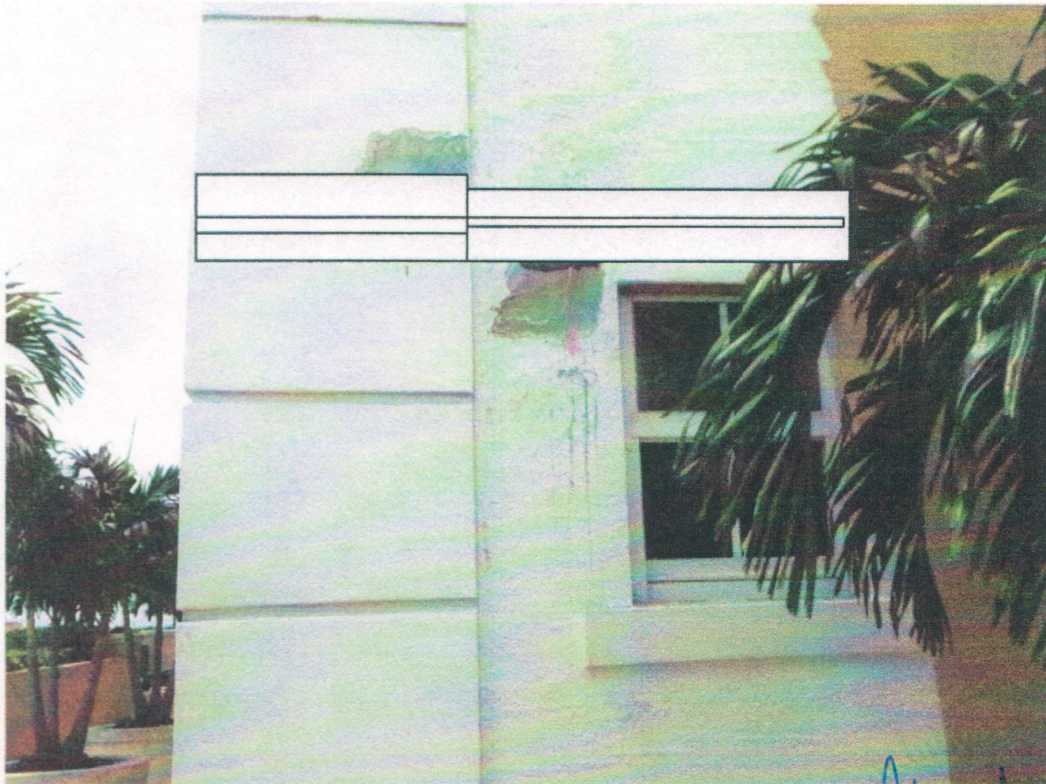
<b>RAS Engineering</b> 374 Ansin Blvd. Hallandale, FL 33009 Phone: (954) 455-2454 Fax: (954) 455-2456 <a href="mailto:ras@RAScompany.com">ras@RAScompany.com</a> <a href="http://www.RASCompany.com">www.RASCompany.com</a>	<b>Project</b> <b>Almeria Park Condominium Unit 505</b>				<b>Job Number:</b> <b>130601</b>	
	<b>Part of Structure</b> <b>Exterior Wall</b>				<b>Sheet no./rev:</b> <b>1 Rev.0</b>	
	<b>Reported by:</b> <b>SS</b>	<b>Date:</b> <b>8/12/13</b>	<b>Drawn by:</b> <b>GS</b>	<b>Date:</b> <b>8/13/13</b>	<b>Specs by:</b> <b>RAS</b>	<b>Date</b> <b>8/19/13</b>
<b>Detail</b>	<b>Repair faulty stucco</b>

1. Cut 8" horizontal strip of stucco, four inches over and below the reveal groove. Extend the cut where indicated in the picture to reach the concrete block.
2. Remove stucco entirely and the plastic reveal form.
3. After opening, call the engineer for inspection.
4. Repair large cracks if necessary by injecting epoxy. Assume 3 LF for bidding, final quantities will be determined by the engineer after demolition.
5. Apply bonding to the masonry block, and one coat of stucco, maximum 5/8" thick.
6. Next day apply second coat of stucco. Make a reveal on the surface matching existing dimension, by pushing wood shim on the fresh stucco. Note the reveal on the column must be larger than the one on the wall.
7. Wait for a couple of days and apply sealer on the new stucco.
8. Call Engineer for final water deluge testing before applying two coats of painting and approval of the work.
