Level 2 Tree Risk Assessment Report 3/30/2025

Location: 1240 San Remo Ave. Coral Gables FL,

Date of Assessment: April 5th, 2025

Assessor: Patrick Hannah Certified Arborist LLC.

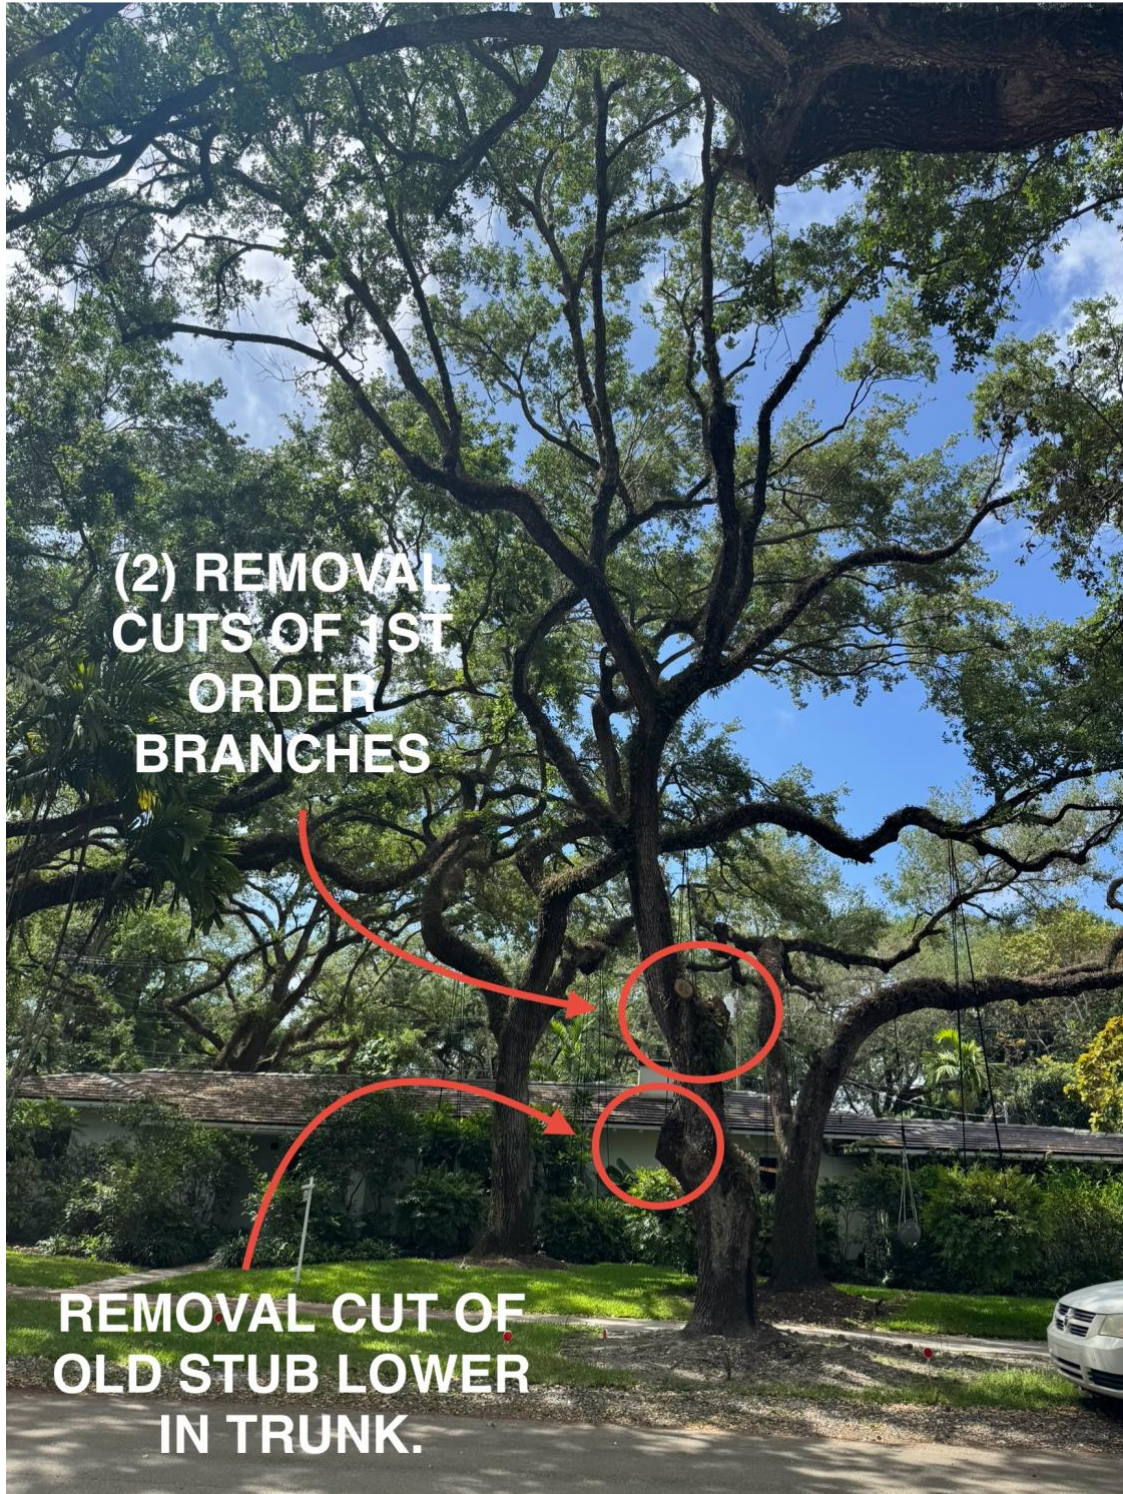
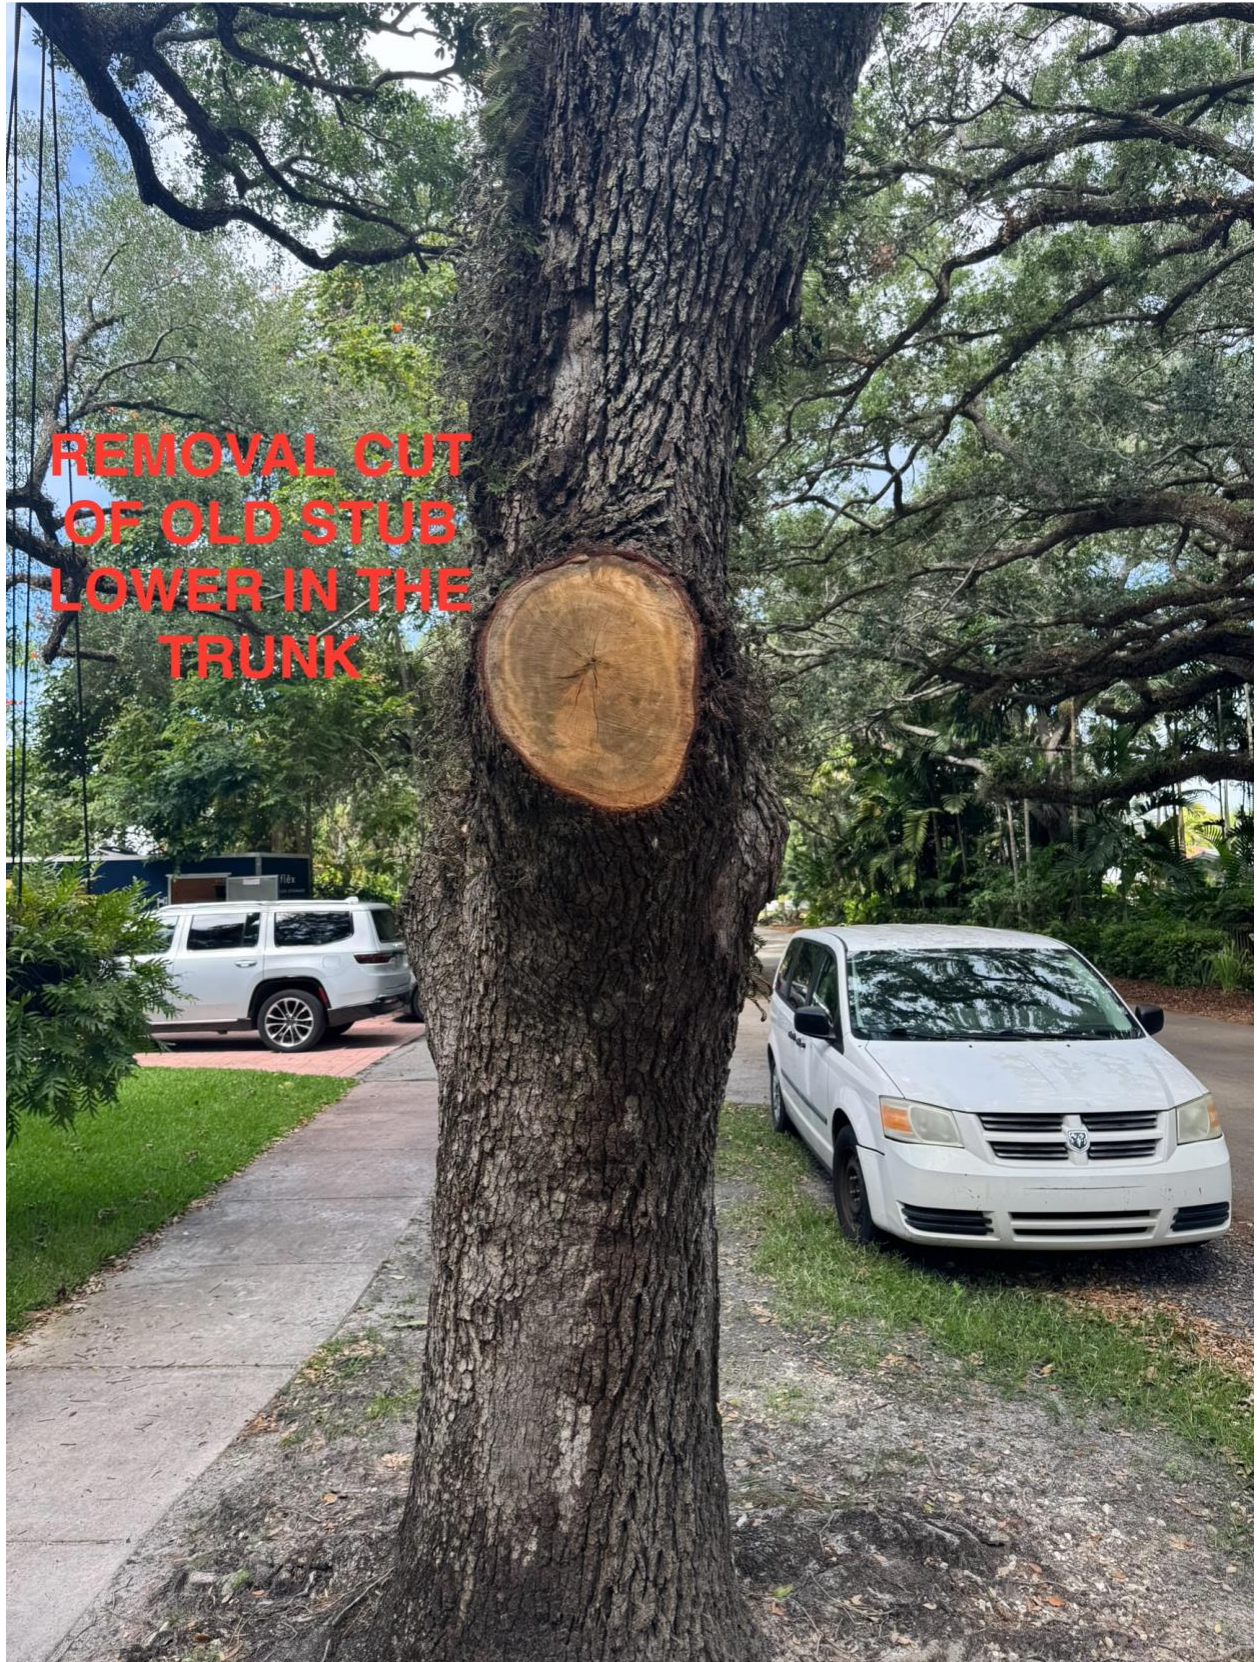
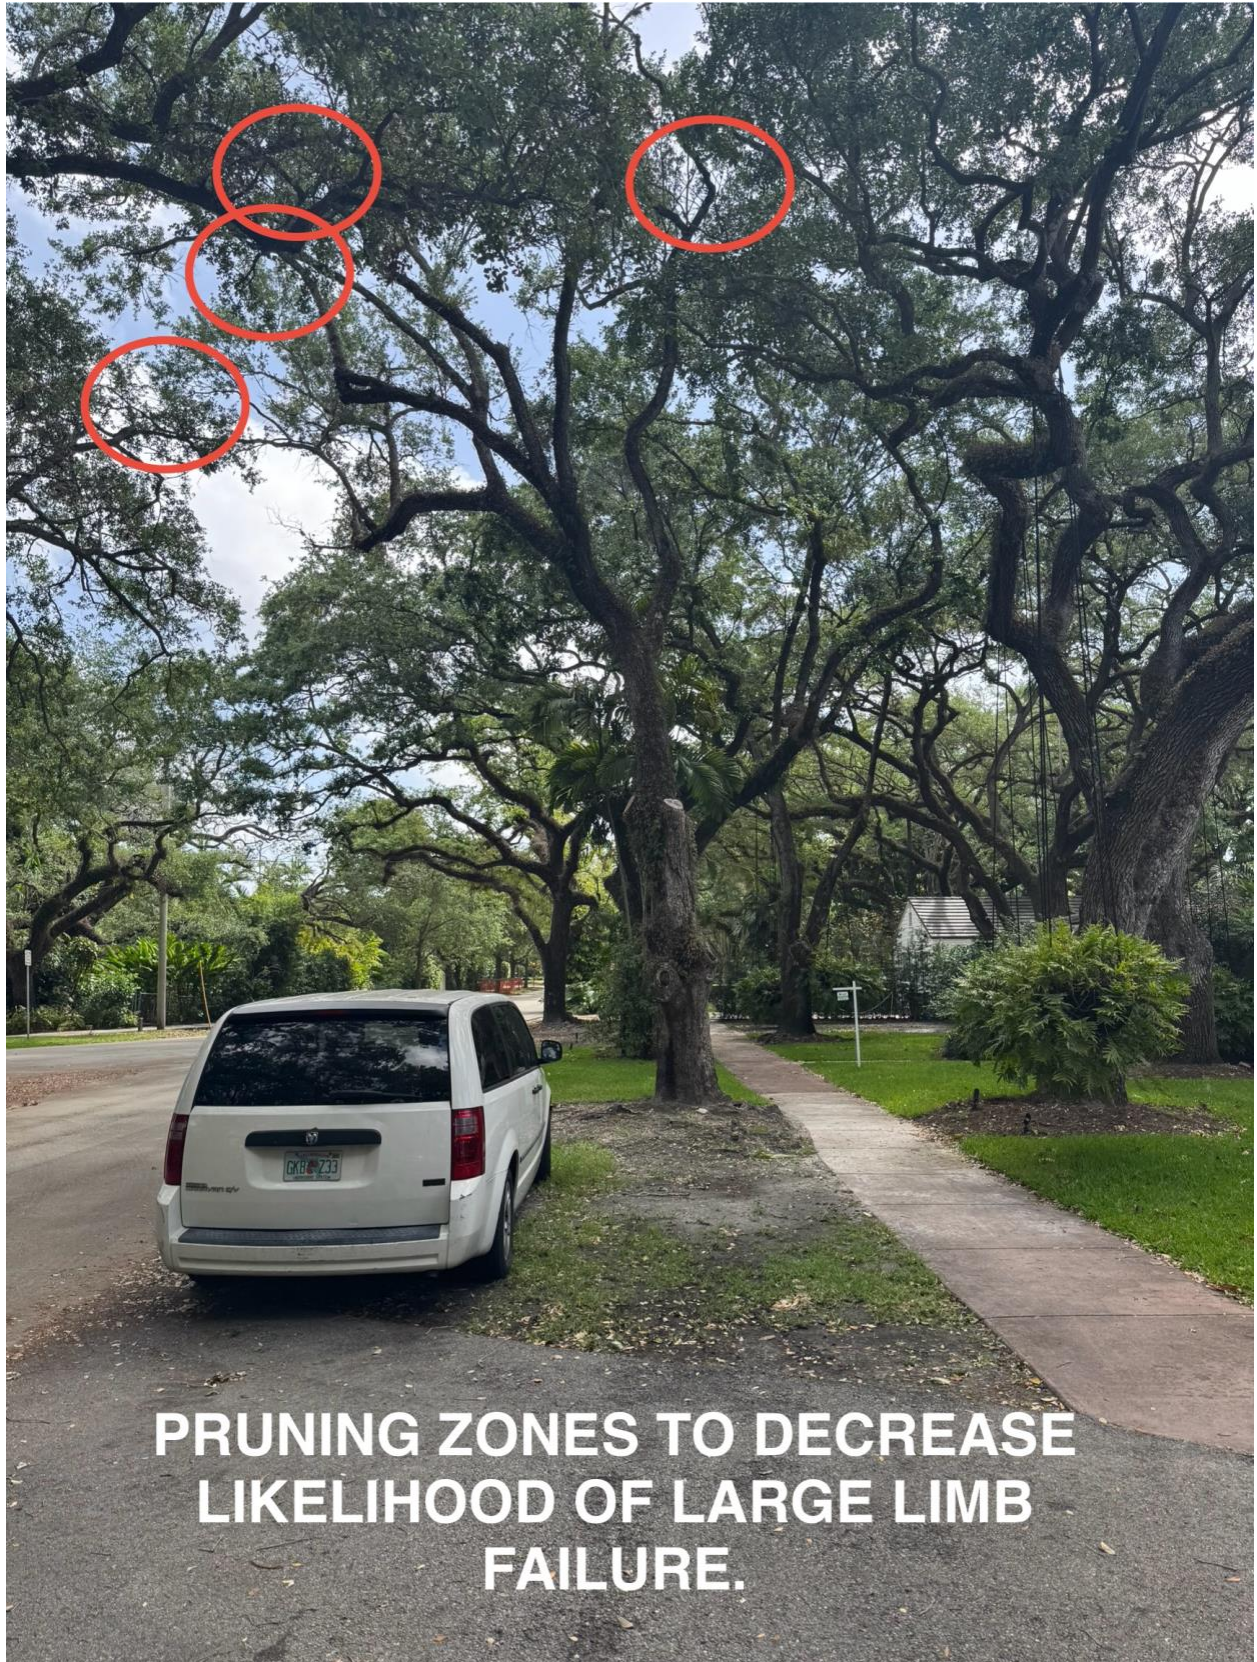
Photo Documentation

At the request of Marcel Pierson, a Level 2 Tree Risk Assessment was conducted for a Live Oak (*Quercus virginiana*) located in the right of way at 1240 San Remo Ave, Coral Gables, FL. This assessment addresses the unpermitted removal of (2) 10-inch 1ST Order Branches, and (1)c12-inch diameter stub lower in trunk, in violation of the City of Coral Gables' regulations.

- **Tree Characteristics:**
- **Species:** Live Oak (*Quercus virginiana*)
- **DBH:** 26 inches
- **Height:** 55 feet
- **Crown Spread:** 46 feet
- **Critical Root Zone (CRZ):** Approximately 40-foot diameter
- **Site Conditions:**
- The tree is situated within the public right-of-way, adjacent to pedestrian pathways and vehicular traffic.
- Soil conditions appear compacted, with limited understory vegetation.
- **Defects and Conditions:**
- Evidence of multiple first-order branch removals in the lower trunk region, including a recent unpermitted removal of a 12-inch diameter branch.
- Resultant overextended upper canopy with imbalanced weight distribution.
- Minor decay observed at previous pruning sites; however, no significant cavities or structural weaknesses detected at the time of assessment.

- **Engage a certified arborist to perform structural pruning, focusing on reducing the length and weight of overextended branches to restore canopy balance.**
- **Ensure all pruning cuts adhere to ANSI A300 Part 1 standards to promote proper wound closure and minimize decay.**
