1414 Galiano St

**NOTICE OF UNSAFE STRUCTURE VIOLATION FOR FAILURE TO RECERTIFY  
AND NOTICE OF HEARING**

1414 Galiano Street, Coral Gables, Florida 33134

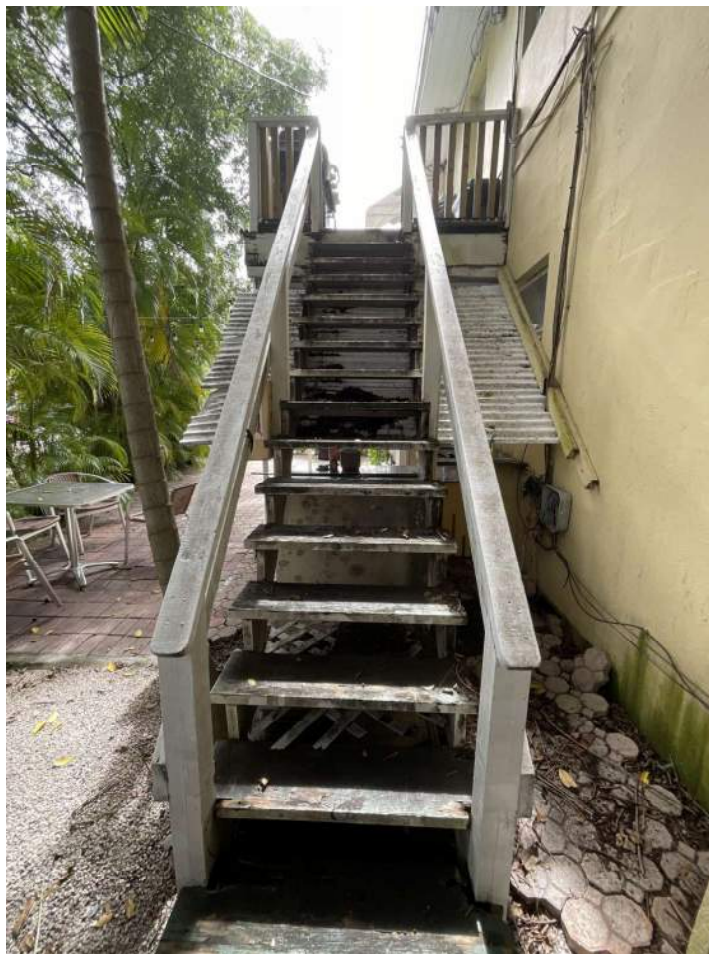
Picture No. 10: Building No.1 Exterior stair, See addendum for deficiencies.

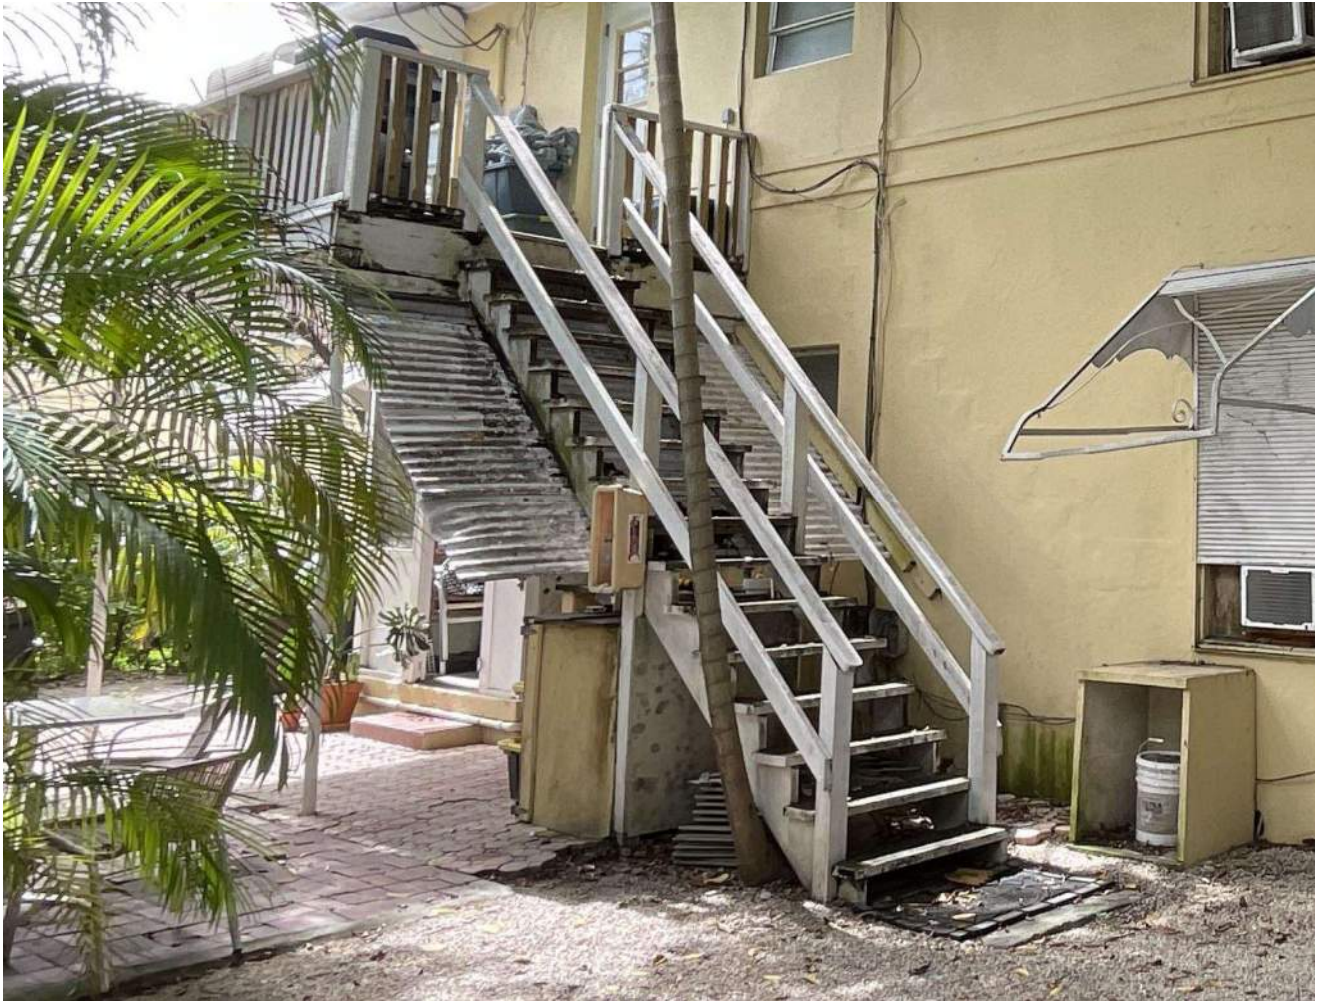
Stair framing of wood elements. the framing has been reinforced and shored, probably for reasons of allowing excessive movements and deflections. We recommend replacing with a new one with the current minimum FBC requirements.

Picture No. 11: Building No.1 Rear stair wood framing of wood members supported on steel and wood columns. See addendum for deficiencies and repairs.

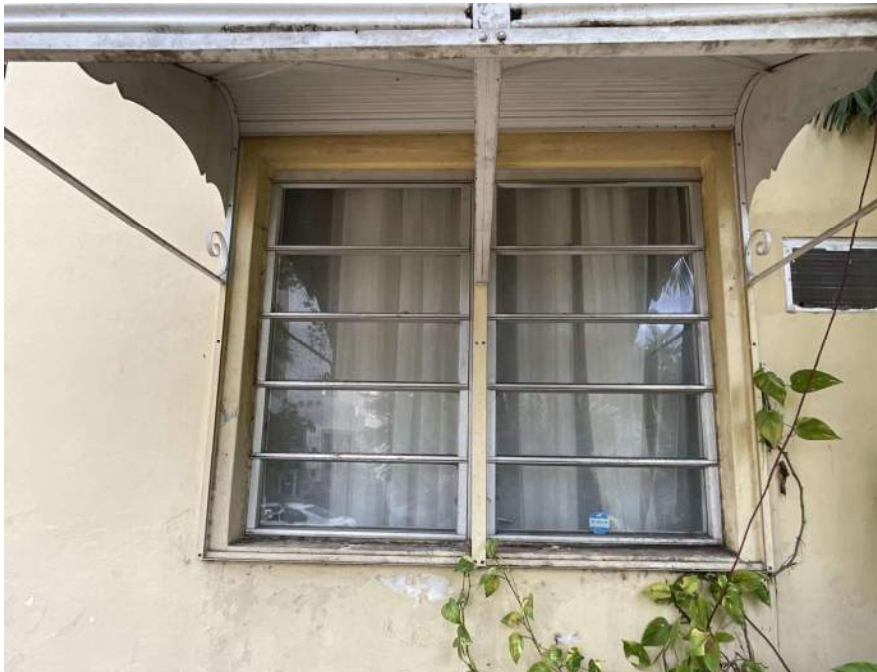
Picture No. 12: Building No.1 Steel and Aluminum glass windows. See addendum for deficiencies and repairs.

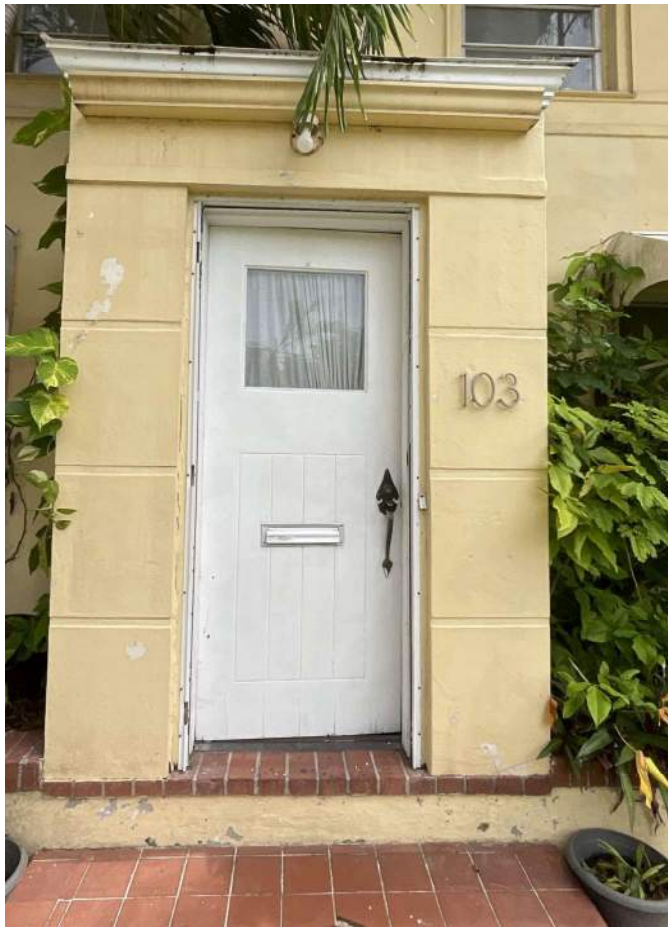
Picture No. 13: Building No.1 Entry Wood doors. See addendum for deficiencies & repairs

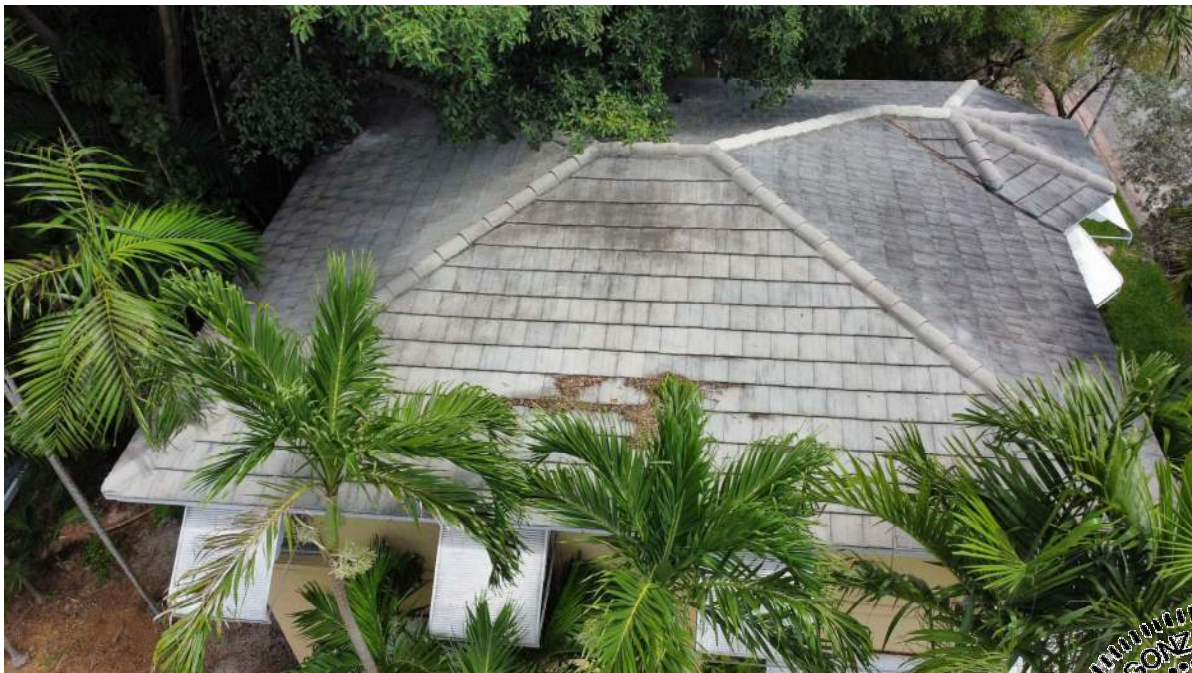
Picture No. 14: Building No.1 Concrete roof tile. See addendum for deficiencies.

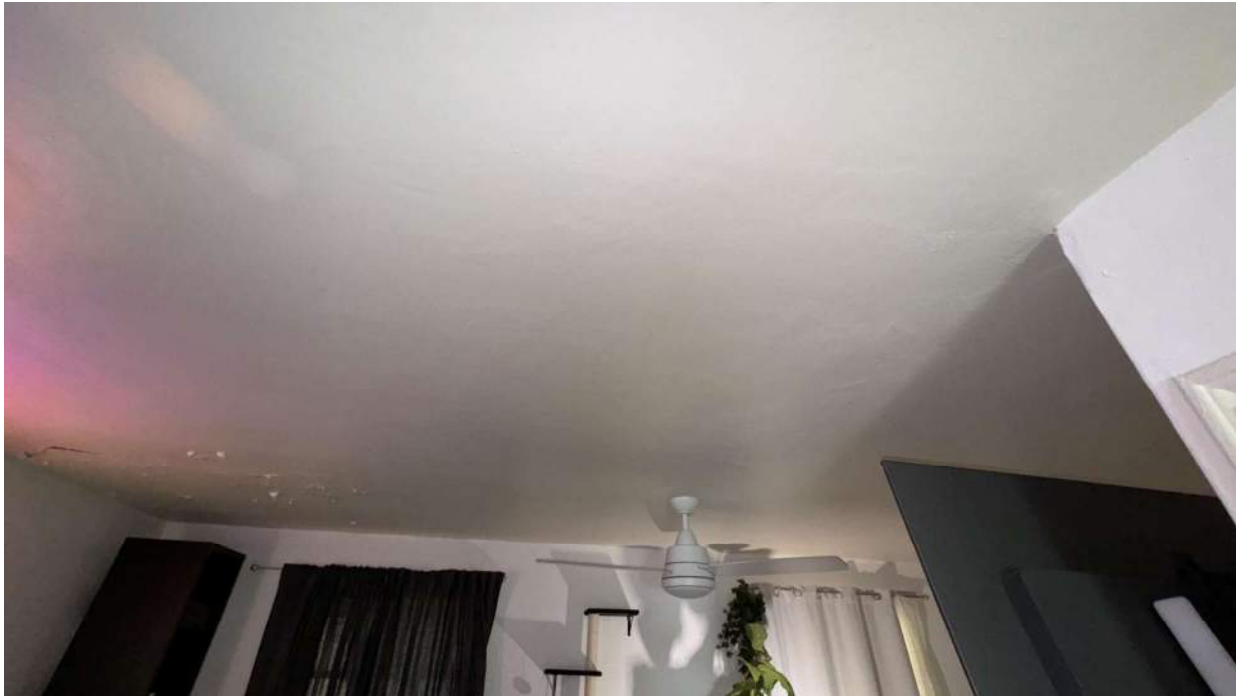
Picture No. 21: Building No.2 Roof framing of wood planks sheathing over wood trusses bearing on concrete masonry perimeter walls. **See addendum for deficiencies.**

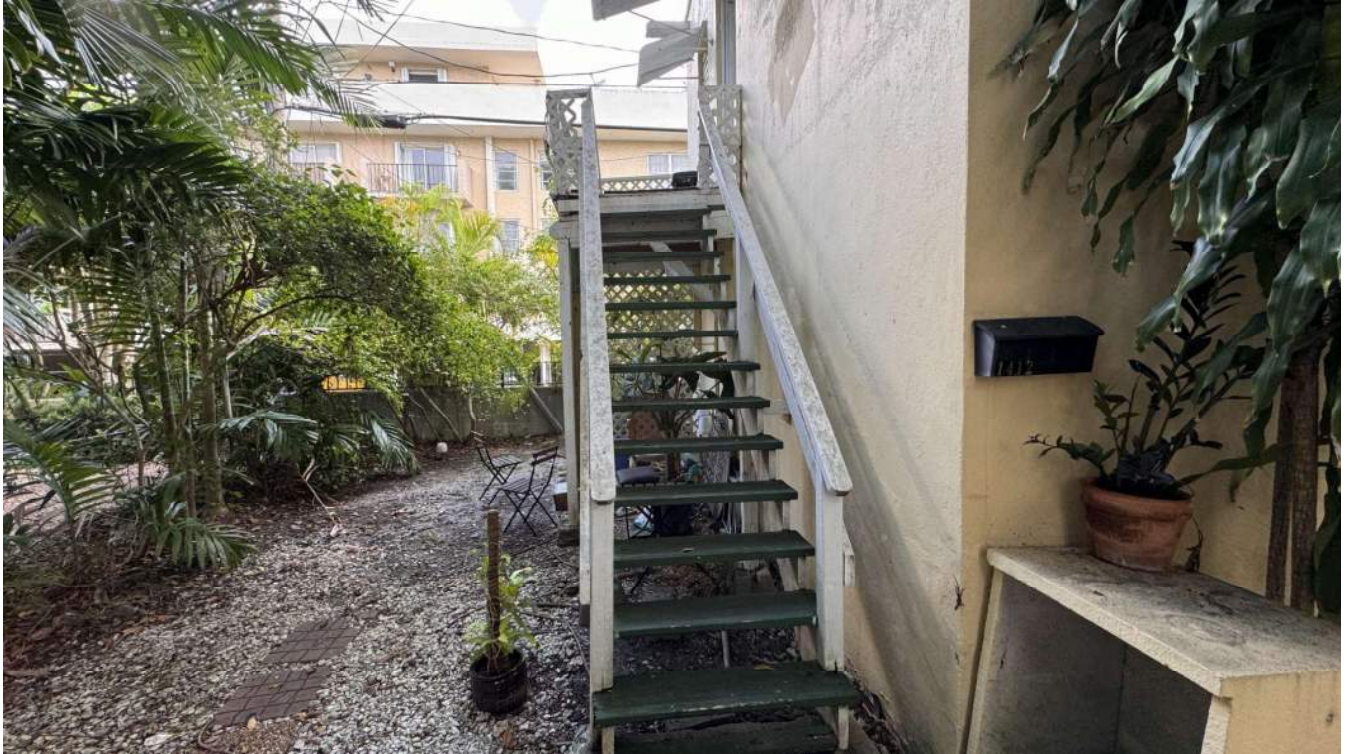
Picture No. 23: Building No.2 Exterior stair, See addendum for deficiencies.

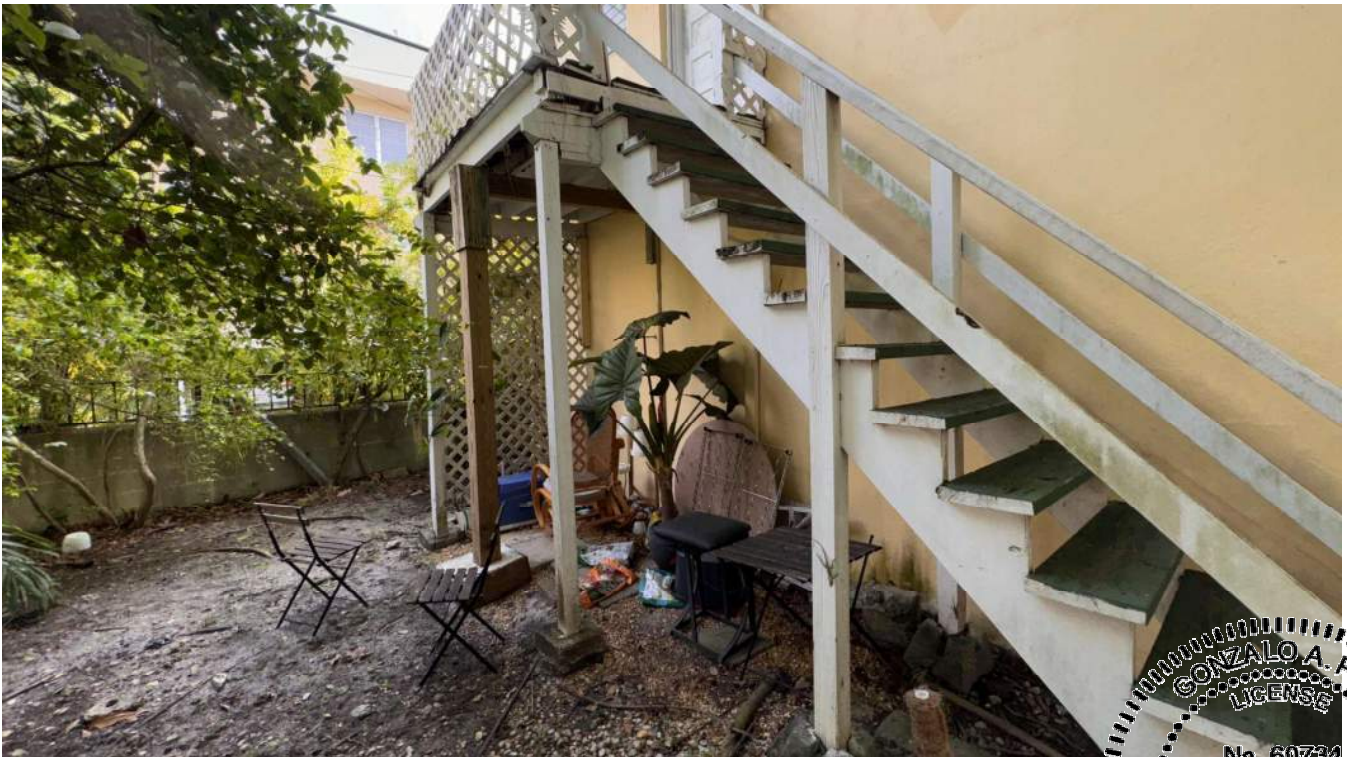
Picture No. 24: Building No.2 Rear stair wood framing of wood members supported on wood columns. See addendum for deficiencies and repairs.

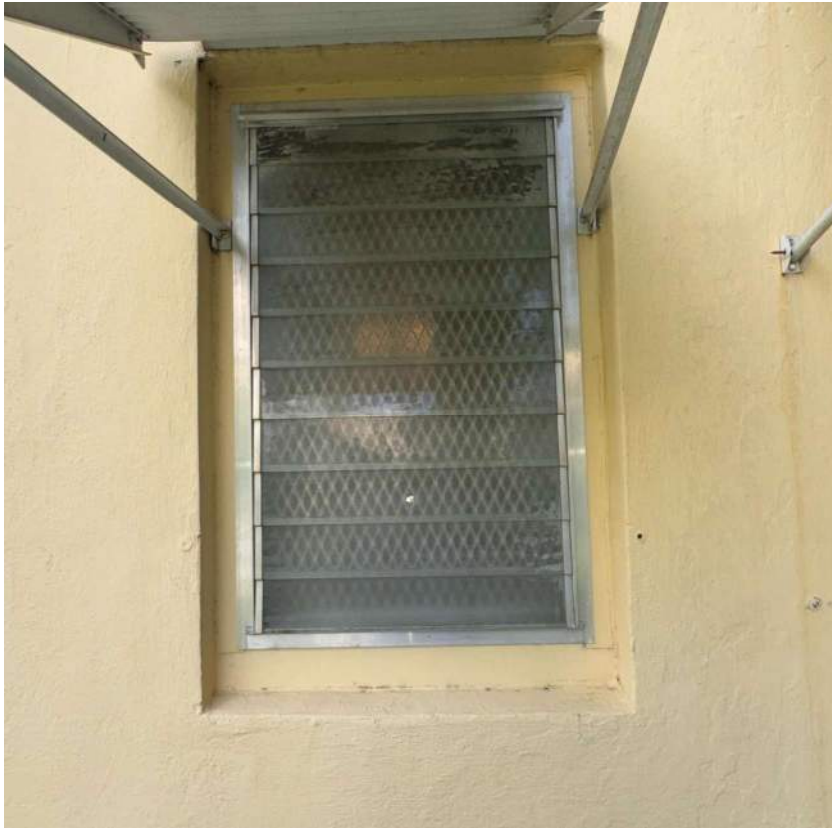
Picture No. 25: Building No.2 Steel and Aluminum glass windows. See addendum for deficiencies and repairs.

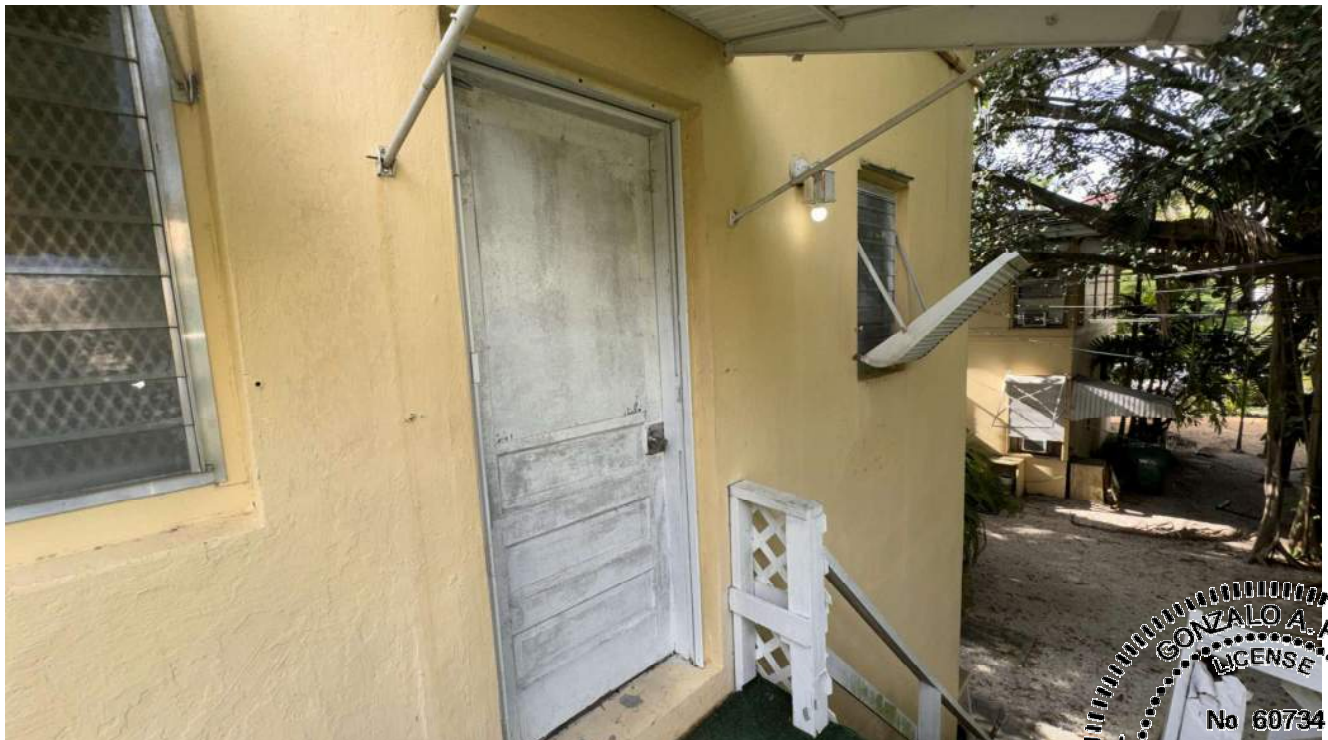
Picture No. 26: Building No.2 Entry Wood doors. See addendum for deficiencies & repairs.

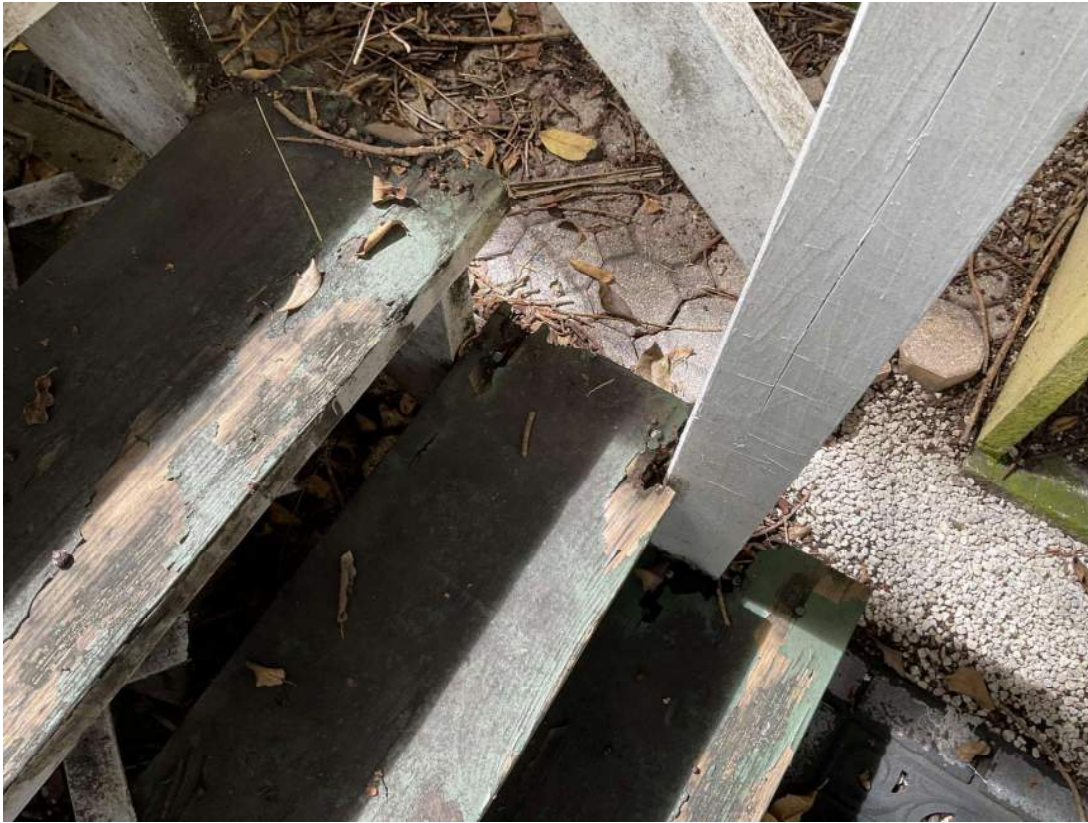
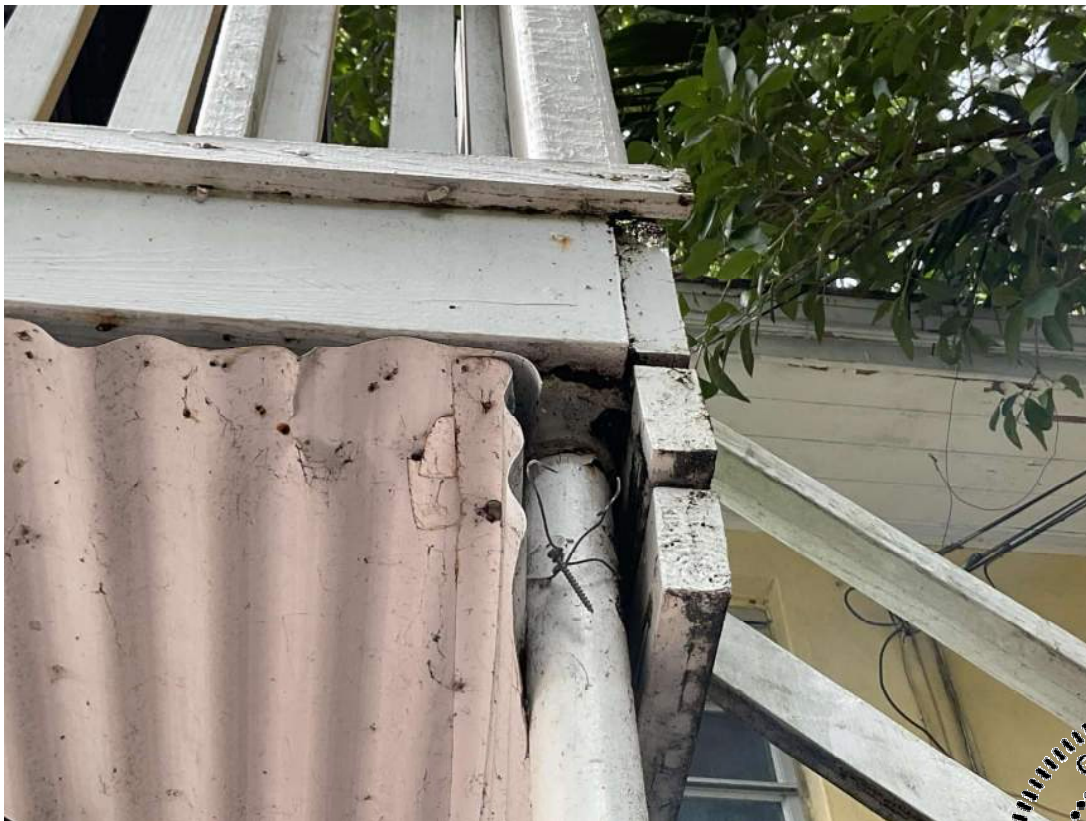
Item 1-Picture No. 1A&1B: Building No.1 Stair framing of wood elements with signs of rotten and missing anchor allowing excessive movements and deflections. We recommend replacing with a new one with the current minimum FBC requirements.

Item 1-Picture No. 1A&1B: Building No.1 Stair framing of wood elements with sign of rotten and missing anchor allowing excessive movements and deflections. We recommend replacing it with a new one with the current minimum FBC requirements.

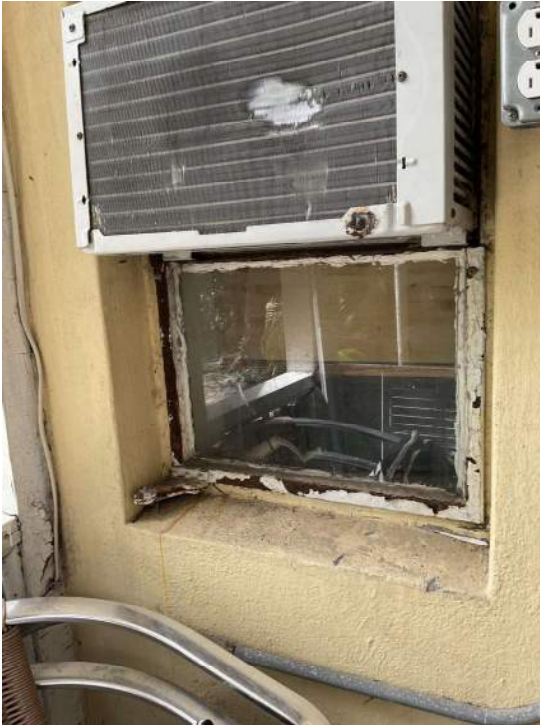
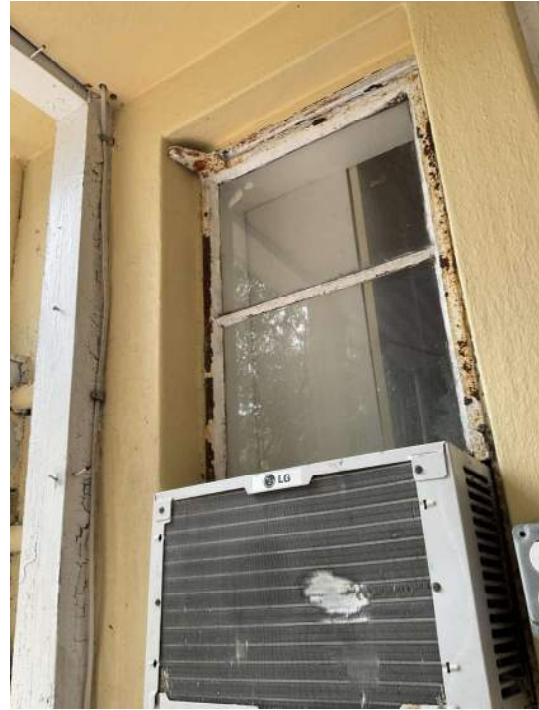
Item 2-Picture No. 2A&2B: Building No.1 Steel casement windows with sign of corrosion. Corrosion shall be removed, and steel painted

Item 2-Picture No. 2A&2B: Building No.1 Steel casement windows with sign of corrosion. Corrosion shall be removed, and steel painted.

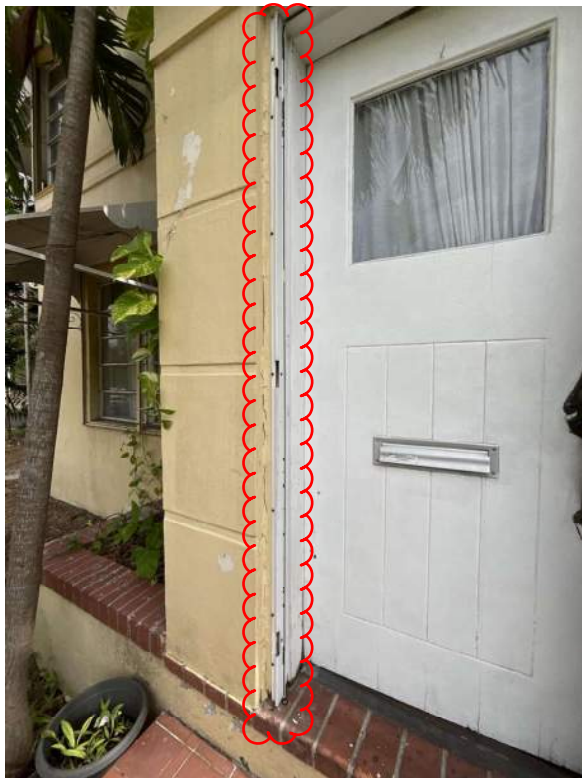
Item 3-Picture No. 3A: Building No.1 Caulk with sign of damage. Sealant shall be replaced.

Item 3-Picture No. 3A: Building No.1 Caulk with sign of damage. Sealant shall be replaced.

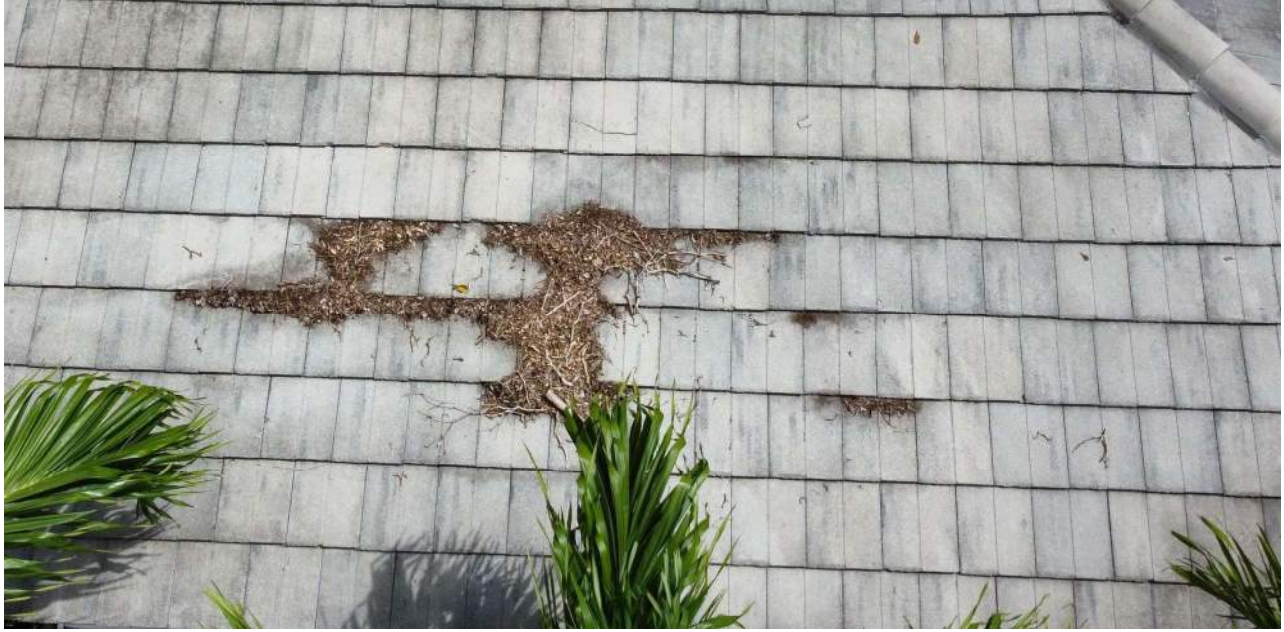
Item 4-Picture No. 4A: Building No.1 Roof and roofing shall be cleaned of any debris and loose roofing granule particles, etc.

Item 4-Picture No. 4A: Building No.1 Roof and roofing shall be cleaned of any debris and loose roofing granule particles, etc.

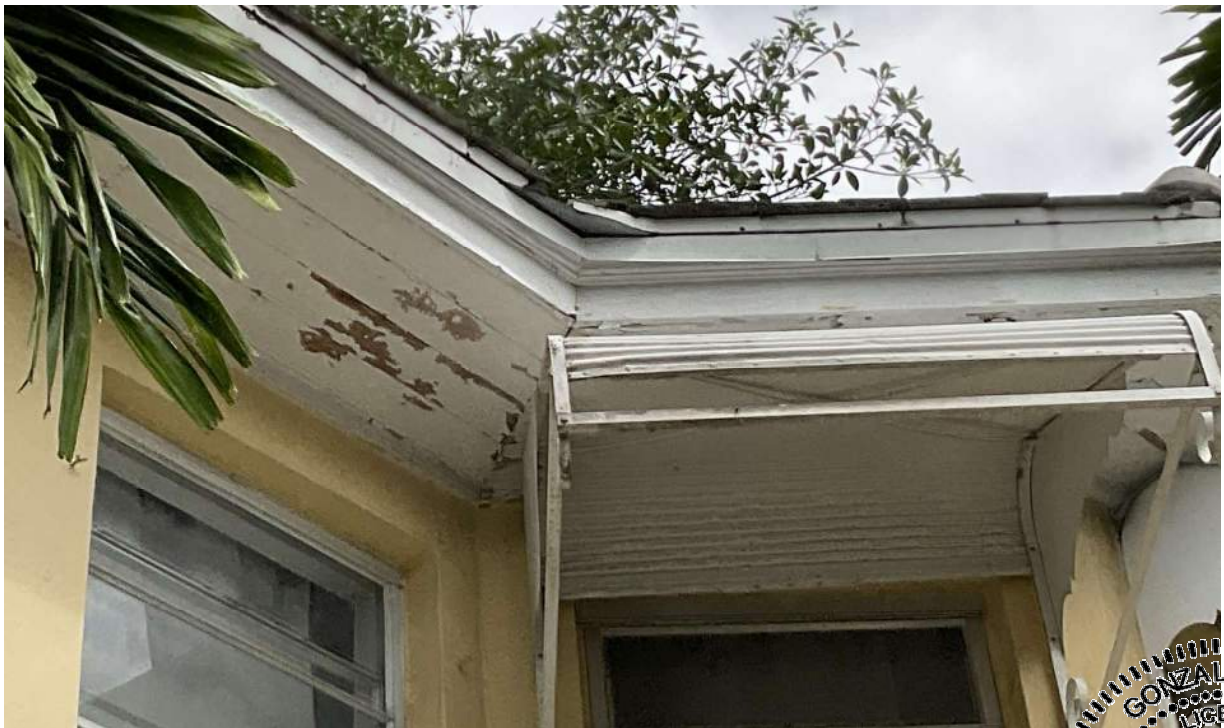
Item 5-Picture No. 5A: Building No.1 Roof Soffit rotted with wood damage. Wood soffit shall be replaced.

Item 5-Picture No. 5A: Building No.1 Roof Soffit rotted with wood damage. Wood soffit shall be replaced.

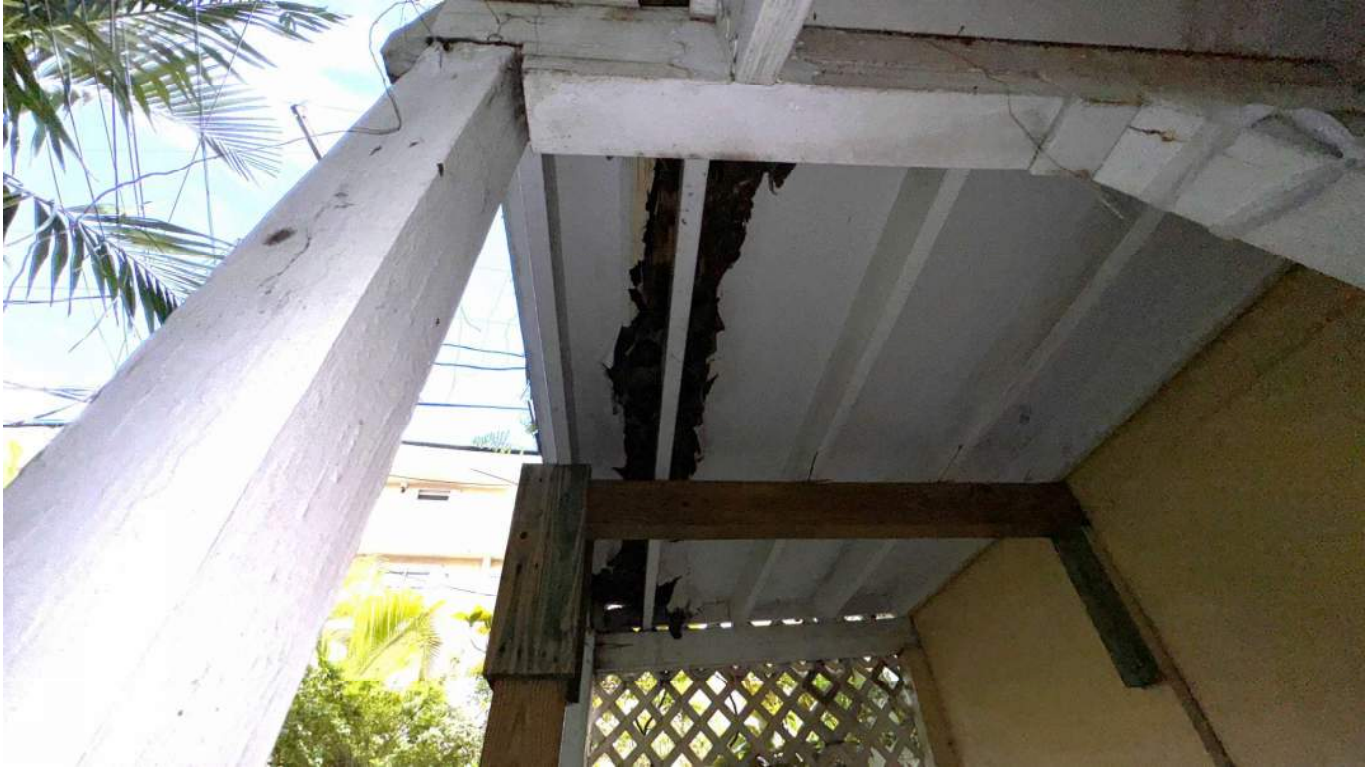
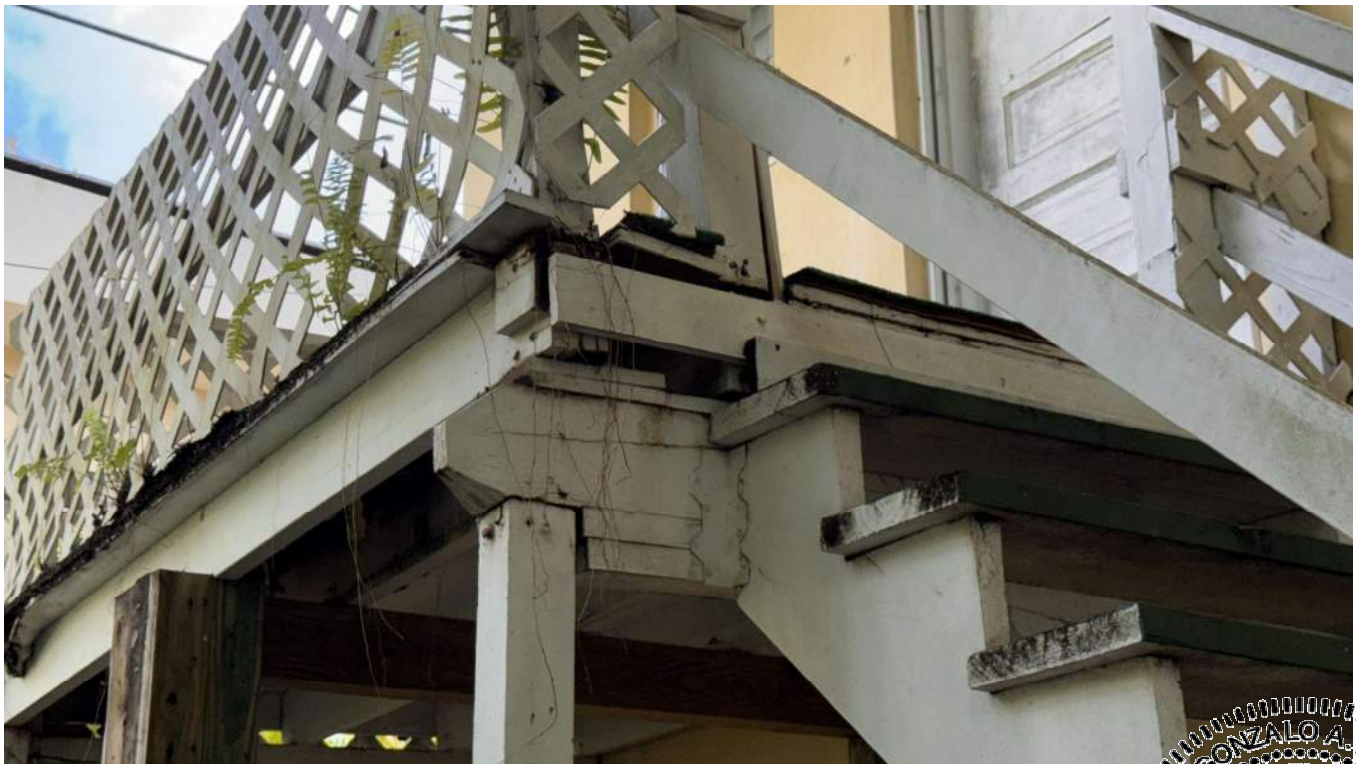
Item 6-Picture No. 6A&6b: Building No.2 Stair framing of wood elements with sign of rotten and missing anchor allowing excessive movements and deflections. We recommend replacing with a new one with the current minimum FBC requirements.

Item 6-Picture No. 6A&6b: Building No.2 Stair framing of wood elements with sign of rotten and missing anchor allowing excessive movements and deflections. We recommend replacing it with a new one with the current minimum FBC requirements.

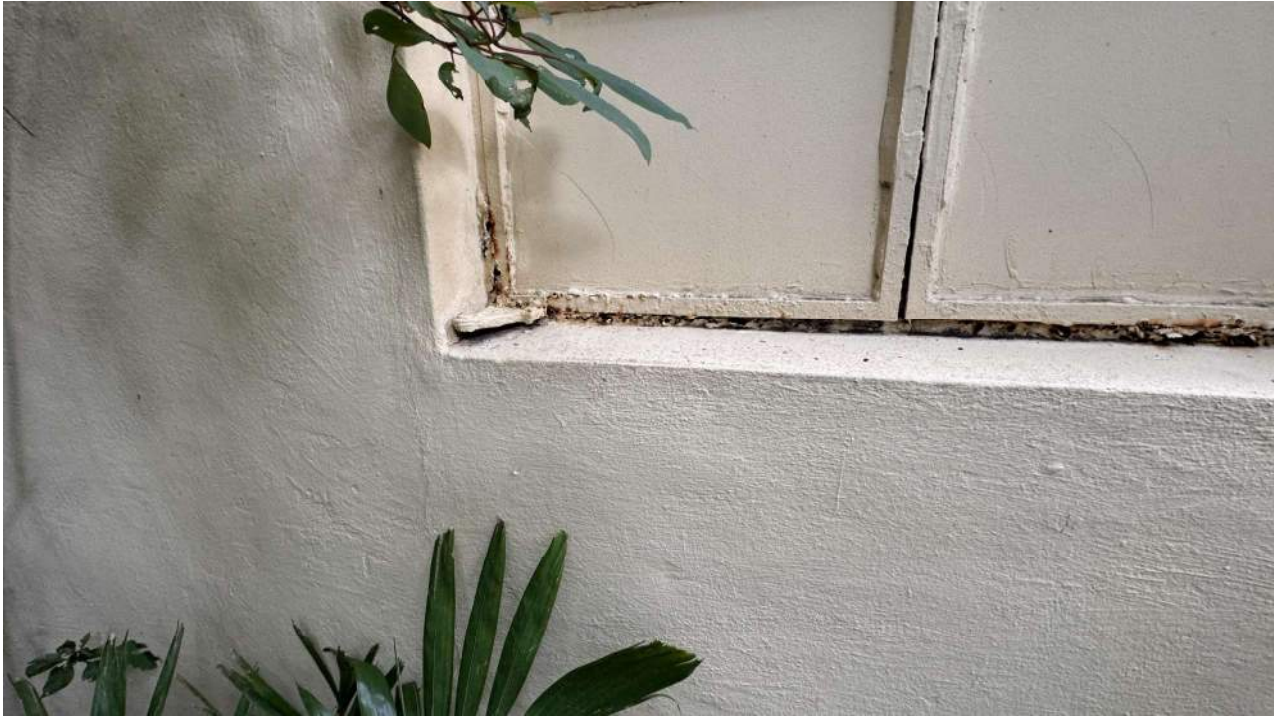
Item 7-Picture No. 7A: Building No.2 Steel casement windows with sign of corrosion. Corrosion shall be removed, and steel painted.

Item 7-Picture No. 7A: Building No.2 Steel casement windows with sign of corrosion. Corrosion shall be removed, and steel painted.

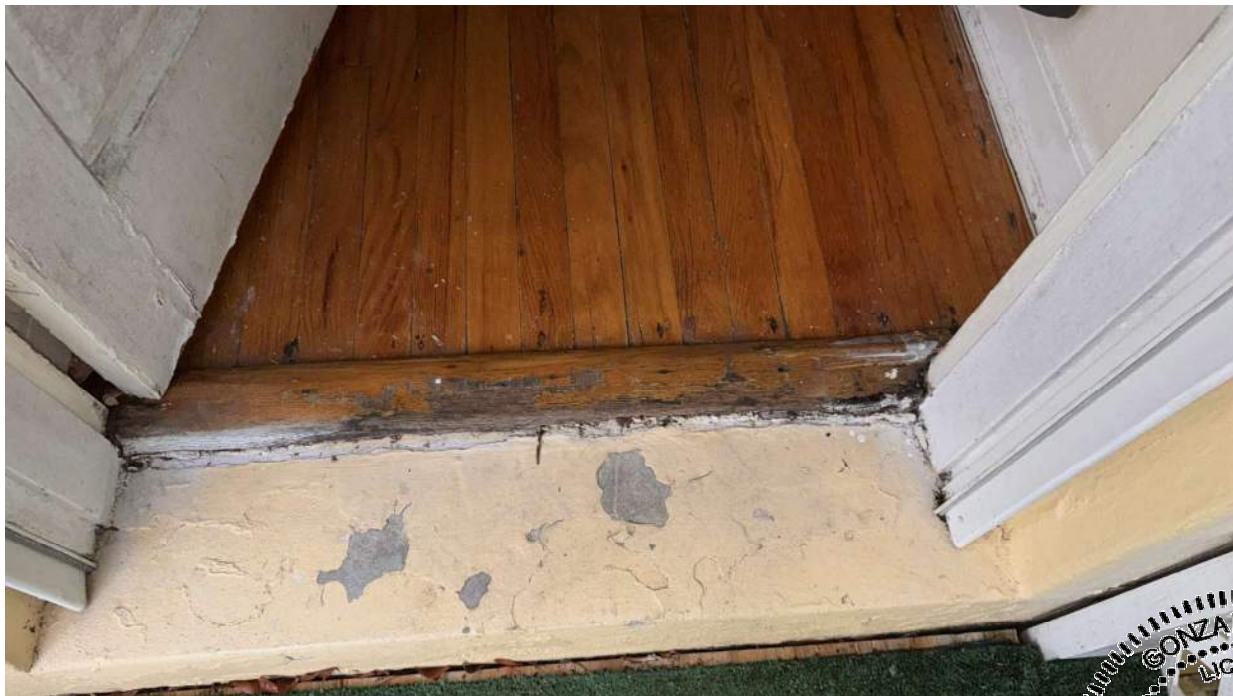
Item 8-Picture No. 8A: Building No.2 Caulk with sign of damage. Sealant shall be replaced.

Item 8-Picture No. 8A: Building No.2 Caulk with sign of damage. Sealant shall be replaced.

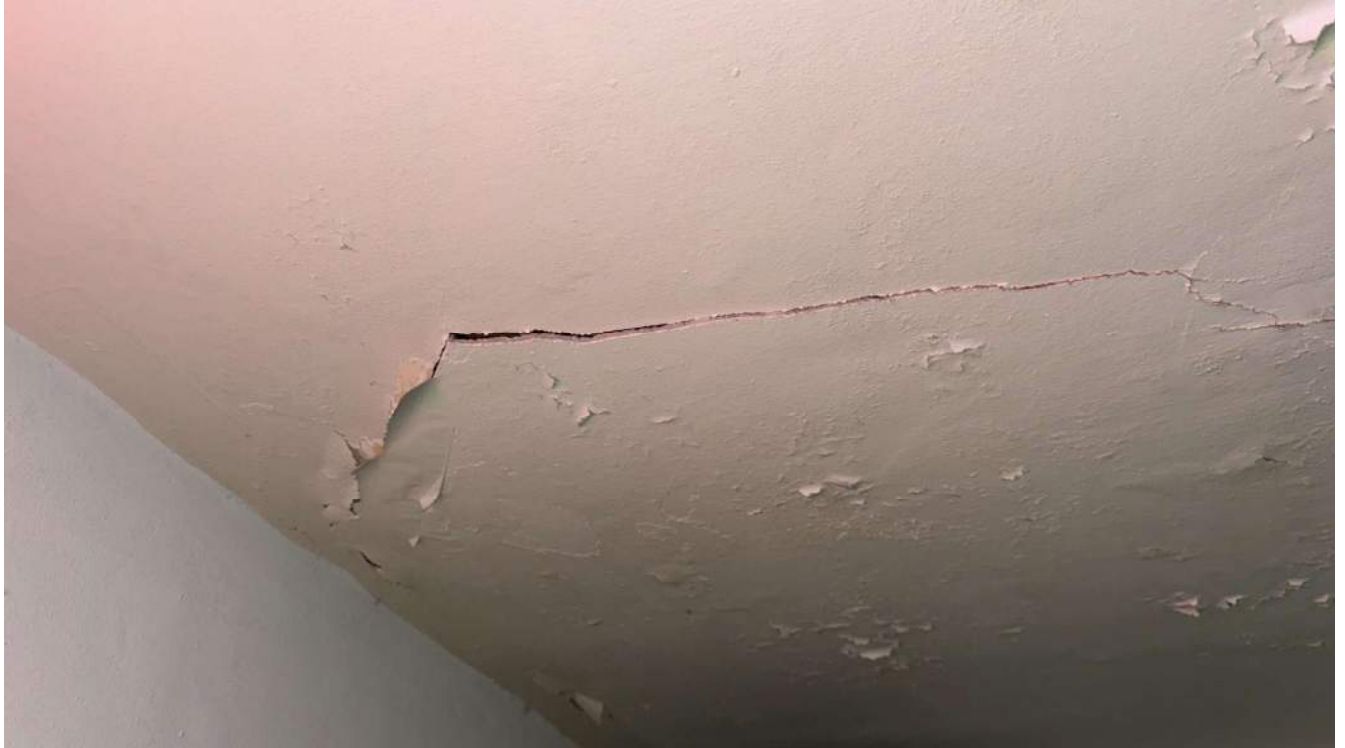
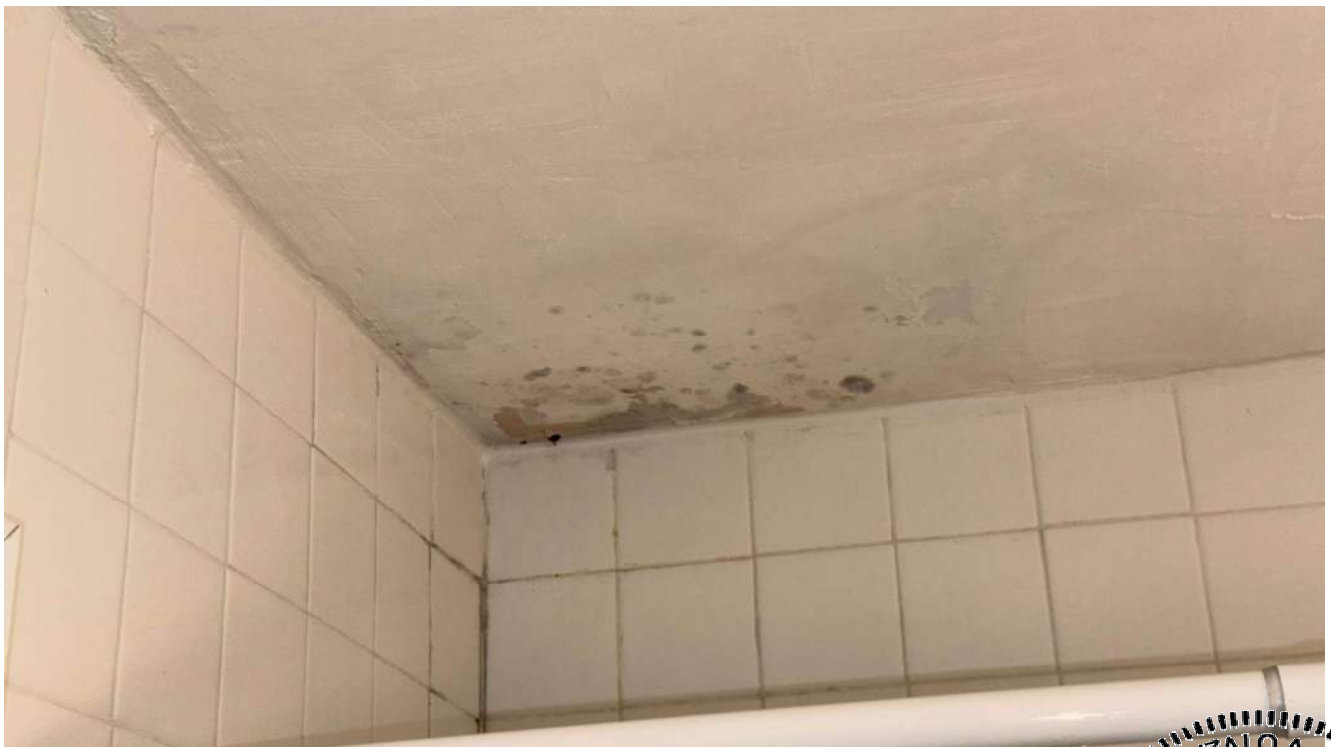
Item 9-Picture No. 9A&9B: Building No.2 Signs of water infiltration through the roof. Roofing shall be repaired. We recommend hiring a contractor specialized in this type of work

Item 9-Picture No. 9A&9B: Building No.2 Signs of water infiltration through the roof. The roofing shall be repaired. We recommend hiring a contractor specialized in this type of work.

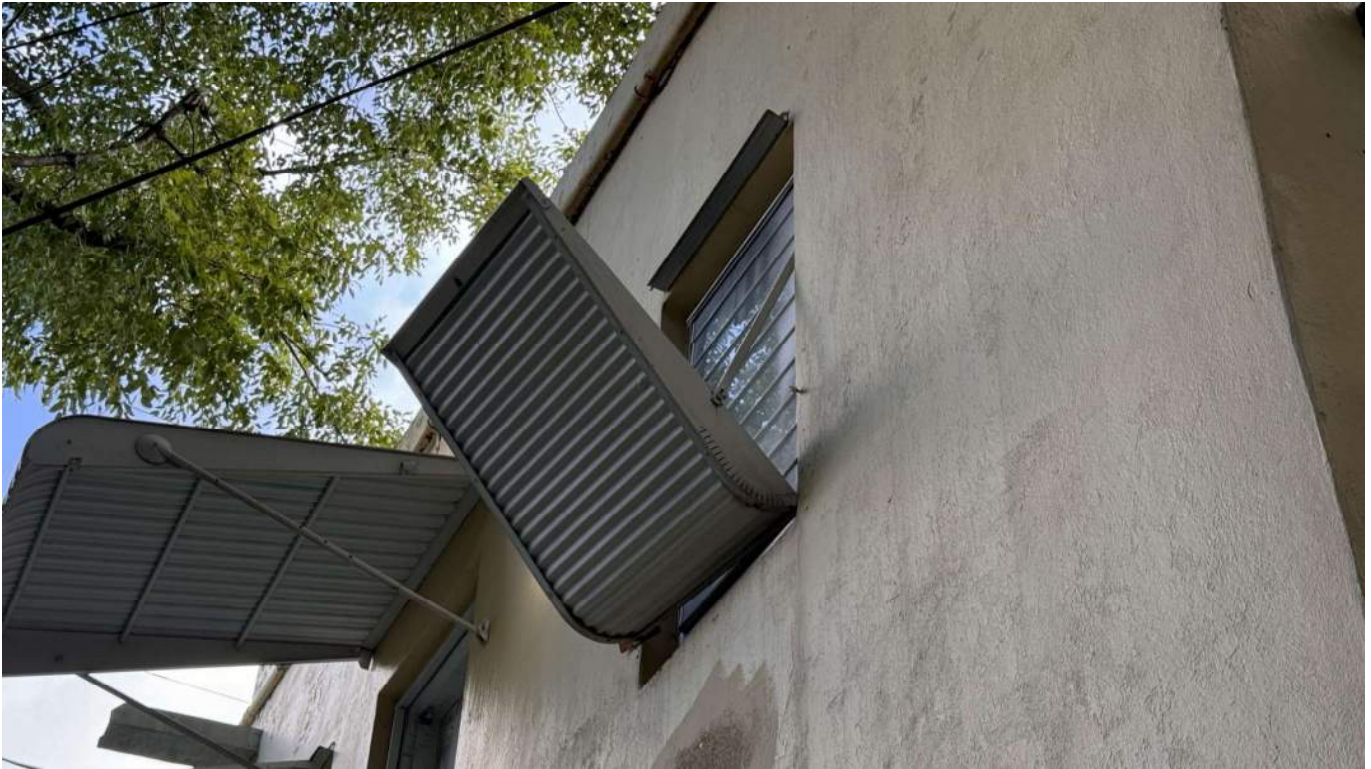
Item 10-Picture No. 10A: Building No.2 Steel windows Shutter shall be repaired and brought back to its original condition.

Item 10-Picture No. 10A: Building No.2 Steel windows Shutter shall be repaired and brought back to its original condition.

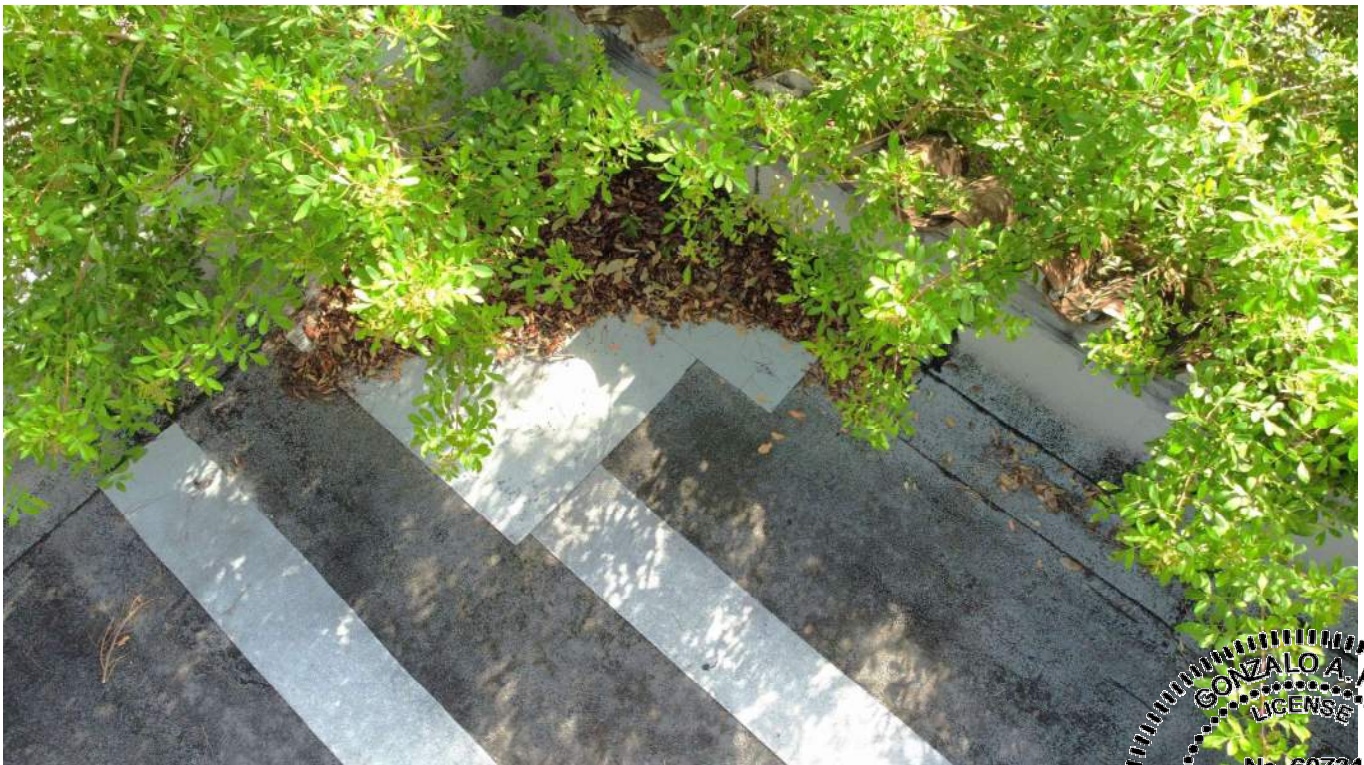
Item 11-Picture No. 11A: Building No.2 Roof and roofing shall be cleaned of any debris and loose roofing granule particles, etc.

Item 11-Picture No. 11A: Building No.2 Roof and roofing shall be cleaned of any debris and loose roofing granule particles, etc.

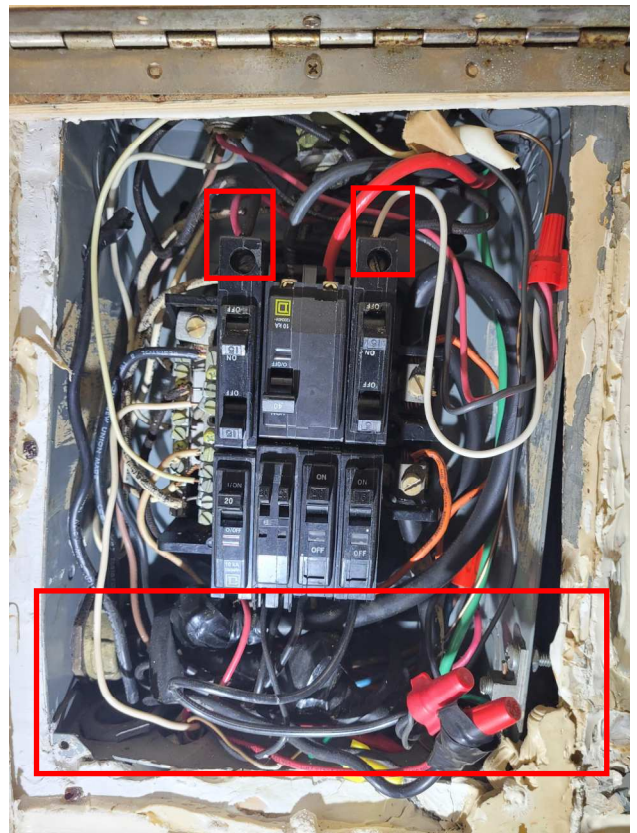
Panel Apt. Unit Ground Floor Open  
Missing main circuit breaker  
Double tapping in breakers 1 & 7  
(p-5)

- 1) Apartment unit ground floor missing main circuit breaker.***
- 2) Remove illegal double tapping on circuit breakers 1 and 7 in "Electrical Panel" apartment unit ground floor.***
