1414 Galiano St

**NOTICE OF UNSAFE STRUCTURE VIOLATION FOR FAILURE TO RECERTIFY
AND NOTICE OF HEARING**

Based on the visual inspection of exposed structural members, **the building is safe for its continued use and occupancy, however repairs will be needed to comply with the 40-year recertification.**

Building Being Certified
Building No.2

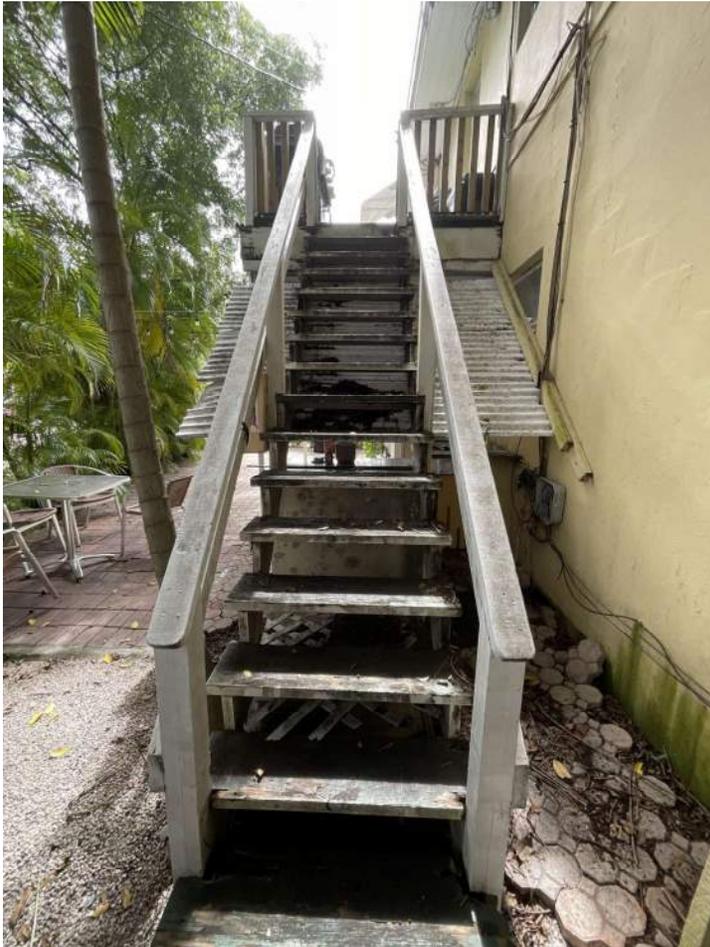
Picture No. 10: Building No.1 Exterior stair, See addendum for deficiencies.

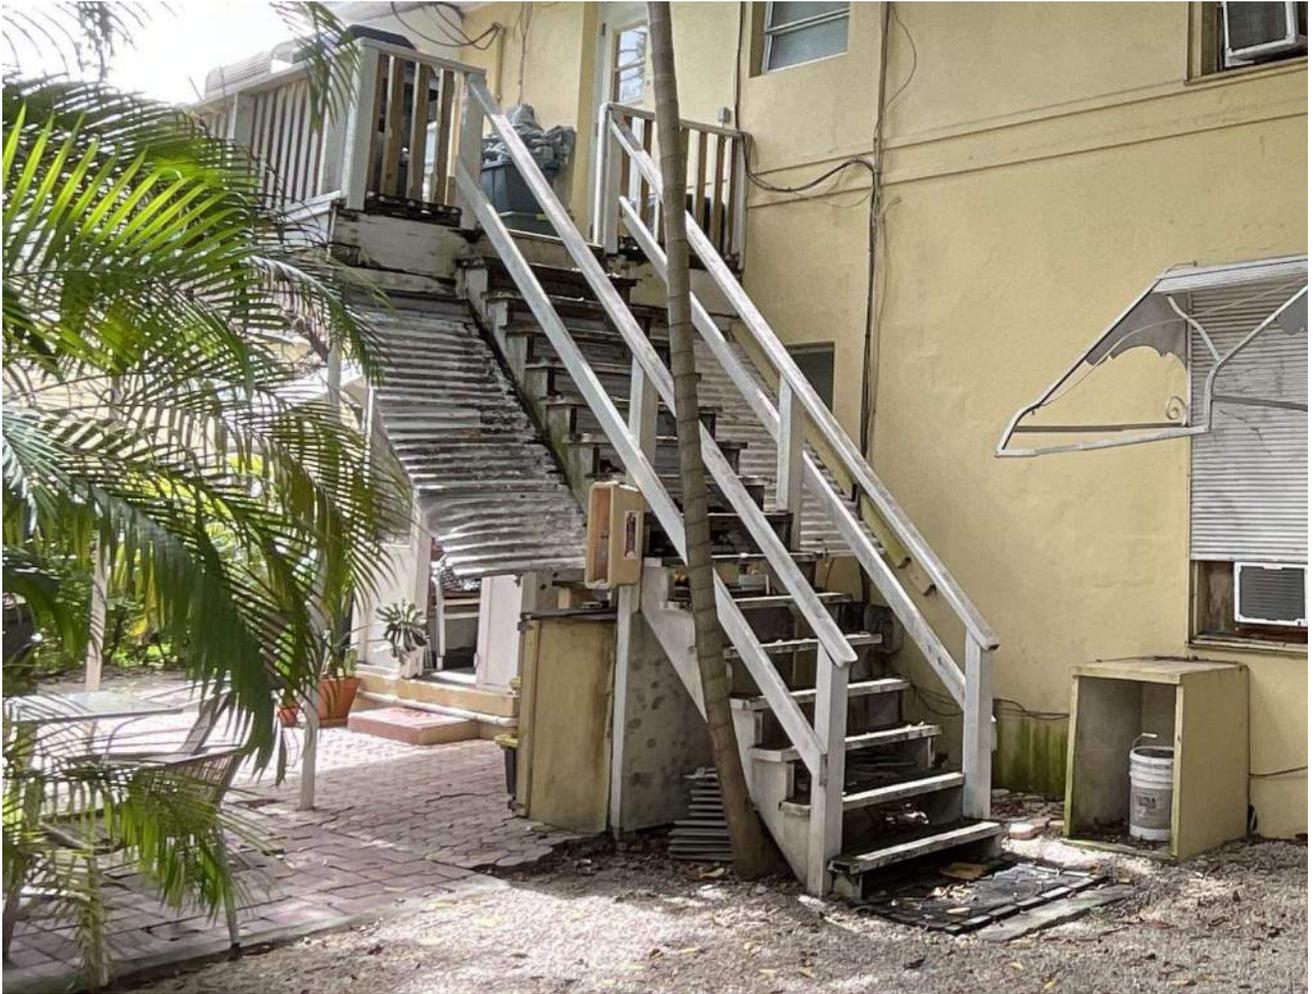
Picture No. 11: Building No.1 Rear stair wood framing of wood members supported on steel and wood columns. See addendum for deficiencies and repairs.

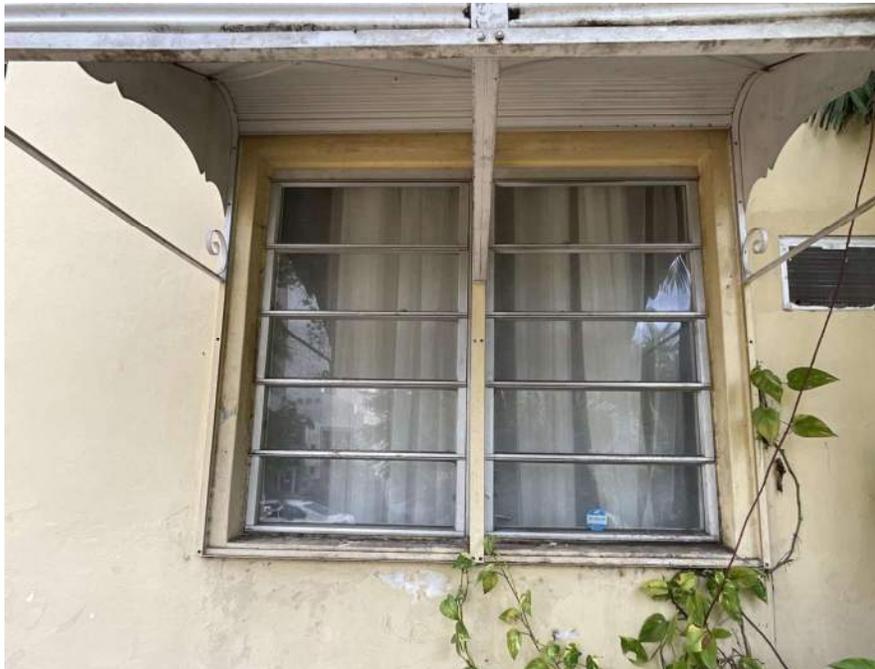
Picture No. 12: Building No.1 Steel and Aluminum glass windows. See addendum for deficiencies and repairs.

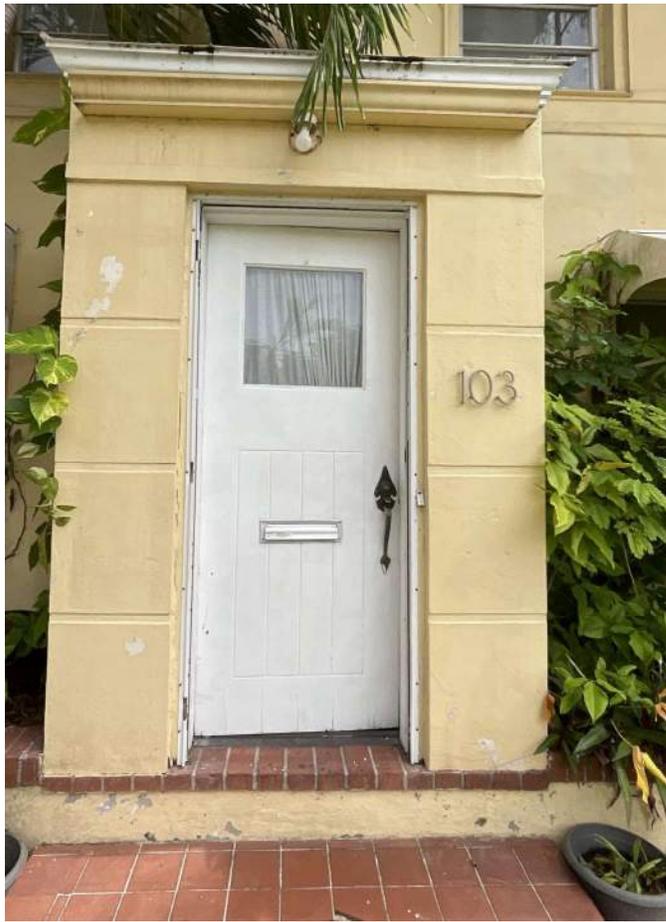
Picture No. 13: Building No.1 Entry Wood doors. See addendum for deficiencies & repairs

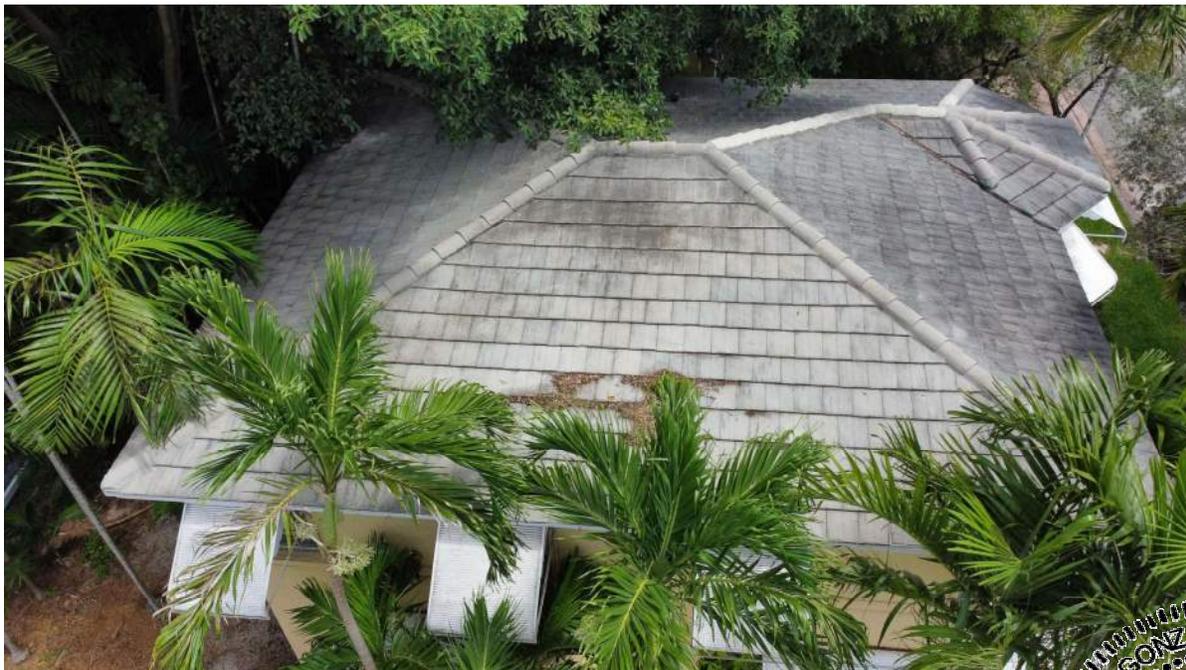
Picture No. 14: Building No.1 Concrete roof tile. See addendum for deficiencies.

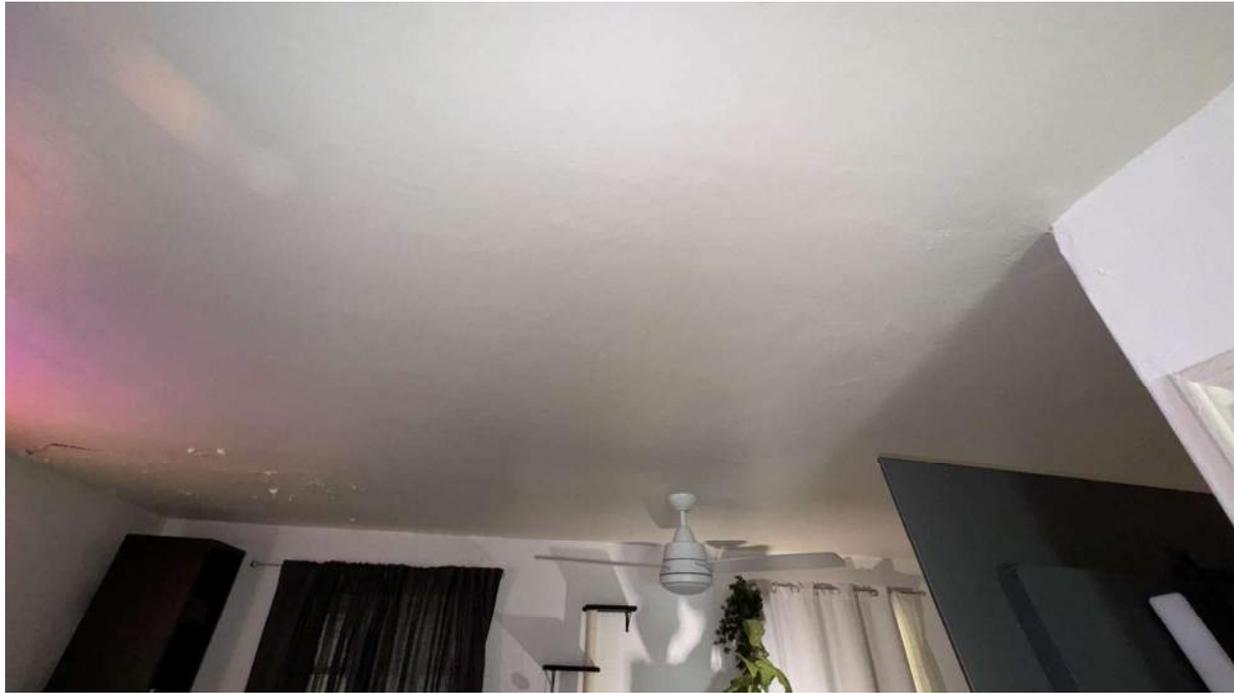
Picture No. 21: Building No.2 Roof framing of wood planks sheathing over wood trusses bearing on concrete masonry perimeter walls. See addendum for deficiencies.

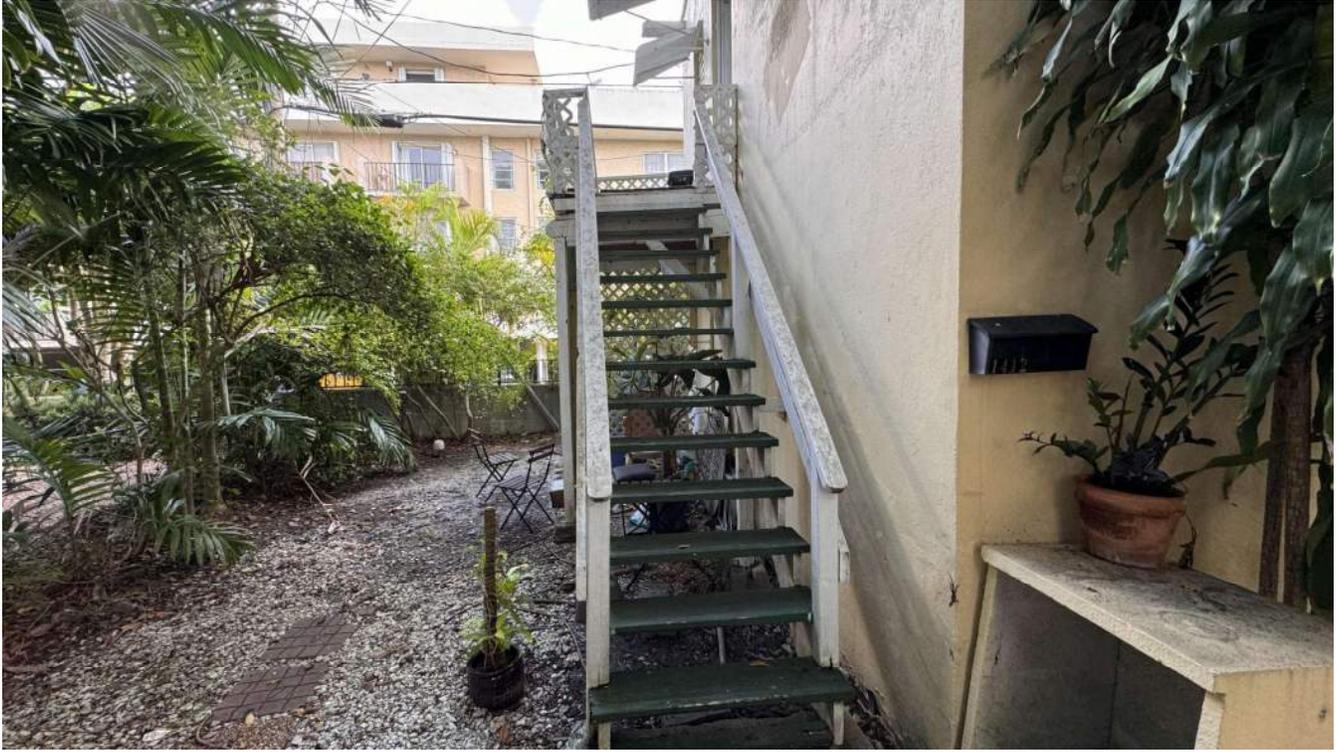
Picture No. 23: Building No.2 Exterior stair, See addendum for deficiencies.

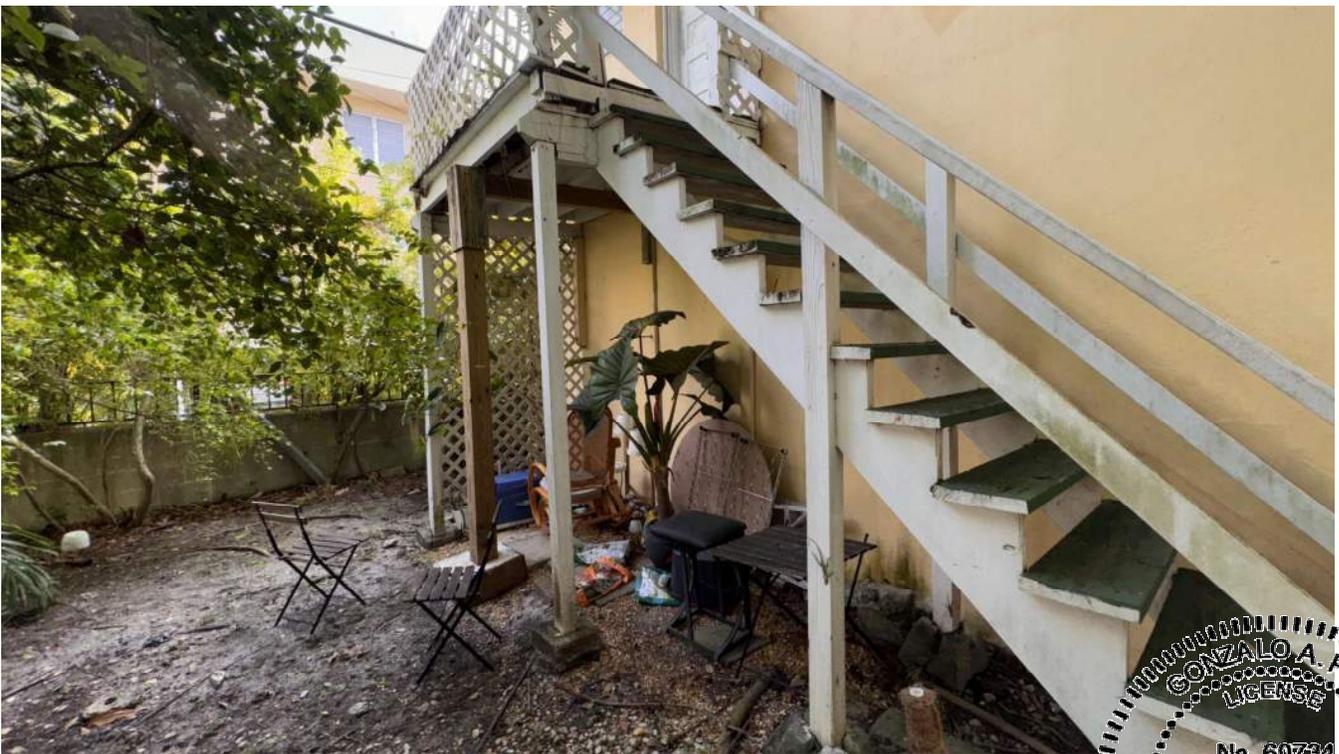
Picture No. 24: Building No.2 Rear stair wood framing of wood members supported on wood columns. See addendum for deficiencies and repairs.

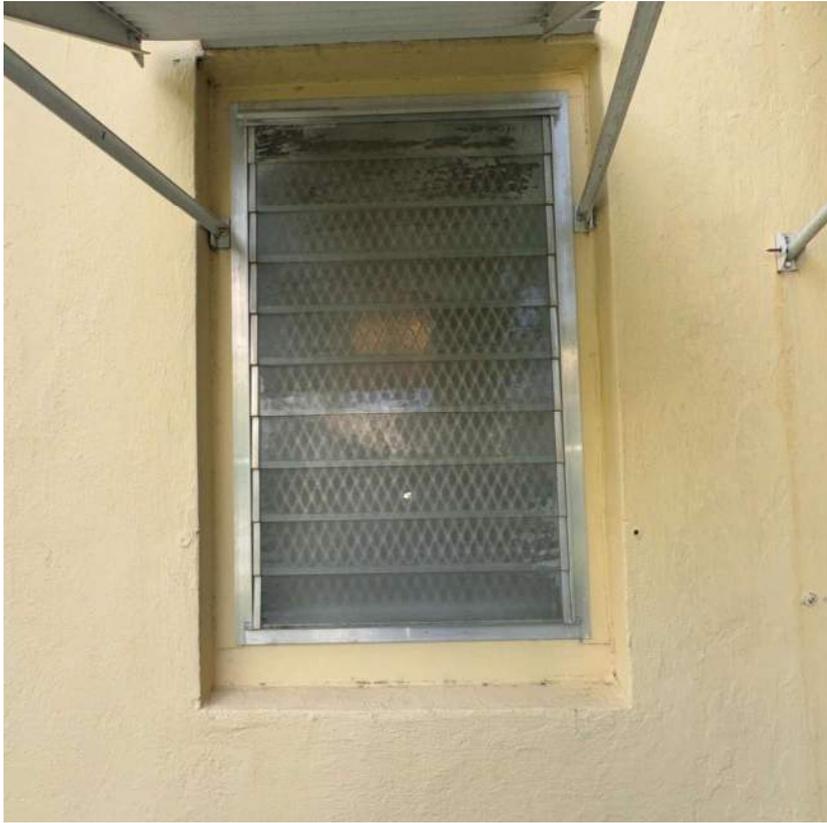
Picture No. 25: Building No.2 Steel and Aluminum glass windows. See addendum for deficiencies and repairs.

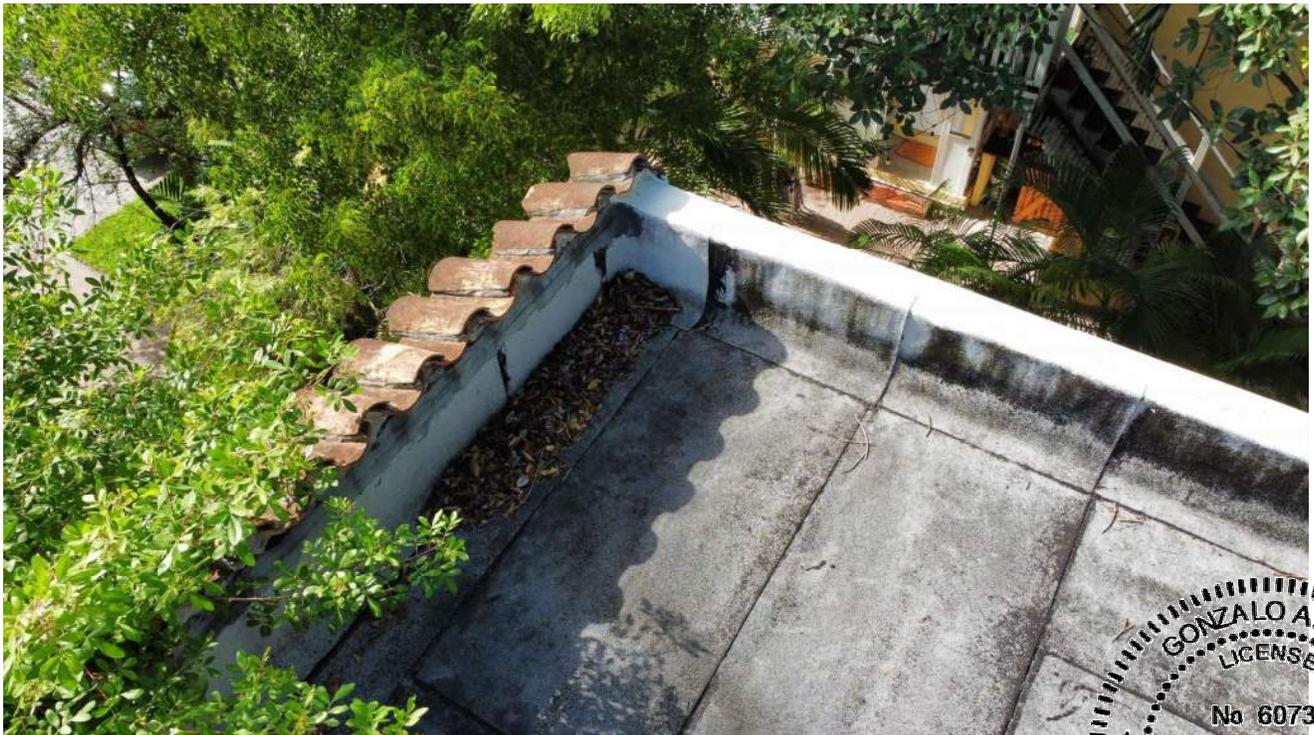
Picture No. 28: Building No.2 Roofing of built-up asphalt bituminous membrane. **addendum for deficiencies.**

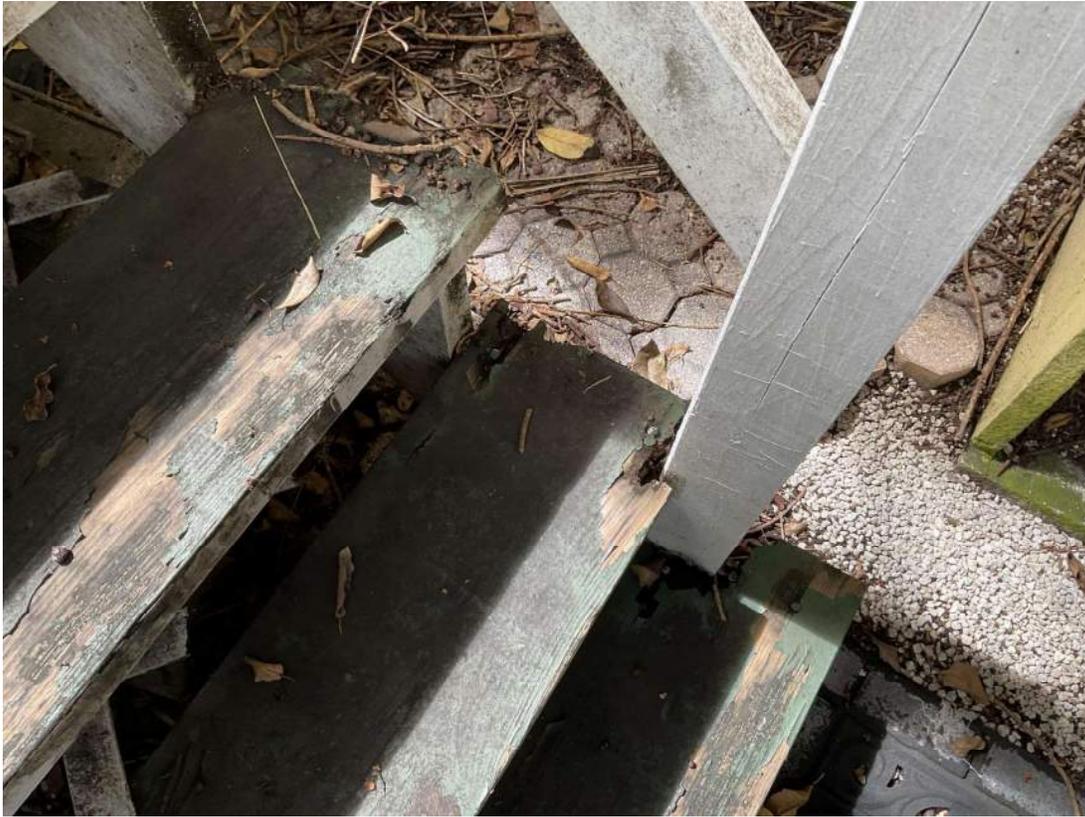
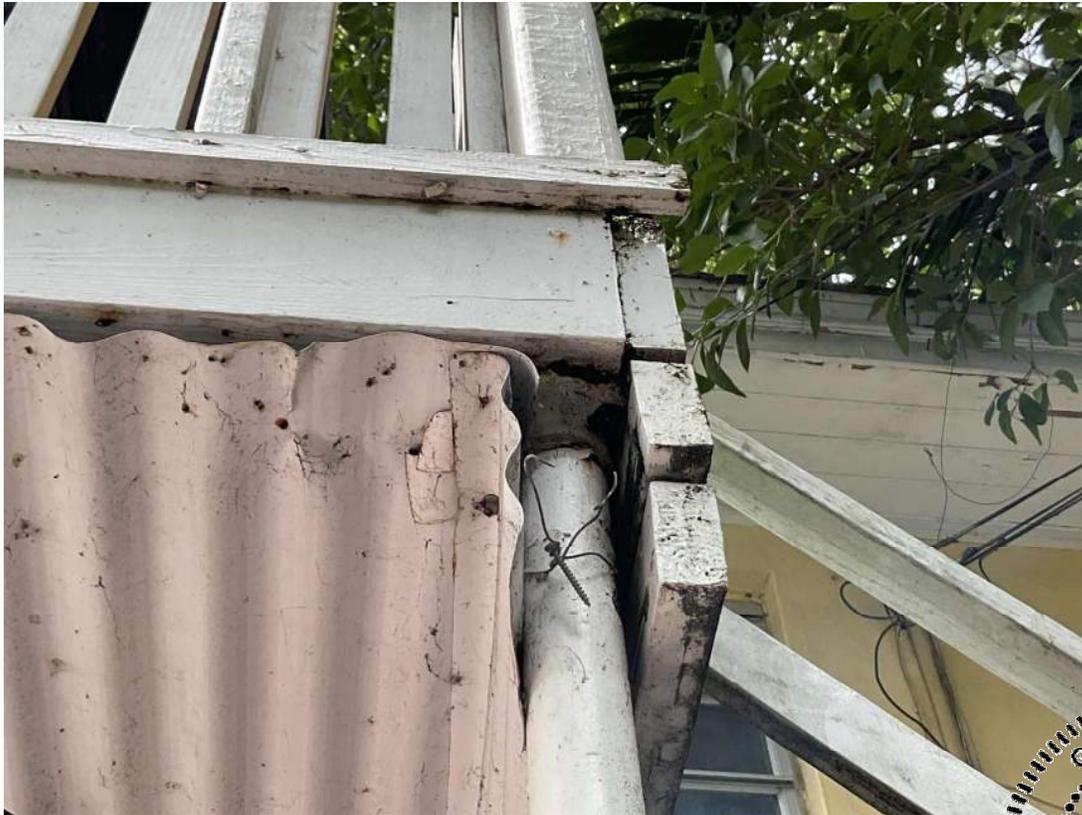
Item 1-Picture No. 1A&1B: Building No.1 Stair framing of wood elements with sign of rotten and missing anchor allowing excessive movements and deflections. We recommend replacing it with a new one with the current minimum FBC requirements.

Item 1-Picture No. 1A&1B: Building No.1 Stair framing of wood elements with signs of rotten and missing anchor allowing excessive movements and deflections. We recommend replacing with a new one with the current minimum FBC requirements.

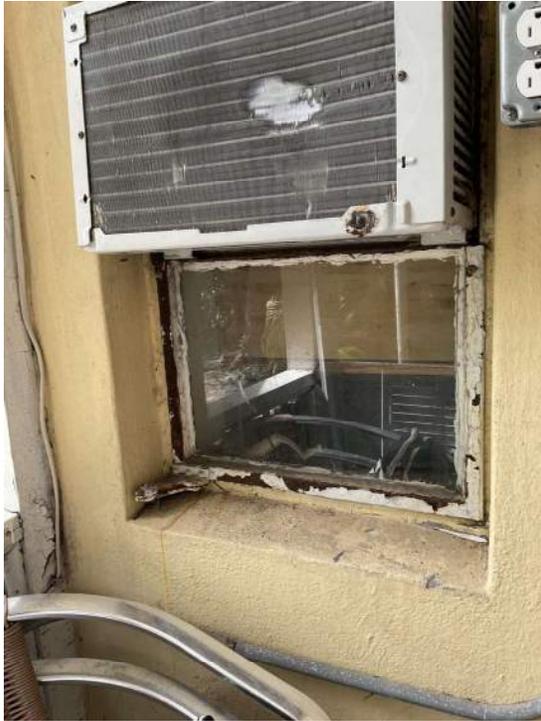
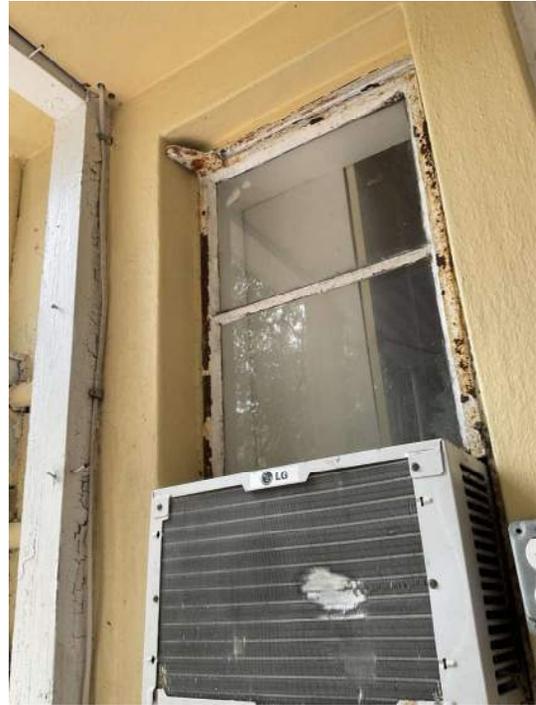
Item 2-Picture No. 2A&2B: Building No.1 Steel casement windows with sign of corrosion. Corrosion shall be removed, and steel painted.

Item 2-Picture No. 2A&2B: Building No.1 Steel casement windows with sign of corrosion. Corrosion shall be removed, and steel painted

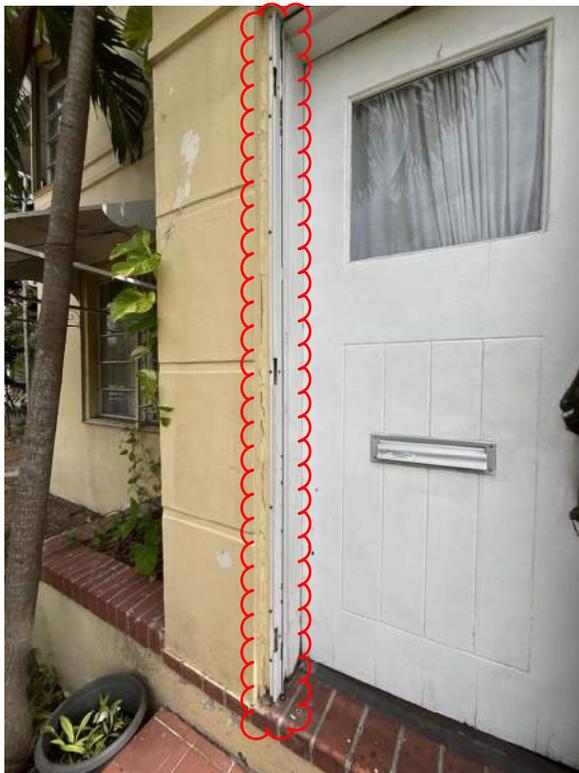
Item 3-Picture No. 3A: Building No.1 Caulk with sign of damage. Sealant shall be replaced.

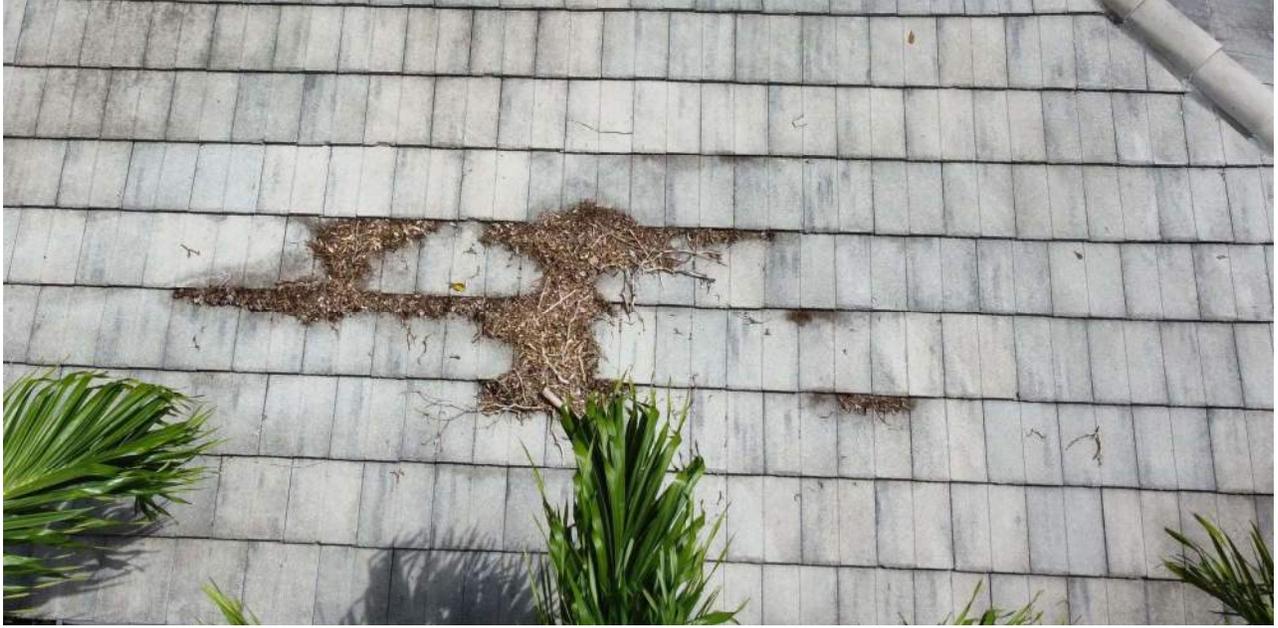
Item 4-Picture No. 4A: Building No.1 Roof and roofing shall be cleaned of any debris and loose roofing granule particles, etc.

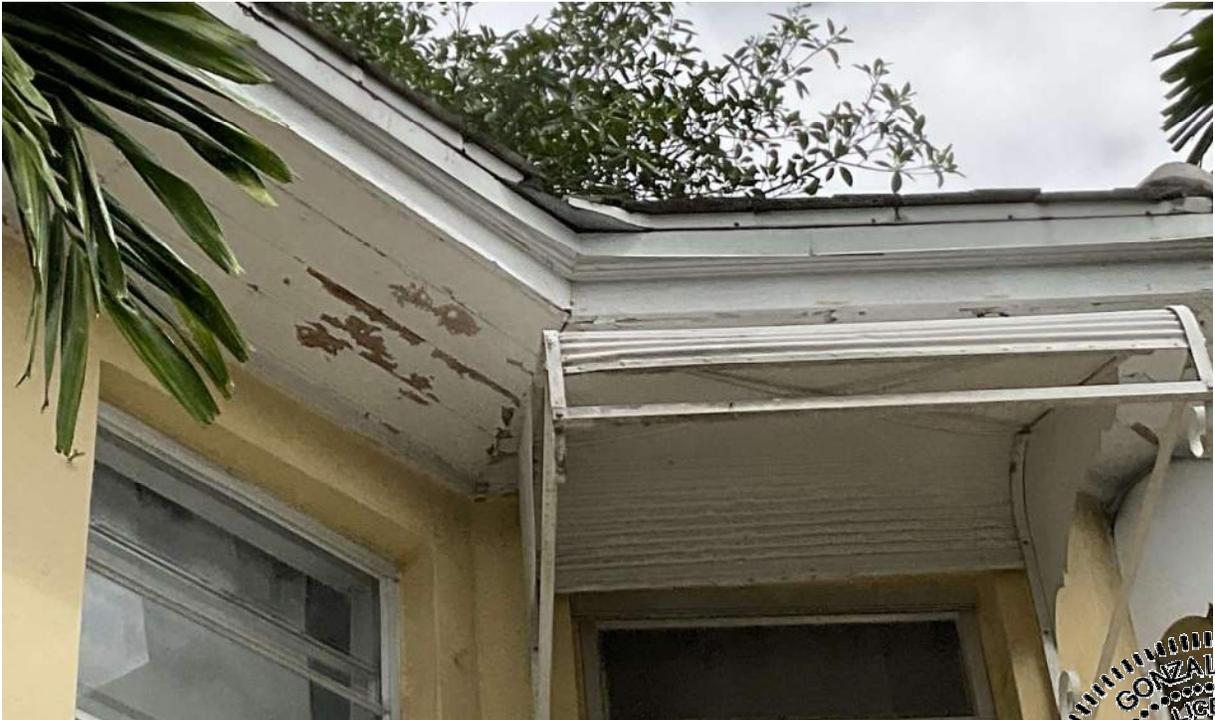
Item 5-Picture No. 5A: Building No.1 Roof Soffit rotted with wood damage. Wood soffit shall be replaced.

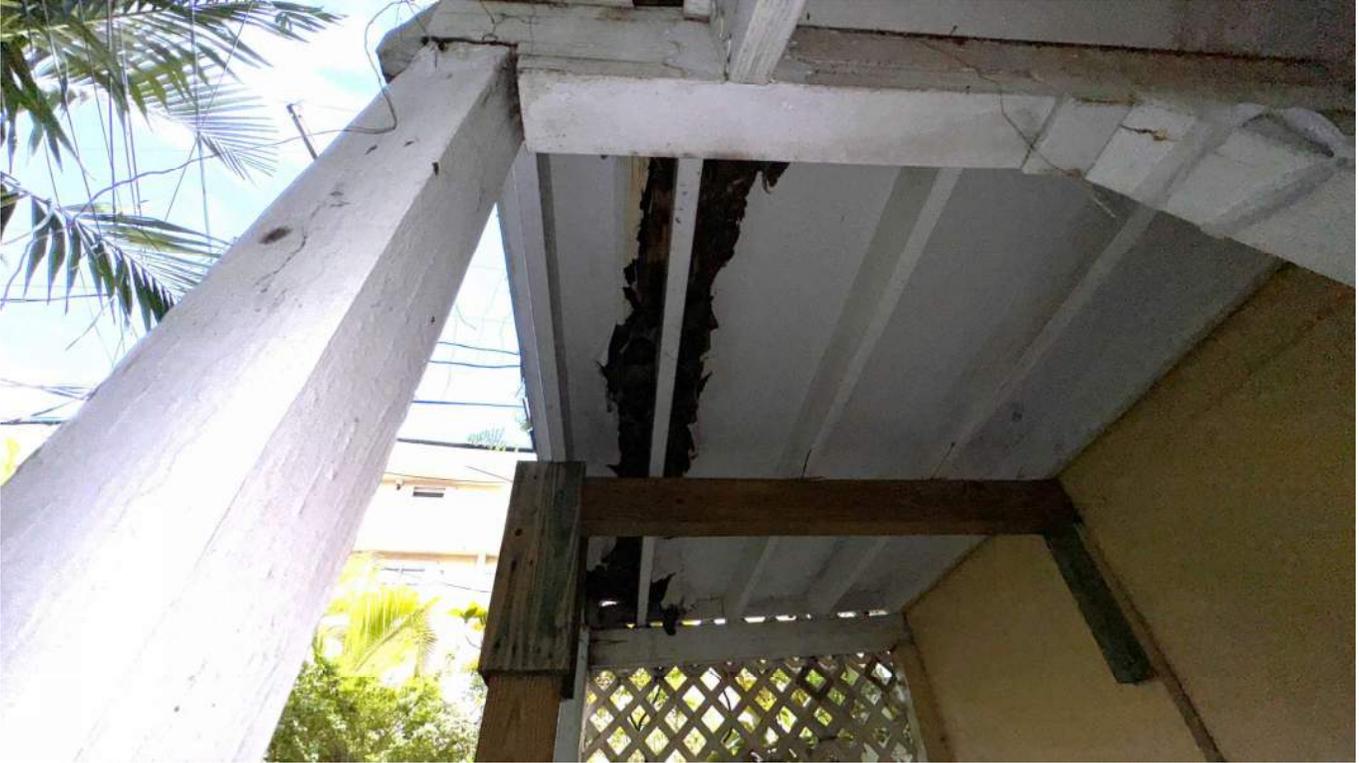
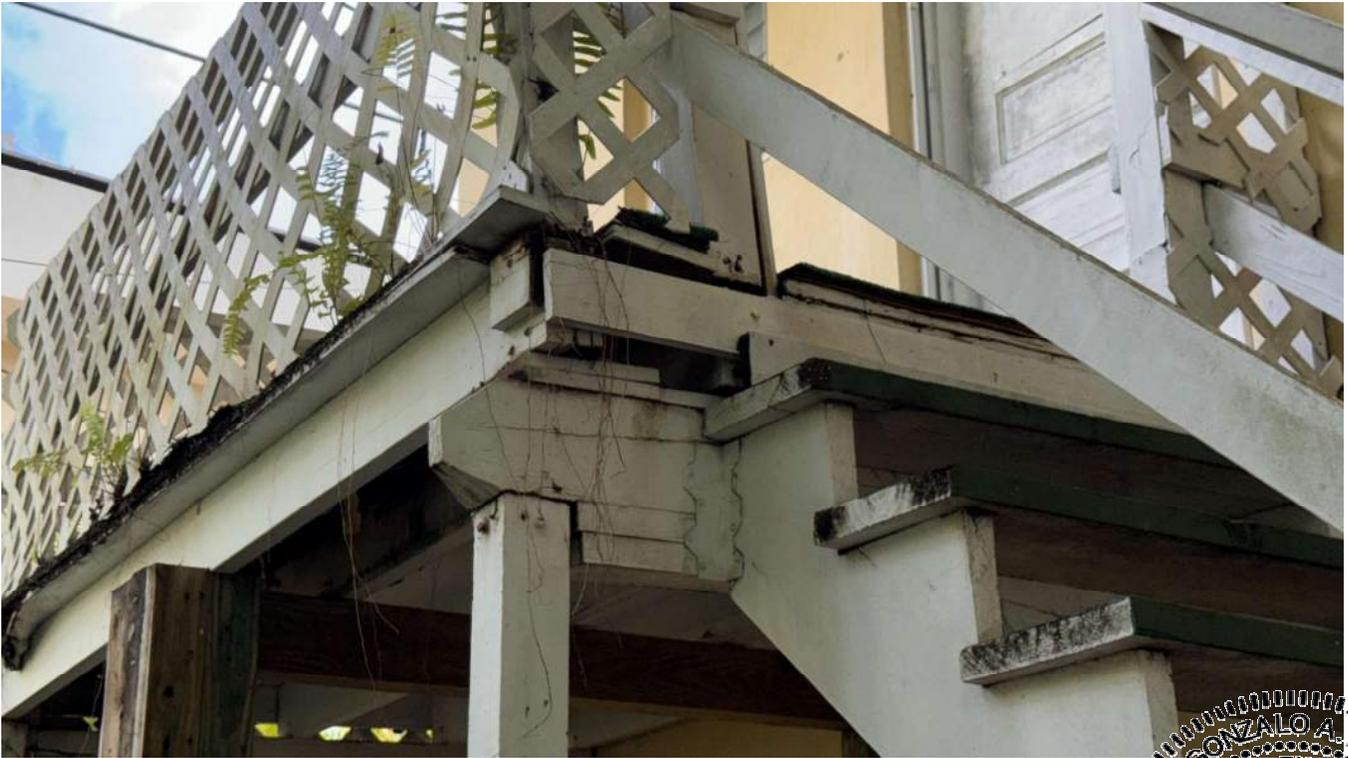
Item 6-Picture No. 6A&6b: Building No.2 Stair framing of wood elements with sign of rotten and missing anchor allowing excessive movements and deflections. We recommend replacing it with a new one with the current minimum FBC requirements.

Item 6-Picture No. 6A&6b: Building No.2 Stair framing of wood elements with significant rot and missing anchor allowing excessive movements and deflections. We recommend replacing with a new one with the current minimum FBC requirements.

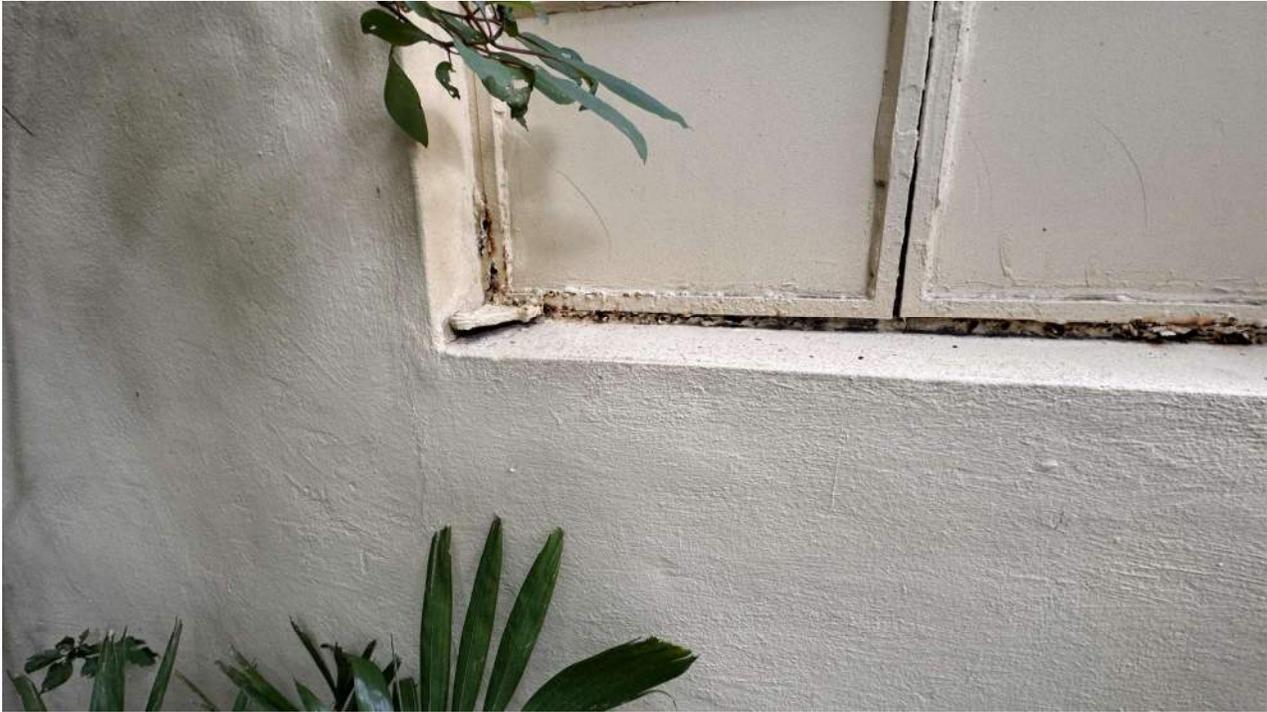
Item 7-Picture No. 7A: Building No.2 Steel casement windows with sign of corrosion. Corrosion shall be removed, and steel painted.

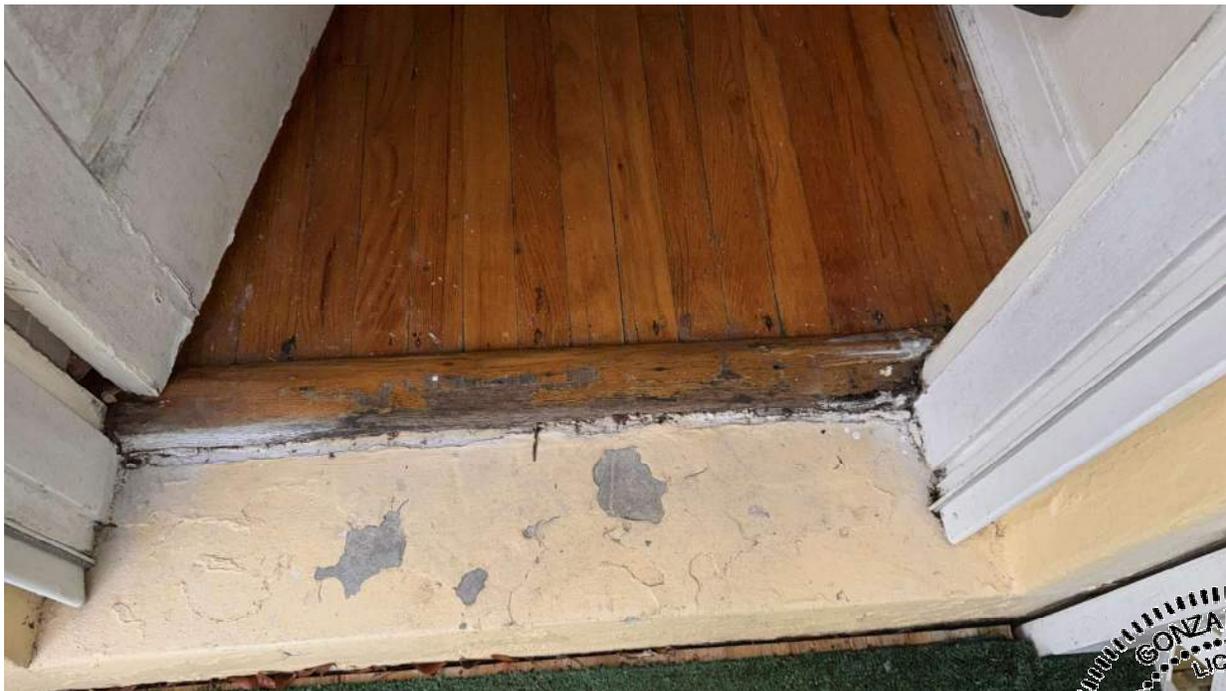
Item 8-Picture No. 8A: Building No.2 Caulk with sign of damage. Sealant shall be replaced.

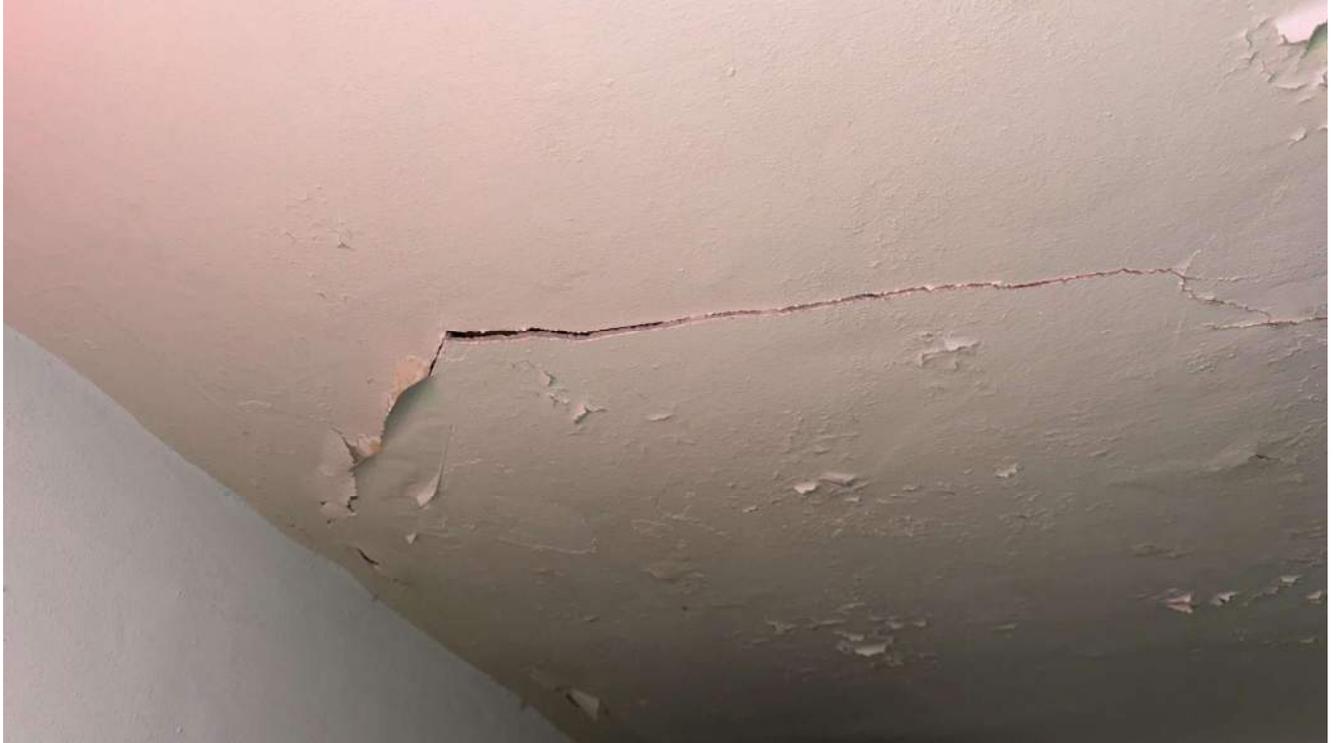
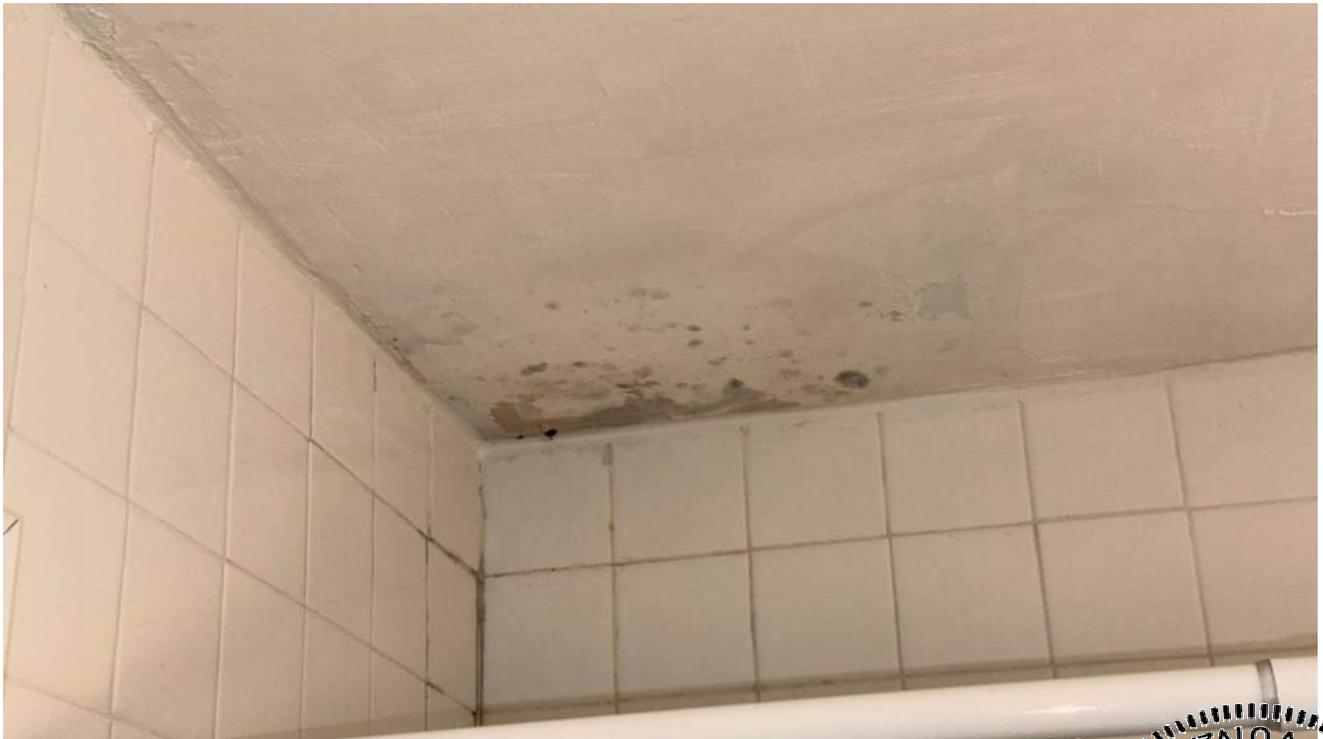
Item 9-Picture No. 9A&9B: Building No.2 Signs of water infiltration through the roof. The roofing shall be repaired. We recommend hiring a contractor specialized in this type of work.

Item 9-Picture No. 9A&9B: Building No.2 Signs of water infiltration through the roof. Roofing shall be repaired. We recommend hiring a contractor specialized in this type of work

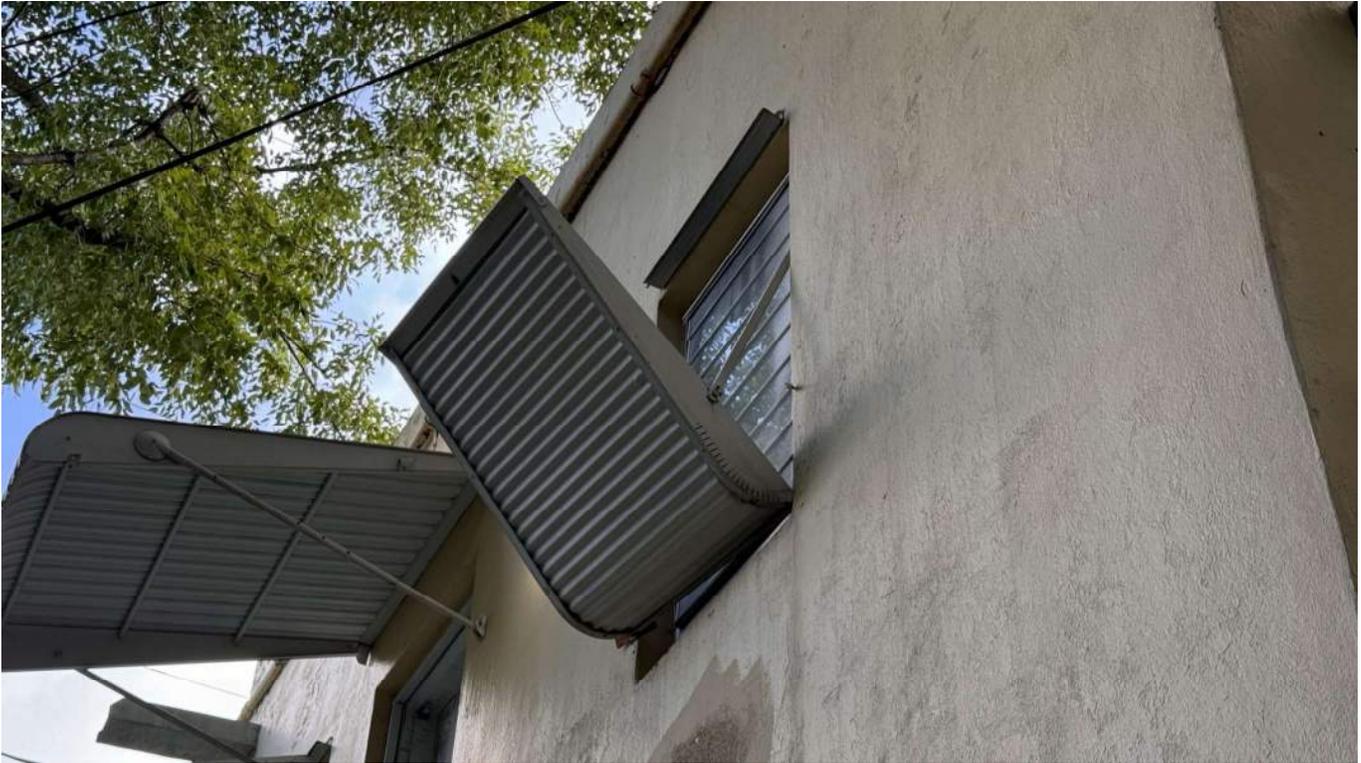
Item 10-Picture No. 10A: Building No.2 Steel windows Shutter shall be repaired and brought back to its original condition.

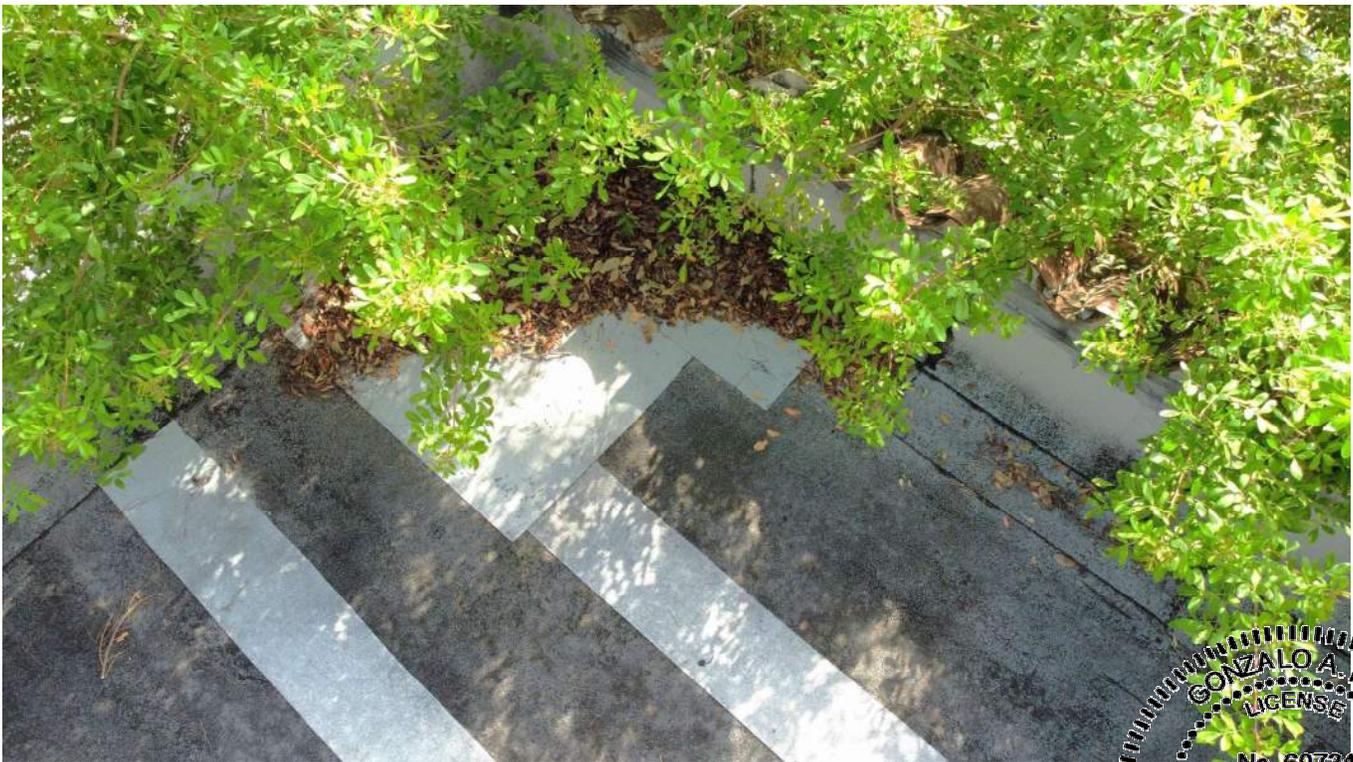
Item 11-Picture No. 11A: Building No.2 Roof and roofing shall be cleaned of any debris and loose roofing granule particles, etc.

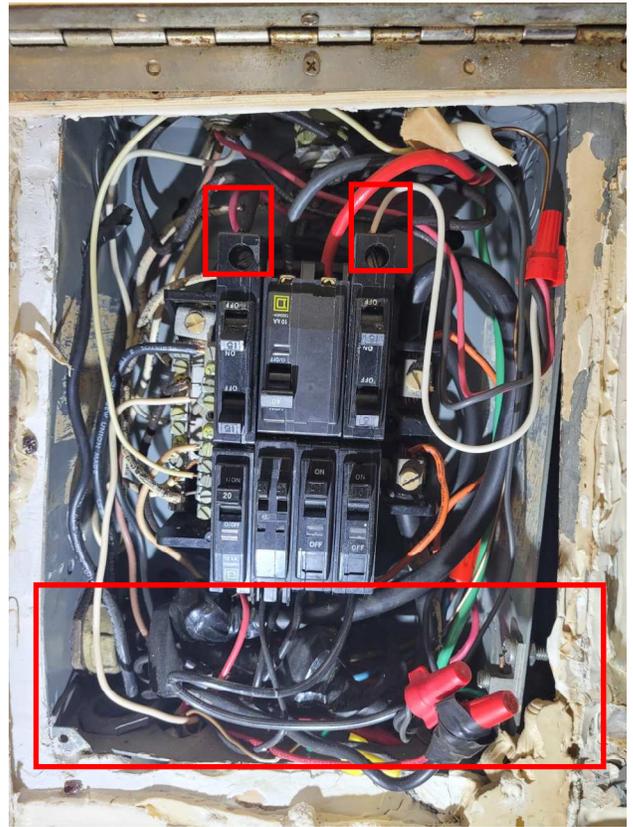
- 1) Apartment unit ground floor missing main circuit breaker.***
- 2) Remove illegal double tapping on circuit breakers 1 and 7 in "Electrical Panel" apartment unit ground floor.***

Panel Apt. Unit Ground Floor Open
Missing main circuit breaker
Double tapping in breakers 1 & 7
(p-5)
