OFFICE OF THE PROPERTY APPRAISER

Summary Report

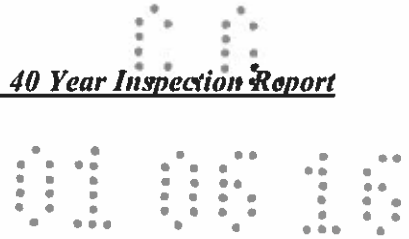
During the inspection, concrete was sounded for delamination, indication of corrosion and other signs of deterioration. No destructive testing was conducted. All common areas were inspected. The structure was inspected at the interior of the Mechanical and Electrical rooms, penthouses and stair cores. Six Units – 219, 407, 416, 619, 1203 and PH – were inspected for balcony inspections.

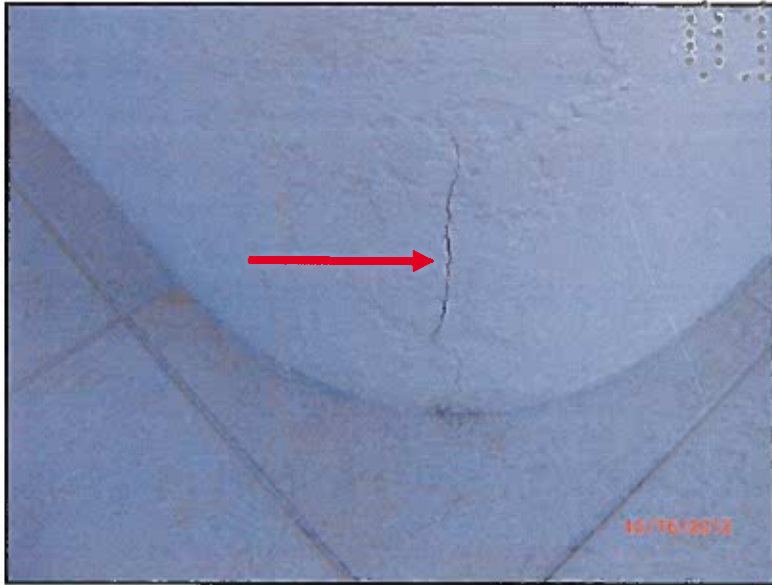
PHOTO # 1: Vertical cracking on building wall located at balcony Unit #219

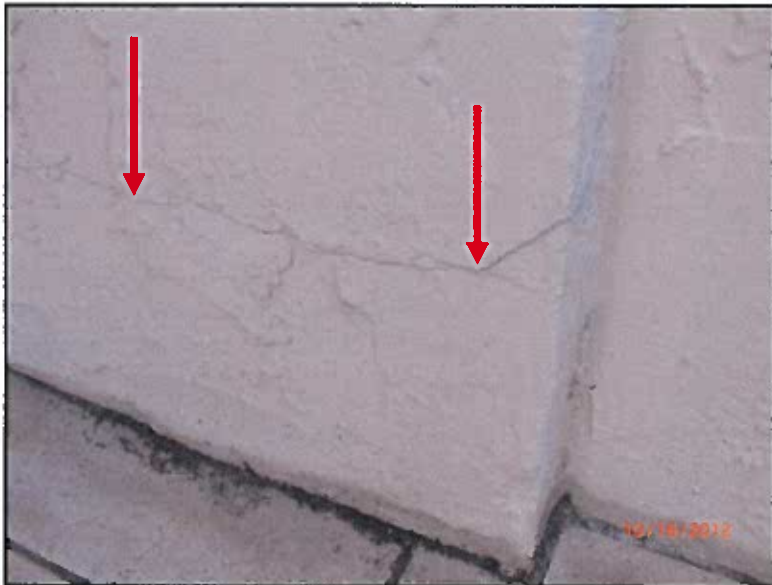
PHOTO # 2: Horizontal cracking/delaminated stucco at balcony wall Unit #219

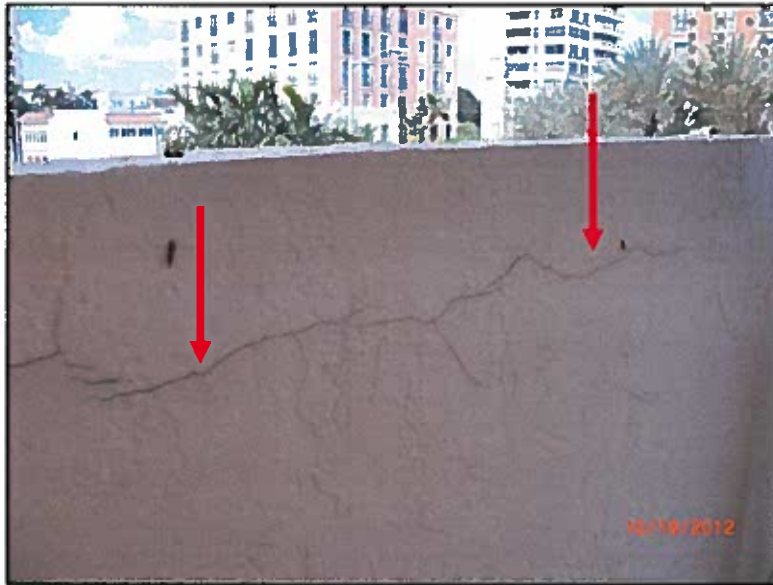
PHOTO # 3: Horizontal cracking on balcony block wall concrete cap at Unit #219

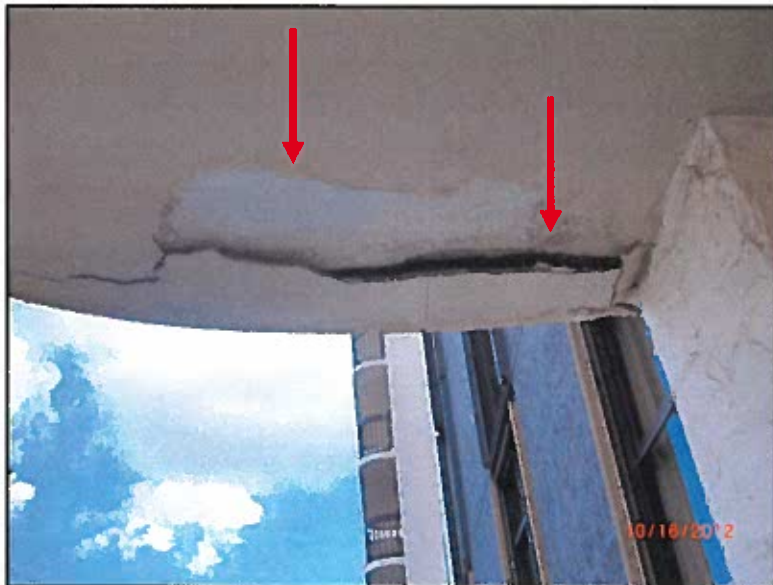
PHOTO # 4: Concrete spalling/exposed steel rebar at balcony ceiling at Unit #219

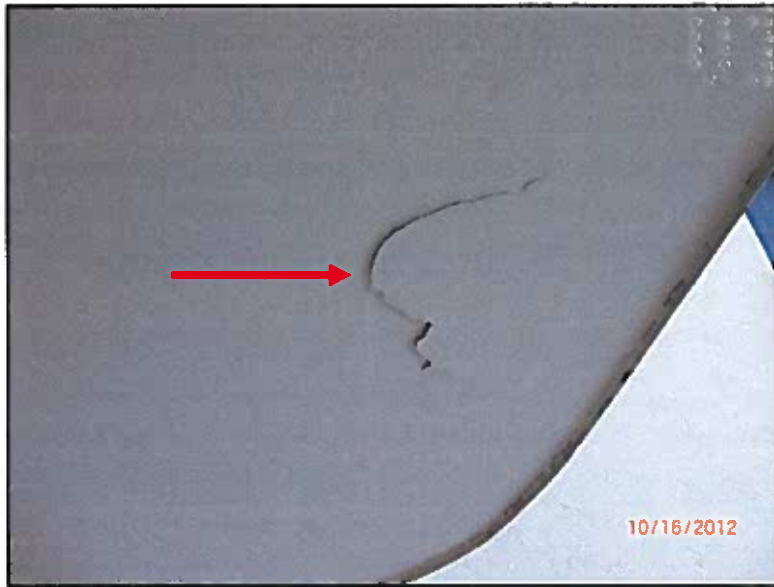
PHOTO # 5: Concrete spalling at balcony ceiling at Unit #416

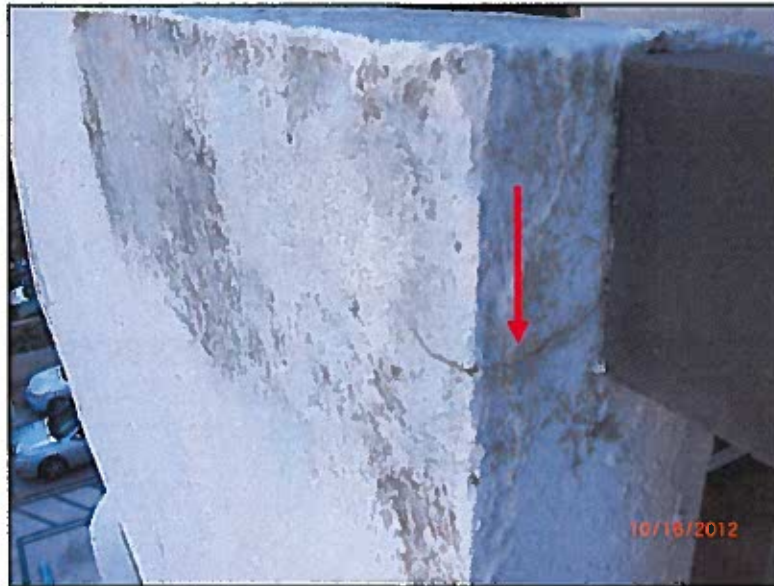
PHOTO # 6: Cracking stucco at balcony railing connection at Unit #407

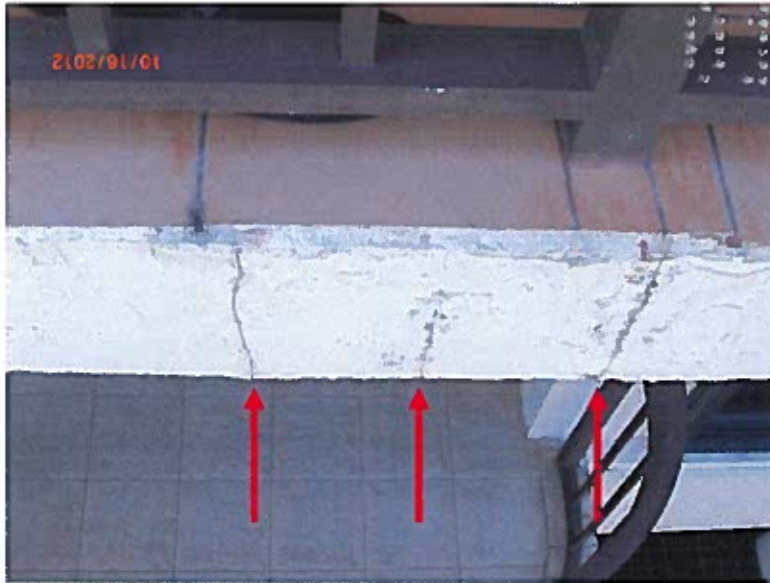
PHOTO # 7: Cracking/delaminated stucco on balcony slab edge at Unit #407

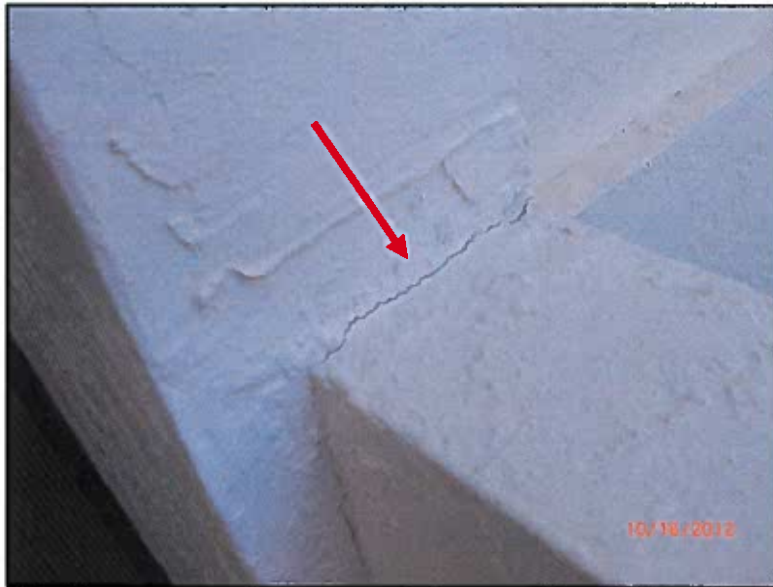
PHOTO # 8: Cracking at connection between balcony wall and bldg. column at Unit #219

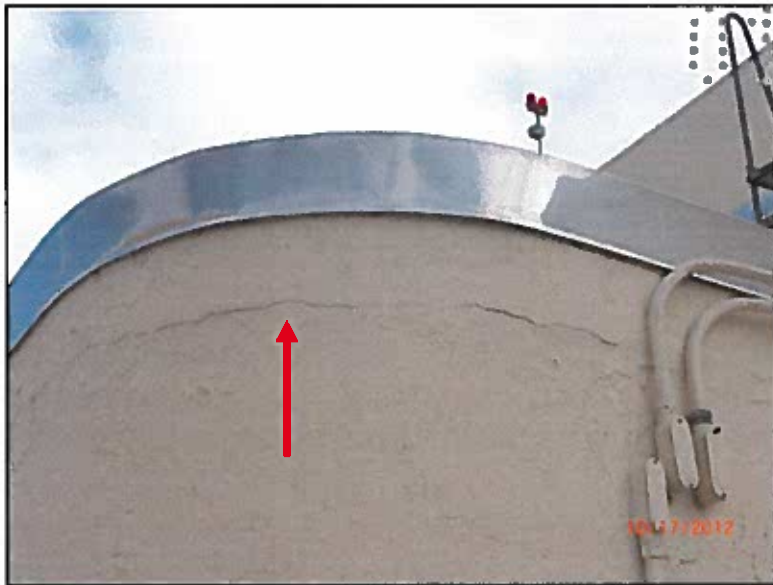
PHOTO # 9: Delaminated/cracking stucco at exterior of Generator Room at roof area

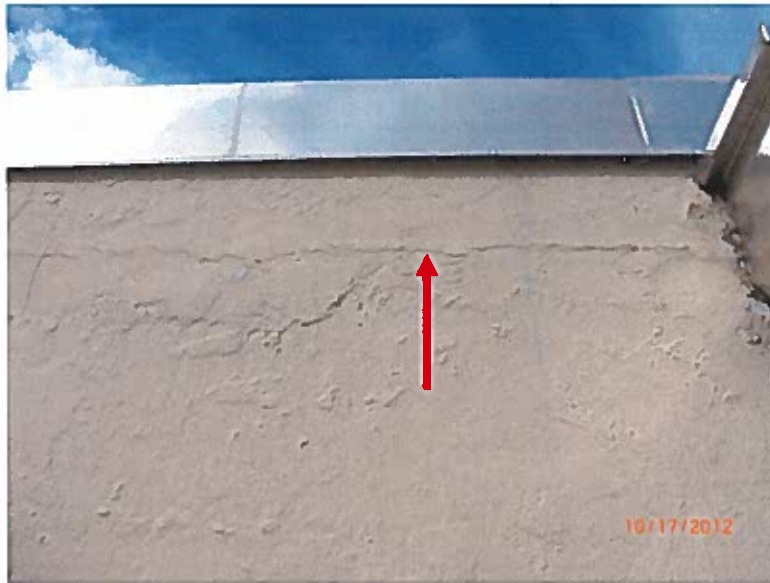
PHOTO # 10: Delaminated/cracking stucco at exterior of east Elevator Machine Room at Roof Area

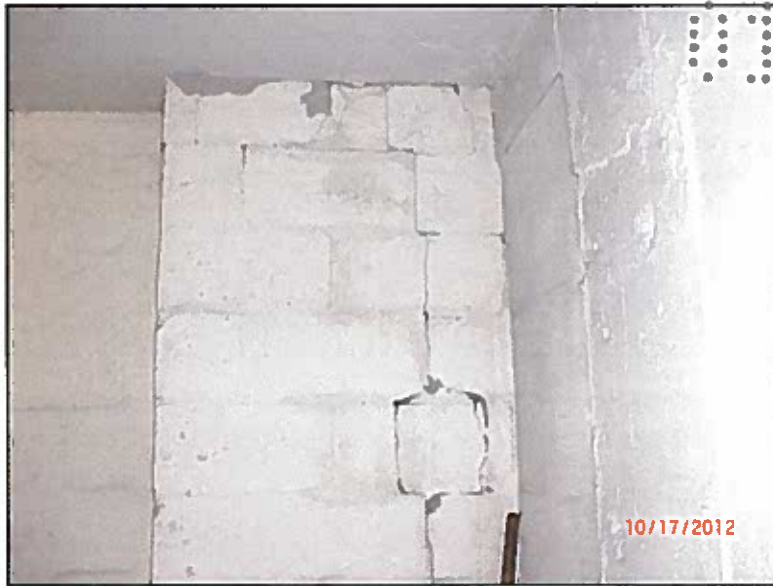
PHOTO # 11: Step cracking at corners of east side Elevator Machine Room

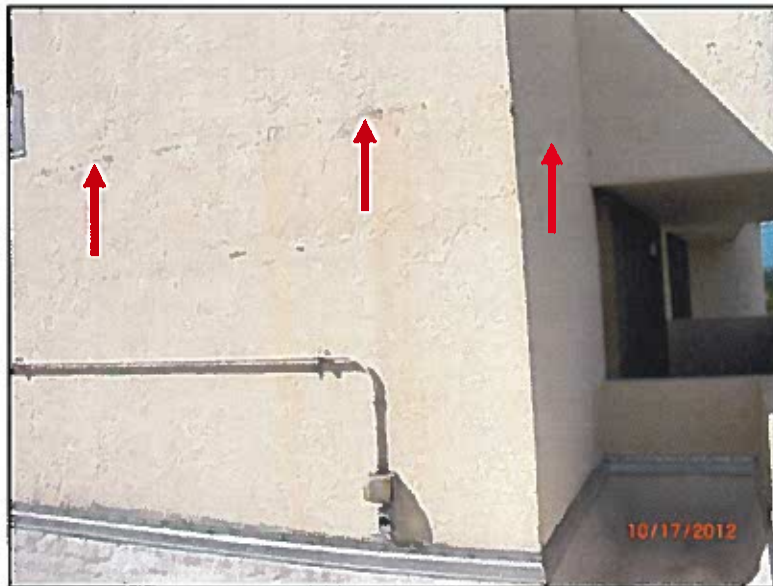
PHOTO # 12: Horizontal cracking at PH exterior wall

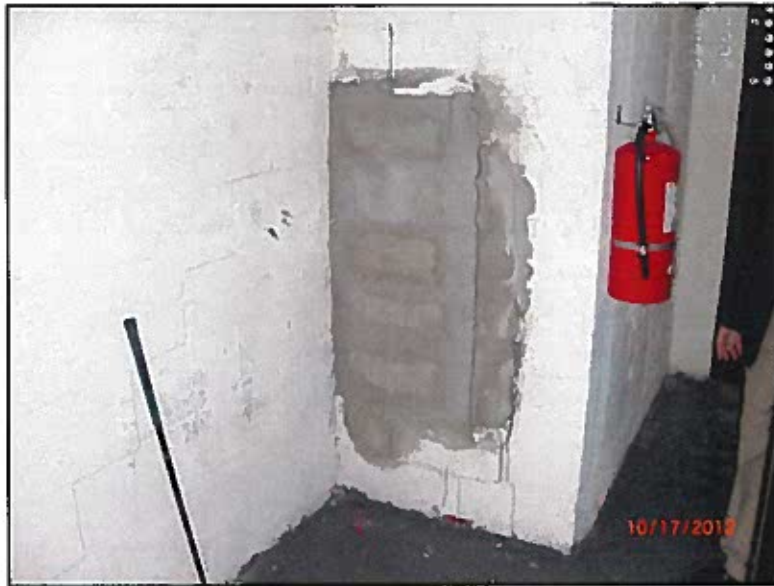
PHOTO # 13: Cracks on block wall at inside of West Elevator Machine Room

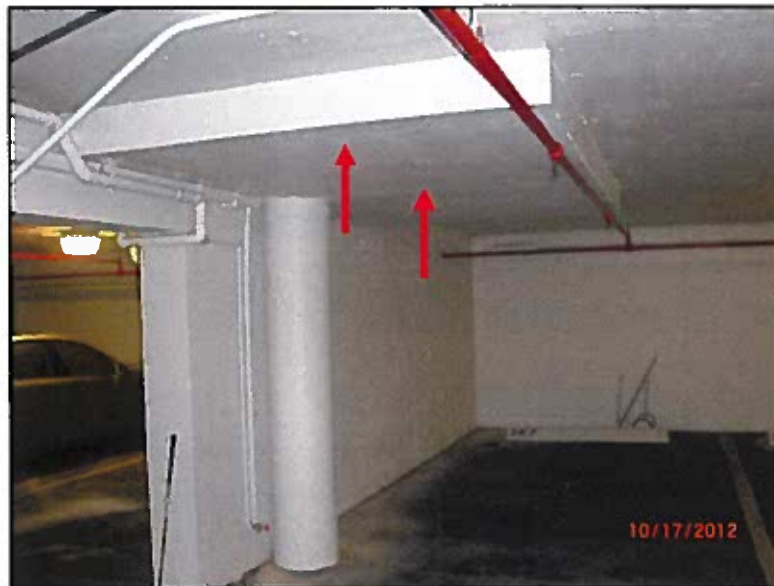
PHOTO # 14: slab cracking at column drop panel next to Parking Space No. 267

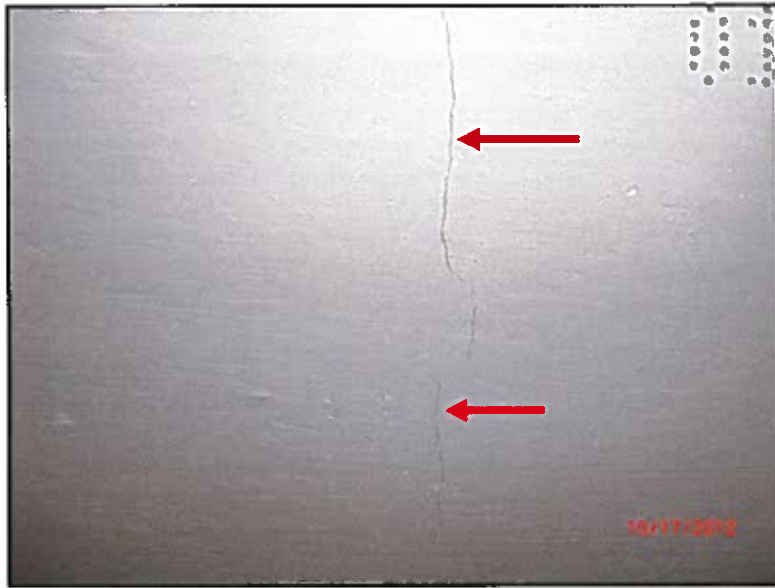
PHOTO # 15: slab cracking at column drop panel next to Parking Space No. 267

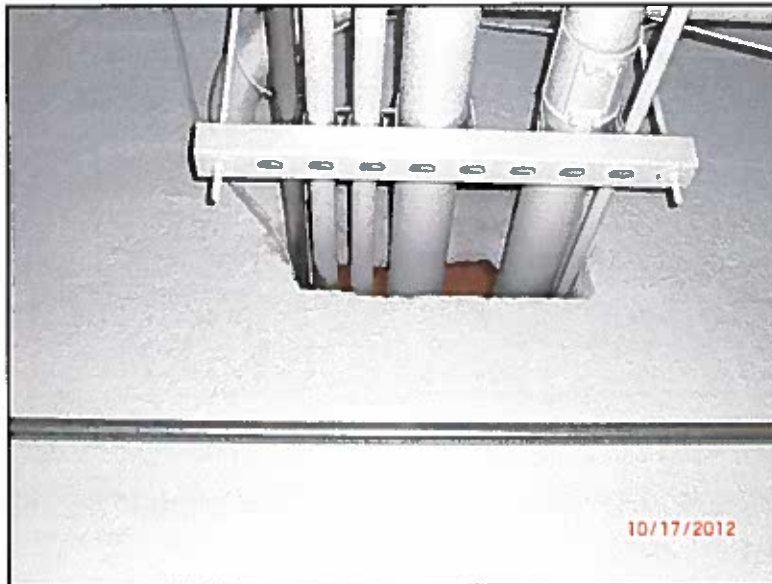
**PHOTO # 16: Unsealed wall, pipe penetration at Fire rated assembly (2hr fire rated assembly)
Paint Storage Room**

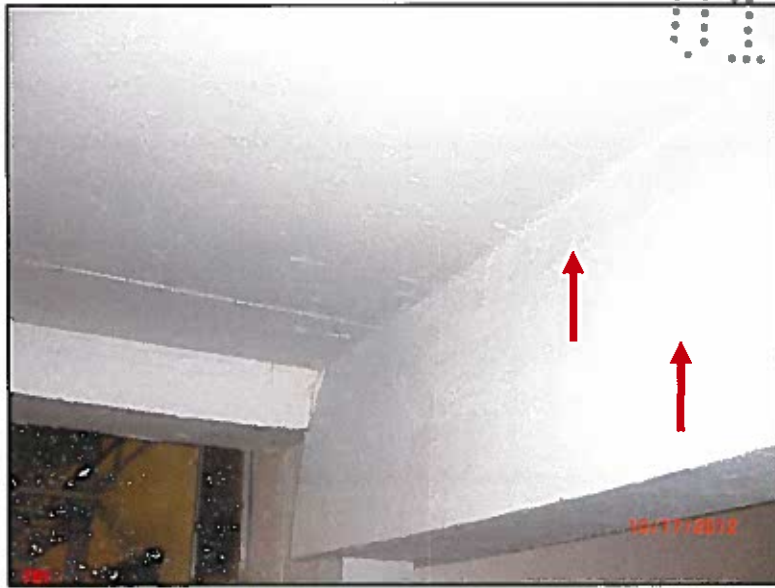
PHOTO # 17: slab cracking and beam cracks next to Parking Space 210

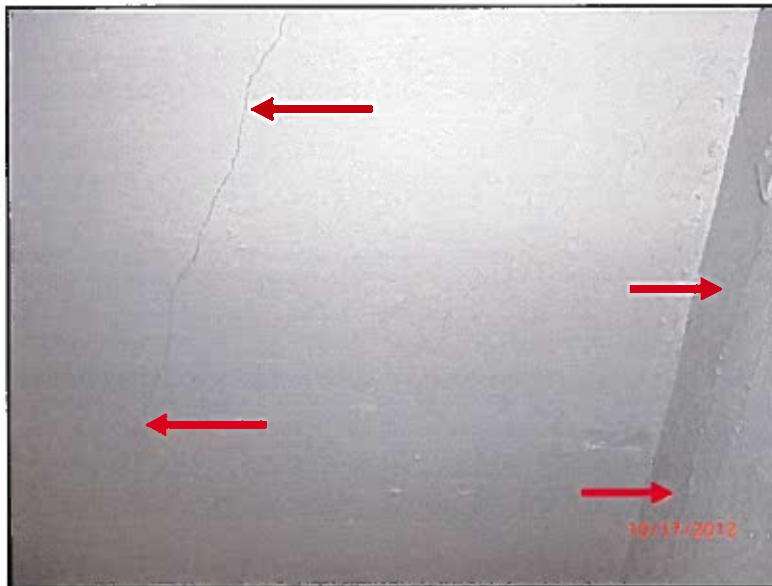
PHOTO # 18: slab cracking at column drop panel next to Parking Space 210

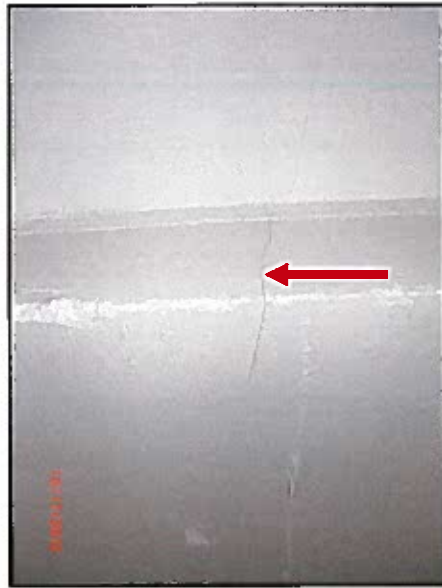
PHOTO # 19: slab cracking at column drop panel between Parking Spaces 248 & 249

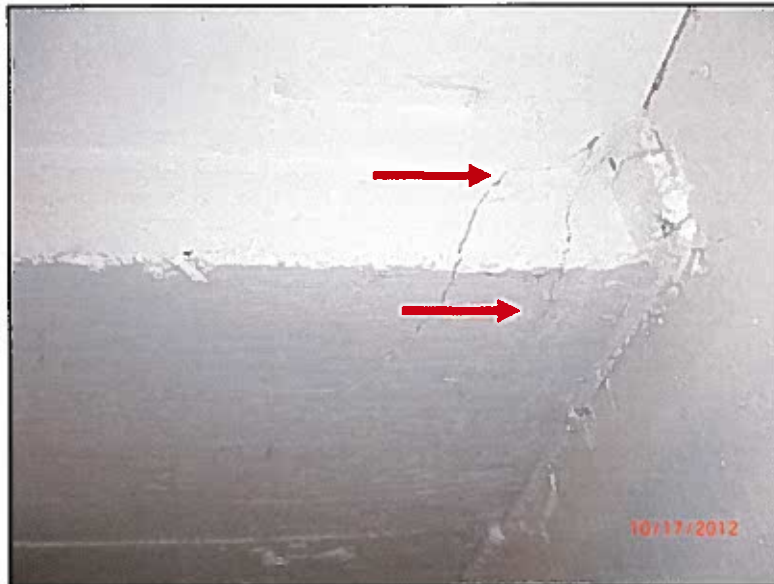
PHOTO # 20: slab cracking at column drop panel between Parking Spaces 245 & 246

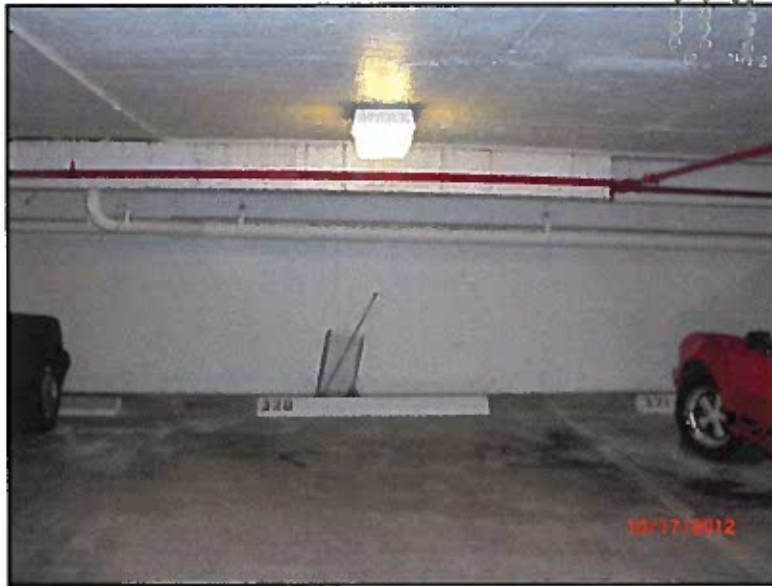
PHOTO # 21: trench drain drop ceiling between Parking Spaces 314 & 327

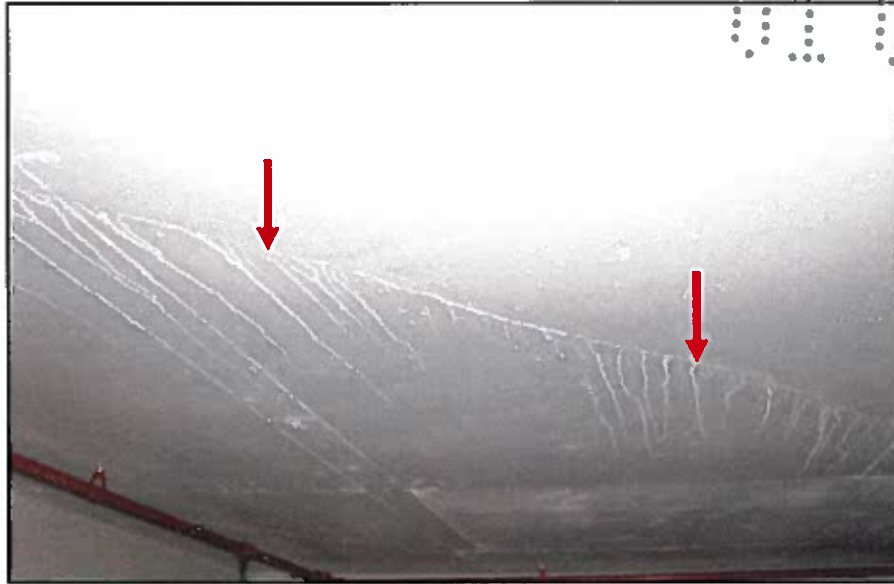
PHOTO # 23: cracking and water intrusion at underside of ramp in front of Parking Space 61

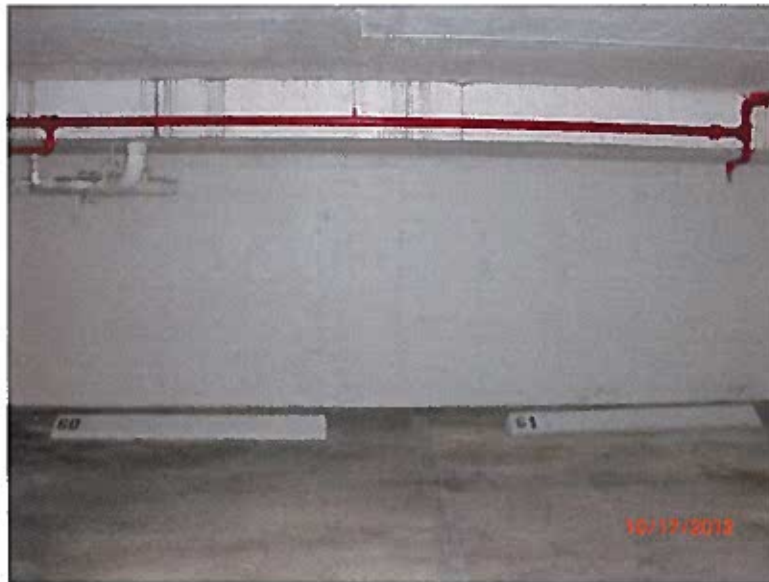
PHOTO # 24: trench drain drop ceiling between Parking Spaces 52 & 61

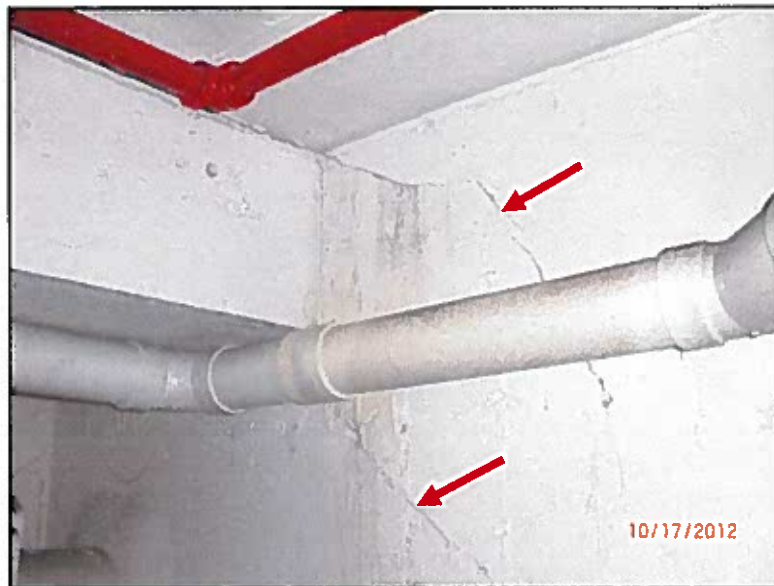
PHOTO # 26: cracking on wall next to Parking Space 51

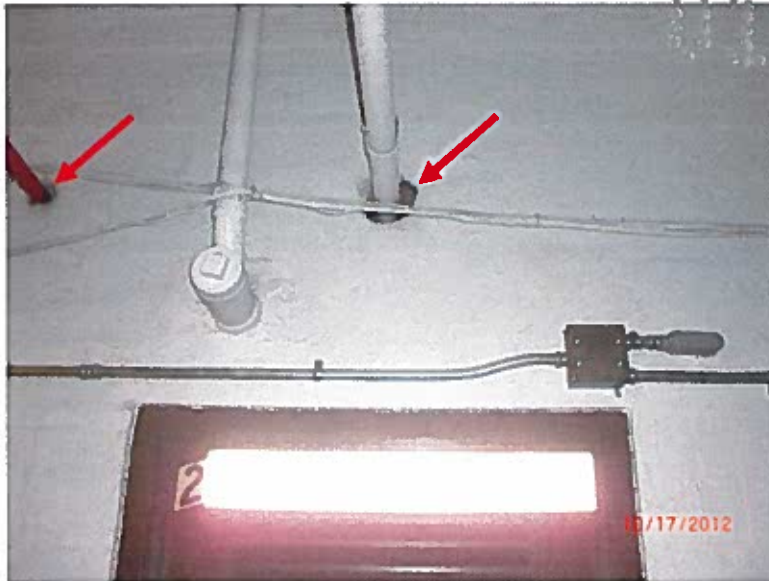
**PHOTO # 27: Unsealed wall, pipe penetration at Fire rated assembly (2hr fire rated assembly)
Paint Storage Room**

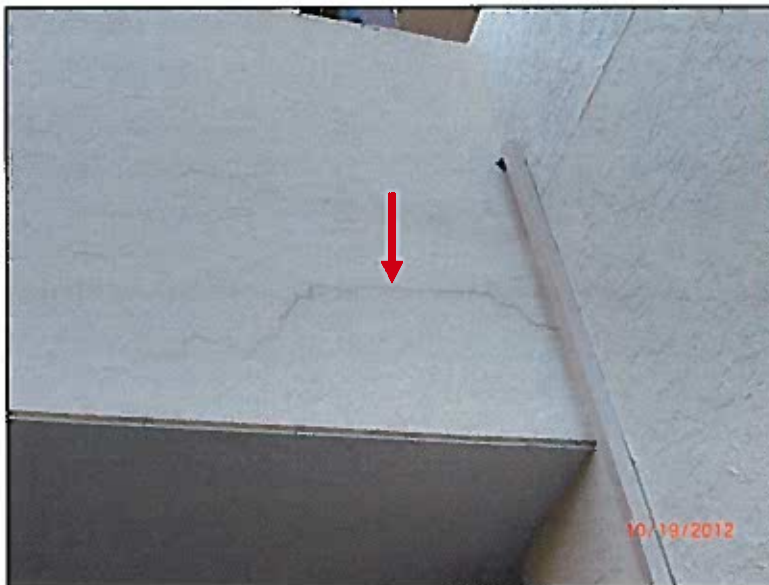
PHOTO # 28: cracking on overhang at West side

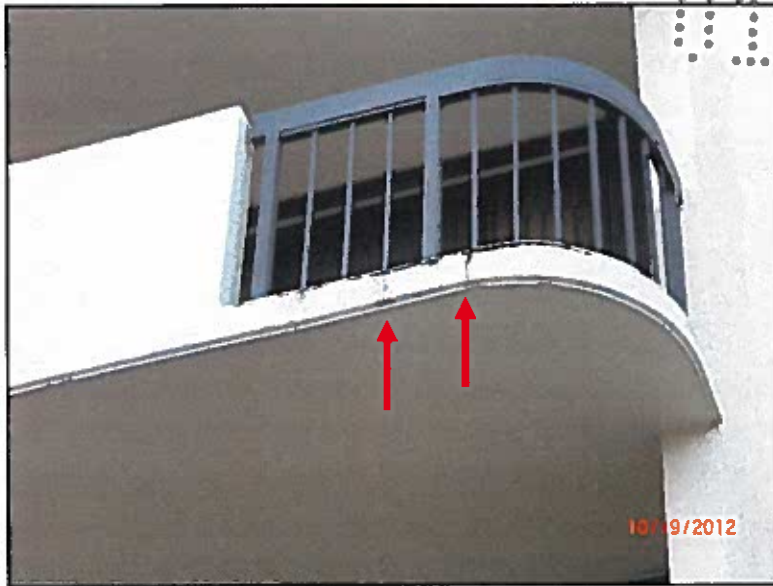
PHOTO # 29: cracking and staining on balcony edge

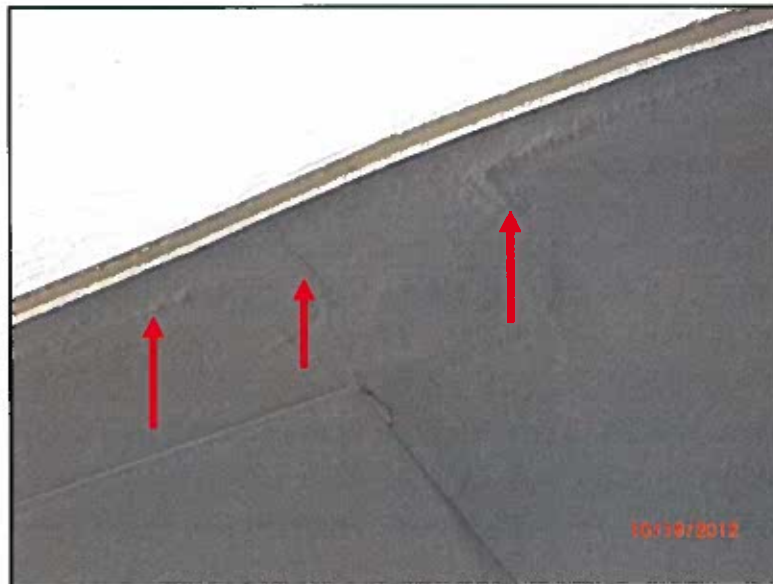
PHOTO # 30: cracking & blistering at underside of overhang edge

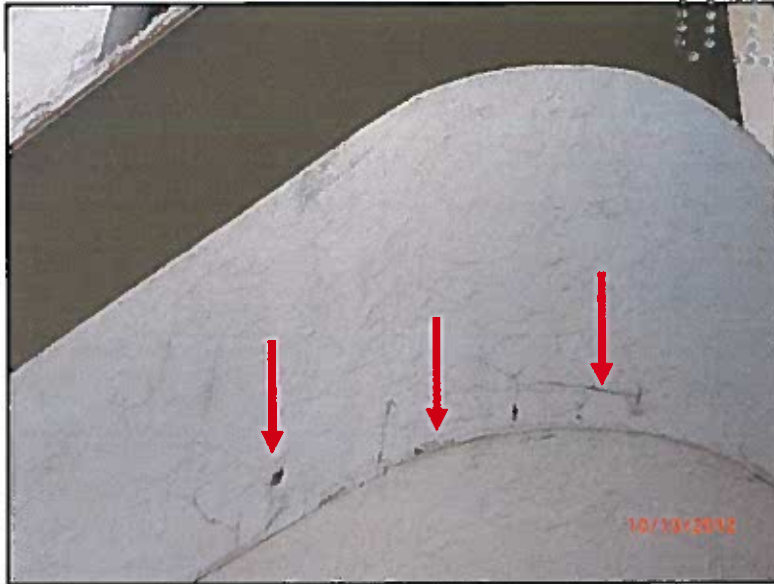
PHOTO # 31: stucco cracking at bottom of third floor balcony wall on East side

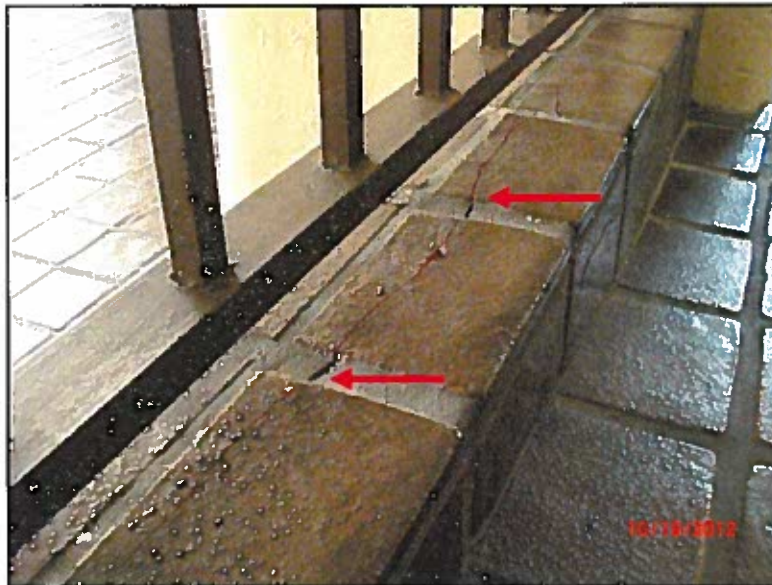
PHOTO # 32: crack along tiled ramp east of main entrance

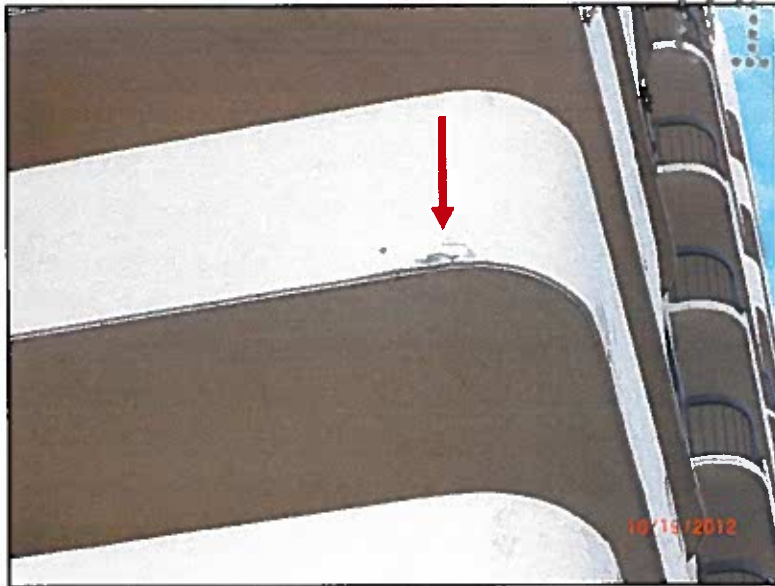
PHOTO # 33: cracking and staining at bottom of fourth floor balcony wall on east

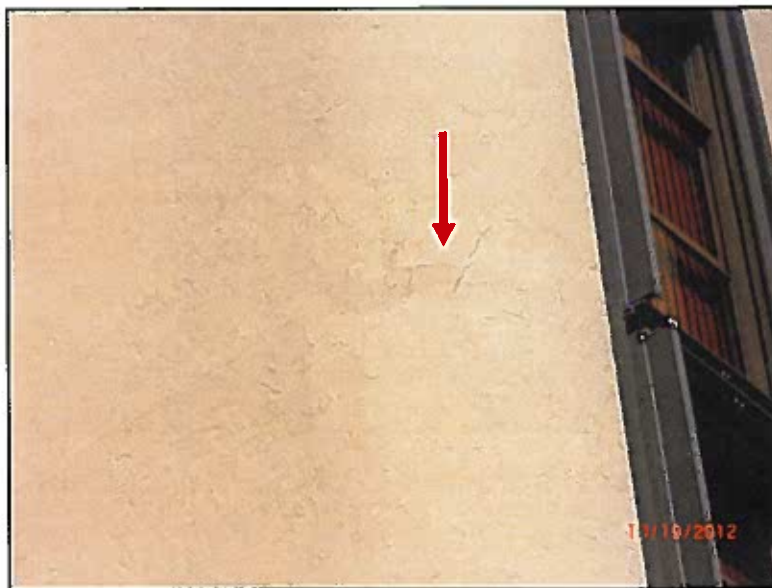
PHOTO # 34: stucco cracking on building wall next to east stairs tower

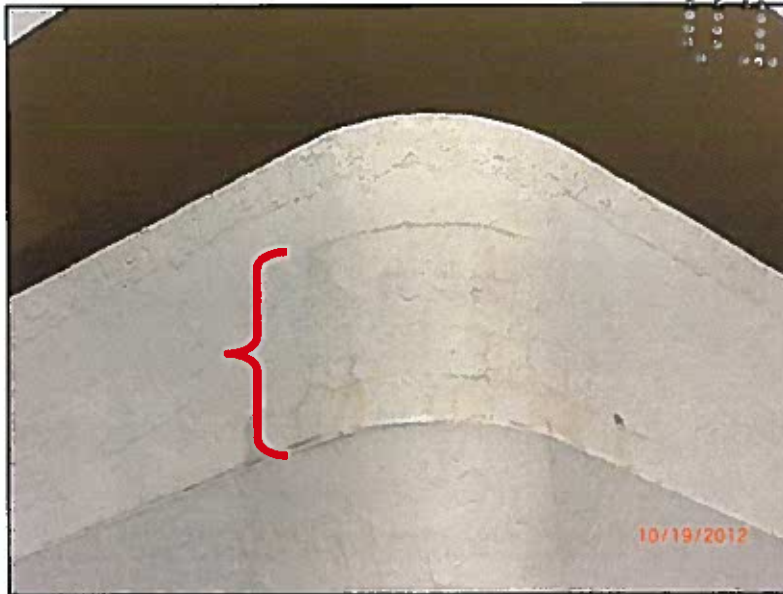
PHOTO # 35: spider web cracking on exterior face at second floor balcony on East side

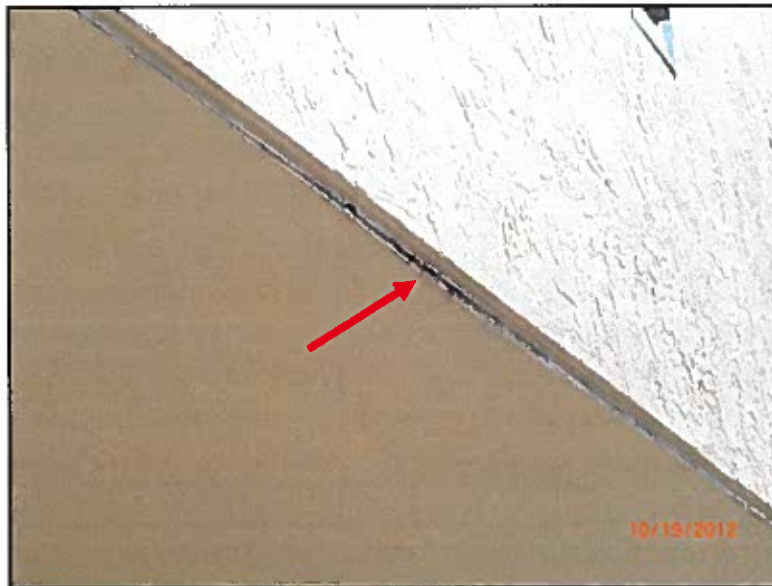
PHOTO # 36: ceiling separation at edge of South overhang

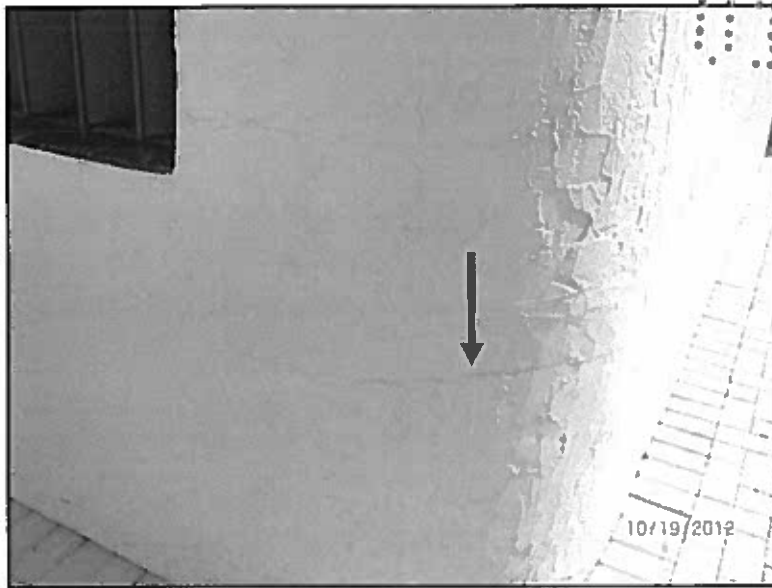
PHOTO # 37: stucco cracking on East side of building corner at pool deck area
