## **AD VALOREM TAX RELIEF:**

### **CASE FILE AV 2012-01**

An application requesting ad valorem tax relief for the property at **641 San Lorenzo Avenue**, a local historic landmark, legally described as Lots 22 thru 24, Block 13, Coral Gables Riviera Section Part 1, according to the Plat thereof, recorded in Plat Book 28, at Page 31, of the Public Records of Miami-Dade County, Florida. The related Certificate of Appropriateness, COA (SP) 2012-011, was granted design approval on September 20, 2012 by the Historic Preservation Board.

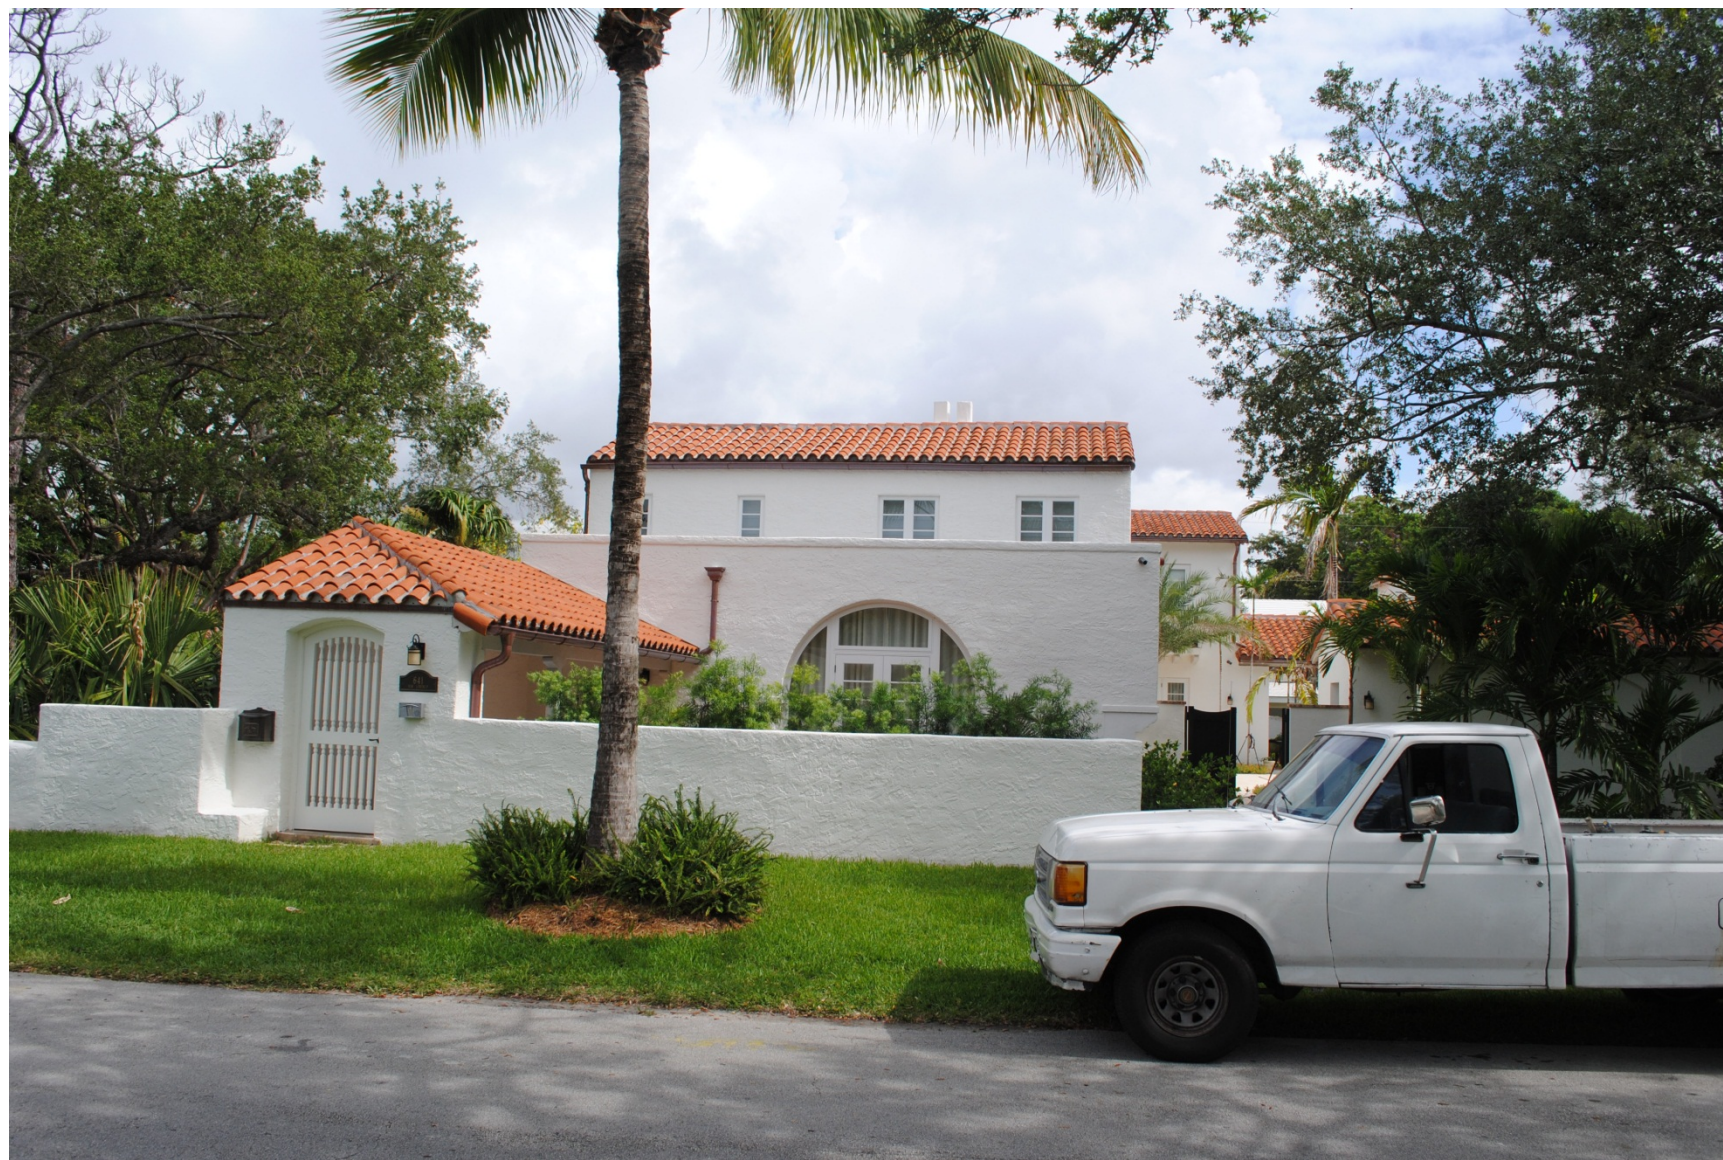
Photo Number: Image 1 (Before)

**Front Elevation**

Describe Work and Impact on Existing Feature: New paint, new impact windows, new roof, and additional landscaping (Existing Structure to Remain)

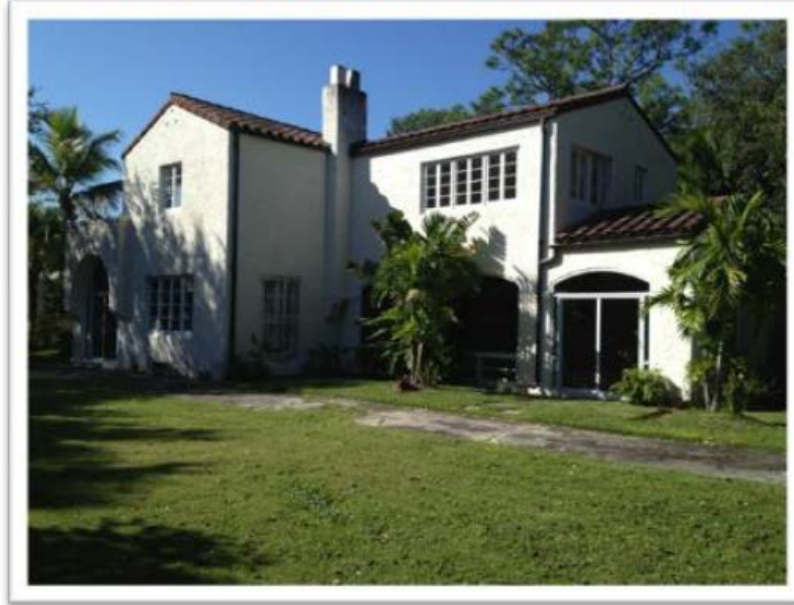
Photo Number: Image 3 (Before)

**Overall East Side Elevation**

Describe Work and Impact on Existing Feature: New paint, new impact windows, new roof, remove windows at terrace and restore as open-air, and additional landscaping (Existing Structure to Remain)

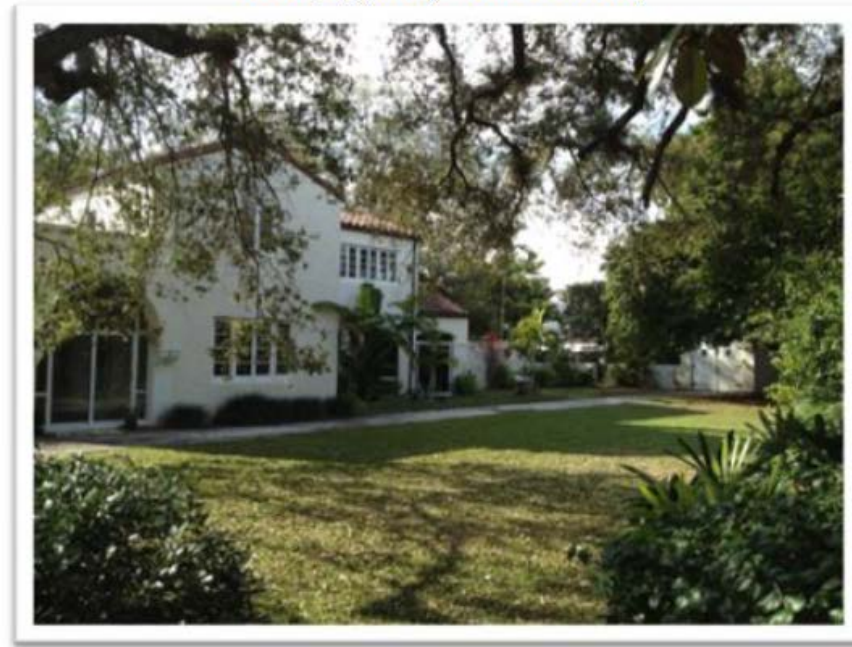
Photo Number: Image 4 (Before)

**Overall East Side Elevation**

Describe Work and Impact on Existing Feature: New paint, new impact windows, new roof, and additional landscaping (Existing Structure to Remain)

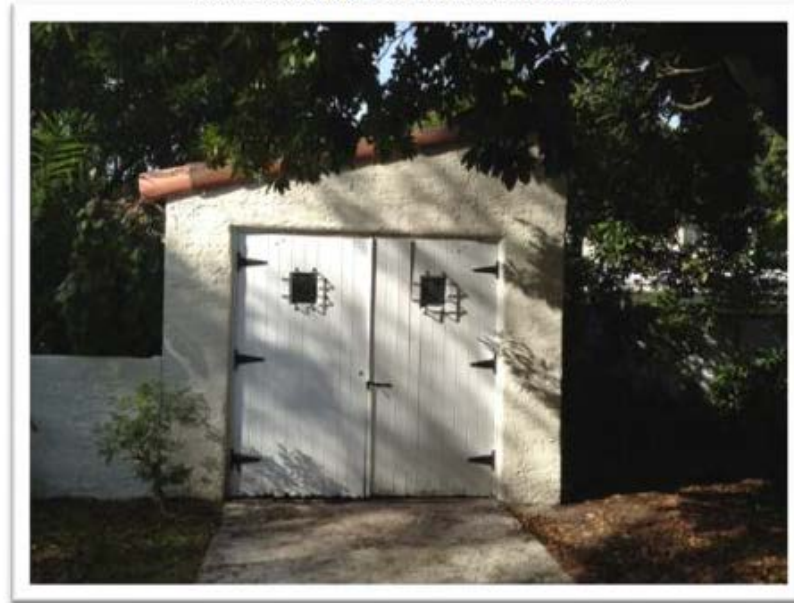
Photo Number: Image 5 (Before)

**Garage**

Describe Work and Impact on Existing Feature: Existing Garage to Remain, New Paint, New Roof, New Impact Windows, Existing Door & Hardware to Remain

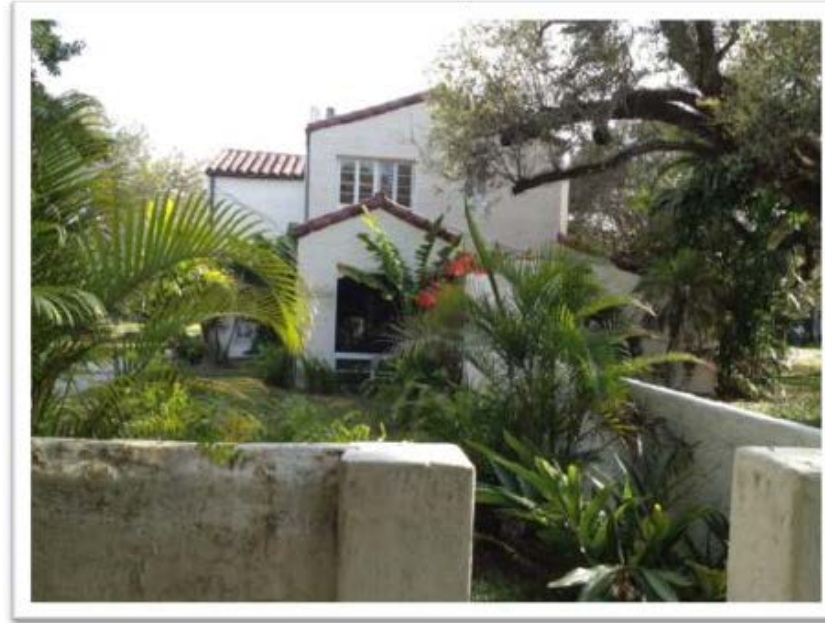
Photo Number: Image 8 (Before)

**View from Garage of Rear Elevation**

Describe Work and Impact on Existing Feature: Garden low wall to be removed, New paint, new impact windows, new roof, remove windows at terrace and restore as open-air and additional landscaping (Existing Structure to Remain)

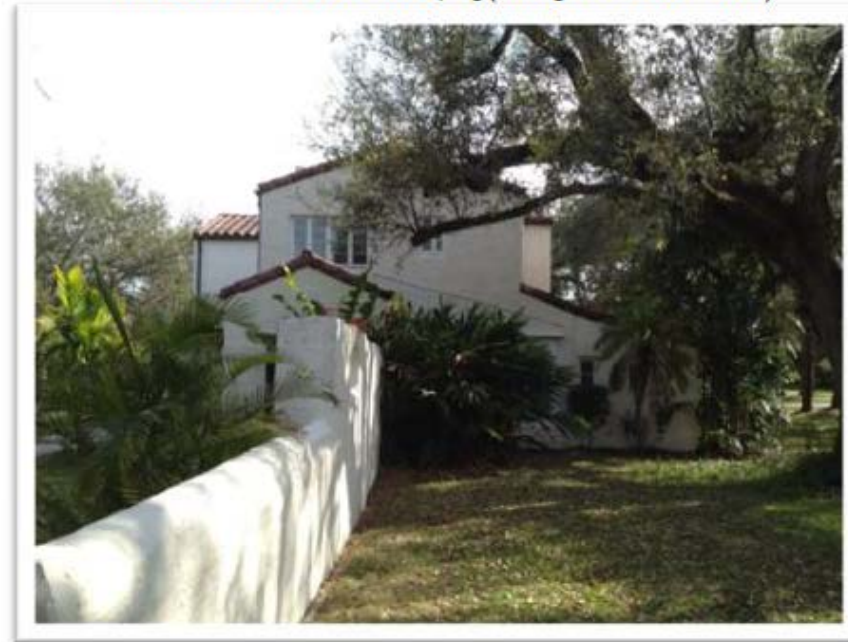
Photo Number: Image 10 (Before)

**Rear Elevation**

Describe Work and Impact on Existing Feature: Garden low wall to be removed, New paint, new impact windows, new roof, and additional landscaping (Existing Structure to Remain)

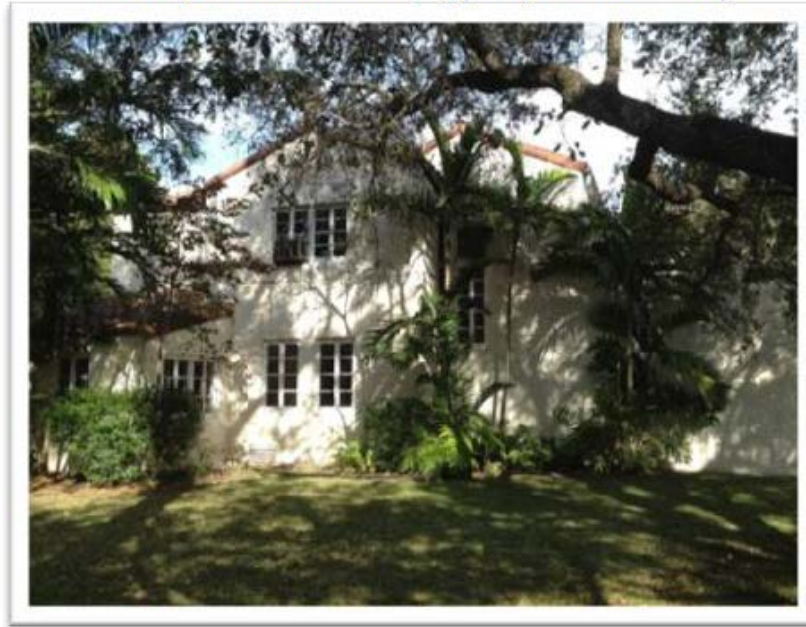
Photo Number: Image 11 (Before)

Side View from Palmarito

Describe Work and Impact on Existing Feature: One-story structure to be removed, New paint, new impact windows, new roof, and additional landscaping (Existing Structure to Remain)

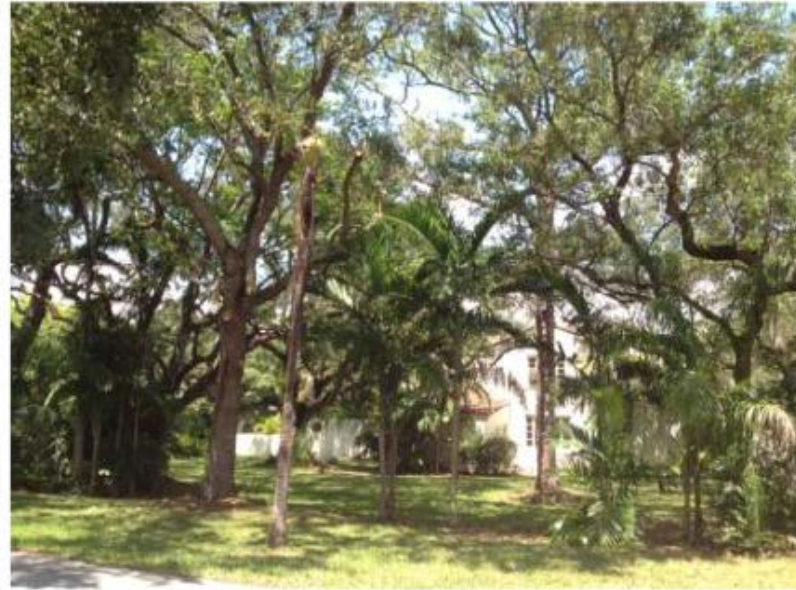
Photo Number: Image 12 (Before)

**Side View from Palmarito**

Describe Work and Impact on Existing Feature: One-Story structure to be removed, New paint, new impact windows, new roof, and additional landscaping (Existing Structure to Remain)

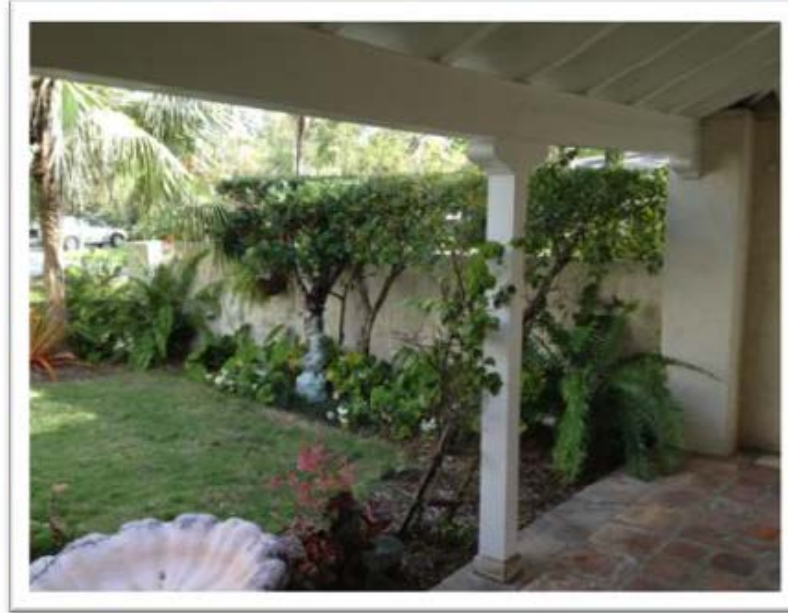
Photo Number: Image 13 (Before)

**Courtyard View**

Describe Work and Impact on Existing Feature: New Paint, Repair Cracks in Existing Beam/Column as needed, Clean & Seal Existing Floor Tiles, and new Landscape

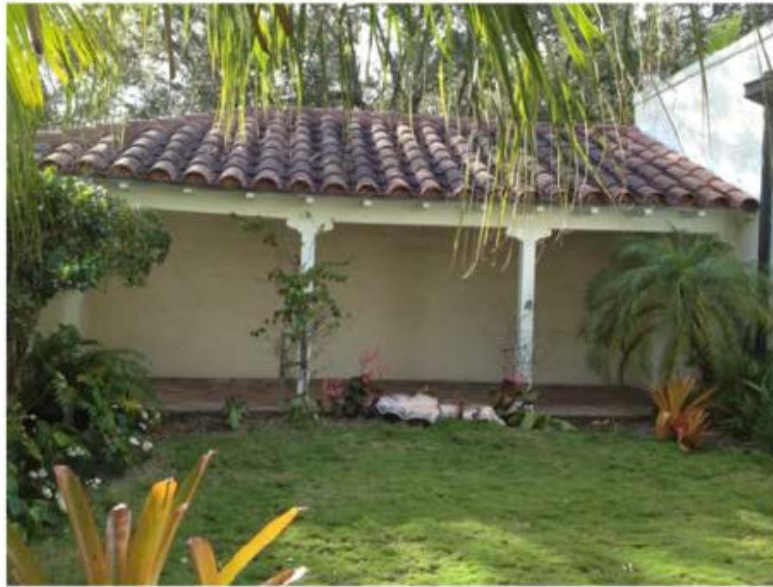
Photo Number: Image 15 (Before)

**Courtyard View**

Describe Work and Impact on Existing Feature: New Paint, Repair Cracks in Existing Beam/Column as needed, Clean & Seal Existing Floor Tiles, New Landscape, New Barrel Roof Tile

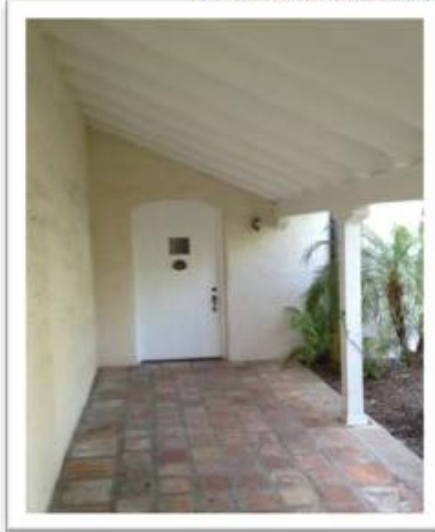
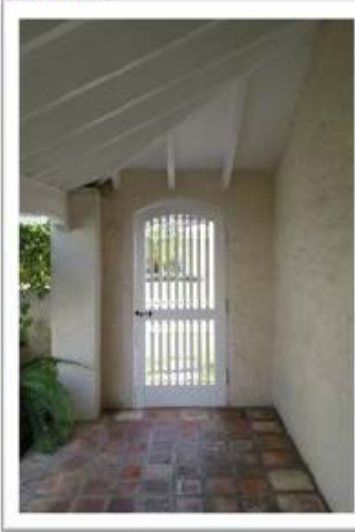
Photo Number: Image 16 & 17 (Before)

**Courtyard View to Front Door & Entry Gate**

Describe Work and Impact on Existing Feature: New Paint, Clean & Seal Existing Floor Tiles, Repair any stucco cracks as needed, Restore Existing Wood Doors

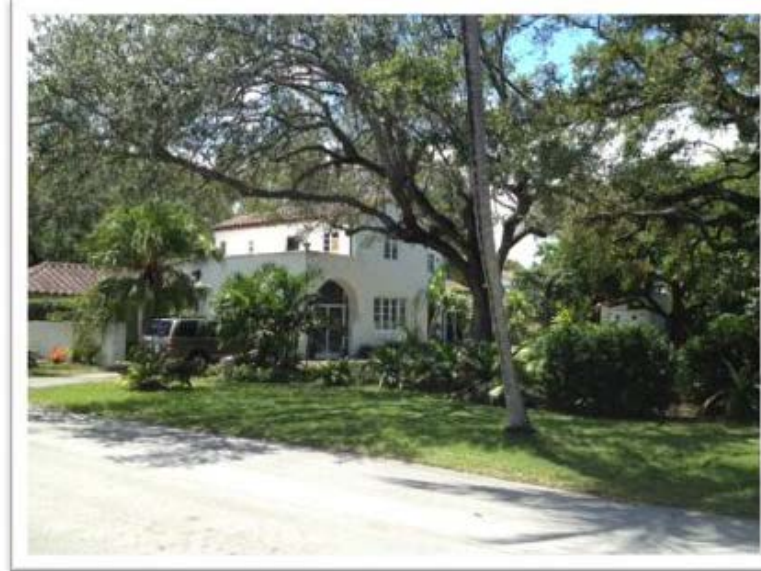
Photo Number: Image 18 (Before)

**View of SE Corner**

Describe Work and Impact on Existing Feature: New paint, new impact windows, new roof, and additional landscaping (Existing Structure to Remain)

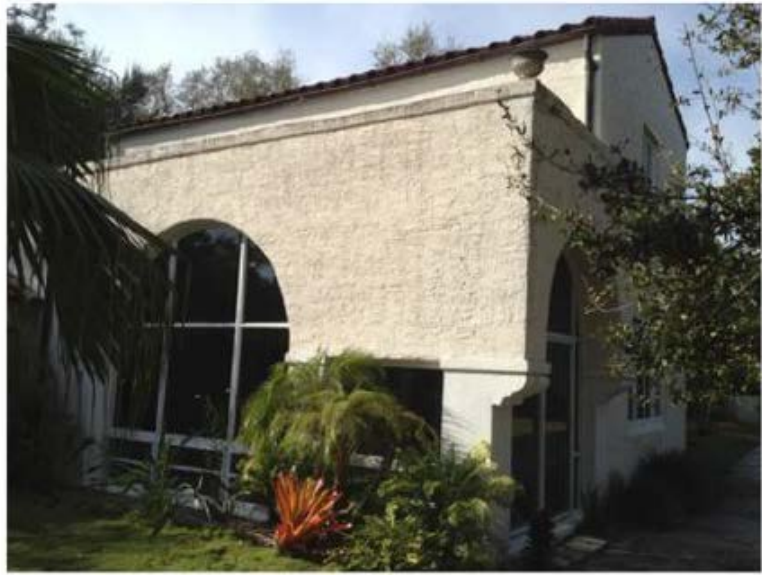
Photo Number: Image 14 (Before)

**Courtyard View**

Describe Work and Impact on Existing Feature: New Paint, New Impact Windows, Repair cracks in decorative stucco trim, New Roof to match existing

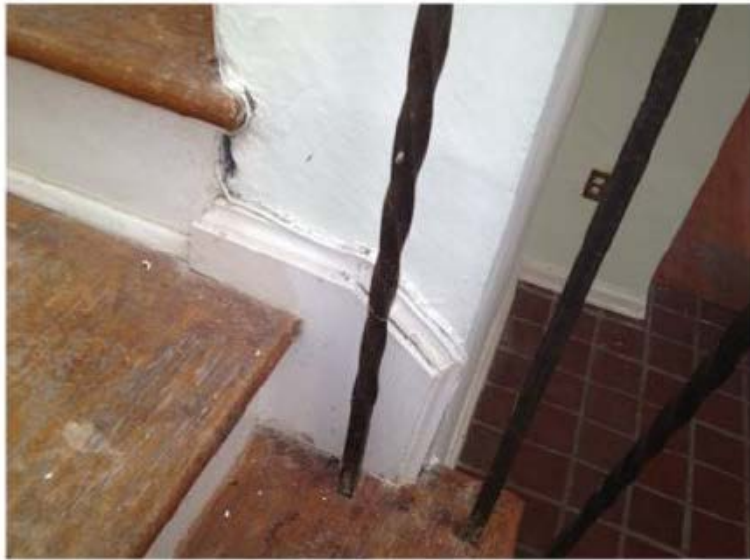
Photo Number: Image 29 (Before)

**Existing Wood Treads & Iron Rails**

Describe Work and Impact on Existing Feature: Refinish Existing Wood Treads, Railings

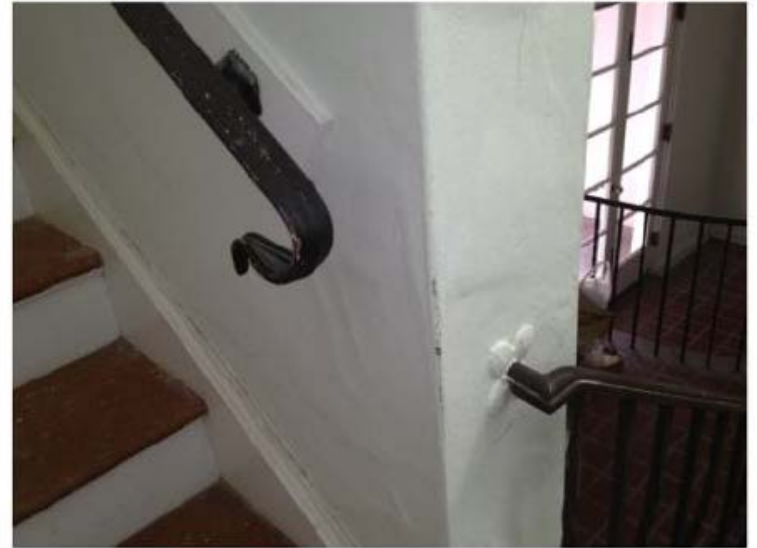
Photo Number: Image 30 (Before)

**Existing Handrail**

Describe Work and Impact on Existing Feature: Re-finish Existing Handrail and Details

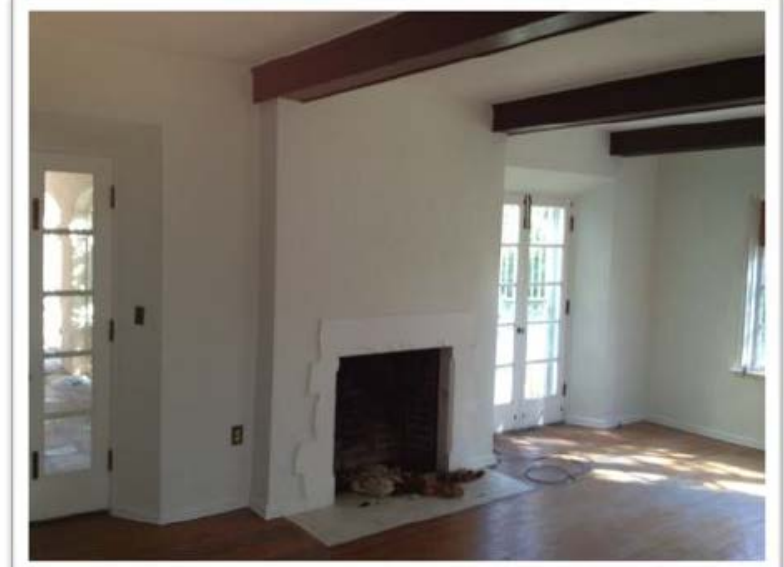
Photo Number: Image 32 (Before)

**Existing Living Room & Fireplace**

Describe Work and Impact on Existing Feature: Restore Fireplace to working order, Refinish existing wood floor, new paint, new Impact-Rated Doors

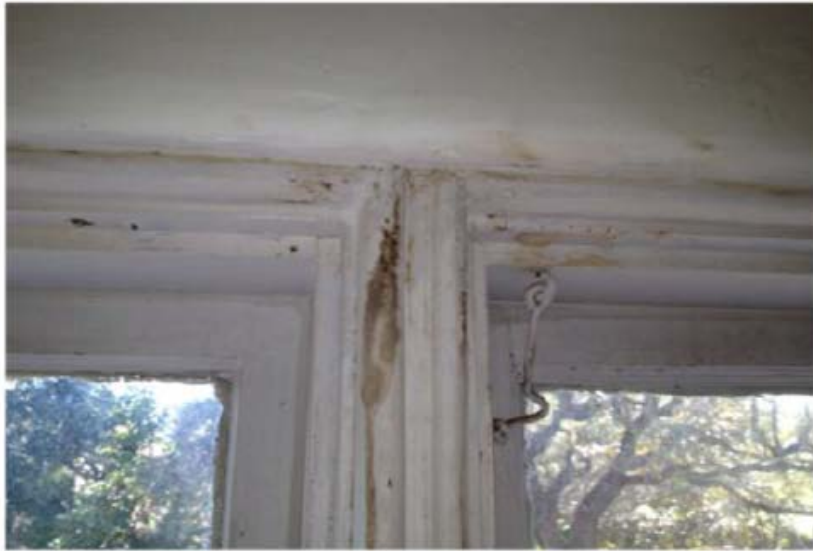
Photo Number: Image 36 (Before)

**Existing Window Frame at Header**

Describe Work and Impact on Existing Feature: Replace with New Impact-Rated Window

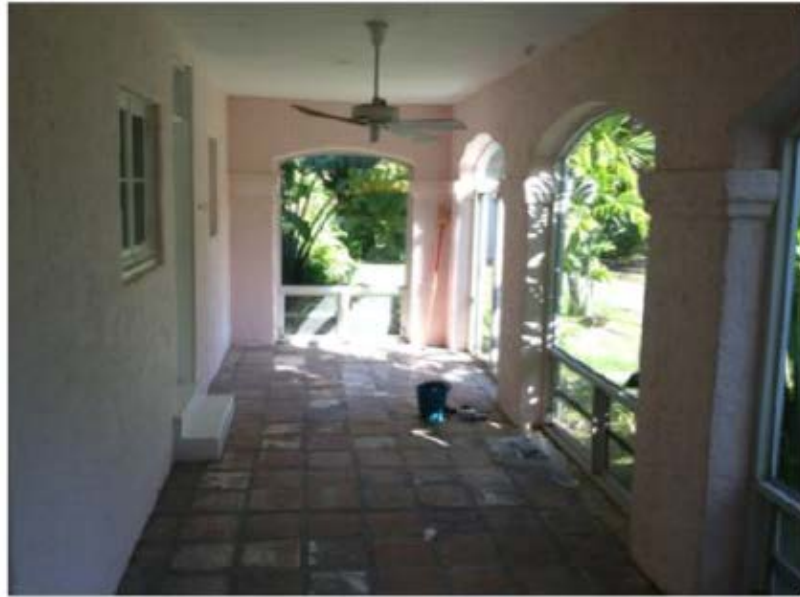
Photo Number: Image 50 (Before)

#### **Existing Enclosed Side Terrace**

Describe Work and Impact on Existing Feature: Windows to be removed and terrace to be open (non a/c), new paint finish, new fans, floors to be cleaned and resealed

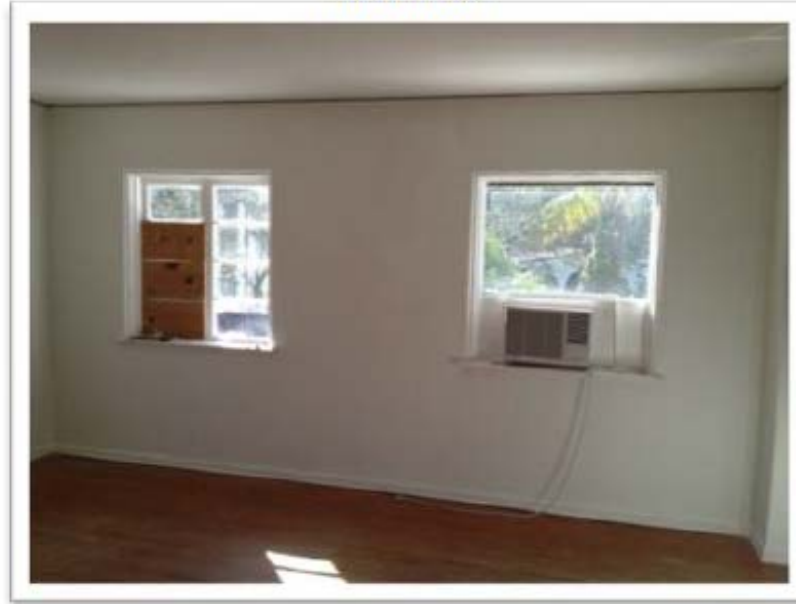
Photo Number: Image 53 (Before)

**Existing Bedroom #2**

Describe Work and Impact on Existing Feature: Remove wall A/C, New paint finish, floors to be refinished, new impact windows

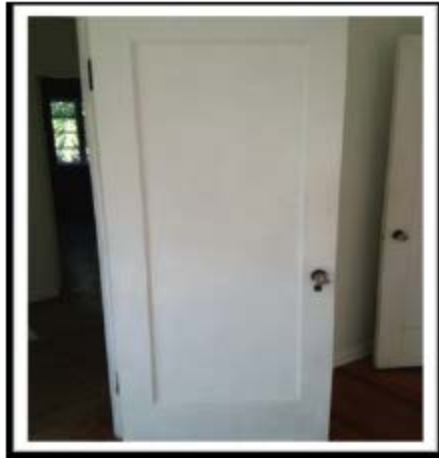
Photo Number: Image 57 (Before)

### Existing Door

Describe Work and Impact on Existing Feature: Existing hardware and interior door to remain, repair as needed
