PROPERTY INSPECTION OR ASSESSMENT OF DAMAGES

ADDRESS: 229 Ridgewood Rd. Coral Gables, Fl.
CLIENT: Phil Padron
ID No: 2016417
DATE: 6/9/2016

PROPERTY INSPECTION –229 Ridgewood Rd Coral Gables, FL
ATTACHMENT - PHOTOGRAPHS
DATE: 06-09-2016

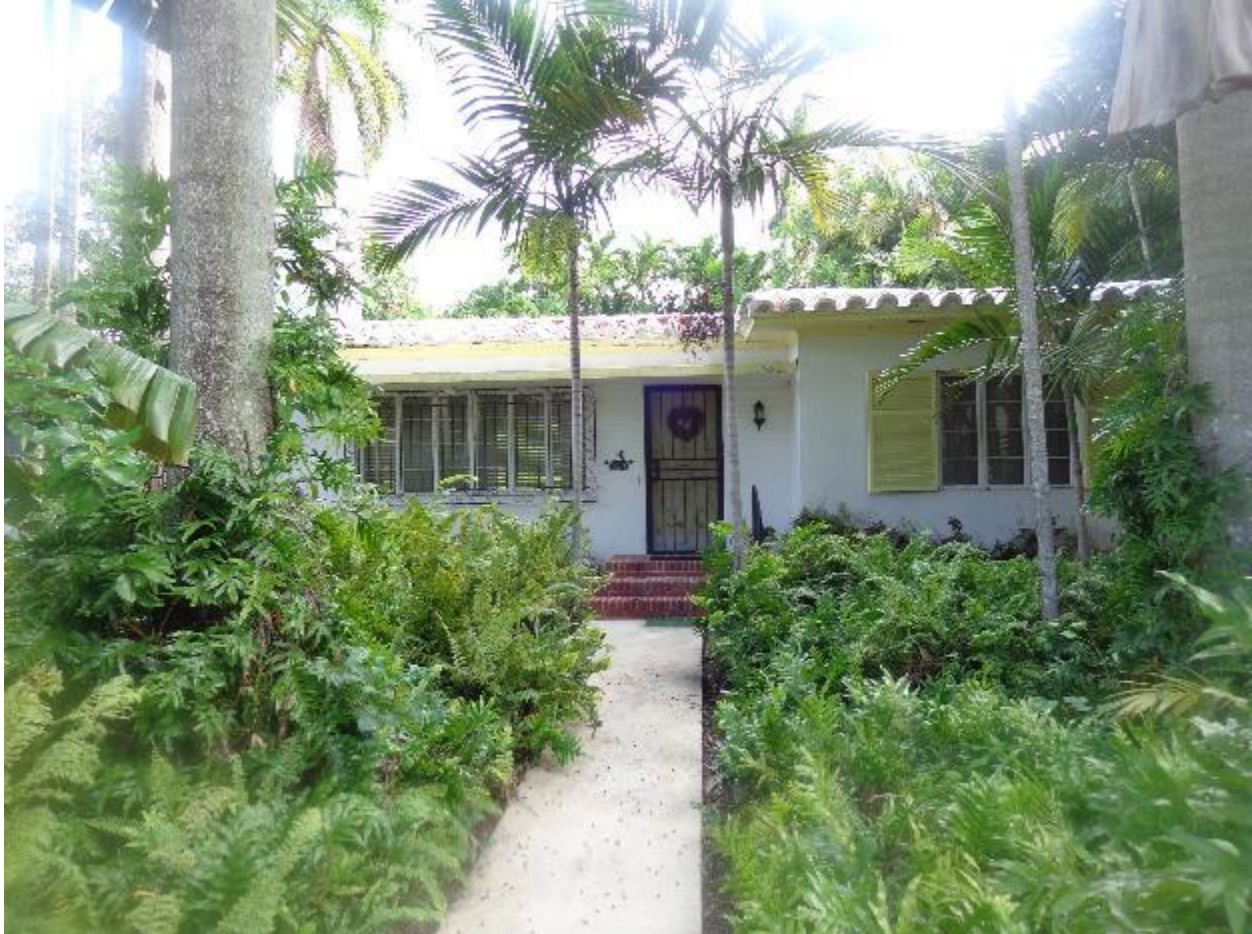
Exterior rehabilitation must include and not limited to:

Pressure wash and paint, replace obsolete and failing window systems, replace exterior doors, fascia and soffit rotted wood replacement, overgrown vegetation removal, structural repairs required. Refer to attached photographs for details.

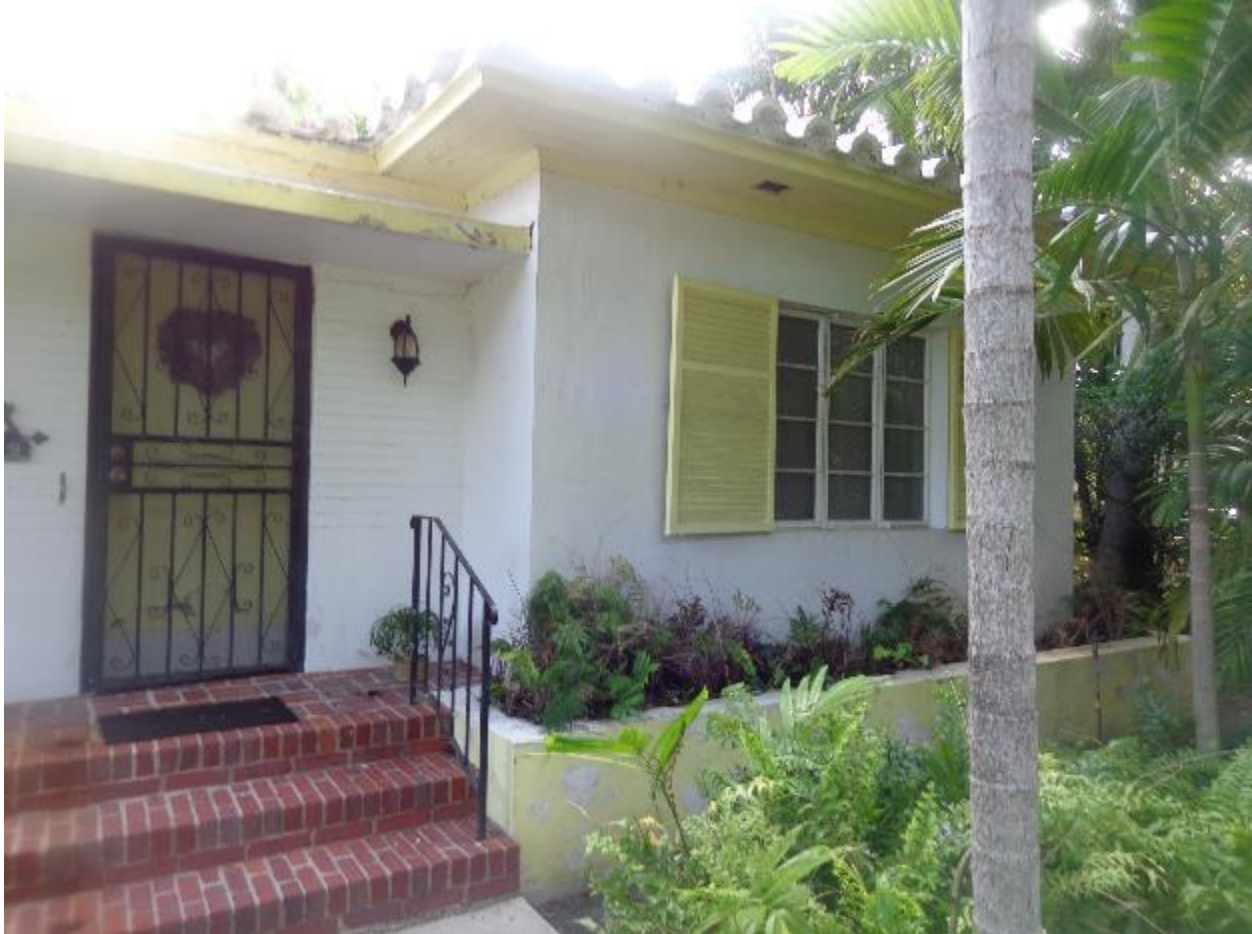
Exterior rehabilitation must include and not limited to:

Pressure wash and paint, replace obsolete and failing window systems, replace exterior doors, fascia and soffit rotted wood replacement, overgrown vegetation removal, structural repairs required. Refer to attached photographs for details.

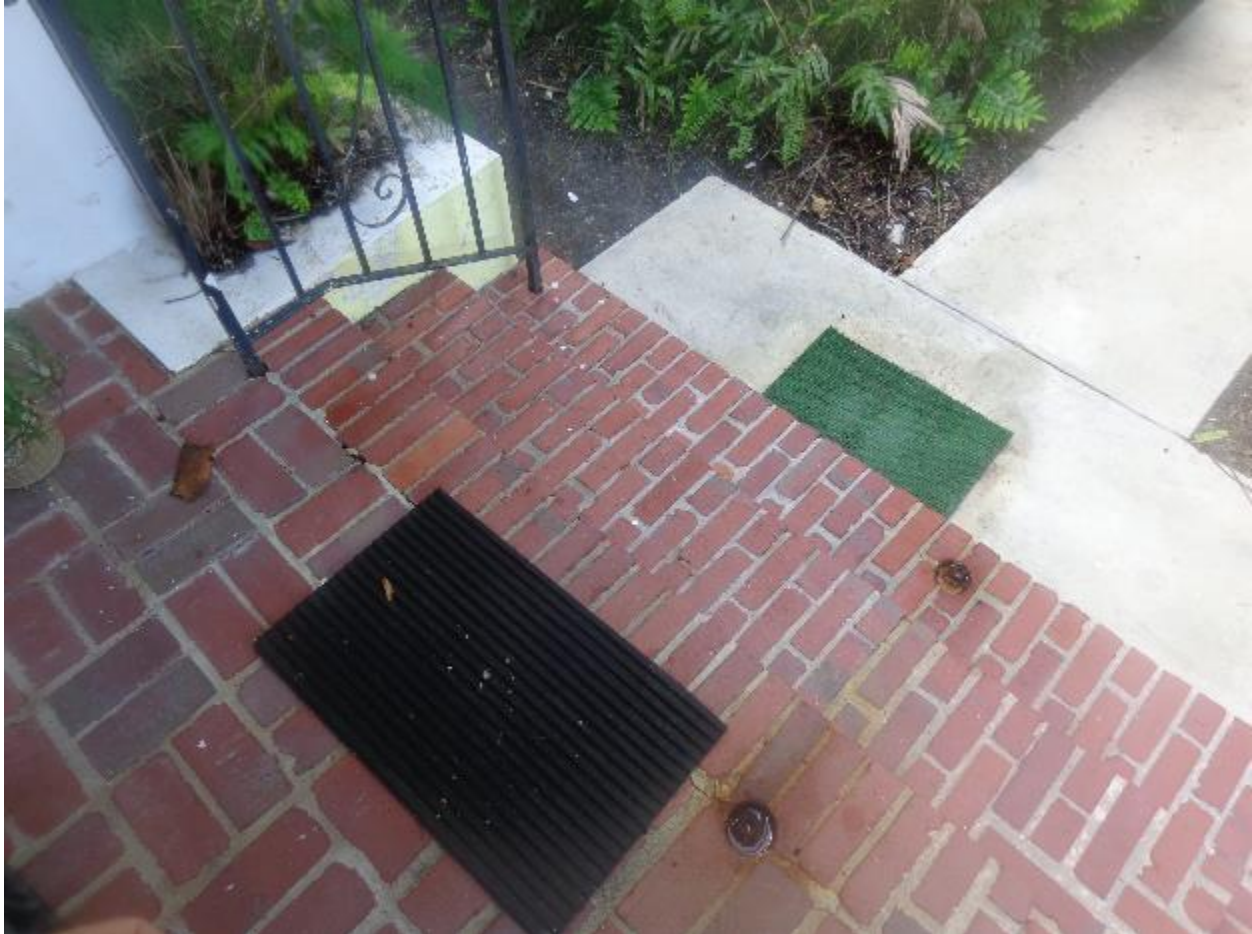
Missing left hand rail. Requires replacement to be brought up to code.

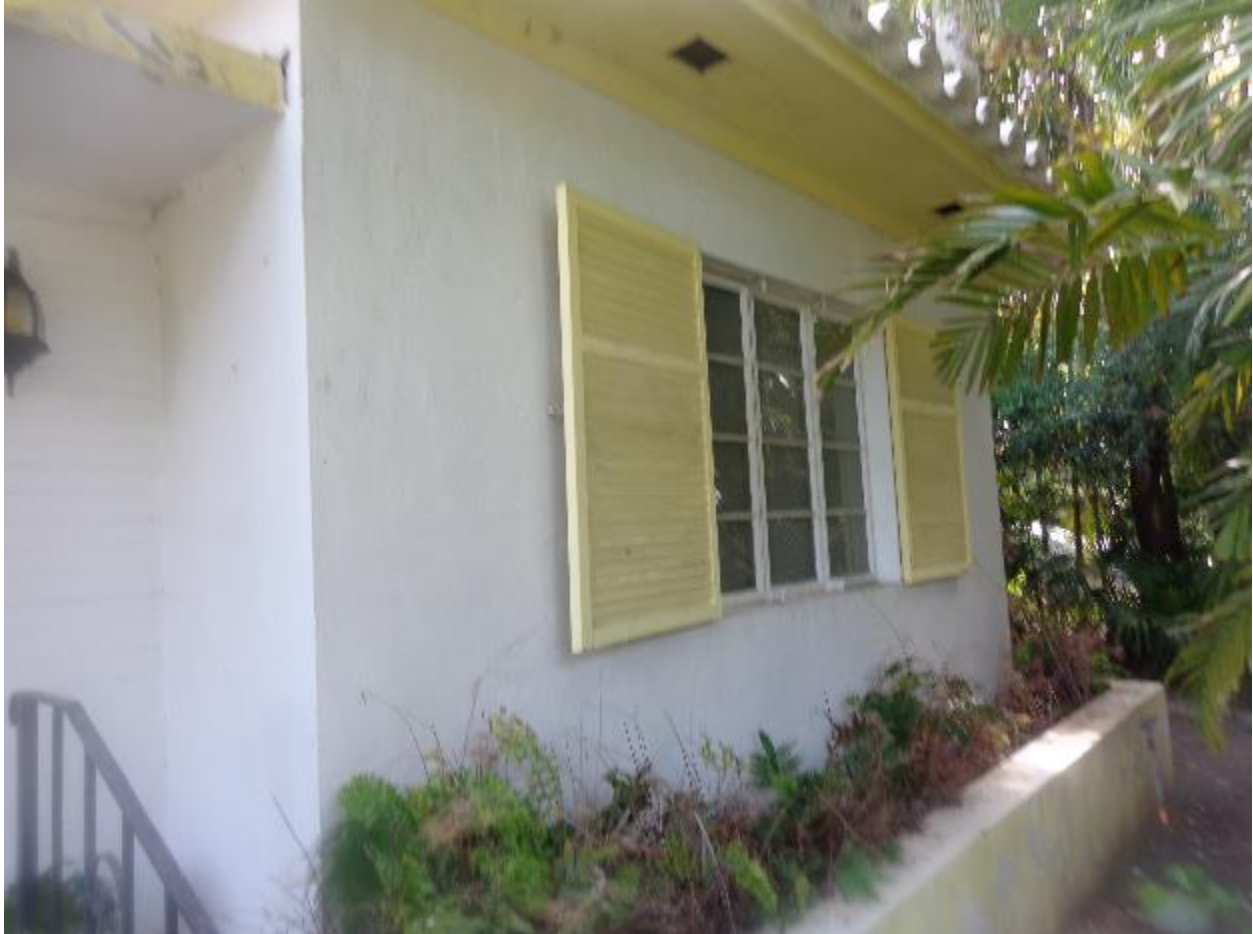
Current window systems are beyond possibilities of repair.

It is recommended a full replacement of windows with impact glass as per current code and avoid the installation of hurricane shutters.

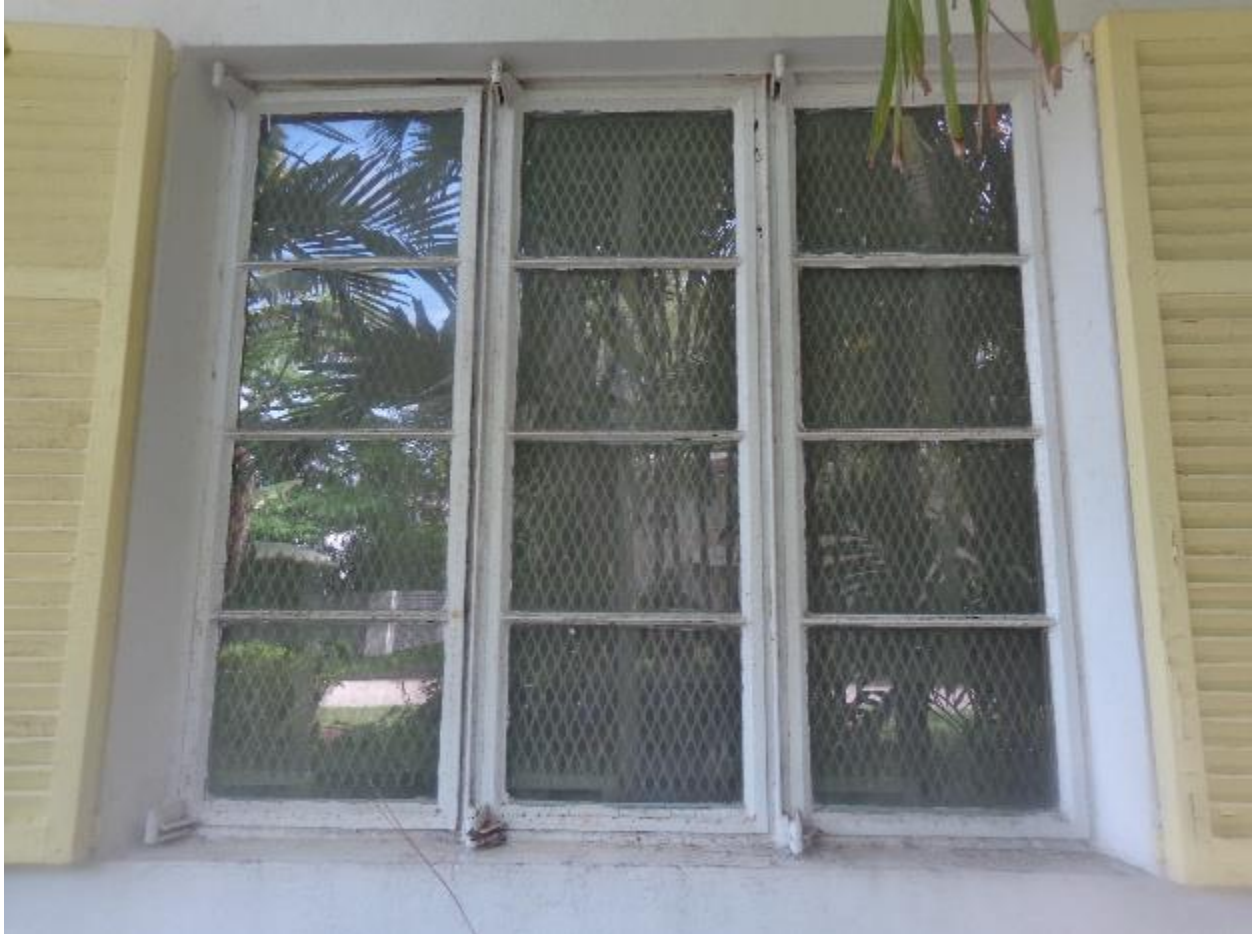
Current window systems are beyond possibilities of repair.

It is recommended a full replacement of windows with impact glass as per current code and avoid the installation of hurricane shutters.

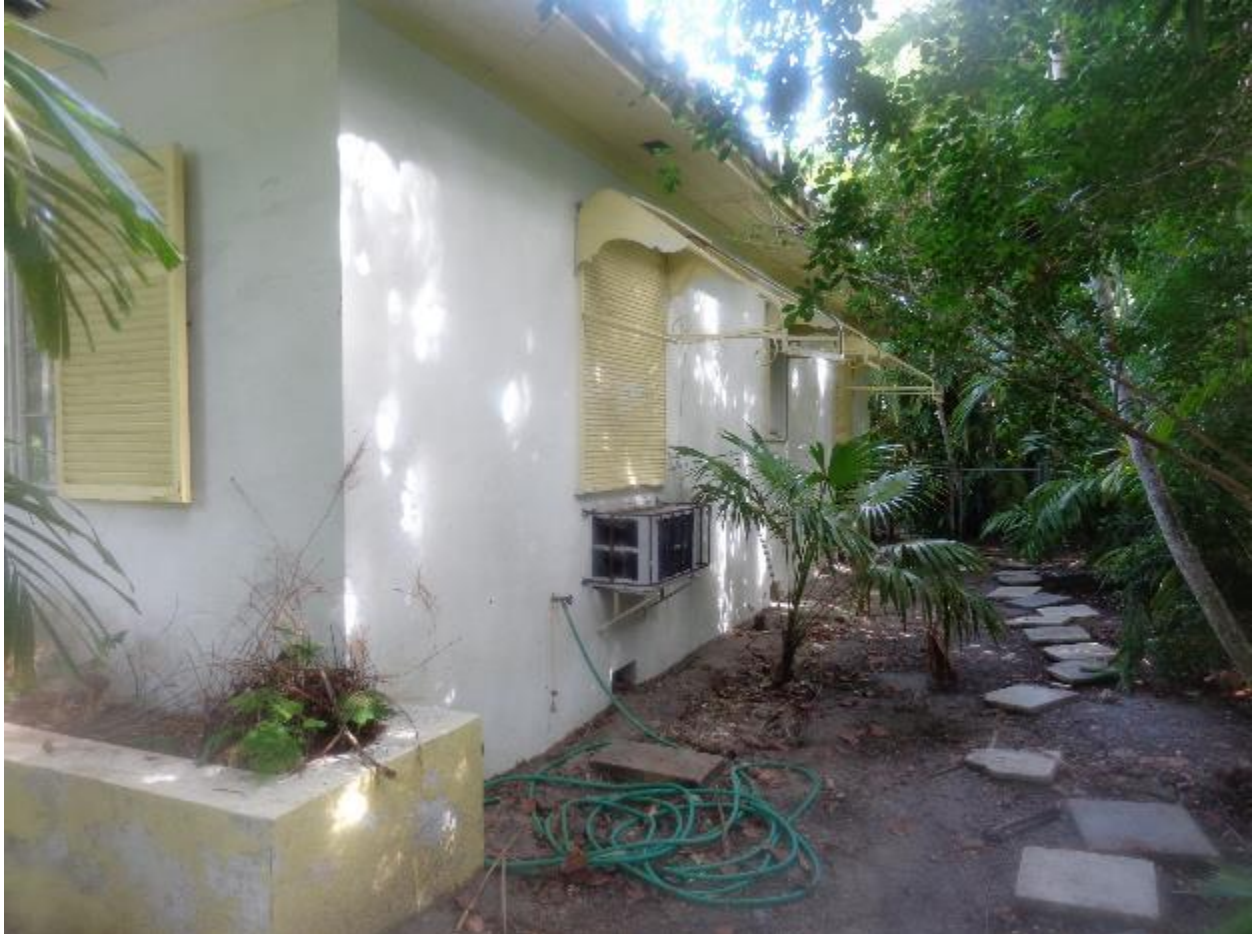
Exterior rehabilitation must include and not limited to:

Pressure wash and paint, replace obsolete and failing window systems, replace exterior doors, fascia and soffit rotted wood replacement, overgrown vegetation removal, structural repairs required. Refer to attached photographs for details.

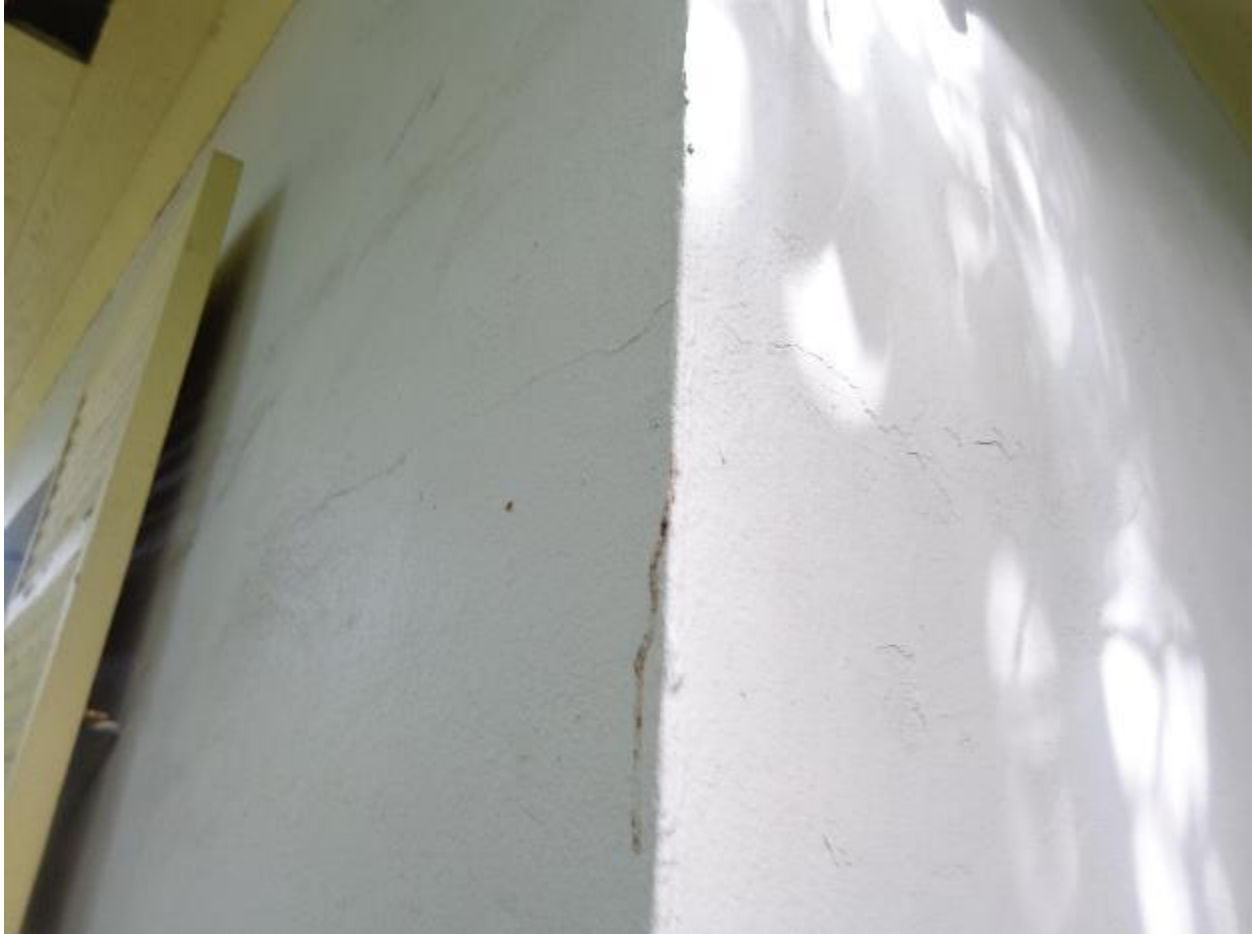
Cracks on vertical planes due to foundation settlement indicating downward and lateral movement. These types of cracks may compromise the ability of the building to function as designed and avoid water intrusion. Structural repair and proper waterproofing treatment are required to avoid further damage to the interior of the building and water infiltration.

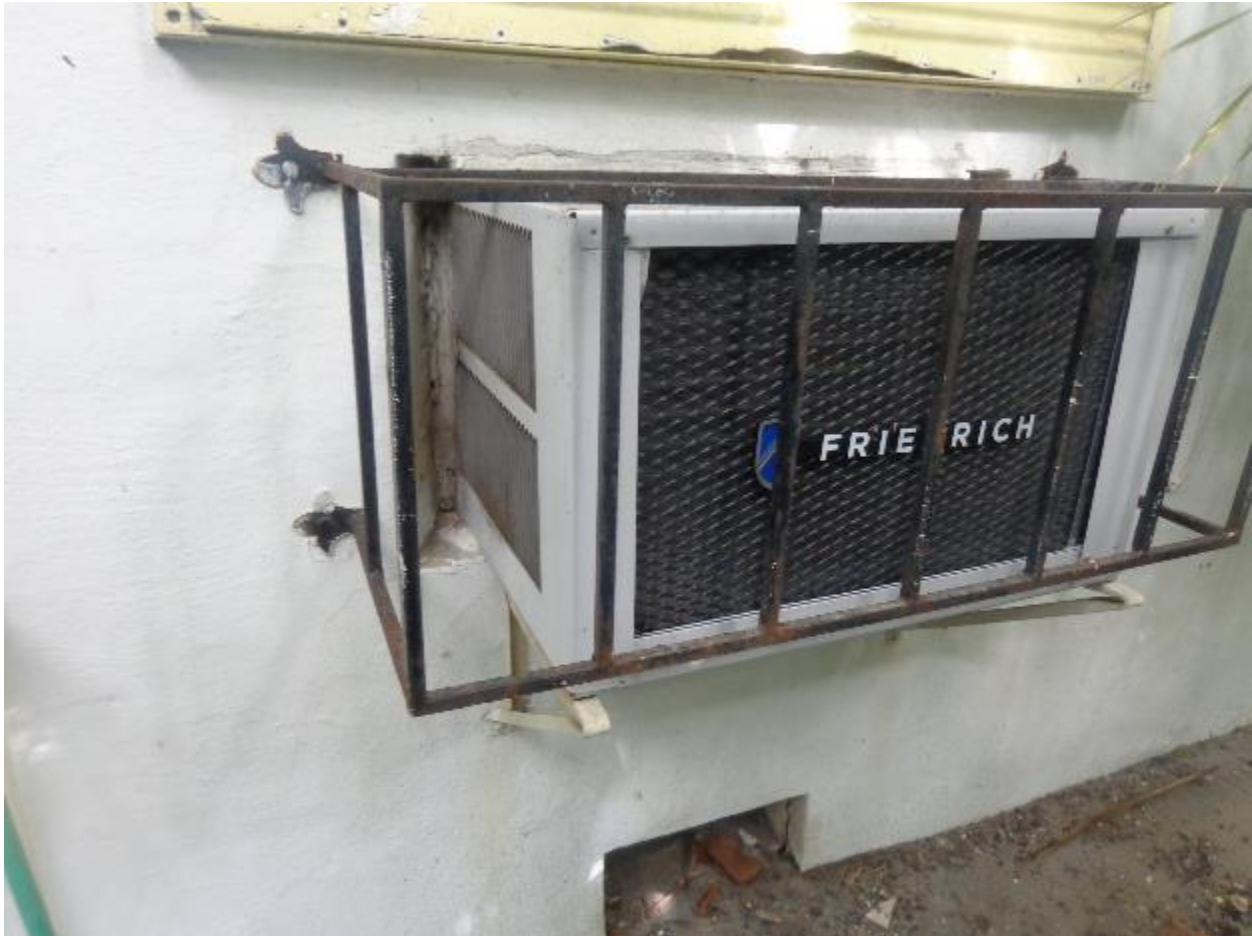
Allowances must be made for the installation of a new central AC system and removal of all window and walls units.

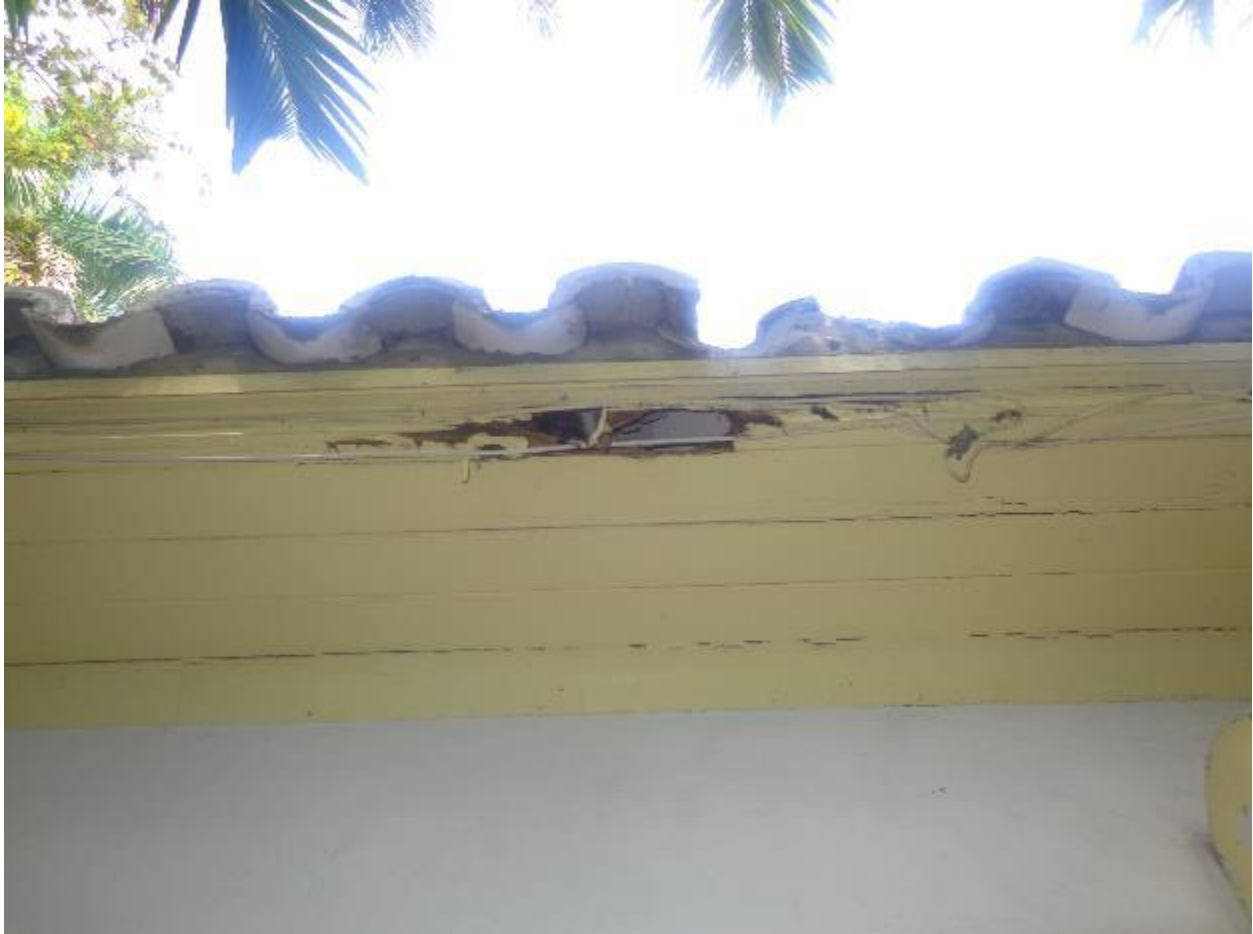
Fascia and soffit deteriorated wood requires replacement.

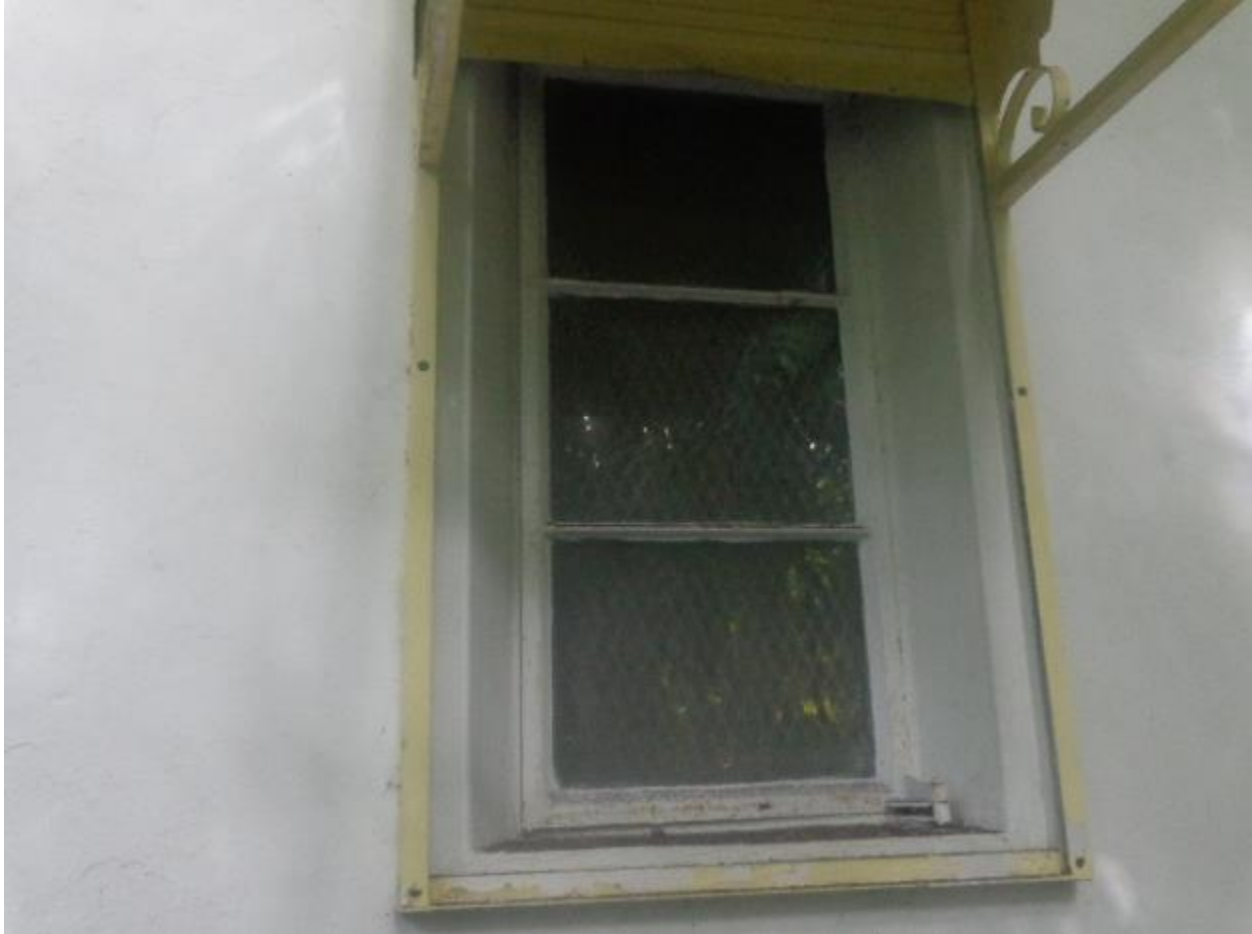
Current window systems are beyond possibilities of repair.

It is recommended a full replacement of windows with impact glass as per current code and avoid the installation of hurricane shutters.

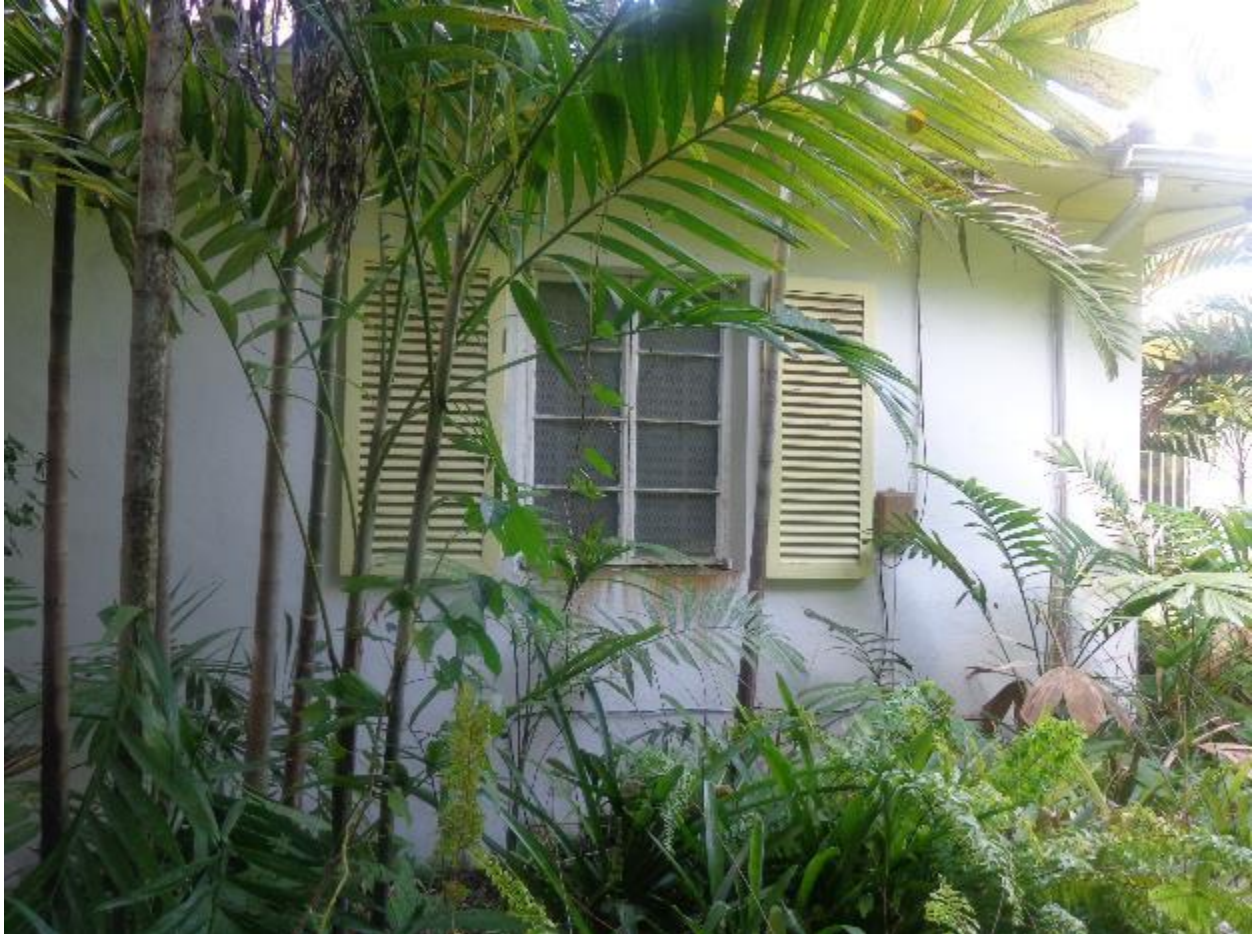
Current window systems are beyond possibilities of repair.

It is recommended a full replacement of windows with impact glass as per current code and avoid the installation of hurricane shutters.

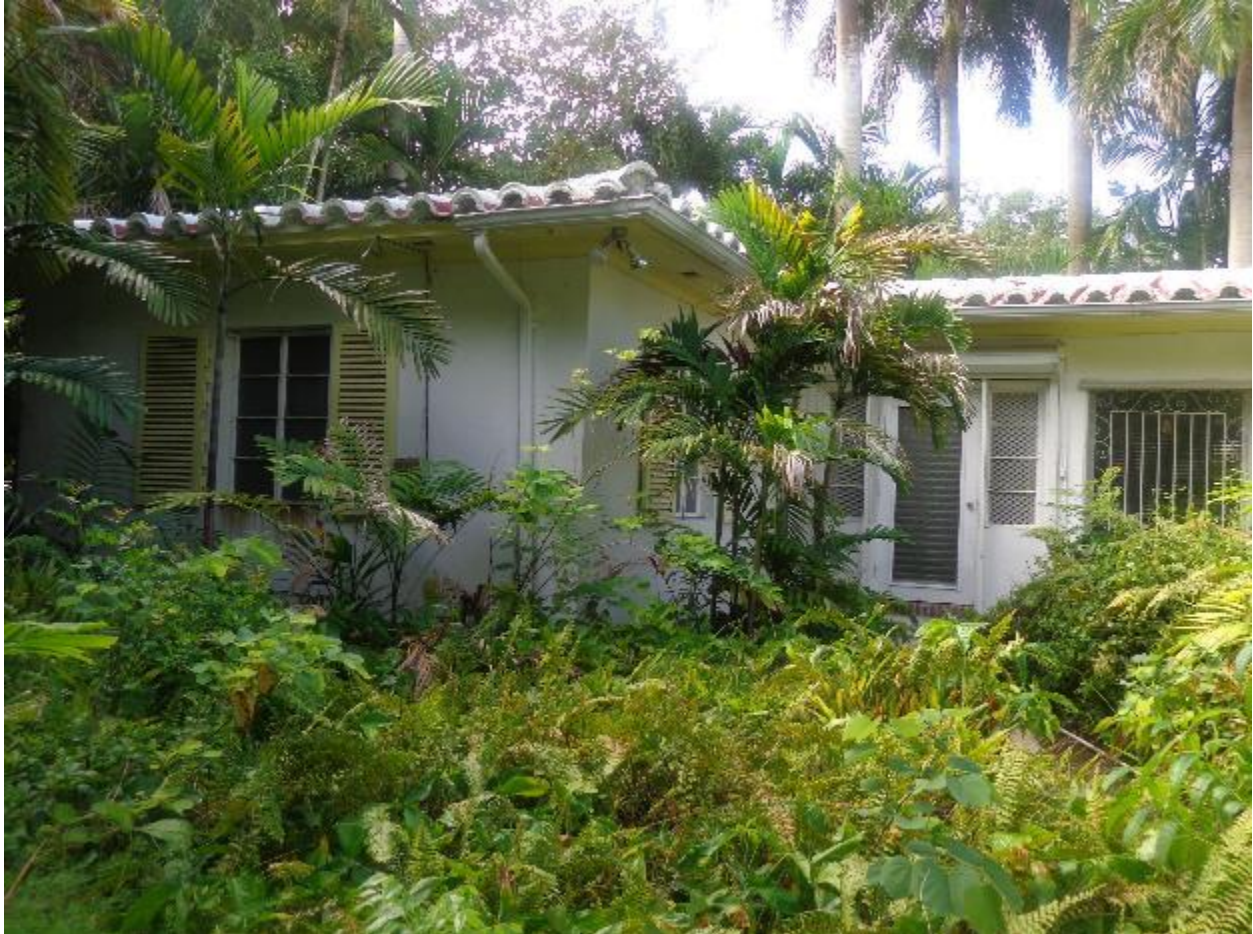
Exterior rehabilitation must include and not limited to:

Pressure wash and paint, replace obsolete and failing window systems, replace exterior doors, fascia and soffit rotted wood replacement, overgrown vegetation removal, structural repairs required. Refer to attached photographs for details.

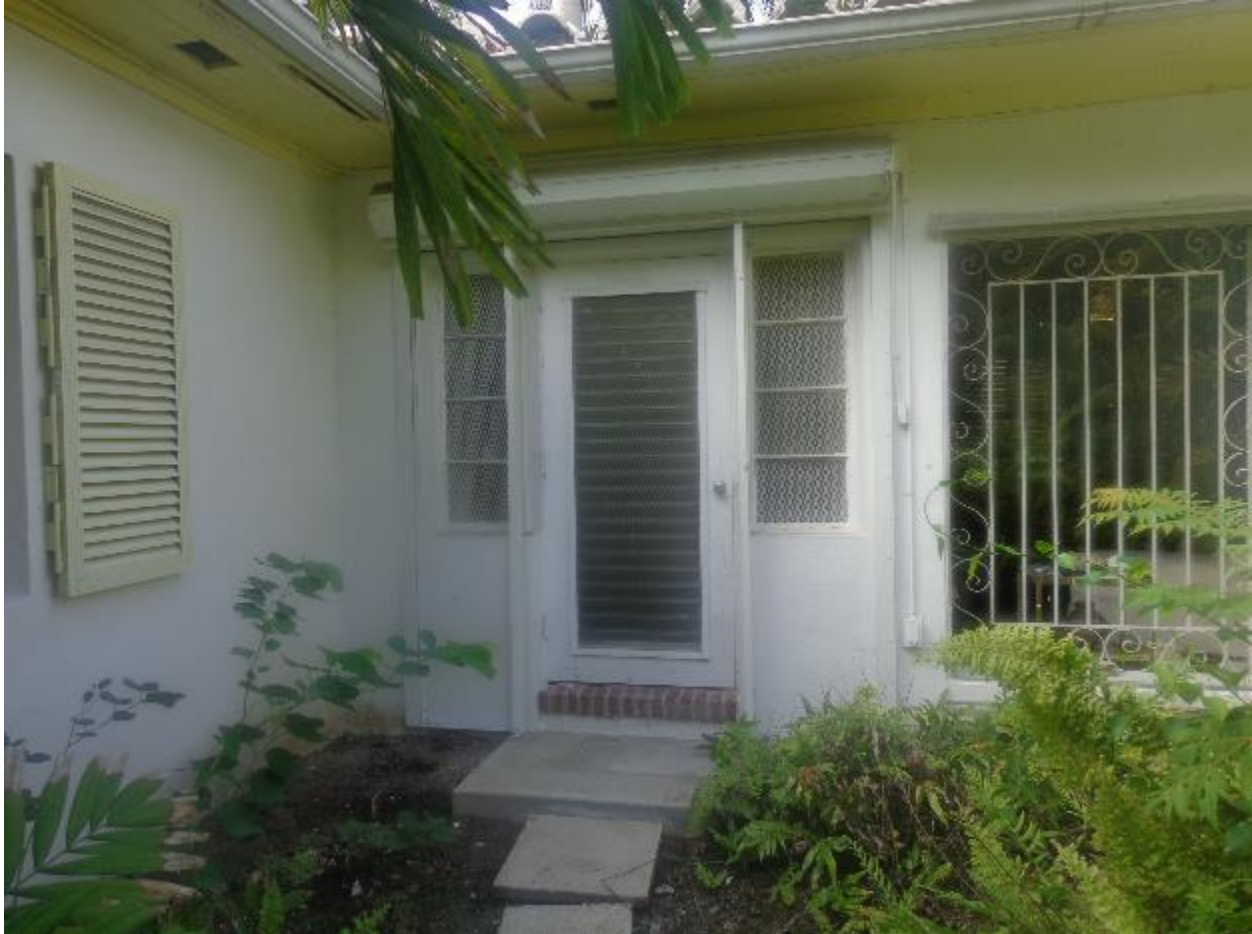
Current window systems are beyond possibilities of repair.

Exterior door(s) require replacement. Currently beyond possibilities of repair.

It is recommended a full replacement of windows with impact glass as per current code and avoid the installation of hurricane shutters.

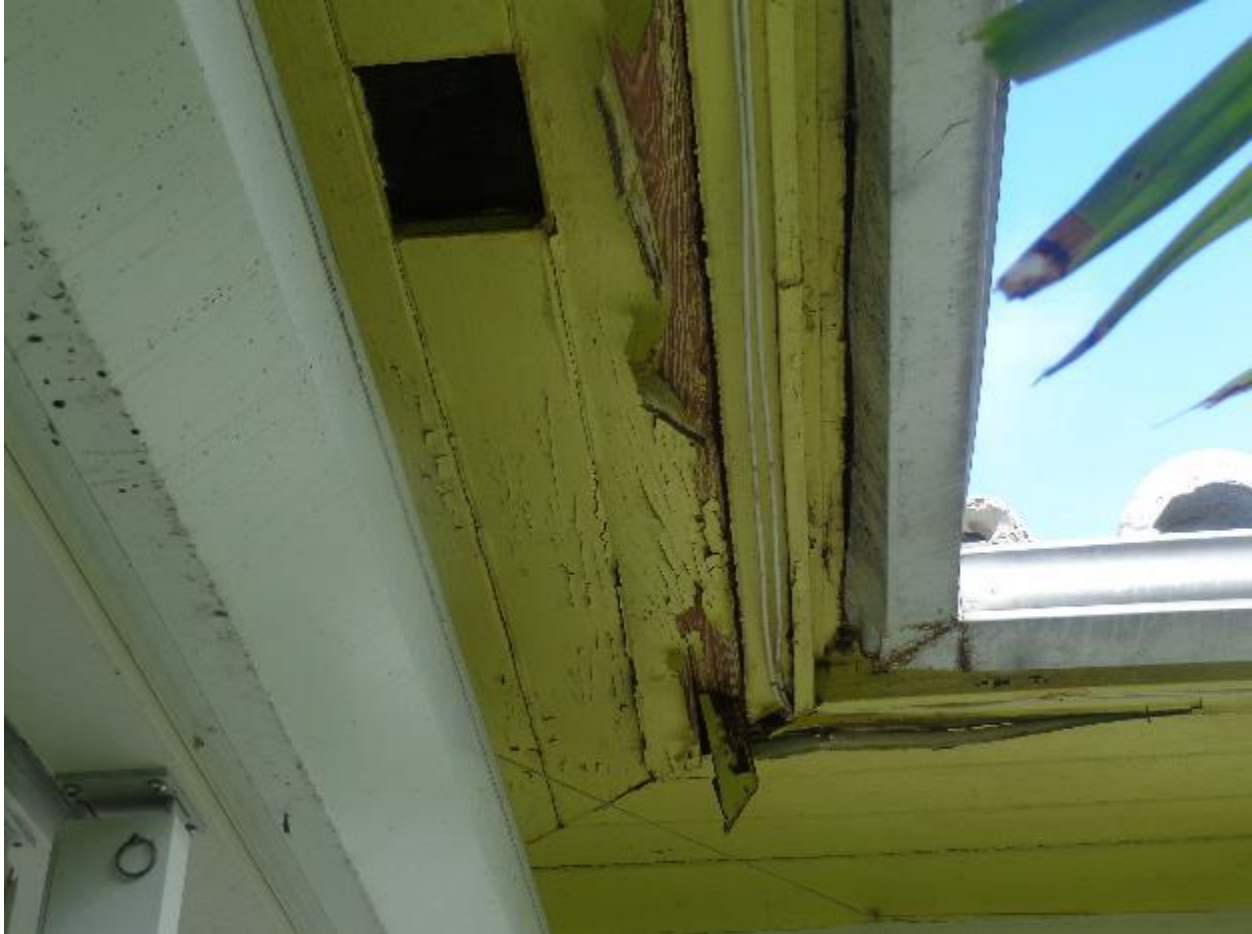
Fascia and soffit deteriorated wood requires replacement.

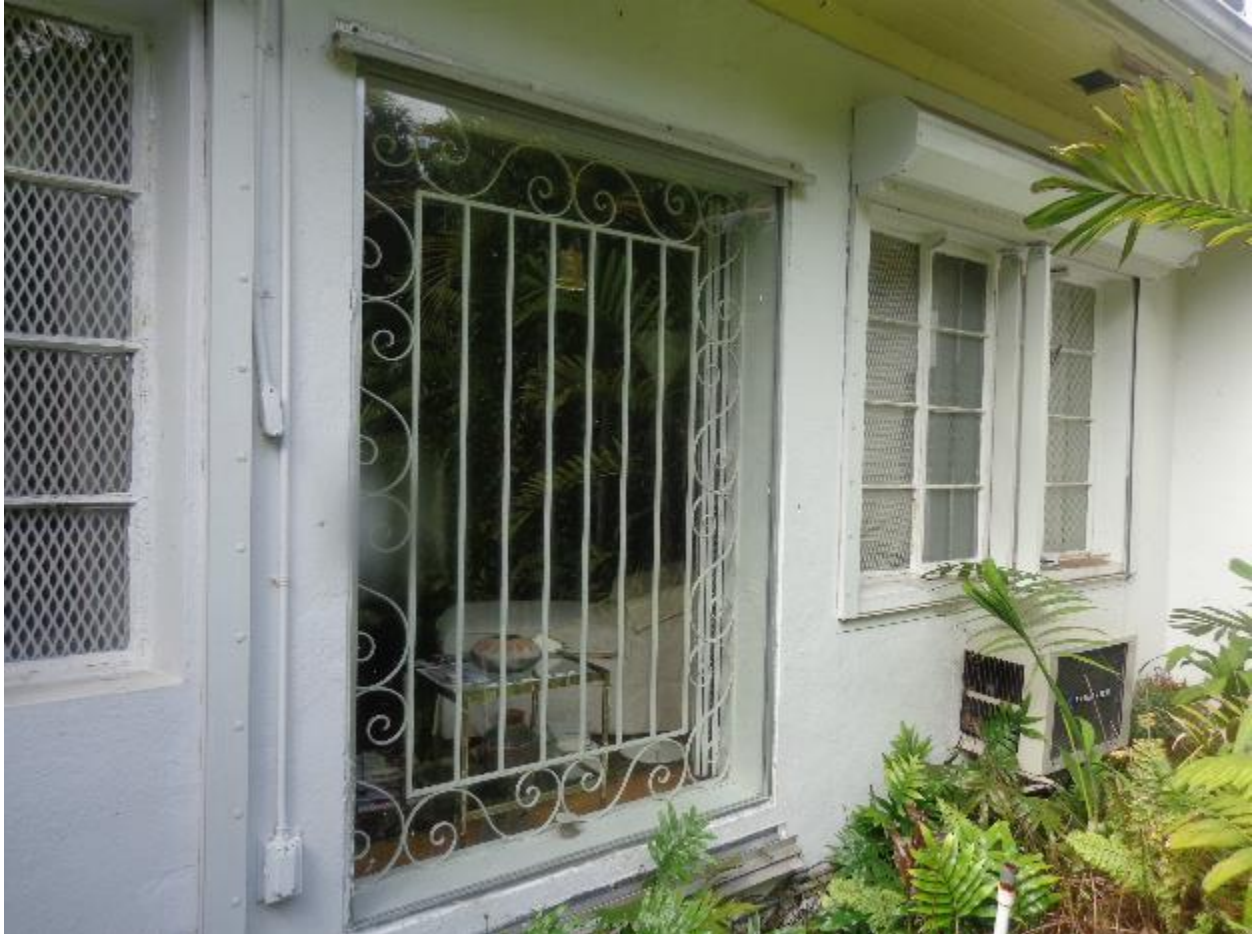
Current window systems are beyond possibilities of repair.

Exterior door(s) require replacement. Currently beyond possibilities of repair.

It is recommended a full replacement of windows with impact glass as per current code and avoid the installation of hurricane shutters.

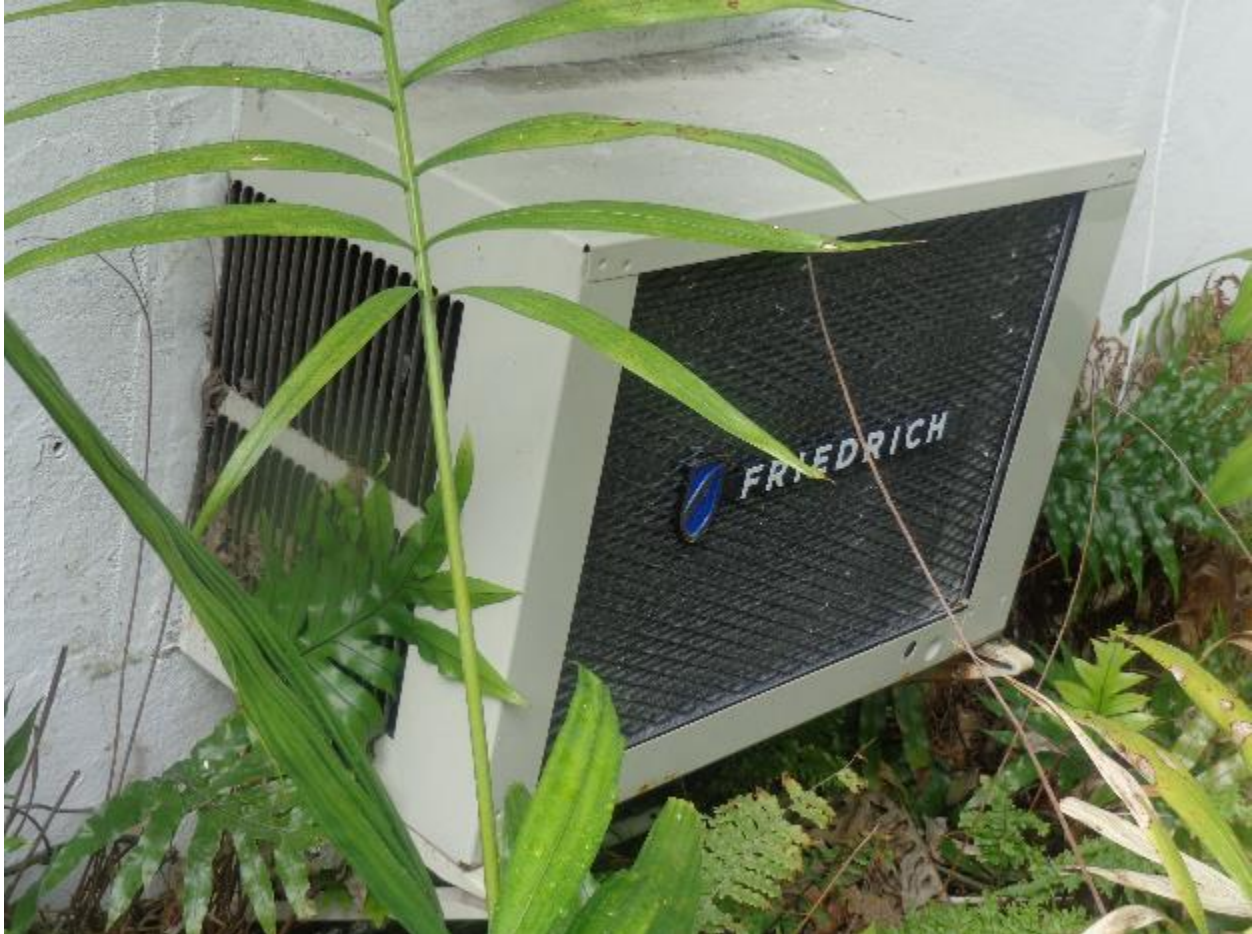
Allowances must be made for the installation of a new central AC system and removal of all window and walls units.

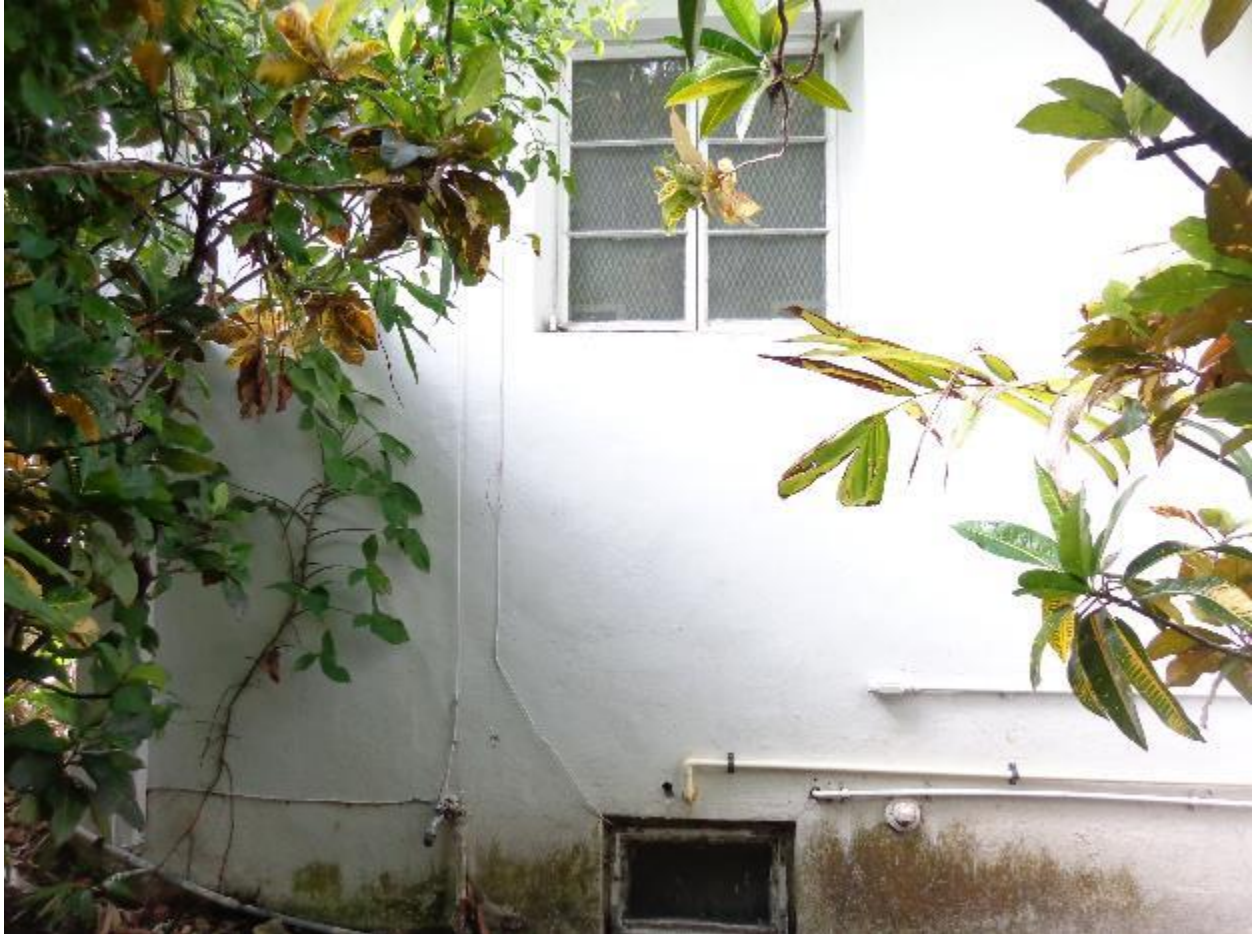
Current window systems are beyond possibilities of repair.

It is recommended a full replacement of windows with impact glass as per current code and avoid the installation of hurricane shutters.

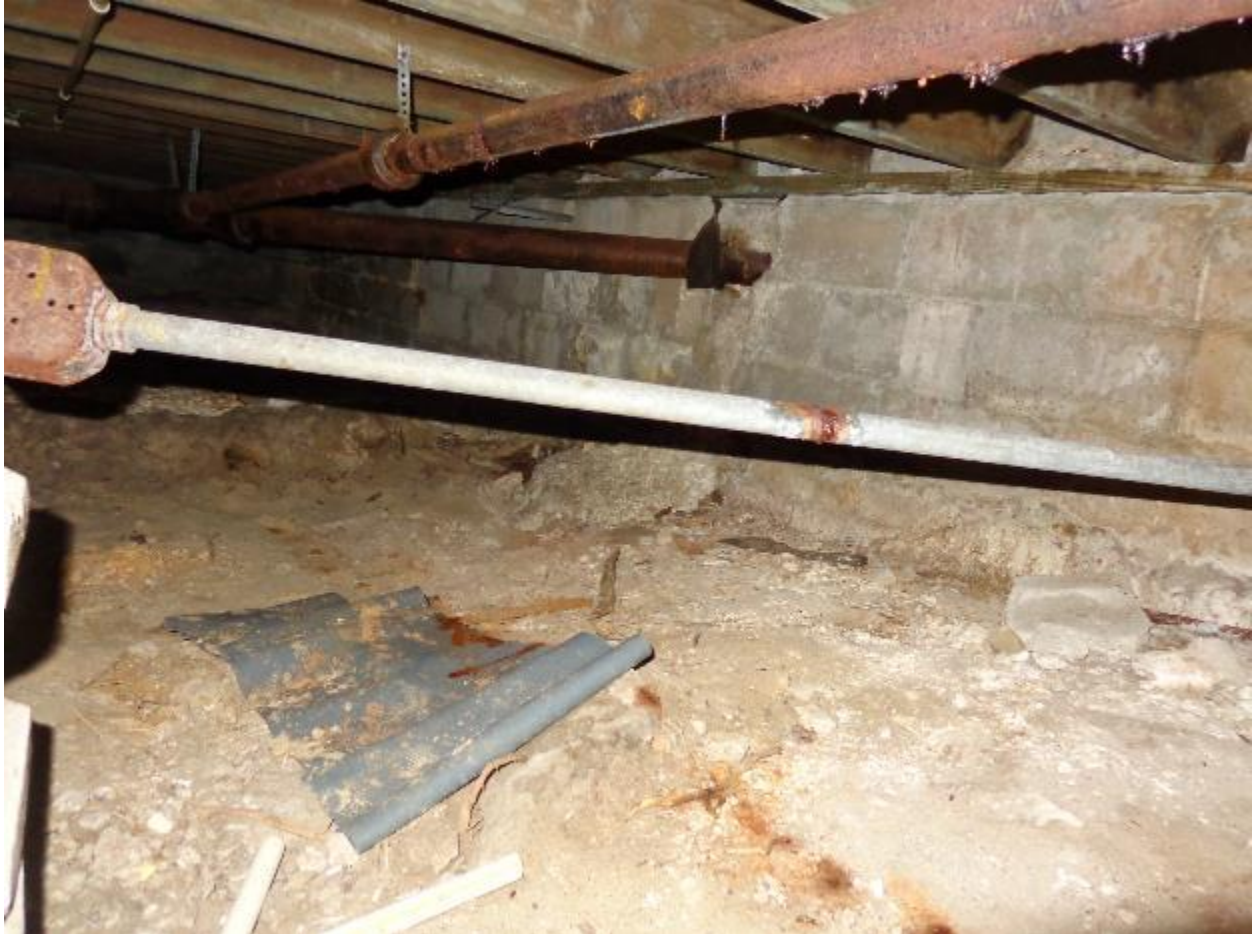
Deteriorated cast iron pipes will require a full upgrade replace with PVC.

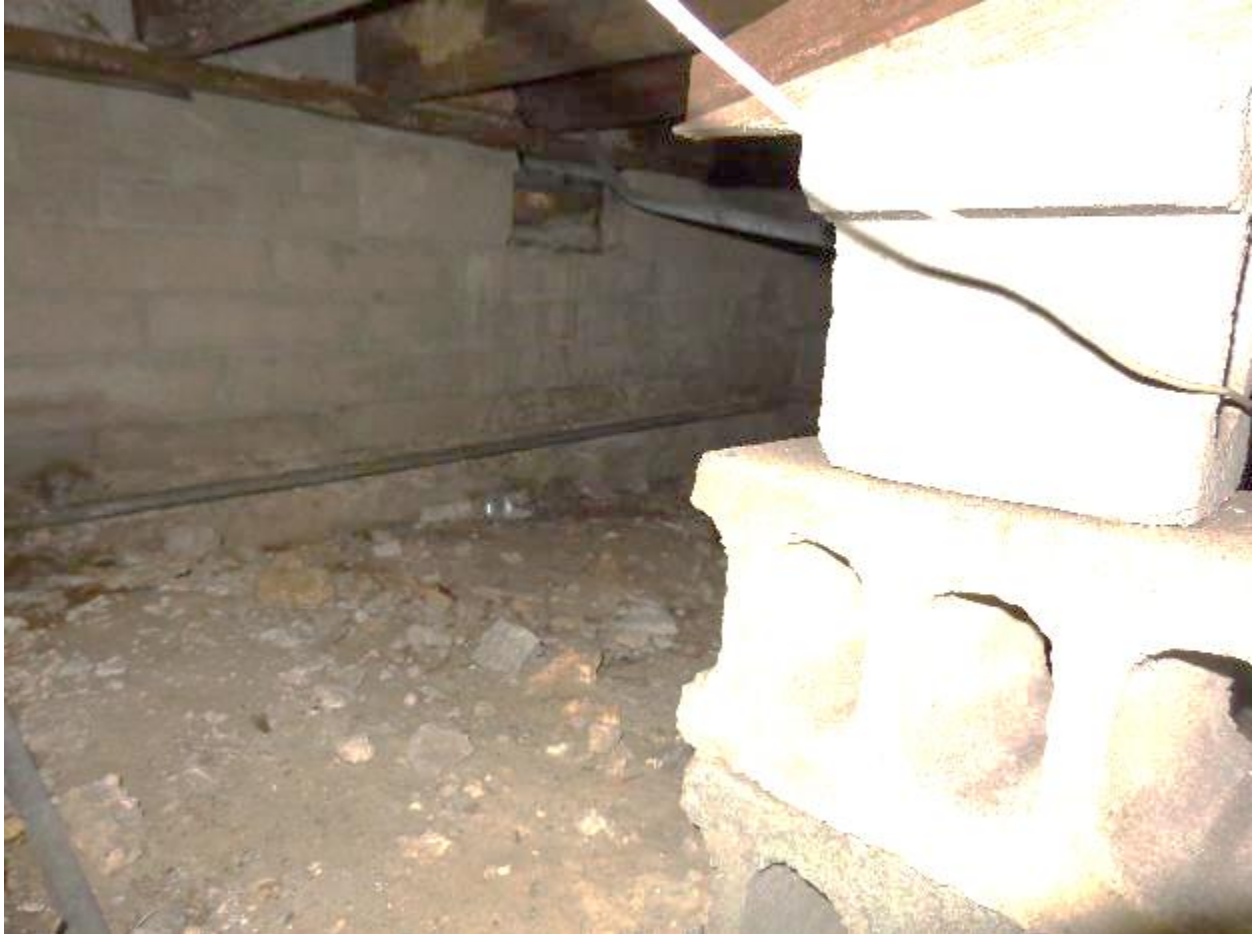
Deteriorated cast iron pipes will require a full upgrade replace with PVC.
