PROPERTY INSPECTION OR ASSESSMENT OF DAMAGES

ADDRESS: 229 Ridgewood Rd. Coral Gables, Fl.
CLIENT: Phil Padron
ID No: 2016417
DATE: 6/9/2016

PROPERTY INSPECTION –229 Ridgewood Rd Coral Gables, FL
ATTACHMENT - PHOTOGRAPHS
DATE: 06-09-2016

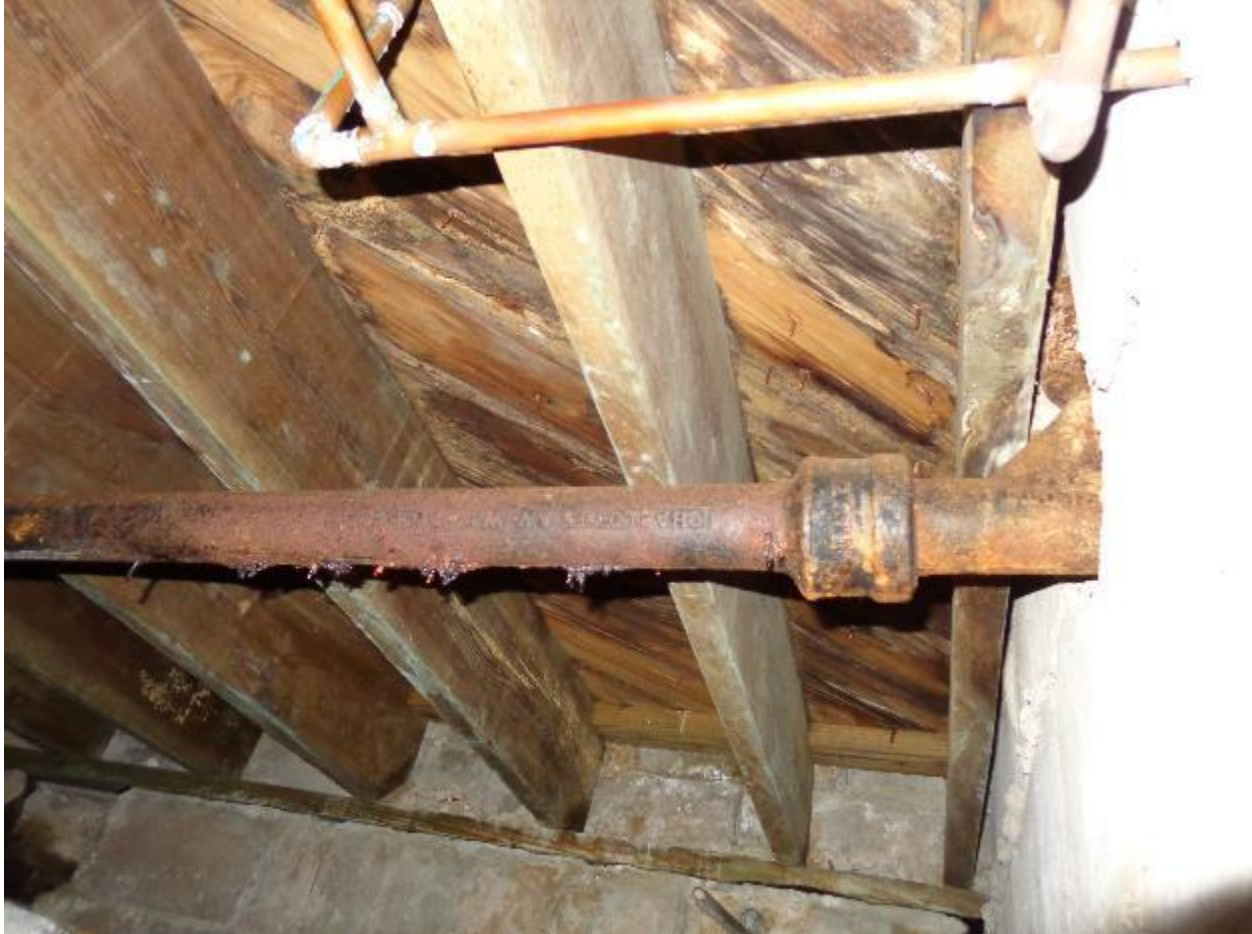
(First bathroom on the right once you enter the house).

Crawl space inspection reveals rotted wood and structural damage related to water leaks caused by failure of plumbing system.

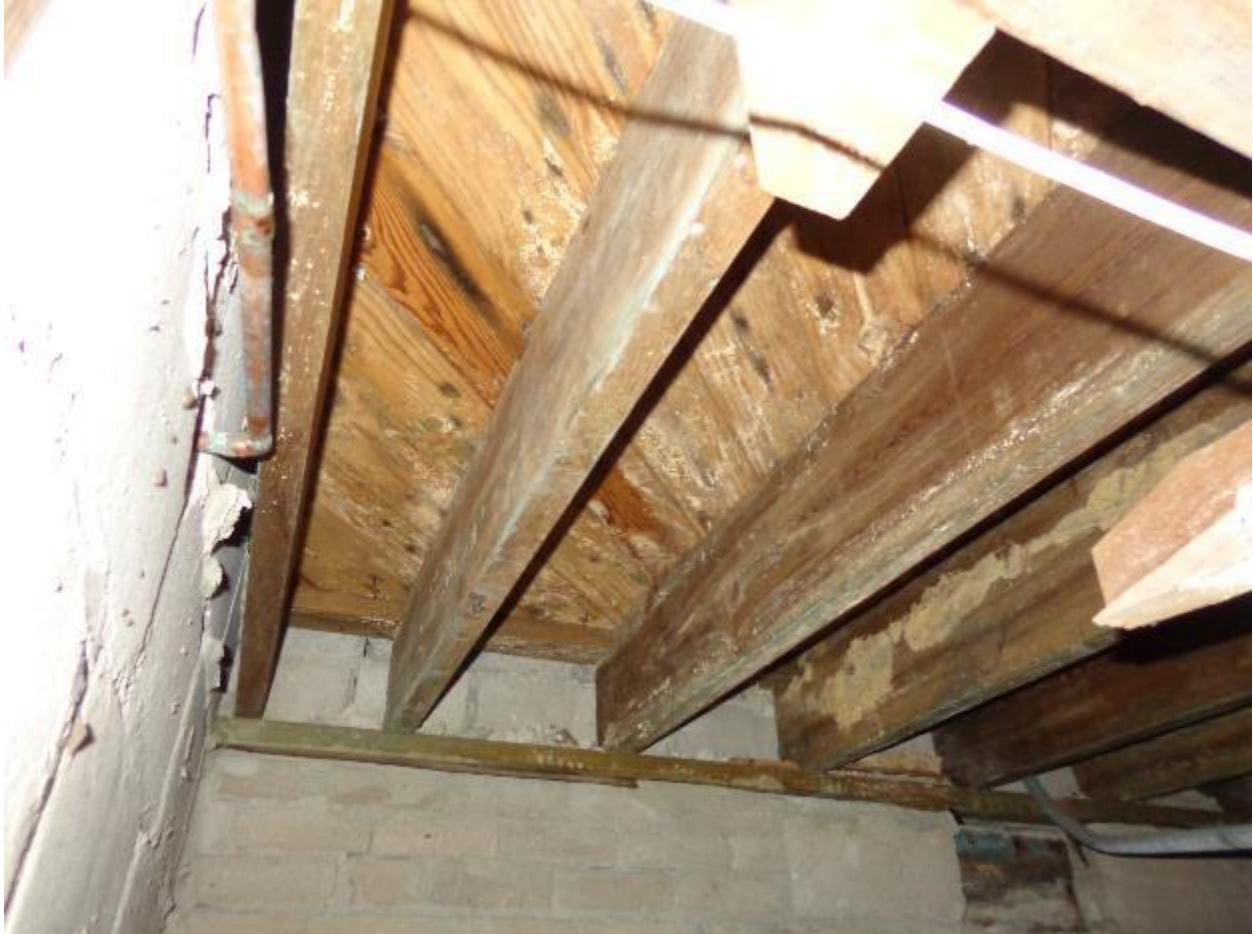
(First bathroom on the right once you enter the house).

Crawl space inspection reveals rotted wood and structural damage related to water leaks caused by failure of plumbing system.

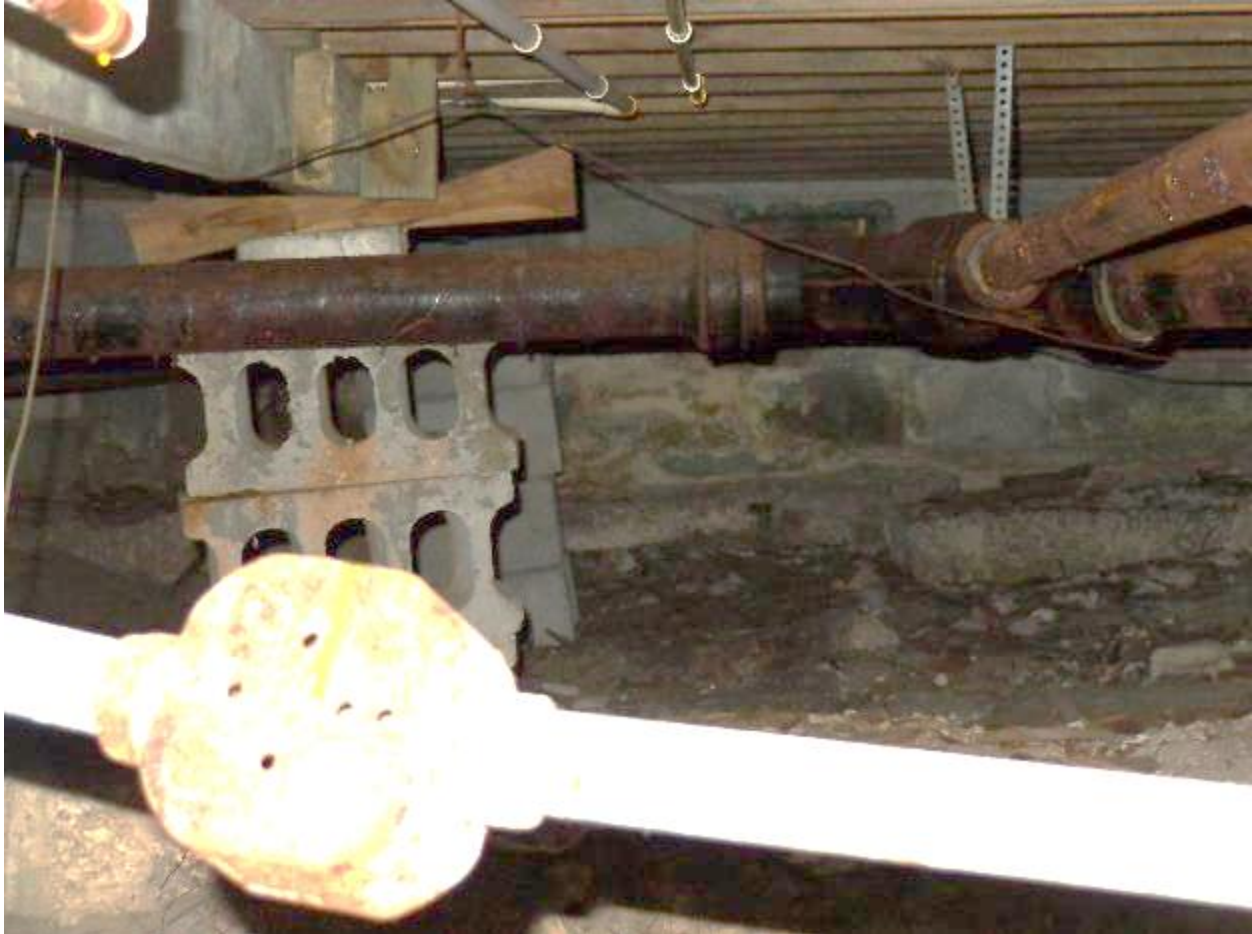
Deteriorated cast iron pipes will require a full upgrade replace with PVC.

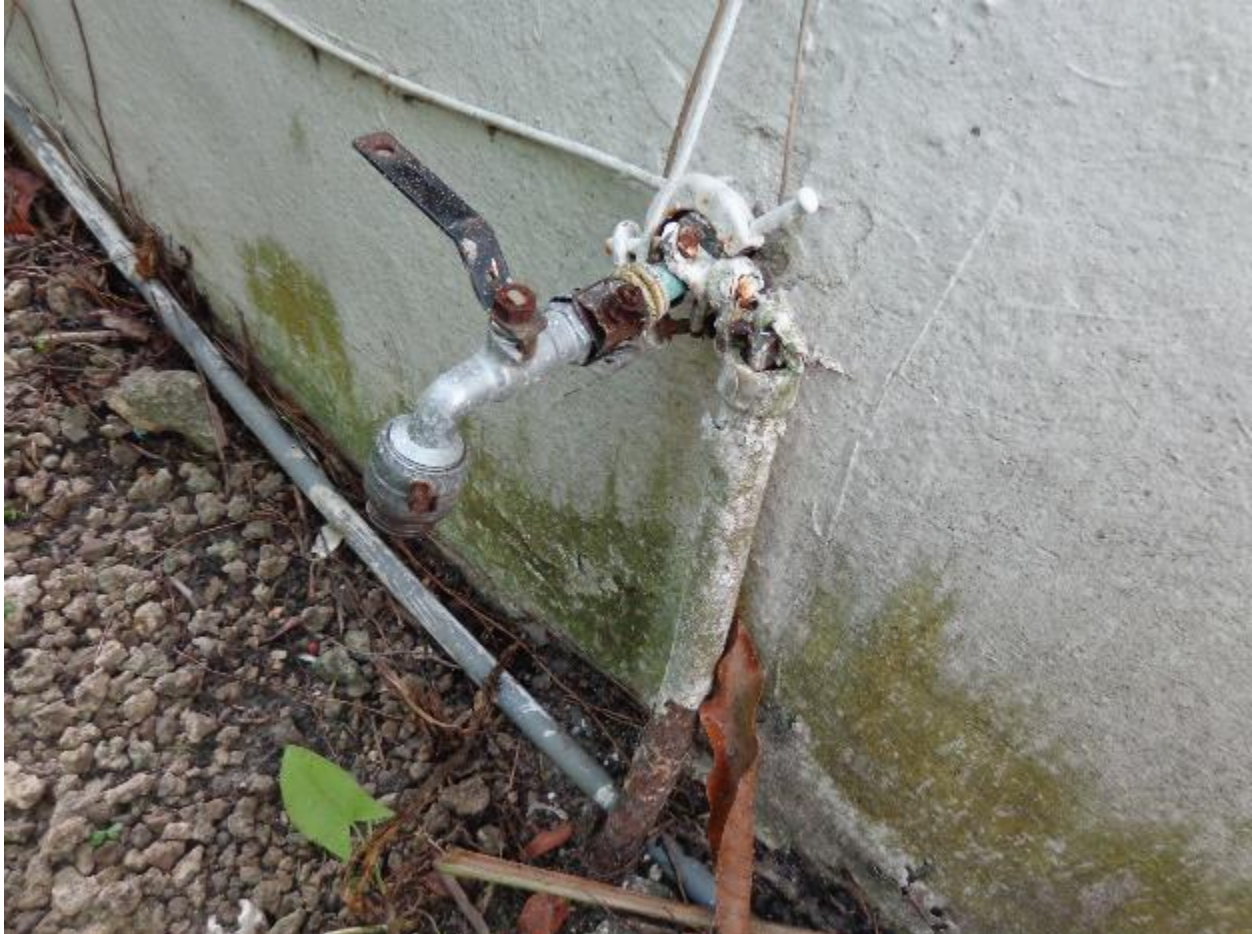
Defective plumbing system requires repairs.

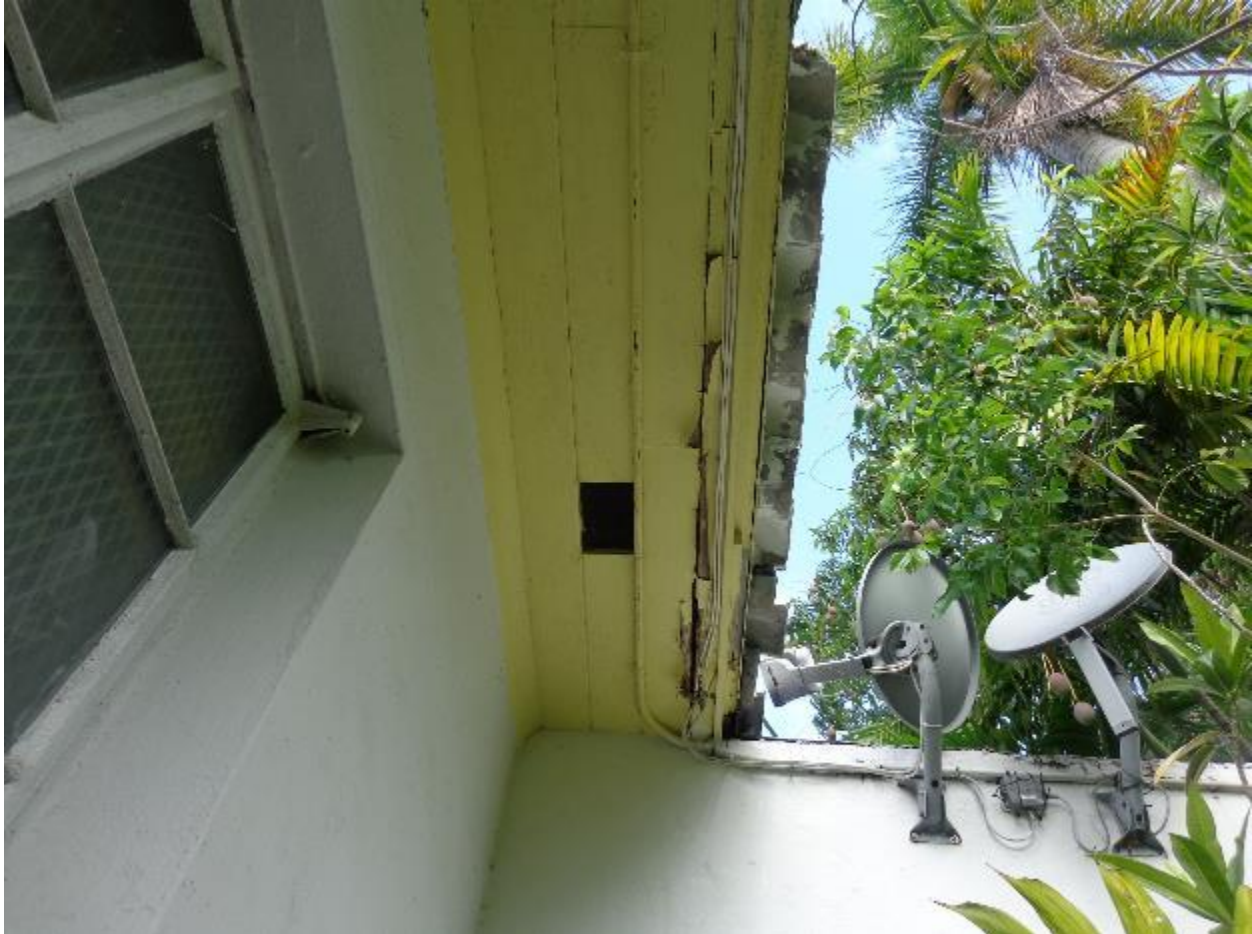
Fascia and soffit deteriorated wood requires replacement.

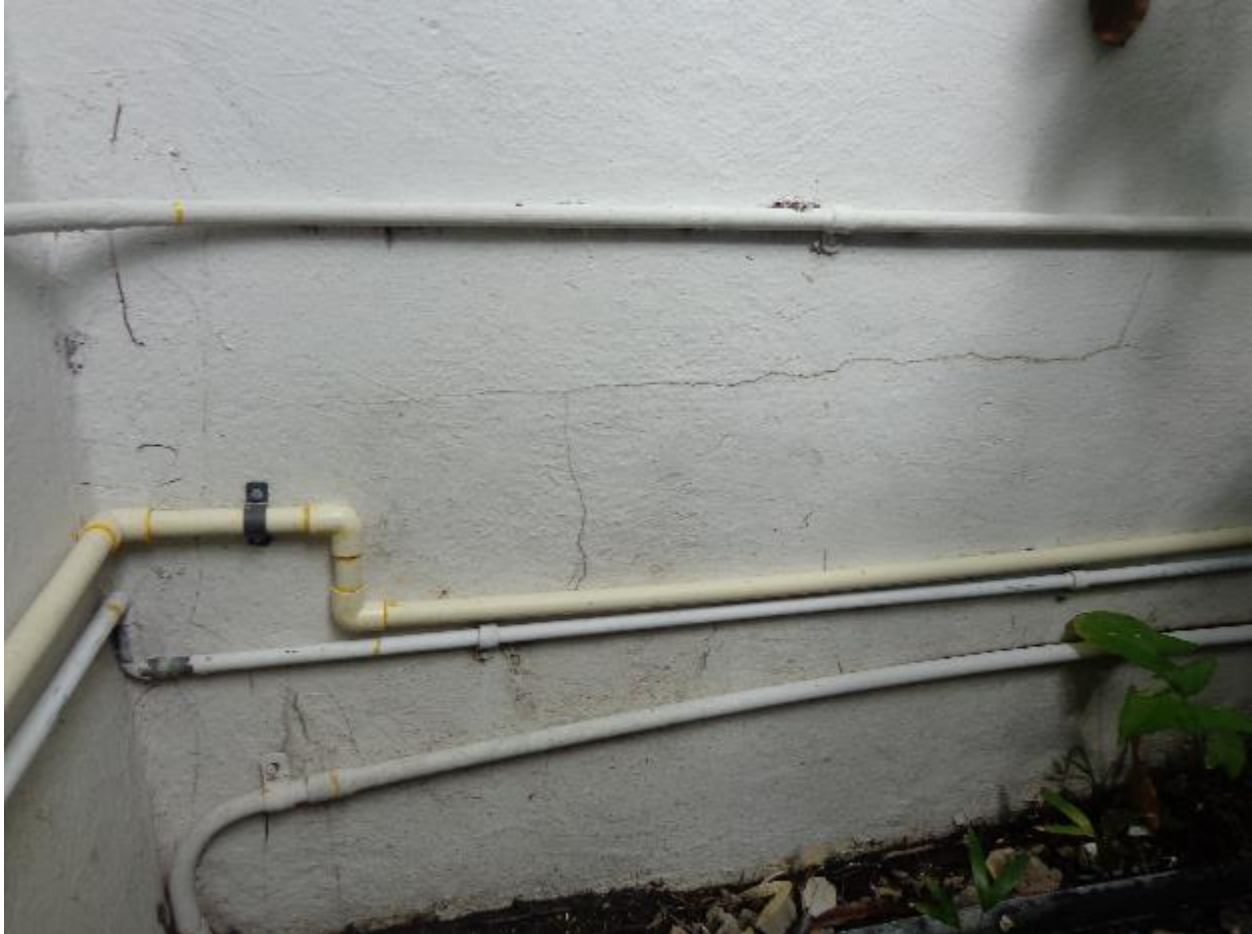
Home was noted to have had a full update of galvanized water lines, to CPVC line.

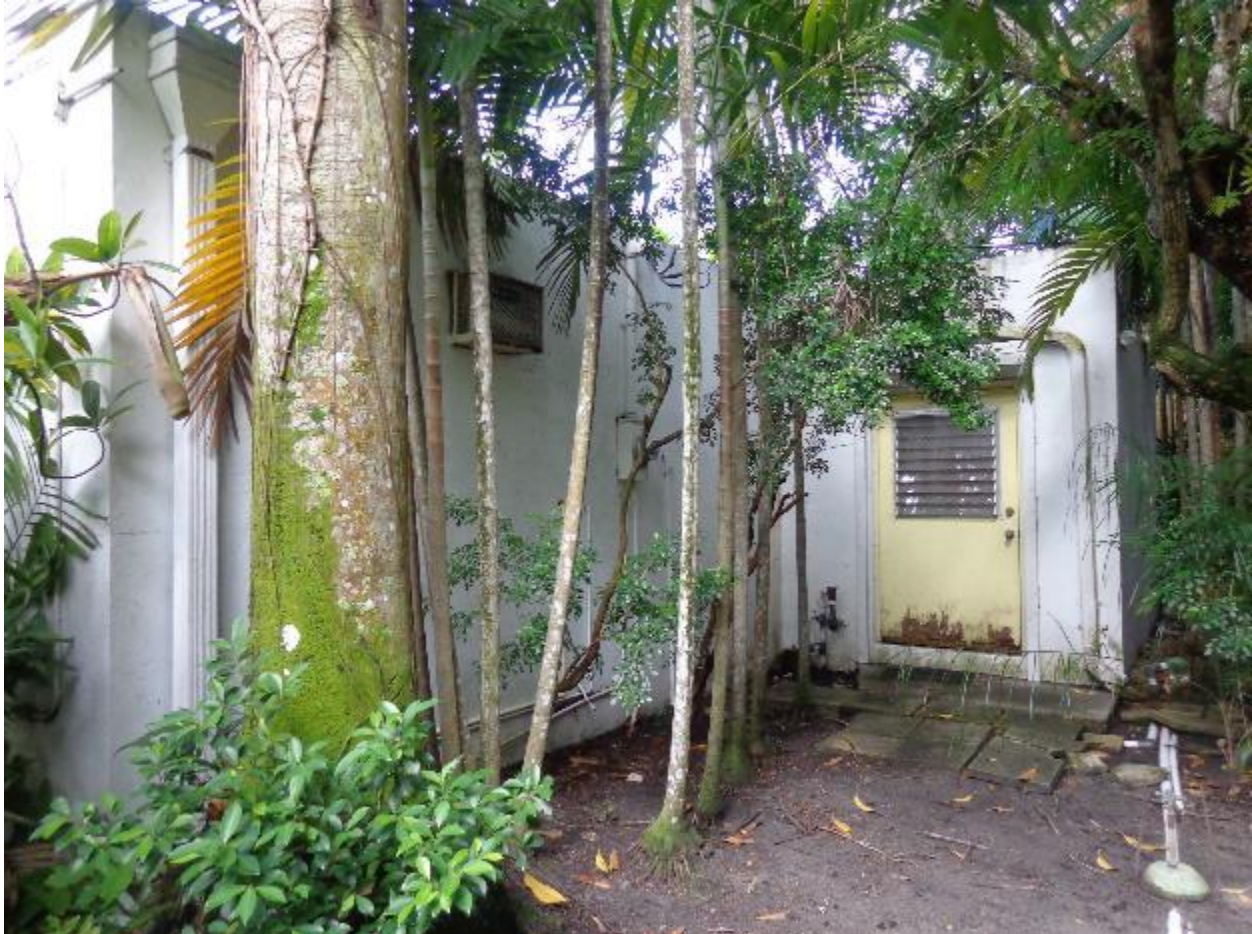
Exterior rehabilitation must include and not limited to:

Pressure wash and paint, replace obsolete and failing window systems, replace exterior doors, fascia and soffit rotted wood replacement, overgrown vegetation removal, structural repairs required. Refer to attached photographs for details.

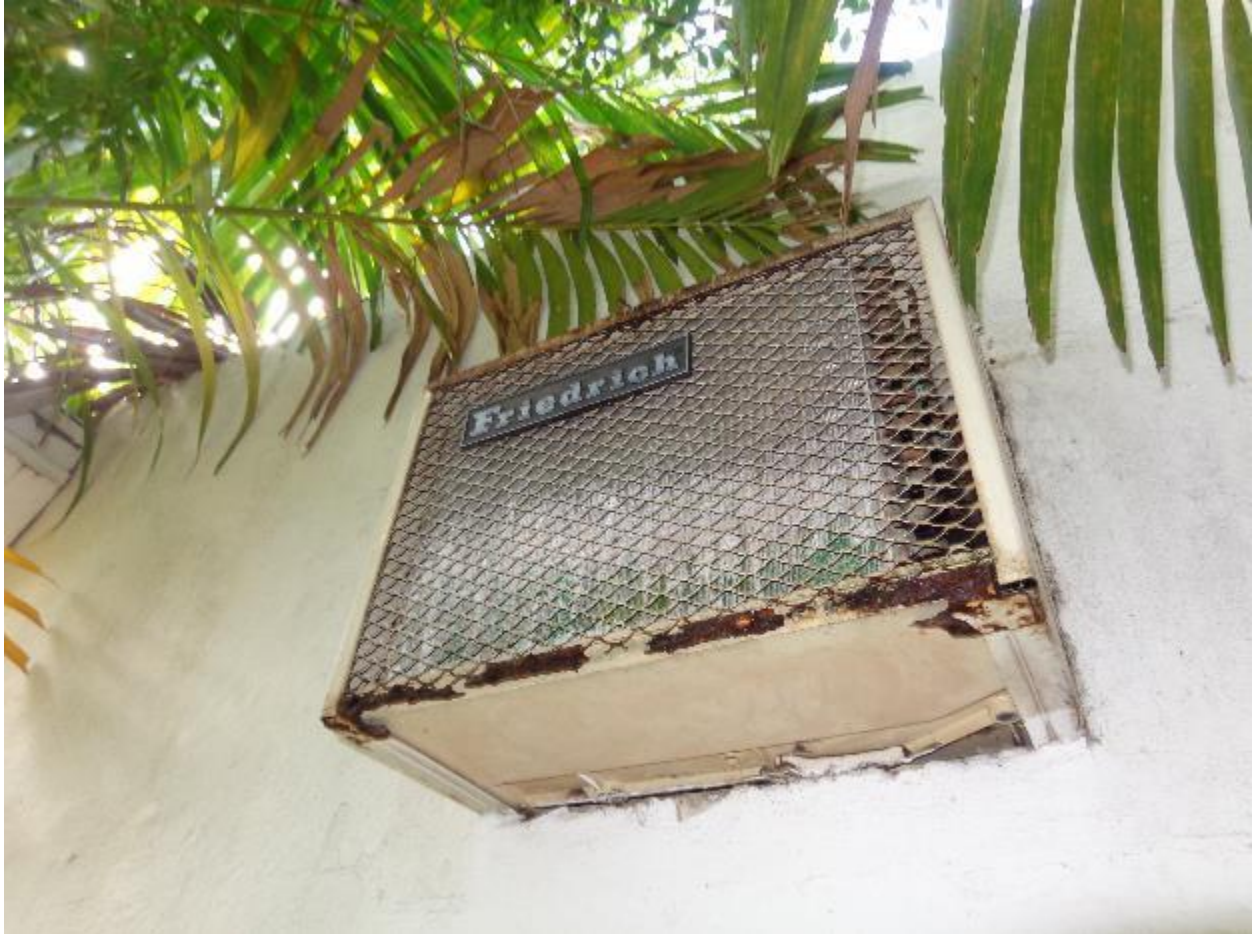
Allowances must be made for the installation of a new central AC system and removal of all window and walls units.

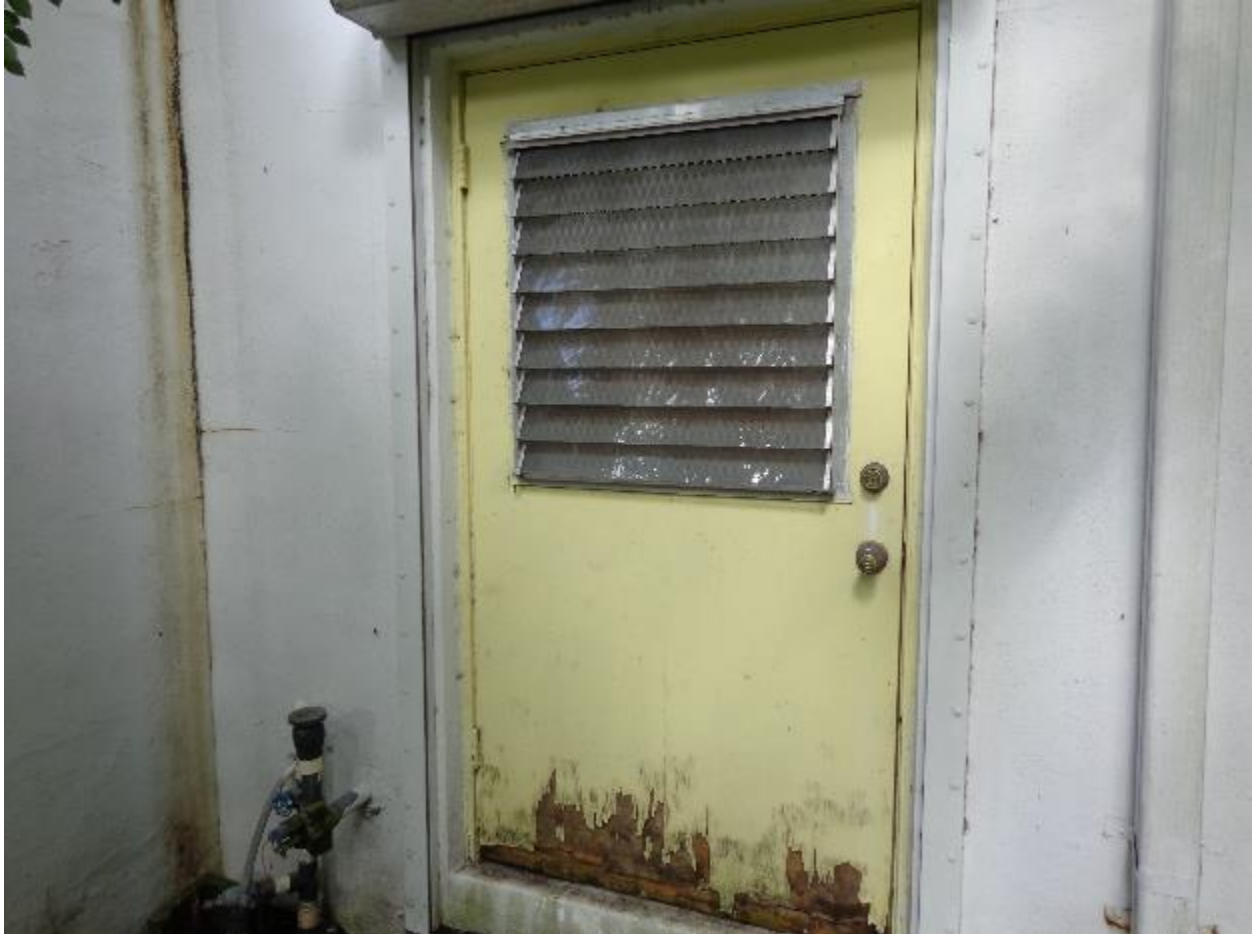
Exterior door(s) require replacement. Currently beyond possibilities of repair.

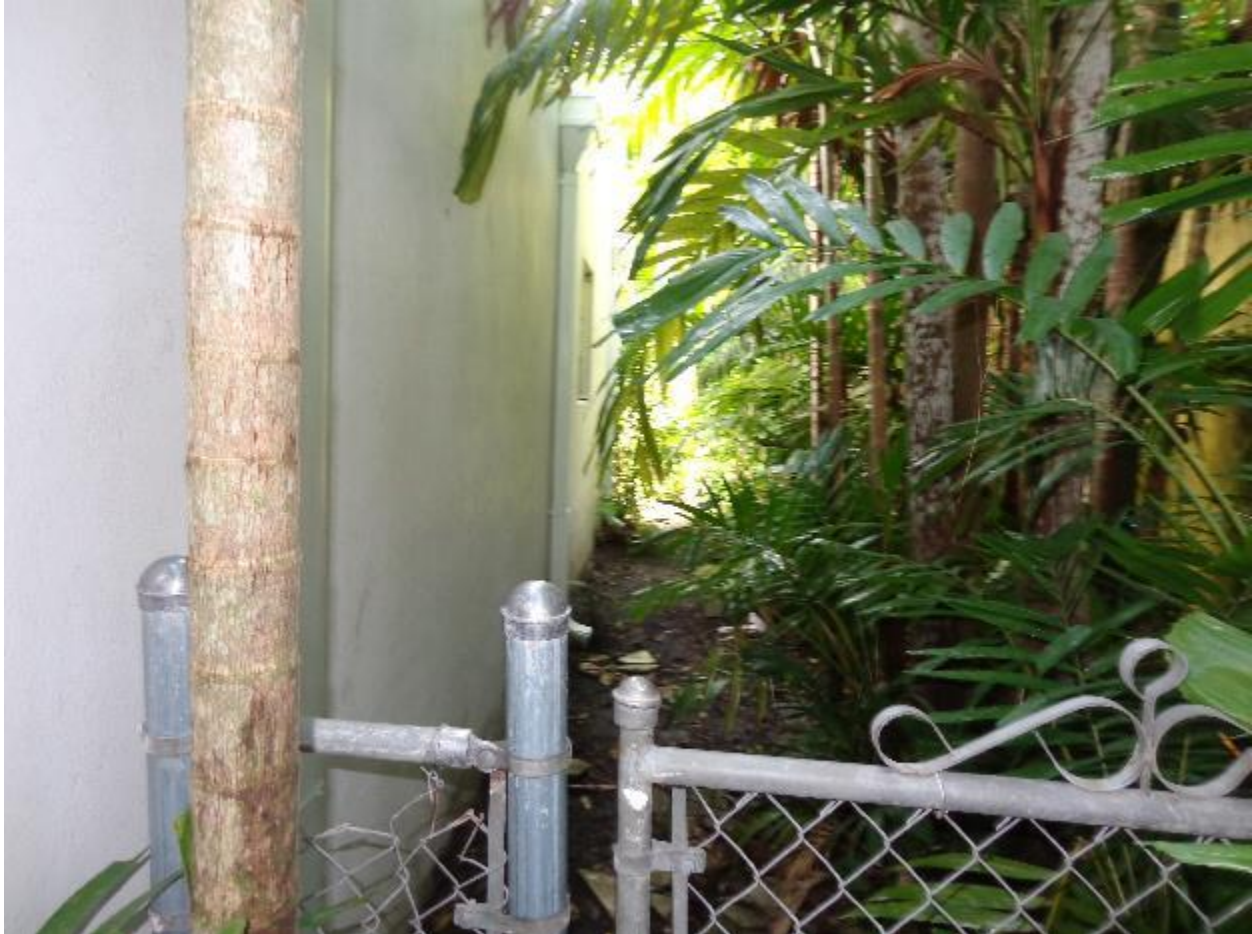
Exterior rehabilitation must include and not limited to:

Pressure wash and paint, replace obsolete and failing window systems, replace exterior doors, fascia and soffit rotted wood replacement, overgrown vegetation removal, structural repairs required. Refer to attached photographs for details.

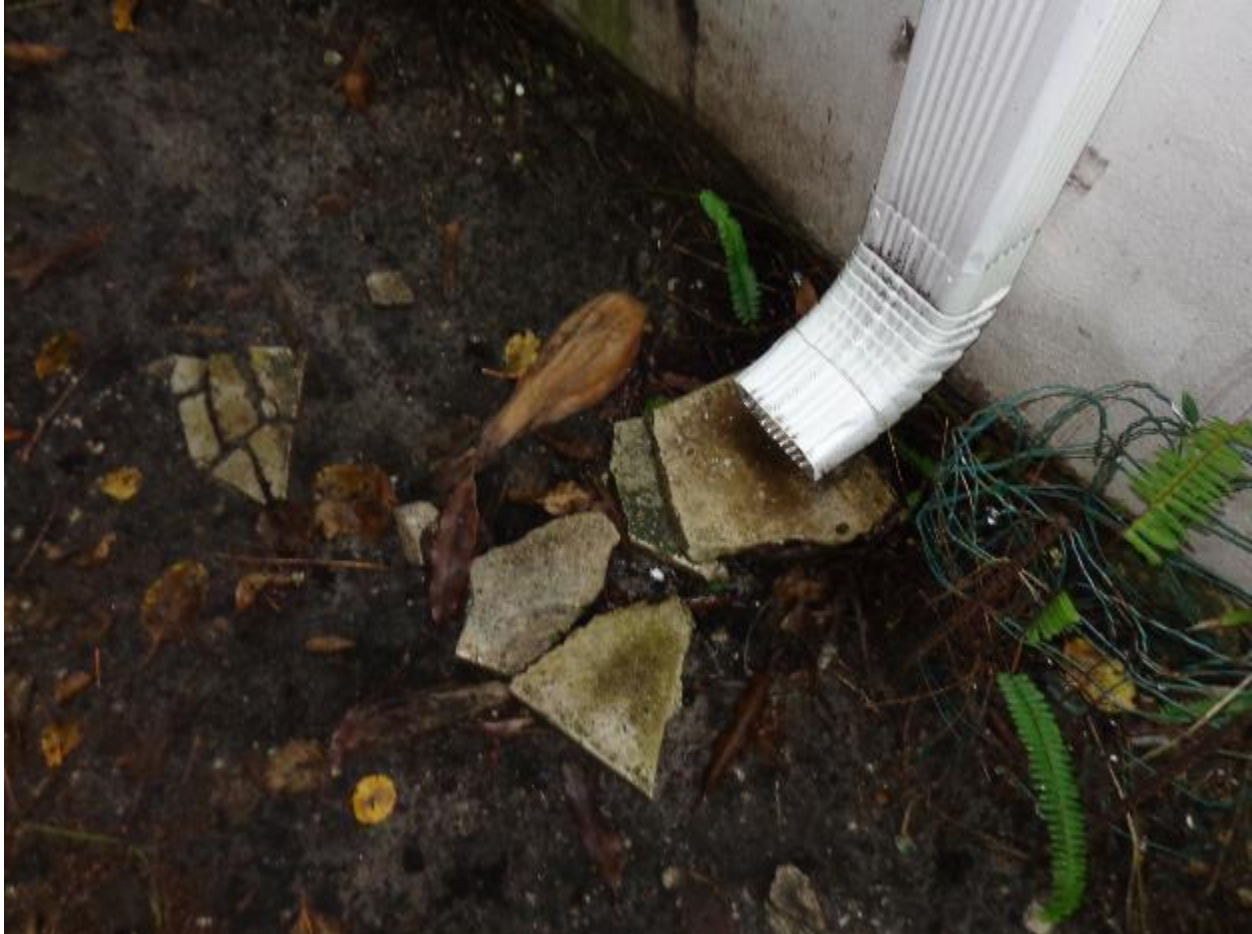
Gutters requires extensions to be installed. Water is not draining properly away from the house.

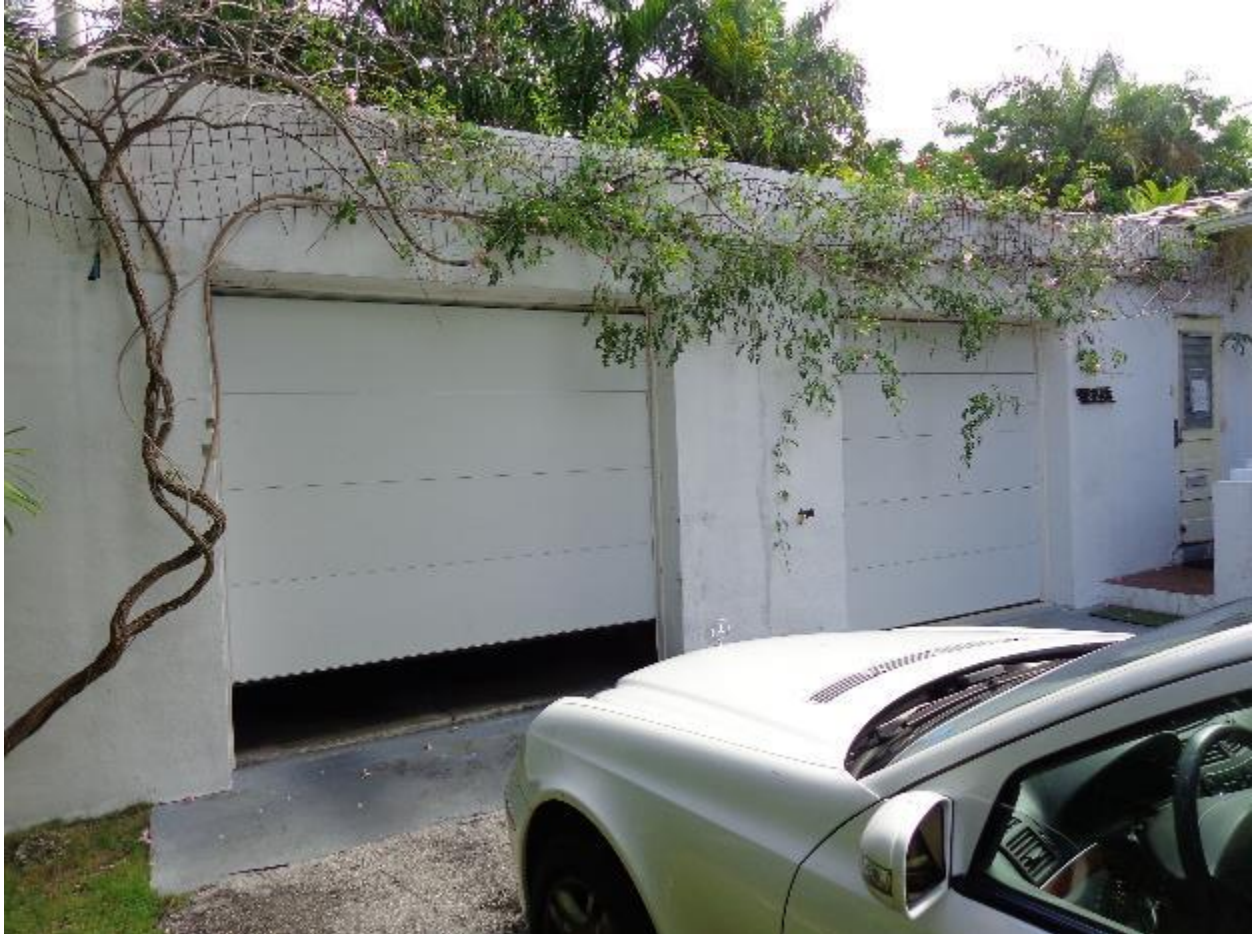
Exterior rehabilitation must include and not limited to:

Pressure wash and paint, replace obsolete and failing window systems, replace exterior doors, fascia and soffit rotted wood replacement, overgrown vegetation removal, structural repairs required. Refer to attached photographs for details.

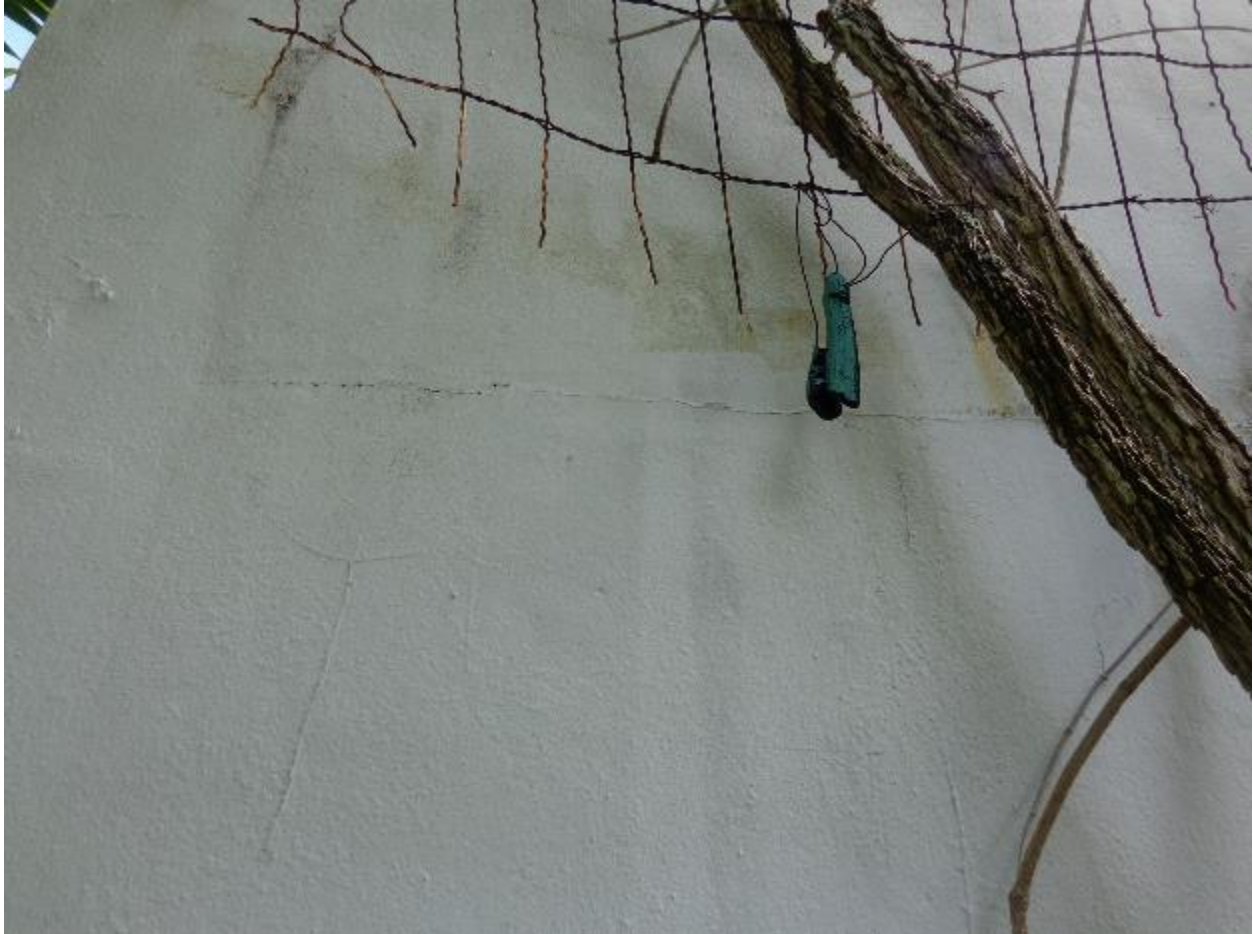
Cracks on vertical planes due to foundation settlement indicating downward and lateral movement. These types of cracks may compromise the ability of the building to function as designed and avoid water intrusion. Structural repair and proper waterproofing treatment are required to avoid further damage to the interior of the building and water infiltration.

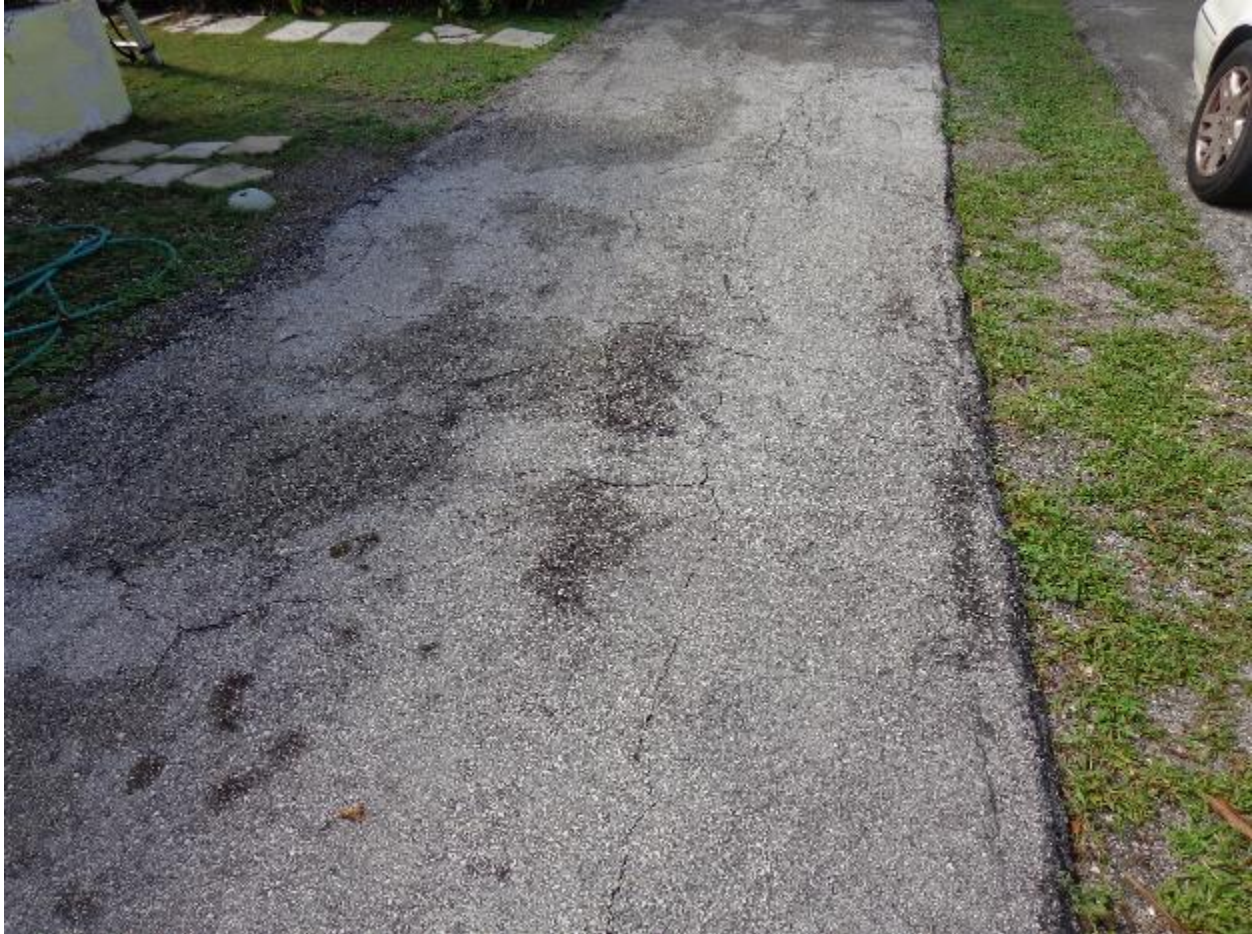
Asphalt recoating required on parking spaces/ driveway.

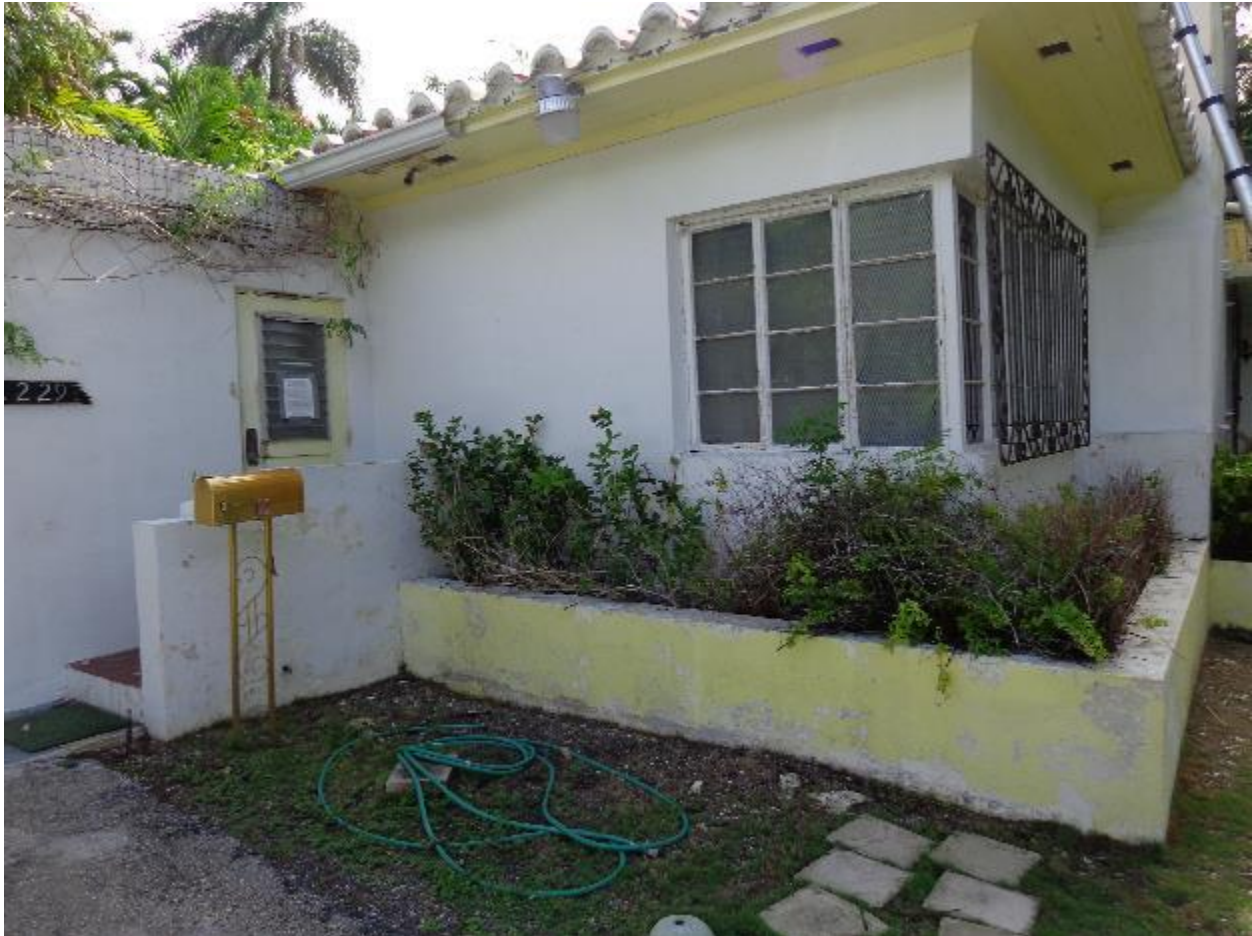
Exterior rehabilitation must include and not limited to:

Pressure wash and paint, replace obsolete and failing window systems, replace exterior doors, fascia and soffit rotted wood replacement, overgrown vegetation removal, structural repairs required. Refer to attached photographs for details.

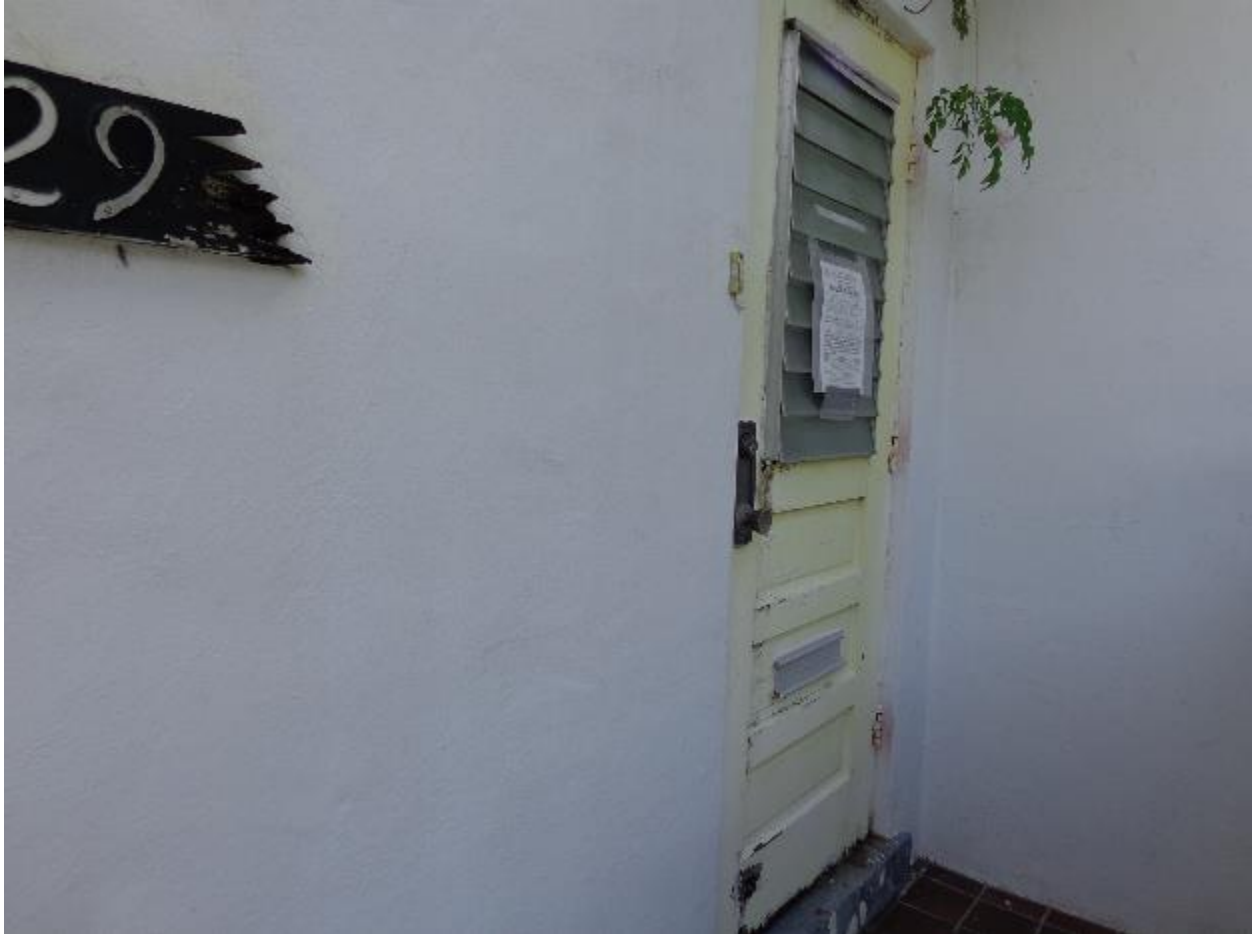
Exterior door(s) require replacement. Currently beyond possibilities of repair.

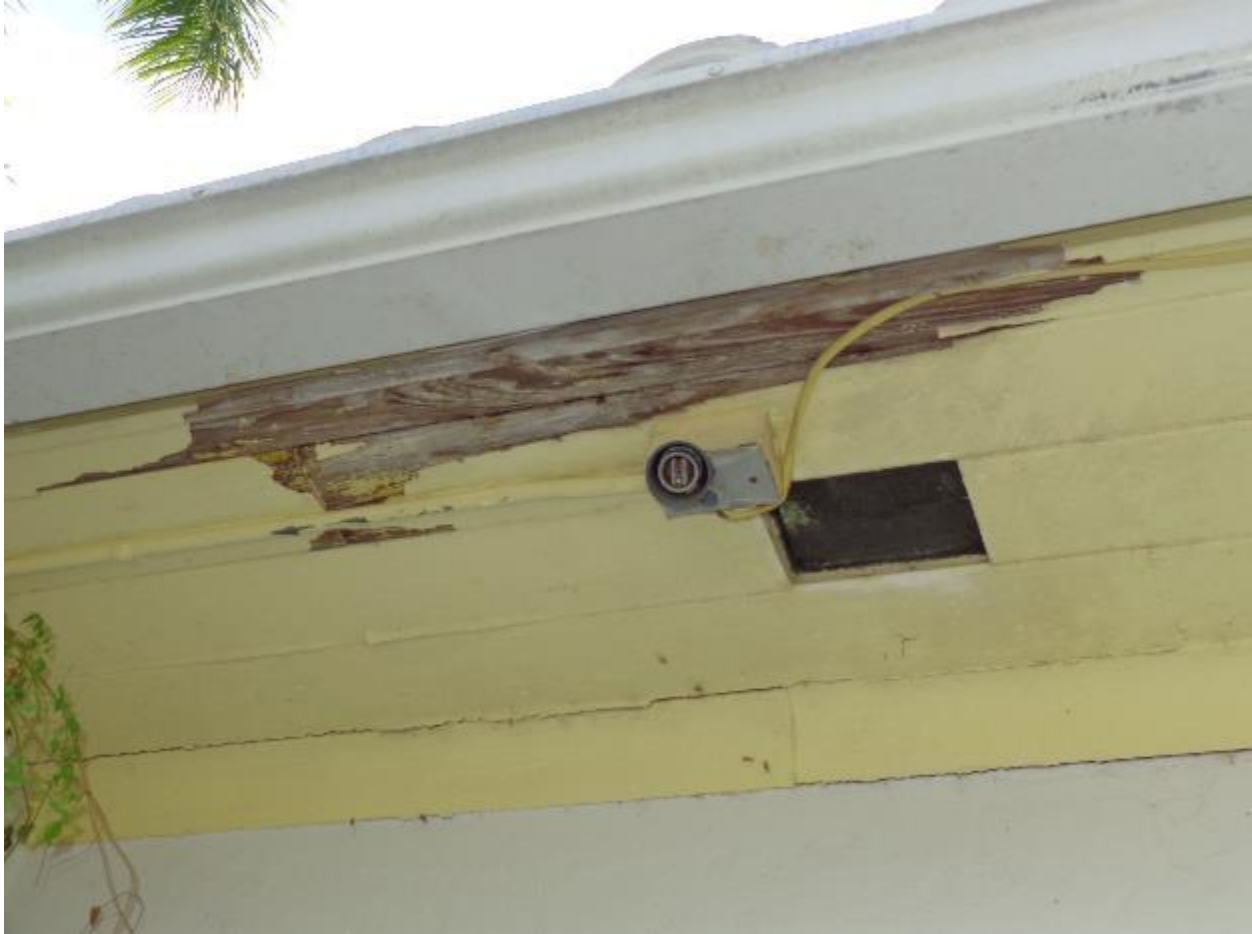
Fascia and soffit deteriorated wood requires replacement.

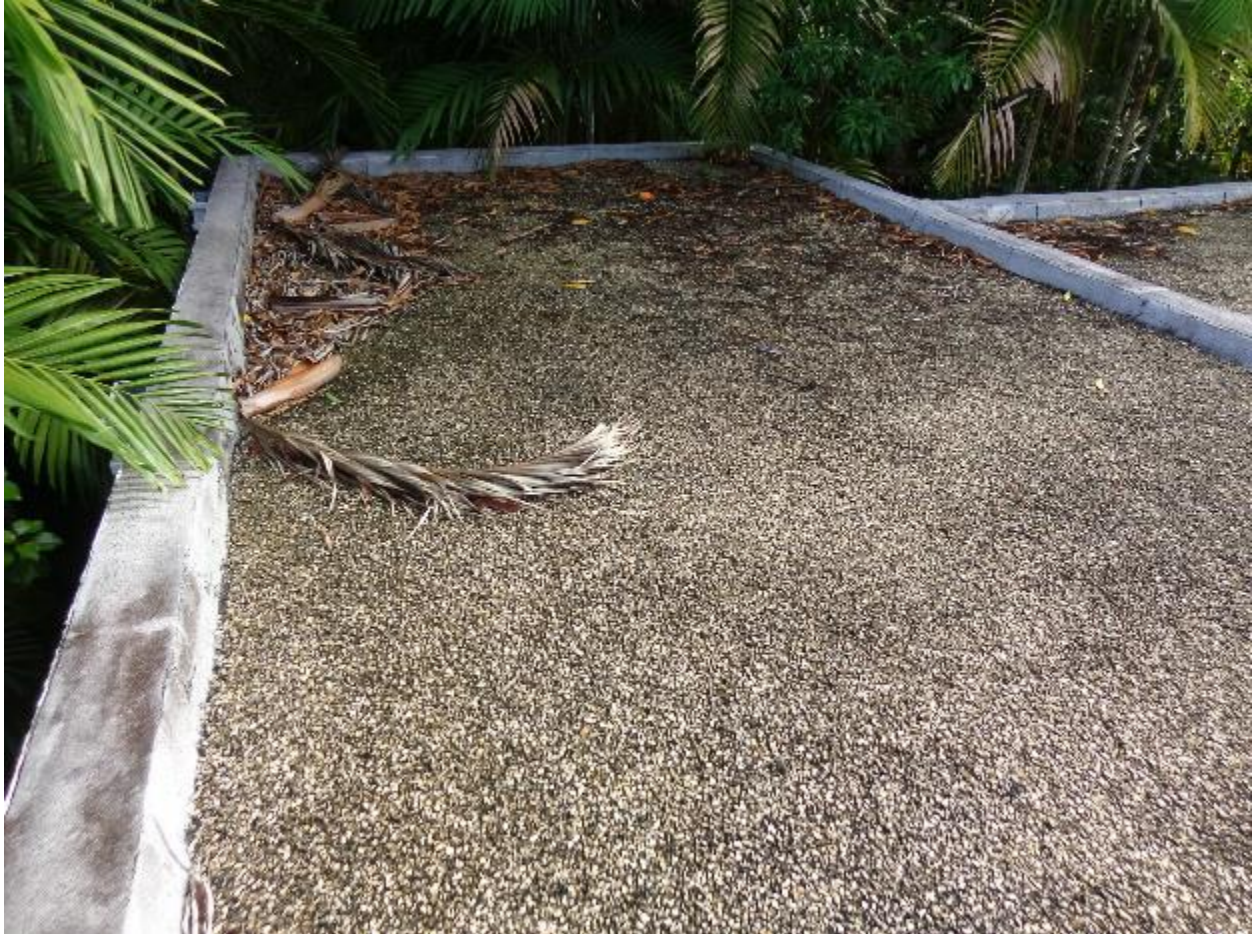
Minimum roofing repairs required, related to possible active leaks and water marks noted inside habitable space.

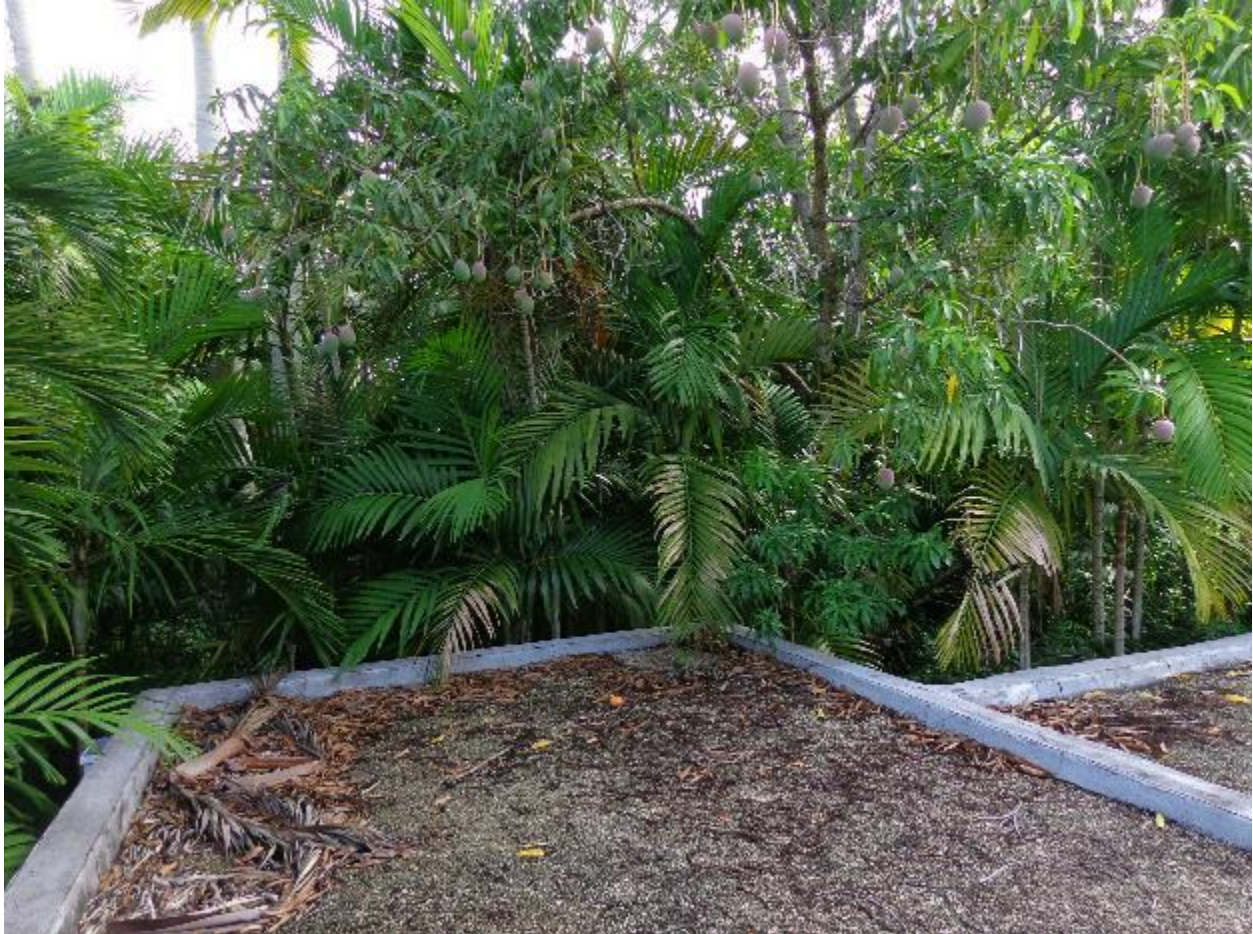
Minimum roofing repairs required, related to possible active leaks and water marks noted inside habitable space.
