PROPERTY INSPECTION OR ASSESSMENT OF DAMAGES

ADDRESS: 229 Ridgewood Rd. Coral Gables, Fl.
CLIENT: Phil Padron
ID No: 2016417
DATE: 6/9/2016

PROPERTY INSPECTION –229 Ridgewood Rd Coral Gables, FL
ATTACHMENT - PHOTOGRAPHS
DATE: 06-09-2016

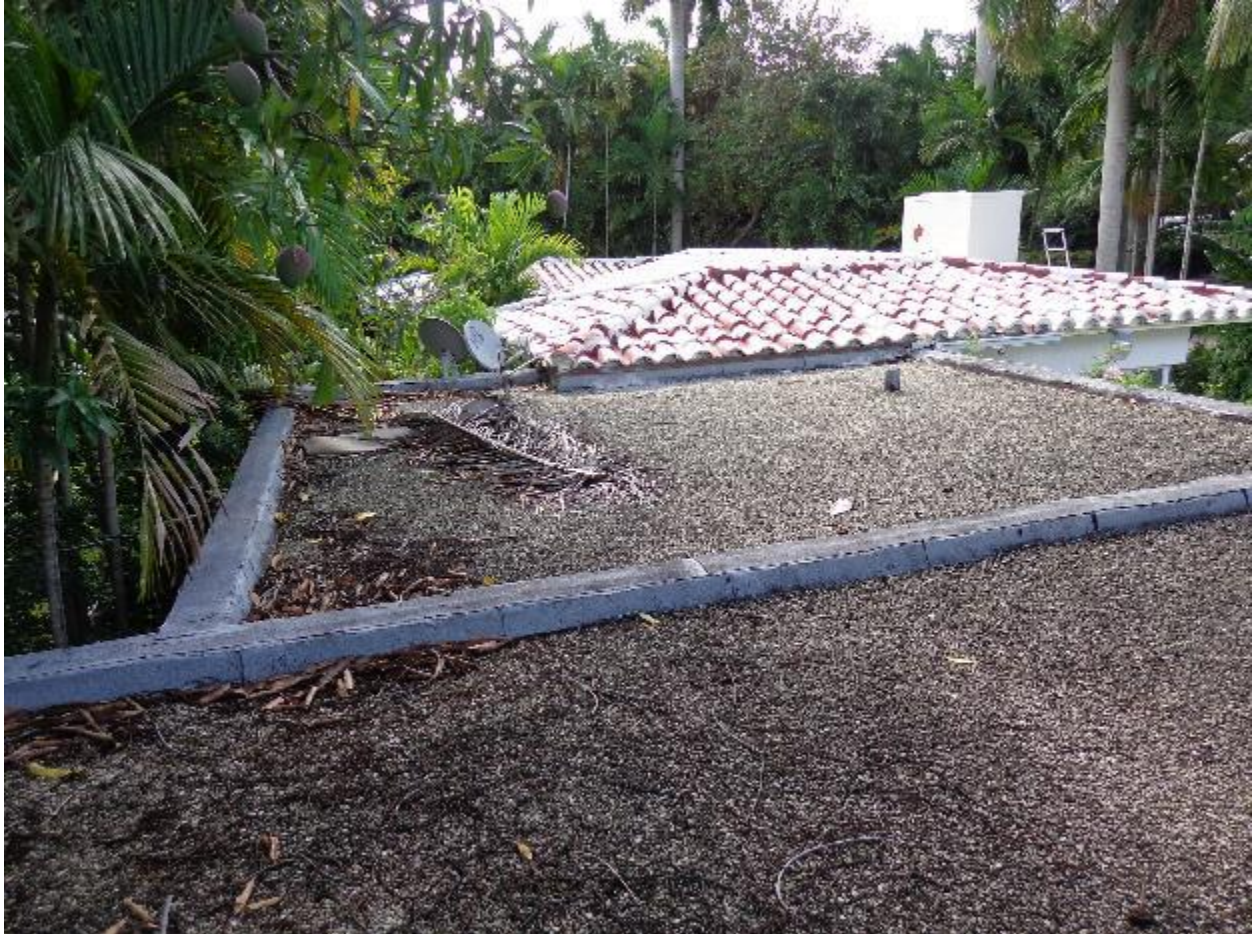
Minimum roofing repairs required, related to possible active leaks and water marks noted inside habitable space.

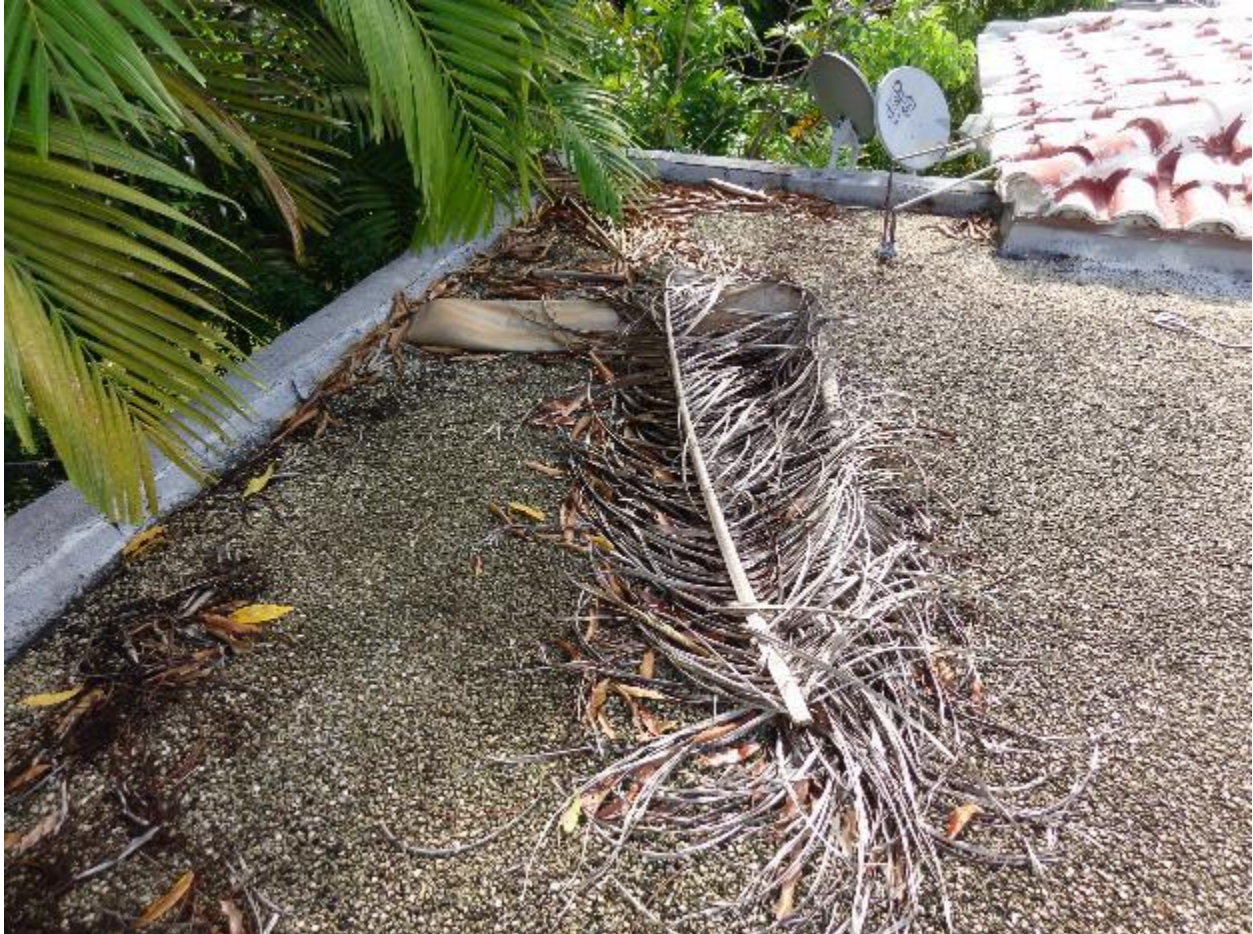
Allowances must be made for the removal of overgrown vegetation.

Minimum roofing repairs required, related to possible active leaks and water marks noted inside habitable space.

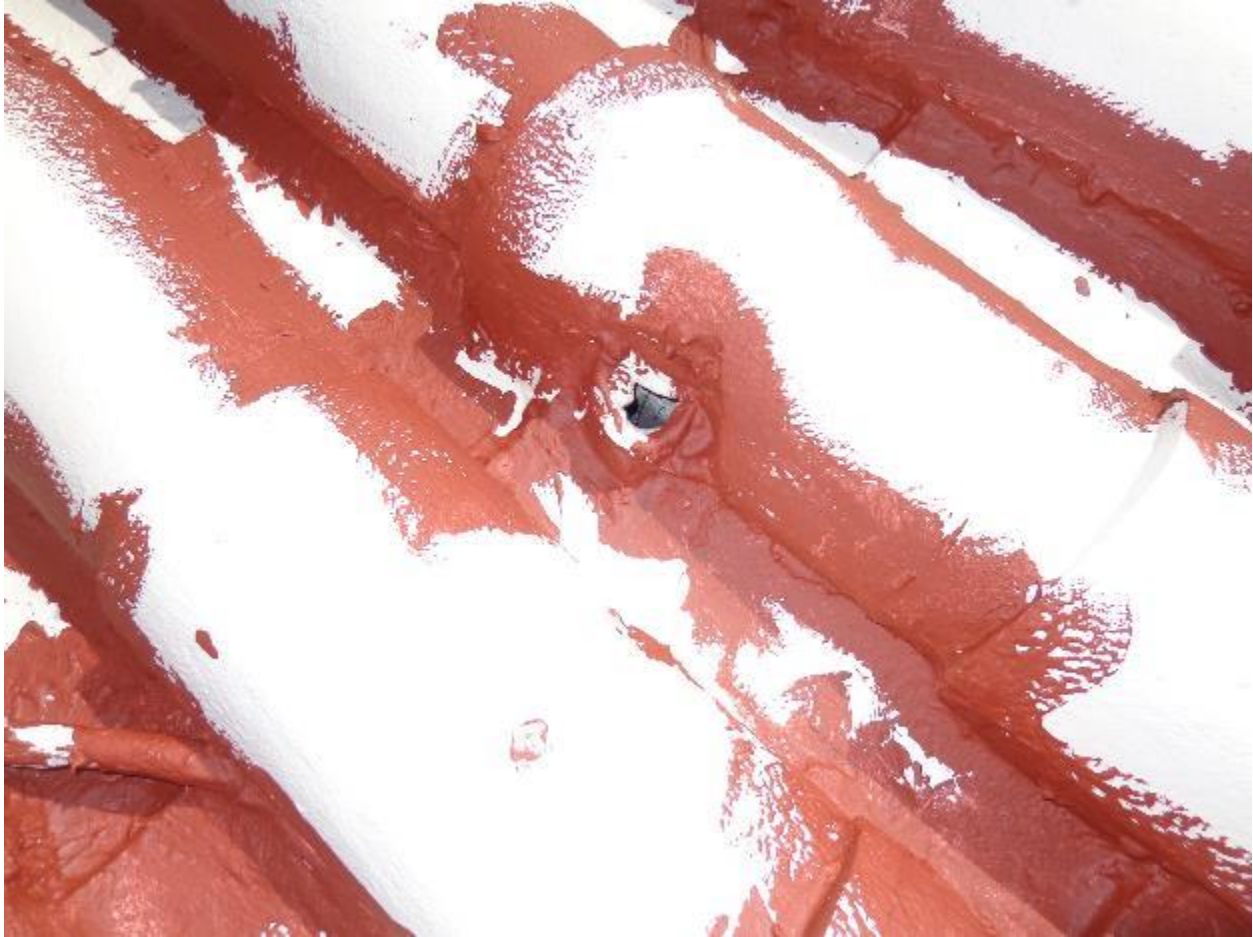
(2nd bathroom near garage) Vent pipe should be a minimum of 3 inches above roofline.

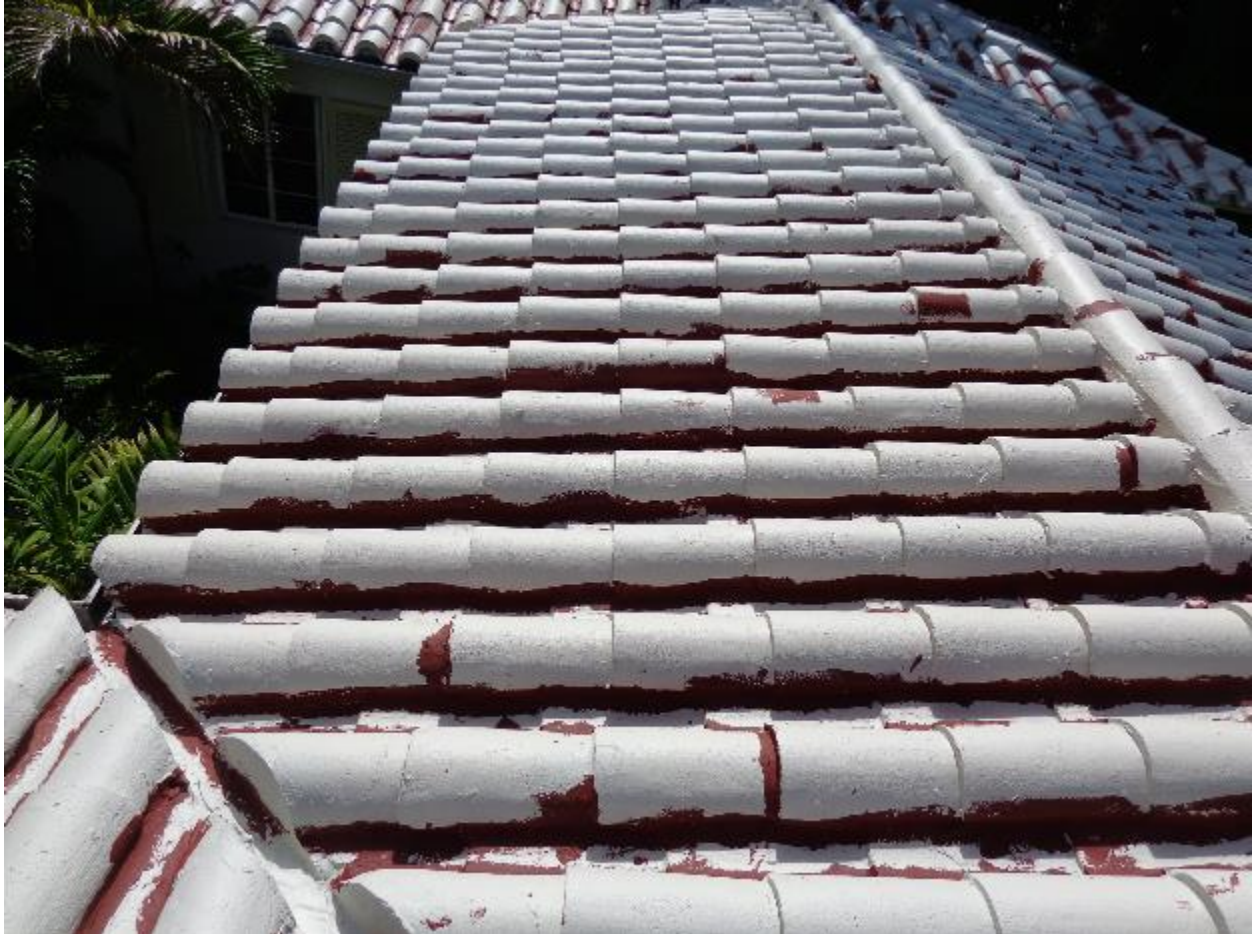
(Roof age unknown)

Roof was noted to be in general good condition and was properly sealed at time of inspection. No active leaks were noted inside home from the main roof.

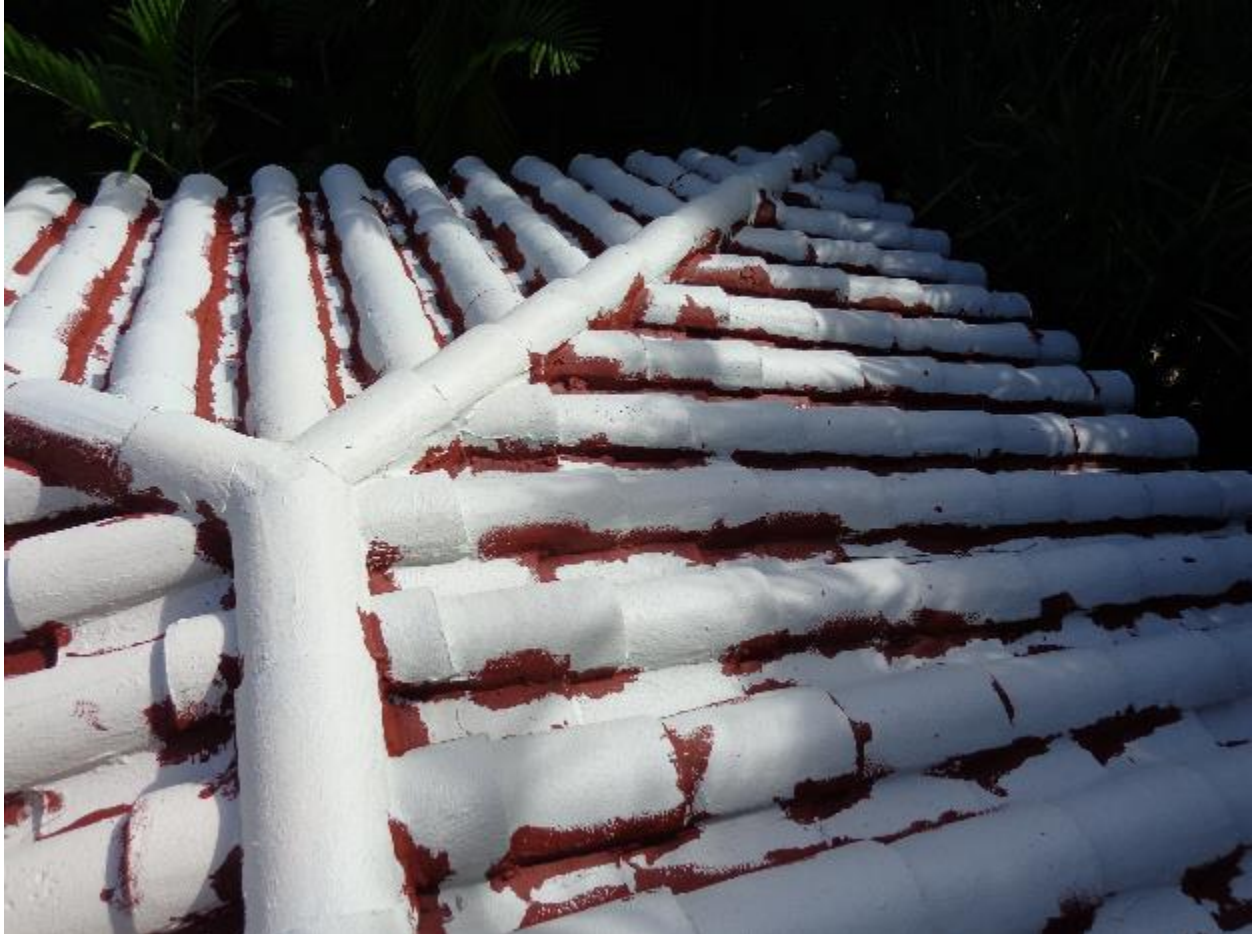
(Roof age unknown)

Roof was noted to be in general good condition and was properly sealed at time of inspection. No active leaks were noted inside home from the main roof.

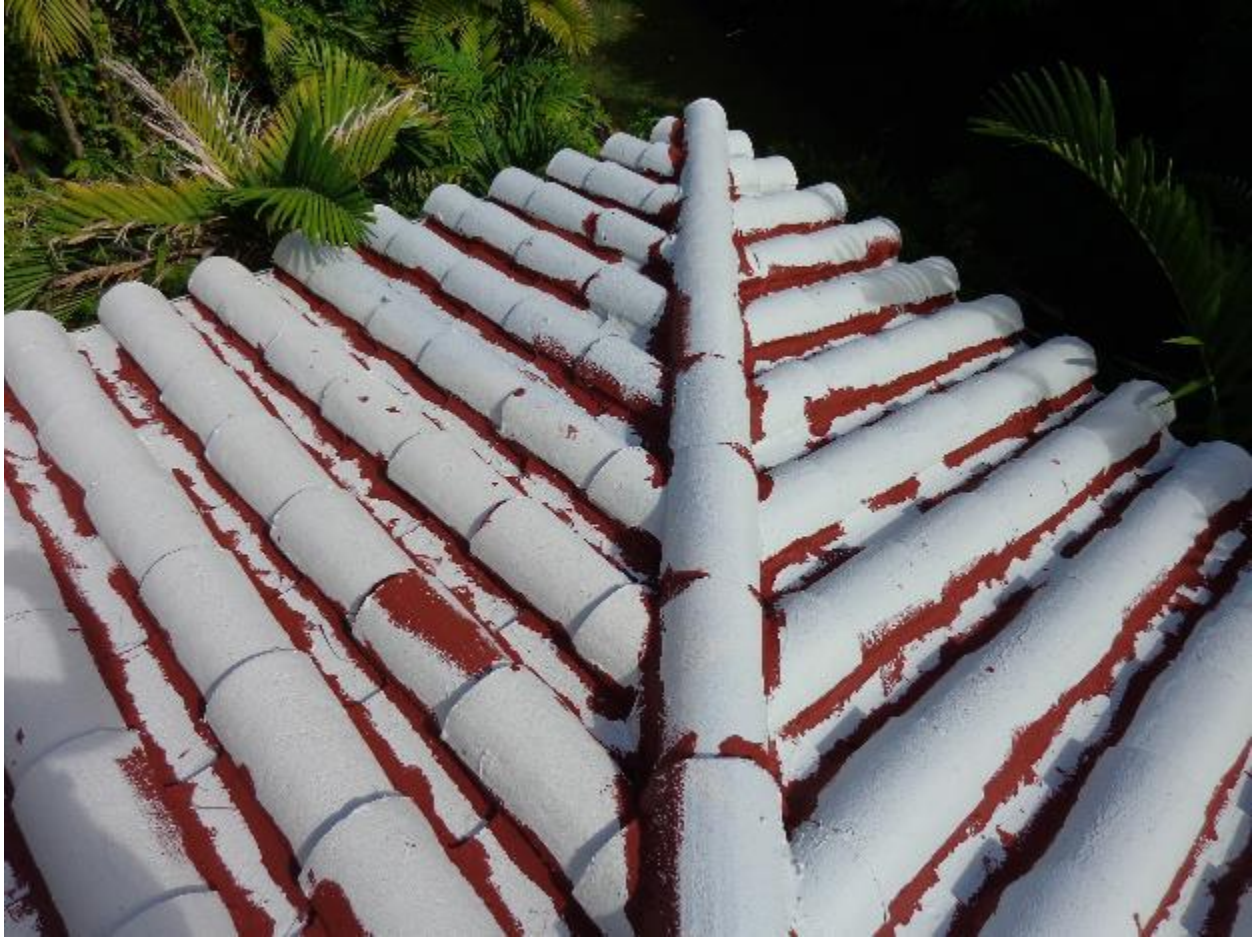
(Roof age unknown)

Roof was noted to be in general good condition and was properly sealed at time of inspection. No active leaks were noted inside home from the main roof.

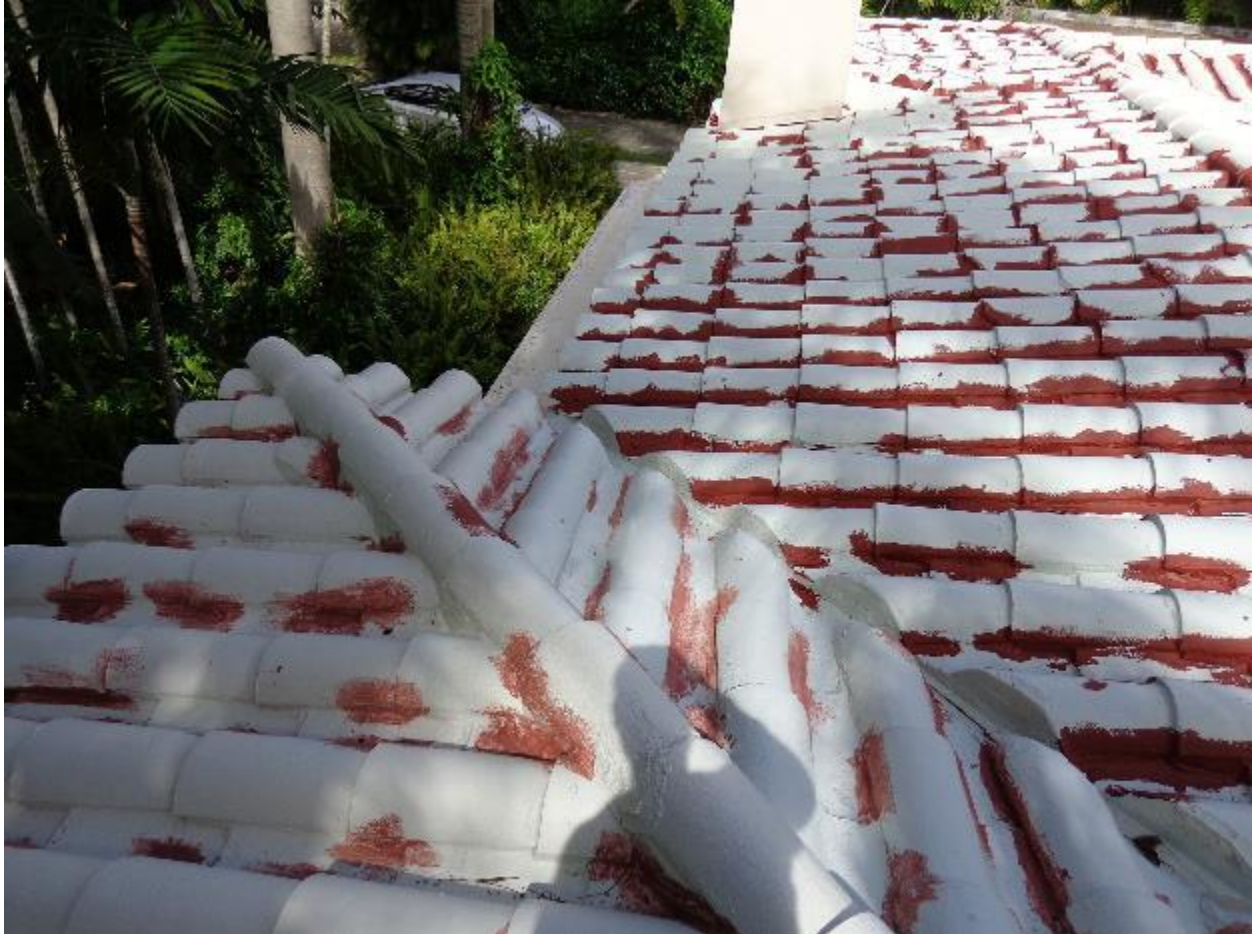
(Roof age unknown)

Roof was noted to be in general good condition and was properly sealed at time of inspection. No active leaks were noted inside home from the main roof.

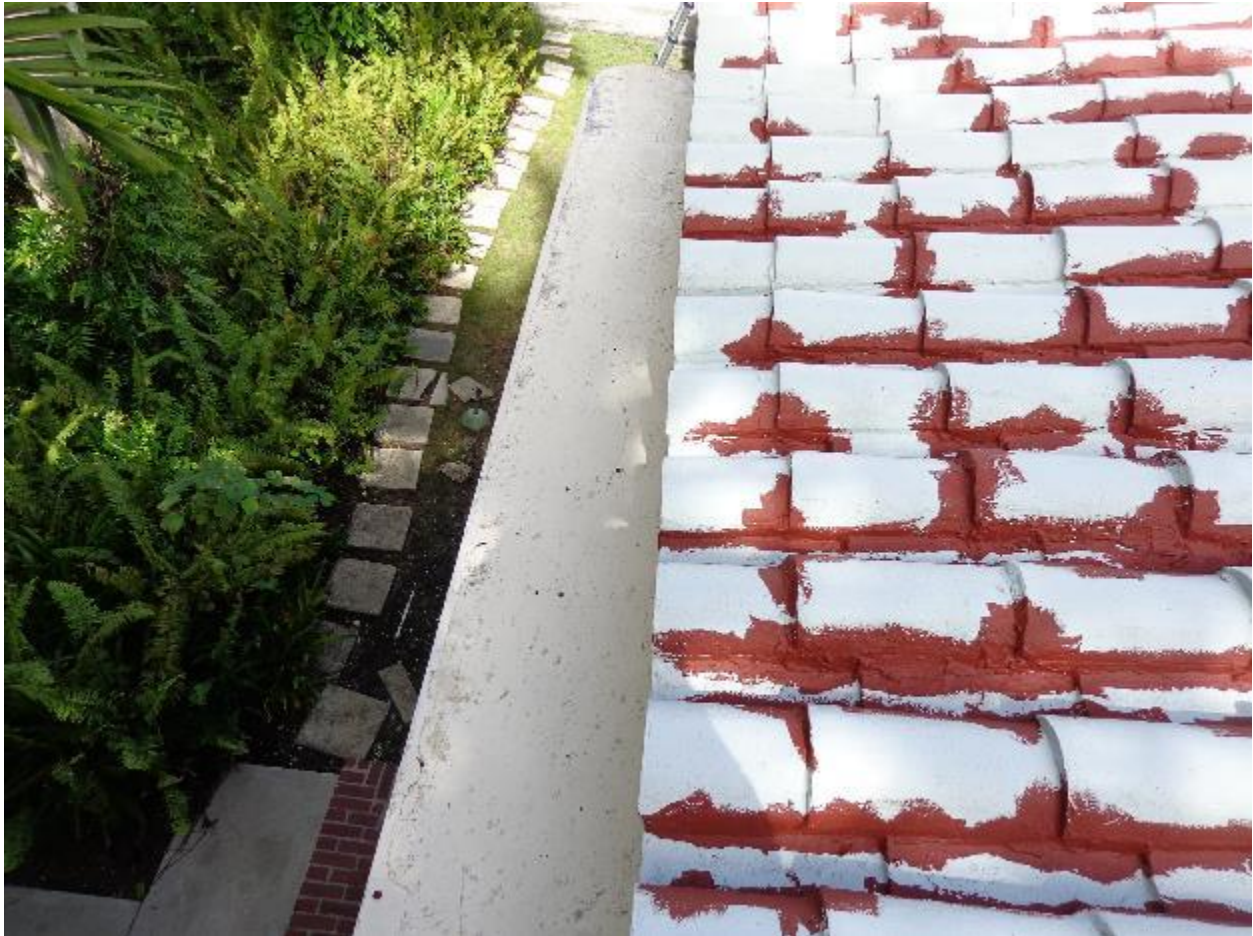
(Roof age unknown)

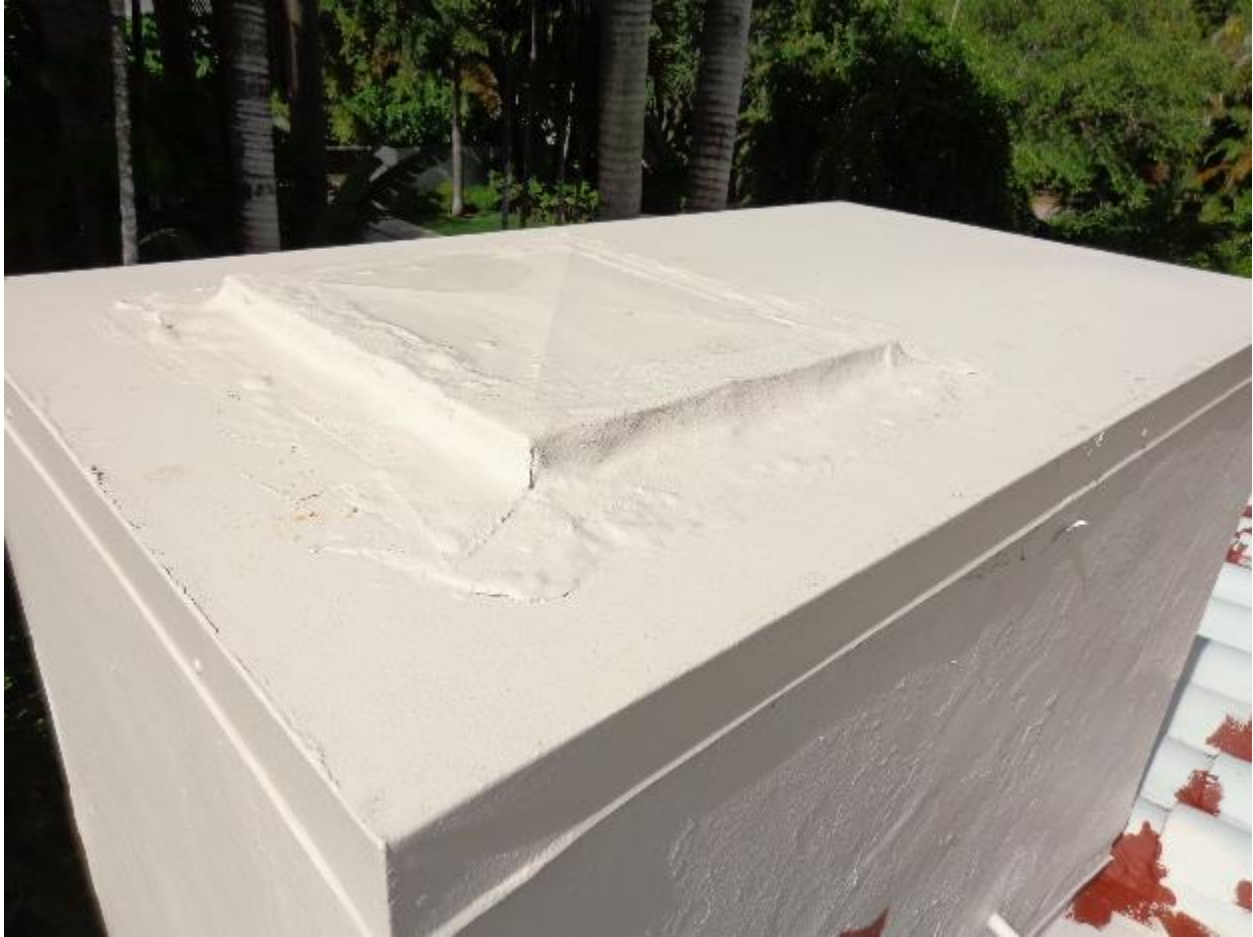
Chimney was noted to be properly capped.

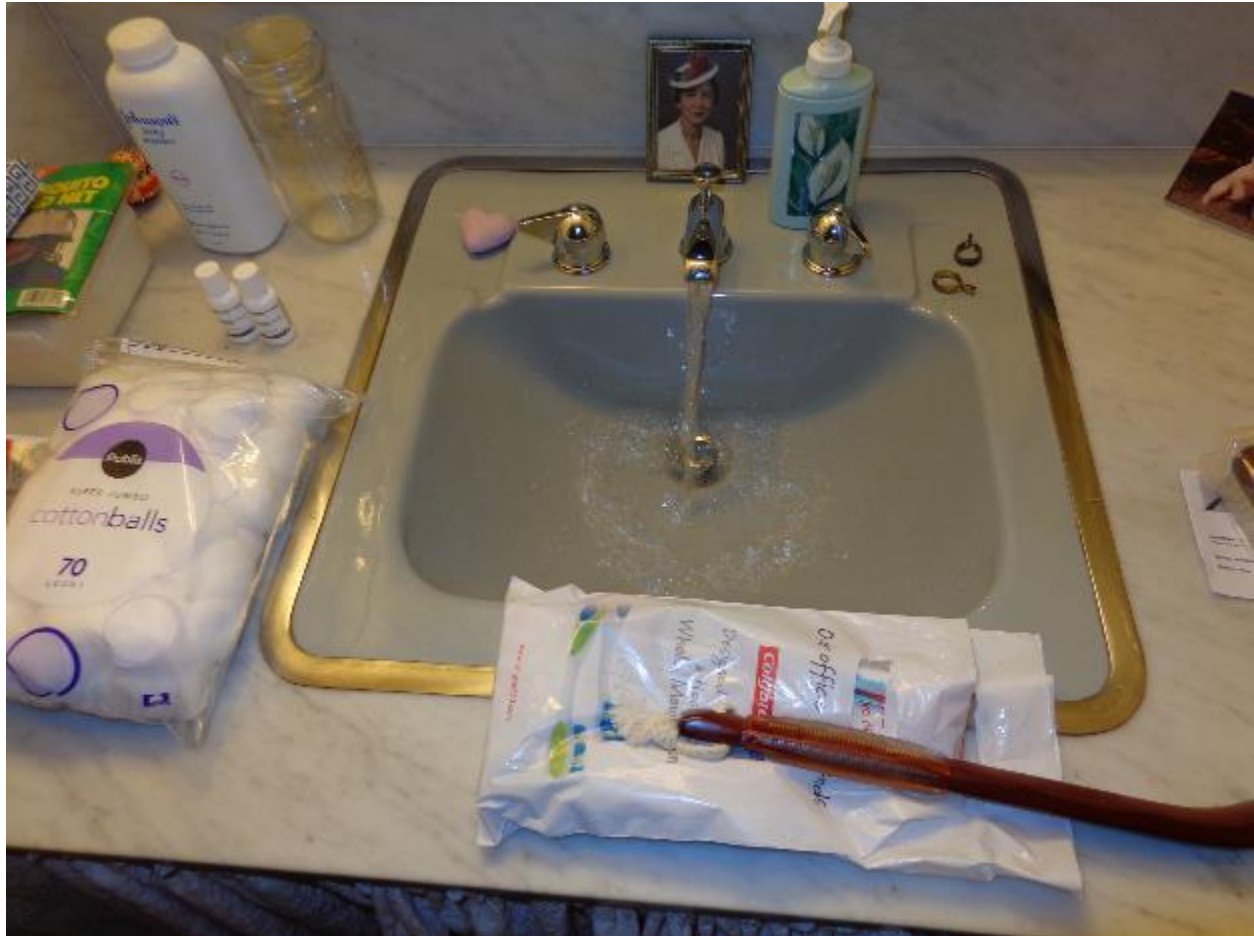
Deteriorated cast iron pipes will require a full upgrade replace with PVC.

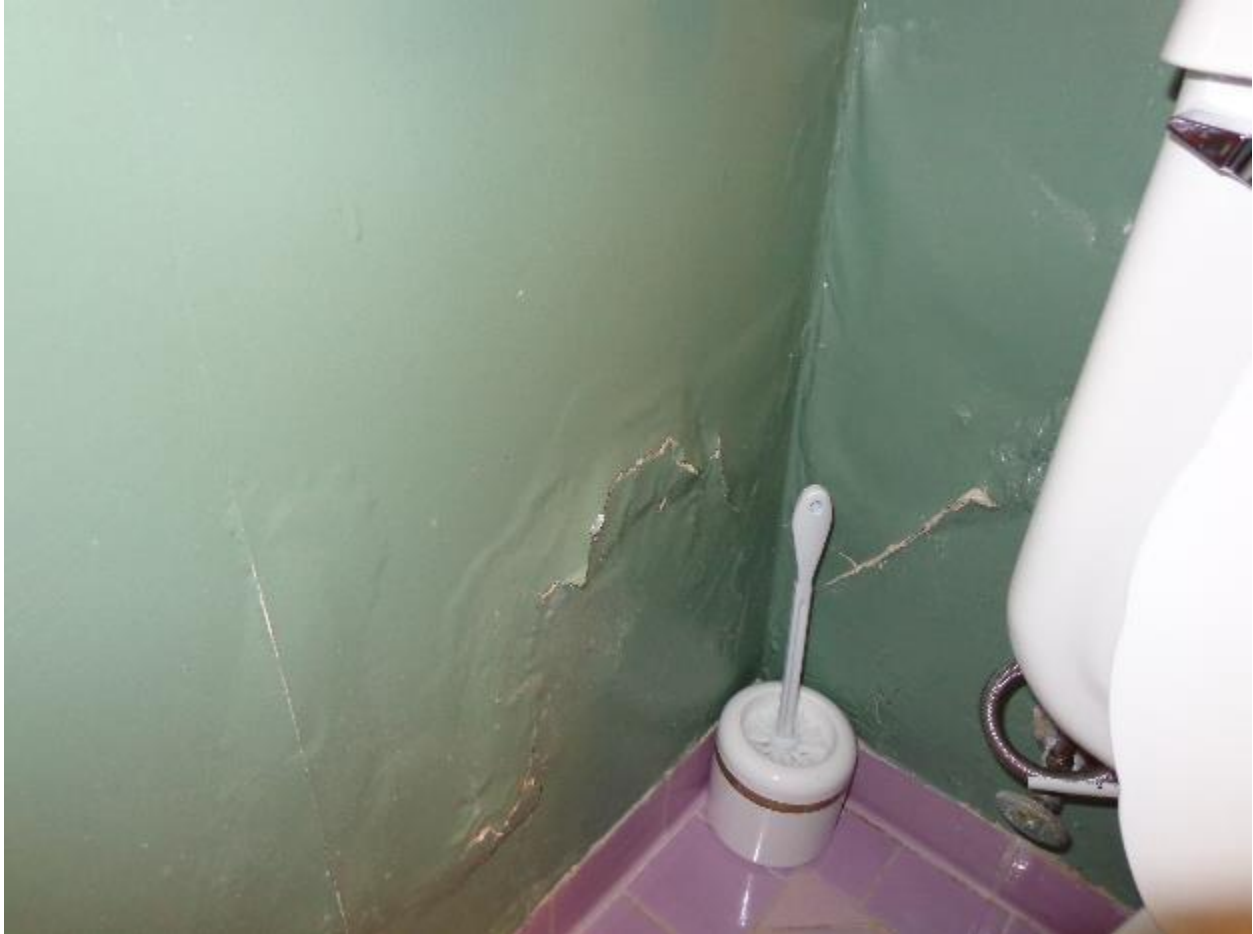
Previous water damage noted.

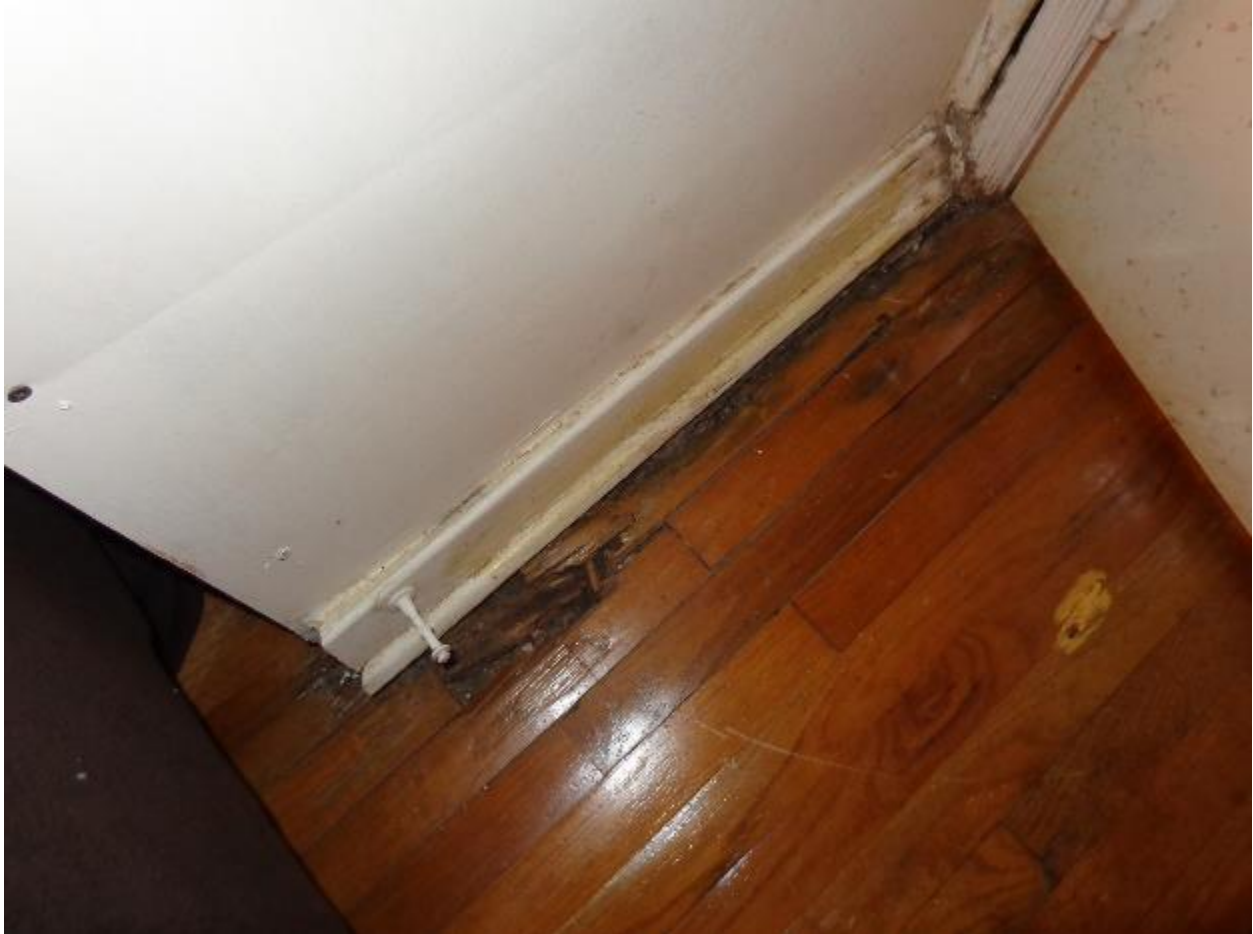
Previous water damage noted.

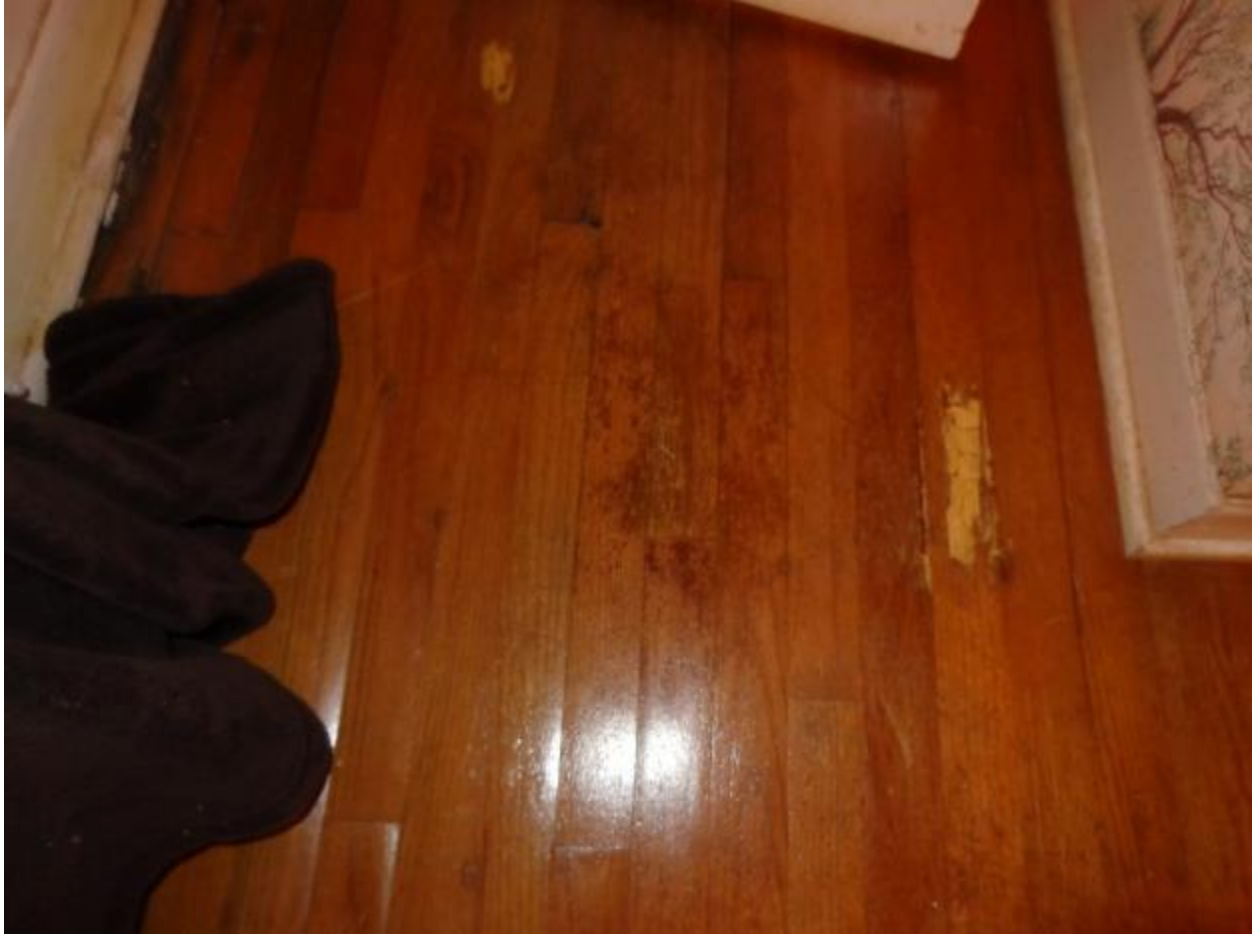
Previous water damage noted.

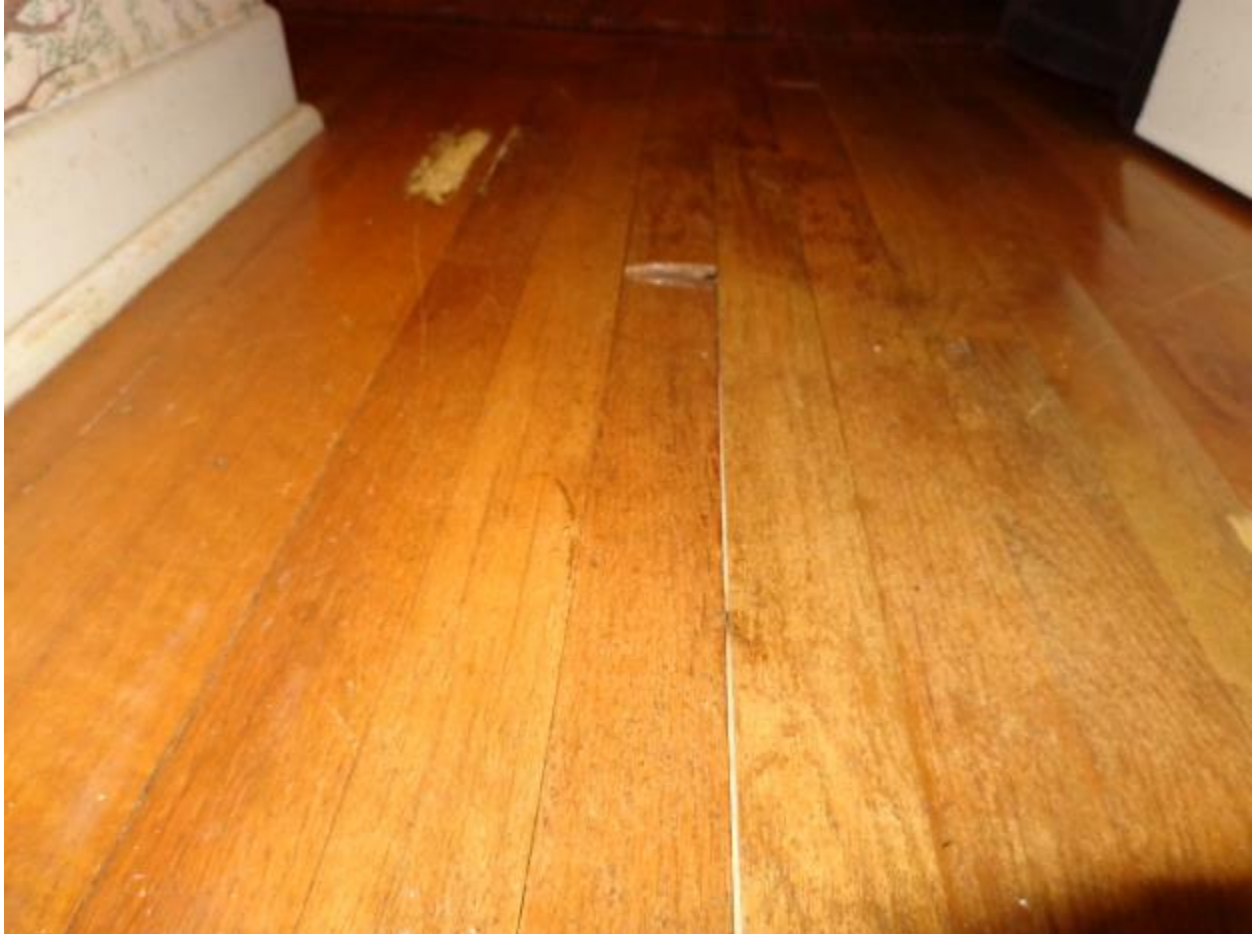
Previous water damage noted.

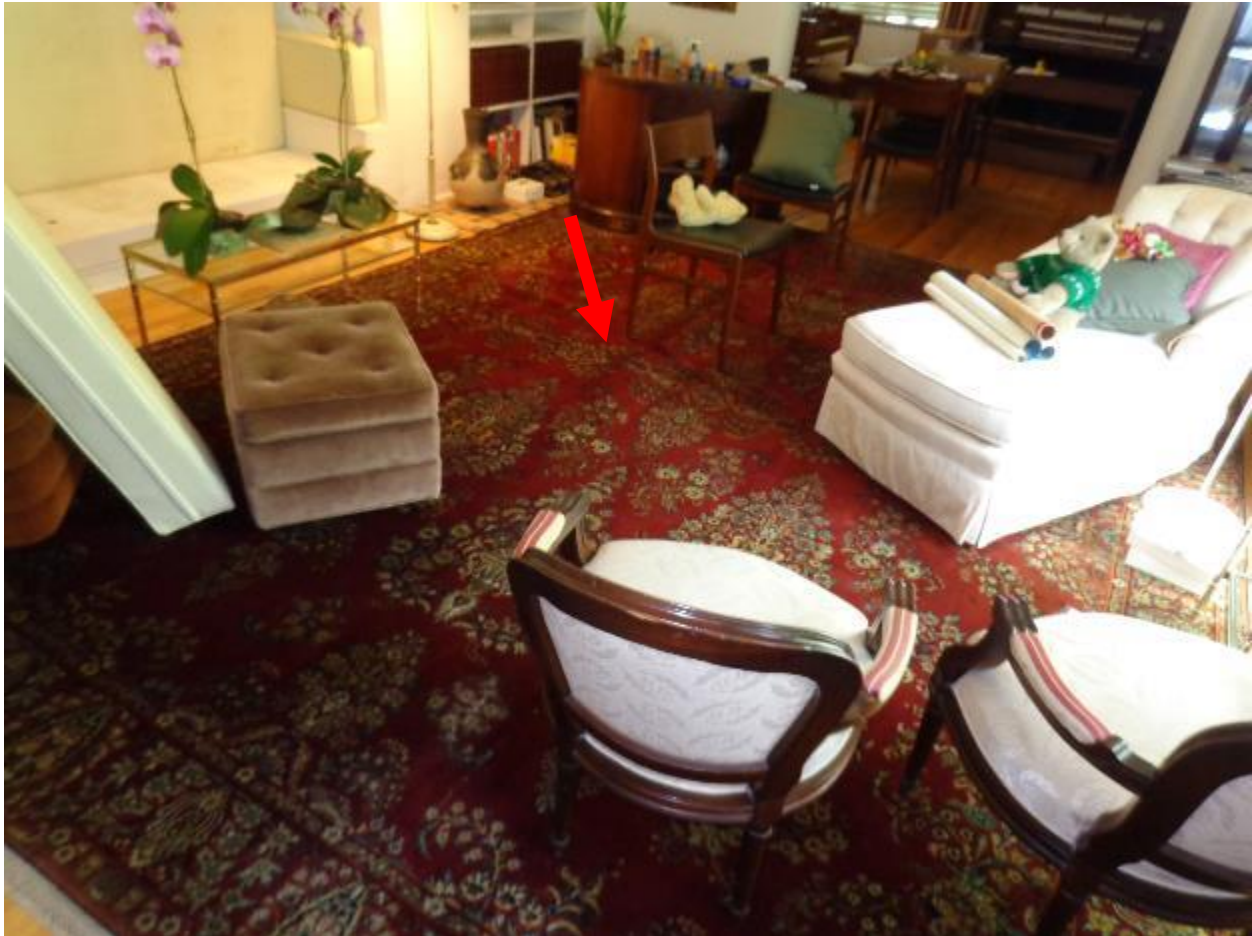
Previous water damage noted.

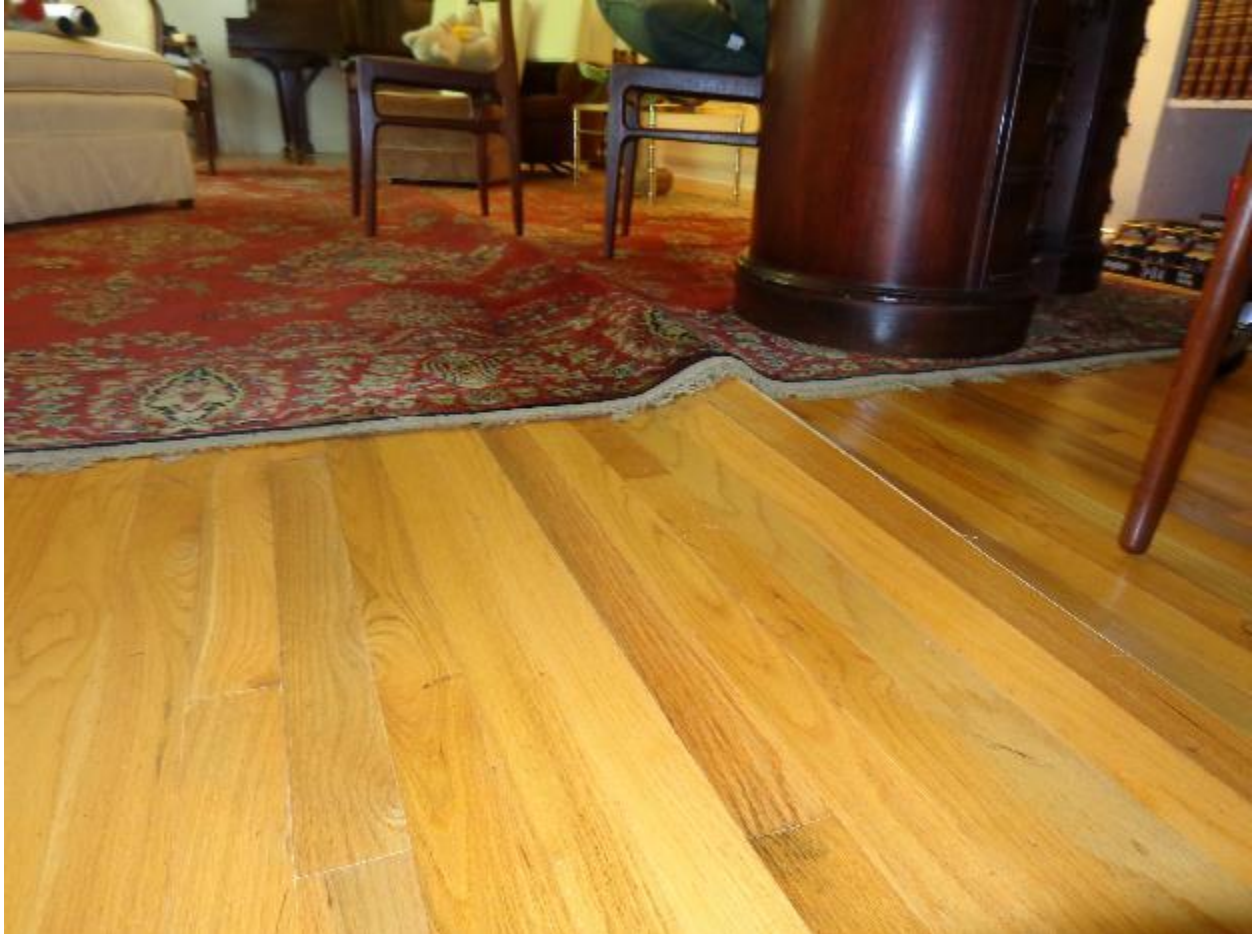
Previous water damage noted.

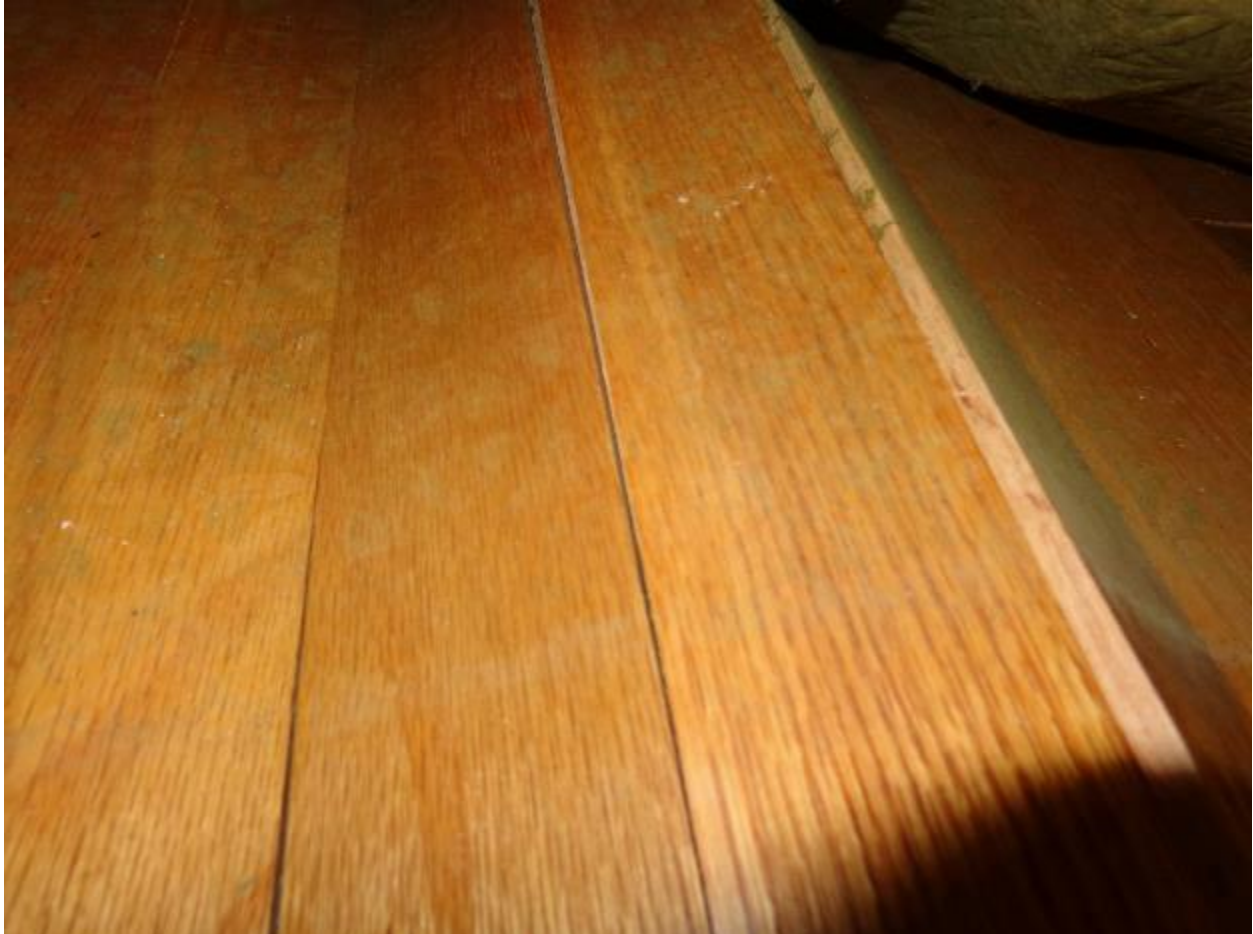
Previous water damage noted.

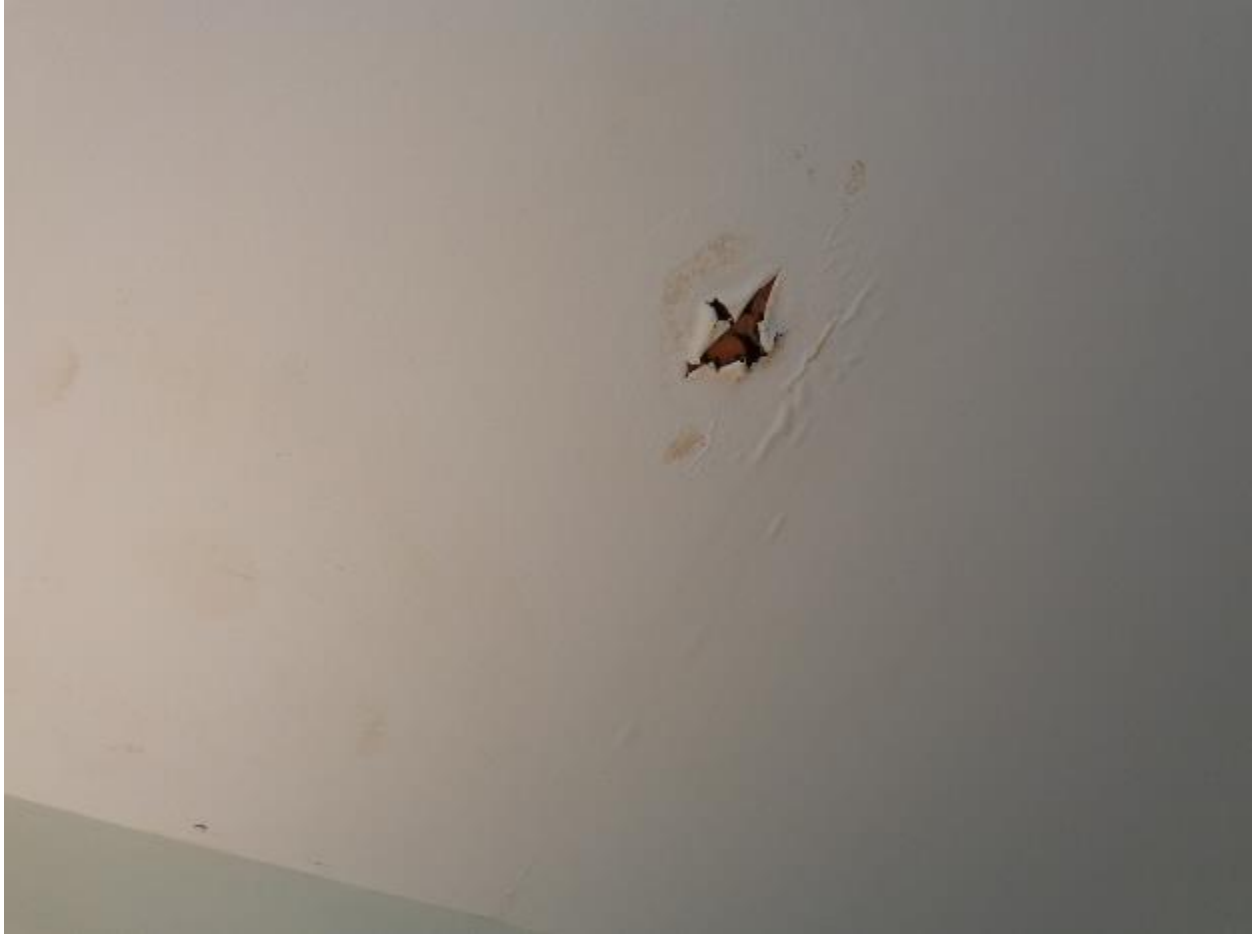
Signs of previous water infiltration due to roof failure noticed at the habitable space ceiling; allowances must be made for ceiling repair.

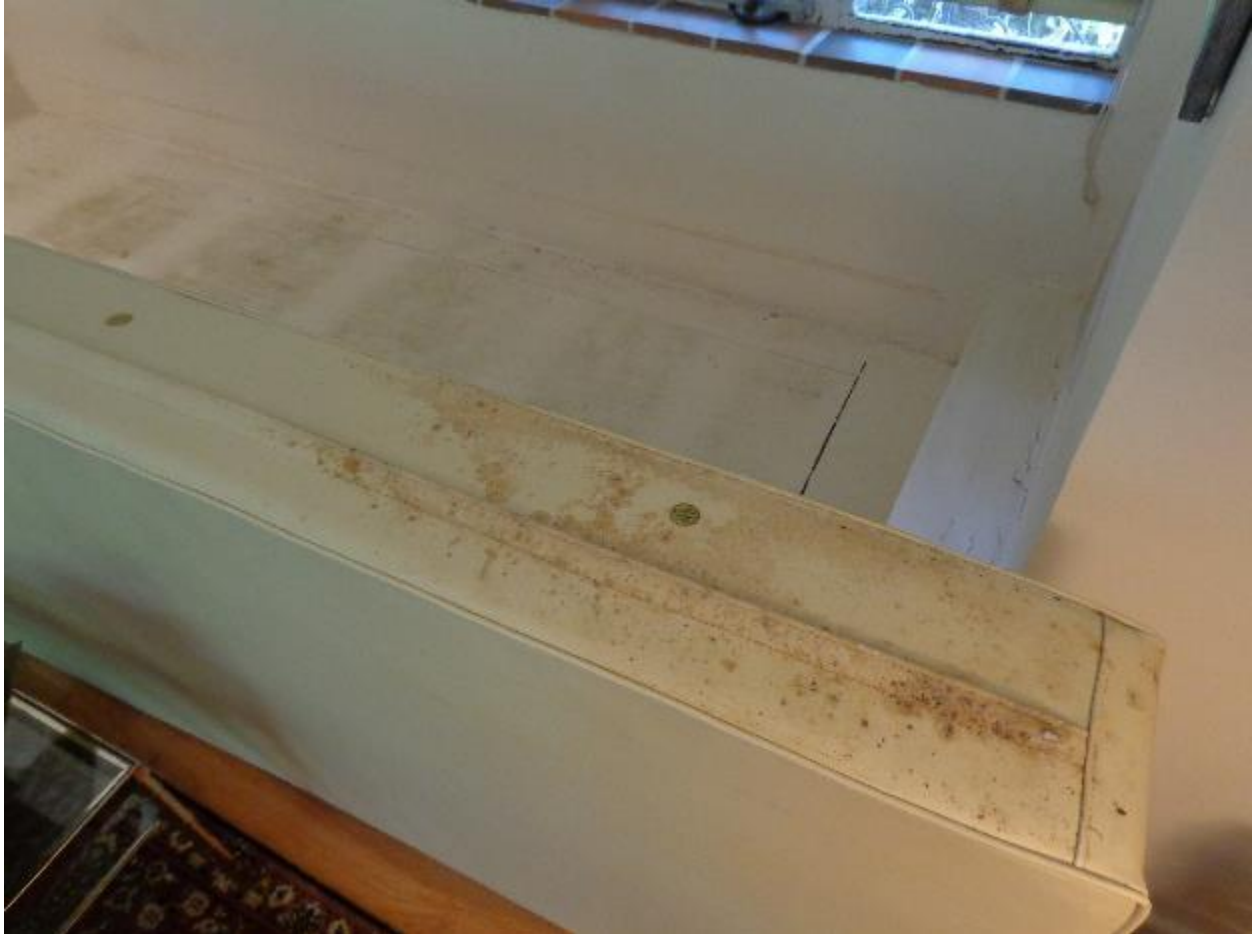
Mold growth caused by water damage is visible. Do not attempt to remove damaged surfaces related to Mold growth or with signs of mold growth on your own. Hire only licensed and Insured Mold remediation services.
