PROPERTY INSPECTION OR ASSESSMENT OF DAMAGES

ADDRESS: 229 Ridgewood Rd. Coral Gables, Fl.
CLIENT: Phil Padron
ID No: 2016417
DATE: 6/9/2016

PROPERTY INSPECTION –229 Ridgewood Rd Coral Gables, FL
ATTACHMENT - PHOTOGRAPHS
DATE: 06-09-2016

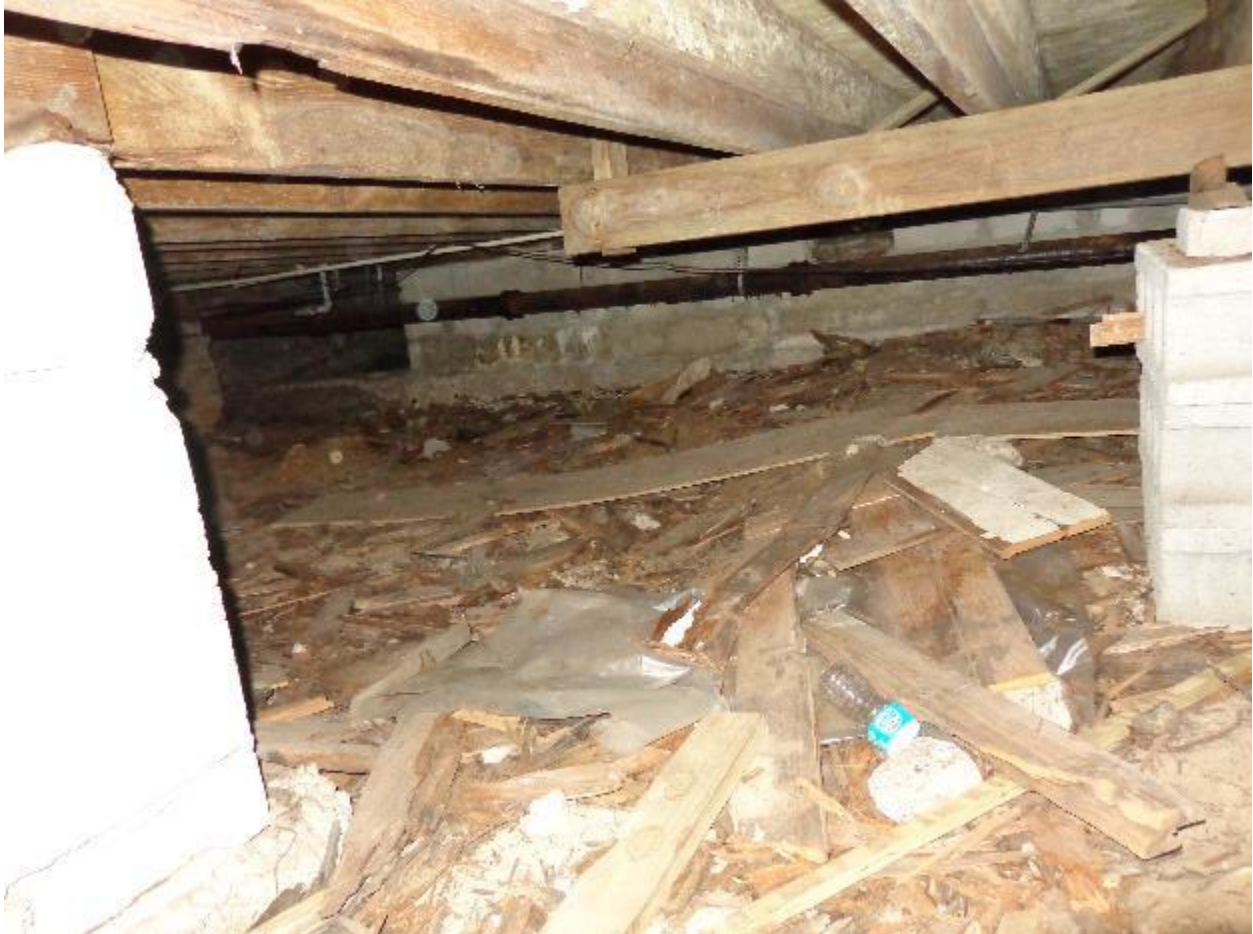
Wood structural joists not properly reinforced. Replacement or proper reinforcement of joists required.

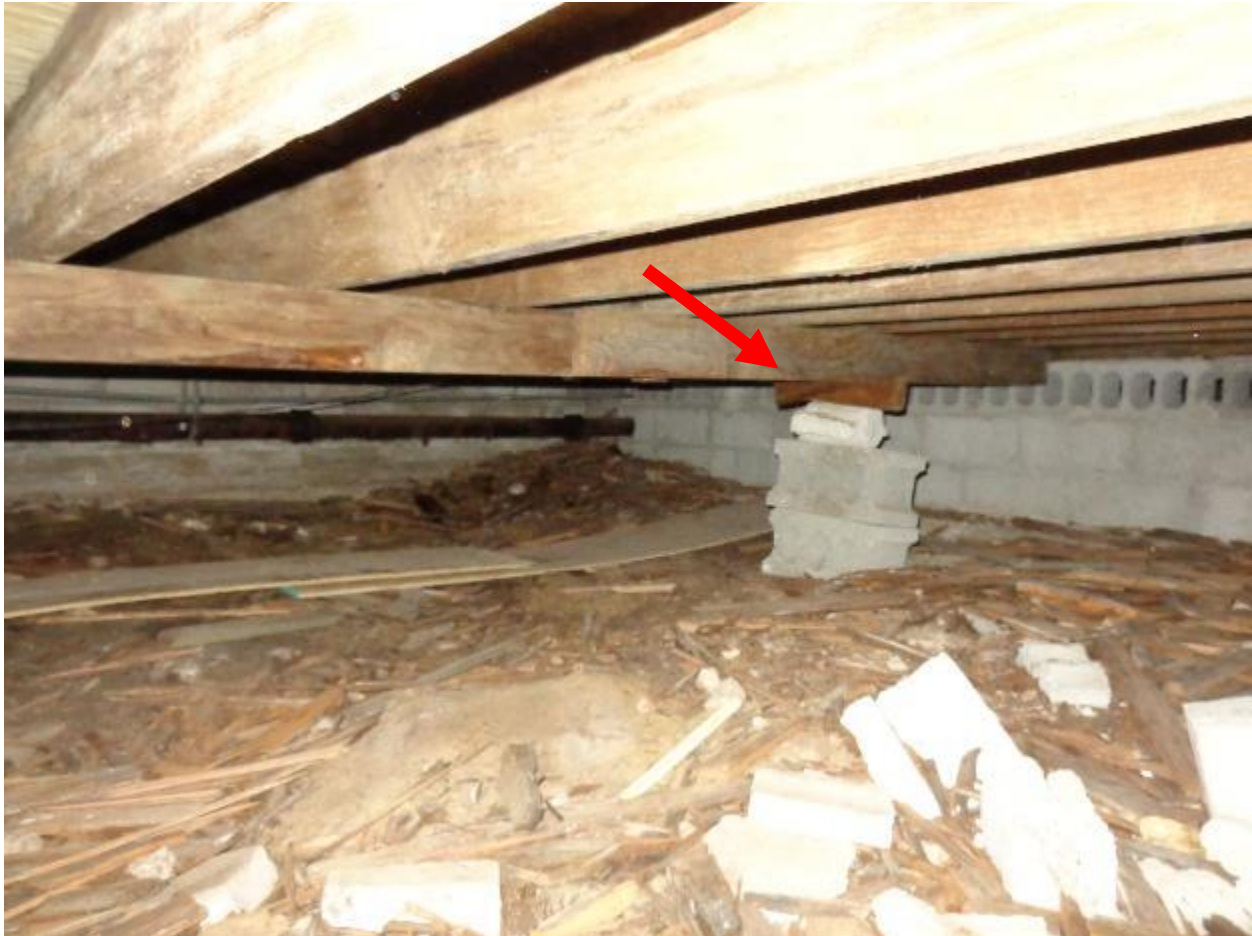
Wood structural joists not properly reinforced. Replacement or proper reinforcement of joists required.

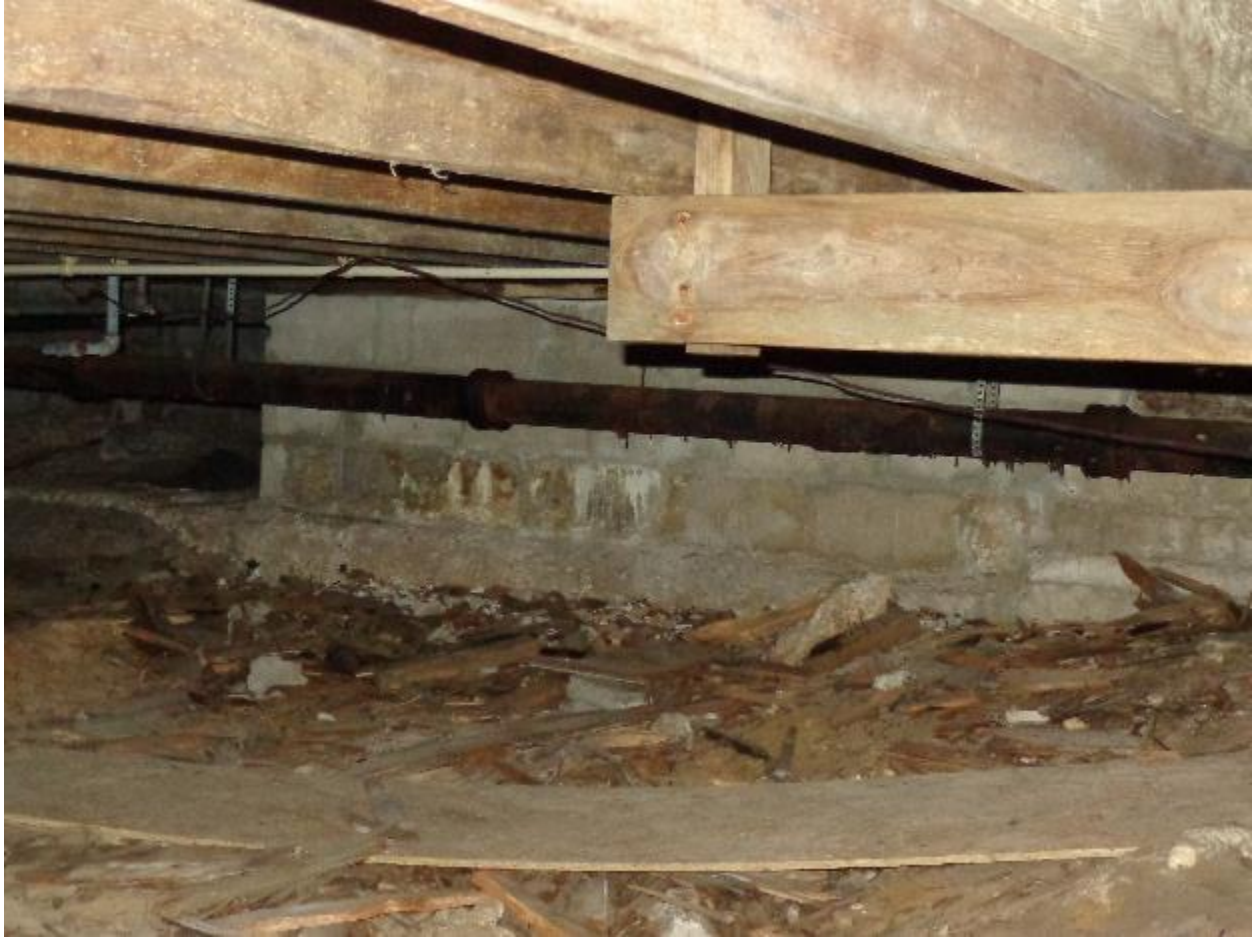
Deteriorated cast iron pipes will require a full upgrade replace with PVC.

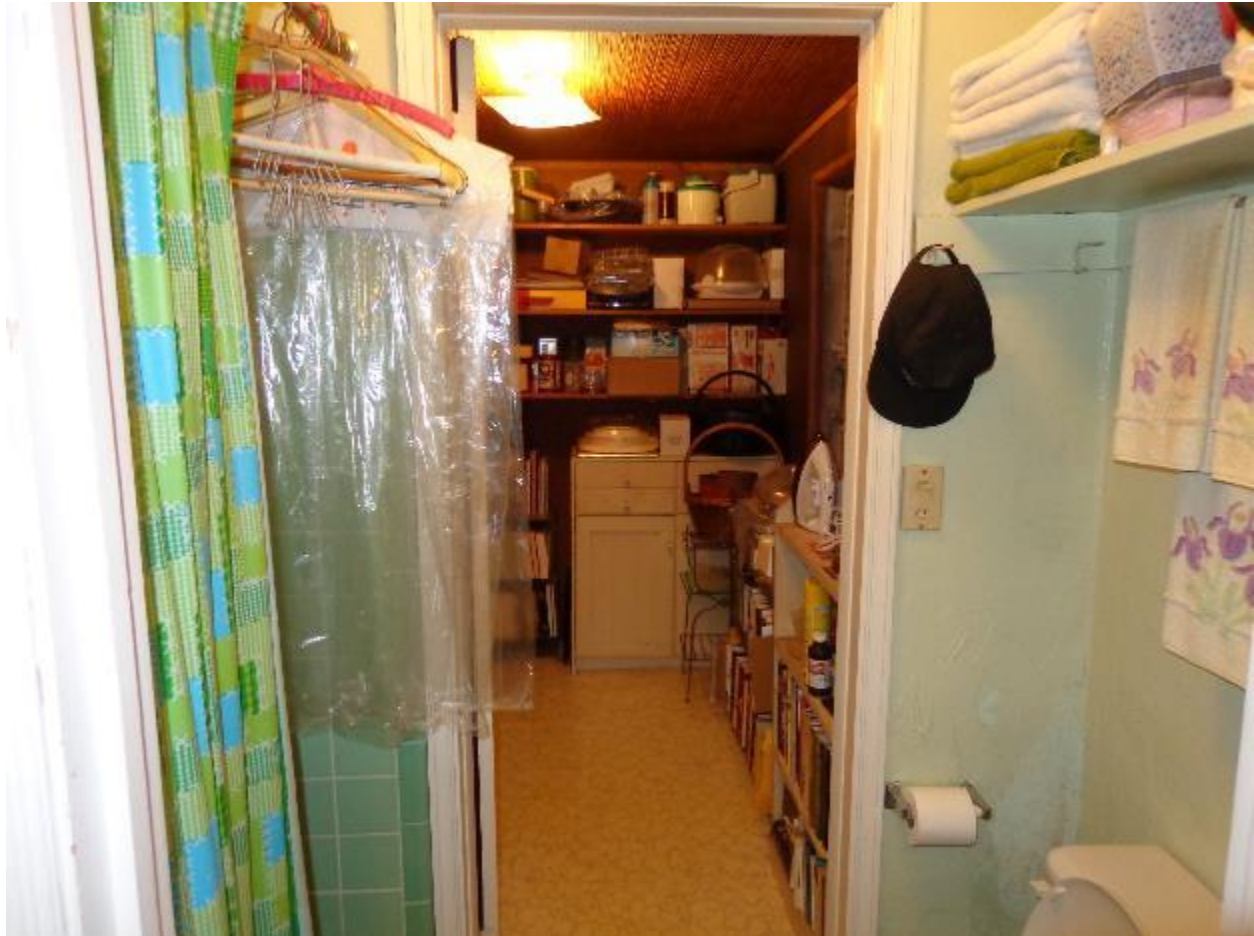
A complete rehabilitation of the interior is recommended. Plumbing, electrical and Ac systems require replacement or repairs.

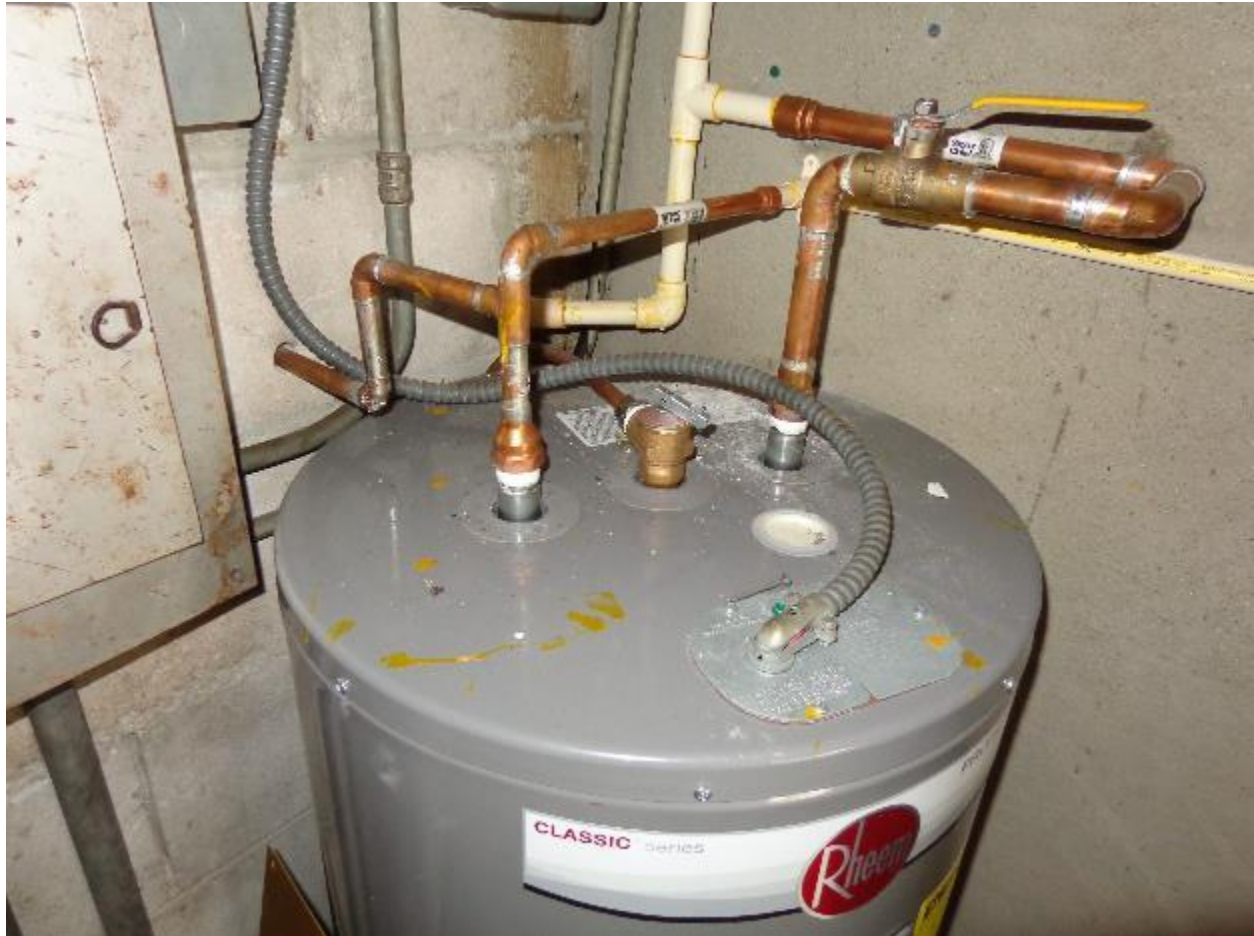
Water heater in good working condition at time of inspection.

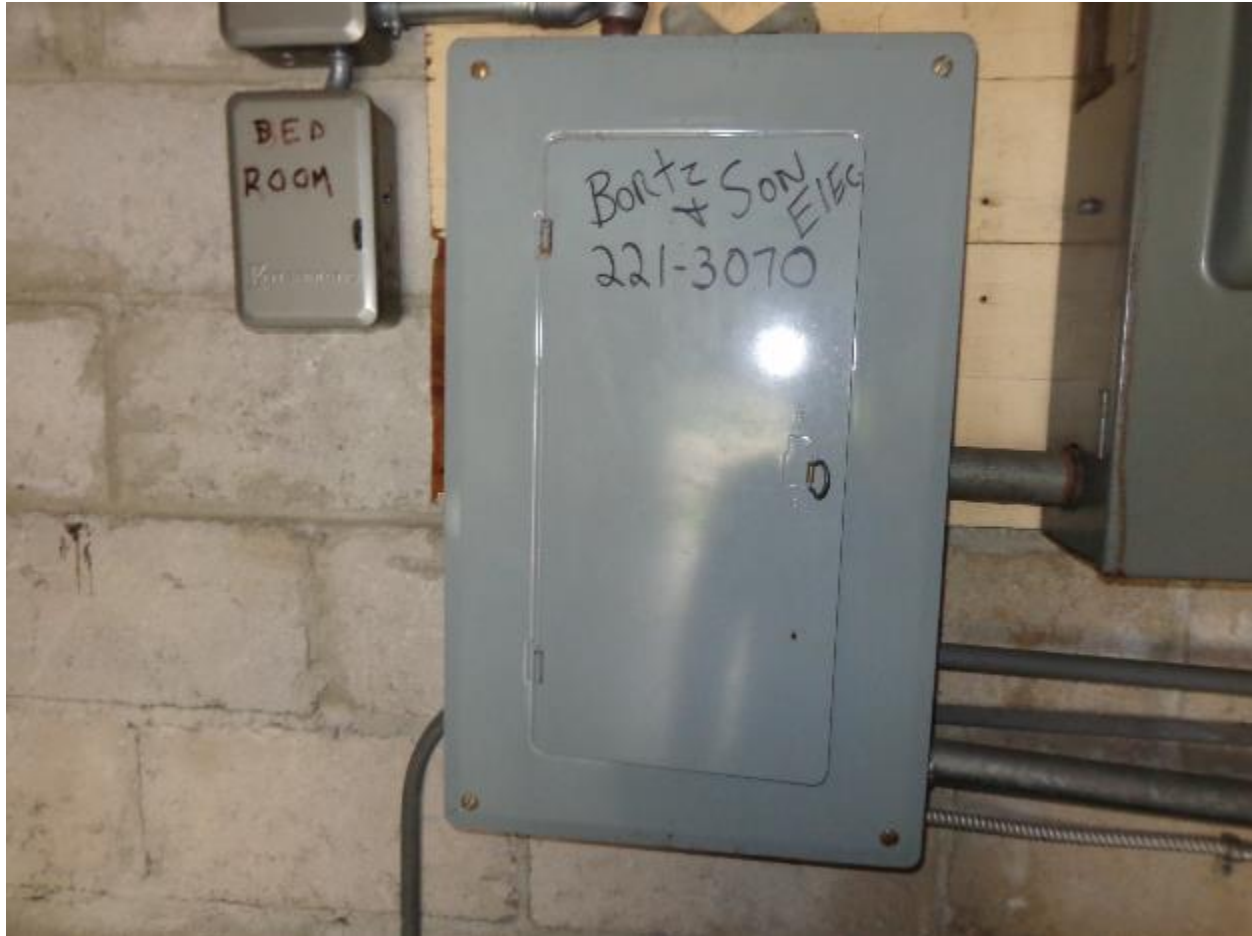
Electrical breaker panel in good condition at the time of inspection.

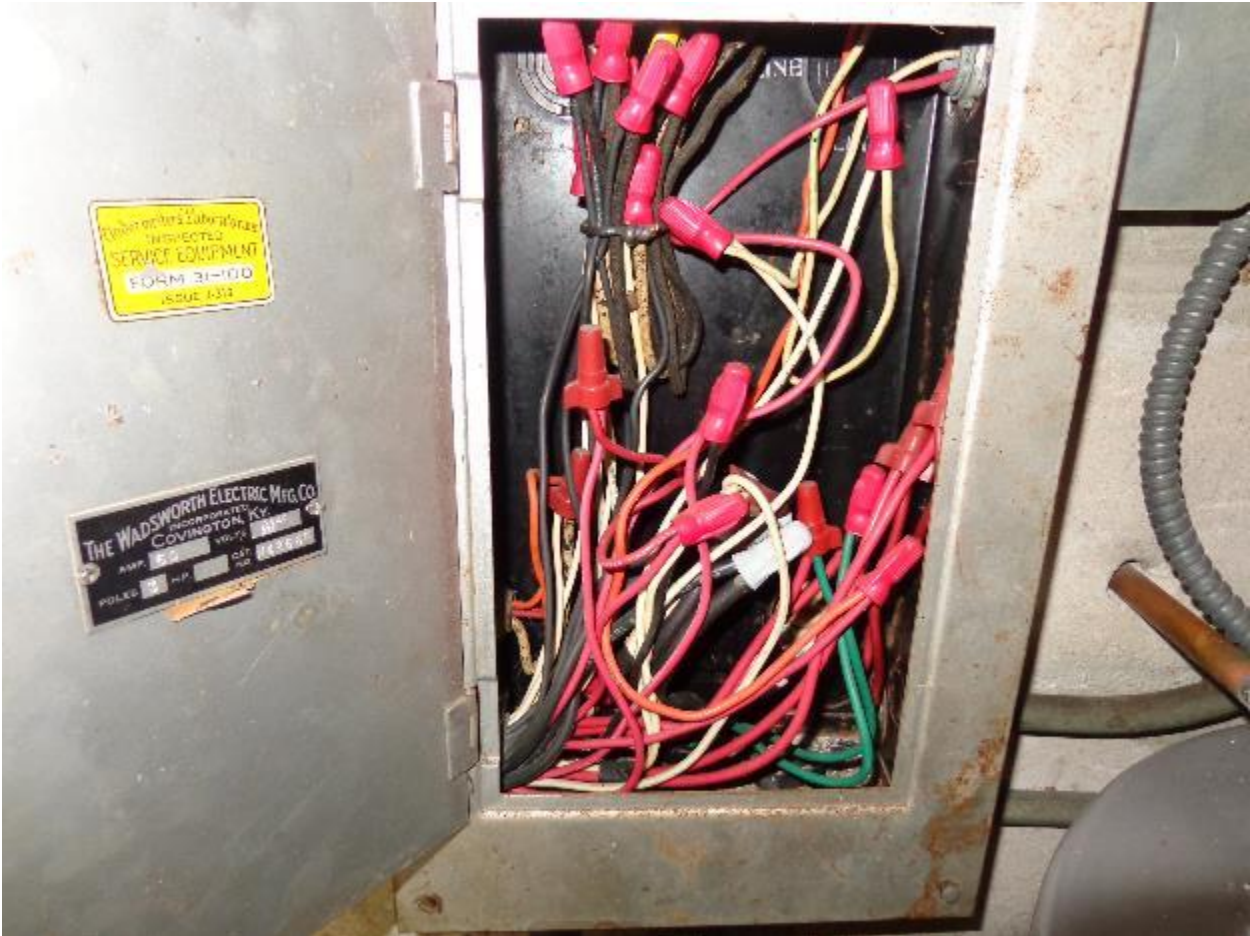
Junction box was found to be in general good condition.
