RE: 935 Catalonia Ave, Apt. 8, Coral Gables, FL 33134
SUBJECT: Report of Limited Moisture and Mold Assessment
RESULTS: Elevated Mold Growth Identified; Remediation Recommended

Thank you for this opportunity to serve you. We inspected the subject building on February 11, 2024, at 3:30 PM. The subject structure is a one-story apartment, approximately 700 square feet, originally built in 1926.

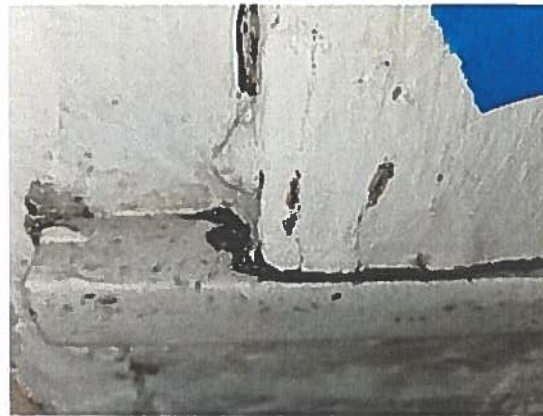
Damage And Mold Growth

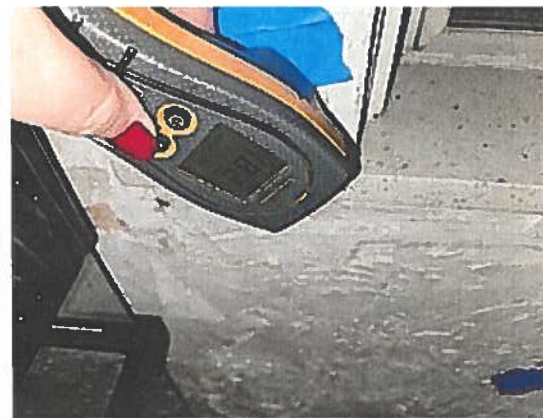
Elevated Moisture Content Detected with A Moisture Meter

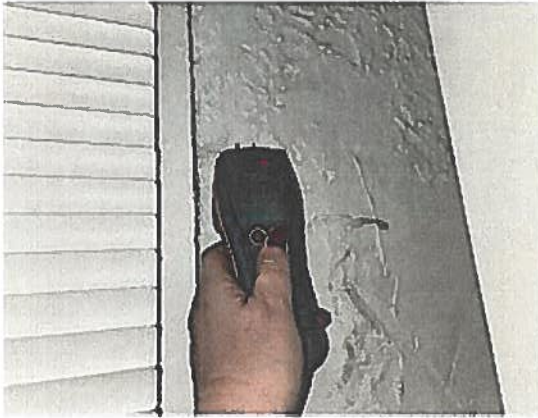
**Elevated Moisture Content Detected with A
Moisture Meter**

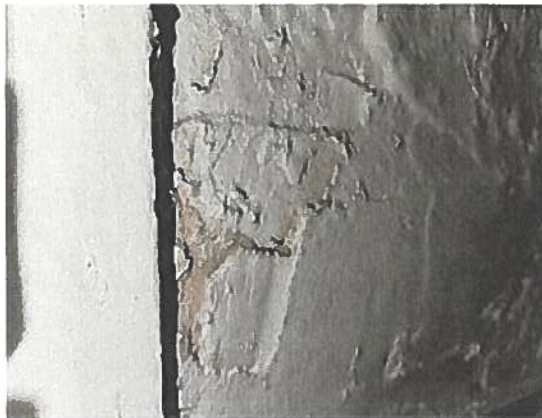
Visible Moisture Stains

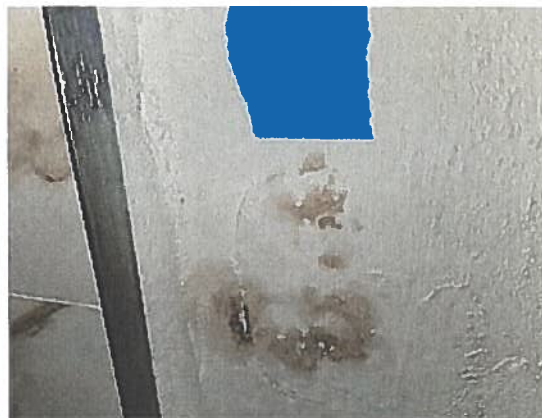
Visible Mold Growth

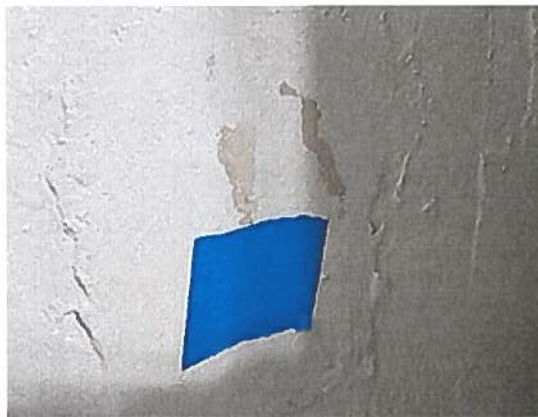
Visible Mold Growth

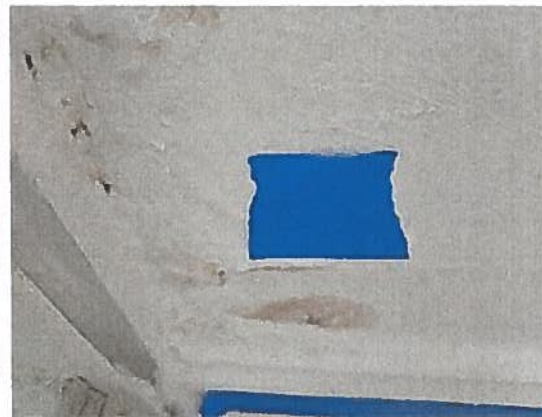
Damage And Mold Growth

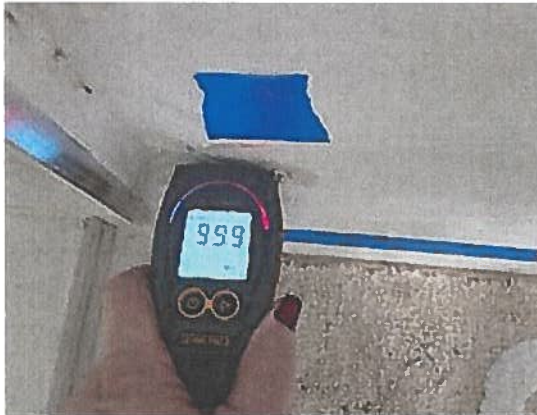
Elevated Moisture Content Detected with A Moisture Meter

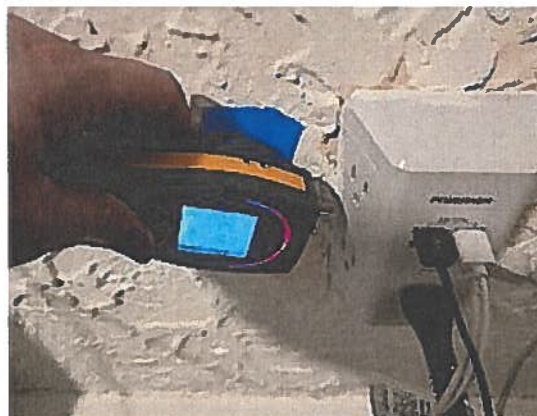
Elevated Moisture Content Detected with A Moisture Meter

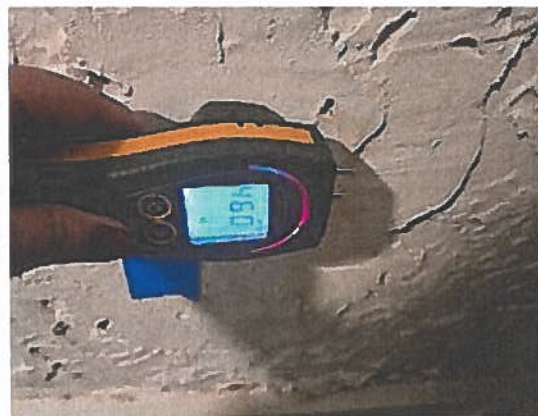
Elevated Moisture Content Detected with A Moisture Meter

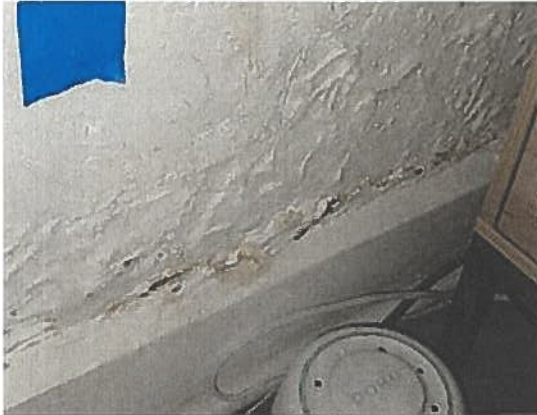
Moisture Stains Noted on Base Wall
