OFFICE OF THE PROPERTY APPRAISER

Summary Report

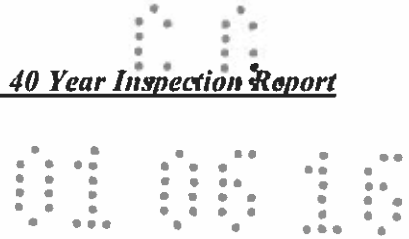
During the inspection, concrete was sounded for delamination, indication of corrosion and other signs of deterioration. No destructive testing was conducted. All common areas were inspected. The structure was inspected at the interior of the Mechanical and Electrical rooms, penthouses and stair cores. Six Units – 219, 407, 416, 619, 1203 and PH – were inspected for balcony inspections.

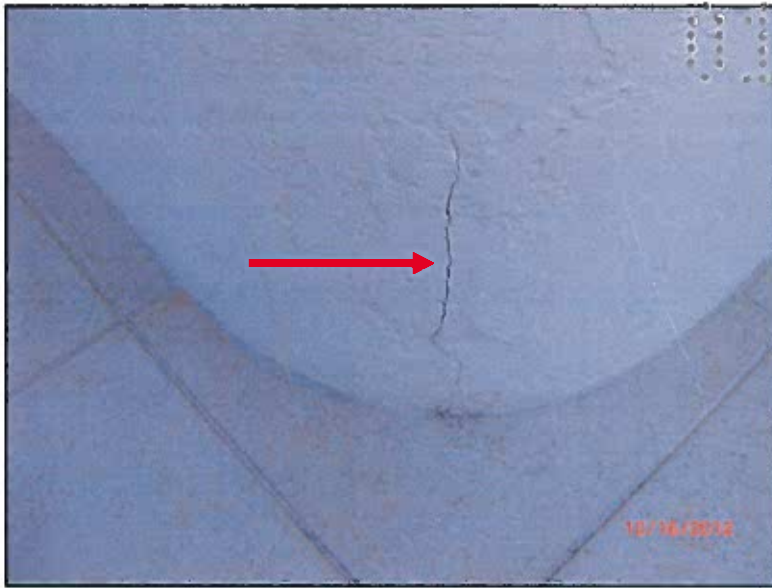
PHOTO # 1: Vertical cracking on building wall located at balcony Unit #219

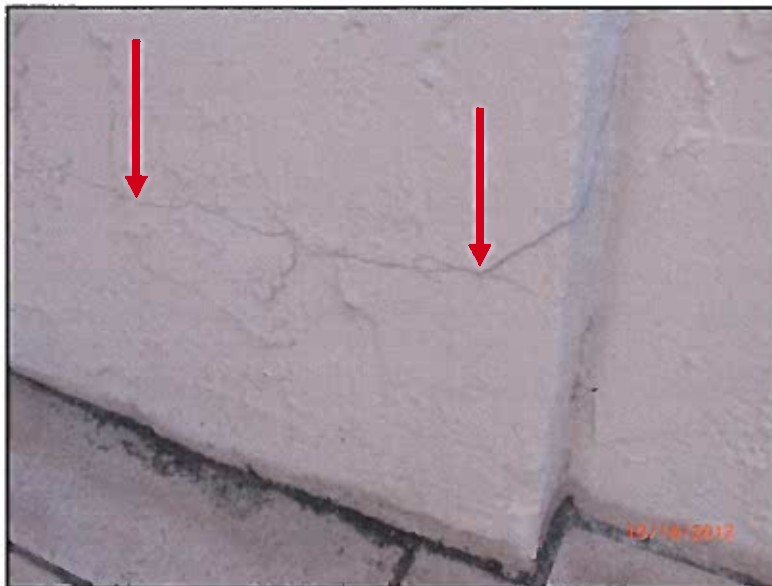
PHOTO # 2: Horizontal cracking/delaminated stucco at balcony wall Unit #219

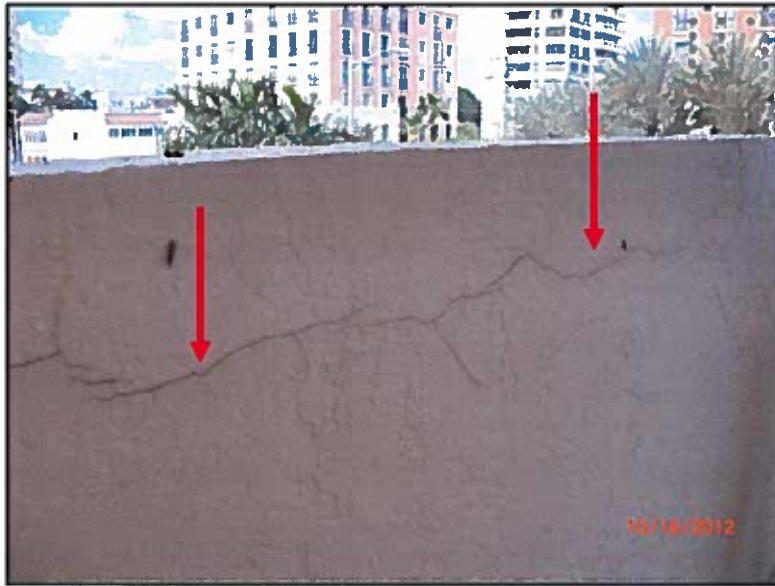
PHOTO # 3: Horizontal cracking on balcony block wall concrete cap at Unit #219

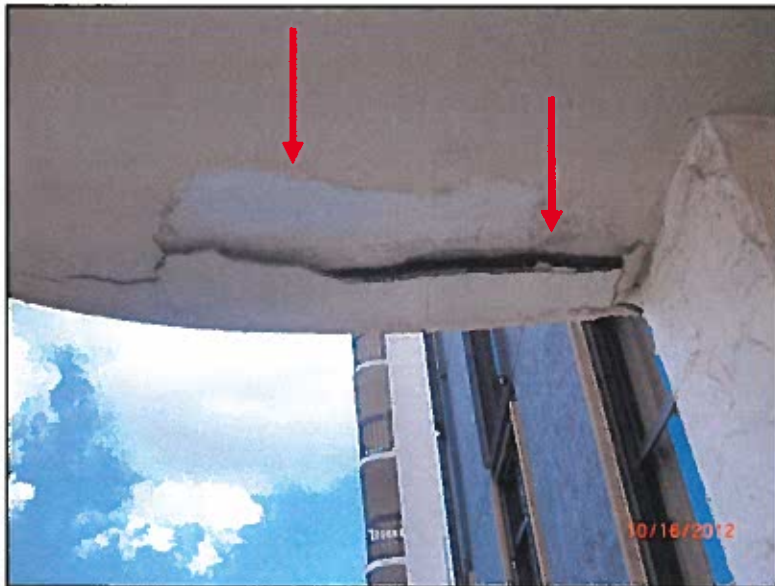
PHOTO # 4: Concrete spalling/exposed steel rebar at balcony ceiling at Unit #219

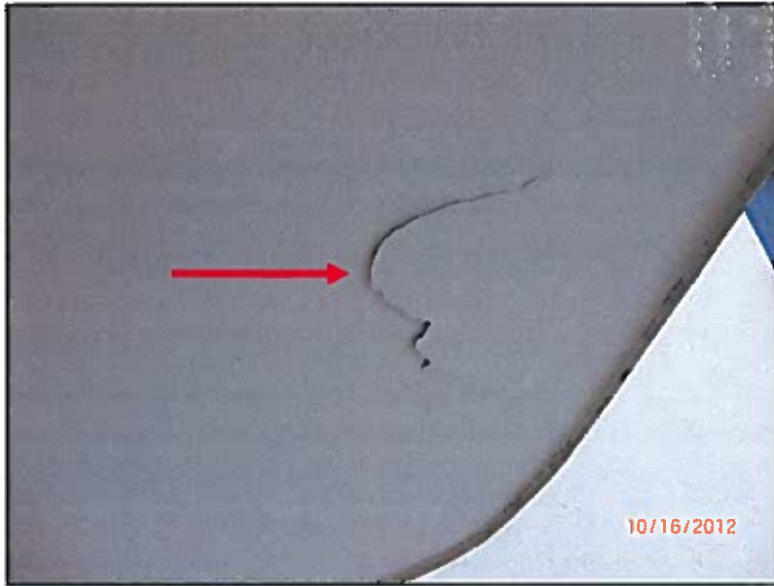
PHOTO # 5: Concrete spalling at balcony ceiling at Unit #416

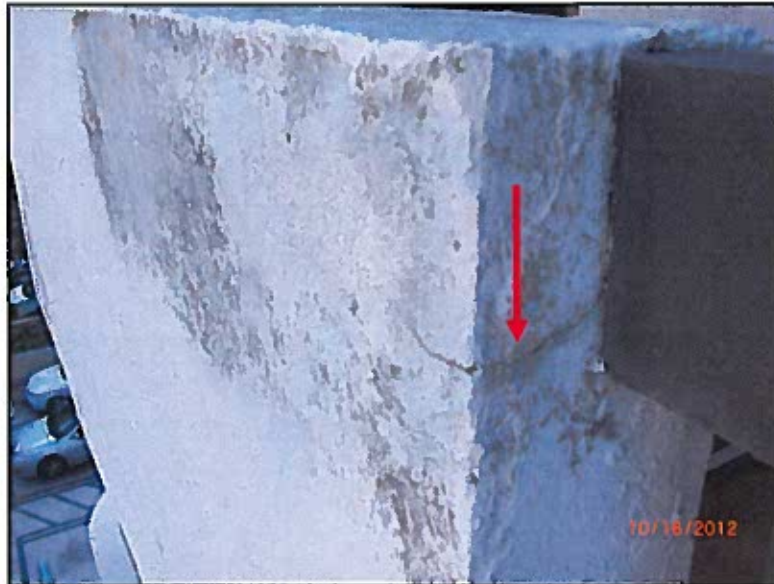
PHOTO # 6: Cracking stucco at balcony railing connection at Unit #407

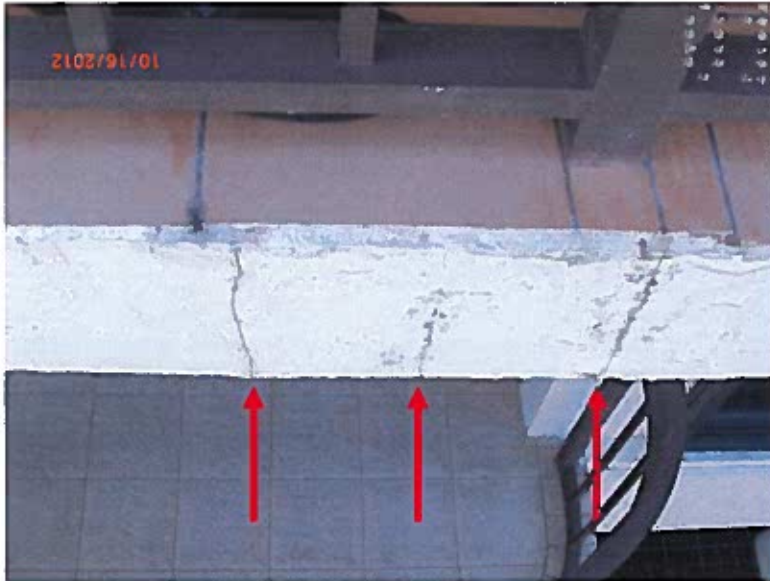
PHOTO # 7: Cracking/delaminated stucco on balcony slab edge at Unit #407

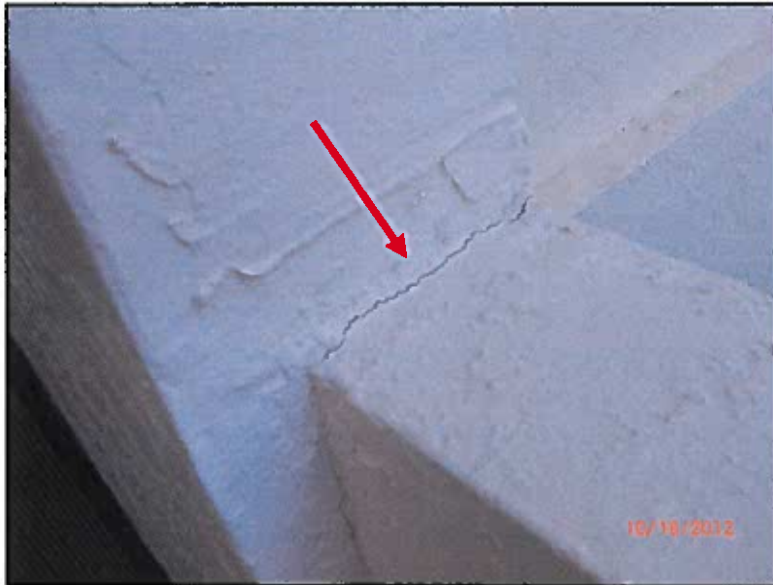
PHOTO # 8: Cracking at connection between balcony wall and bldg. column at Unit #219

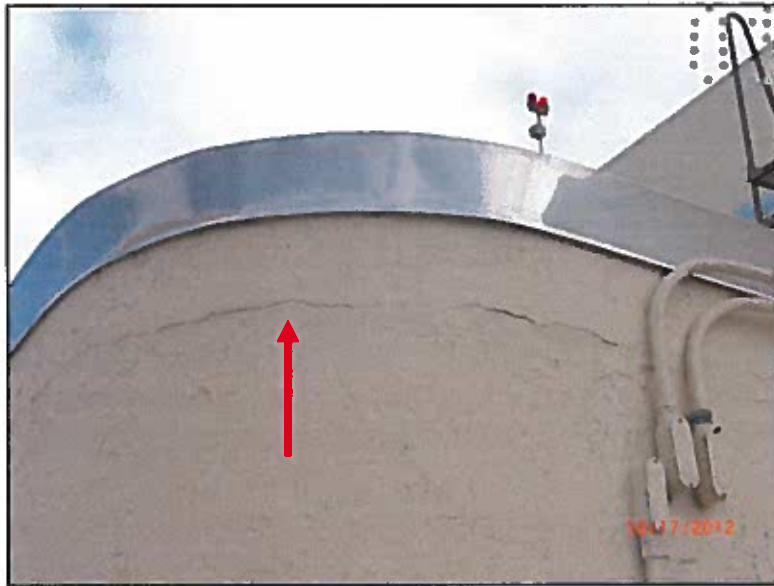
PHOTO # 9: Delaminated/cracking stucco at exterior of Generator Room at roof area

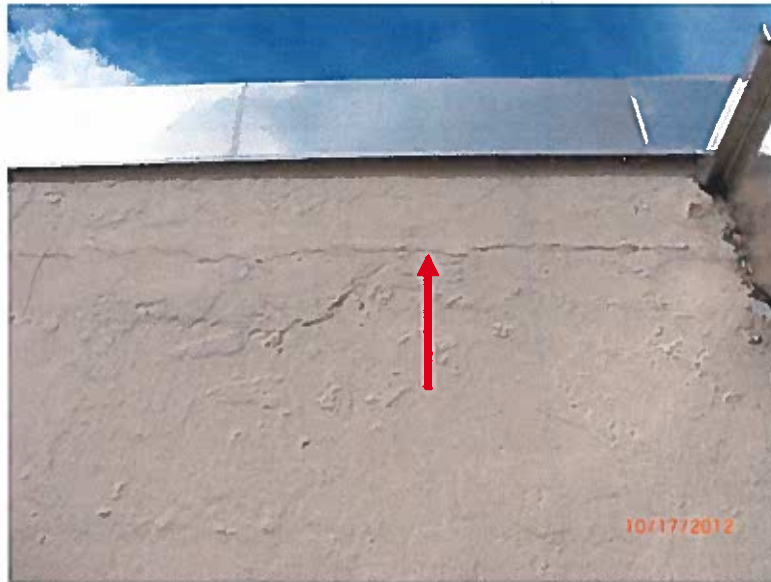
PHOTO # 10: Delaminated/cracking stucco at exterior of east Elevator Machine Room at Roof Area

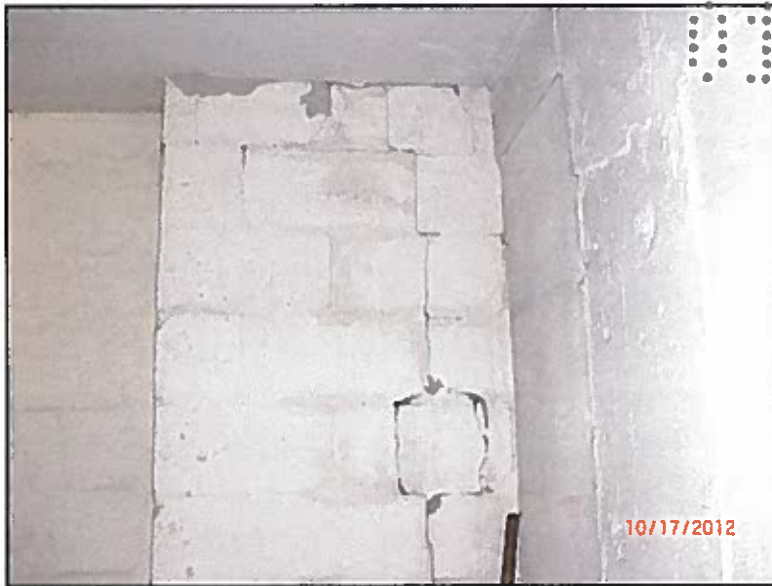
PHOTO # 11: Step cracking at corners of east side Elevator Machine Room

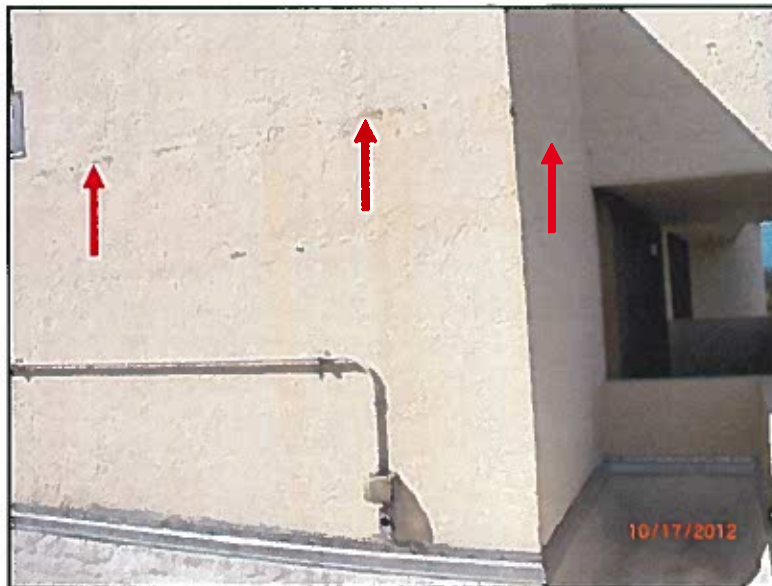
PHOTO # 12: Horizontal cracking at PH exterior wall

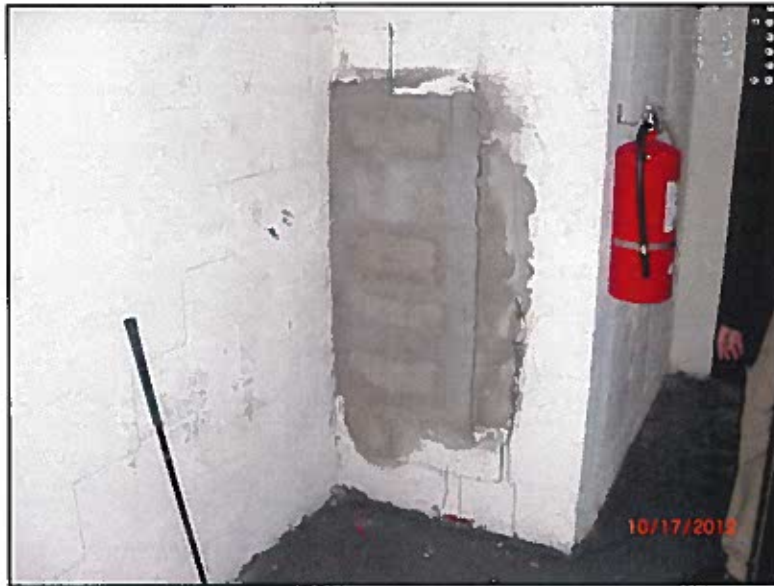
PHOTO # 13: Cracks on block wall at inside of West Elevator Machine Room

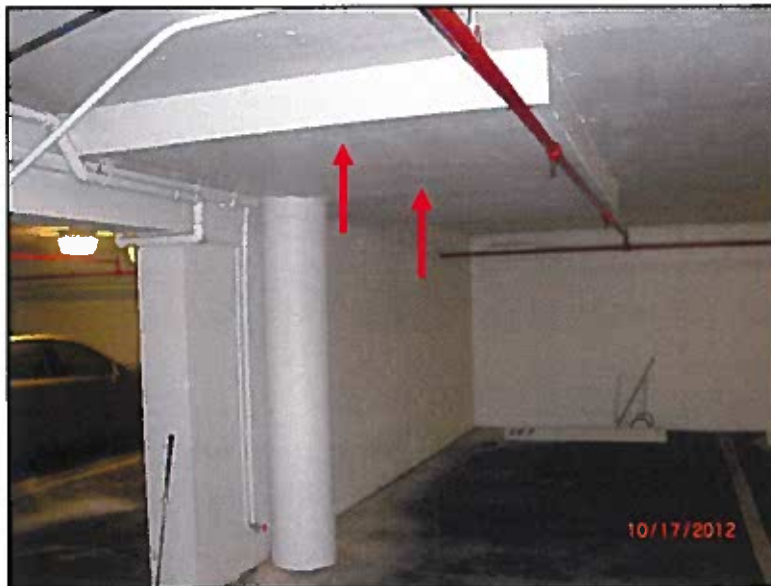
PHOTO # 14: slab cracking at column drop panel next to Parking Space No. 267

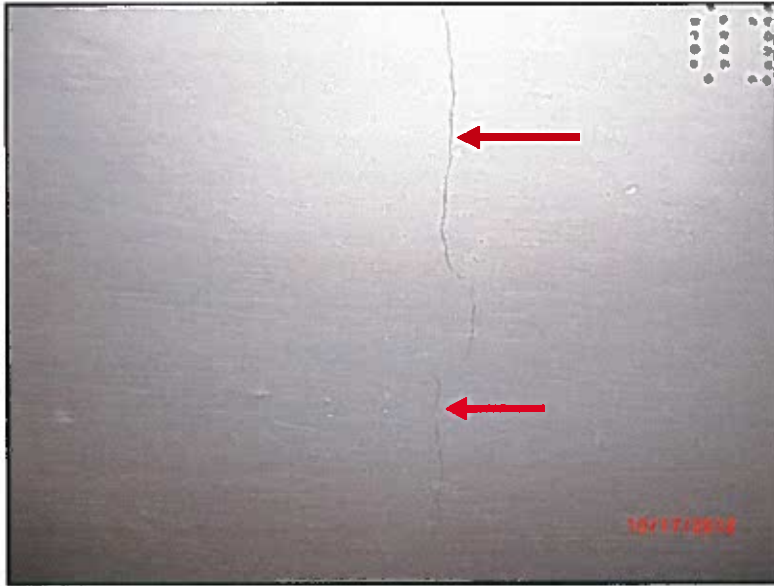
PHOTO # 15: slab cracking at column drop panel next to Parking Space No. 267

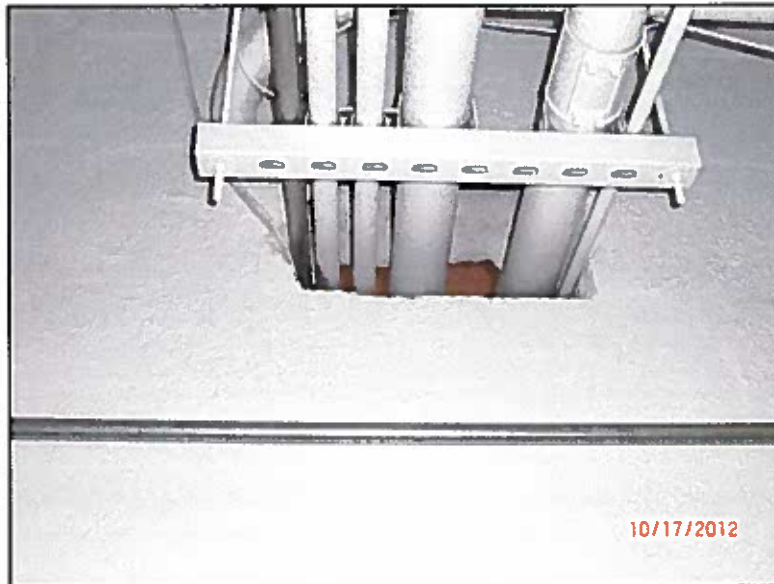
PHOTO # 16: Unsealed wall, pipe penetration at Fire rated assembly (2hr fire rated assembly)
Paint Storage Room

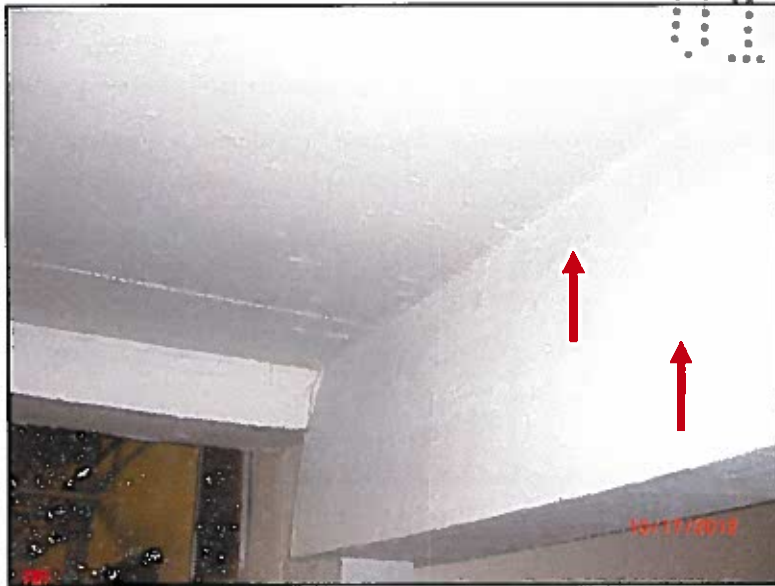
PHOTO # 17: slab cracking and beam cracks next to Parking Space 210

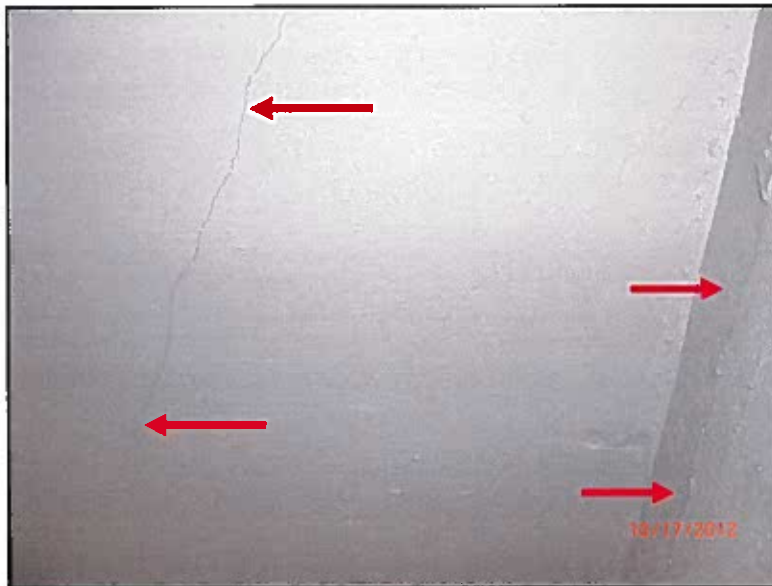
PHOTO # 18: slab cracking at column drop panel next to Parking Space 210

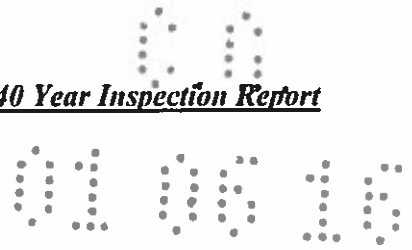
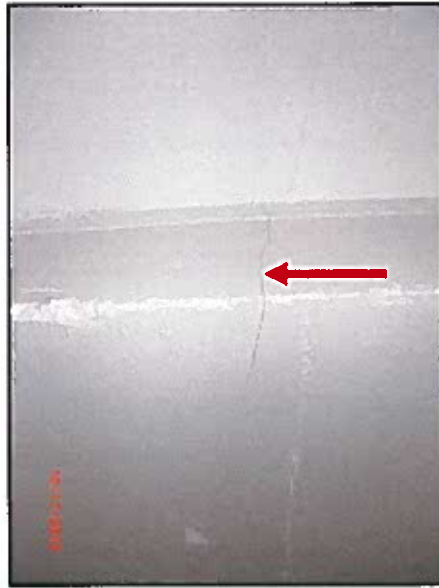
PHOTO # 19: slab cracking at column drop panel between Parking Spaces 248 & 249

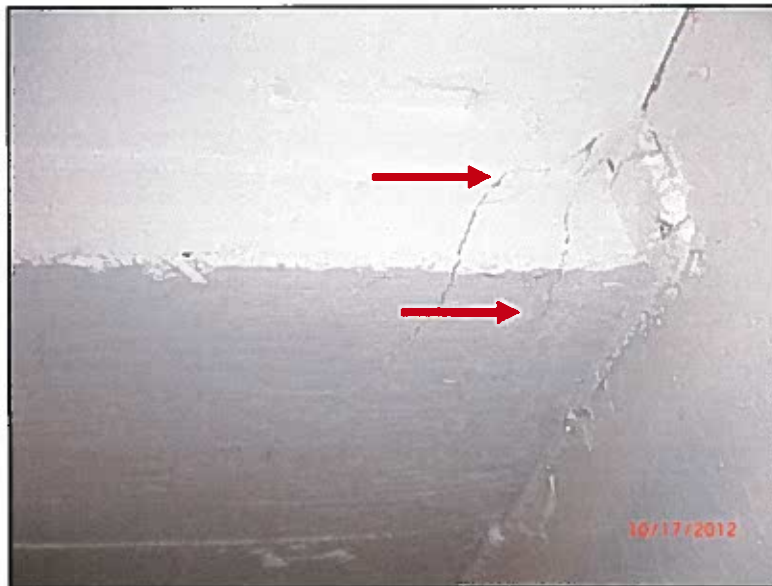
PHOTO # 20: slab cracking at column drop panel between Parking Spaces 245 & 246

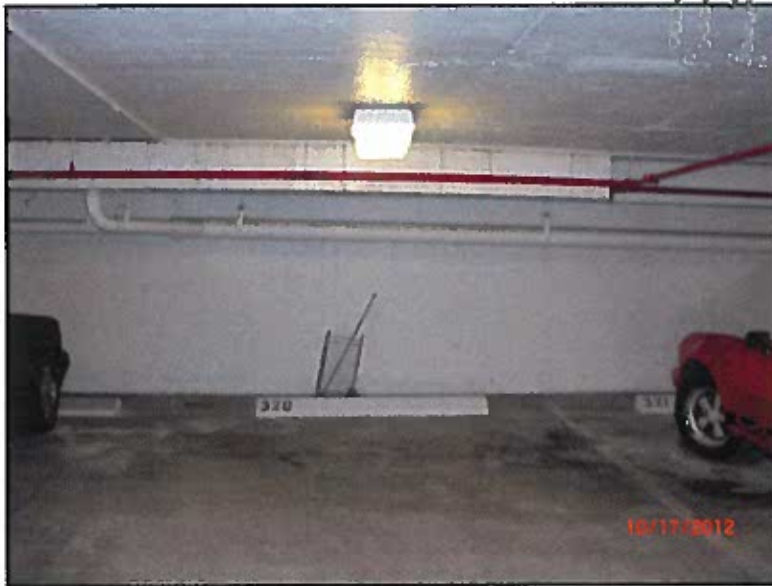
PHOTO # 21: trench drain drop ceiling between Parking Spaces 314 & 327

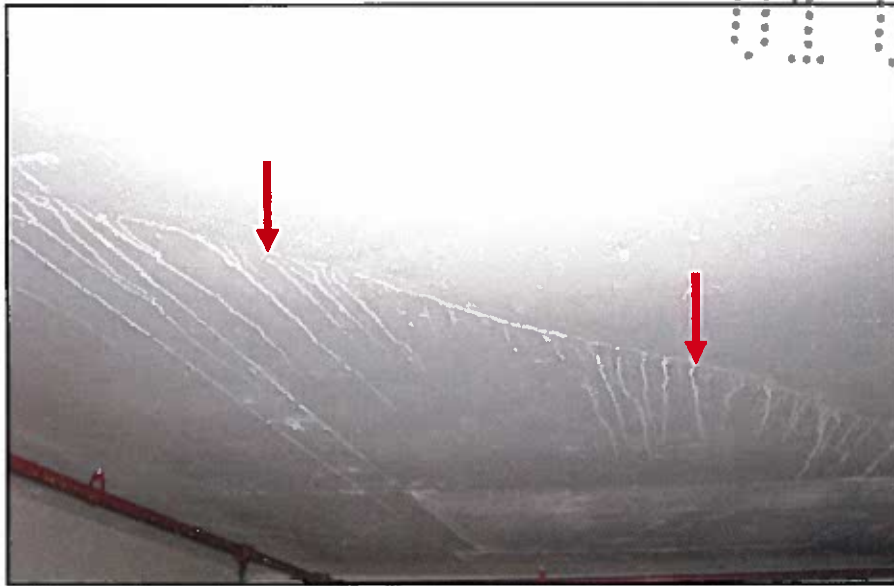
PHOTO # 23: cracking and water intrusion at underside of ramp in front of Parking Space 61

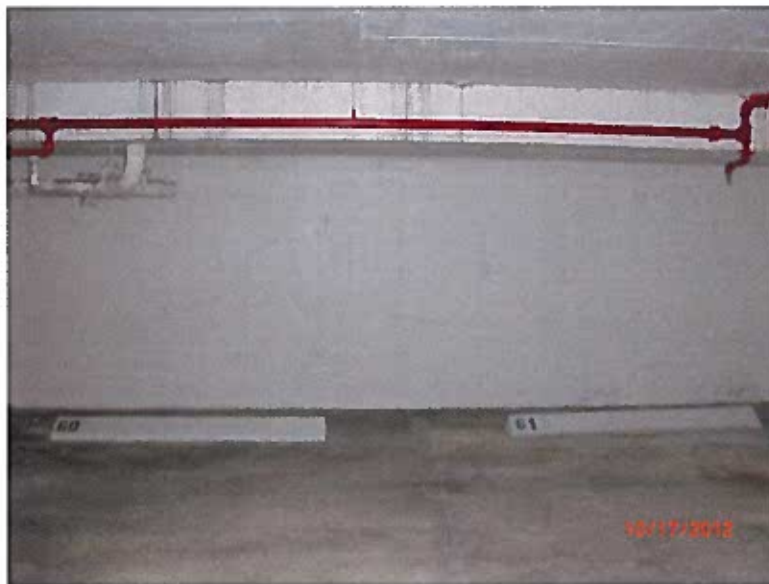
PHOTO # 24: trench drain drop ceiling between Parking Spaces 52 & 61

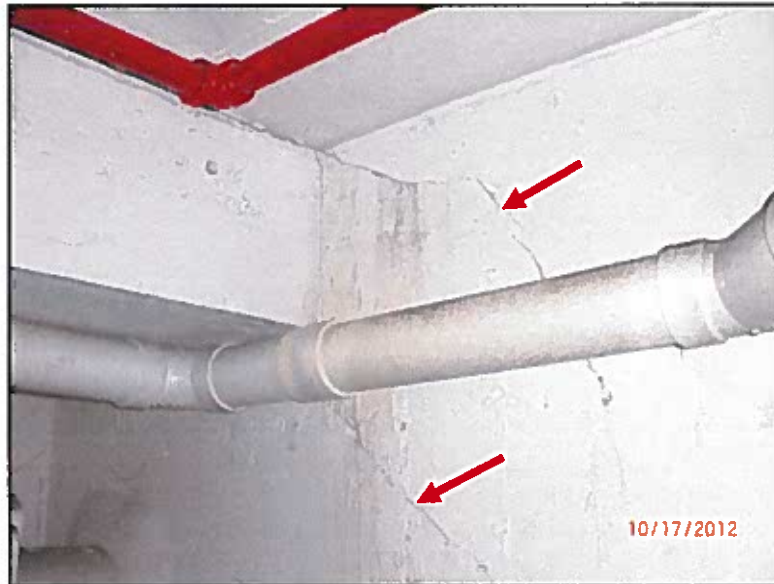
PHOTO # 26: cracking on wall next to Parking Space 51

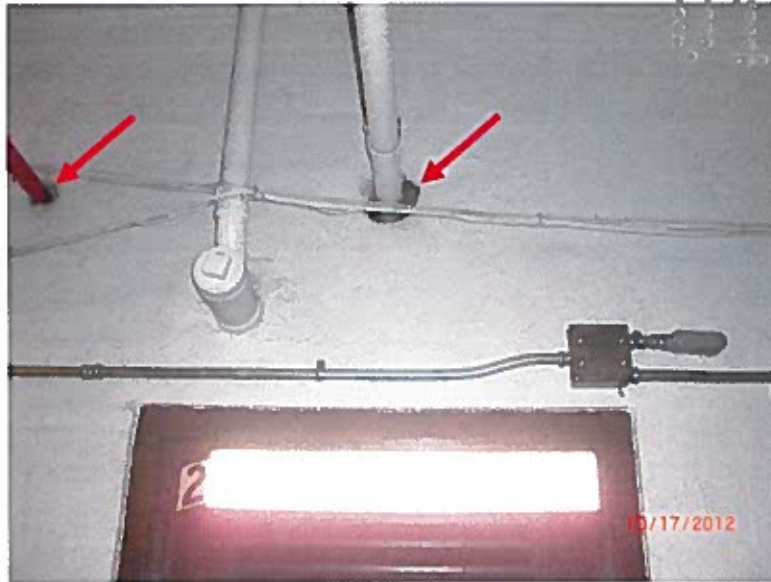
**PHOTO # 27: Unsealed wall, pipe penetration at Fire rated assembly (2hr fire rated assembly)
Paint Storage Room**

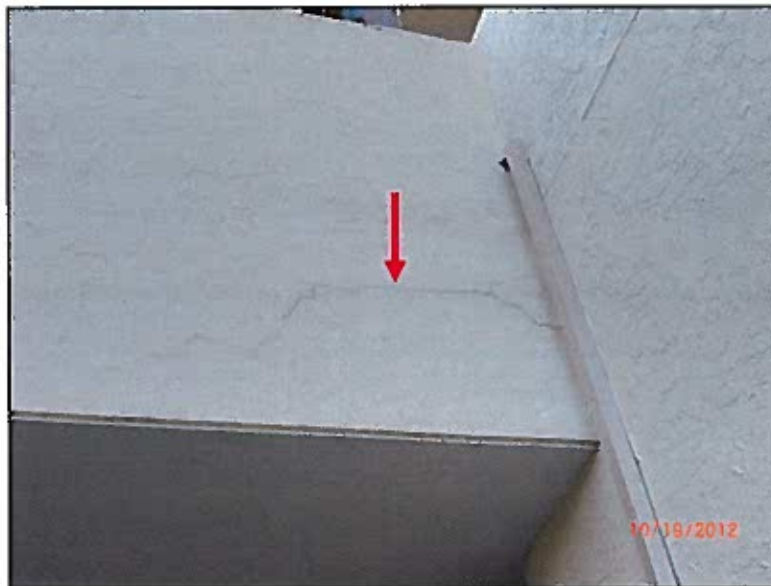
PHOTO # 28: cracking on overhang at West side

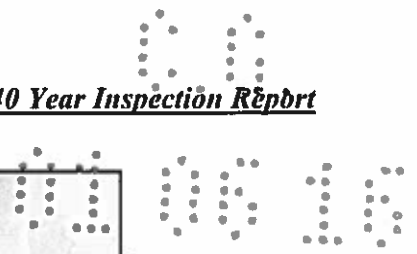
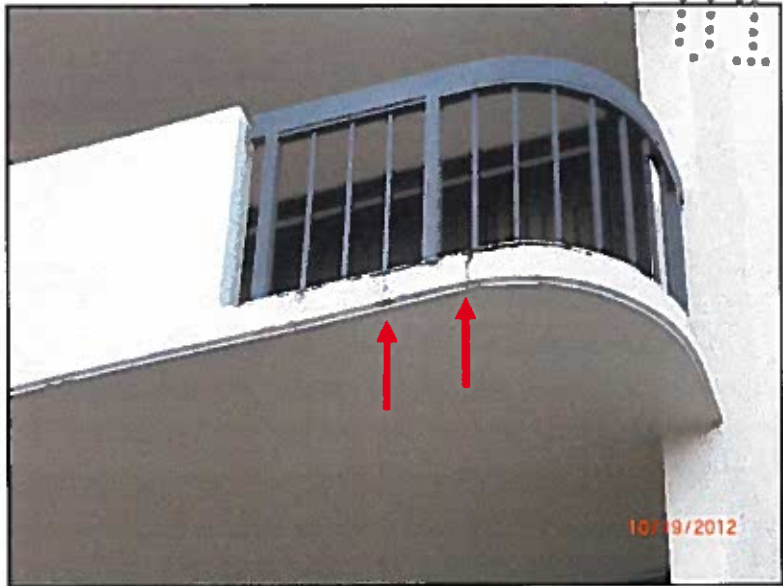
PHOTO # 29: cracking and staining on balcony edge

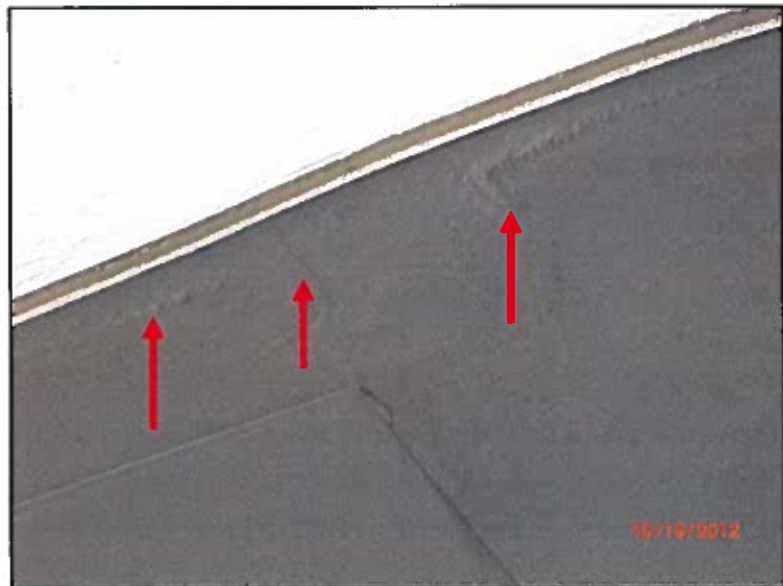
PHOTO # 30: cracking & blistering at underside of overhang edge

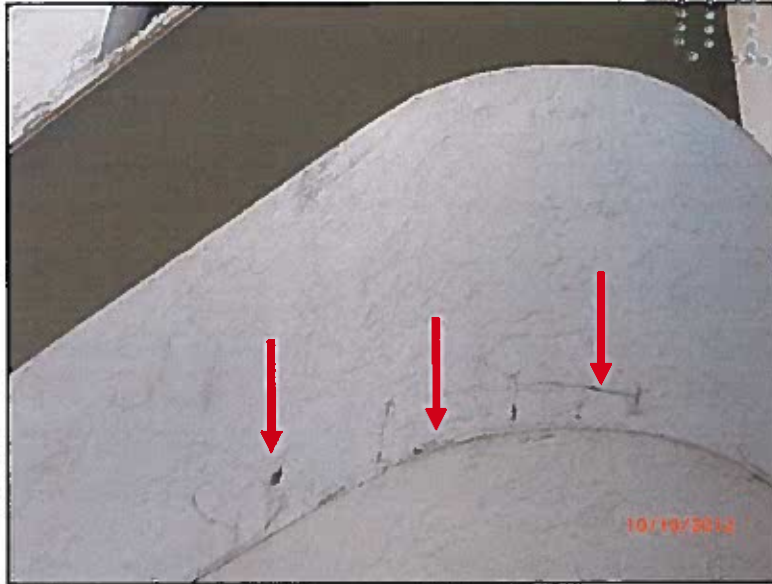
PHOTO # 31: stucco cracking at bottom of third floor balcony wall on East side

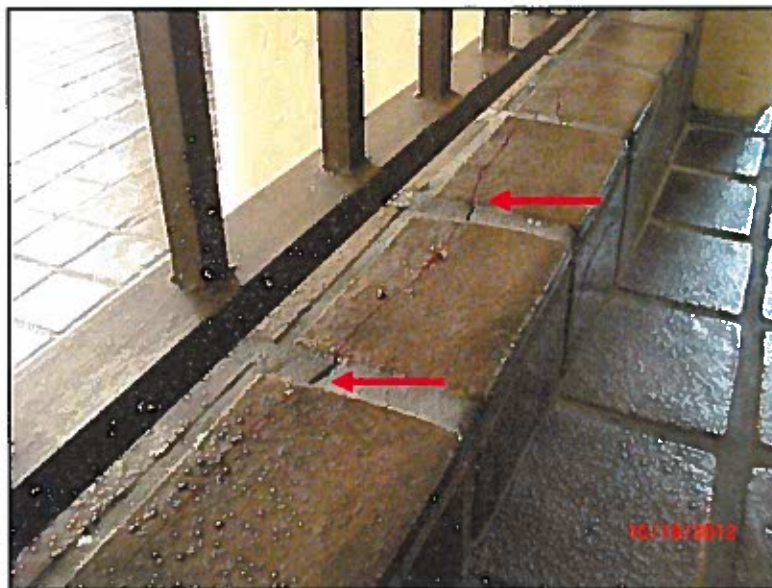
PHOTO # 32: crack along tiled ramp east of main entrance

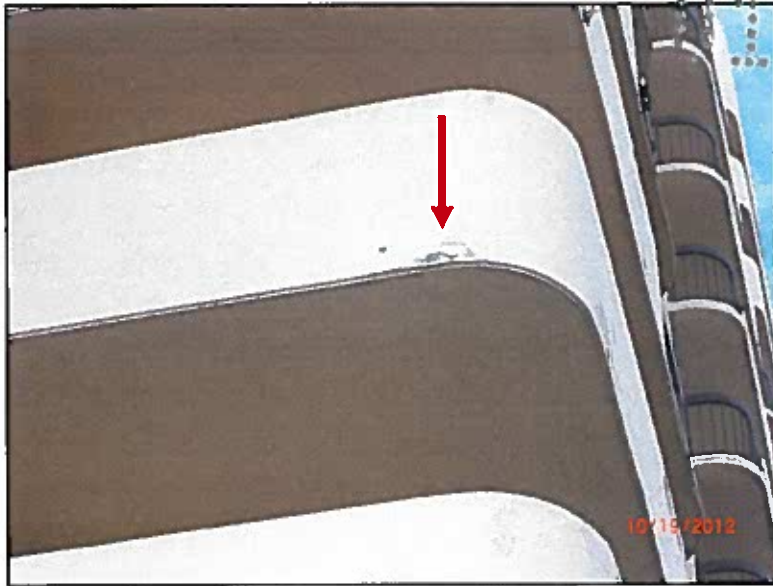
PHOTO # 33: cracking and staining at bottom of fourth floor balcony wall on east

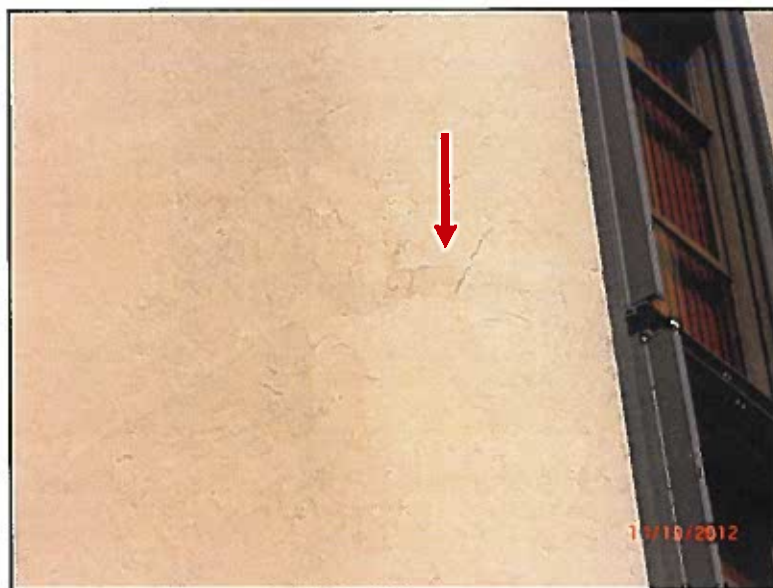
PHOTO # 34: stucco cracking on building wall next to east stairs tower

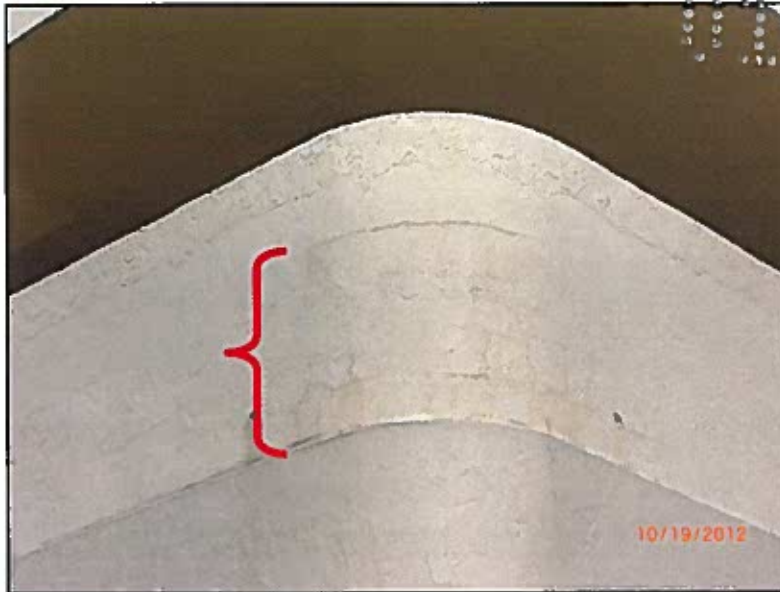
PHOTO # 35: spider web cracking on exterior face at second floor balcony on East side

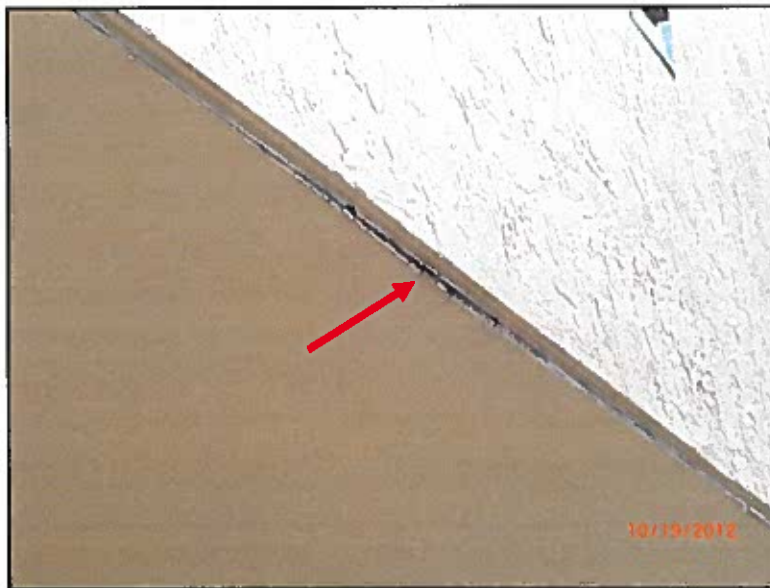
PHOTO # 36: ceiling separation at edge of South overhang

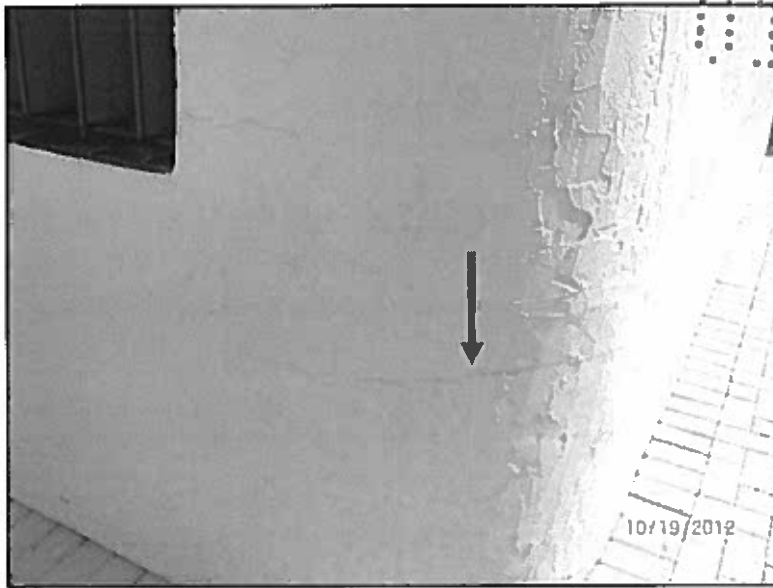
PHOTO # 37: stucco cracking on East side of building corner at pool deck area
